CASTLEMAN BULL HOUSE RESTORATION

201 RED RIVER AUSTIN, TX 78701

ISSUED FOR: HISTORICAL LANDMARK DETERMINATION

HISTORIC LANDMARK DETERMINATION

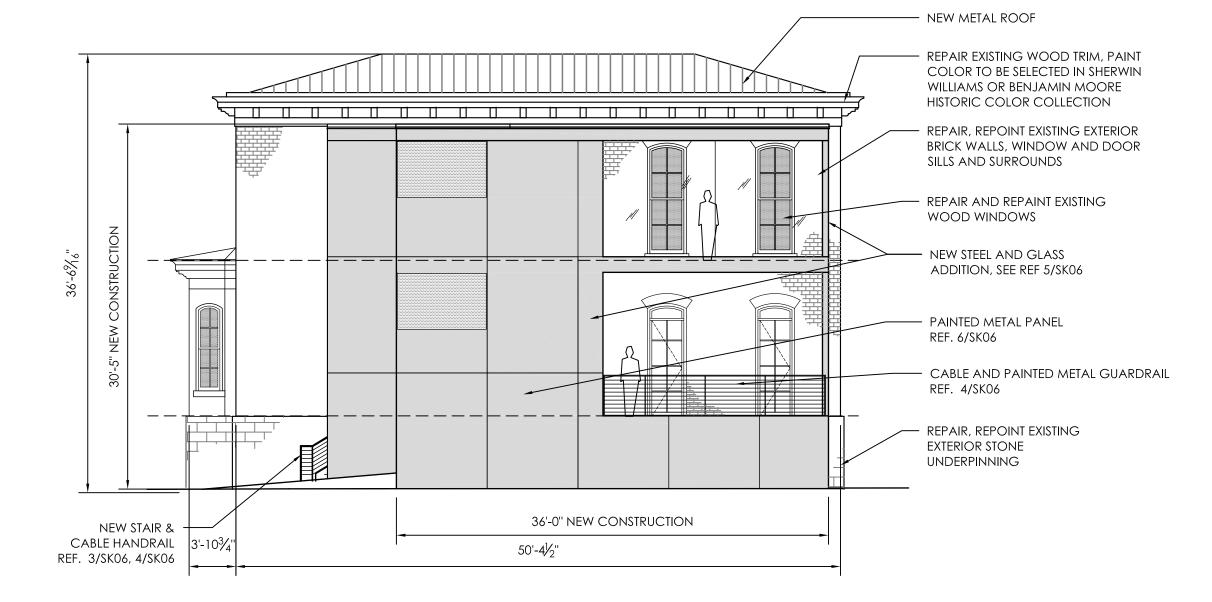
SCALE: 1/8" = 1'-0"

PAINTED METAL AND CABLE HANDRAIL (SEE 4/SK05) WITH ARCHITECTURAL CONCRETE STAIRS

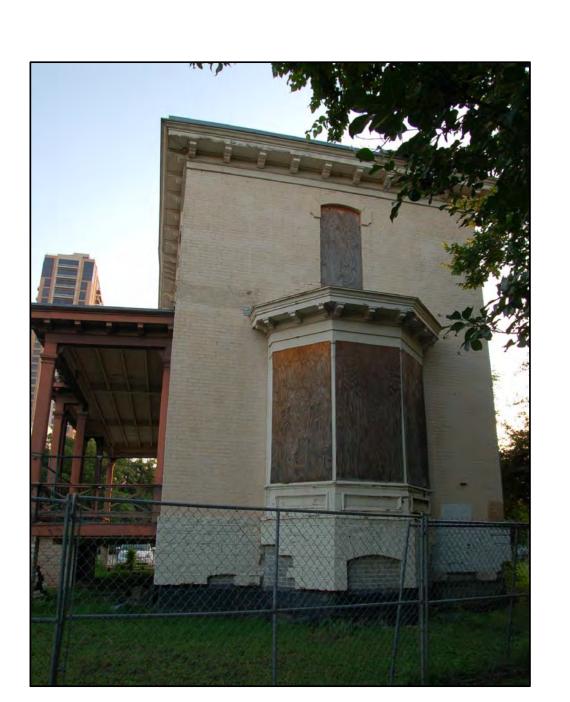
PAINTED METAL PANELING

NEW STEEL AND GLASS

WOOD WINDOWS

NEW TPO FLAT ROOF —

ADDITION, SEE REF 5/SK07

REF. 6/SK07

- REPAIR AND REPAINT EXISTING

22'-0" NEW CONSTRUCTION

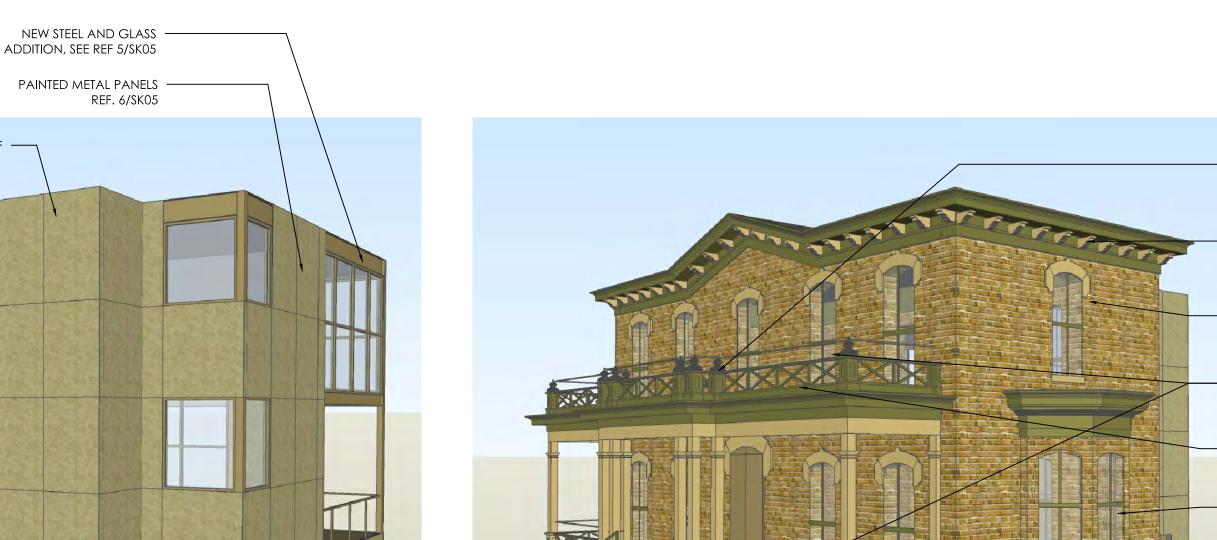
5 VIEW FROM SOUTH EAST SCALE: NTS

RECONSTRUCT ORIGINAL GUARDRAIL AT 2ND FLOOR BALCONY TO HISTORICALLY ACCURATE DEPICTION REPAIR EXISTING WOOD TRIM, PAINT COLOR TO BE SELECTED IN SHERWIN WILLIAMS OR BENJAMIN MOORE HISTORIC COLOR COLLECTION REPAIR, REPOINT EXISTING EXTERIOR BRICK WALLS, WINDOW AND DOOR SILLS AND SURROUNDS NEW PAINTED METAL AND CABLE GUARDRAILS IBC 1013.2, REF. 4/SK04 REPAIR AND REPAINT EXISTING WOOD COLUMNS AND GUARDRAILS REPAIR AND REPAINT EXISTING WOOD WINDOWS REPAIR, REPOINT EXISTING EXTERIOR STONE UNDERPINNING

NEW TPO FLAT ROOF -
