HISTORIC LANDMARK COMMISSION
APRIL 22, 2013
APPLICATION FOR A CERTIFICATE OF APPROPRIATENESS
C14H-1990-0006
Mount Bonnell
3800 Mount Bonnell Road

Repair the original, historic limestone monument on Mount Bonnell, or install a new granite monument.

Updated Assessment of Mt. Bonnell Monument Restoration/Rehabilitation from Catherine Williams:

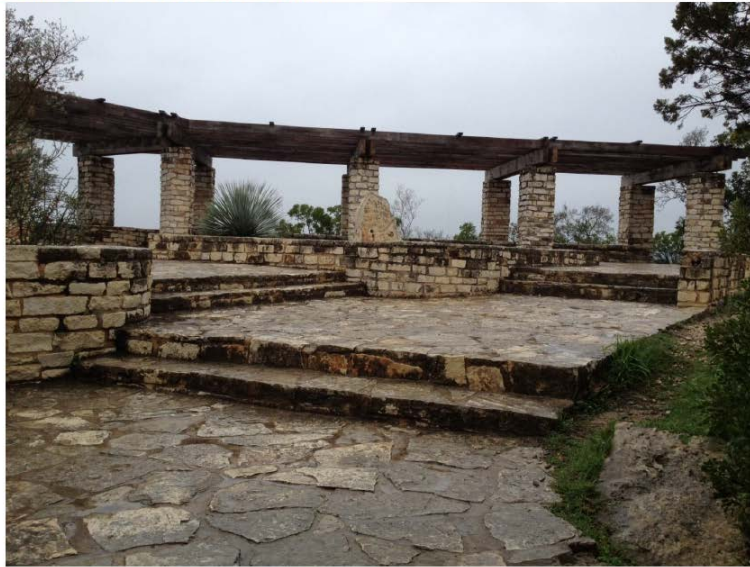
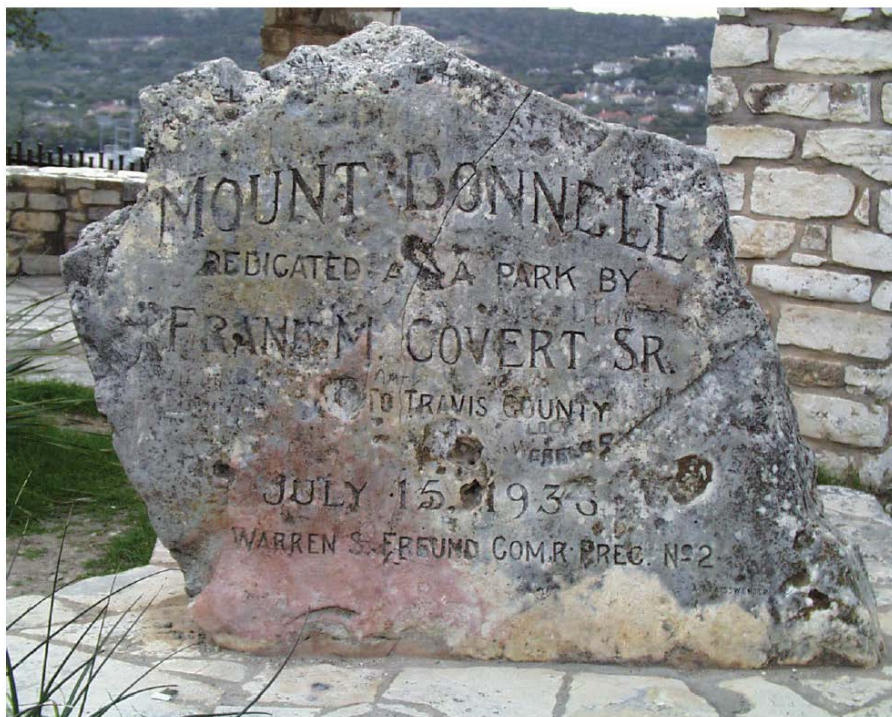
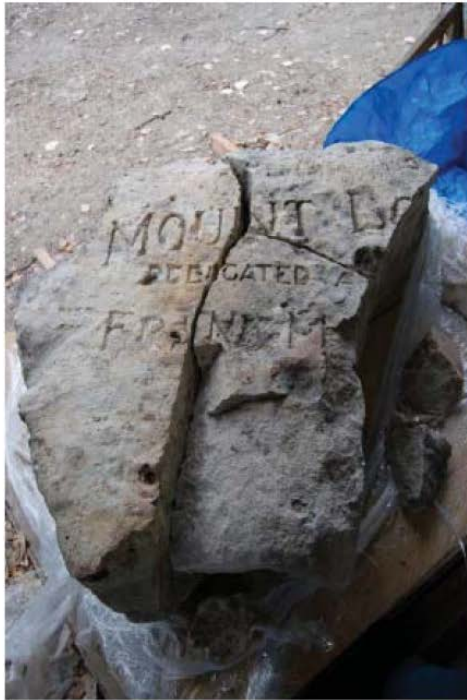
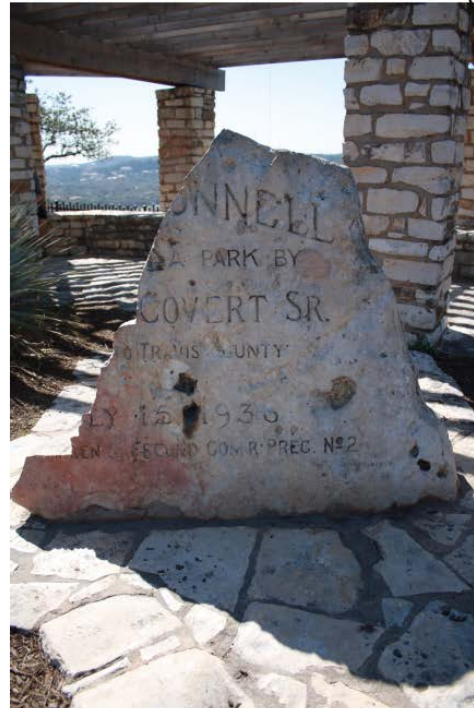
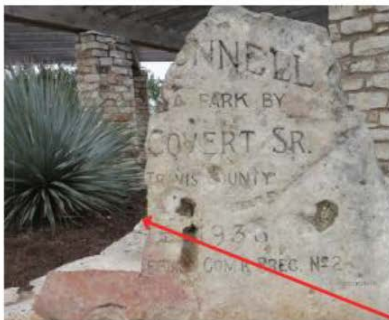
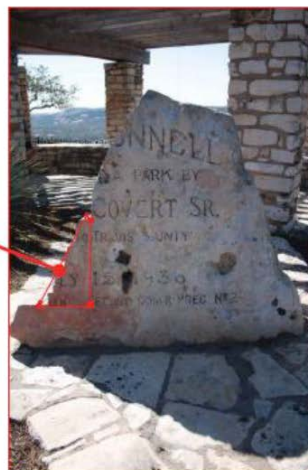
Current Conditions

The large losses on the south side of the stone marker are the most noticeable problem. During my brief inspection, I noticed several other conditions, including surface erosion, small cracks and old repair work. In addition to general soiling, staining includes reddish discoloration, dark streaking and graffiti. Also, I understand that there is some concern that the marker is no longer in a vertical position. Fortunately, it looks as though the stone "buttress" on the west side of the marker has resolved this issue.

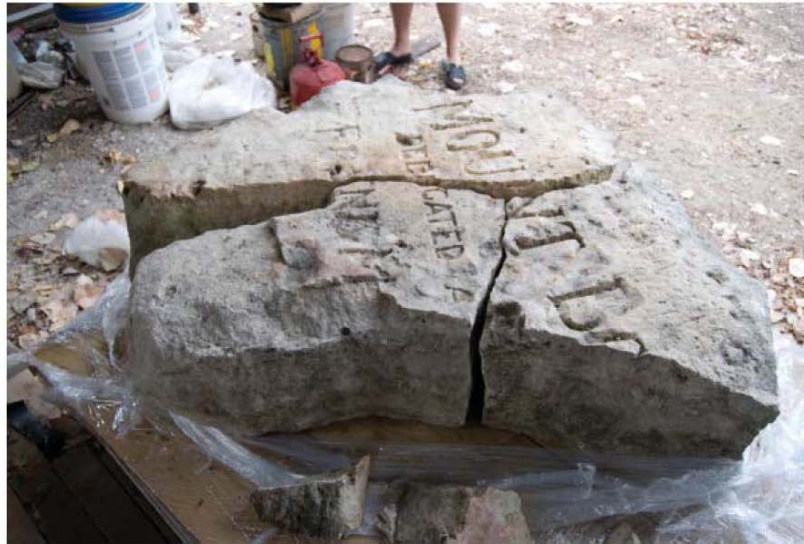
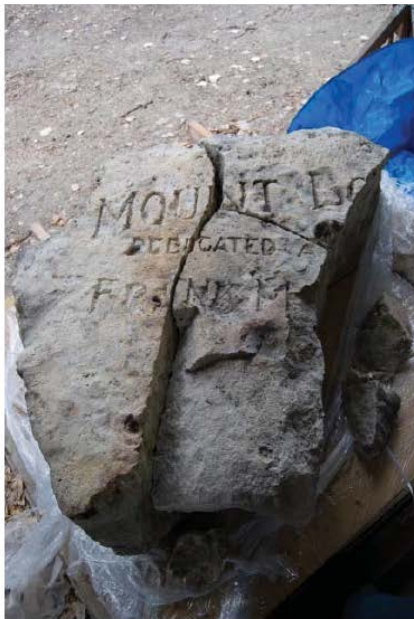
Additional deterioration
of monument

The photo on the left shows the fragments that are in storage. The photo to the right shows the monument prior to 2013. Since this photo was taken, a small triangular piece of the monument has become dislodged and is no longer in storage. The photo above shows the monument today with the triangular piece missing. The photo on the following page shows the monument prior to damage.
