ITEM FOR ENVIRONMENTAL BOARD AGENDA

NAME & NUMBER
OF PROJECT: OVERLOOK AT DAVENPORT
SPC-2012-0425C

REQUEST: Variance request is as follows:
1. To allow fill greater than 4 feet not to exceed 9.2 feet
Lake Austin Watershed Ordinance Section 9-10-409(a)

SUBJECT: Overlook at Davenport – SPC-2012-0425C

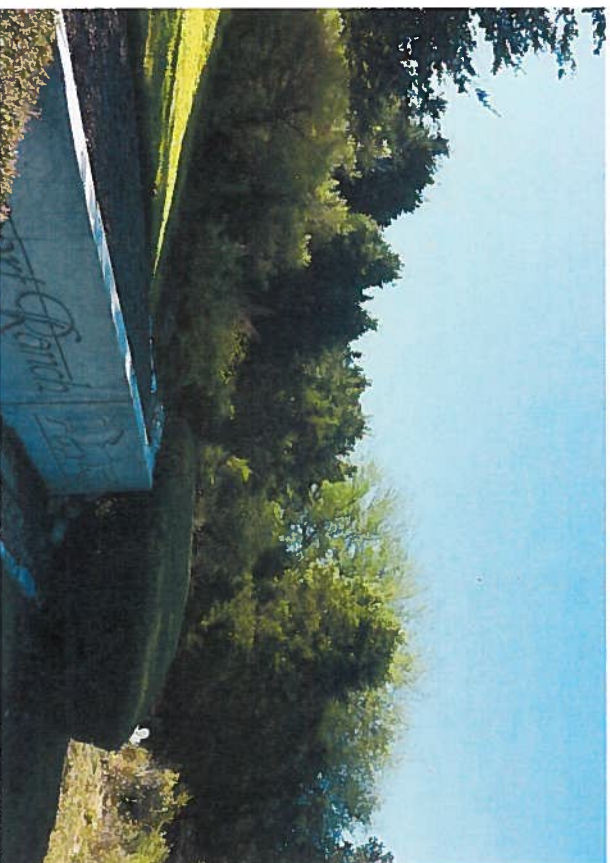
Loop 360 ordinance buffer area 50 feet looking west

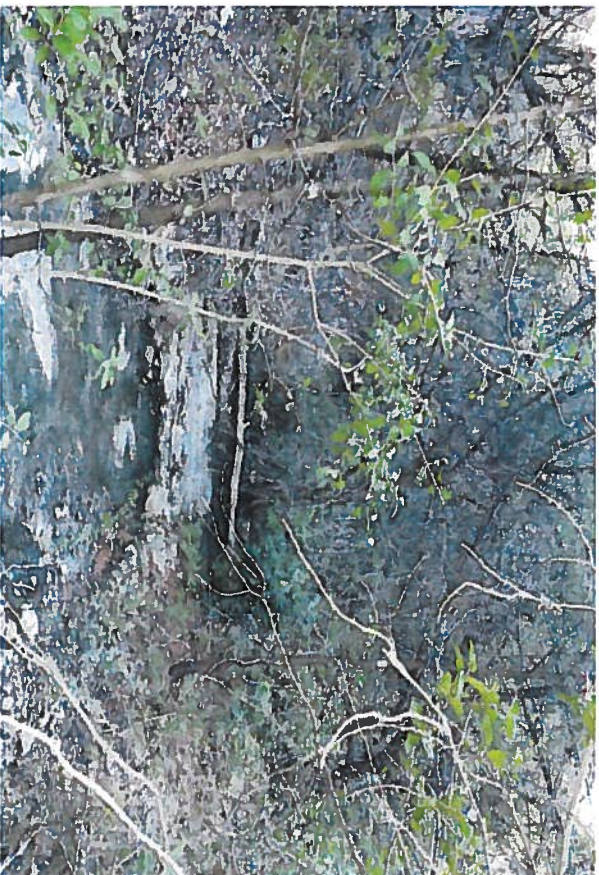
Seep/Spring CEF centrally located along the southern property line

There is one CEF on-site. It is a seep/spring and is centrally located near the southern property line. The required 150' setback has been placed around this feature to prevent impacts by the proposed development.

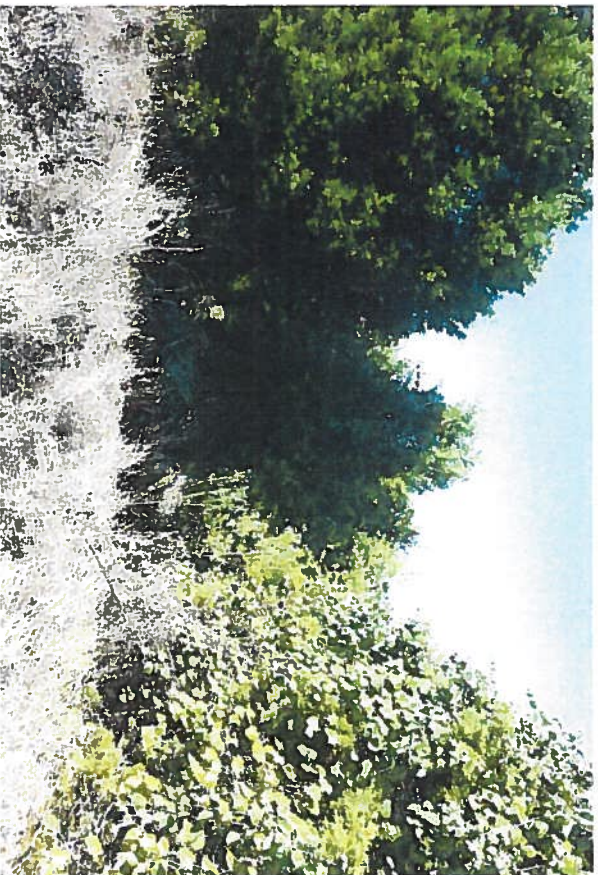
Area of proposed fill greater than 4' not to exceed 9.2 feet
at entrance off Bold Ruler Way and into proposed parking area looking west

Extent of Fill. The area affected by this variance is primarily within the drive and loading area of the surface parking lot. A structural wall is proposed along the west side of the parking area, ranging in height from five to twelve feet. In addition, portions of pond walls exceed four feet as shown in the exhibit accompanying this request.

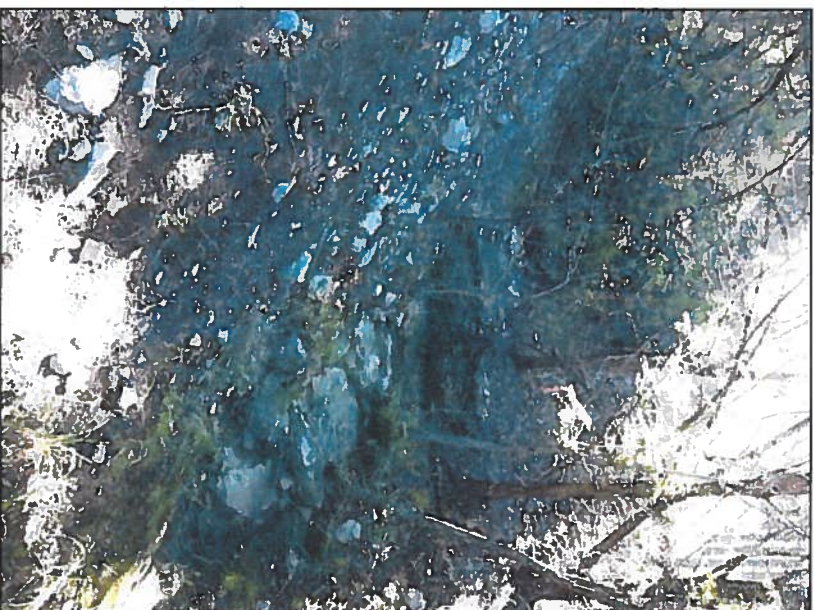
A dry, ephemeral tributary along the southern boundary of the subject area. No springs or wetland plant species were observed during field investigations.
