SITE VISIT

Benito Huerta, *Snake Path* (2007, MACC)

2/28/2014

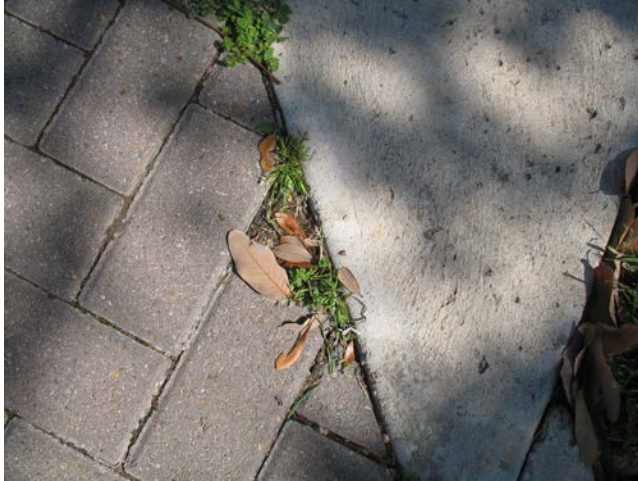
Corner brick missing (on path near snake's head)

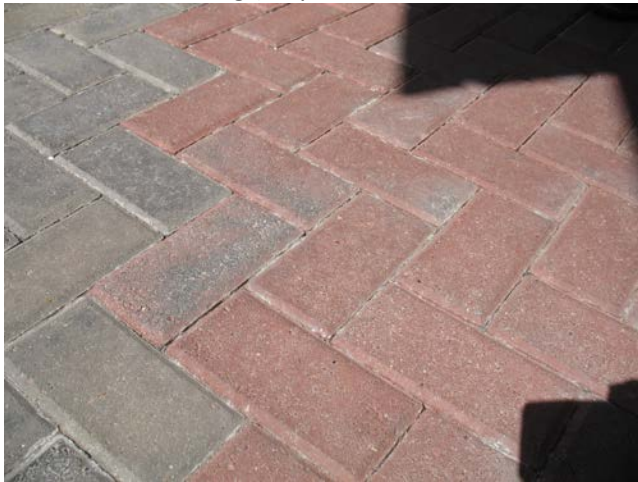
Some of the stains are dark (could be either dirt, mold, or moisture held in the bricks); some of the stains are whitish (possibly calcium deposits from the water used to power wash the bricks).

Red bricks look dirty (just near shady area)

Chris noted that they regularly power wash the sidewalk, but without soap. Chris thought perhaps he would try to wash with soap in the dirtier areas. Laura thought perhaps a product that removed calcium deposits would help.

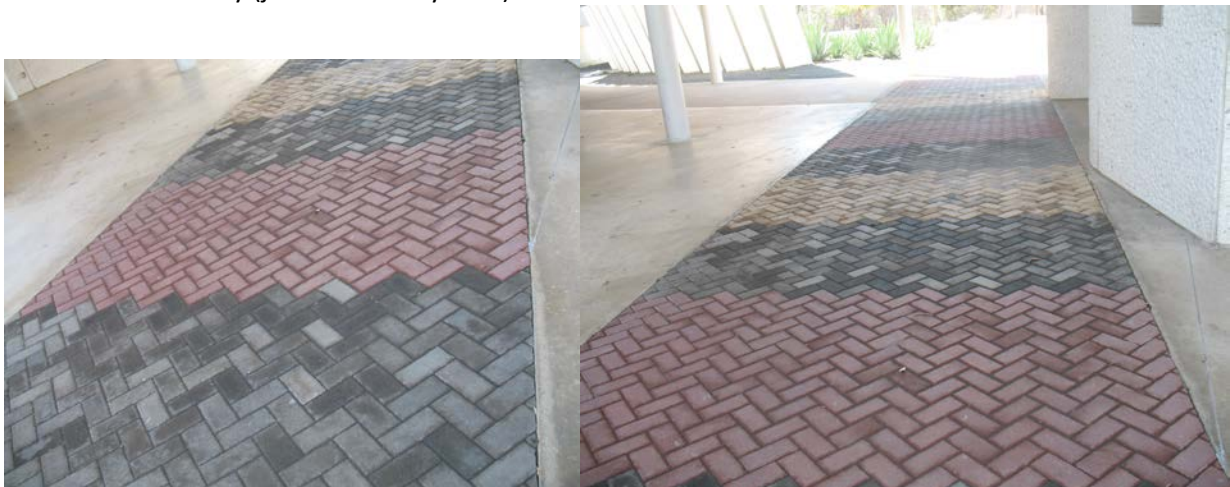
The issue we noted today was that the bricks under the building's overhang were moist and/or stained, most probably from water drainage issues. This part of the sidewalk doesn't get much sun, and it's quite likely that the sand underneath the bricks does not drain well. (NOTE: though today is sunny, we have had rain the last few days—quite possibly takes a few days to dry out.)

Under the overhang the bricks are different colors, likely due to moisture under the bricks and/or mold

Repair options: Possibly one way to tackle the problem would be to remove the bricks and improve drainage underneath, if the issue is caused by drainage problems. Easier methods would be applying products to the bricks to remove stains. If moisture is the issue, it will not be eliminated by adding new coat of sealer or other products. Question would be whether the artwork itself is damaged and needs repair (AIPP issue) or whether it is a building/grounds issue that needs to be addressed by public works. If it is determined that AIPP should repair the work, we would consider this repair in the context of other AIPP repairs on our list and prioritize according to budget, etc.
