VARIANCE REQUEST DOCUMENT

HOMESTEAD OAKS
3226 WEST SLAUGHTER LANE
AUSTIN, TEXAS 78748

Re: City File No: SP-2013-0435C.SH
Homestead Oaks
Construction In WQTZ Variance

25-8-482 Water Quality Transition Zone Development

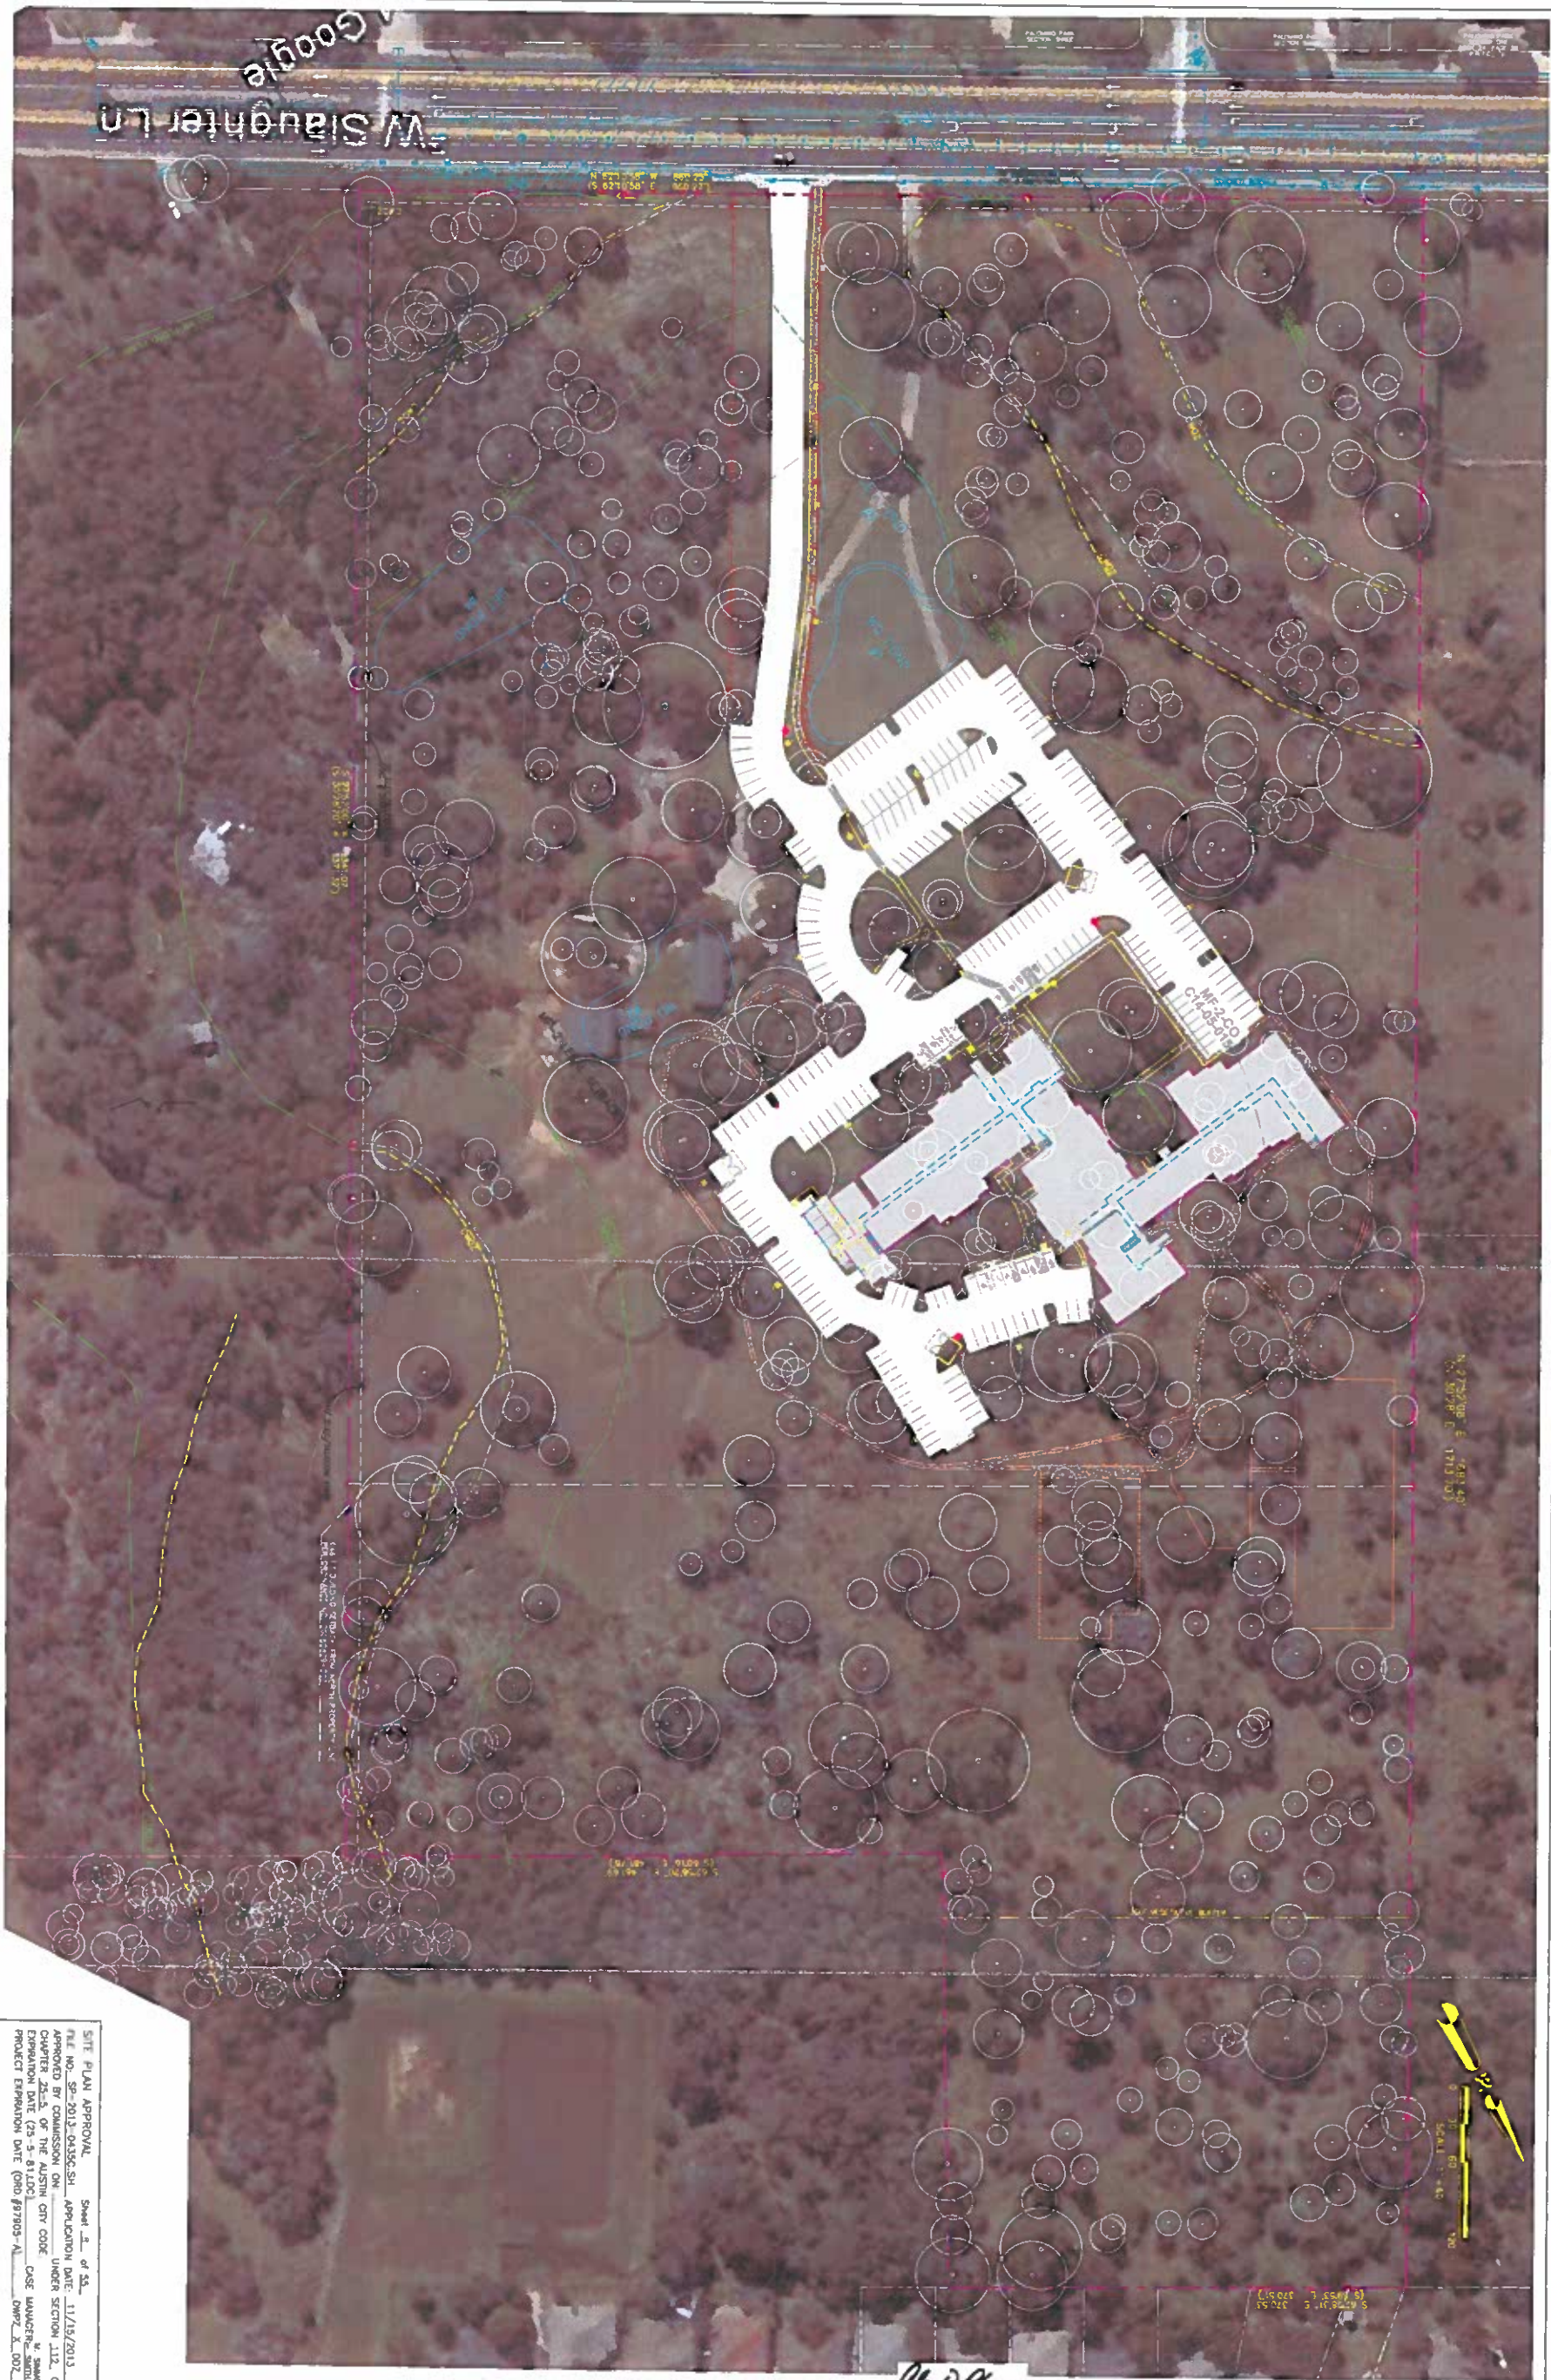
AERIAL PHOTO WITH DEVELOPMENT OVERLAY

HOMESTEAD OAKS
3226 WEST SLAUGHTER LANE
Austin, Texas 78748
AERIAL OVERLAY OF SITE

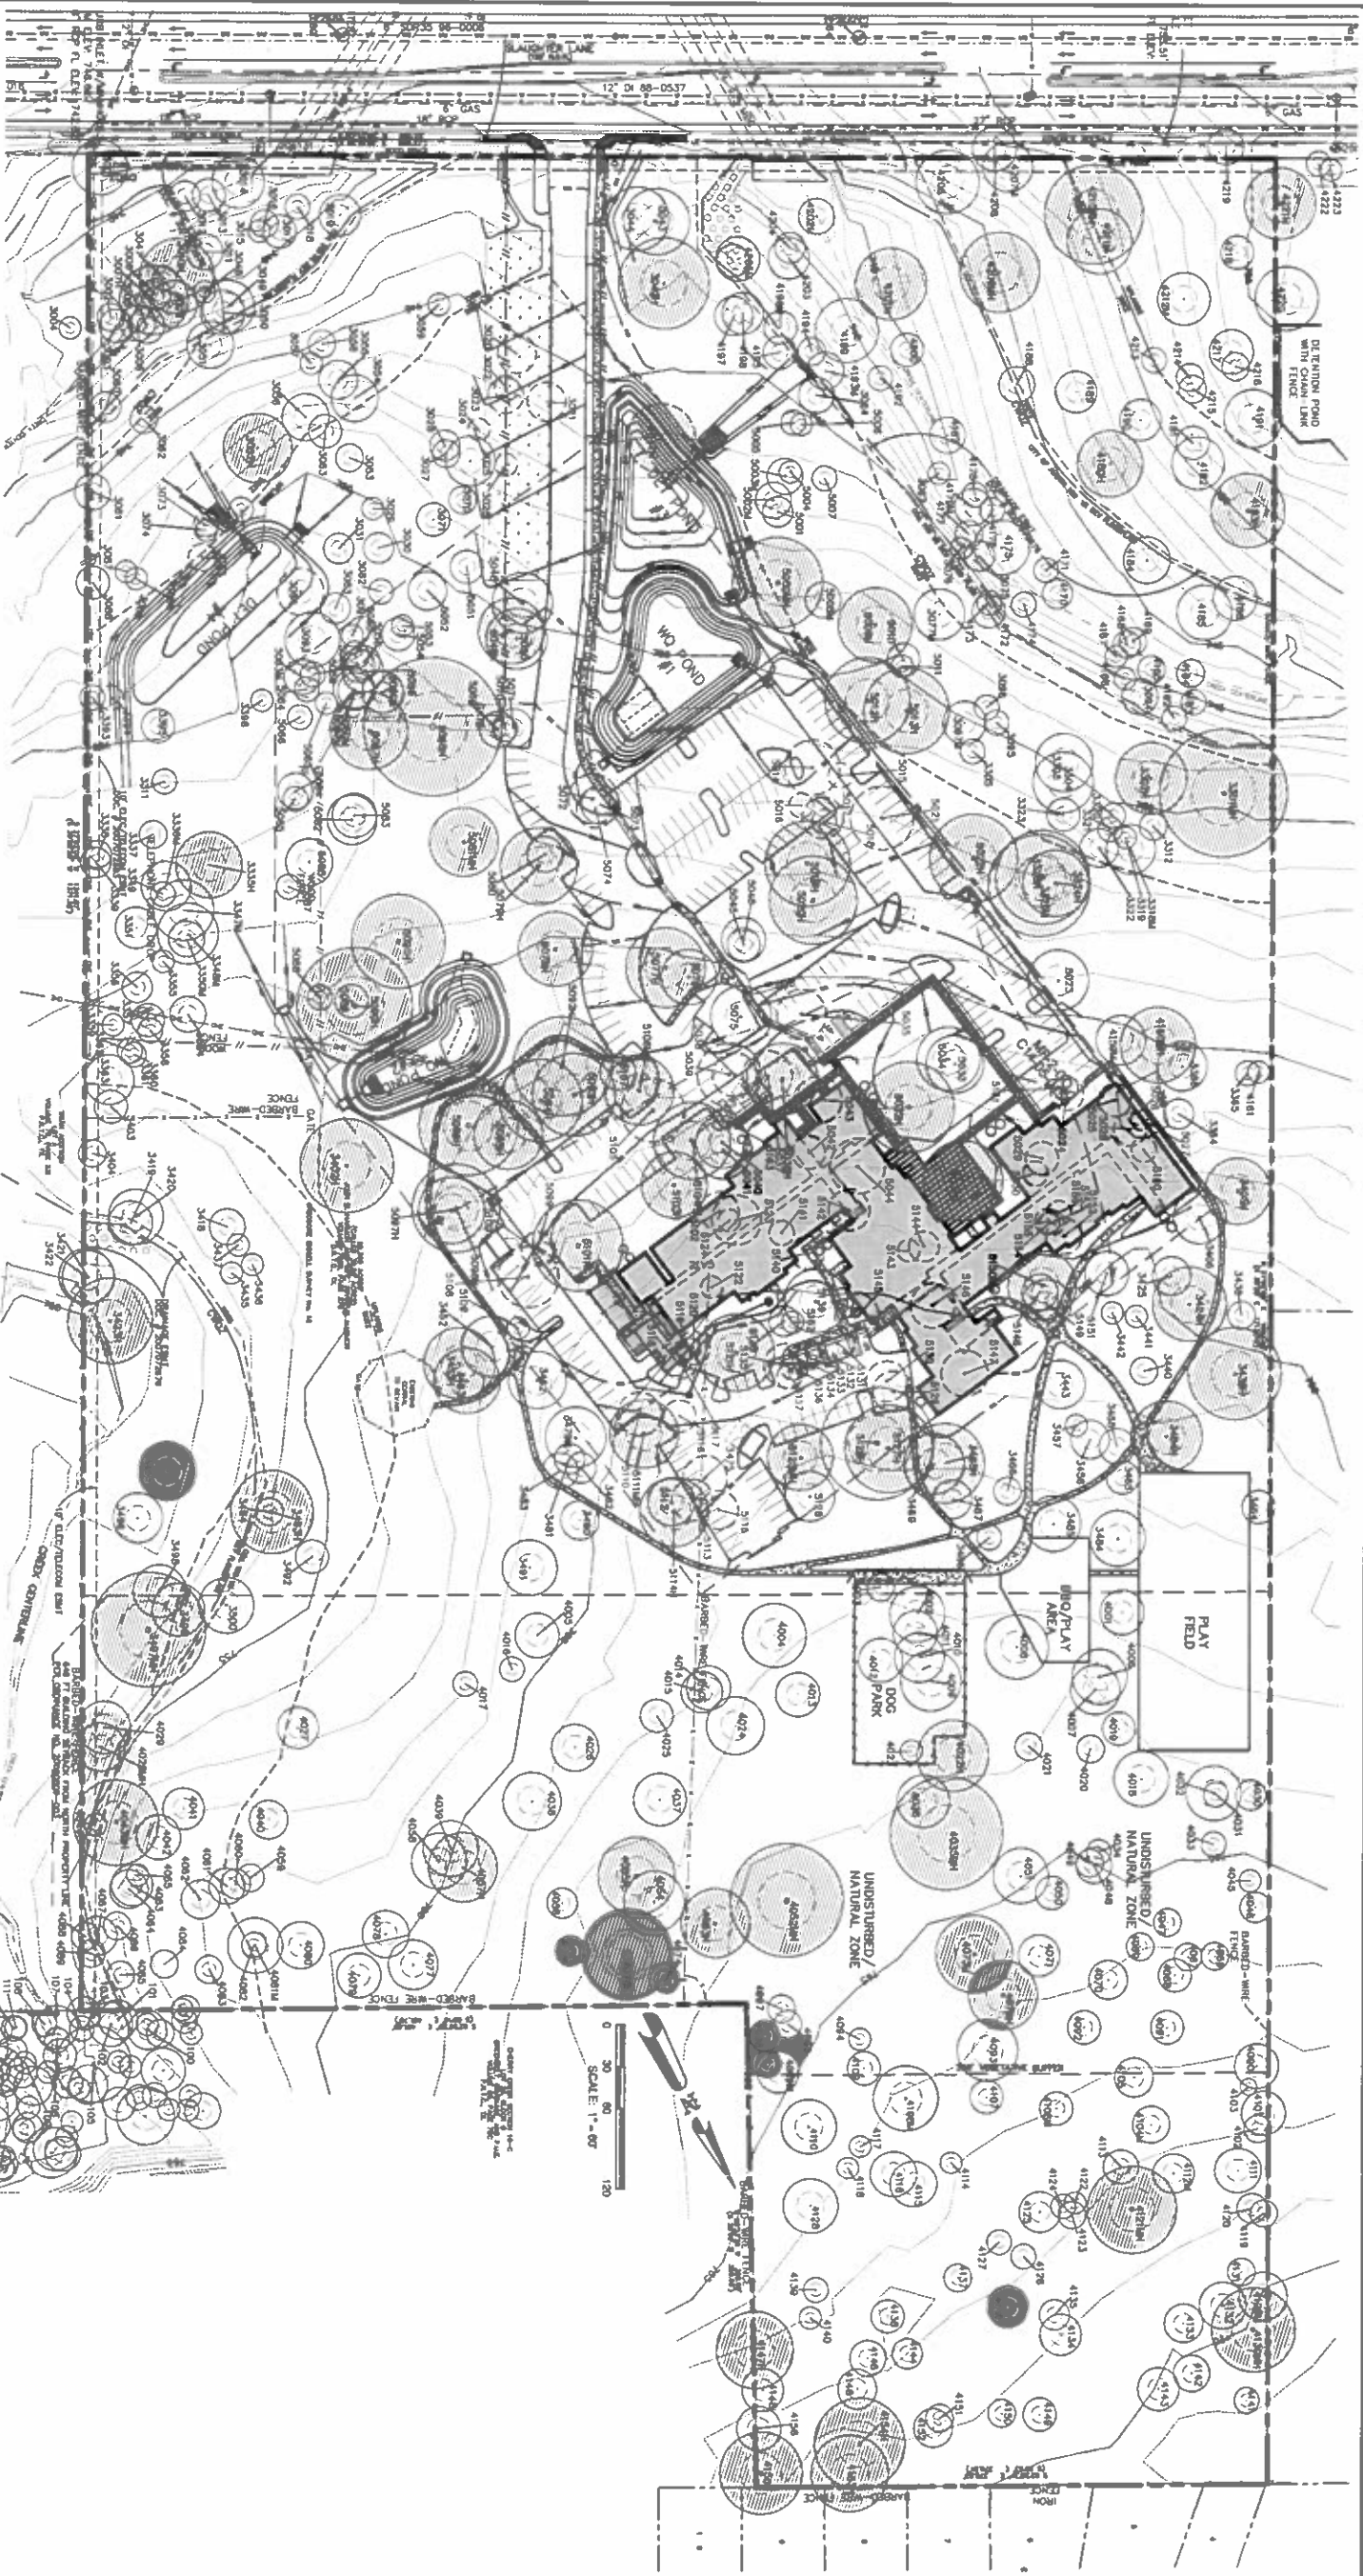
NOTE: NO CRITICAL ENVIRONMENTAL FEATURES WERE IDENTIFIED ON THE SITE.
NOTE: THE ENTIRE SITE OVERLIES THE EDWARDS AQUIFER RECHARGE ZONE.

HOMESTEAD OAKS
3226 WEST SLAUGHTER LANE
Austin, Texas 78748
ENVIRONMENTAL MAP

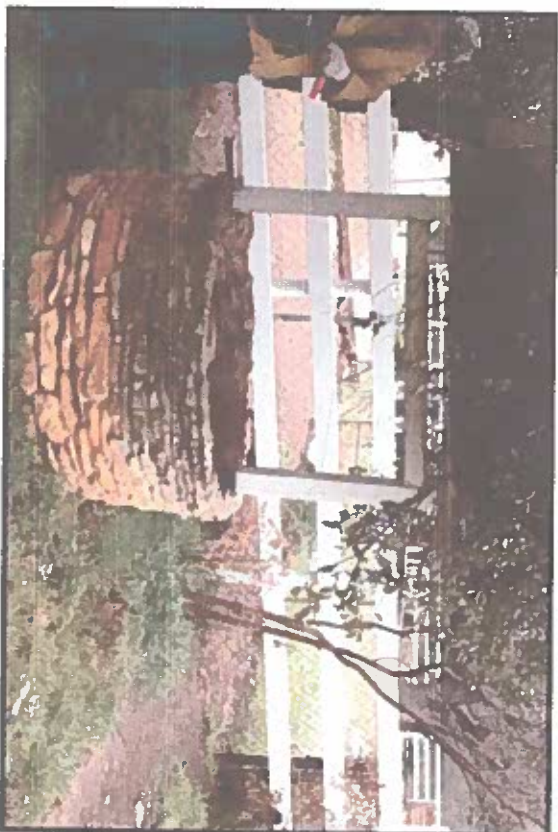
PHOTO 6
View of on-site water well

A review of the records of the Texas Water Development Board (TWDB) revealed no documented water wells on or within 150 feet from the subject site (TWDB, 2013). One water well was observed on the subject site near the SFR during Horizon's site reconnaissance.
