Concordia  
SP-2013-0476C  
Site Photos

**Re: Variance Request Letter – Cut and Fill  
Concordia University Texas - Site Plan Application SP-2013-0476C  
11400 Concordia University Drive  
Austin, Texas 78726**

Please accept this letter as a request for a variance to the Lake Austin Ordinance #840301-F, Sections 9-10-409(A) and 9-10-409(B) for a max cut of +/- 9.25 ft and a max fill of +/- 14.85' for the above referenced project.

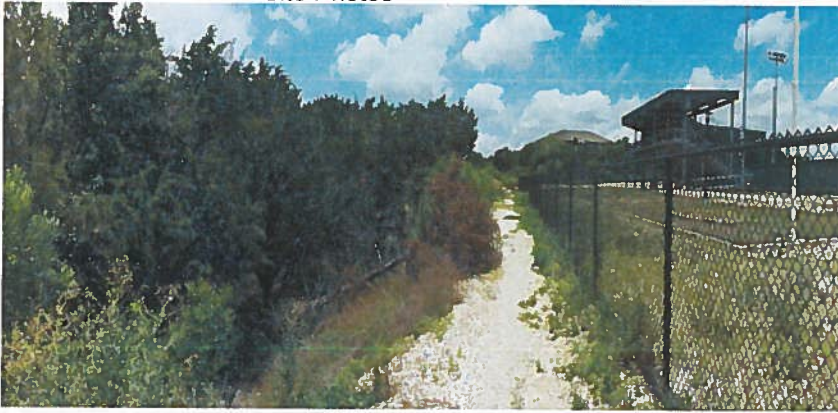
Area of fill between new softball field and existing baseball field to match fill left from that construction looking west

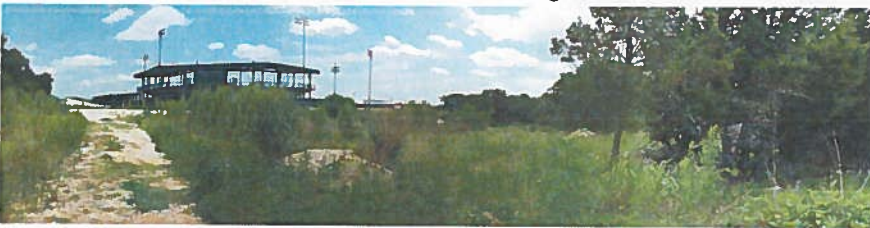
Area of proposed cut for new softball field looking north

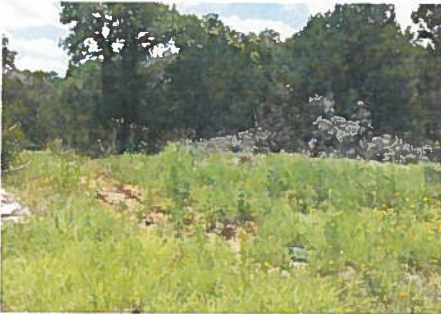
Area of proposed cut and fill within southern detention/water quality pond looking east

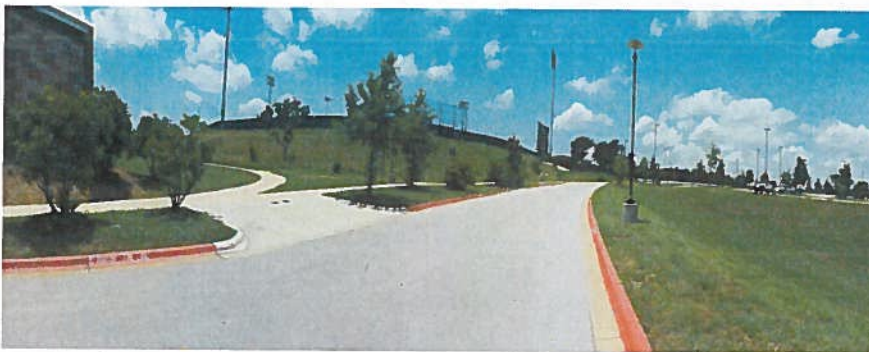
Example of fill approved with the previous variance granted for the baseball field

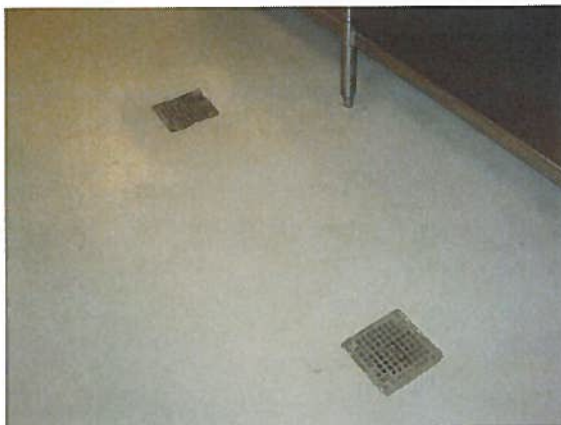
Interior floor drains were observed throughout the site at the time of the site reconnaissance. No spills or releases were observed in the vicinity of the observed floor drains. According to Mr. Cherry, the floor drains located in the office buildings and cafeteria discharge into the sanitary sewer and the floor drains located in the restroom facilities near the recreation area discharge into a septic system. Please see below for further discussion of the septic system. Based on this information, the floor drains do not appear to constitute RECs in connection to the site.

**Photo 5** Typical view of interior floor drains.

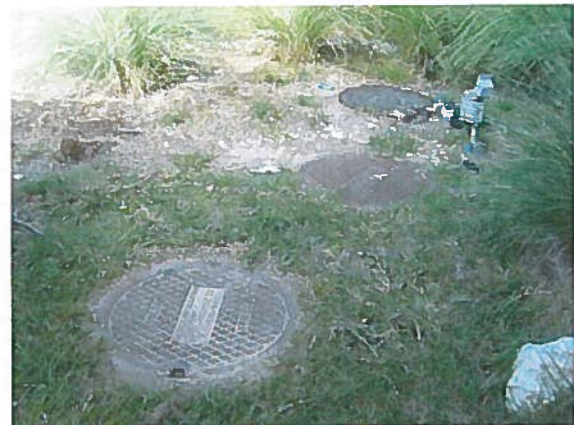
A subgrade cooking grease trap system (unknown capacity) is located outside and southwest of Building E. According to Mr. Cherry, the grease trap system was cleaned out in January 2006 and he is not aware of any problems. No evidence of releases was observed in the vicinity of the grease trap system at the time of the site reconnaissance. Based on site observations and this information, the cooking grease trap system does not appear to constitute a REC in connection to the site at this time.

**Photo 6** View of the grease trap located next to Building E, cafeteria.

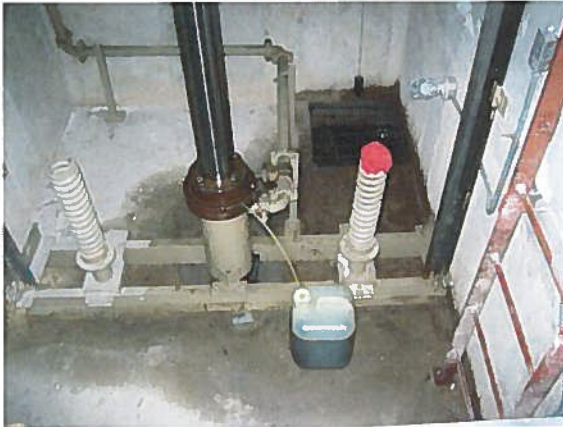
- At the time of the site reconnaissance, three hydraulic elevators and one freight elevator were observed during the site reconnaissance. According to Mr. David Cherry, property manager, the elevators are maintained by Thyssen-Krupp Elevators, and were inspected in December 2005; no major problems or concerns were reported. Minor concrete

staining was observed within the three hydraulic elevator pits. Based on the minimal nature of the releases and the relatively low impervious nature of concrete, the staining appears to be a *de minimis* condition that does not constitute a REC in connection with the site at this time. When no further use is intended, the elevator components should be removed and disposed of in accordance with applicable regulations. Terracon has found that there is a high incidence of hydraulic fluid releases from elevators with underground hydraulic components; however, these releases usually affect relatively small amounts of native soil and rarely result in groundwater impact. In Terracon's opinion, evaluation of the elevators using soil borings is of limited value; therefore, the subsurface conditions around the vicinity of the elevators should be evaluated only after the elevators are removed.

**Photo 7** Typical view of elevator pit with concrete staining.

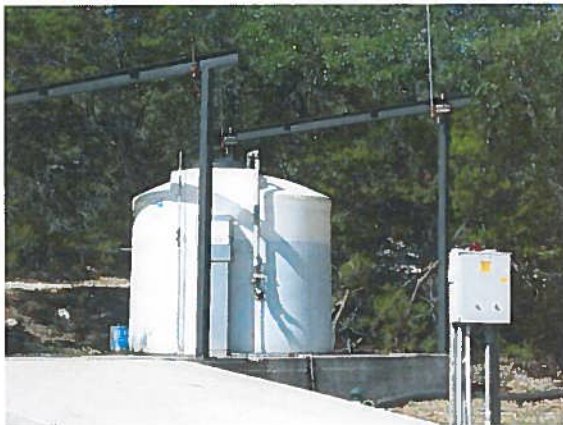
At the time of the site reconnaissance, a large plastic above ground storage tank (AST) of deodorizer was observed on a concrete slab to the northwest of Building B. According to Mr. Cherry, the AST is maintained by US Filter and discharges into the sanitary sewer to control the odor. At the time of the site reconnaissance, a release was observed around the AST. Based on the nature of its contents, the release does not appear to constitute a REC in connection to the site; however, the AST should be repaired to minimize future releases.

**Photo 9** View of deodorizer AST.

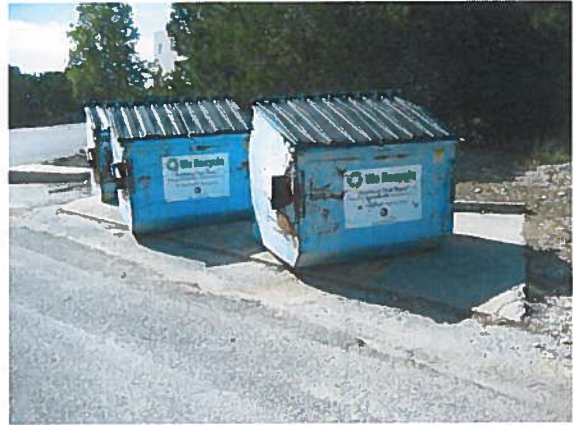
At the time of the site reconnaissance, two roll off dumpsters and four solid waste dumpsters (managed by Accurate and Texas Disposal Systems) were identified. No hazardous materials were observed in or around the dumpster at the time of the site reconnaissance. Minor concrete discoloration was observed in the vicinity of the solid waste dumpster at the time of the site reconnaissance. Based on the minimal area affected and the relatively low impervious nature of concrete, the discoloration appears to be a *de minimis* condition that does not constitute a REC in connection with the site at this time. Based on site observations, the dumpsters do not appear to constitute RECs in connection to the site at this time.

**Photo 10** Typical view of solid waste dumpsters.

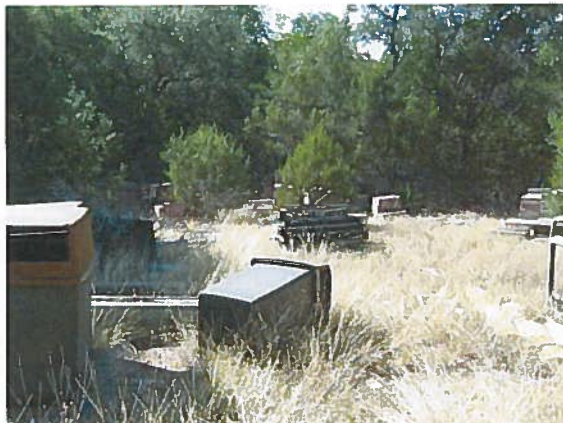
**Photo 11** Typical view of trash/debris located on the northwest portion of Lot 2.

At the time of the site reconnaissance, trash/debris (including, but not limited to, trash cans, wood pallets, granite rocks, pieces of concrete slabs, landscaping debris, and gravel piles) were observed on Lot 1 and the northwestern portion of Lot 2. According to Mr. Cherry, the gravel piles are excess material from trenching activities associated with renovations to the HVAC systems. No spills, releases, distressed vegetation, or noxious odors were observed associated with the trash/debris at the time of the site reconnaissance. Based on site observations, the trash/debris does not appear to constitute RECs in connection to the site at this time. It should be noted that the trash/debris should be removed and disposed of in accordance with applicable regulations.

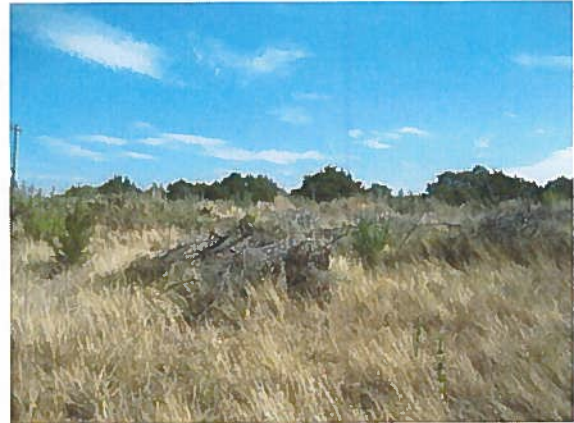
**Photo 12** Typical view of trash/debris located on Lot 1.

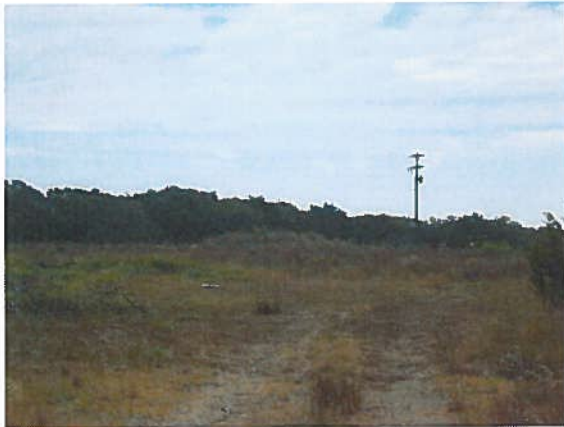
time of the site reconnaissance, a large pile of soil was observed on Lot 1 which was reportedly used to fill in the hole during the removal of the septic system. No noxious odors or distressed vegetation was observed in the vicinity of the septic systems. Based on the operational history of the septic systems (non-manufacturing or production), the septic tanks and/or leach fields present on site would not appear to constitute a REC in connection with the site. However, if no further use is intended, the septic system on Lot 4 should be removed/abandoned in accordance with applicable regulations.

**Photo 13** Typical view of former septic system area on Lot 1.

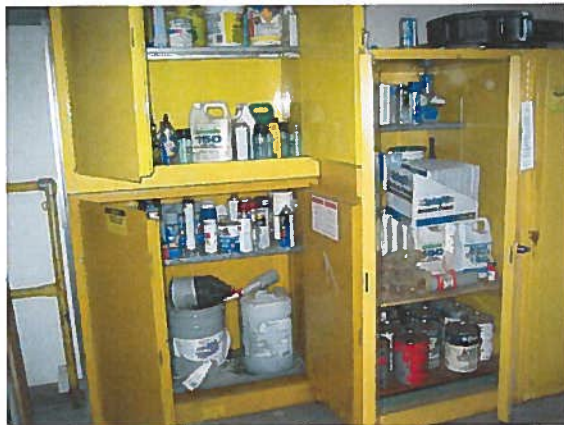
At the time of the site reconnaissance, spray paints, paints, and thinners were observed within flame retardant cabinets located in Building B. These materials appeared to be in good condition, stored in small volume, and in their original containers. Based on their observed condition, they do not appear to constitute a REC in connection with the site at this time.

**Photo 15** View of flame retardant cabinets located in Building B.

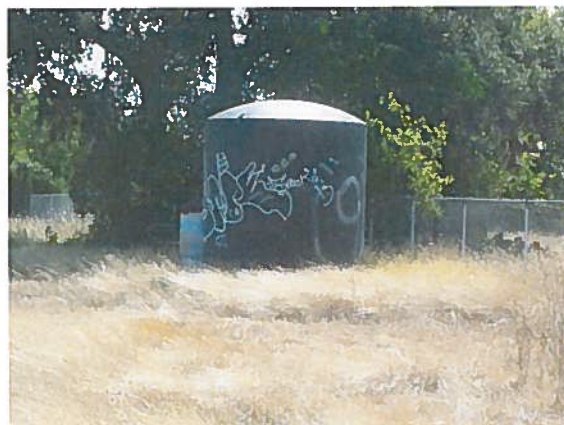
**Photo 17** View of water well located near the recreation area.

At the time of the site reconnaissance, the site was equipped with two water wells which have reportedly been capped. One water well was observed near the parking lot area just west of Building A and the other was located near the recreation area. If the water wells are likely to be used in the future, they should be tested by a licensed laboratory to evaluate water quality. If no further use is intended, they should be plugged in accordance with the Texas Water Well Driller's Rule 30 TAC 338.48, and a plugging report be filed with the State of Texas Water Well Driller's Board.

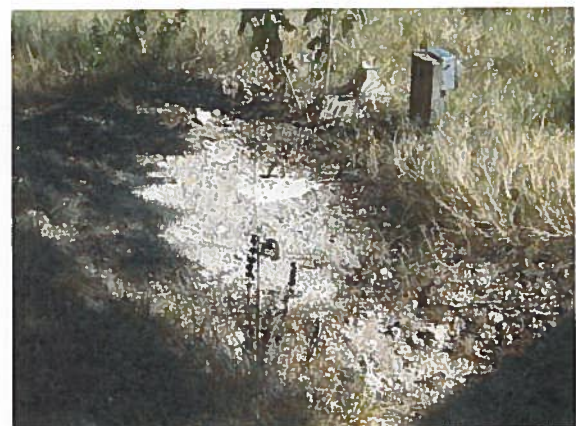
**Photo 18** View of septic system located near the recreation center.

At the time of the site reconnaissance, one septic tank and leach field was formerly located on Lot 1 and a septic tank and leach field is located on Lot 4, near the recreation area. According to Mr. Cherry, the septic system formerly located on Lot 1 was removed in accordance with applicable regulations when City services were provided to the site. At the time of the site reconnaissance, a large pile of soil was observed on Lot 1 which was reportedly used to fill in the hole during the removal of the septic system. No noxious odors or distressed vegetation was observed in the vicinity of the septic systems. Based on the operational history of the septic systems (non-manufacturing or production), the septic tanks and/or leach fields present on site would not appear to constitute a REC in connection with the site. However, if no further use is intended, the septic system on Lot 4 should be removed/abandoned in accordance with applicable regulations.

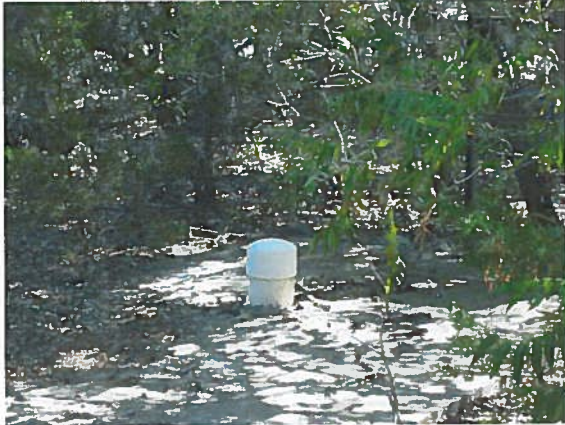
**Photo 19** View of water well located near Building A.

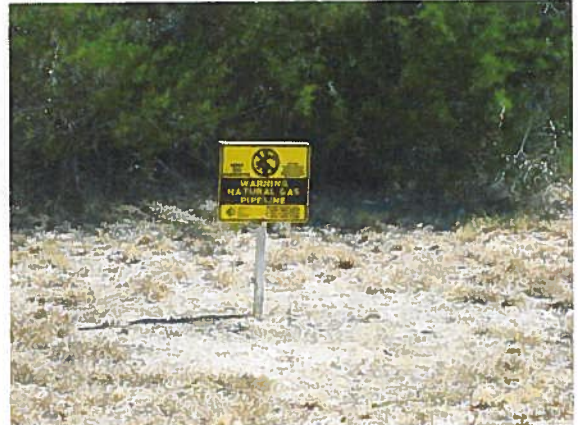
At the time of the site reconnaissance, a Texas Gas Service natural gas pipeline marker was observed along the driveway on the western portions of the site. Based on site observations, the marker appeared to be associated with a natural gas distribution line to nearby structures. No spills, releases, noxious odors, or distressed vegetation were observed in the vicinity of the marker at the time of the site reconnaissance. Based on the physical properties of natural gas (not a liquid at standard pressure and temperature) and site observations, potential releases of this material are not likely to constitute a REC in connection with the site.

**Photo 20** View of natural gas pipeline marker.

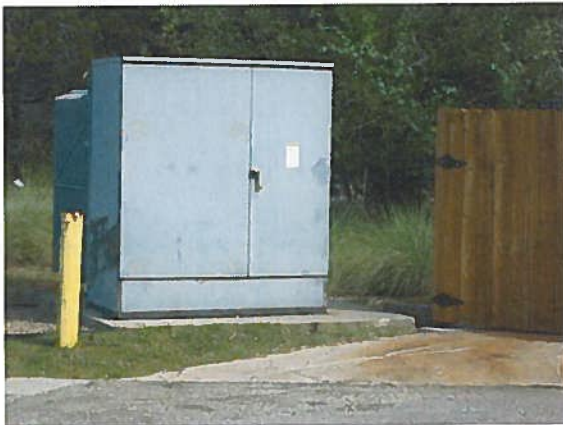
Two unlabeled pad-mounted electrical transformers and two unlabeled pole-mounted transformers, owned by Pedernales Electric Cooperative (PEC), were observed during the site reconnaissance. The on-site pad- and pole-mounted transformers appeared to be in good condition, and no evidence of dielectric fluid leakage was observed on or below the units at the time of the site reconnaissance. PEC has acknowledged responsibility for cleanup of PCB or non-PCB spills for the transformers. Based on this information, the on-site transformers do not appear to constitute a REC in connection with the site.

**Photo 21** Typical view of pad-mounted transformer.

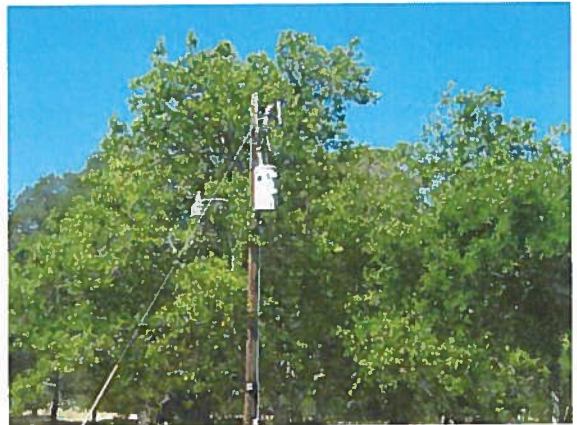
**Photo 22** Typical view of pole-mounted transformer.

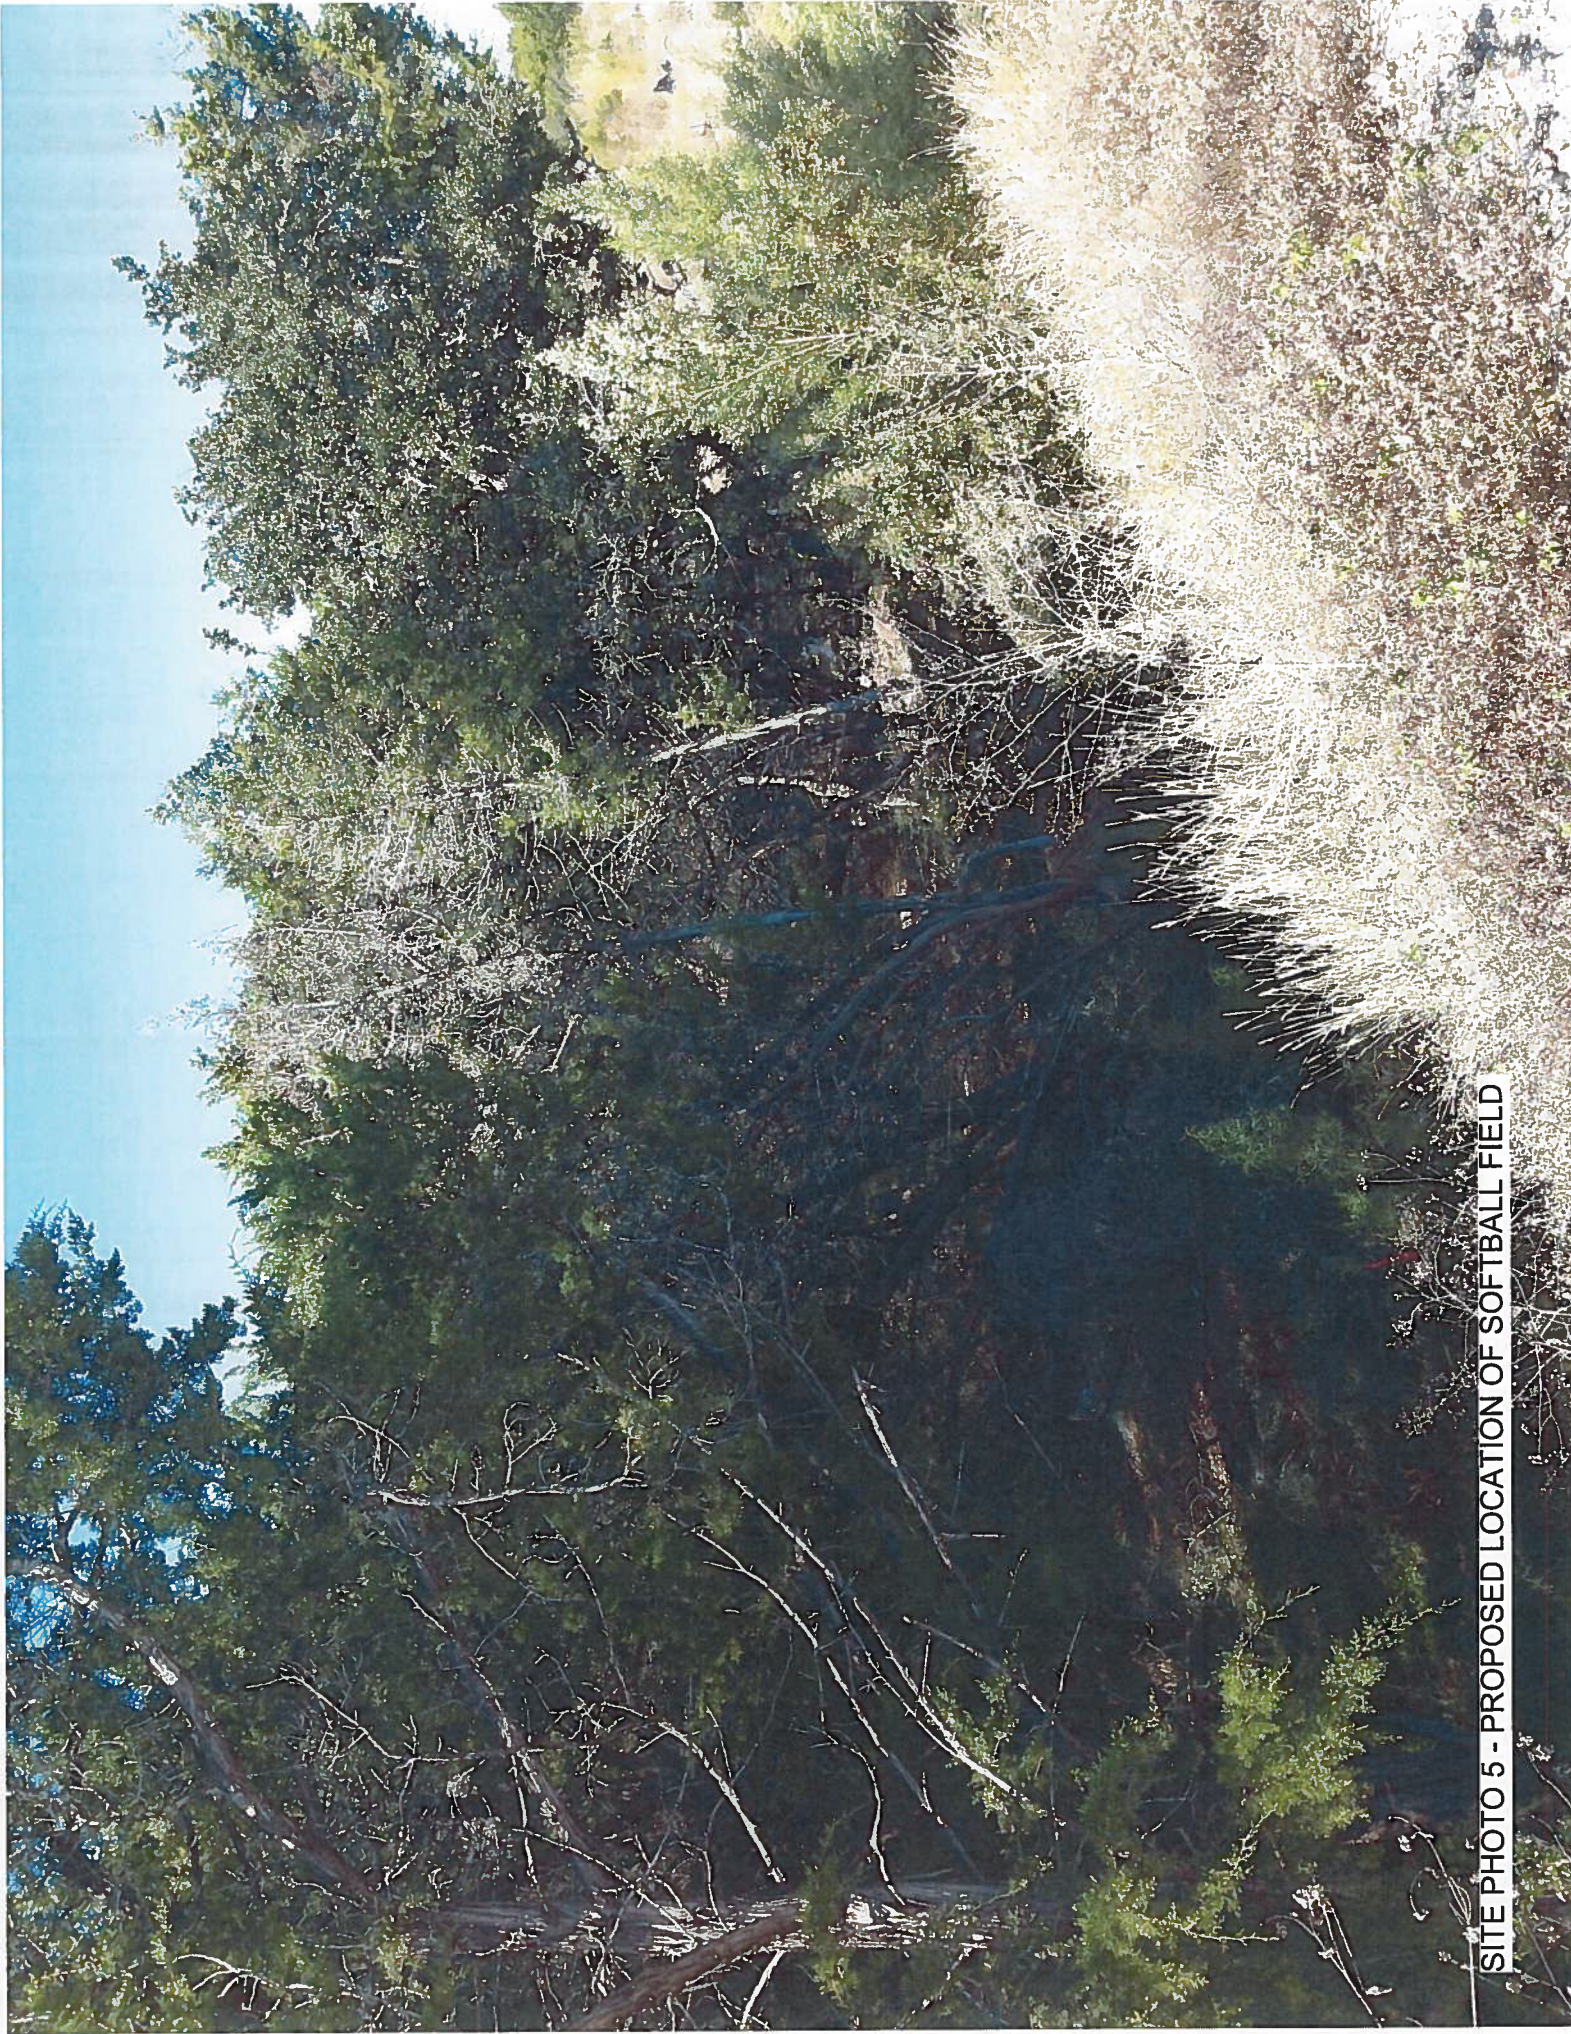
SITE PHOTO 5 - PROPOSED LOCATION OF SOFTBALL FIELD
