ZONING AND PLATTING COMMISSION
SITE PLAN VARIANCE REQUEST REVIEW SHEET

CASE NUMBER: SP-2013-0504DS

PROJECT NAME: 2009 Lakeshore Drive (Boat Dock)

PROJECT DESCRIPTION: The applicant proposes to construct a 14 ft. x 30 ft. single-slip, two-story residential boat dock, including a gangway, stairs and other appurtenances on Lake Austin.

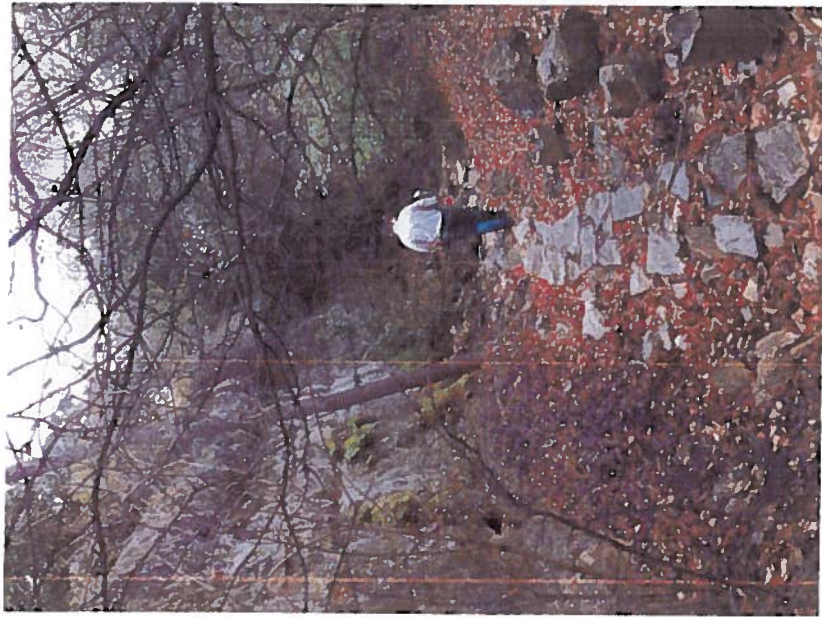
Rimrock and existing access

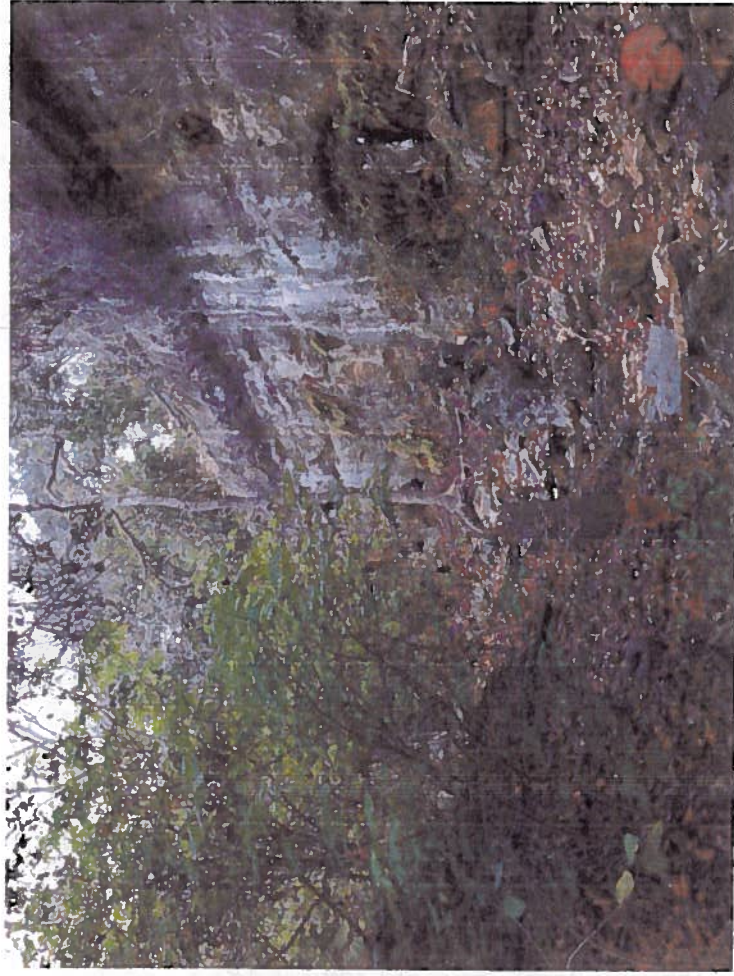
Rimrock

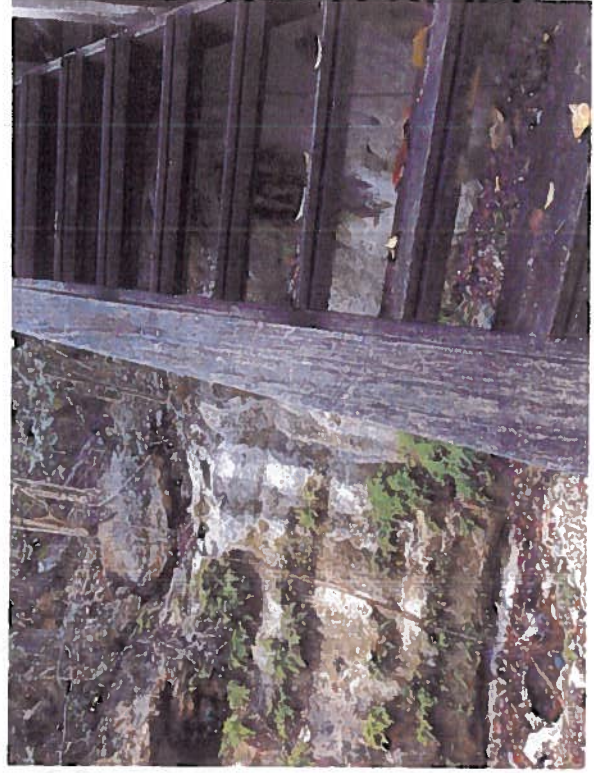
Rimrock and existing access

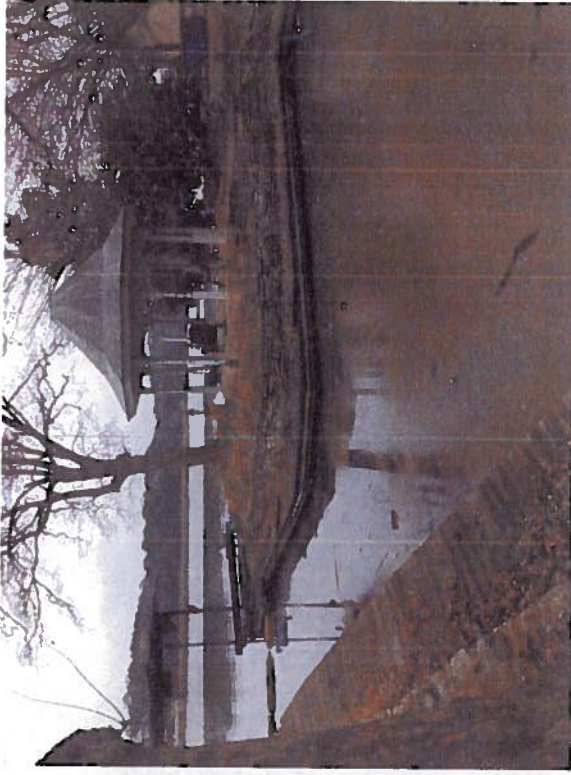
Existing shoreline improvements. Dock and boardwalk to be removed, gazebo to remain.

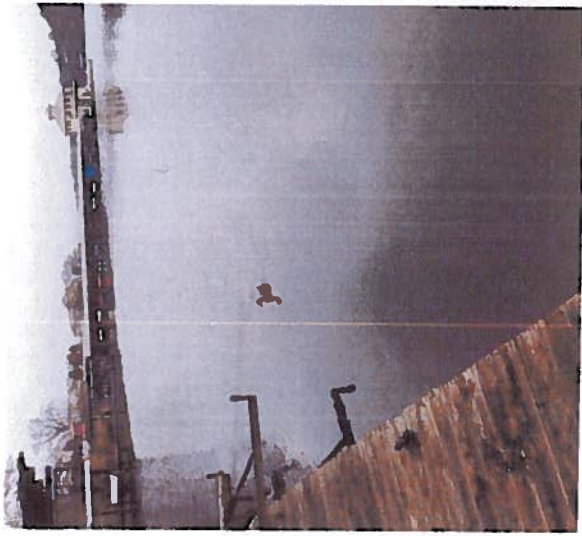
View downriver from proposed dock location.

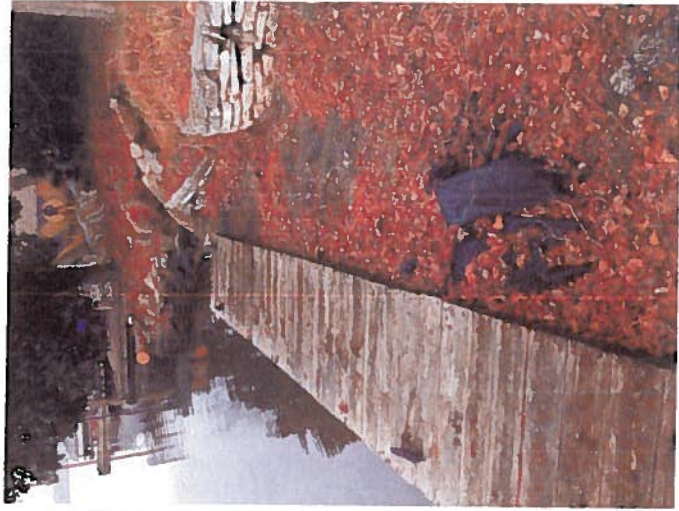
View upriver from proposed dock location.

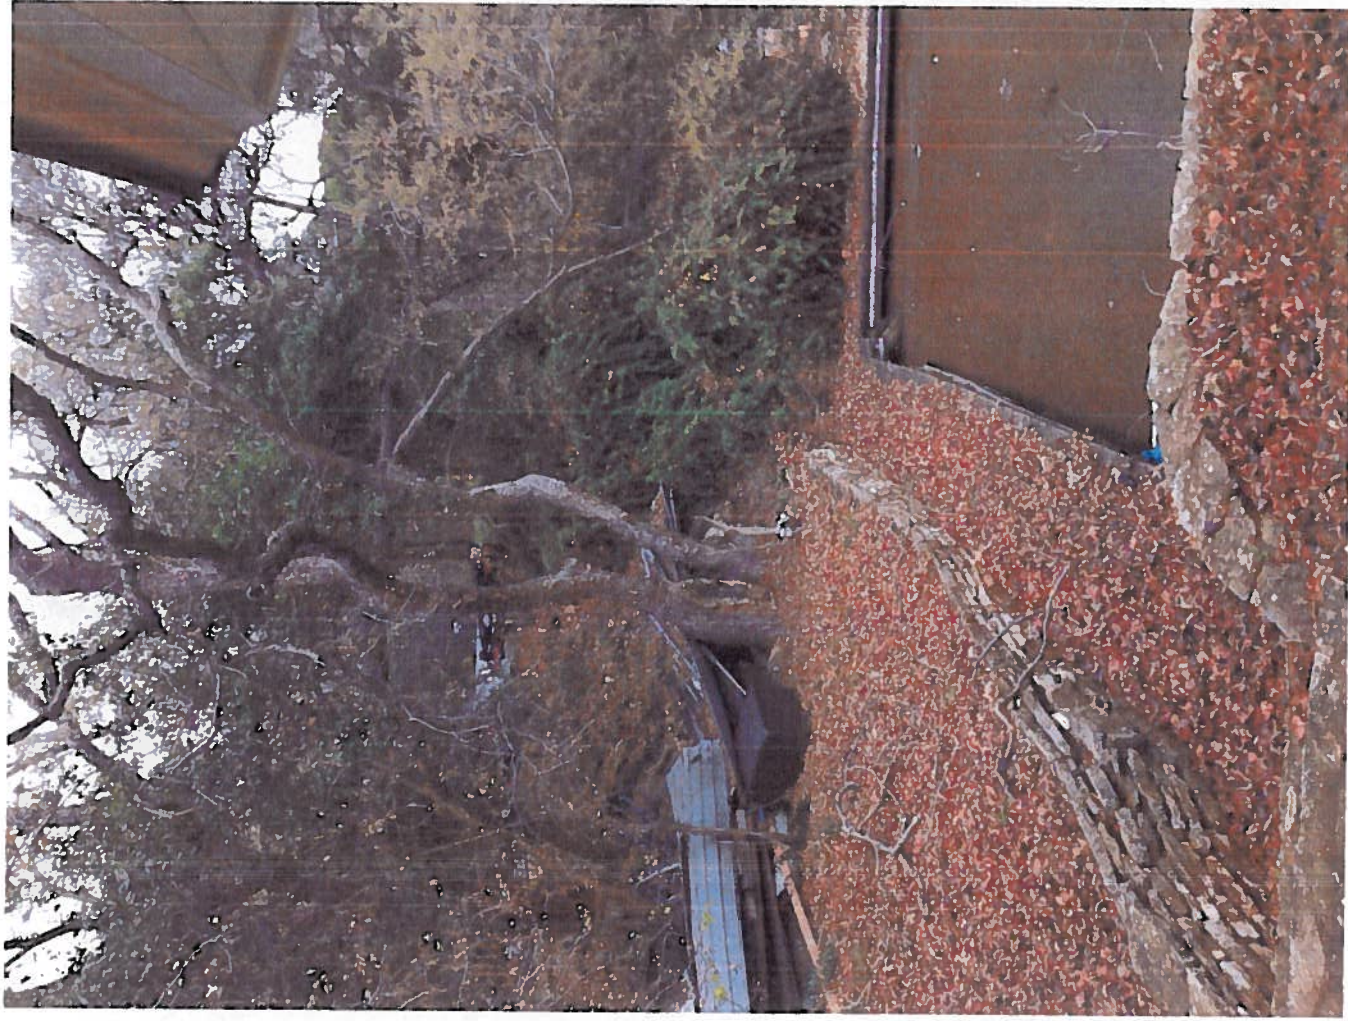
View west from peninsula towards Island Way.

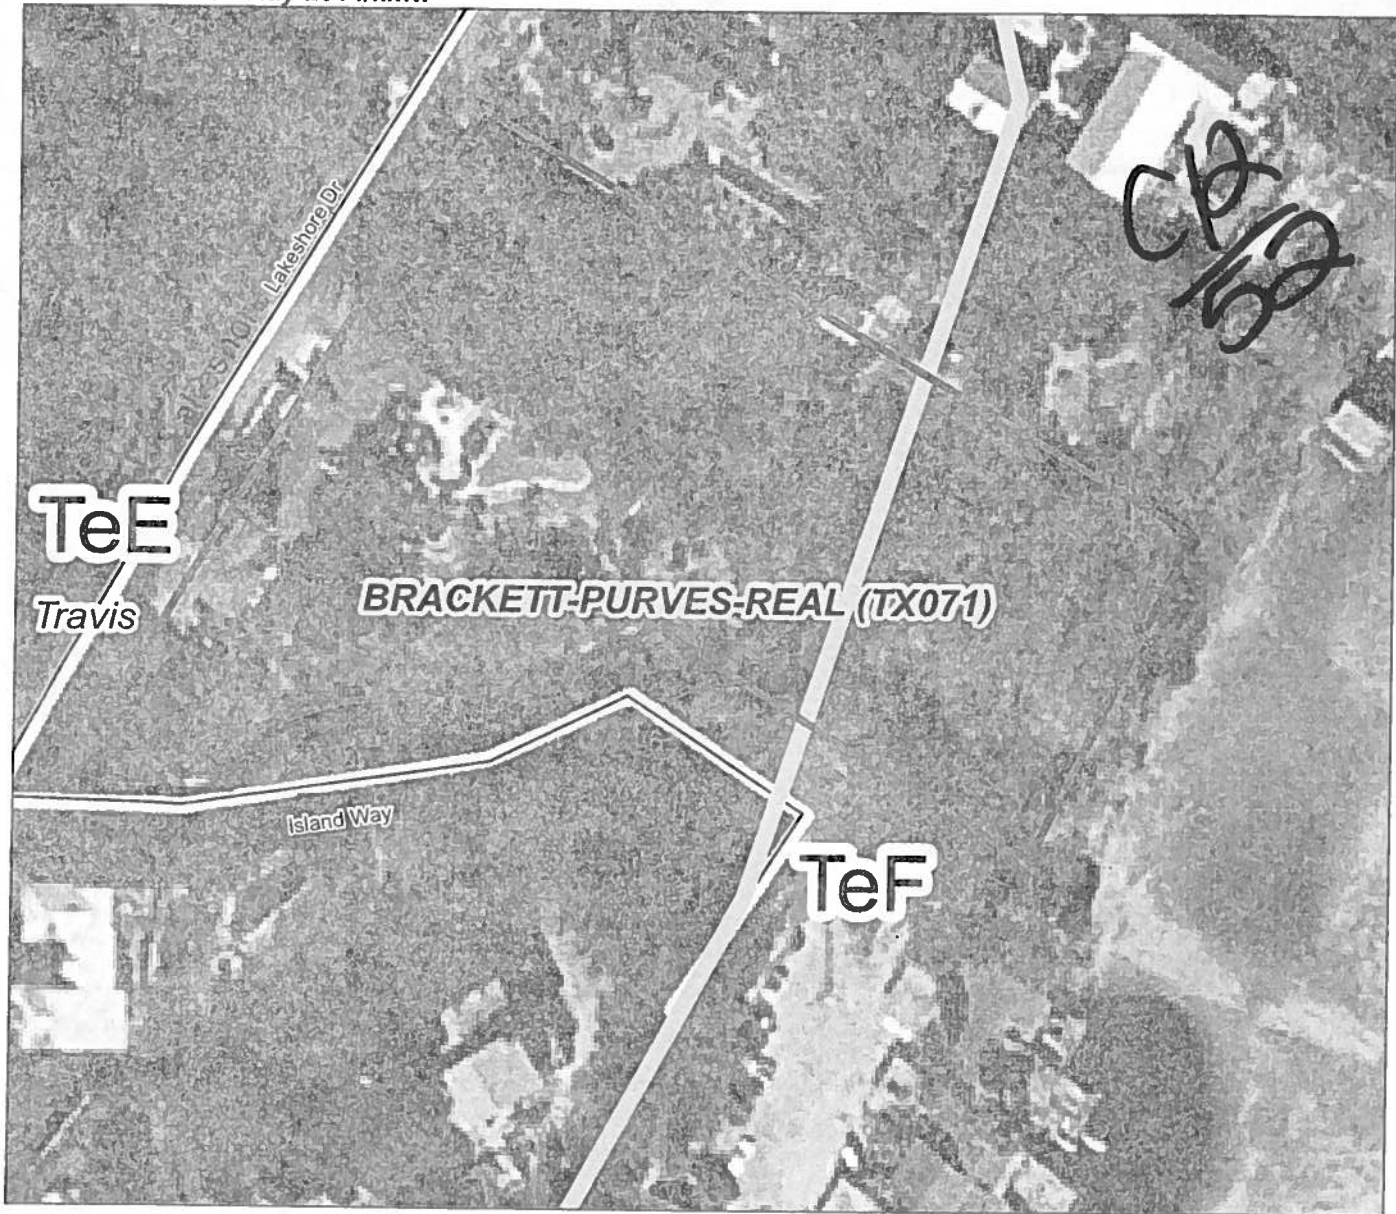
Figure 3

Tarrant soils and Urban land, 5 to 18% slopes (TeE)
Tarrant soils and Urban landm 18 to 40% slopes (TeF)
Open Water (W)

Soil Association Map
1.572025-acre property
Lakeshore Addition
Lots 15 & 16, part of Lot 14
2009 Island Way
Austin, Travis County, Texa

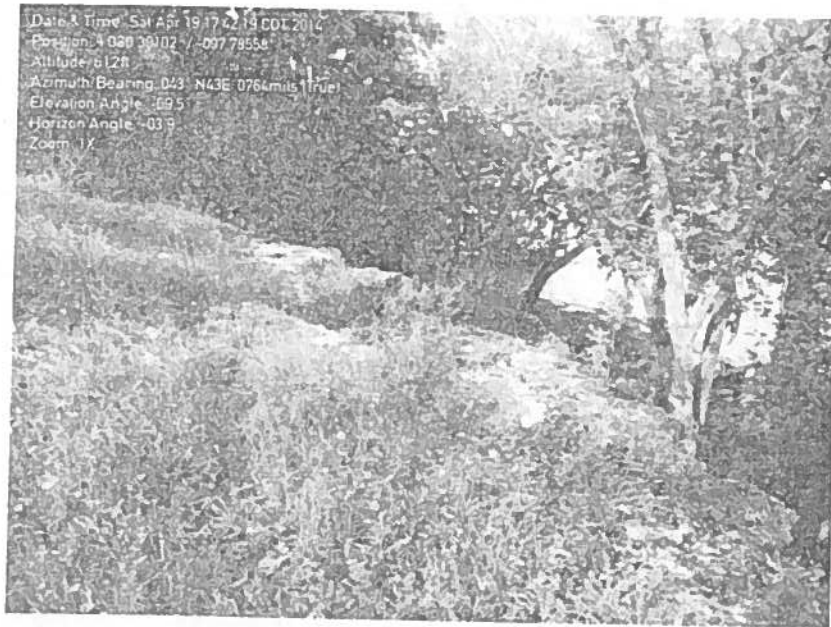
Photo 13

View facing southeast from the top of the rimrock feature (S-1).

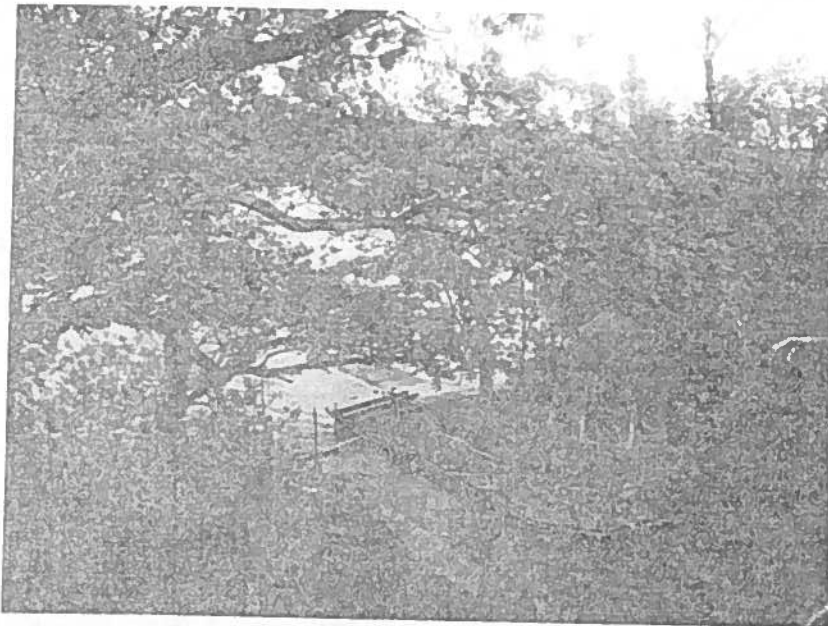
Photo 14

View facing east (toward Lake Austin) from the top of the canyon rimrock feature (S-1).

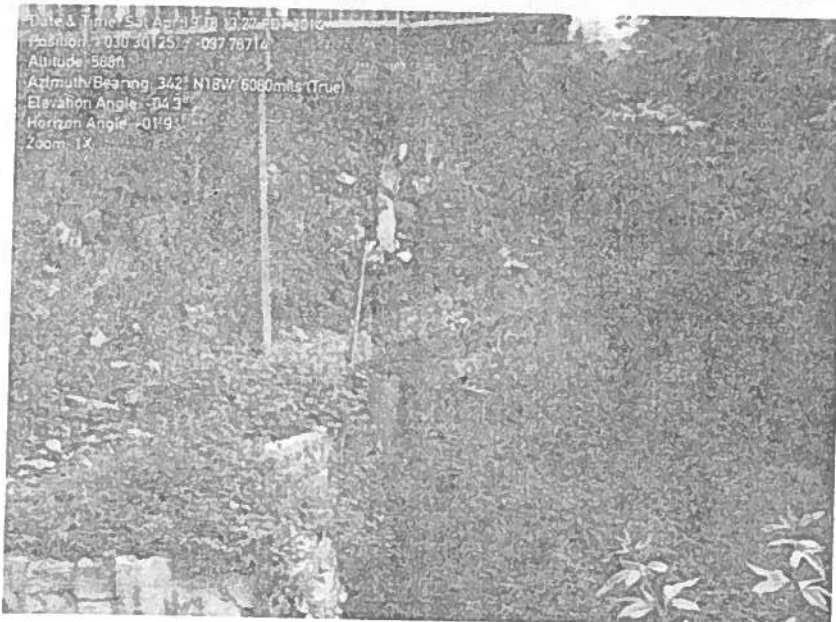
Photo 15

View of rimrock feature S-2, southwest of the intersection of Lake Shore Drive and Island Way. This feature is formed by an exposed geologic fault scarp (Figure 4). The rimrock is only 42 feet long and does not meet the COA criteria to be considered protected rimrock. S-2 is in the location of a known fault that divides the Edwards from Upper Glen Rose Limestone (UT-BEG, 1981). This fault forms the boundary of the Edwards Aquifer Contributing and Recharge Zone.
