Application for Certificate of Appropriateness for a City Landmark or Local Historic District

Address: Norwood Park, 1012 Edgecliff Terrace

Demolition and reconstruction of non-historic foundation; structural stabilization of historic wood structure.

Norwood House Phase 1 Certificate of Appropriateness Application

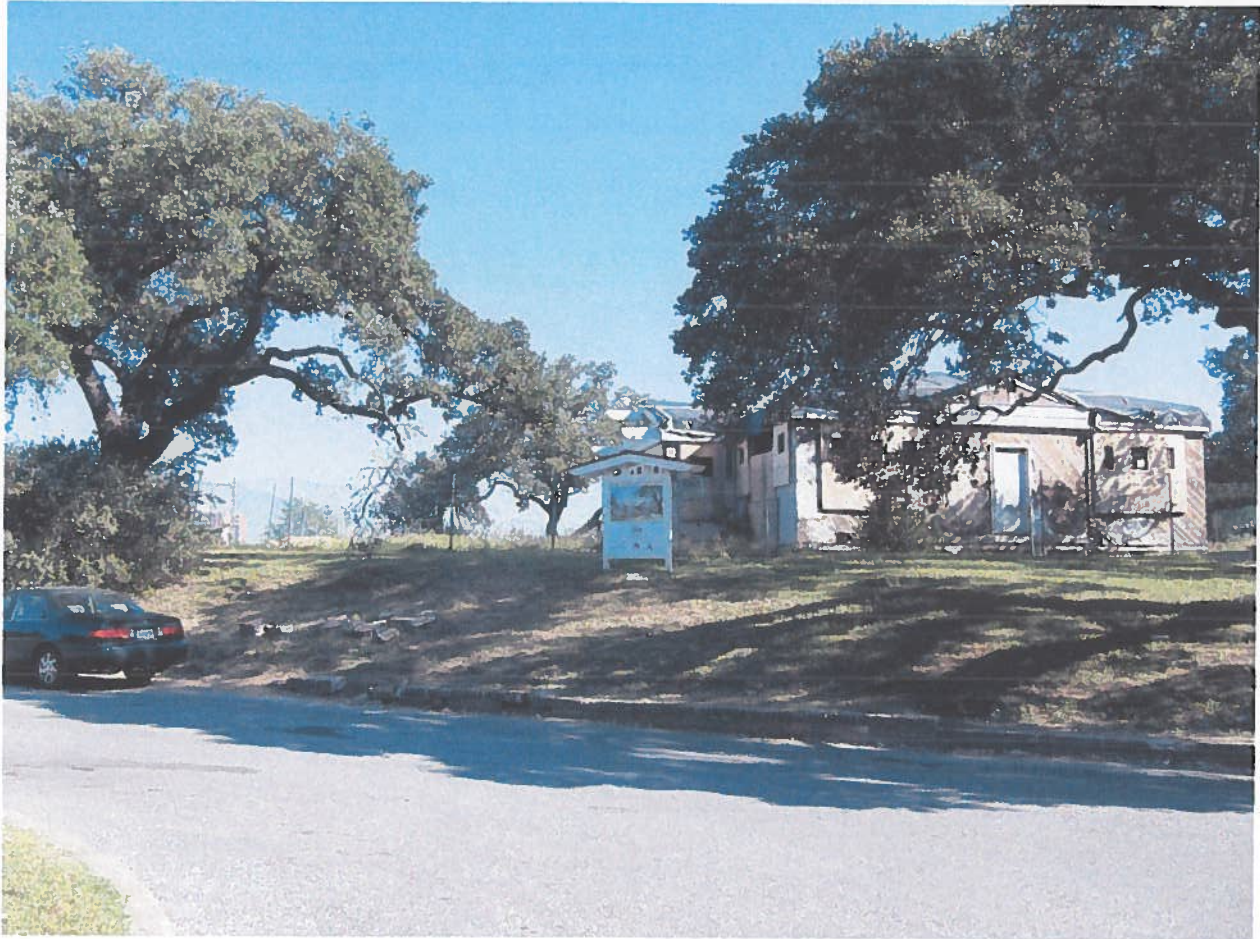
FIGURE 1. EXISTING SITING OF HOUSE (OCTOBER 2014). WHEN MOVED, HOUSE WILL BE PLACED TO THE LEFT OF THE CURRENT LOCATION, AS SEEN IN THIS PHOTO.

The Norwood House was removed from its original site and foundation in the early 1980s, when it was temporarily placed on the portion of the site west of Edgecliff Terrace. The original foundation was removed at that time. The house was moved back to the eastern section of the site (Figure 1) and placed on its existing foundation in 1999. The existing foundation consists of pre-cast concrete and concrete block piers resting on an unstable soil layer, consisting partially of rubble fill (Figures 2 and 3). Our structural engineers have determined that this system is not sufficient to support the future use of the building as an assembly space (see Appendix A). A geotechnical test and report was completed in April 2014 as part of the studies of existing structural conditions. This test found that the site is covered in layers of soil and clay down to a depth of 12 to 13 feet, on top of limestone bedrock. The report recommends two possible foundation systems based on these findings: concrete piers drilled at a depth that extends several feet into the bedrock or spread footings poured at least two feet below grade. Given the depth of soils and the proposed use of the structure, a deep pier foundation is recommended as being the most stable and least susceptible to potential future movement.

- Physical reinforcing of the house with temporary shear walls and other measures to prepare it for moving
- Moving the house off the current foundation (house will be temporarily “parked” on the northwestern end of the site (Figure 1))

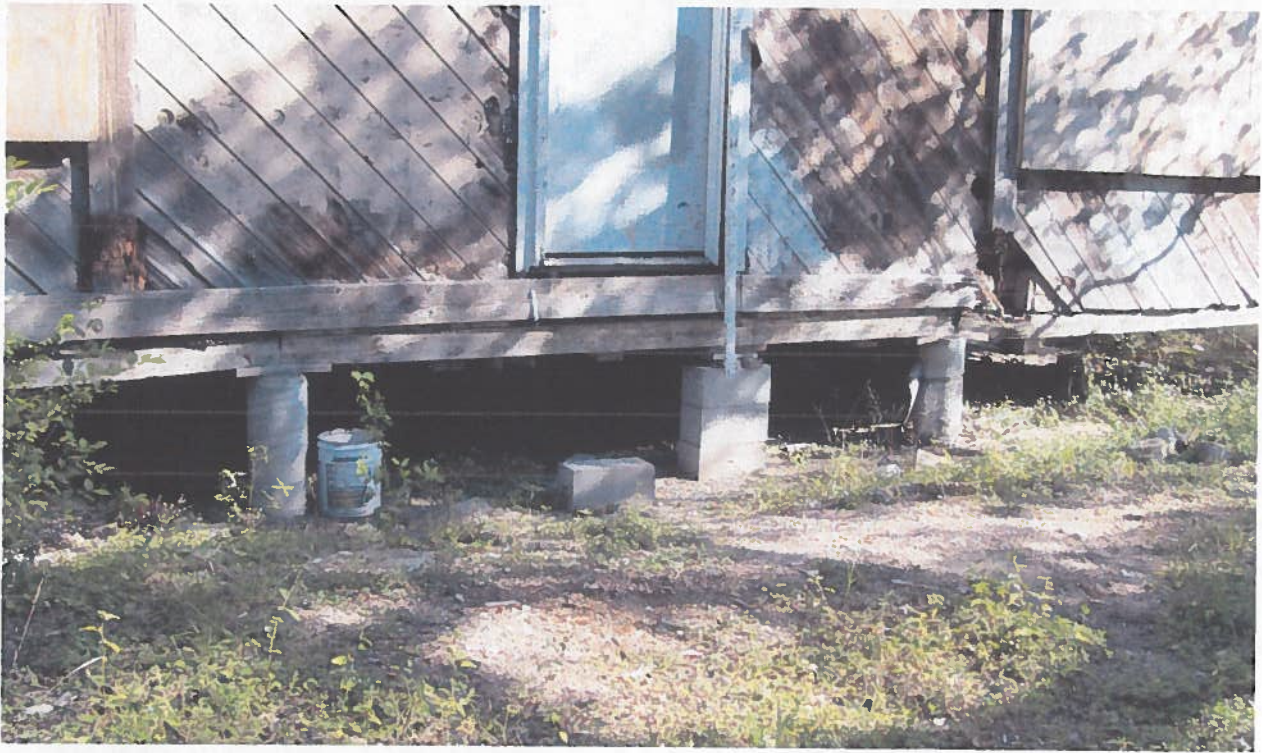
FIGURE 2. CURRENT FOUNDATION CONDITIONS (OCTOBER 2014).

The proposed new foundation, as designed, includes a system of piers 16' to 18' deep supporting a concrete grade beam and stem wall around the perimeter of the structure. Interior wood beams will be replaced with steel I-beams. When placed on the new foundation, the existing floor structure of the house will be reinforced with new sill plates and 2x10s sistered to the existing joists. This work will be a permanent structural solution for the house.

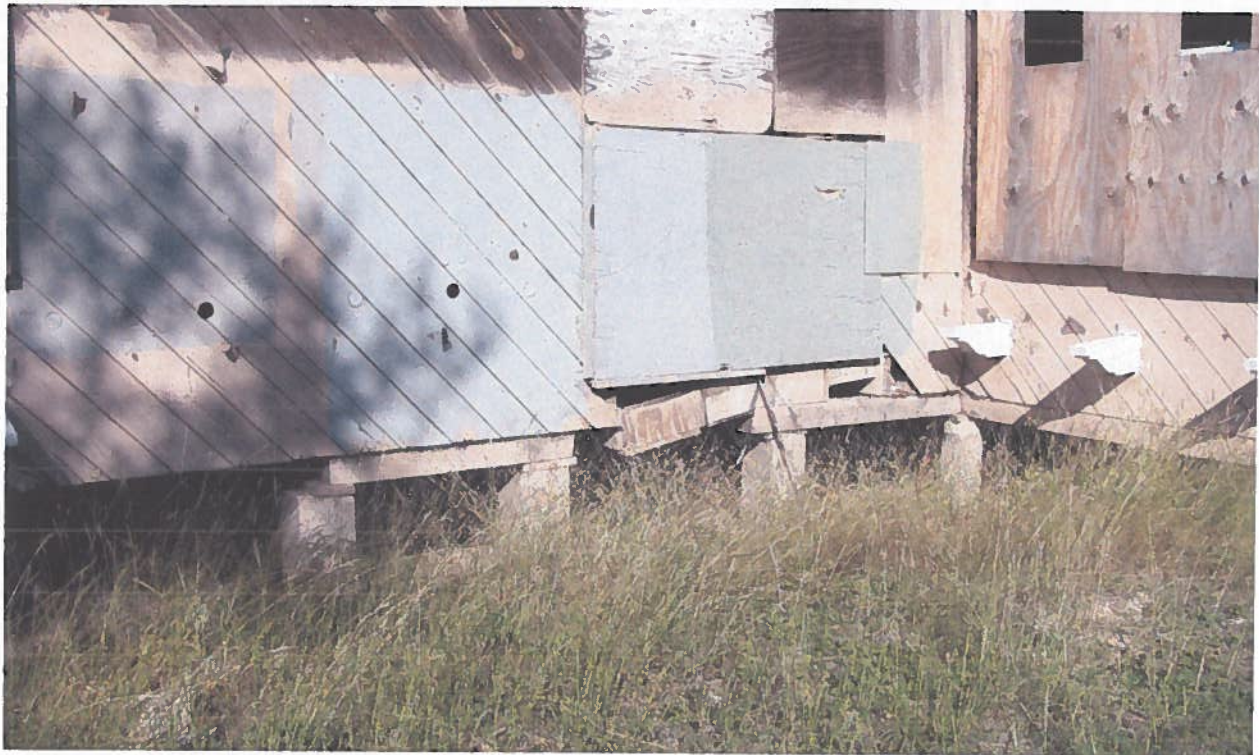
FIGURE 3. CURRENT FOUNDATION AND SILL CONDITIONS (OCTOBER 2014).

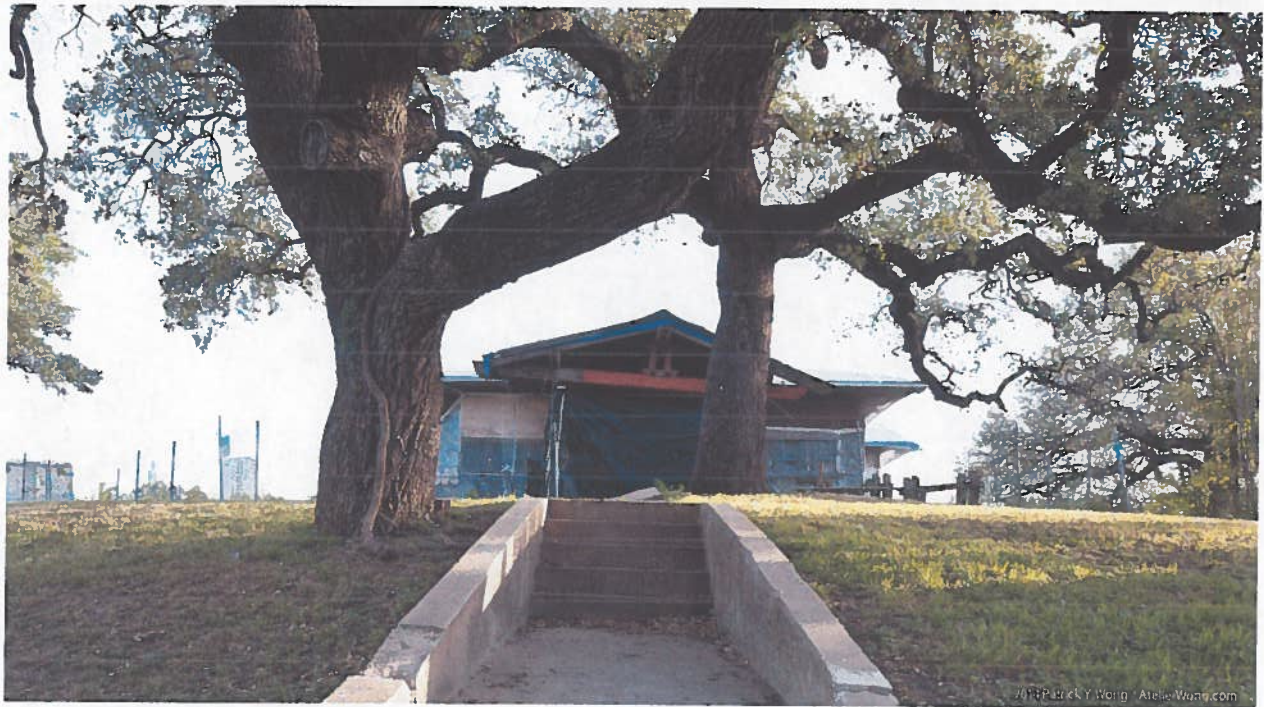
FIGURE 5. CURRENT LOCATION OF HOUSE, VIEWED FROM ENTRY STAIRS (SPRING 2014).

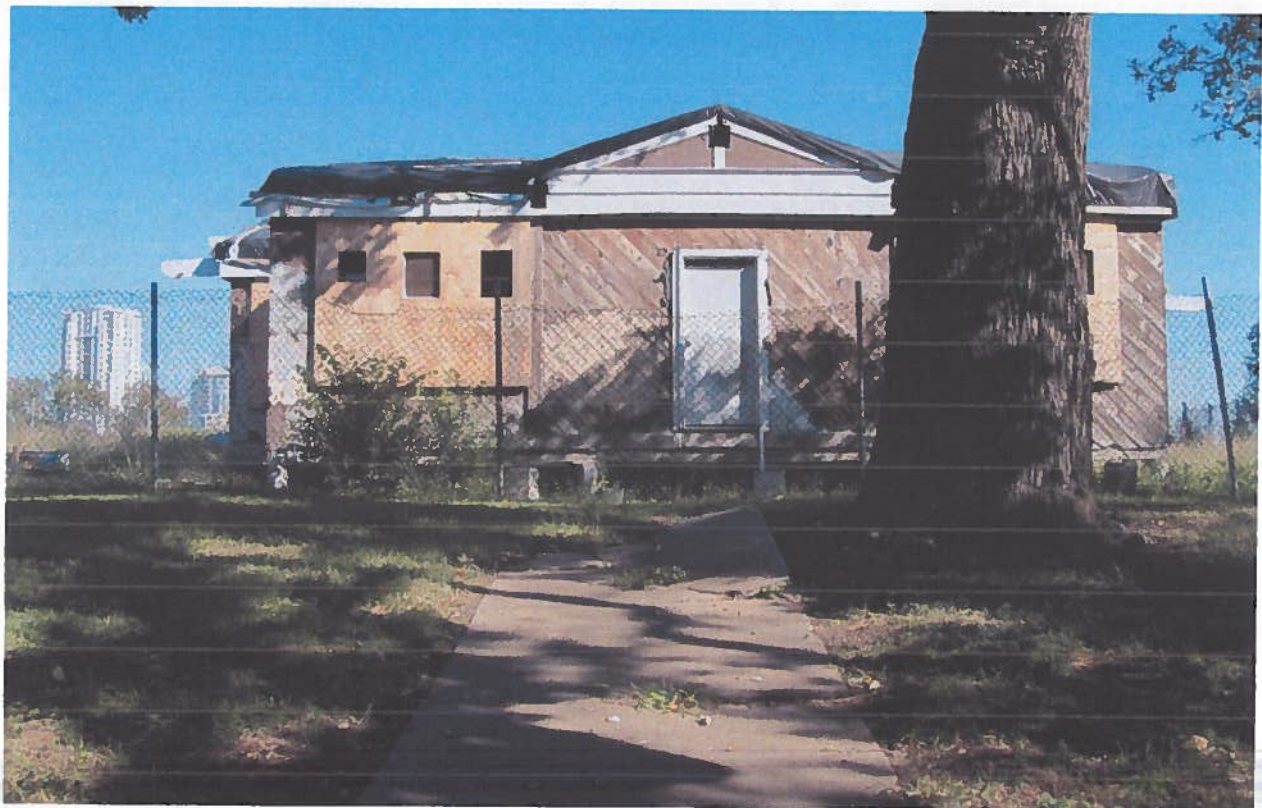
FIGURE 6. CURRENT VIEW OF HOUSE SHOWING MISALIGNMENT OF SIDEWALK AND ENTRY (OCTOBER 2014).

The need to correct the structural deficiencies of the existing foundation is an opportunity to also correct the siting of the house. Although the physical difference in location appears minor, correcting this will make a significant difference in the accurate restoration and interpretation of the landscape.

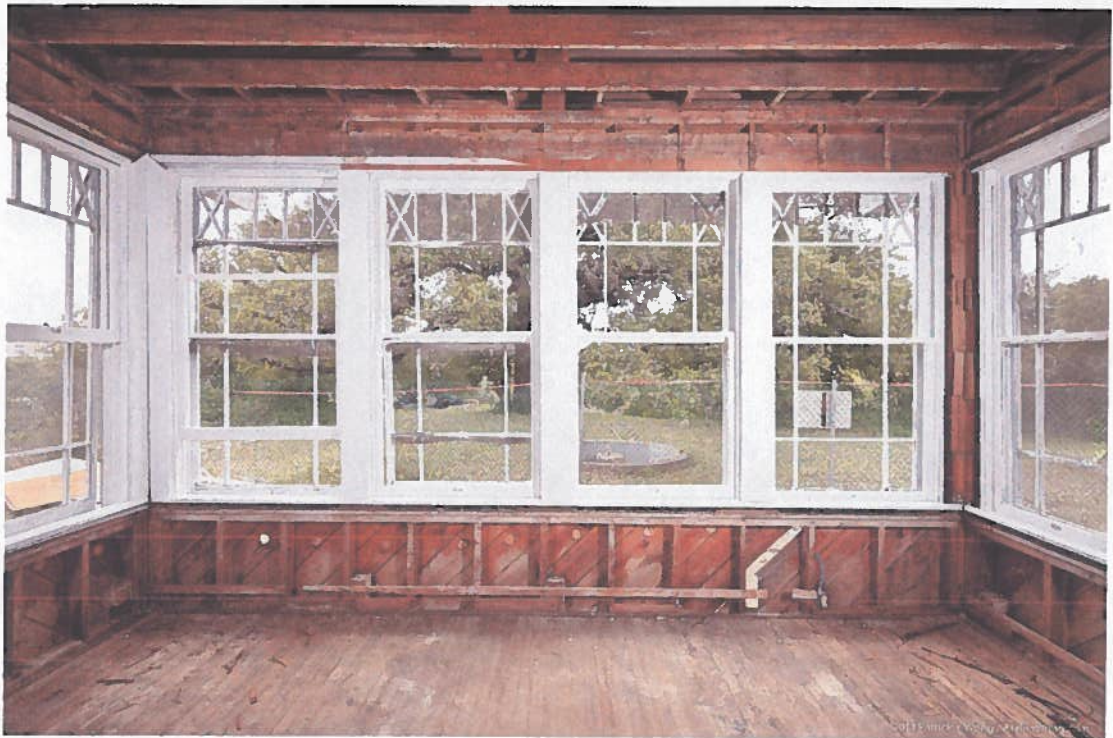
**FIGURE 7. CURRENT LOCATION OF THE HOUSE IN
RELATION TO THE HISTORIC FOUNTAIN, AS SEEN
FROM OLLIE'S SLEEPING PORCH. THE CENTERLINE OF
THIS EXTENDED BAY SHOULD ALIGN WITH THE CENTER
OF THE FOUNTAIN.**

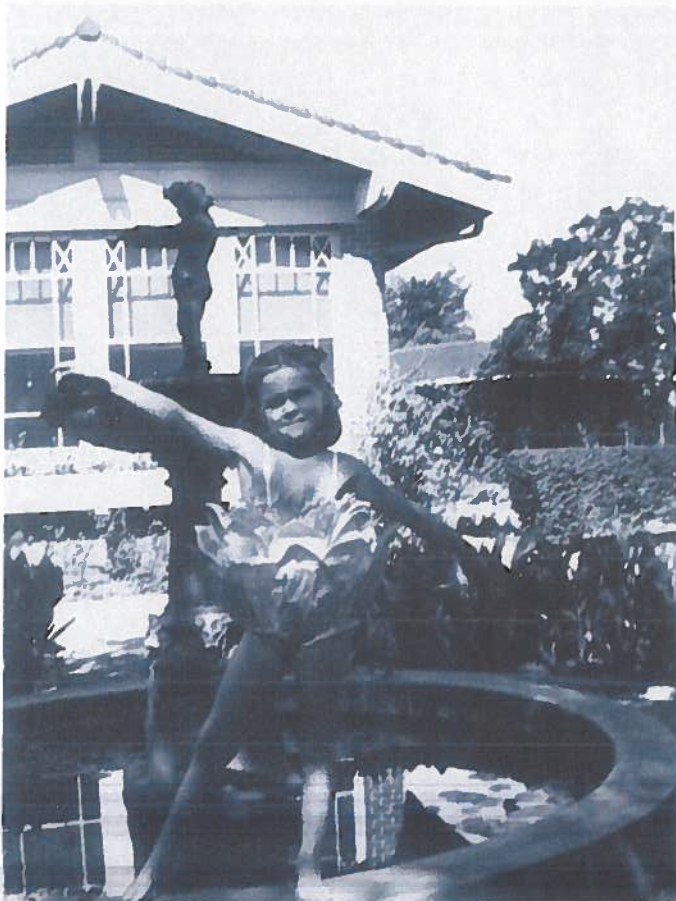
**FIGURE 8. HISTORIC IMAGE ILLUSTRATING ALIGNMENT OF
FOUNTAIN WITH SLEEPING PORCH BAY.**
