MEMORANDUM

Re: Short Spring Branch Turbidity investigation.

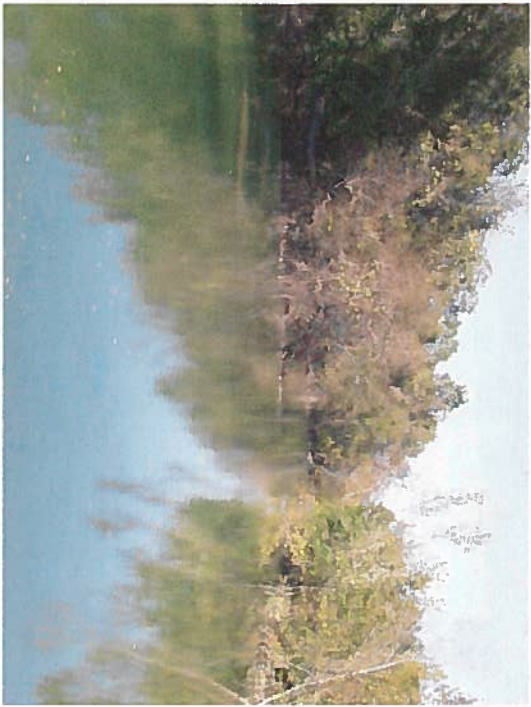
Photo1

- Photo 1 An upstream view of Barton Creek below the confluence of Short Spring Branch. Photo take from the lower Lost Creek Blvd. bridge.
- Photo 2 A view of the turbidity of Barton Creek on the upstream side of the bridge taken from the left bank (if facing upstream).

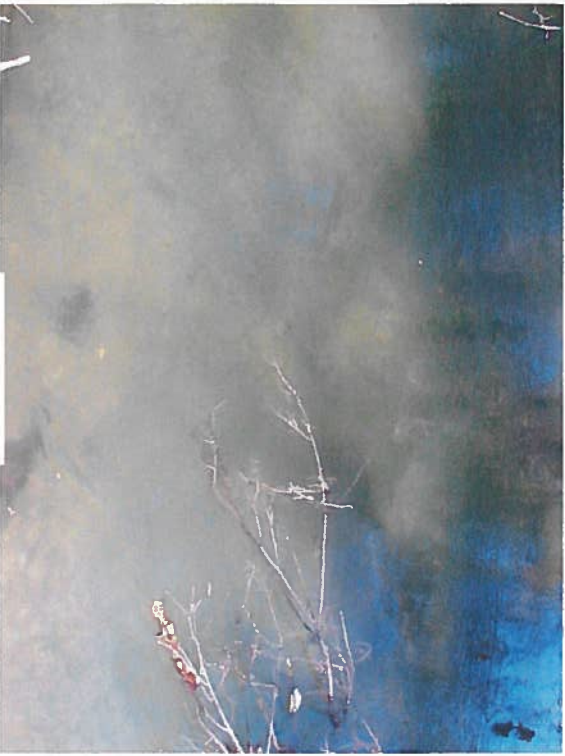
Photo3

- Photo 3 A view of the turbidity of Barton Creek on the upstream side of the bridge taken from the right side of bank (if looking upstream).
- Photo 4 A view of Barton Creek's discharge on the downstream side of the lower bridge. Water samples collected opposite bank from the first pipe on the right (if looking downstream).

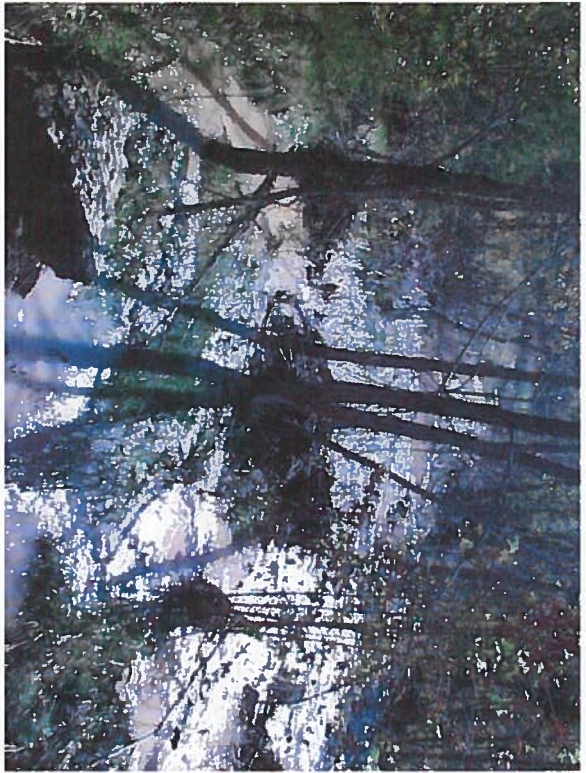
Photo5

At Short Spring Branch at Lost Creek Blvd. I observed sediment-laden water discharging downstream towards the Lost Creek Country Club (Photo 5-8), and the deposition of sand-size sediment in Short Spring Branch's floodplain and along its the banks (Photos 9-12). No evidence of high turbidity were observed upstream at Short Travis Cook Road (Photos 13-16) or at Short Spring Branch at its confluence with Barton Creek. The water chemistry analysis on the water samples collected that day confirms my field observations (see below).

- Photo 5 An upstream view of Short Spring Branch at Lost Creek Blvd.
- Photo 6 A view of Short Spring Branch flowing into the culvert on the right side of the bridge (if facing upstream).

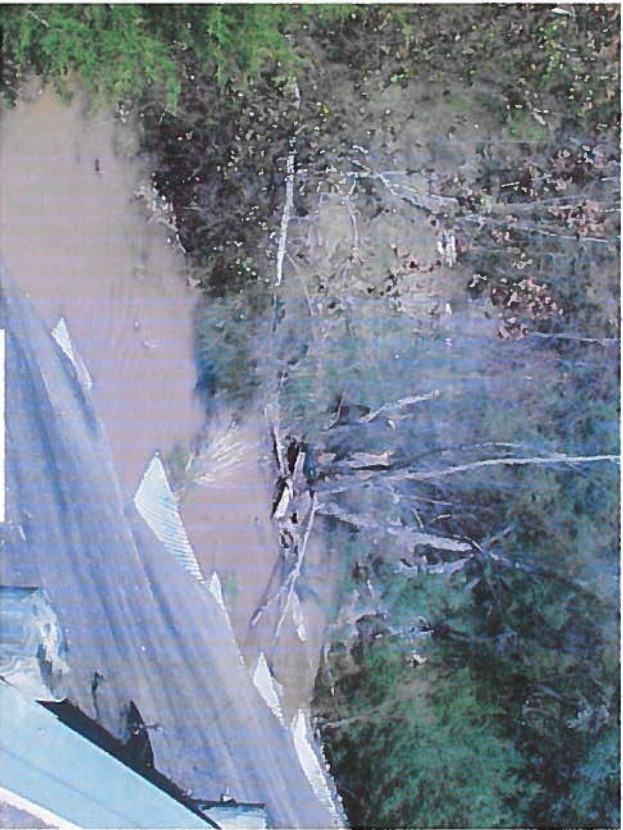
Photo7

- Photo 7 & 8 A downstream view of Short Spring Branch from the Lost Creek Blvd. Bridge. Photo taken from the left side of the bridge (if facing downstream).

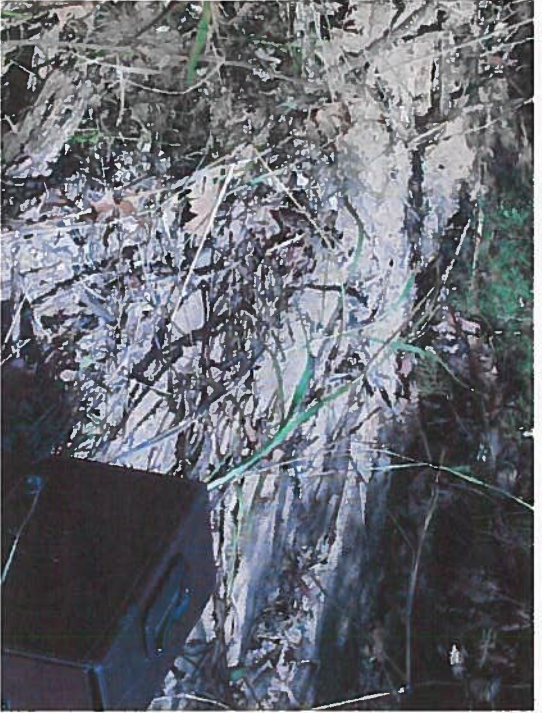
Photo9

- Photo 9 A photo of the sand deposition along the banks of Short Spring Branch on the upstream side of the Lost Creek Blvd. Bridge.
- Photo 10 A photo of the sand deposition along the banks of Short Spring Branch on the upstream side of the Lost Creek Blvd. Bridge.

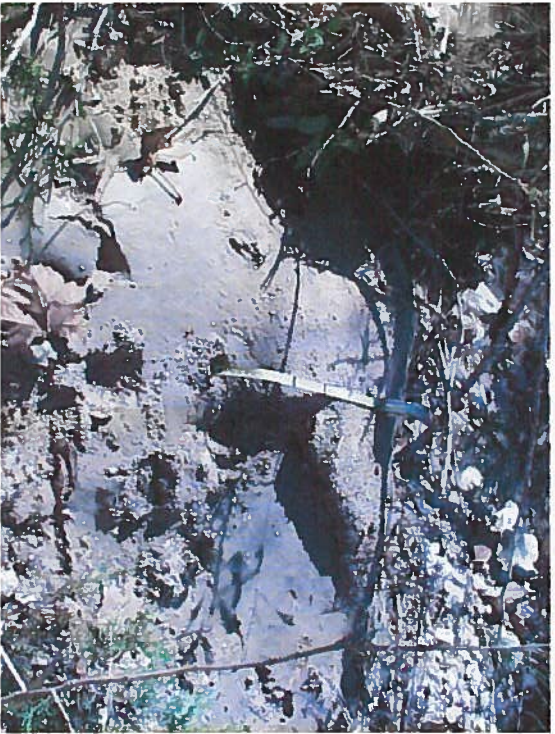
Photo11

- Photo 11 A photo of the sand deposition along the banks of Short Spring Branch on the upstream side of the Lost Creek Blvd. Bridge.
- Photo 12 A photo of the sand deposition along the banks of Short Spring Branch on the upstream side of the Lost Creek Blvd. Bridge.

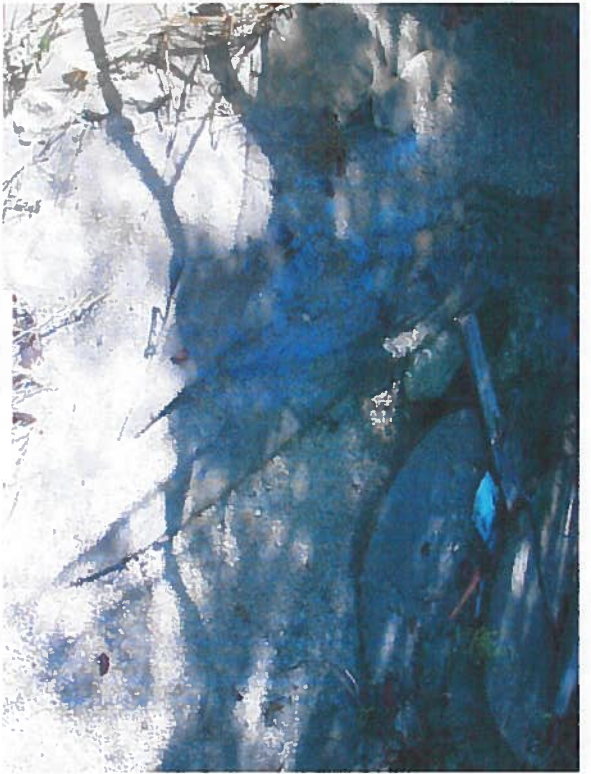
Photo13

- Photo 13 An upstream view of Short Spring Branch were it crossing Travis Cook Rd.
- Photo 14-16 An view of Short Spring Branch downstream side of Travis Cook Rd.

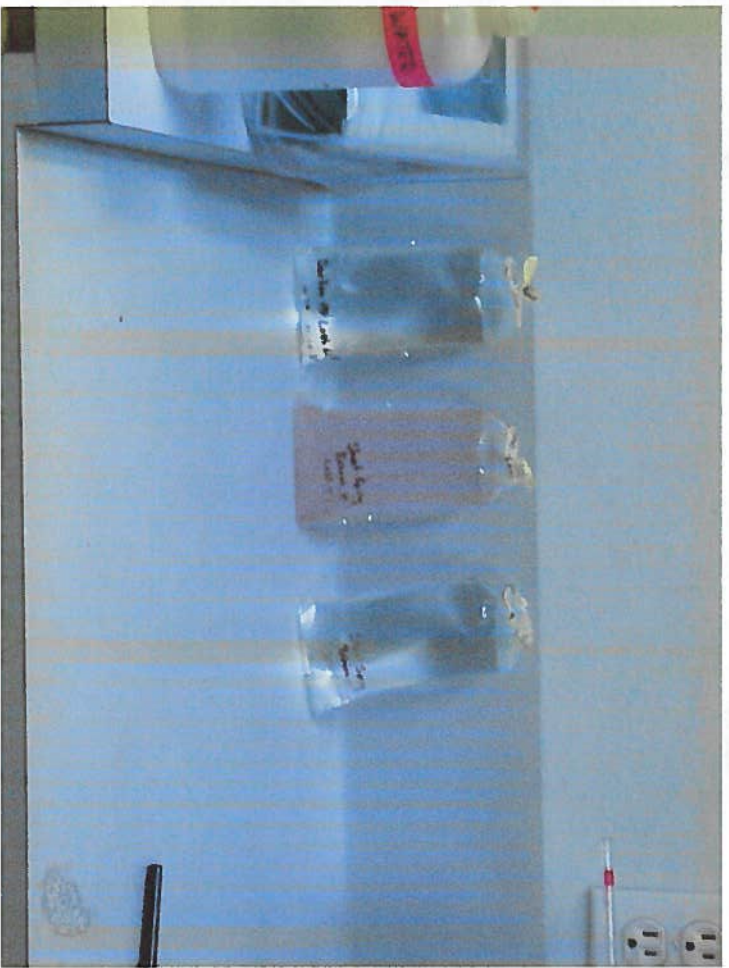
Photo17

Barton @ L.C.	Short Spring @ L.C.	Short Spring @ T.C.
pH	8.1	8.0	7.8
Total Dissolved Solids (mg/l)	285	294	347
Conductivity (μ S/cm)	571	593	695
Turbidity (NTUs)	2.9	208	1.5
Ammonia-nitrogen (mg/l)	<0.01	<0.01	<0.01
Orthophosphorus (mg/l)	0.01	0.01	0.03
Nitrate-nitrogen (mg/l)	0.3	0.6	1.7
Total Suspended Solids (mg/l)	2.4	185.2	0.8

- Photo 17 A picture of grab samples collected at Barton Creek at Lost Creek Blvd., Short Spring Branch at Lost Creek Blvd., and Short Spring Branch at Travis Cook (Left to Right).
