ZONING CHANGE REVIEW SHEET

CASE NUMBER: C14H-2015-0001

HISTORIC NAME: Dedrick-Hamilton House

HISTORIC PRESERVATION PLAN (VA)

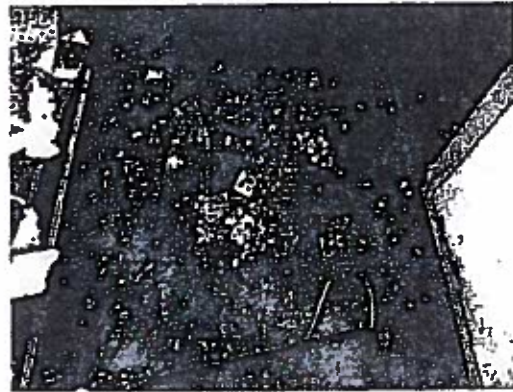
Figure 13 - An example of recently discovered turn-of-the-century patterned linoleum found in Room 3.

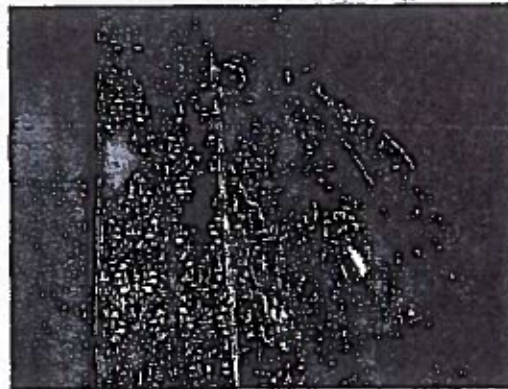
Figure 16 - An example of wallpapers found in Room 2 that will be collected and archived.
