ZONING CHANGE REVIEW SHEET

CASE NUMBER: C14H-2014-0014

HISTORIC NAME: Bluebonnet Hills Historic District

ADDRESS OF PROPOSED ZONING CHANGE: Roughly bounded by Annie Street on the north, East Side Drive on the east, Leland Street on the south, and Brackenridge Street on the west.

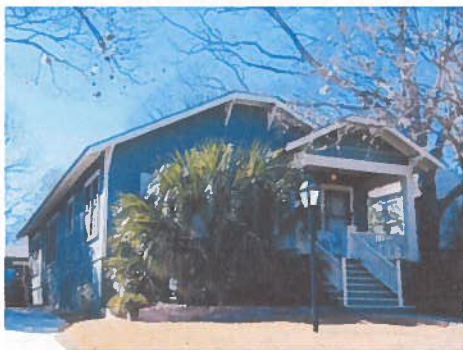
511 Lockhart Drive is a good example of the **Craftsman** style in the Blue Bonnet Hills Historic District. This single-family, rectangular plan dwelling was constructed in 1928. The structure has clapboard siding and rests on a masonry pier and beam foundation. The windows are double hung and feature wooden screens. The glazed front door also has a screen door. The roof is a front-facing jerkinhead gable featuring an extended cornice, exposed rafters, and brackets. The partial-width front porch features a smaller jerkinhead gable and mimics the detailing of the larger gable. The porch is supported by square posts and features wood railings and banisters.

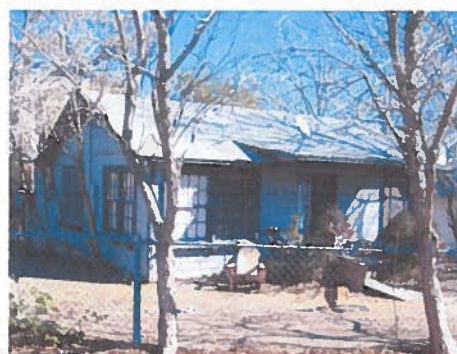
500 Lockhart Drive is a good example of the **Minimal Traditional** style. Constructed in 1950, this one-story, side-gabled, massed plan house is clad in wood. The low-pitched roof has composition shingles. Consistent with the simplicity of design common to Minimal Traditional style homes, the house has a little architectural detailing. The windows are double hung wood, featuring eight-over-eight and six-over-six pane styles. A partial width porch features a shed roof and metal porch supports.

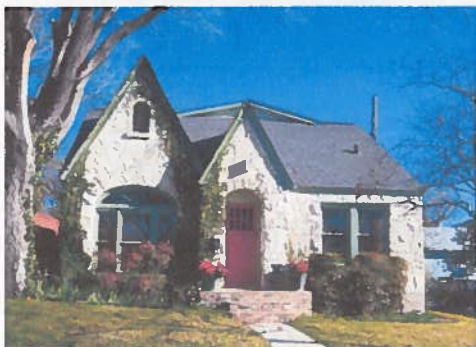
514 Terrace Drive is a good example of the **Tudor Revival** style. The house was constructed in 1937 and features rubblework masonry exterior walls. The roof is comprised of composition shingles with steeply pitched front gables typical of the Tudor style. The larger gable features a decorative arched attic vent echoing the arched fanlight window below. The entryway is also arched, with a glazed front door.

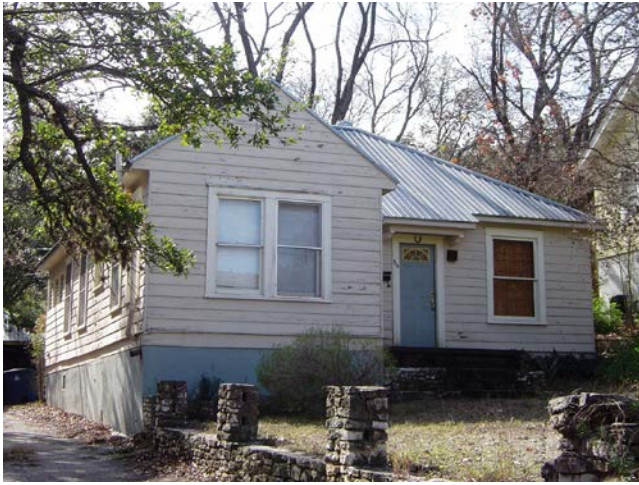
L-Plan House (515 Annie St.)

Most L-plan houses were constructed after the arrival of the railroad using milled lumber with prefabricated decorative elements. These houses typically are one or one-and-a-half stories in height with an L-shaped floor plan and a cross-gabled roof form. Historic additions to the rear of the building are typical. L-plan houses are usually set back with a front yard. Wood or cast iron fences may be present. Original barns or sheds may be present. Although not original, detached garages may have been added within the district's period of significance.

- Exterior Walls: Typically constructed with wood siding or wood shingles finished with paint, although occasionally brick or stone.
- Foundation: Pier and beam, typically with brick or wood piers.

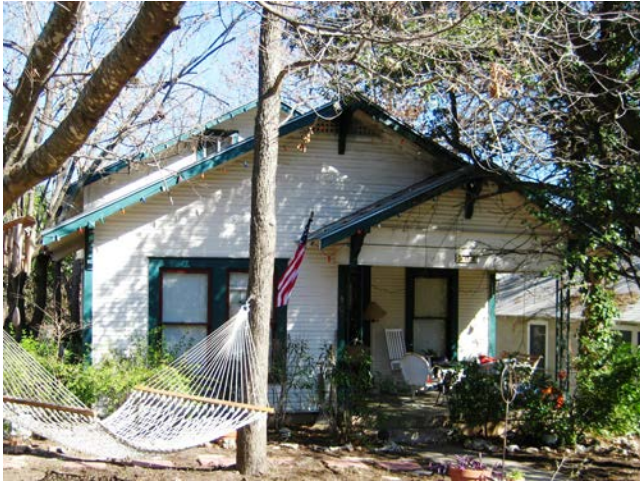
Front-gabled Bungalow (502 Lockhart Dr.)

The bungalow is a nationally popular house form that was always constructed after the arrival of the railroad, and typically constructed after local popularization of the automobile. Bungalow plans were standardized, often distributed through lumber companies. Bungalows are usually one-story in height, but sometimes one-and-a-half or two-stories. Floor plans usually are organized with the living room, dining room, and kitchen aligned on one side of the house, and the bedrooms aligned on the other side, so that corridor space is minimized. In Austin, bungalows typically are set back from the street, with a front yard. Concrete sidewalks or driveway runners may be present. Because bungalows often were constructed after the advent of the automobile, a detached garage may be associated with the house, and/or a porte cochere attached to a side of the house.

- Exterior Walls: Typically constructed of milled lumber with wood siding finished with paint, but sometimes constructed of brick or stone masonry.
- Foundation: Typically pier and beam with brick piers, but sometimes concrete stem wall and footing.

Additions to contributing structures allow the buildings to retain integrity and are therefore commonly found at the rear of the house and executed with compatible materials and scale. 502 Lockhart Drive provides an example of a half-story addition that is compatible with the existing character.

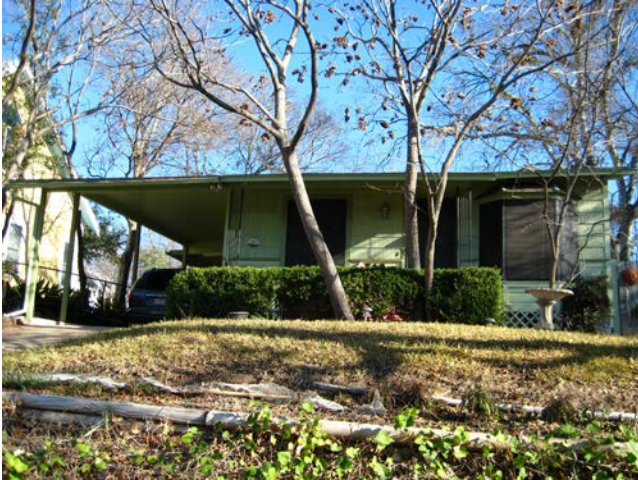
Compact Ranch Form (510 Terrace Dr.)

The Ranch house probably is the most common house form found in Austin. These houses were constructed nationwide beginning ca. 1940 and continuing with the post-World War II housing boom. Ranch houses were constructed using prefabricated building materials, and often standardized plans were repeated within subdivisions. The Ranch house form is nearly always one-story. The footprint may be rectangular, L-plan, rambling and irregular, or even split-level. The interior floor plan of a Ranch house is open, with free-flowing living, dining, and kitchen spaces, many of which open out to outdoor spaces, such as courtyards or patios. Ranch houses typically lack applied architectural ornament, and instead feature details integral to the design of the house that are influenced by the Ranch Style, Modern Style, or Contemporary Style. In Austin, neighborhoods of Ranch houses include typically suburban landscape patterns, with houses set back from the street with a front yard. Concrete sidewalks and driveways are often present. Garages or carports are integral to the overall form and design of the Ranch house, and most examples include an attached carport or one- or two-car garage.

- Foundation: Typically concrete slab.
- Porches: Typically partial-width and recessed under the main roof form. Often feature geometric wood or decorative metal porch supports, or porch roof may be cantilevered. Porch floors typically concrete. Brick or stone planters sometimes integrated into porch design.

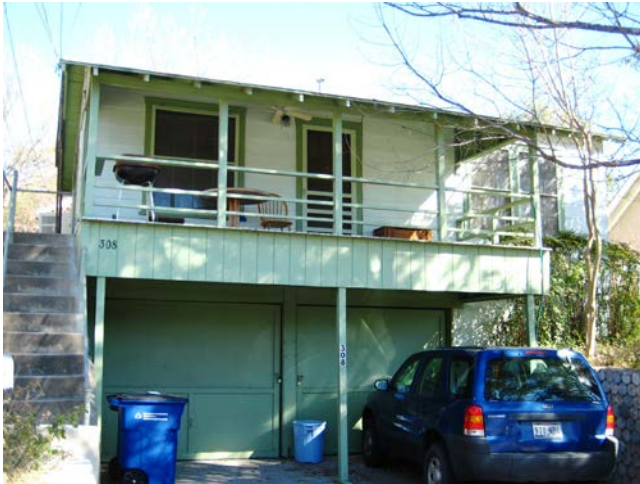
Detached Garage Apartment (308 Leland St)

The detached garage is the overwhelmingly most common historic domestic outbuilding found in Austin. Detached garages typically are one-story in height with a rectangular footprint and a single, open interior space. Garage apartments may be two stories in height, with an open garage space on the ground floor and a living space above. Some domestic properties retain agricultural outbuildings, such as barns or sheds, which pre-date the residential development of the surrounding neighborhood. Domestic outbuildings typically are sited at the rear of the lot, behind the main house.

- Exterior Walls: Most commonly wood siding or board-and-batten, but may be brick or stone.
- Foundation: Usually poured concrete slab, but some examples have no foundation, only a dirt floor.
- Porches: Domestic outbuildings seldom include porches.
- Roofs: Roof form most often front-gabled, but may be side-gabled or hipped. Roofing material usually matches the associated main house.
- Windows: Usually limited to side façades. Window materials and configuration typically match associated main house.
- Doors: In garages, overhead rolling doors are common, but original hasp-hung doors or hinged doors may be present.
- Chimneys: Domestic outbuildings seldom include chimneys.

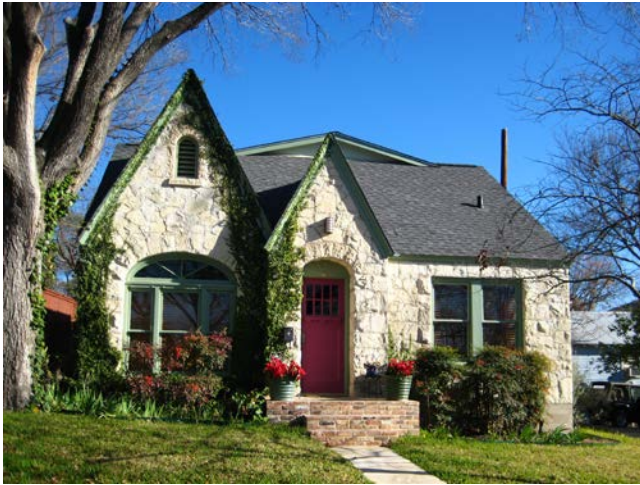
Tudor Revival House (514 Terrace Dr.)

- Building Form: Bungalow, L-plan, or irregular.
- Exterior Walls: Usually brick masonry in varying colors, patterns, and textures, with exaggerated mortar joints, sometimes seeping. Sometimes stucco. Faux half-timbering often adorning gable-ends. Wing walls or buttresses sometimes accenting front façade.
- Foundation: Usually skirted with brick.
- Porches: If present, sometimes include low-sloped Gothic arches supported by brick piers.
- Roofs: Gable-on-hip or front gabled. Often complex. Eaves sometimes swept.
- Windows: Usually double-hung wood sash. Window openings sometimes feature low-sloped Gothic arches. Sometimes feature picture windows with leaded glass in a lattice pattern.
- Doors: Round-arched wood doors with small lites.
- Chimneys: Prominent brick chimneys, often on front façade. Sometimes feature chimney caps with corbelling or crenellations.

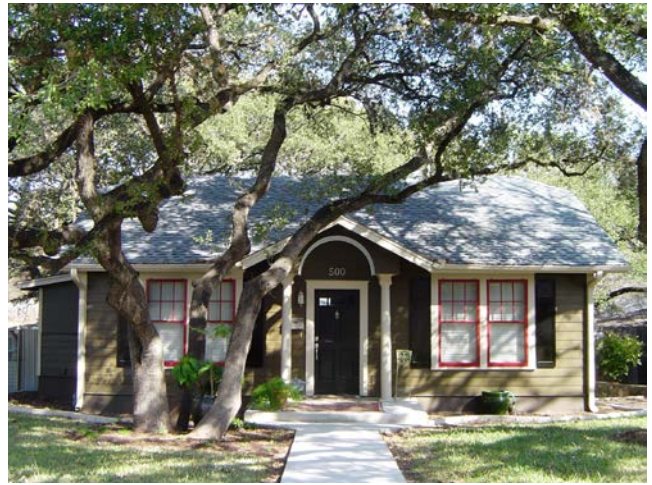
Colonial Revival House (500 Mary St.)

- Building form: American four-square, two-story center-passage, or bungalow.
- Exterior walls: Typically red brick.
- Foundations: Typically pier and beam skirted with brick.
- Porches: Often lack porches. Sometimes include front-gabled or arched awnings over the main entrance, supported by brackets. If present, porches usually partial-width, with front-gabled roof supported by white wood or stone columns.
- Roofs: Side-gable. Wood cornice and enclosed eaves, often painted white.
- Windows: Typically double-hung wood sash, painted white. Often flanked by wood shutters.
- Doors: Typically wood, sometimes topped with fanlights. Commonly include sidelights, ornate door surrounds, pediments, etc.
- Chimneys: Typically red brick.

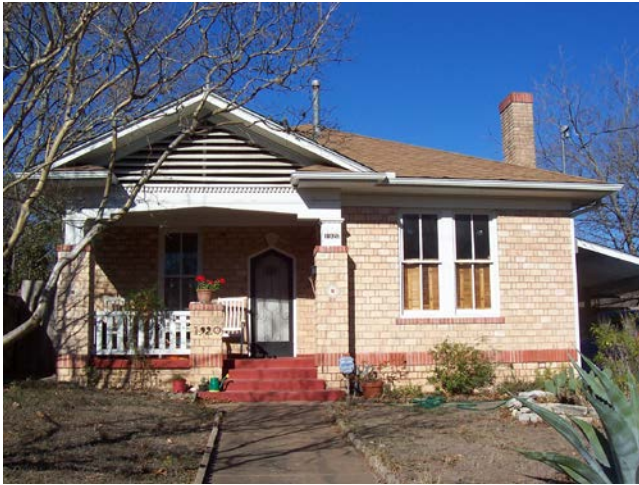
Prairie Style House (1920 Newning Ave.)

- Building Form: American four-square, L-plan or bungalow.
- Exterior Walls: Typically brick or stone, with wood trim details .
- Foundation: Typically skirted with wood, stone or brick.
- Porches: Partial-width or full-width, often with front-gabled roof, typically supported by tapered wood or massive square stone or brick columns.
- Roofs: Low-sloped hipped or gabled, with deep eaves, often with clean, boxed ends.
- Windows: Typically double-hung wood sash, often with decorative transoms and wood screens with geometric detail.
- Doors: Typically wood with glazing, sometimes with transoms and sidelights.
- Chimneys: Brick, sometimes with corbelling or stone coping.

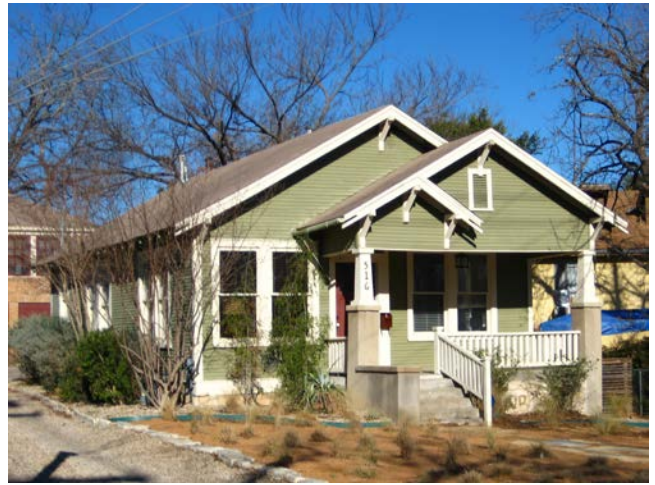
Craftsman House (516 Leland St.)

- Building Form: L-plan or bungalow.
- Exterior Walls: Typically wood siding or asbestos shingle, sometimes brick. Sometimes feature wood shingle detailing.
- Foundation: Typically skirted with wood or brick. Skirt walls sometimes battered.
- Porches: Partial-width or full-width, often with front-gabled roof, typically supported by tapered wood or stone columns but sometimes supported by decorative metal posts.
- Roofs: Low-sloped hipped or gabled, with deep eaves, often with exposed rafter ends.
- Windows: Typically double-hung wood sash, often with wood screens with geometric detail.
- Doors: Typically wood with glazing, sometimes with transoms and sidelights.
- Chimneys: Brick, sometimes with corbelling or stone coping.

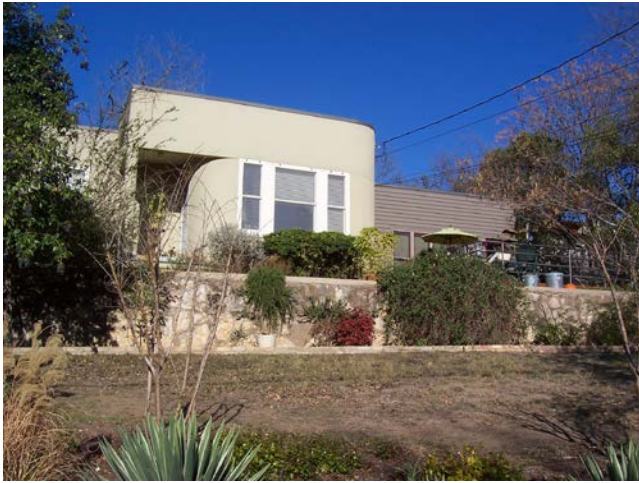
Modernistic House (1928 Newning Ave.)

- Building Form: Split-Level or irregular.
- Exterior Walls: Often smooth stucco, sometimes with brick detailing
- Foundation: Concrete slab.
- Porches: If present, typically a small stoop or recessed assymetrically.
- Roofs: Flat with parapet, sometimes with small coping at roof line
- Windows: Steel fixed and casement frames, also often round “porthole” windows and glass brick; windows often wrap corners
- Doors: Wood, often with small simple square or circular lites.
- Chimneys: If present, broad and simple stuccoed brick or stone.

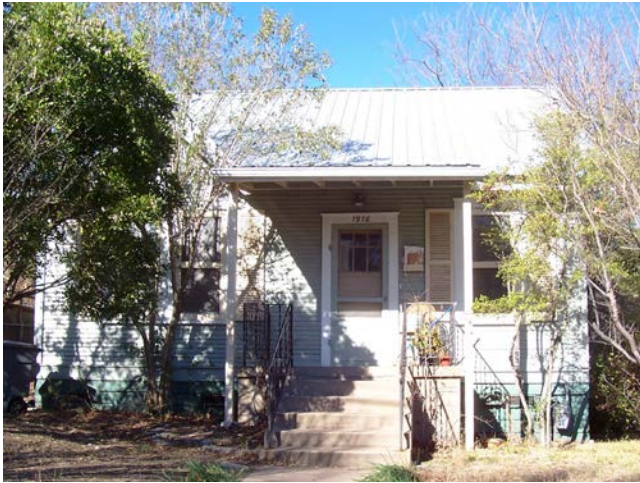
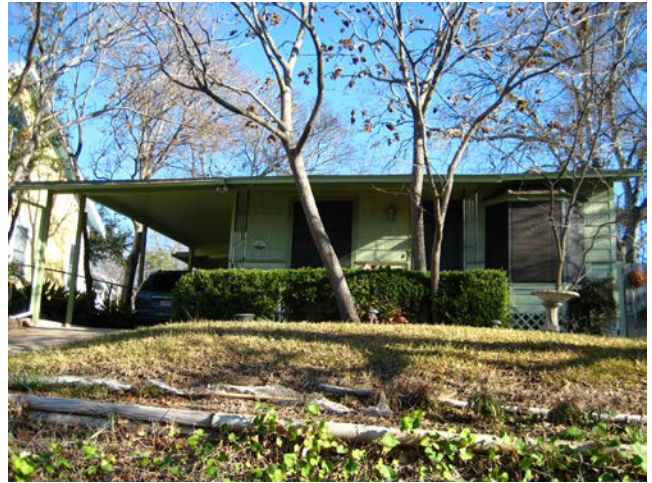
- Building Form: L-plan, modified L-plan, bungalow, or ranch.
- Exterior walls: Wood siding or asphalt shingle. Decorative wood shingles, board-and-batten, or waney-edge siding sometimes present at gable ends. Brick or stone veneer sometimes present at water table.
- Foundation: Pier and beam with wood skirt, or concrete slab.
- Porches: Typically partial-width, supported by simple wood posts, geometric wood posts, or decorative metal posts.
- Roofs: Cross-gabled or gable-on-hip.
- Windows: Casement or double-hung, wood or metal sash. Fixed picture windows sometimes present at front façade. Decorative wood shutters common.
- Doors: Wood, often with small lites in geometric patterns.
- Chimneys: If present, simple brick or stone.

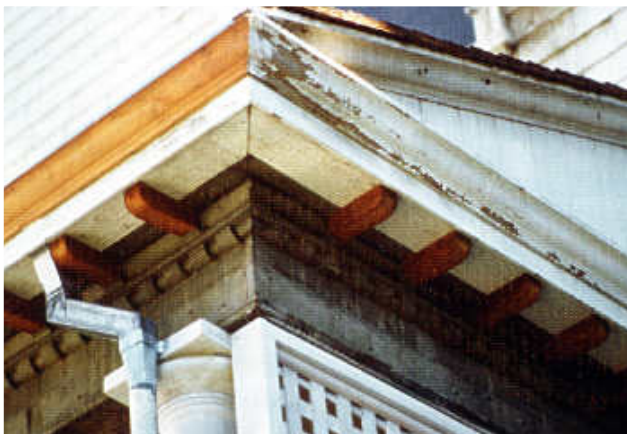
Damaged exterior wall materials can be repaired or replaced in kind, as in this example of a replaced fascia board. --
http://www.cr.nps.gov/hps/tps/standguide/preserve/preserve_wood.htm

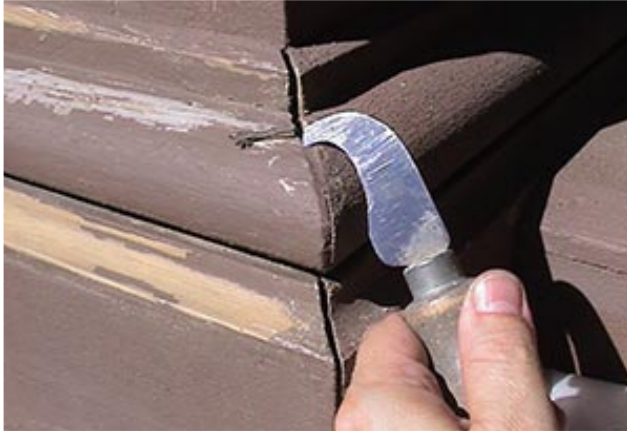
Cracks and unpainted wood on porch elements can lead to decay due to water seepage. Proper caulking and painting can help preserve these elements.--
<http://www.nps.gov/tps/how-to-preserve/briefs/45-wooden-porches.htm>

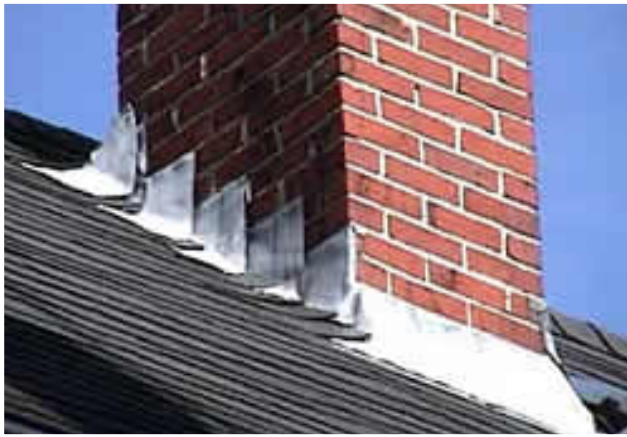
Protect and maintain a roof by cleaning the gutters and downspouts and replacing deteriorated flashing.--
http://www.cr.nps.gov/hps/tps/standguide/rehab/rehab_oofs.htm

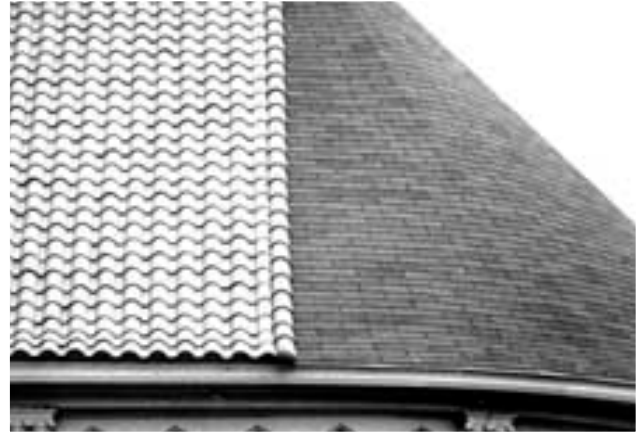
Asphalt shingles are an incompatible replacement substitute for the original Spanish clay tiles.--
http://www.cr.nps.gov/hps/tps/standguide/rehab/rehab_oofs.htm

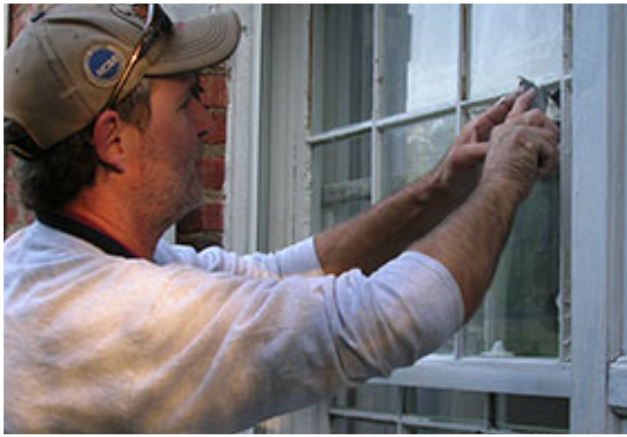
Glazing putty on historic windows should be maintained in sound condition to prevent unwanted air infiltration and water damage.--<http://www.nps.gov/tps/how-to-preserve/briefs/47-maintaining-exterior.htm>

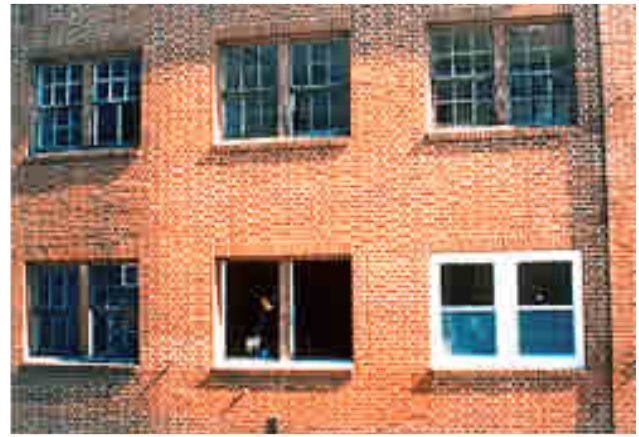
Do not replace historic windows with new windows that do not convey the same visual appearance.--
http://www.cr.nps.gov/hps/tps/standguide/rehab/rehab_windows.htm

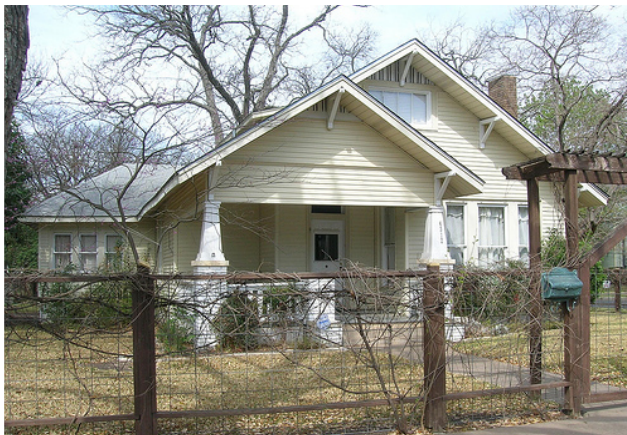
This side addition (to the left) is compatible because it is set back from the front of the house.

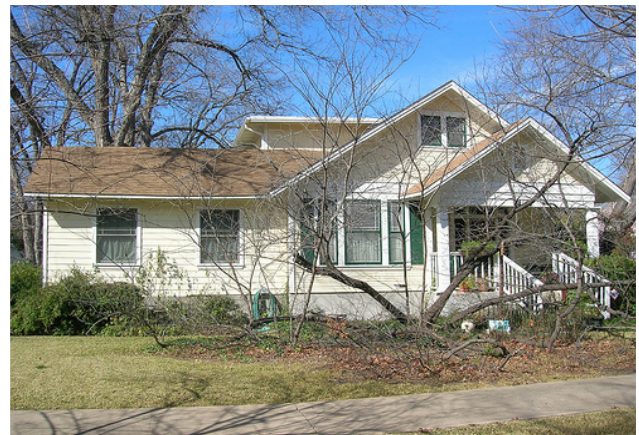
This side addition is incompatible because it is flush with the front of the house.

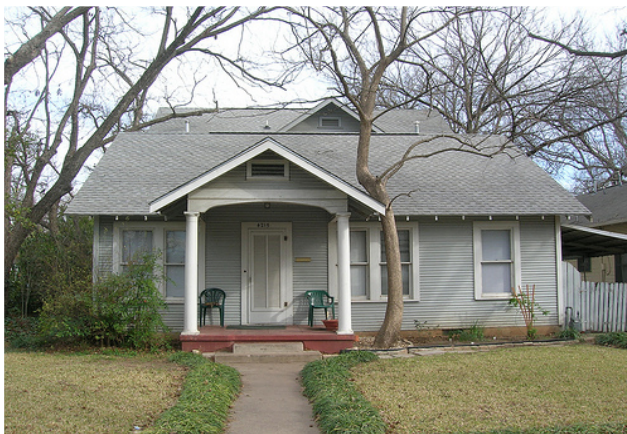
This rear addition is compatible because it is subordinate to the main house

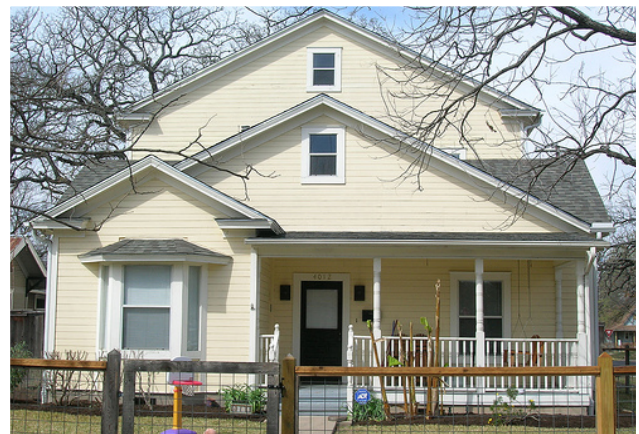
This rear addition is incompatible because it is too dominant compared to the main house.

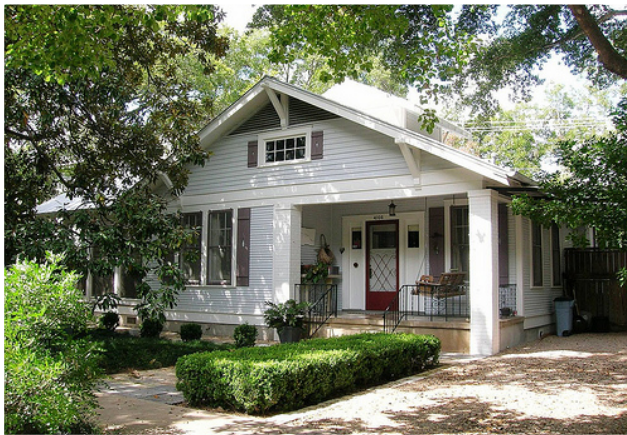
This roof pop-up is compatible because it is located near the back the house and is subordinate in design to the house.

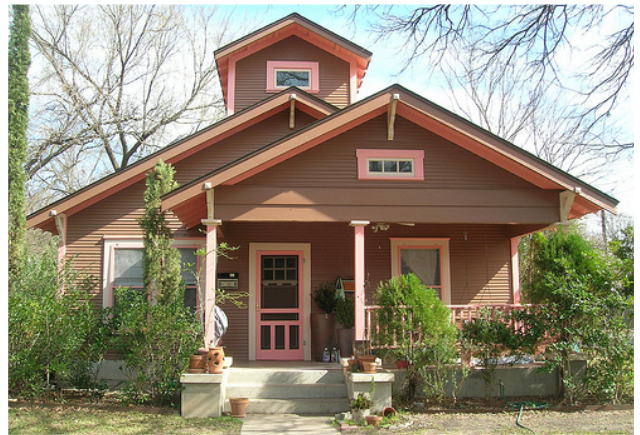
This roof pop-up is not compatible because it is set too far forward and dominates the design of elements on the original house.

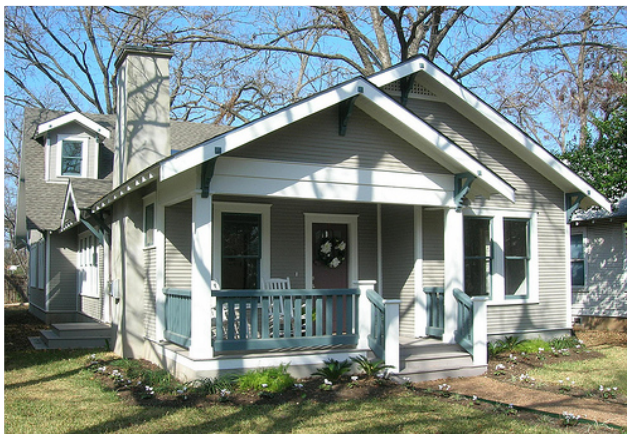
Even though this rear addition has as a potentially-dominant front facing dormer, it is compatible because it is set back far from the front of the house.

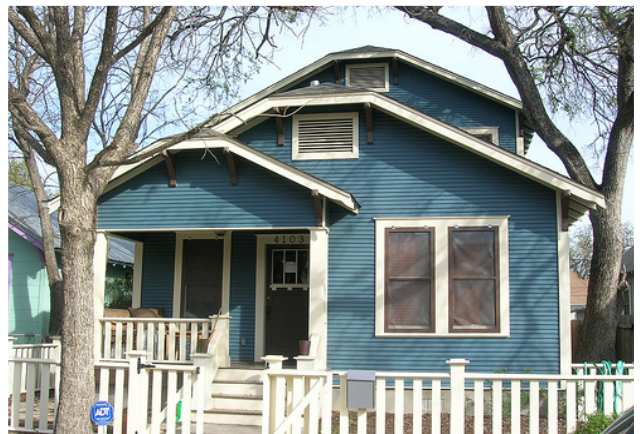
This rear addition is questionably compatible. It is set back from the front of the house but it might be too high and its design might not be differentiated enough. This proposal would need further review.

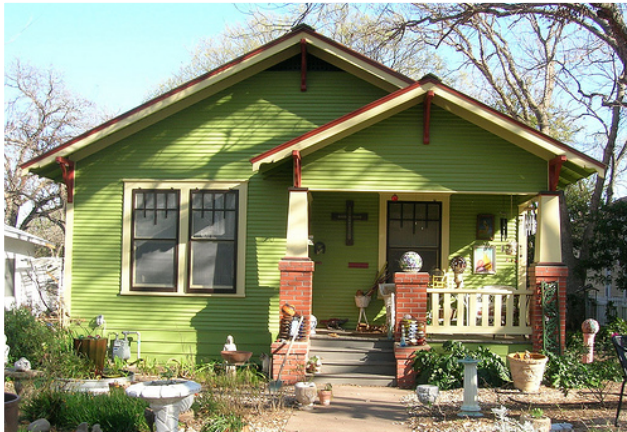
This house has a very compatible two-story rear addition. It is not visible from the street.

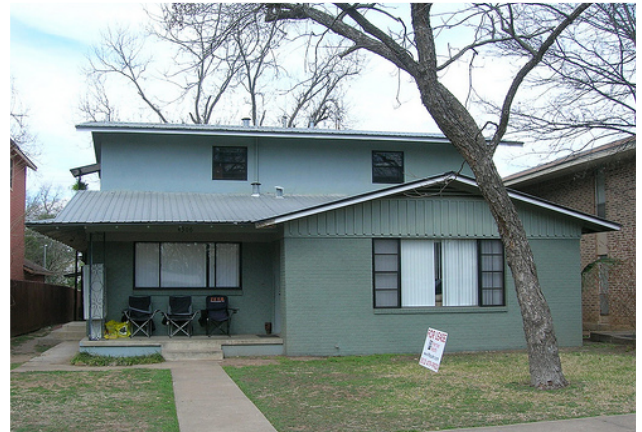
This second story addition is not compatible because it is highly visible from the street.

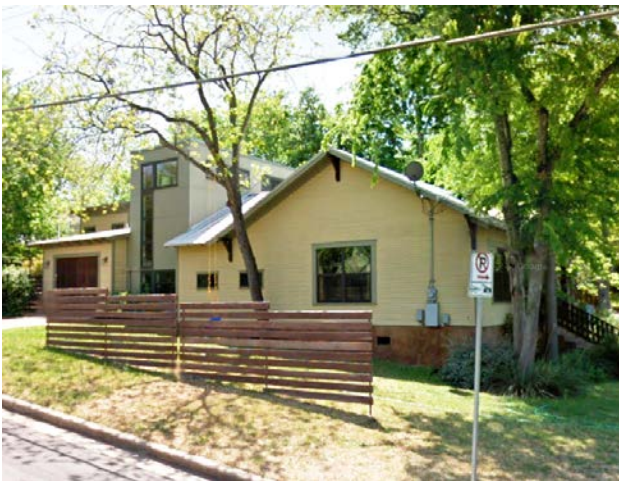
The contemporary two-story addition behind this house is compatible because it is located in the rear of the property and is subordinate in scale to the main house

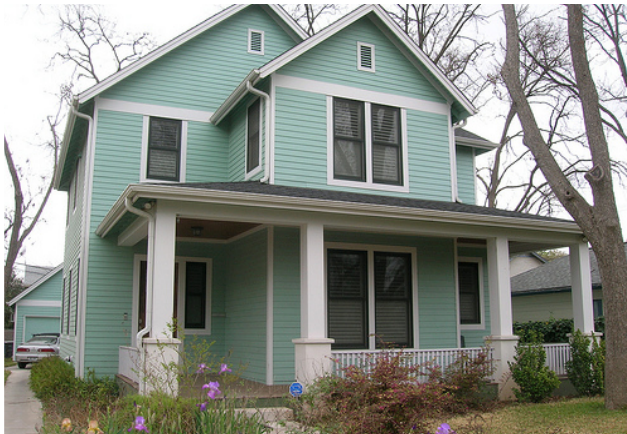
This 2004 house is compatible with the district because it places its garage at the rear of the parcel.

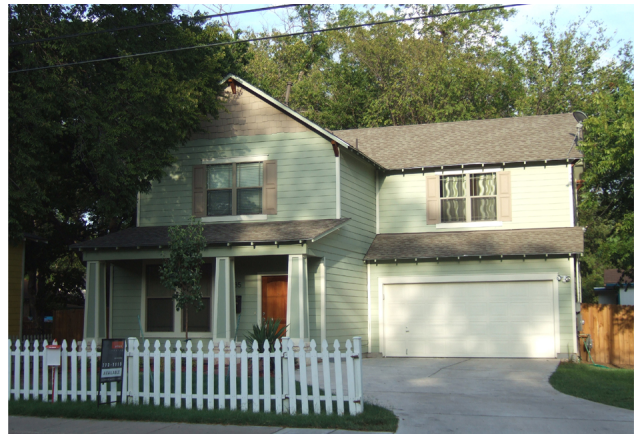
This 2006 house is not compatible because its garage is situated too close to the front of the house.

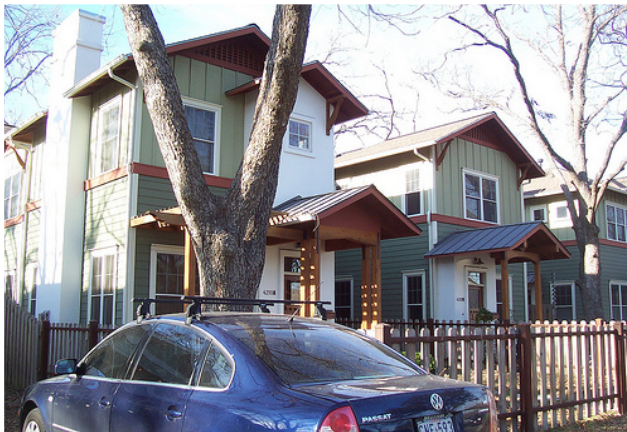
This new multiple dwelling development is compatible because each unit is a separate building facing the street. The units are compatible in scale and design.

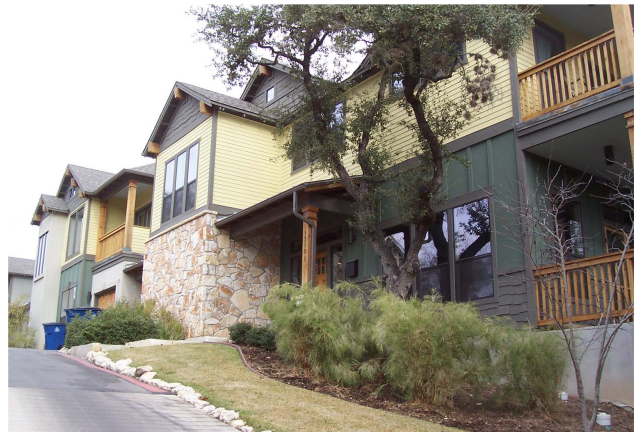
This new multiple dwelling development is not compatible because it is a single large building that faces an internal driveway instead of the public street.

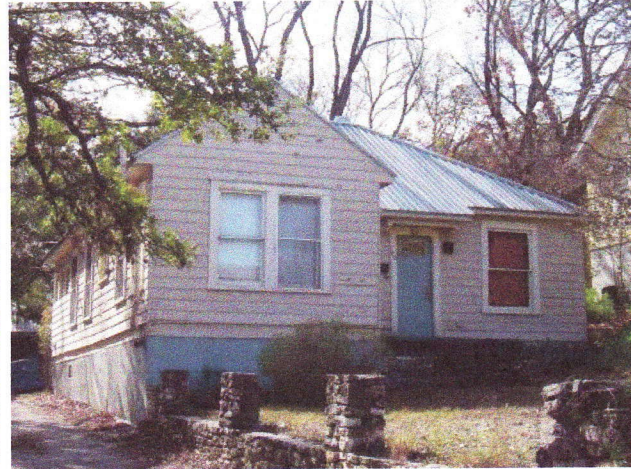
515 E Annie St

Date of Construction	1933 Source: City Directories	Roof Type	Hipped with Gable	Porch Railings	None
Stylistic Influences	Minimal Traditional	Roof Materials	Metal	Outbuildings	1 Story Detached Garage, Garage Wall Material: Wood, Garage Roof Material: Metal, Garage Roof Type: Hipped
Historic Use	Dwelling, single	Number of Chimneys	Exterior: 0, Interior: 0	Landscape Features	Stone retaining wall along driveway w/2' stone piers, concrete walk
Current Use	Dwelling, single	Windows	Wood Double Hung	Moved	Has Not Moved
Stories	1	Door Features	Glazing, Not Original		
Plan	Square or rectangular	Porch Type	Stoop Roof		
Foundation	Pier-and-Beam	Porch Supports	None		
Exterior Materials	Wood

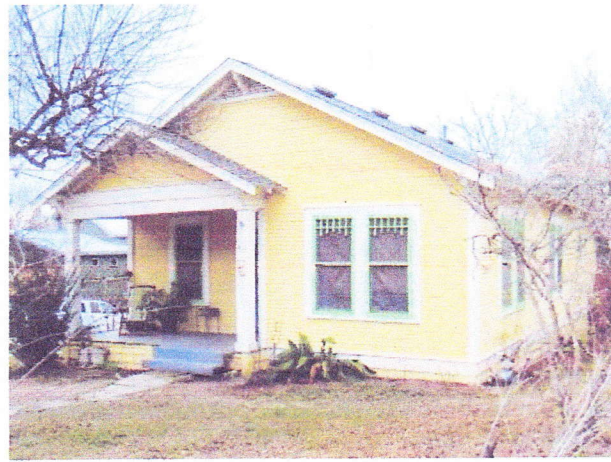
Property ID **283213**
411 Terrace Dr

CONTRIBUTING

Date of Construction	1930	Roof Type	Front Gable	Porch Supports	Square Full Height Wood
Source	City Directories	Roof Materials	Composition shingles	Porch Railings	None
Stylistic Influences	Craftsman	Roof Decoration	Exposed Rafter Ends, Brackets	Moved	Has Not Moved
Historic Use	Dwelling, single	Number of Chimneys	Exterior: 0, Interior: 0	Integrity	Possible rear porch enclosure.
Current Use	Dwelling, single	Windows	Wood Double Hung, Decorative Screens		
Stories	1	Porch Type	Partial Width, Independent		
Plan	Square or rectangular	Porch Roof Types	Gabled		
Foundation	Pier-and-Beam				
Exterior Materials	Wood

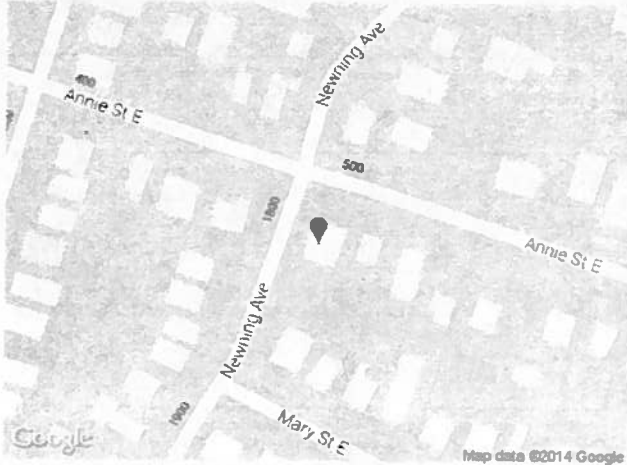
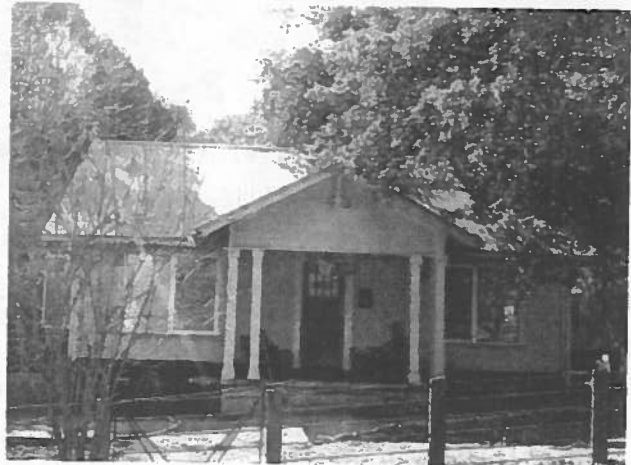
Property ID 283371
501 E Annie St

Date of Construction	1931 Source: City Directories	Roof Materials	Metal	Porch Supports	Square Full Height Wood
Stylistic Influences	Craftsman	Roof Decoration	Brackets	Porch Railings	None
Historic Use	Dwelling, single	Number of Chimneys	Exterior: 1, Interior: 0	Fences	Two fences: 6ft corrugated metal w/wood posts and 4ft iron w/wood posts
Current Use	Dwelling, single	Chimney Materials	Metal	Outbuildings	1 Story Detached Garage, Garage Wall Material: Wood, Garage Roof Material: Composition shingles
Stories	1	Windows	Aluminum	Moved	Has Not Moved
Plan	Square or rectangular	Door Features	Glazing	Integrity	Windows replaced, chimney material replaced
Foundation	Pier-and-Beam	Porch Type	Partial Width		
Exterior Materials	Wood	Porch Roof Types	Gabled		
Roof Type	Side Gable

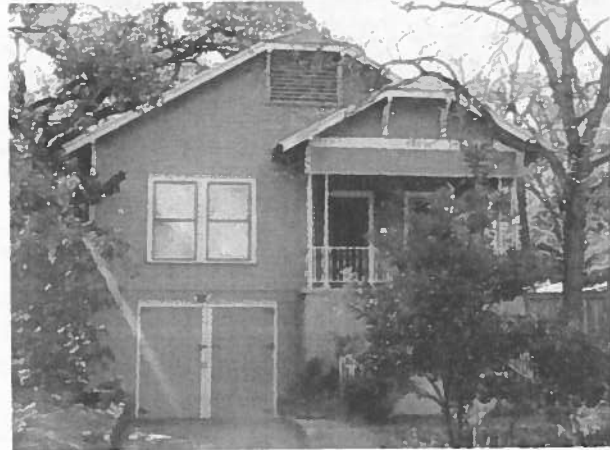
Date of Construction	1935 Source: City Directories	Roof Materials	Composition shingles	Porch Railings	Metal
Stylistic Influences	Craftsman	Roof Decoration	Exposed Rafter Ends, Clipped Gables, Brackets	Outbuildings	Attached single-story garage
Historic Use	Dwelling, single	Number of Chimneys	Exterior: 0, Interior: 0	Landscape Features	Concrete walkway
Current Use	Dwelling, single	Windows	Wood Double Hung	Moved	Has Not Moved
Stories	1	Door Features	Glazing		
Plan	Square or rectangular	Porch Type	Partial Width, Inset		
Foundation	Pier-and-Beam	Porch Roof Types	Gabled Clipped		
Exterior Materials	Wood, Stucco	Porch Supports	Metal		
Roof Type	Front Gable

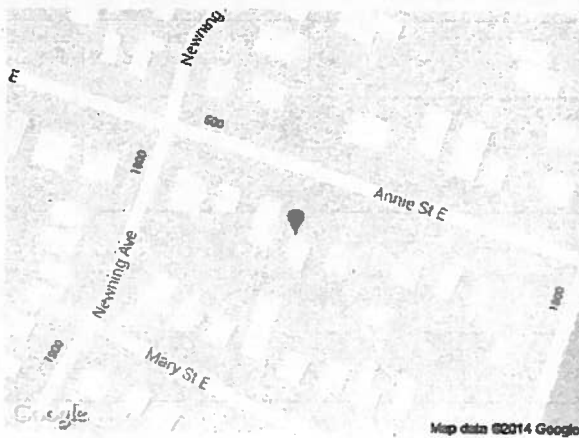
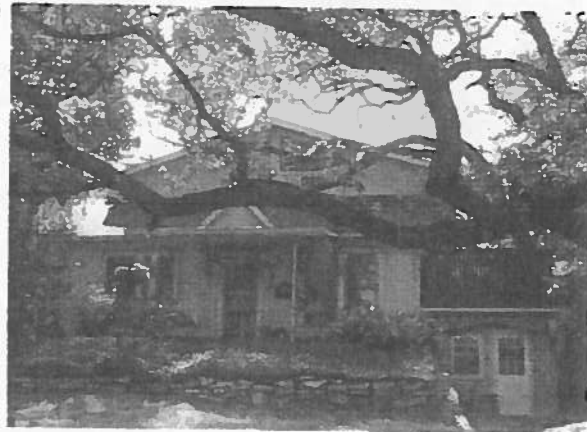
Property ID 283374
507 E Annie St

Date of Construction	1937 Source: TCAD	Roof Decoration	Exposed Rafter Ends, Brackets	Landscape Features	4ft stone retaining wall
Stylistic Influences	Craftsman	Number of Chimneys	Exterior: 0, Interior: 0	Moved	Has Not Moved
Historic Use	Dwelling, single	Windows	Wood Double Hung, Decorative Screens	Integrity	2nd-story addition, side addition w/deck above, new porch roof
Current Use	Dwelling, single	Door Features	Glazing		
Stories	2	Porch Type	Partial Width, Independent		
Plan	Square or rectangular	Porch Roof Types	Flat		
Exterior Materials	Wood	Porch Supports	Metal		
Roof Type	Front Gable	Porch Railings	None		
Roof Materials	Composition shingles

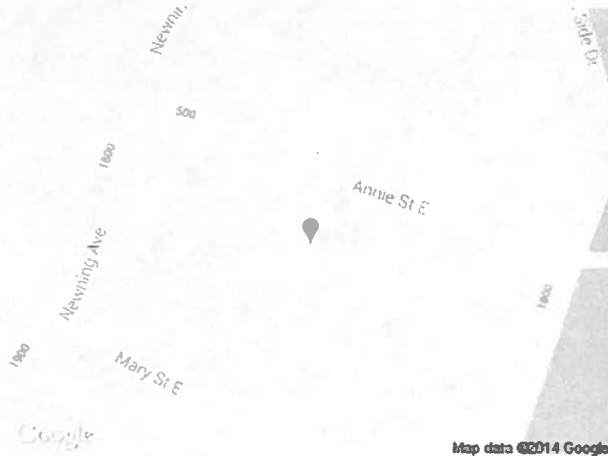
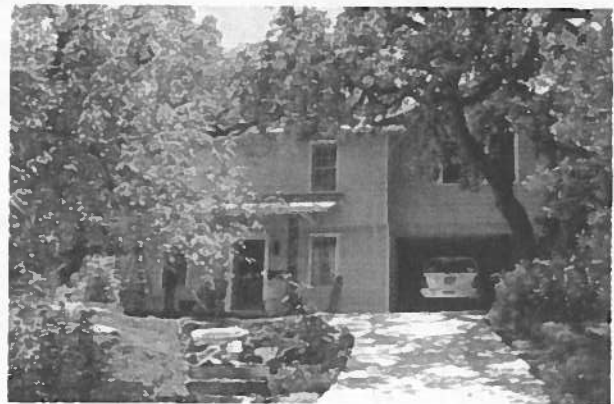
Property ID **283375**
509 E Annie St

Date of Construction	1940 Source: TCAD	Roof Type	Side Gable	Porch Supports	Metal
Stylistic Influences	Colonial Revival	Roof Materials	Composition shingles	Porch Railings	None
Historic Use	Dwelling, single	Number of Chimneys	Exterior: 0, Interior: 0	Landscape Features	1' stone retaining wall, concrete walk
Current Use	Dwelling, single	Windows	Wood Double Hung, 6/6/2010	Moved	Has Not Moved
Stories	2	Door Features	Glazing	Integrity	New side addition
Plan	Square or rectangular	Porch Type	Partial Width, Independent		
Foundation	Pier-and-Beam	Porch Roof Types	Flat		
Exterior Materials	Asbestos

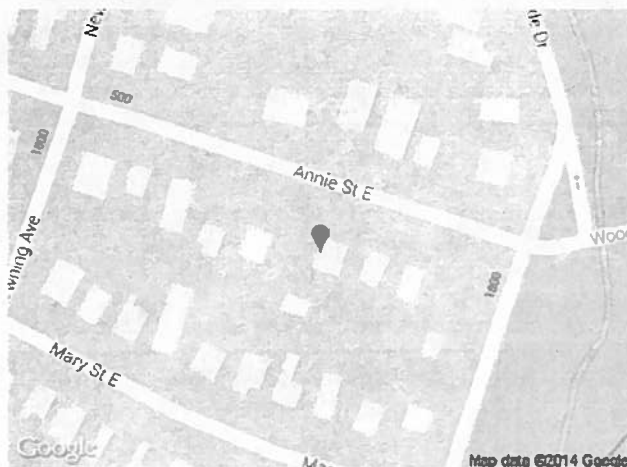
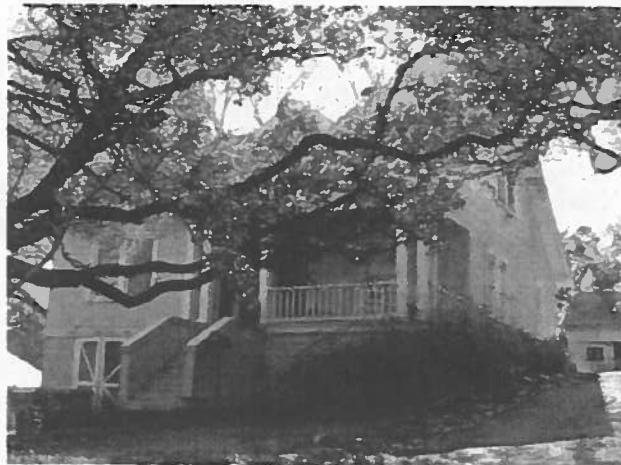
Property ID **817418**
513 E Annie St

Date of Construction	1935 Source: City Directories	Roof Type	Cross Gable	Porch Supports	Square Full Height Wood
Stylistic Influences	Craftsman	Roof Materials	Composition shingles	Porch Railings	Square Wood
Historic Use	Dwelling, single	Number of Chimneys	Exterior: 0, Interior: 0	Outbuildings	1 Story Detached Garage, Garage Wall Material: Wood, Garage Roof Material: Composition shingles, Garage Roof Type: Gabled
Current Use	Dwelling, single	Windows	Wood Double Hung	Landscape Features	4' Concrete walls around front steps; non-historic
Stories	1.5	Door Features	Glazing	Moved	Has Not Moved
Plan	Square or rectangular	Porch Type	Partial Width, Integrated		
Foundation	Pier-and-Beam	Porch Roof Types	Gabled		
Exterior Materials	Asbestos

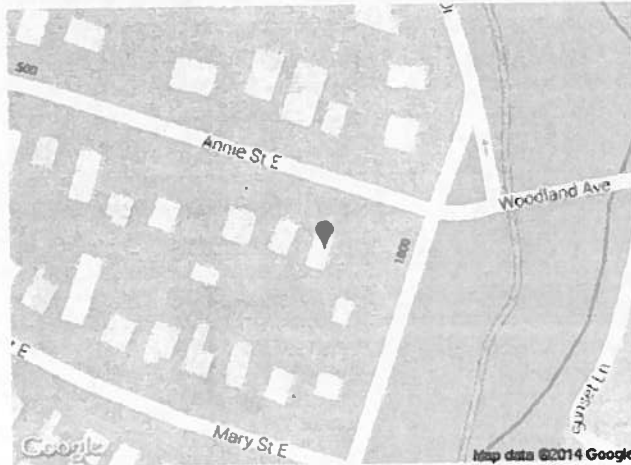
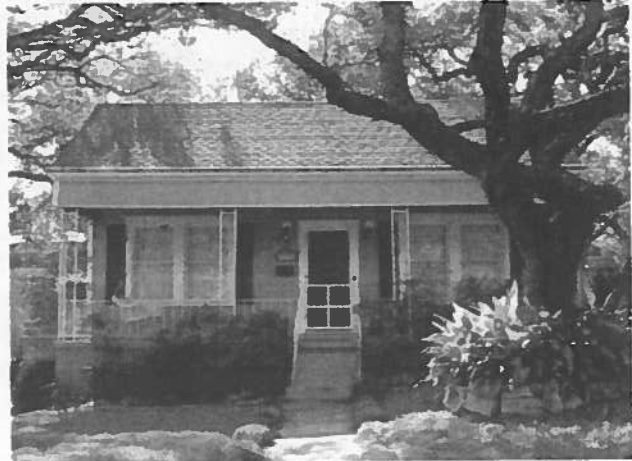
Property ID **283378**
517 E Annie St

Date of Construction	1946 Source: TCAD	Roof Type	Side Gable	Porch Supports	Metal
Stylistic Influences	Minimal Traditional	Roof Materials	Composition shingles	Porch Railings	Metal
Historic Use	Dwelling, single	Number of Chimneys	Exterior: 1, Interior: 0	Outbuildings	1 Story Detached Garage, Garage Wall Material: Wood, Garage Roof Material: Composition shingles, Garage Roof Type: Gabled
Current Use	Dwelling, single	Chimney Materials	Brick	Landscape Features	1-3' stone wall along driveway
Stories	1	Windows	Wood Double Hung	Moved	Has Not Moved
Plan	Square or rectangular	Door Features	Glazing	Integrity	Garage converted
Foundation	Pier-and-Beam	Porch Type	Full Width, Inset		
Exterior Materials	Asbestos

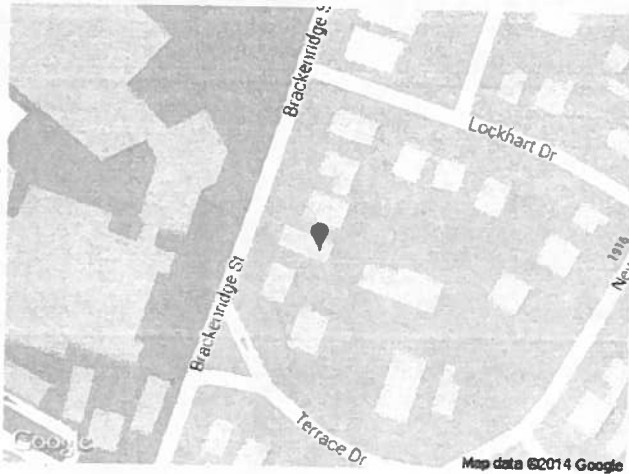
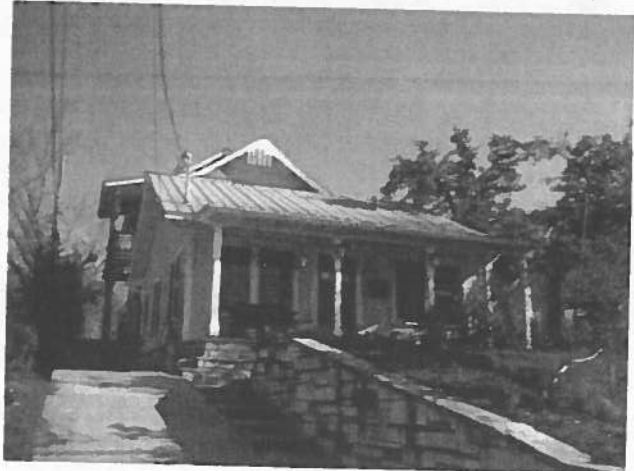
1913 Brackenridge St

Date of Construction	1935 Source: TCAD	Roof Type	Side Gable	Porch Roof Types	Shed
Stylistic Influences	Craftsman	Roof Materials	Metal	Porch Supports	Square Full Height Wood
Historic Use	Dwelling, single	Roof Decoration	Brackets	Porch Railings	None
Current Use	Dwelling, single	Number of Chimneys	Exterior: 0, Interior: 0	Landscape Features	3' stone retaining wall. Raised lot.
Stories	2	Windows	Wood Double Hung, w/new screens	Moved	Has Not Moved
Plan	Square or rectangular	Door Features	Glazing	Integrity	Large two-story addition circa 2008. Porch rebuilt.
Foundation	Pier-and-Beam	Porch Type	Full Width, Independent		
Exterior Materials	Wood

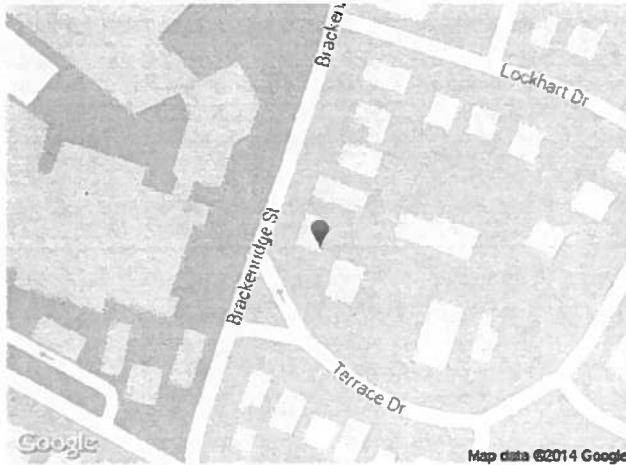
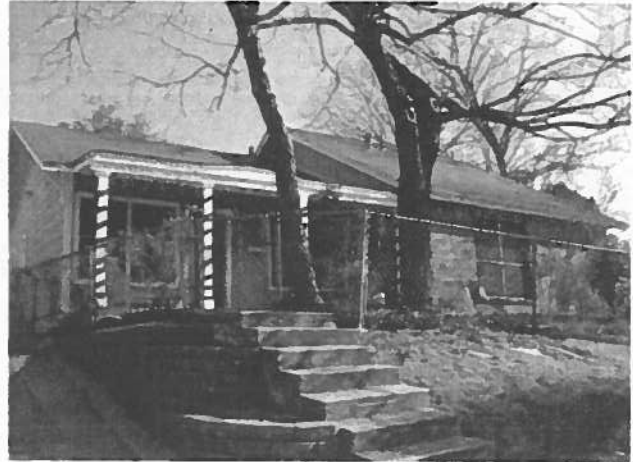
1915 Brackenridge St

Date of Construction	1950	Integrity	Large brick addition on side. Porch rebuilt.
Source	TCAD		
Stylistic Influences	None		
Historic Use	Dwelling, single		
Current Use	Dwelling, single		
Stories	1		
Moved	Has Not Moved

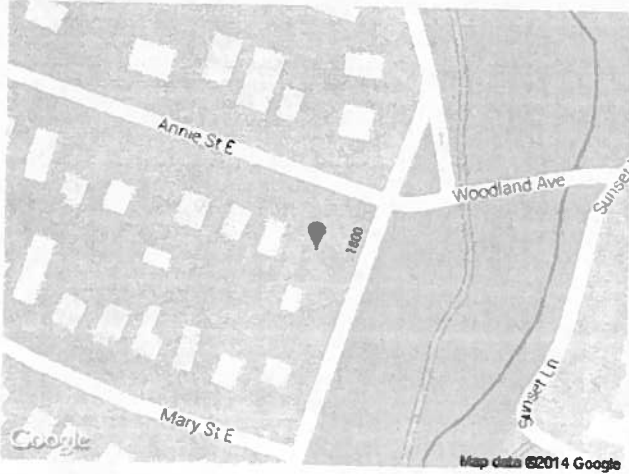
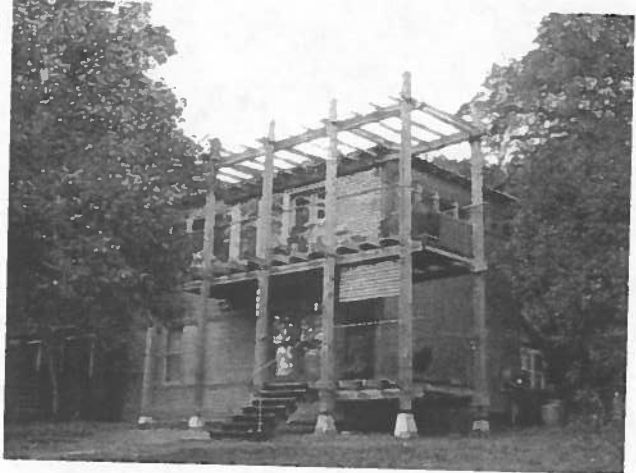
1802 East Side Dr

Date of Construction 1940
Source: TCAD
Stylistic Influences None
Historic Use Dwelling, single
Current Use Dwelling, single
Stories 2
Moved Has Not Moved

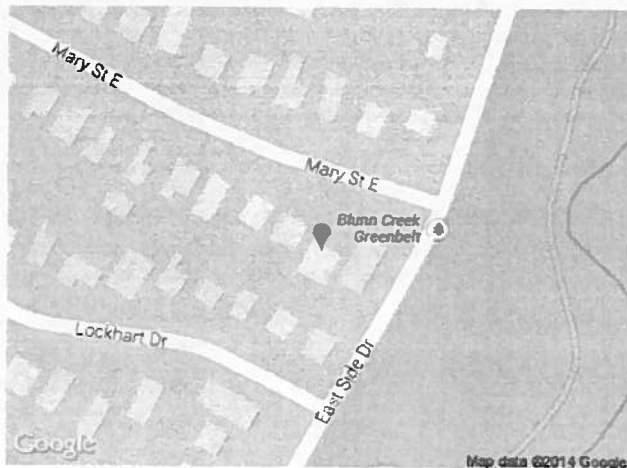
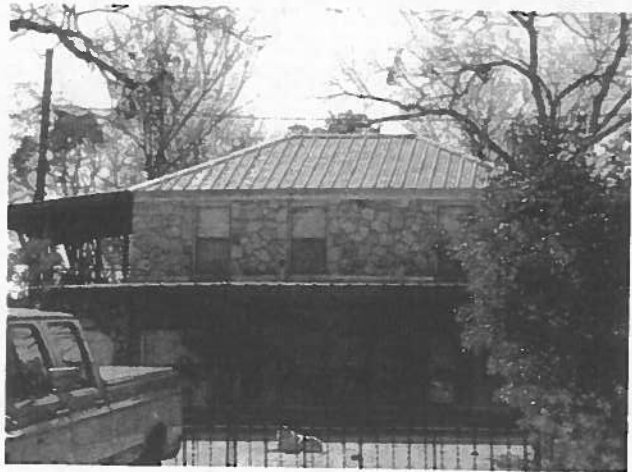
519 E Mary St

Date of Construction	Estimated 1939	Roof Type	Hipped	Porch Railings	Other, Wood and wire
Stylistic Influences	Minimal Traditional	Roof Materials	Metal	Moved	Has Not Moved
Historic Use	Garage Apartment	Number of Chimneys	Exterior: 0, Interior: 0	Integrity	Garage enclosed with windows and siding. Second story porch roof added. Porch altered.
Current Use	Dwelling, single	Windows	Wood Double Hung, Vinyl		
Stories	2	Porch Type	Full Width, Independent		
Plan	Square or rectangular	Porch Roof Types	Shed		
Foundation	Perimeter Wall	Porch Supports	Square Full Height Wood		
Exterior Materials	Stone

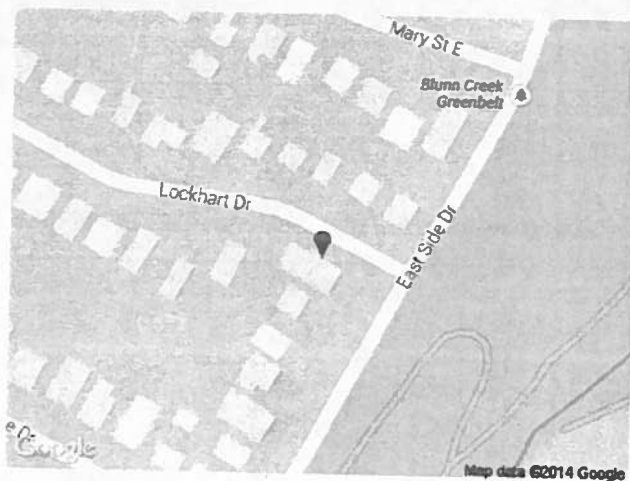
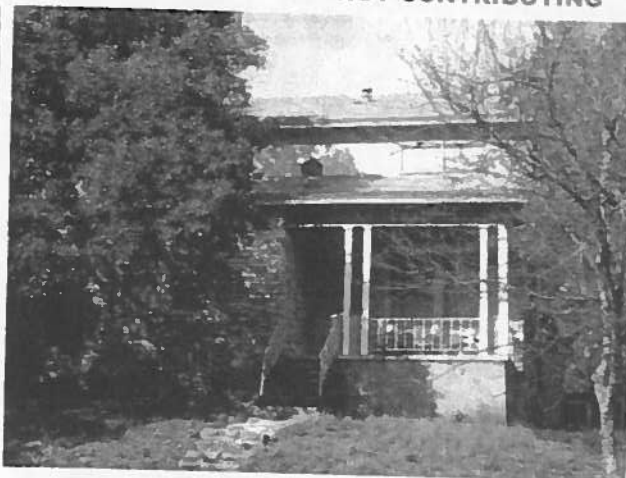
1910 East Side Dr

Date of Construction	1937	Integrity	Second story addition, stone veneer added, and porch alteration circa 1955.
Source	TCAD		
Stylistic Influences	None		
Historic Use	Dwelling, single		
Current Use	Dwelling, single		
Stories	2		
Moved	Has Not Moved
