ZONING CHANGE REVIEW SHEET

CASE NUMBER: C14H-2014-0014

HISTORIC NAME: Bluebonnet Hills Historic District

ADDRESS OF PROPOSED ZONING CHANGE: Roughly bounded by Annie Street on the north, East Side Drive on the east, Leland Street on the south, and Brackenridge Street on the west.

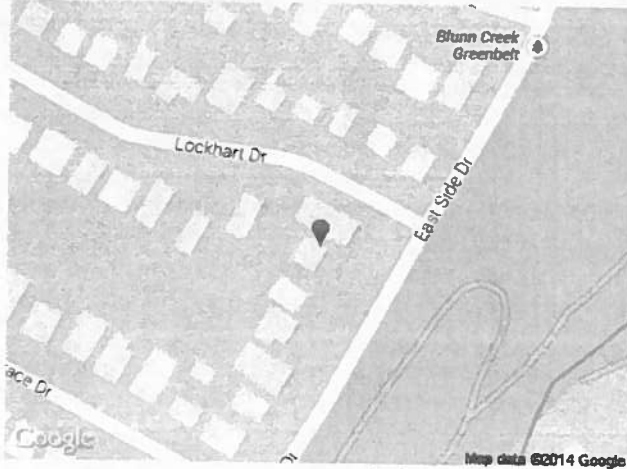
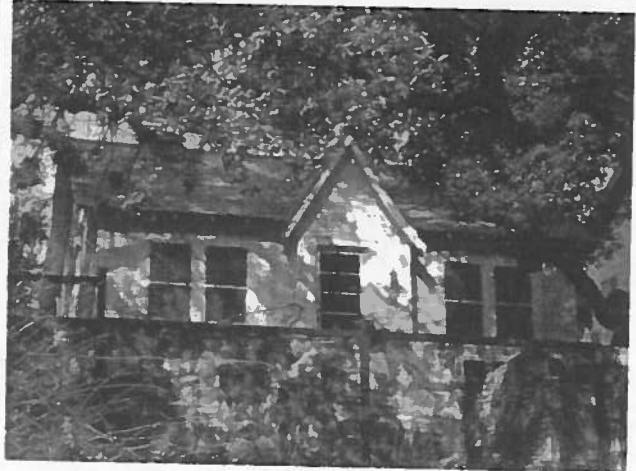
1912 East Side Dr

Date of Construction	1937 Source: TCAD	Roof Materials	Metal	Porch Railings	None
Stylistic Influences	Revival - Tudor	Roof Decoration	Exposed Rafter Ends	Fences	Height: 5 ft, Metal w/gate
Historic Use	Dwelling, single	Number of Chimneys	Exterior: 0, Interior: 0	Landscape Features	6' stone retaining wall w/steps to house.
Current Use	Dwelling, single	Windows	Wood Double Hung	Moved	Has Not Moved
Stories	1	Door Features	Glazing	Integrity	Small addition on north side w/corrugated sheet metal siding.
Plan	Square or rectangular	Porch Type	Stoop Roof		
Foundation	Pier-and-Beam	Porch Roof Types	None		
Exterior Materials	Wood	Porch Supports	None		
Roof Type	Side Gable

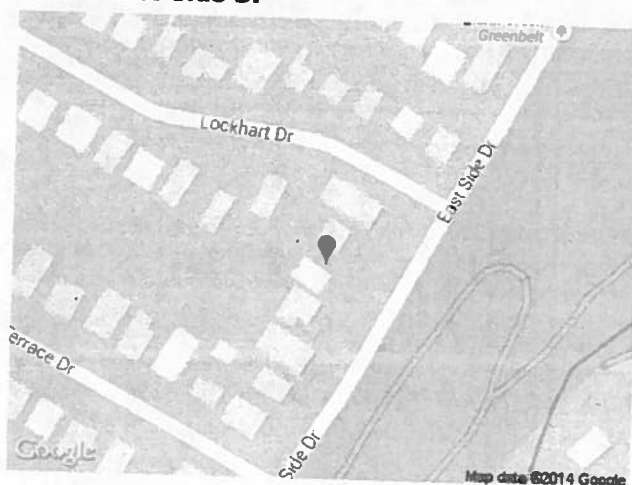
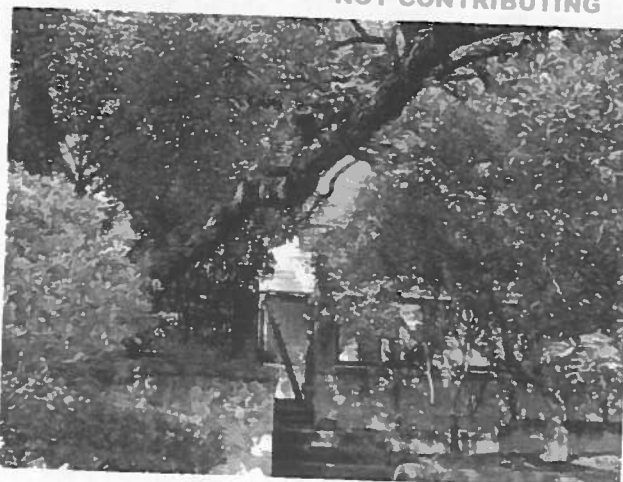
1914 East Side Dr

Date of Construction **1984**
Source: TCAD
Stylistic Influences **None**
Historic Use **Dwelling, single**
Current Use **Dwelling, single**
Stories **2**
Moved **Has Not Moved**

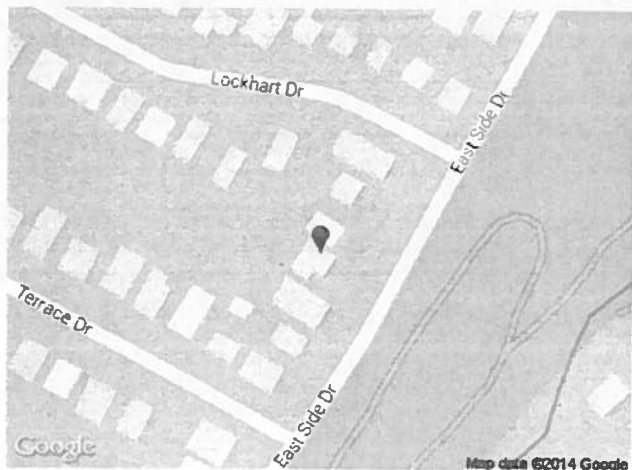
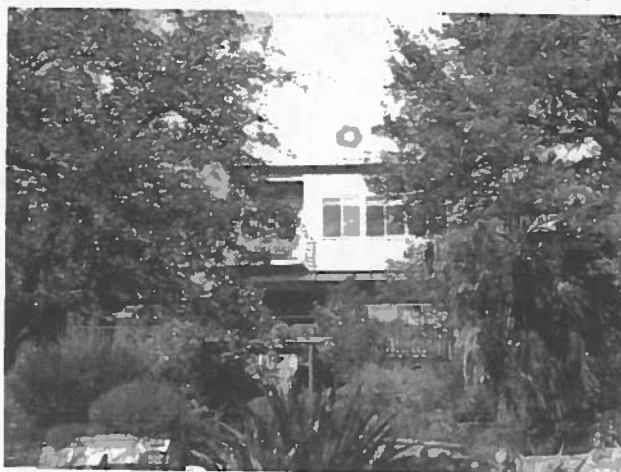
NOT CONTRIBUTING

Date of Construction	1925 Source: TCAD	Integrity	Second floor added (sheet metal material). Upper deck added. Windows replaced.
Stylistic Influences	None		
Historic Use	Dwelling, single		
Current Use	Dwelling, single		
Stories	2		
Moved	Has Not Moved

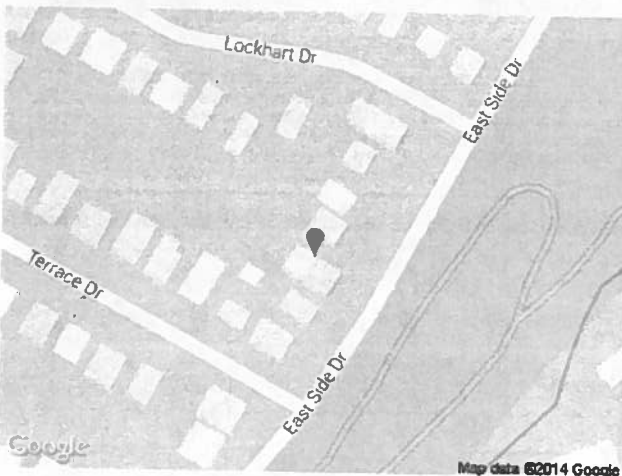
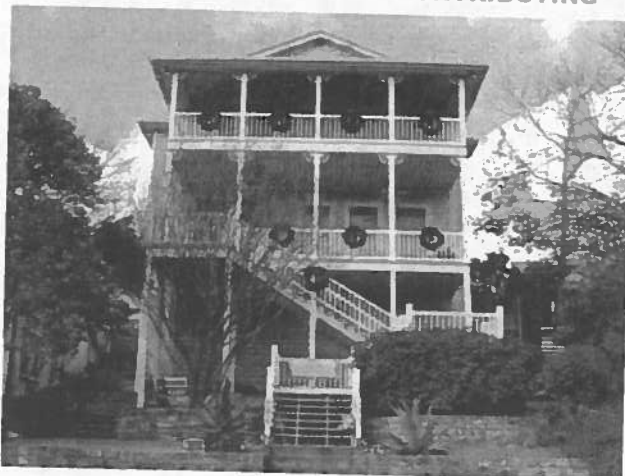
1918 East Side Dr

Date of Construction 1985
Source: TCAD
Stylistic Influences None
Historic Use Dwelling, single
Current Use Dwelling, single
Stories 3
Moved Has Not Moved

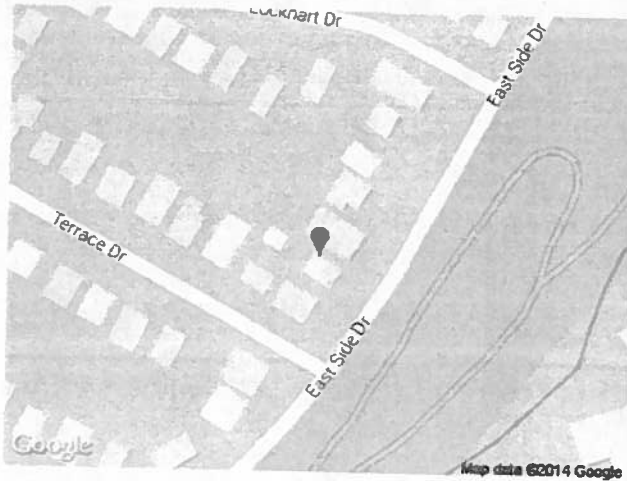
1920 East Side Dr

Date of Construction	1935	Moved	Has Not Moved
Source	TCAD	Integrity	Windows replaced. Door replaced. Porch posts and railings replaced.
Stylistic Influences	Minimal Traditional		
Historic Use	Dwelling, single		
Current Use	Dwelling, single		
Stories	1

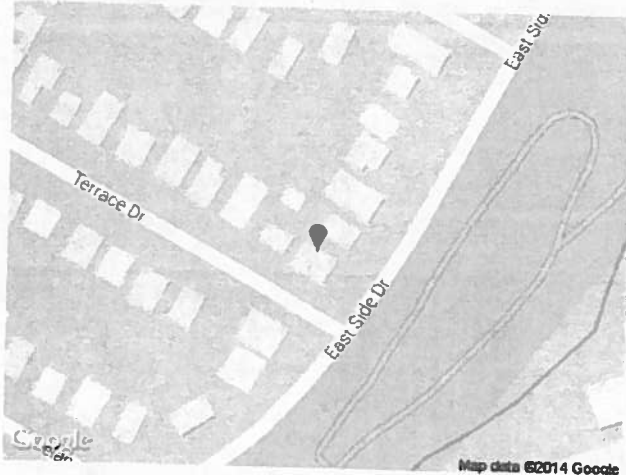
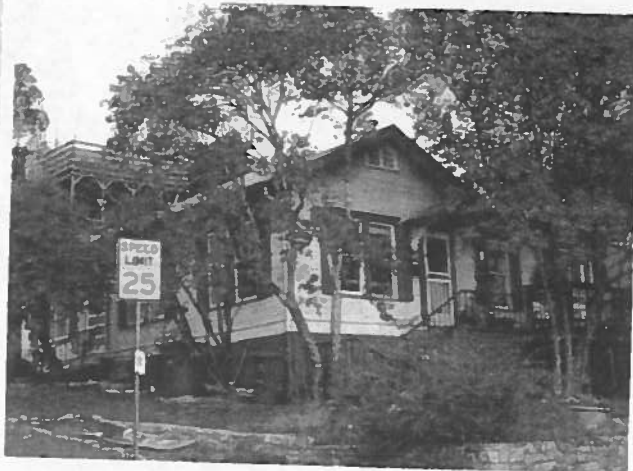
1922 East Side Dr

Date of Construction	1935 Source: TCAD	Roof Type	Hipped with Gable	Porch Supports	None
Stylistic Influences	Minimal Traditional	Roof Materials	Metal	Porch Railings	Metal
Historic Use	Dwelling, single	Number of Chimneys	Exterior: 0, Interior: 0	Outbuildings	Concrete stairs
Current Use	Dwelling, duplex	Windows	Wood Double Hung, Decorative Screens	Landscape Features	2' stone retaining wall
Stories	1	Door Features	Glazing	Moved	Has Not Moved
Plan	Square or rectangular	Porch Type	Stoop Roof	Integrity	Small front deck added.
Foundation	Pier-and-Beam	Porch Roof Types	Gabled, w/brackets		
Exterior Materials	Wood

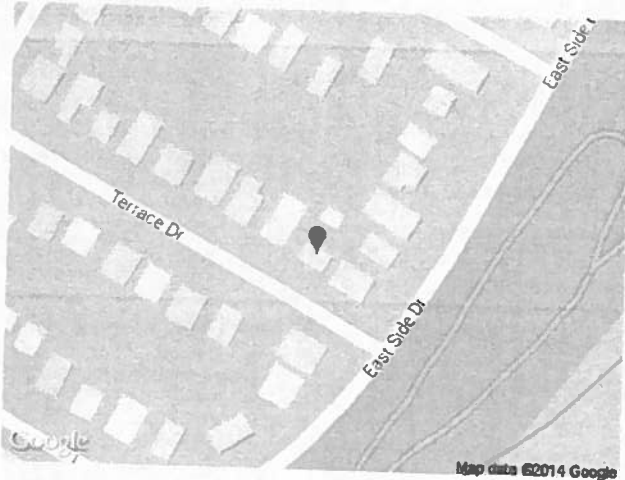
516 Terrace Dr

NOT CONTRIBUTING

Date of Construction	Estimated 1950	Integrity	Windows replaced. Large side deck and roof with spiral staircase added. Lower level enclosed.
Stylistic Influences	None		
Historic Use	Garage Apartment		
Current Use	Dwelling, single		
Stories	2		
Moved	Has Not Moved

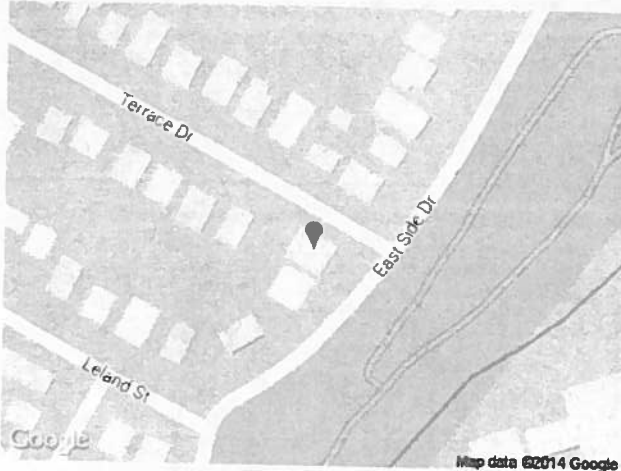
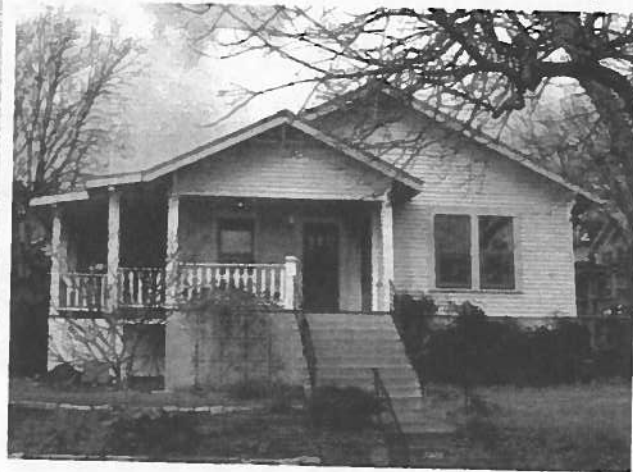
2000 East Side Dr

CONTRIBUTING

Date of Construction	1935 Source: TCAD	Roof Materials	Metal	Porch Railings	Square Wood
Stylistic Influences	Craftsman	Roof Decoration	Brackets	Outbuildings	Outbuilding w/wood siding and metal gabled roof.
Historic Use	Dwelling, single	Number of Chimneys	Exterior: 0, Interior: 0	Moved	Has Not Moved
Current Use	Dwelling, single	Windows	Wood Double Hung, Wood Screens	Integrity	Wraparound porch addition on SW corner. Porch stairs and railings replaced.
Stories	1	Door Features	Glazing		
Plan	Square or rectangular	Porch Type	Partial Width, Independent, Wraparound addition on SW corner.		
Foundation	Pier-and-Beam	Porch Roof Types	Gabled		
Exterior Materials	Wood	Porch Supports	Square Full Height Wood		
Roof Type	Front Gable

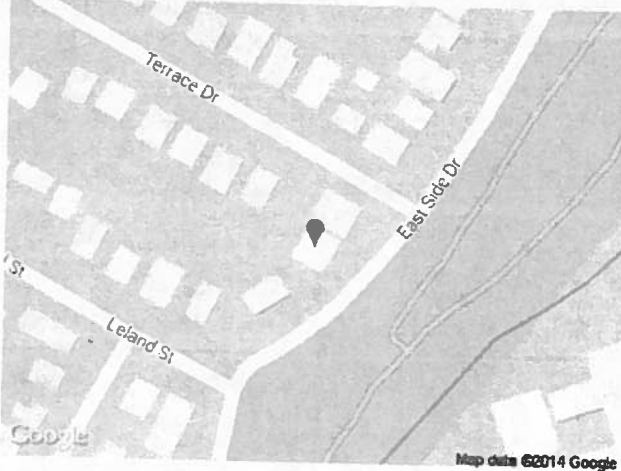
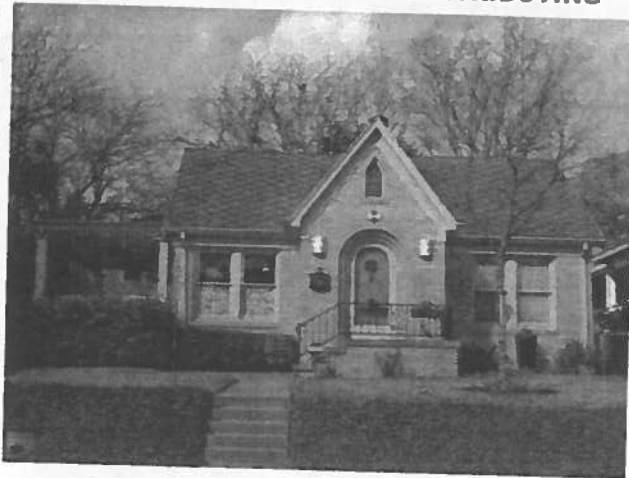
2002 East Side Dr

CONTRIBUTING

Date of Construction	1939 Source: TCAD	Roof Materials	Composition shingles, Diamond pattern	Outbuildings	2 Story Detached Garage, Garage Wall Material: Synthetic - Asbestos, Garage Roof Material: Composition shingles, Garage Roof Type: Hipped
Stylistic Influences	Revival - Tudor	Number of Chimneys	Exterior: 0, Interior: 0	Landscape Features	Concrete steps to lot.
Historic Use	Dwelling, single	Windows	Wood Double Hung	Moved	Has Not Moved
Current Use	Dwelling, single	Door Features	Glazing, Arched door w/decorative recessed brick arches.	Integrity	Pergola-style porch on south side.
Stories	1	Porch Type	Independent		
Plan	Square or rectangular	Porch Roof Types	None		
Foundation	Perimeter Wall	Porch Supports	None		
Exterior Materials	Brick	Porch Railings	Metal		
Roof Type	Cross Gable

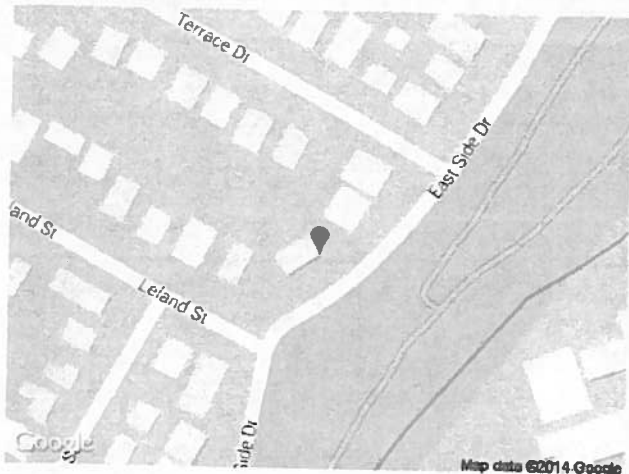
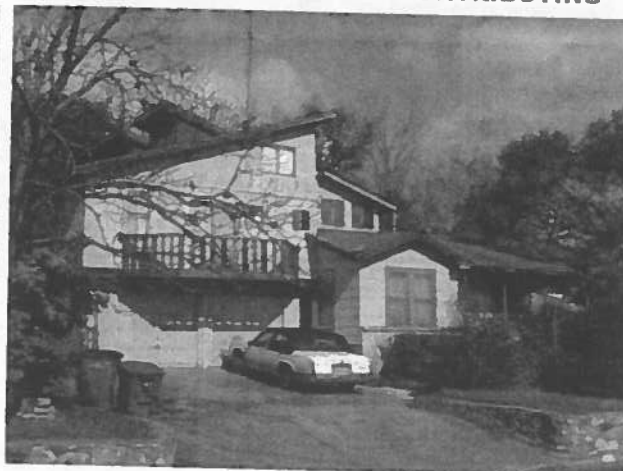
2004 East Side Dr

NOT CONTRIBUTING

Date of Construction	1956	Integrity	Large 2.5 story front addition. Dormer addition at roof ridge.
Source	TCAD		
Stylistic Influences	Ranch		
Historic Use	Dwelling, single		
Current Use	Dwelling, single		
Stories	2.5		
Moved	Has Not Moved

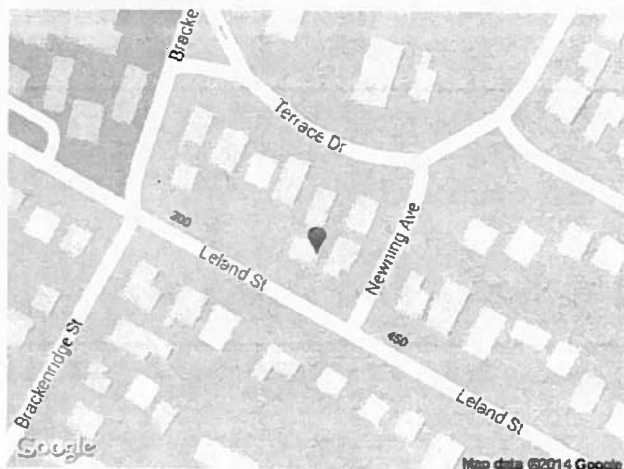
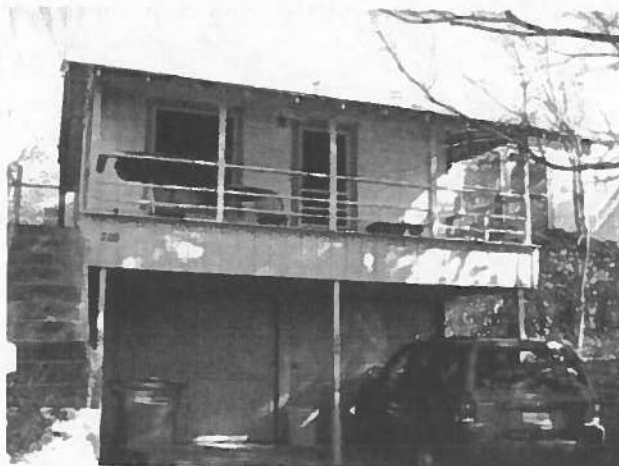
308 Leland St

CONTRIBUTING

Date of Construction	1951 Source: TCAD	Roof Materials	Composition shingles	Porch Supports	Square Full Height Wood
Stylistic Influences	Minimal Traditional	Roof Decoration	Exposed Rafter Ends	Porch Railings	Square Wood
Historic Use	Garage Apartment	Number of Chimneys	Exterior: 0, Interior: 0	Landscape Features	3' concrete retaining wall.
Stones	2	Windows	Wood Double Hung, Wood Screens, 8/8; 6/6	Moved	Has Not Moved
Plan	Square or rectangular	Door Features	Glazing		
Foundation	Perimeter Wall	Porch Type	Partial Width, Independent		
Exterior Materials	Asbestos	Porch Roof Types	Shed		
Roof Type	Side Gable

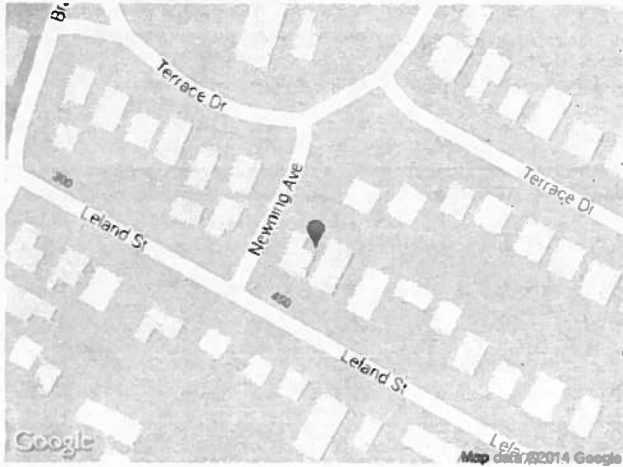
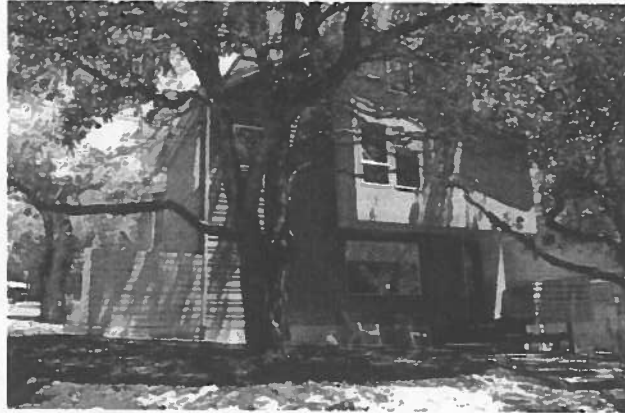
500 Leland St

NOT CONTRIBUTING

Date of Construction **2008**
Source: TCAD
Stylistic Influences **None**
Historic Use **Dwelling, single**
Current Use **Dwelling, single**
Stories **2.5**
Moved **Has Not Moved**

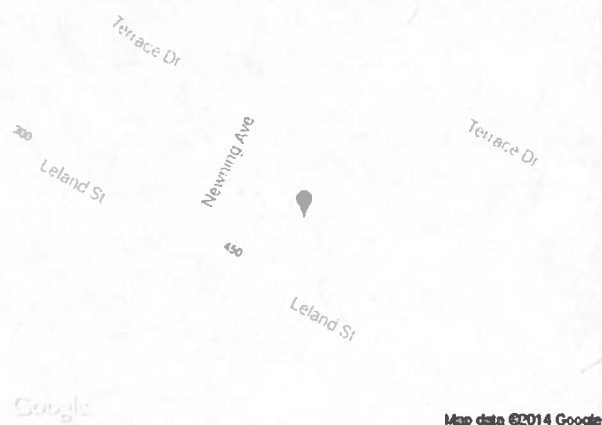
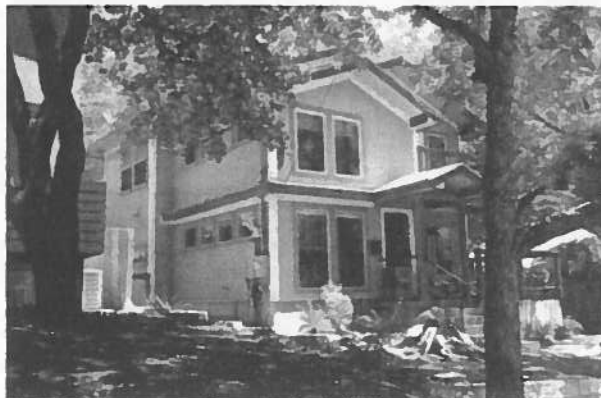
Property ID **283322**
502 Leland St

NOT CONTRIBUTING

Date of Construction **2008**
Source: TCAD
Stylistic Influences **None**
Historic Use **Dwelling, single**
Current Use **Dwelling, single**
Stories **2**
Moved **Has Not Moved**

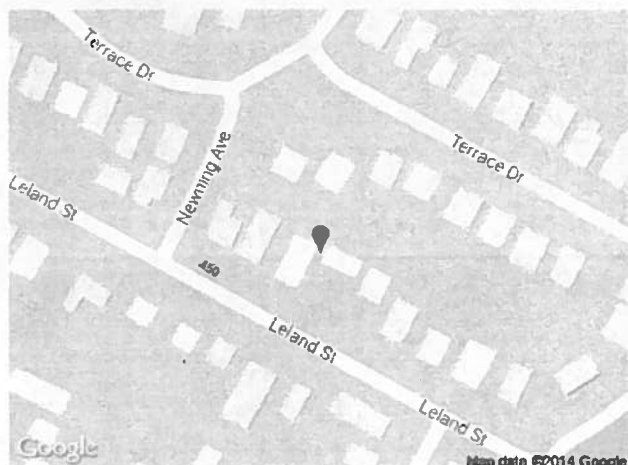
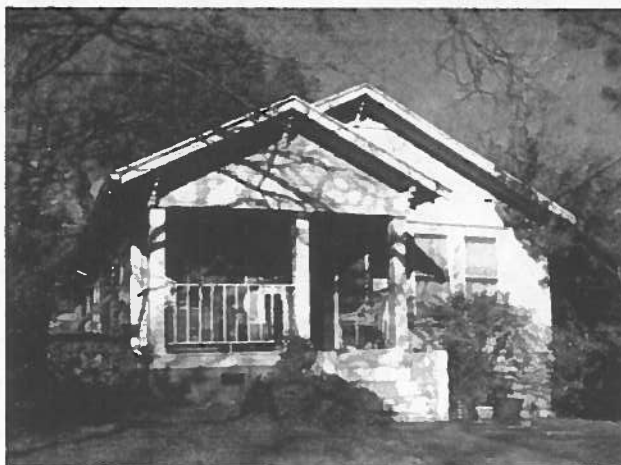
Property ID **283321**
504 Leland St

CONTRIBUTING

Date of Construction	1933 Source: City Directories	Roof Materials	Metal	Porch Railings	Square Wood
Stylistic Influences	Craftsman	Roof Decoration	Exposed Rafter Ends, Brackets	Outbuildings	1 Story Detached Garage, Garage Wall Material: Wood, Garage Roof Material: Metal, Garage Roof Type: Gabled
Historic Use	Dwelling, single	Number of Chimneys	Exterior: 0, Interior: 0	Landscape Features	2' stone retaining wall.
Current Use	Dwelling, single	Windows	Wood Double Hung, Decorative Screens	Moved	Has Not Moved
Stories	1	Door Features	Glazing	Integrity	Historic rear addition.
Plan	Square or rectangular	Porch Type	Partial Width, Independent		
Foundation	Pier-and-Beam	Porch Roof Types	Gabled		
Exterior Materials	Wood	Porch Supports	Square Full Height Wood		
Roof Type	Front Gable

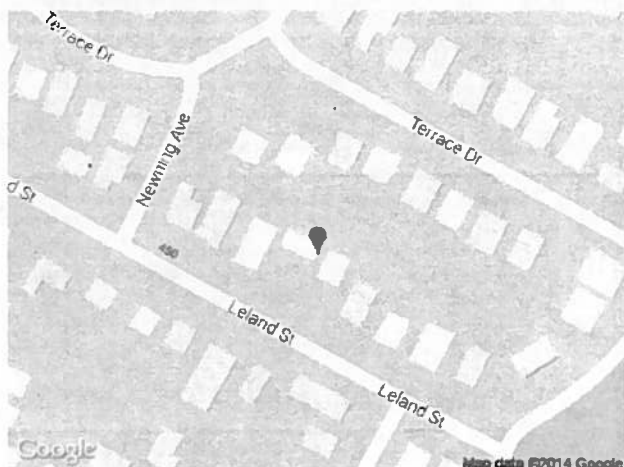
Property ID **283320**
506 Leland St

CONTRIBUTING

Date of Construction	1935 Source: City Directories	Roof Materials	Composition shingles	Porch Railings	Metal
Stylistic Influences	Craftsman	Roof Decoration	Exposed Rafter Ends, Brackets	Outbuildings	1 Story Detached Garage, Garage Wall Material: Wood, Garage Roof Material: Metal, Garage Roof Type: Gabled
Historic Use	Dwelling, single	Number of Chimneys	Exterior: 0, Interior: 0	Landscape Features	Set far back on lot.
Current Use	Dwelling, single	Windows	Wood Double Hung, Wood Screens	Moved	Has Not Moved
Stories	1	Door Features	Glazing		
Plan	Square or rectangular	Porch Type	Partial Width, Independent, Stoop Roof		
Foundation	Pier-and-Beam	Porch Roof Types	Gabled, w/brackets		
Exterior Materials	Wood, Board and batten	Porch Supports	None		
Roof Type	Side Gable

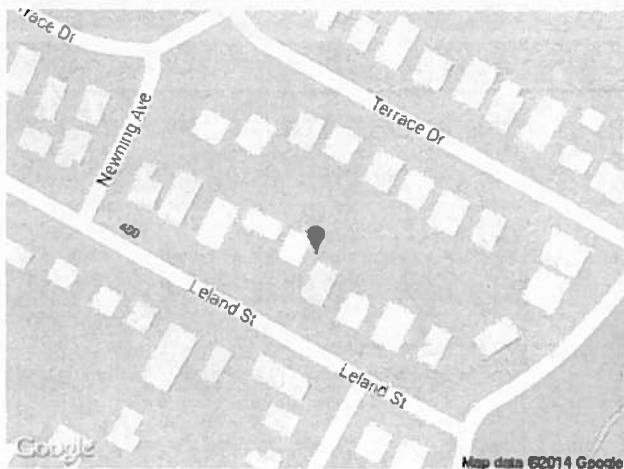
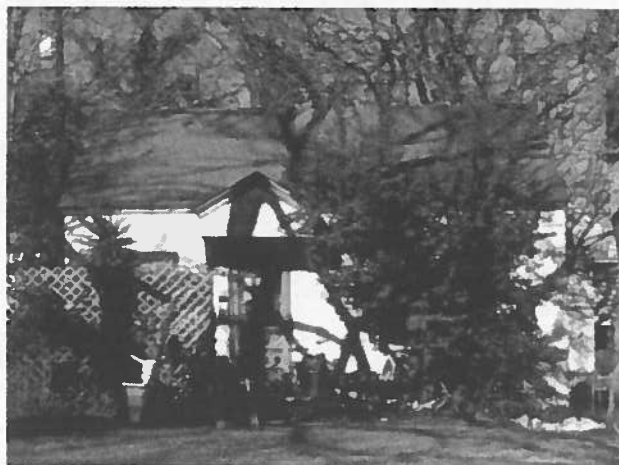
508 Leland St

CONTRIBUTING

Date of Construction	1936 Source: TCAD	Roof Type	Side Gable	Porch Supports	None
Stylistic Influences	Minimal Traditional	Roof Materials	Composition shingles	Porch Railings	None
Historic Use	Dwelling, single	Number of Chimneys	Exterior: 0, Interior: 0	Outbuildings	Small detached garage/workshop of like materials.
Current Use	Dwelling, single	Windows	Wood Double Hung	Landscape Features	Set far back on lot.
Stories	1	Door Features	Glazing	Moved	Has Not Moved
Plan	Square or rectangular	Porch Type	Partial Width, Independent, Stoop Roof		
Foundation	Pier-and-Beam	Porch Roof Types	Gabled, w/brackets		
Exterior Materials	Stucco

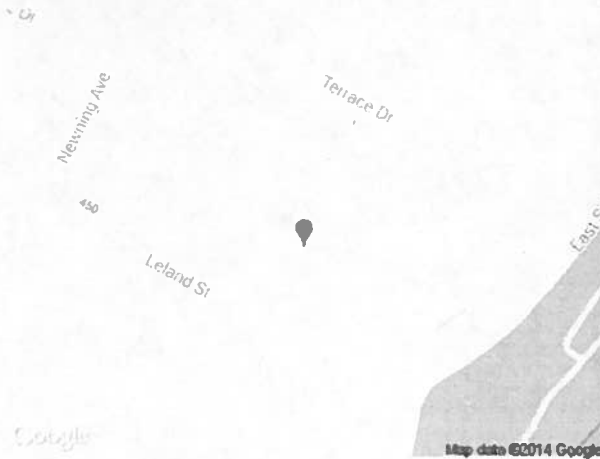
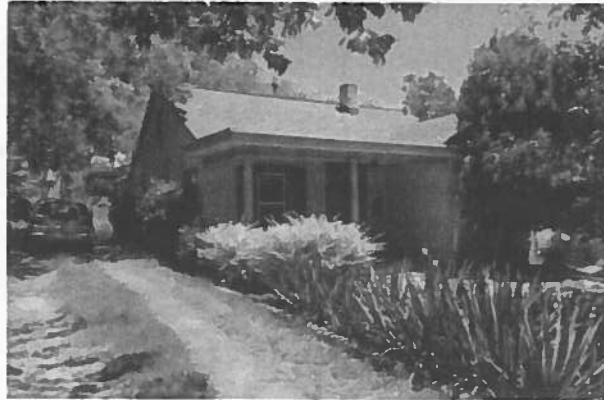
Property ID **283318**
510 Leland St

CONTRIBUTING

Date of Construction	1943 Source: TCAD	Roof Materials	Asphalt Composition Shingles	Moved	Has Not Moved
Stylistic Influences	Minimal Traditional	Number of Chimneys	1	Integrity	Front porch altered. Brick on chimney replaced. New shutters.
Historic Use	Dwelling, single	Chimney Materials	Brick		
Current Use	Dwelling, single	Windows	Double Hung		
Stories	1	Porch Type	Partial Width		
Plan	Asymmetrical	Porch Roof Types	Flat		
Exterior Materials	Stucco	Porch Supports	Classical Columns		
Roof Type	Gable

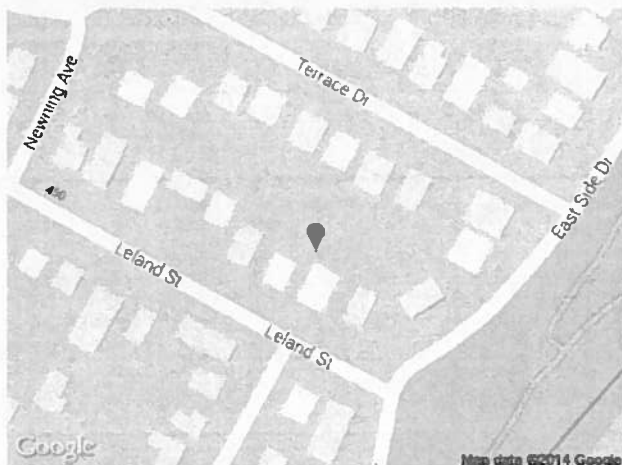
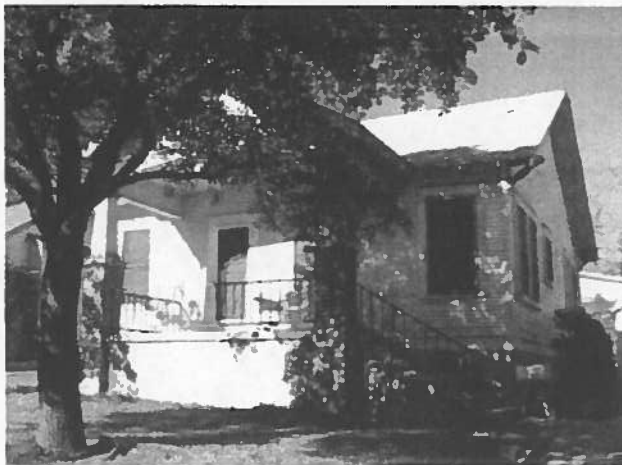
512 Leland St

CONTRIBUTING

Date of Construction	1938 Source: TCAD	Roof Materials	Composition shingles	Porch Railings	Metal
Stylistic Influences	Craftsman	Roof Decoration	Exposed Rafter Ends, Brackets	Outbuildings	Historic, Garage Wall Material: Wood, Garage Roof Material: Metal, Garage Roof Type: Gabled
Historic Use	Dwelling, single	Number of Chimneys	Exterior: 0, Interior: 0	Moved	Has Not Moved
Current Use	Dwelling, single	Windows	Wood Double Hung, Wood Screens		
Stories	1	Door Features	Glazing		
Plan	Square or rectangular	Porch Type	Partial Width, Independent		
Foundation	Pier-and-Beam	Porch Roof Types	Gabled		
Exterior Materials	Wood	Porch Supports	Tapered on Pier, Brick Piers		
Roof Type	Side Gable

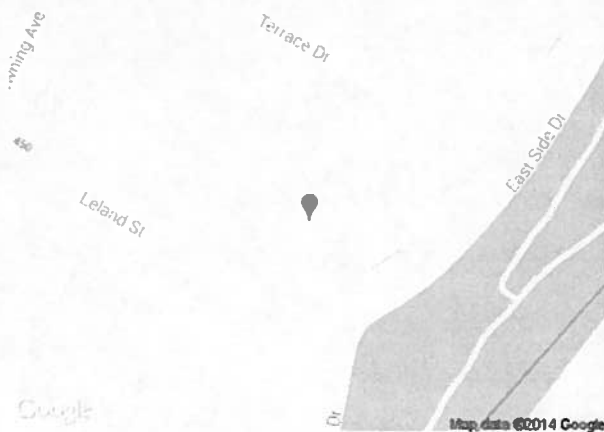
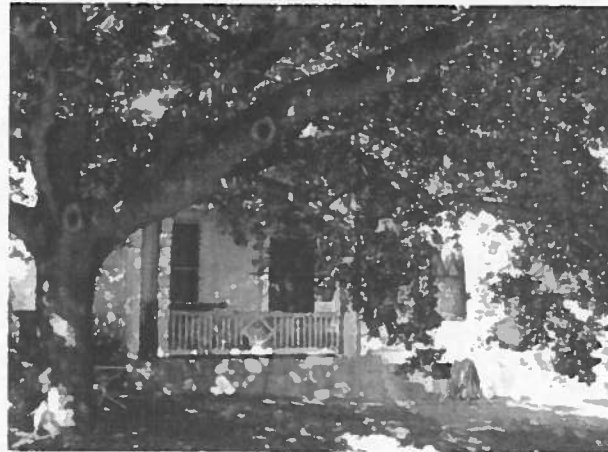
Property ID 283316
514 Leland St

CONTRIBUTING

Date of Construction	1933 Source: City Directories	Roof Type	Front Gable	Porch Roof Types	Gabled
Stylistic Influences	Craftsman	Roof Materials	Composition shingles	Porch Supports	Square Full Height Wood
Historic Use	Dwelling, single	Roof Decoration	Exposed Rafter Ends	Porch Railings	Other, Wood w/diamond pattern
Current Use	Dwelling, single	Number of Chimneys	Exterior: 0, Interior: 0	Moved	Has Not Moved
Stories	1	Windows	Wood Double Hung, Decorative Screens		
Plan	Square or rectangular	Door Features	Glazing		
Foundation	Pier-and-Beam	Porch Type	Partial Width, Independent		
Exterior Materials	Wood

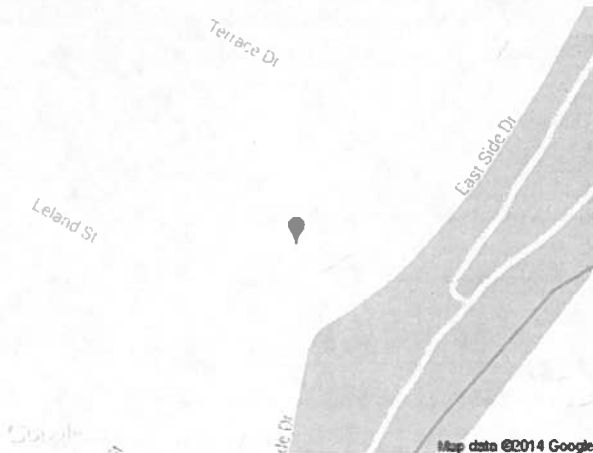
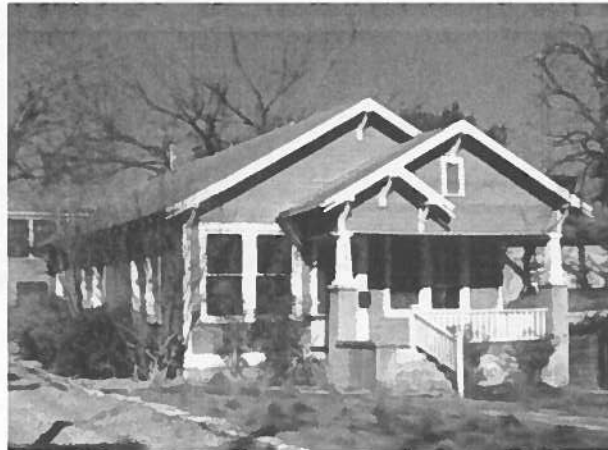
Property ID 283315
516 Leland St

CONTRIBUTING

Date of Construction	1931	Roof Type	Front Gable	Porch Roof Types	Gabled
Source:	City Directories	Roof Materials	Composition shingles	Porch Supports	Tapered on Pier, Stucco Piers
Stylistic Influences	Craftsman	Roof Decoration	Exposed Rafter Ends, Brackets	Porch Railings	Square Wood
Historic Use	Dwelling, single	Number of Chimneys	Exterior: 0, Interior: 0	Outbuildings	2 Story Detached Garage, Garage Wall Material: Brick, Garage Roof Material: Composition shingles, Garage Roof Type: Hipped
Current Use	Dwelling, single	Windows	Wood Double Hung	Landscape Features	Stone retaining wall.
Stories	1	Door Features	Glazing	Moved	Has Not Moved
Plan	Square or rectangular	Porch Type	Partial Width, Independent		
Foundation	Pier-and-Beam				
Exterior Materials	Wood

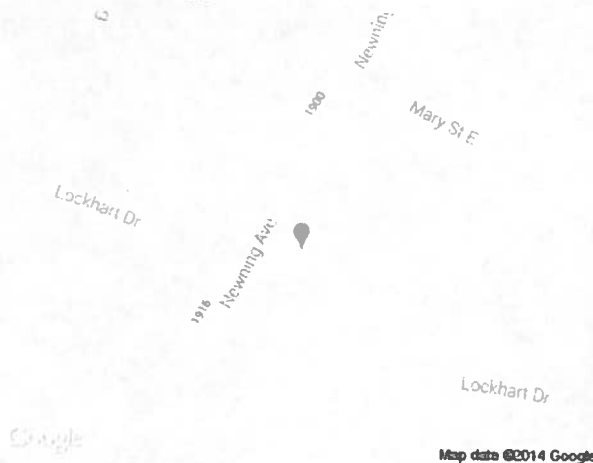
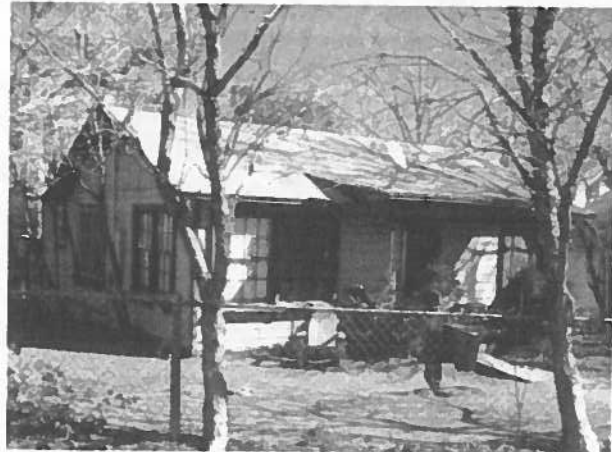
Property ID 283369
500 Lockhart Dr

CONTRIBUTING

Date of Construction	1950 Source: TCAD	Roof Materials	Composition shingles	Fences	Height: 4 ft, Chain Link
Stylistic Influences	Craftsman	Number of Chimneys	Exterior: 0, Interior: 0	Outbuildings	1 Story Detached Garage, Garage Wall Material: Wood, Garage Roof Material: Built up Tar & Gravel, Garage Roof Type: Flat
Historic Use	Dwelling, single	Windows	Wood Double Hung, 8/8/2010	Moved	Has Not Moved
Current Use	Dwelling, single	Door Features	Glazing	Integrity	New window surrounds.
Stories	1	Porch Type	Partial Width, Independent		
Plan	Square or rectangular	Porch Roof Types	Shed		
Foundation	Pier-and-Beam	Porch Supports	Metal		
Exterior Materials	Wood	Porch Railings	None		
Roof Type	Side Gable

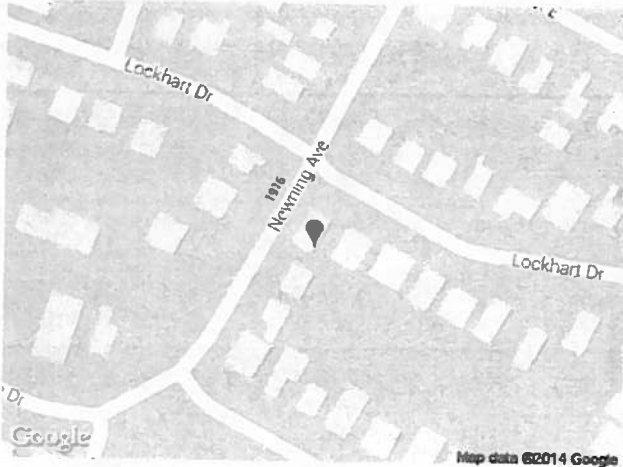
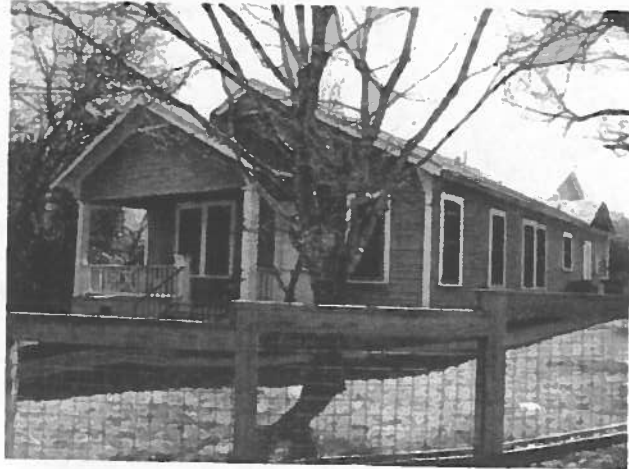
501 Lockhart Dr

CONTRIBUTING

Date of Construction	1933 Source: City Directories	Roof Materials	Composition shingles	Porch Railings	Wood Wall
Stylistic Influences	Craftsman	Roof Decoration	Brackets	Fences	Height: 3 ft, Metal
Historic Use	Dwelling, single	Number of Chimneys	Exterior: 0, Interior: 0	Outbuildings	2 Story Detached Garage, Garage Wall Material: Synthetic - Asbestos, Garage Roof Material: Metal, Garage Roof Type: Gabled
Current Use	Dwelling, single	Windows	Wood Double Hung, Decorative Screens	Moved	Has Not Moved
Stories	1	Door Features	Glazing, Not Original	Integrity	Rear addition; historic. Door replaced.
Plan	Square or rectangular	Porch Type	Partial Width, Independent		
Foundation	Pier-and-Beam	Porch Roof Types	Gabled		
Exterior Materials	Wood	Porch Supports	Square Full Height Wood		
Roof Type	Front Gable

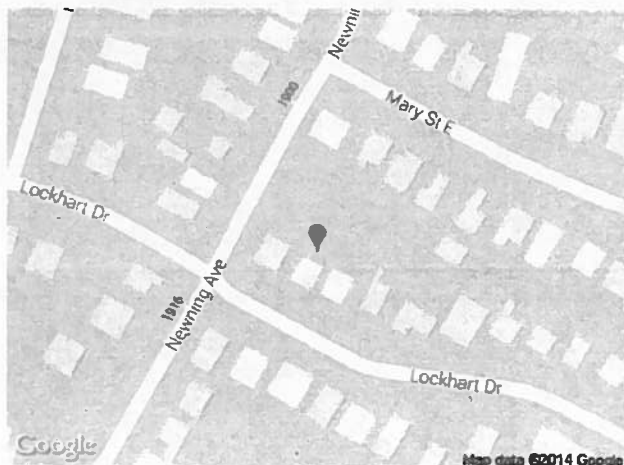
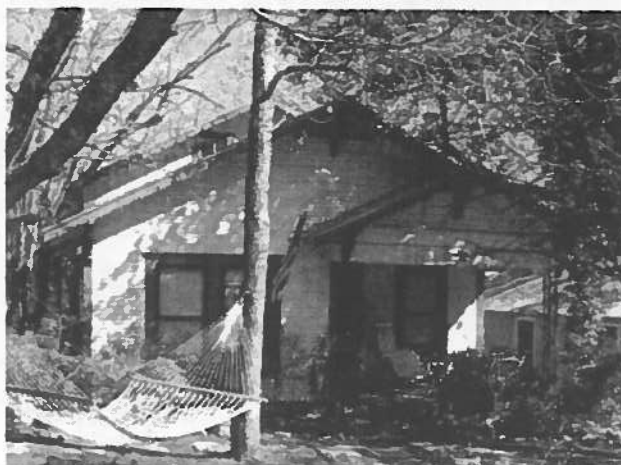
502 Lockhart Dr

CONTRIBUTING

Date of Construction	1929 Source: City Directories	Roof Type	Front Gable	Porch Roof Types	Gabled
Stylistic Influences	Craftsman	Roof Materials	Composition shingles	Porch Supports	Metal
Historic Use	Dwelling, single	Roof Decoration	Exposed Rafter Ends, Brackets	Porch Railings	None
Current Use	Dwelling, single	Number of Chimneys	Exterior: 0, Interior: 0	Moved	Has Not Moved
Stories	1.5	Windows	Wood Double Hung, Aluminum	Integrity	1.5 story rear addition (one story historic addition w/non-historic half story added). Porch posts altered circa 1950's.
Plan	Square or rectangular	Door Features	Glazing		
Foundation	Pier-and-Beam	Porch Type	Partial Width, Semi-Inset		
Exterior Materials	Wood

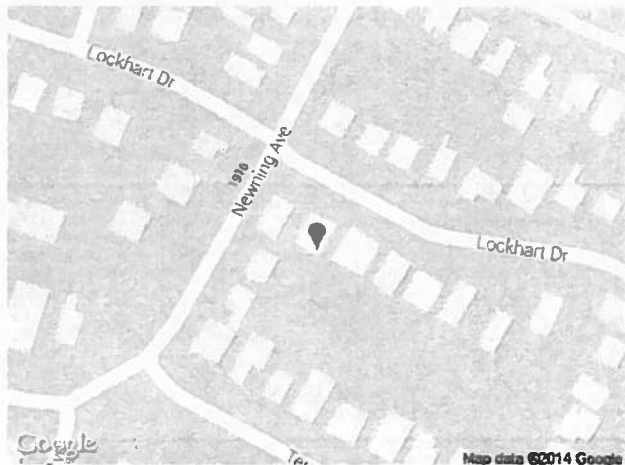
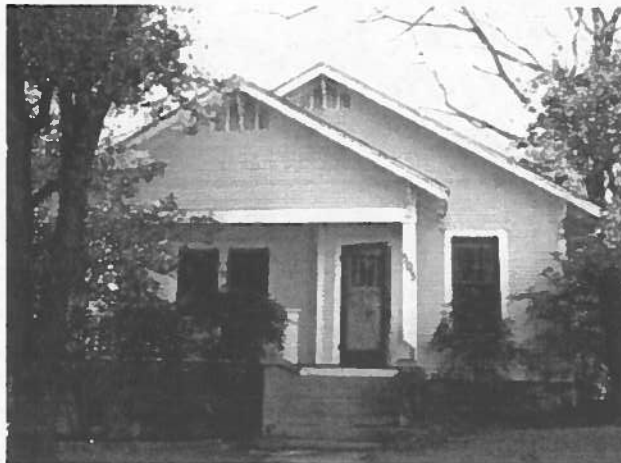
503 Lockhart Dr

CONTRIBUTING

Date of Construction	1933 Source: City Directories	Roof Materials	Composition shingles	Porch Railings	Square Wood
Stylistic Influences	Craftsman	Roof Decoration	Exposed Rafter Ends, Brackets	Outbuildings	Historic, Garage Wall Material: Wood, Garage Roof Material: Composition shingles, Garage Roof Type: Hipped
Historic Use	Dwelling, single	Number of Chimneys	Exterior: 0, Interior: 0	Landscape Features	Slightly raised lot.
Current Use	Dwelling, single	Windows	Wood Double Hung, Decorative Screens	Moved	Has Not Moved
Stories	1	Door Features	Glazing		
Plan	Square or rectangular	Porch Type	Partial Width, Independent		
Foundation	Pier-and-Beam	Porch Roof Types	Gabled		
Exterior Materials	Wood	Porch Supports	Square Full Height Wood		
Roof Type	Cross Gable

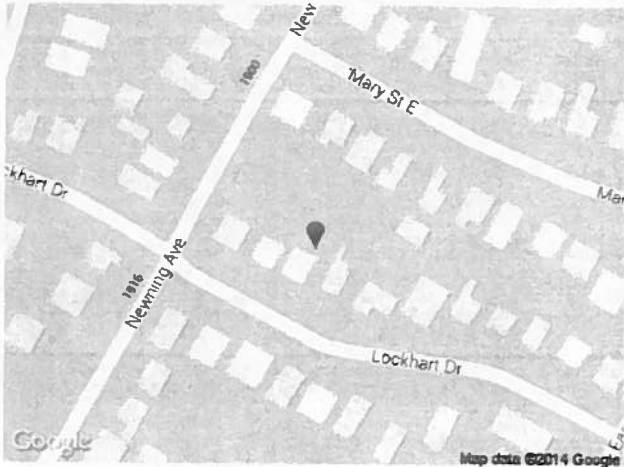
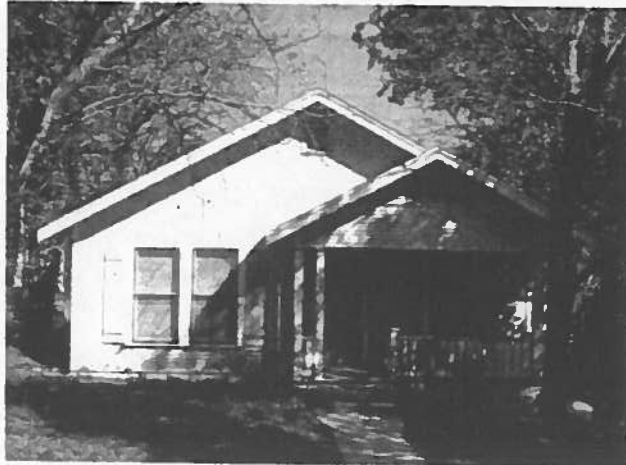
504 Lockhart Dr

CONTRIBUTING

Date of Construction	1938 Source: TCAD	Roof Type	Front Gable	Porch Roof Types	Gabled
Stylistic Influences	Craftsman	Roof Materials	Composition shingles	Porch Supports	Square Full Height Wood
Historic Use	Dwelling, single	Roof Decoration	Exposed Rafter Ends	Porch Railings	Square Wood
Current Use	Dwelling, single	Number of Chimneys	Exterior: 0, Interior: 0	Moved	Has Not Moved
Stories	1	Windows	Wood Double Hung, Wood Screens	Integrity	Shutters added. One door replaced.
Plan	Square or rectangular	Door Features	Glazing		
Foundation	Pier-and-Beam	Porch Type	Independent, Inset		
Exterior Materials	Wood

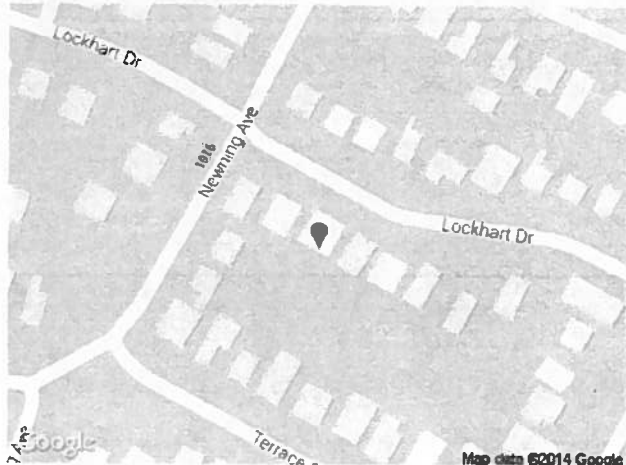
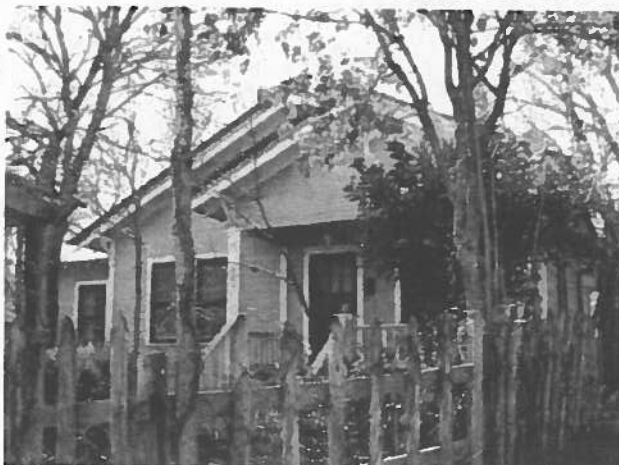
505 Lockhart Dr

CONTRIBUTING

Date of Construction	1930 Source: City Directories	Roof Materials	Metal	Porch Railings	Square Wood
Stylistic Influences	Craftsman	Roof Decoration	Exposed Rafter Ends, Brackets	Fences	Height: 4 ft, Picket
Historic Use	Dwelling, single	Number of Chimneys	Exterior: 0, Interior: 0	Outbuildings	Shed in back
Current Use	Dwelling, single	Windows	Wood Double Hung, Decorative Screens	Landscape Features	Wood pergola. Slightly raised lot.
Stories	1	Door Features	Glazing	Moved	Has Not Moved
Plan	Asymmetrical	Porch Type	Partial Width, Independent	Integrity	Small shed-roof rear addition and historic period side addition. Screens replaced.
Foundation	Pier-and-Beam	Porch Roof Types	Gabled		
Exterior Materials	Wood	Porch Supports	Square Full Height Wood		
Roof Type	Cross Gable

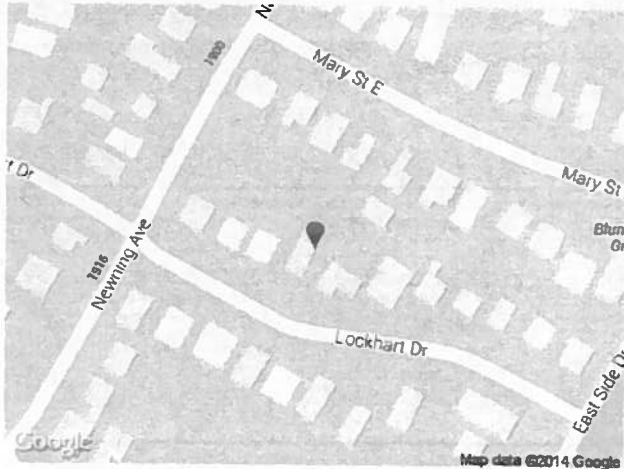
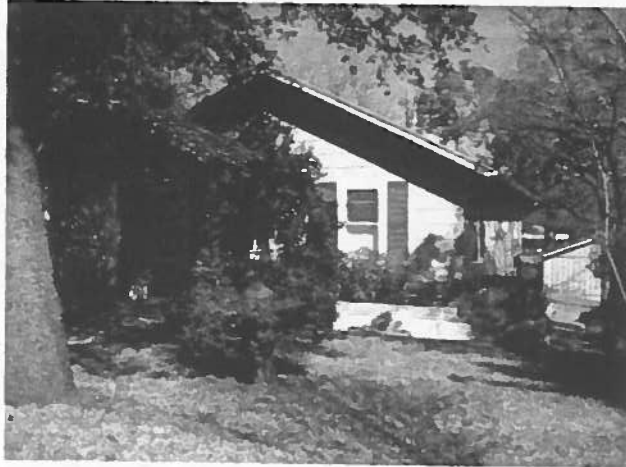
506 Lockhart Dr

CONTRIBUTING

Date of Construction	1931 Source: City Directories	Roof Type	Front Gable	Porch Railings	Square Wood
Stylistic Influences	Craftsman	Roof Materials	Metal	Outbuildings	1 Story Detached Garage, Frame, Historic
Historic Use	Dwelling, single	Windows	Wood Double Hung, Steel Casement, Wood Screens	Landscape Features	Brick planters
Current Use	Dwelling, single	Door Features	Glazing, Not Original	Moved	Has Not Moved
Stories	1	Porch Type	Partial Width, Independent	Integrity	Front porch rebuilt. Front door replaced. Porch floor is terracotta tile. Steel casement windows on side.
Plan	Square or rectangular	Porch Roof Types	Gabled		
Foundation	Pier-and-Beam	Porch Supports	Square Full Height Wood		
Exterior Materials	Asbestos

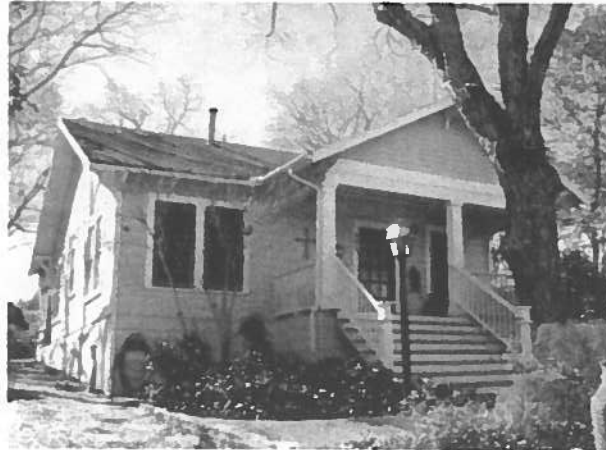
CONTRIBUTING

Date of Construction	1931 Source: City Directories	Roof Materials	Composition shingles	Porch Railings	Square Wood
Stylistic Influences	Craftsman	Roof Decoration	Exposed Rafter Ends, Brackets	Outbuildings	Small outbuilding.
Historic Use	Dwelling, single	Number of Chimneys	Exterior: 0, Interior: 0	Landscape Features	Raised lot.
Current Use	Dwelling, single	Windows	Wood Double Hung, Decorative Screens	Moved	Has Not Moved
Stories	1	Door Features	Glazing, Not Original	Integrity	Small rear shed-roof addition (likely historic). New front door.
Plan	Square or rectangular	Porch Type	Partial Width, Independent		
Foundation	Pier-and-Beam	Porch Roof Types	Gabled		
Exterior Materials	Wood	Porch Supports	Square Full Height Wood		
Roof Type	Side Gable

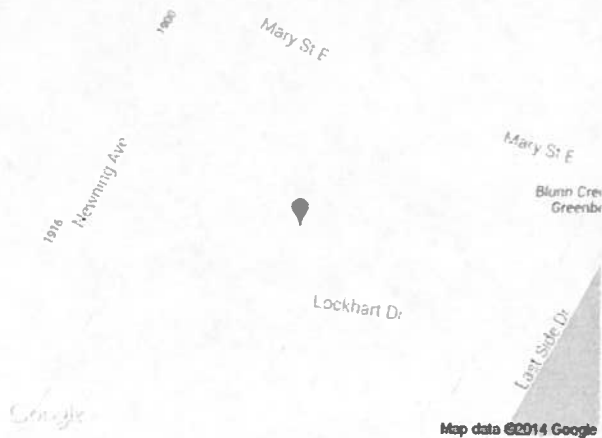
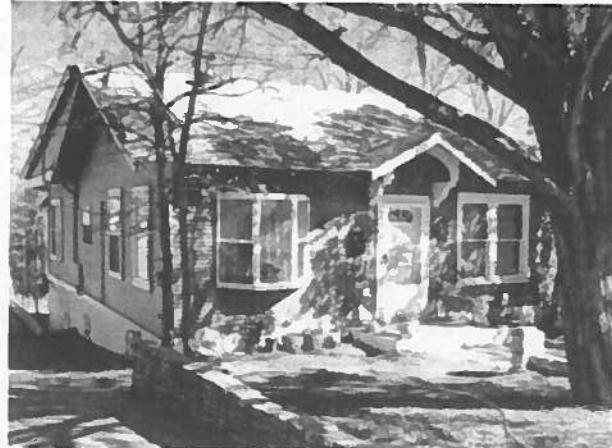
Property ID 283365
508 Lockhart Dr

Date of Construction	1931 Source: City Directories	Roof Materials	Composition shingles	Walls	Height: 1 ft, Stone
Stylistic Influences	Craftsman	Roof Decoration	Exposed Rafter Ends, Brackets	Outbuildings	Carport.
Historic Use	Dwelling, single	Number of Chimneys	Exterior: 0, Interior: 0	Moved	Has Not Moved
Current Use	Dwelling, single	Windows	Wood Double Hung	Integrity	Rear addition. Bay window added to front circa 1990's. New front door. Window surrounds changed on side elevation.
Stories	1	Door Features	Glazing		
Plan	Square or rectangular	Porch Type	Stoop Roof, w/brackets		
Foundation	Pier-and-Beam	Porch Supports	None		
Exterior Materials	Wood	Porch Railings	None		
Roof Type	Side Gable

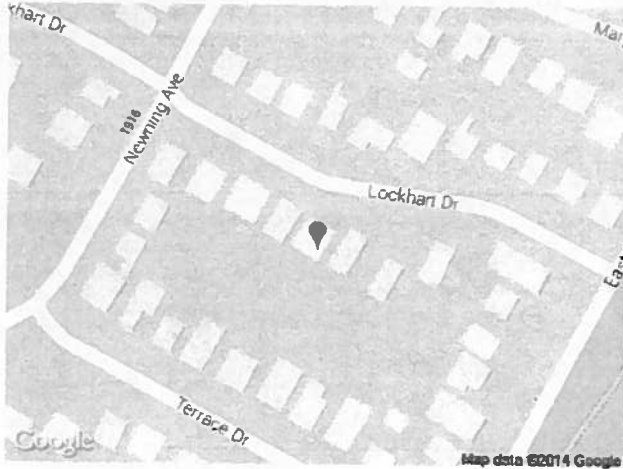
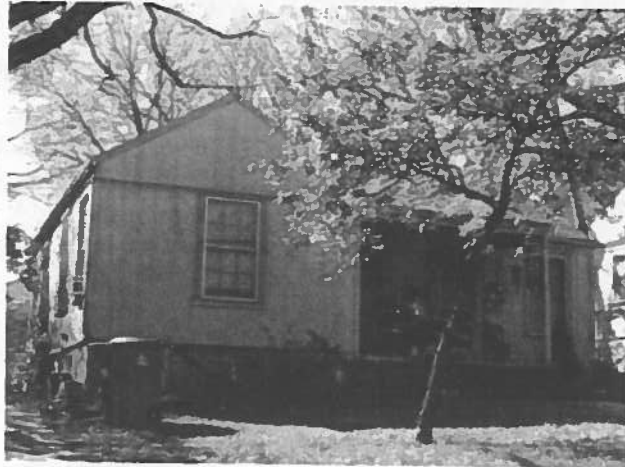
509 Lockhart Dr

Date of Construction	1938 Source: TCAD	Roof Materials	Composition shingles	Outbuildings	1 Story Detached Garage, Garage Wall Material: Wood, Garage Roof Material: Metal, Garage Roof Type: Gabled
Stylistic Influences	Minimal Traditional	Number of Chimneys	Exterior: 0, Interior: 0	Moved	Has Not Moved
Historic Use	Dwelling, single	Windows	Wood Double Hung, 6/6/2010	Integrity	Siding replaced w/vertical siding.
Current Use	Dwelling, single	Door Features	Not Original		
Stones	1	Porch Type	Partial Width, Independent		
Plan	Wing-and-Gable (L plan)	Porch Roof Types	Shed		
Foundation	Pier-and-Beam	Porch Supports	Square Full Height Wood		
Exterior Materials	Synthetic- Unknown	Porch Railings	None		
Roof Type	Cross Gable

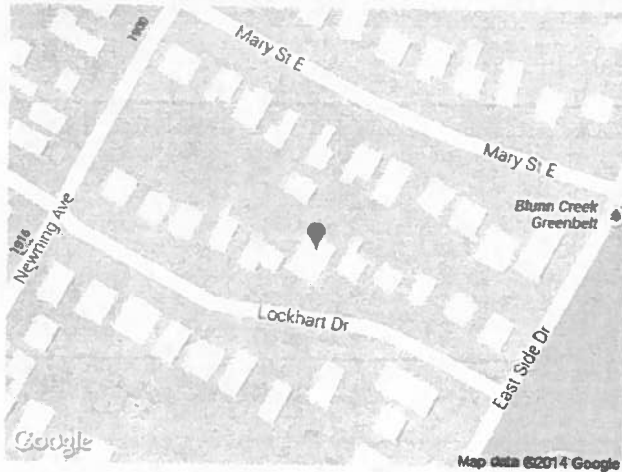
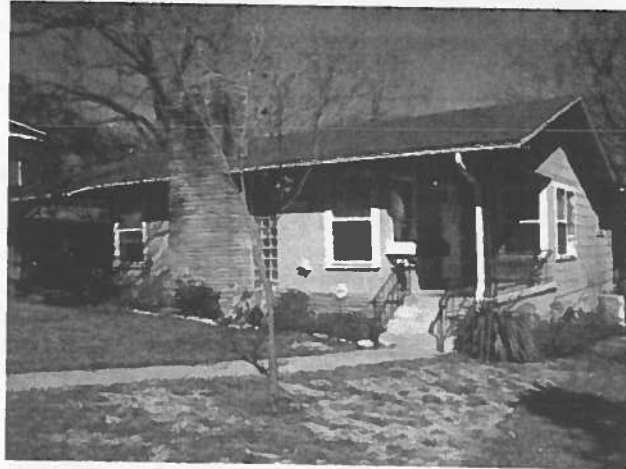
510 Lockhart Dr

Date of Construction	1953 Source: TCAD	Roof Materials	Composition shingles	Outbuildings	Inset carport.
Stylistic Influences	Ranch	Number of Chimneys	Exterior: 1, Interior: 0	Moved	Has Not Moved
Historic Use	Dwelling, single	Chimney Materials	Stone	Integrity	Door replaced. Storm windows added. Siding on front elevation replaced.
Current Use	Dwelling, single	Windows	Wood Double Hung		
Stories	1	Door Features	Glazing, Not Original		
Plan	Square or rectangular	Porch Type	Partial Width, Inset		
Foundation	Pier-and-Beam	Porch Supports	Metal		
Exterior Materials	Wood, Stone, Asbestos	Porch Railings	Metal		
Roof Type	Side Gable

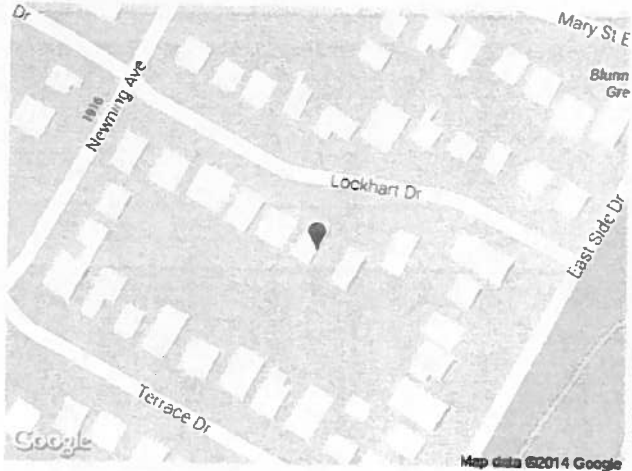
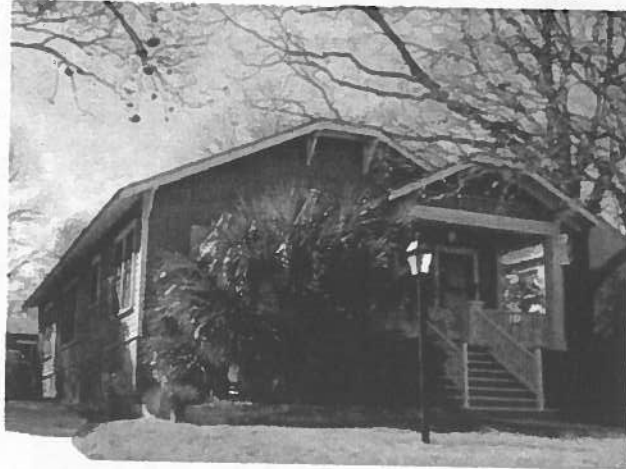
511 Lockhart Dr

Date of Construction	1928 Source: TCAD	Roof Materials	Composition shingles	Porch Railings	Square Wood
Stylistic Influences	Craftsman	Roof Decoration	Exposed Rafter Ends, Brackets	Outbuildings	Rear cottage/office w/wood walls and gabled roof.
Historic Use	Dwelling, single	Number of Chimneys	Exterior: 0, Interior: 0	Dormer Type	Clipped
Current Use	Dwelling, single	Windows	Wood Double Hung, Decorative Screens	Moved	Has Not Moved
Stories	1	Door Features	Glazing		
Plan	Square or rectangular	Porch Type	Partial Width, Independent		
Foundation	Pier-and-Beam	Porch Roof Types	Gabled Clipped		
Exterior Materials	Wood	Porch Supports	Square Full Height Wood		
Roof Type	Front Gable
