ZONING CHANGE REVIEW SHEET

CASE NUMBER: C14H-2014-0014

HISTORIC NAME: Bluebonnet Hills Historic District

ADDRESS OF PROPOSED ZONING CHANGE: Roughly bounded by Annie Street on the north, East Side Drive on the east, Leland Street on the south, and Brackenridge Street on the west.

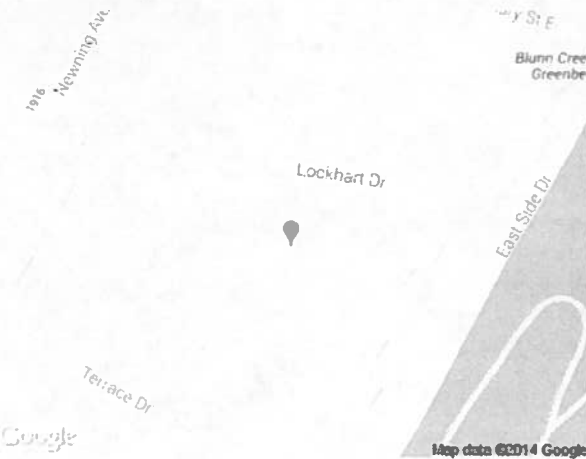
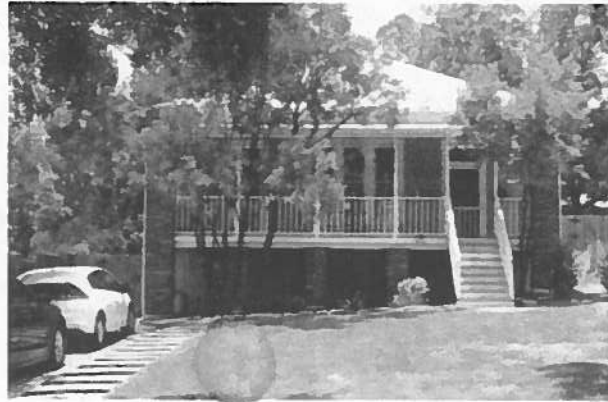
513 Lockhart Dr

Date of Construction	1960 Source: TCAD	Roof Type	Hipped	Porch Supports	Square Full Height Wood
Stylistic Influences	Neoclassical	Roof Materials	Metal	Porch Railings	Square Wood
Historic Use	Dwelling, single	Number of Chimneys	Exterior: 0, Interior: 0	Walls	Height: 2 ft, Stone
Current Use	Dwelling, single	Windows	Wood Double Hung	Landscape Features	Set far back on lot.
Stories	1	Door Features	Glazing, Transom	Moved	Moved to this Location in 1980
Plan	Square or rectangular	Porch Type	Full Width, Independent	Integrity	Porch railings replaced
Foundation	Pier-and-Beam	Porch Roof Types	Shed		
Exterior Materials	Wood

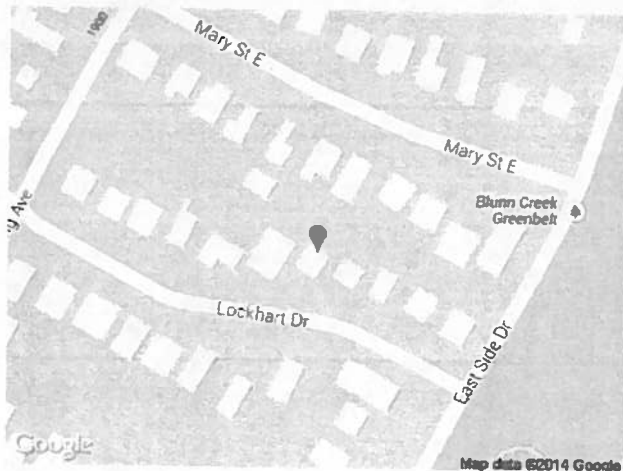
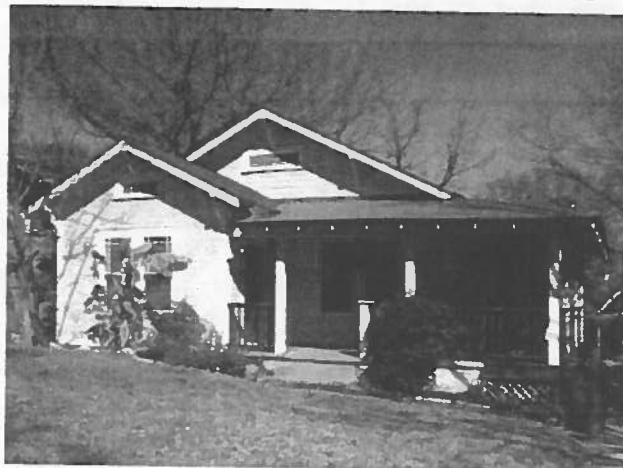
514 Lockhart Dr

Date of Construction	1928 Source: TCAD	Roof Materials	Composition shingles	Porch Railings	Square Wood
Stylistic Influences	Craftsman	Roof Decoration	Exposed Rafter Ends, Brackets	Outbuildings	Small detached rear office w/wood walls and metal roof.
Historic Use	Dwelling, single	Number of Chimneys	Exterior: 0, Interior: 0	Moved	Has Not Moved
Current Use	Dwelling, single	Windows	Wood Double Hung, Decorative Screens	Integrity	Porch railings replaced.
Stones	1	Door Features	Glazing, French Doors, Several doors		
Plan	Wing-and-Gable (L plan)	Porch Type	Wraparound		
Foundation	Pier-and-Beam	Porch Roof Types	Shed		
Exterior Materials	Wood	Porch Supports	Square Full Height Wood		
Roof Type	Cross Gable

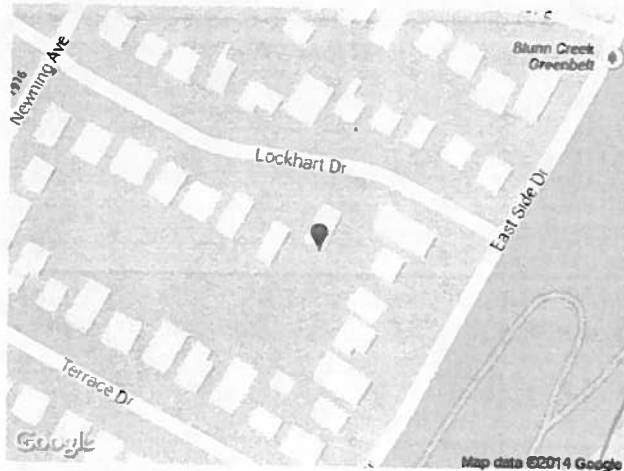
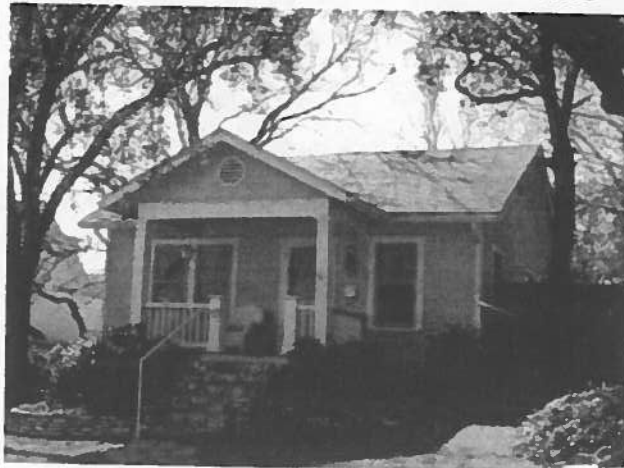
515 Lockhart Dr

Date of Construction	1929 Source: City Directories	Roof Materials	Composition shingles	Walls	Height: 3 ft, Stone
Stylistic Influences	Craftsman	Number of Chimneys	Exterior: 0, Interior: 0	Landscape Features	Raised lot.
Historic Use	Dwelling, single	Windows	Wood Double Hung, Wood Screens	Moved	Has Not Moved
Current Use	Dwelling, single	Door Features	Not Original	Integrity	Small rear addition. Door replaced.
Stories	1	Porch Type	Partial Width, Independent		
Plan	Square or rectangular	Porch Roof Types	Gabled		
Foundation	Pier-and-Beam	Porch Supports	Square Full Height Wood		
Exterior Materials	Wood	Porch Railings	Square Wood		
Roof Type	Side Gable

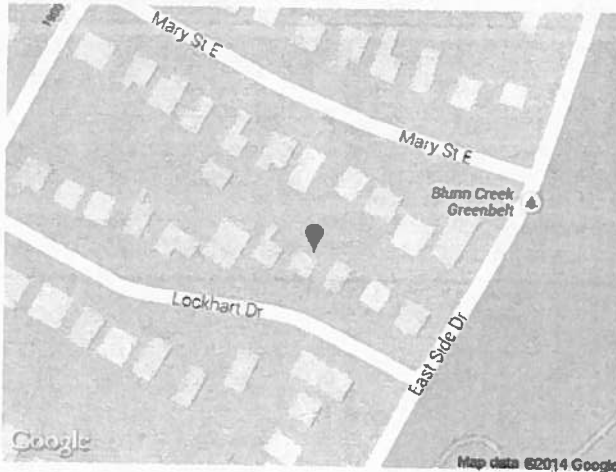
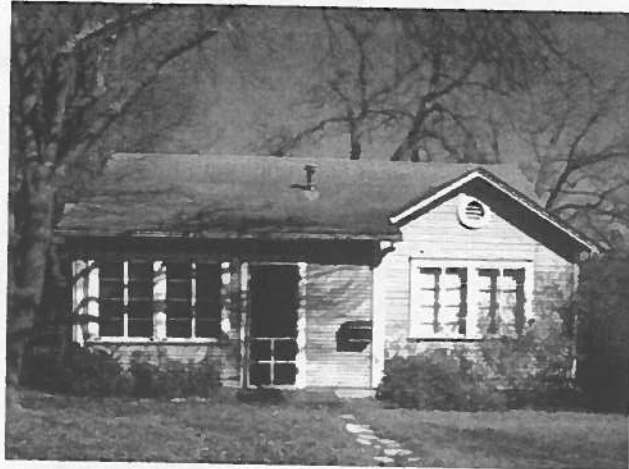
516 Lockhart Dr

Date of Construction	1939 Source: TCAD	Roof Type	Cross Gable	Porch Supports	None
Stylistic Influences	Minimal Traditional	Roof Materials	Composition shingles	Porch Railings	None
Historic Use	Dwelling, single	Roof Decoration	Exposed Rafter Ends	Outbuildings	1 Story Detached Garage, Garage Wall Material: Wood, Garage Roof Material: Metal, Garage Roof Type: Gabled
Current Use	Dwelling, single	Number of Chimneys	Exterior: 0, Interior: 0	Moved	Has Not Moved
Stories	1	Windows	Wood Double Hung, Steel Casement	Integrity	Small rear addition. Front porch enclosed. Roof line changed. Steel casement windows added to front.
Plan	Asymmetrical	Door Features	Glazing		
Foundation	Pier-and-Beam	Porch Type	No Front Porch		
Exterior Materials	Wood

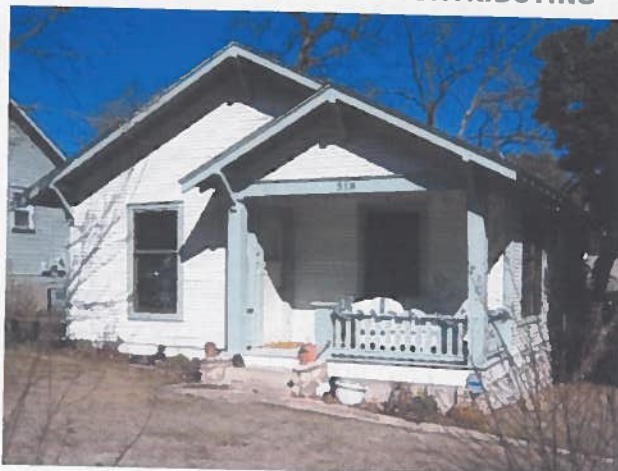
518 Lockhart Dr

Date of Construction	1931 Source: City Directories	Roof Type	Front Gable	Porch Roof Types	Gabled
Stylistic Influences	Craftsman	Roof Materials	Composition shingles	Porch Supports	Square Full Height Wood
Historic Use	Dwelling, single	Roof Decoration	Exposed Rafter Ends, Brackets	Porch Railings	Square Wood
Current Use	Dwelling, single	Number of Chimneys	Exterior: 0, Interior: 0	Moved	Has Not Moved
Stories	1	Windows	Wood Double Hung	Integrity	Windows possibly replaced.
Plan	Square or rectangular	Door Features	Glazing		
Foundation	Pier-and-Beam	Porch Type	Partial Width, Semi-Inset		
Exterior Materials	Wood

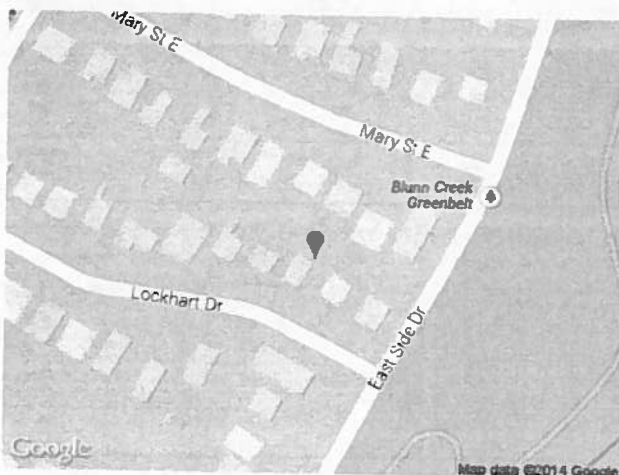
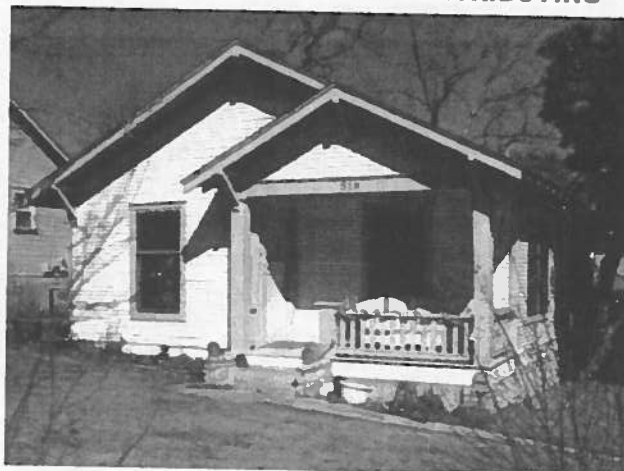
518 Lockhart Dr

Date of Construction	1931 Source: City Directories	Roof Type	Front Gable	Porch Roof Types	Gabled
Stylistic Influences	Craftsman	Roof Materials	Composition shingles	Porch Supports	Square Full Height Wood
Historic Use	Dwelling, single	Roof Decoration	Exposed Rafter Ends, Brackets	Porch Railings	Square Wood
Current Use	Dwelling, single	Number of Chimneys	Exterior: 0, Interior: 0	Moved	Has Not Moved
Stories	1	Windows	Wood Double Hung	Integrity	Windows possibly replaced.
Plan	Square or rectangular	Door Features	Glazing		
Foundation	Pier-and-Beam	Porch Type	Partial Width, Semi-Inset		
Exterior Materials	Wood

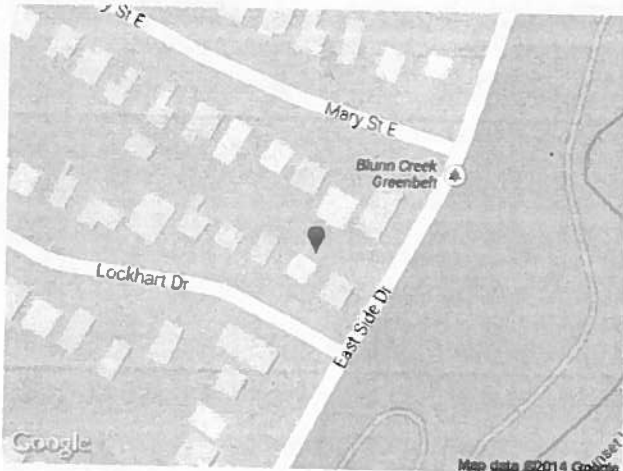
520 Lockhart Dr

Date of Construction	1948 Source: TCAD	Roof Type	Side Gable	Porch Supports	Other, Rustic wood logs
Stylistic Influences	Minimal Traditional	Roof Materials	Metal	Porch Railings	None
Historic Use	Dwelling, single	Roof Decoration	Exposed Rafter Ends	Moved	Has Not Moved
Current Use	Dwelling, single	Number of Chimneys	Exterior: 0, Interior: 0	Integrity	Windows replaced w/aluminum. Porch replaced w/rustic porch posts and corrugated metal. Metal security bars added to windows.
Stories	1	Windows	Aluminum		
Plan	Square or rectangular	Porch Type	Partial Width, Independent		
Foundation	Pier-and-Beam	Porch Roof Types	Shed		
Exterior Materials	Wood

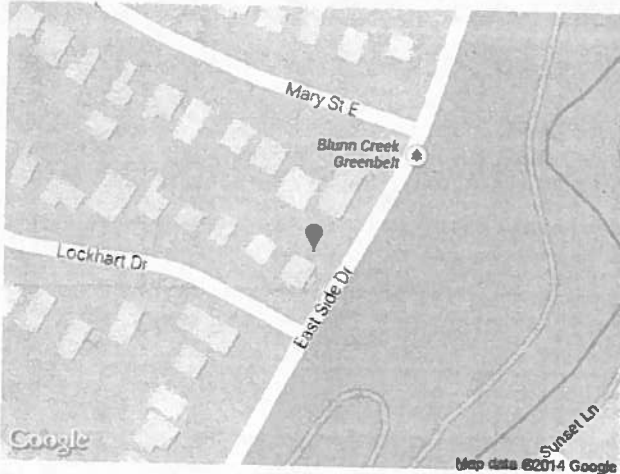
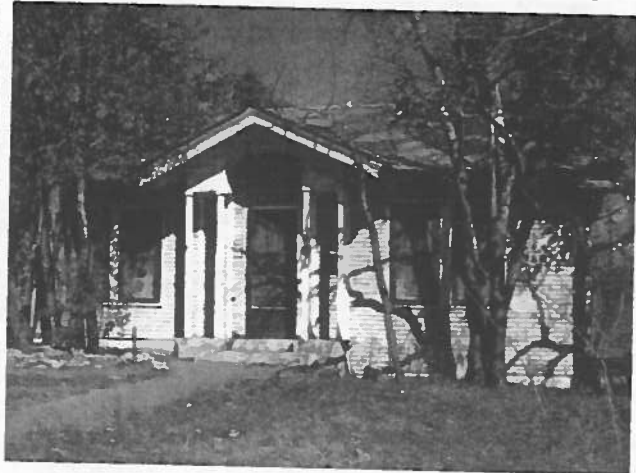
522 Lockhart Dr

Date of Construction	1930 Source: TCAD	Roof Materials	Metal	Porch Railings	None
Stylistic Influences	Craftsman	Roof Decoration	Exposed Rafter Ends	Outbuildings	Shed.
Historic Use	Dwelling, single	Number of Chimneys	Exterior: 0, Interior: 0	Moved	Has Not Moved
Current Use	Dwelling, single	Windows	Wood Double Hung	Integrity	Screens replaced during historic period
Stories	1	Door Features	Glazing		
Plan	Square or rectangular	Porch Type	Stoop Roof, Two entrances		
Foundation	Pier-and-Beam	Porch Roof Types	Gabled		
Exterior Materials	<i>Brick</i>	Porch Supports	Square Full Height Wood		
Roof Type	Side Gable

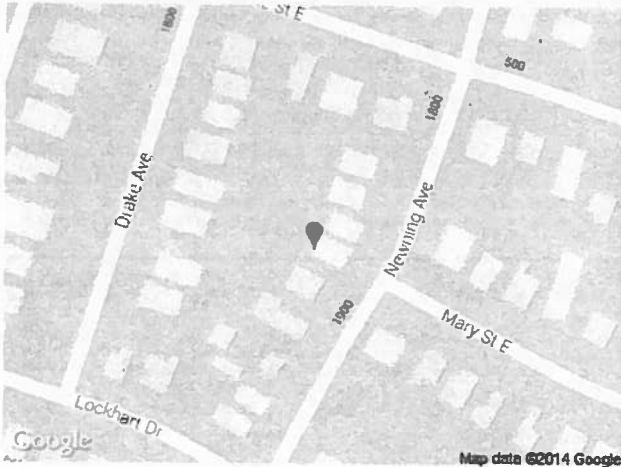
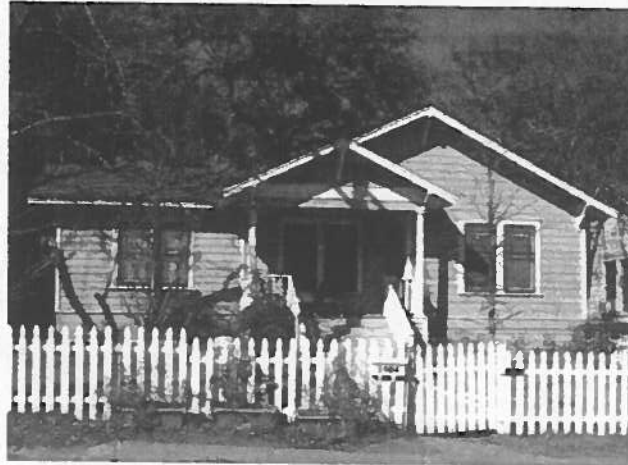
1904 Newning Ave

Date of Construction	1931 Source: City Directories	Roof Materials	Composition shingles	Porch Railings	Square Wood
Stylistic Influences	Craftsman	Roof Decoration	Brackets	Fences	Height: 3 ft, Wood picket
Historic Use	Dwelling, single	Number of Chimneys	Exterior: 0, Interior: 0	Moved	Has Not Moved
Current Use	Dwelling, single	Windows	Wood Double Hung, Decorative Screens	Integrity	Circa 1995: 1-story front addition w/matching siding and screens.
Stories	1	Door Features	Glazing		
Plan	Wing-and-Gable (L plan)	Porch Type	Partial Width, Independent		
Foundation	Pier-and-Beam	Porch Roof Types	Gabled		
Exterior Materials	Wood	Porch Supports	Column Full Height, Wood columns with Doric capitals.		
Roof Type	Cross Gable

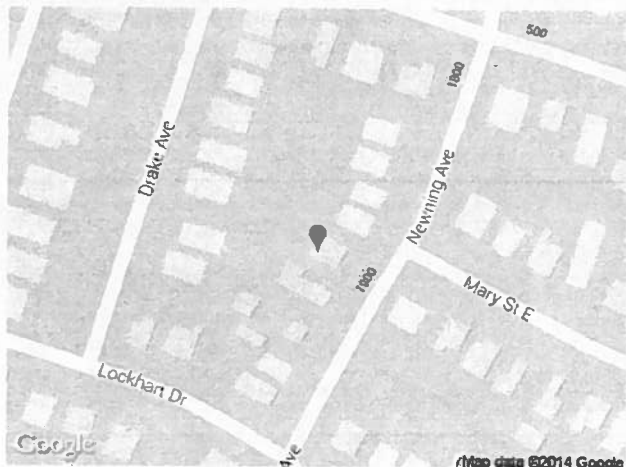
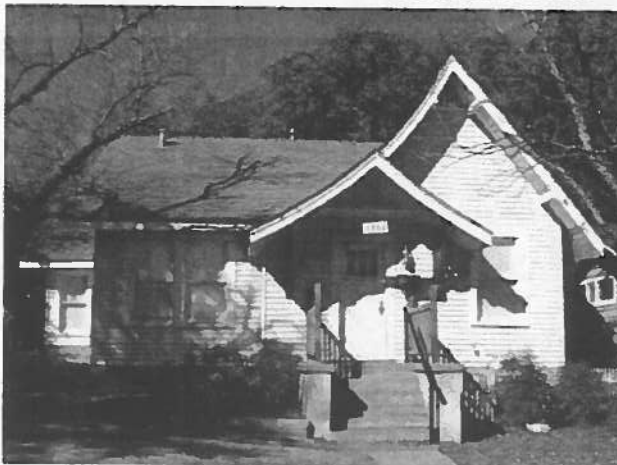
1906 Newning Ave

Date of Construction	1931 Source: City Directories	Roof Type	Cross Gable	Porch Supports	None
Stylistic Influences	Revival - Tudor	Roof Materials	Composition shingles	Porch Railings	Square Wood
Historic Use	Dwelling, single	Number of Chimneys	Exterior: 0, Interior: 0	Moved	Has Not Moved
Current Use	Dwelling, single	Windows	Wood Double Hung	Integrity	Small side addition. Porch railings replaced. Soffit enclosed or altered.
Stories	1	Door Features	Glazing		
Plan	Wing-and-Gable (L plan)	Porch Type	Inset, Stoop Roof, Concrete stoop with non-historic railing.		
Foundation	Pier-and-Beam	Porch Roof Types	Gabled		
Exterior Materials	Wood, Unknown synthetic

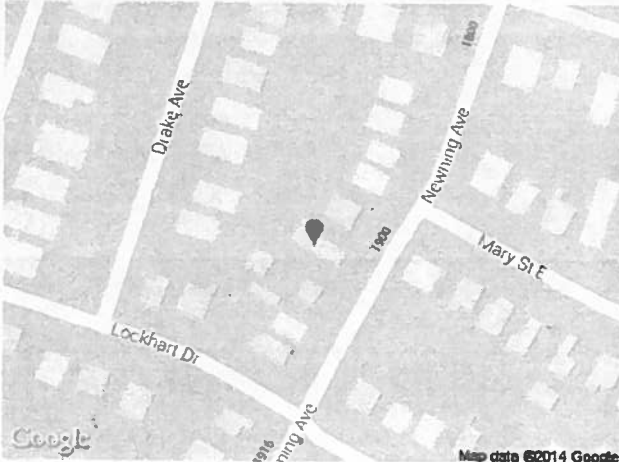
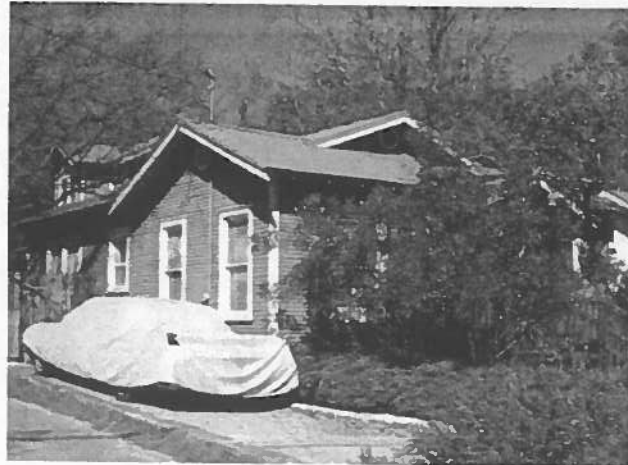
1908 Newning Ave

Date of Construction	1933	Roof Materials	Metal	Porch Railings	Square Wood
Source	City Directories	Roof Decoration	Exposed Rafter Ends, Brackets	Landscape Features	Stone walkway.
Stylistic Influences	Craftsman	Number of Chimneys	Exterior: 0, Interior: 0	Number of Dormers	1
Historic Use	Dwelling, single	Windows	Wood Double Hung	Moved	Has Not Moved
Current Use	Dwelling, single	Door Features	Glazing	Integrity	Large 2-story addition (not visible from street). Front deck and stairs added.
Stories	2	Porch Type	Independent, Stoop Roof		
Plan	Square or rectangular	Porch Roof Types	Gabled, w/starburst trim		
Foundation	Pier-and-Beam	Porch Supports	Other, Wood brackets		
Exterior Materials	Wood				
Roof Type	Cross Gable

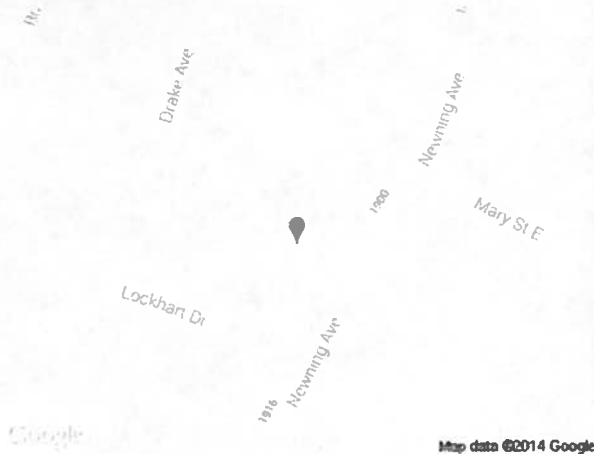
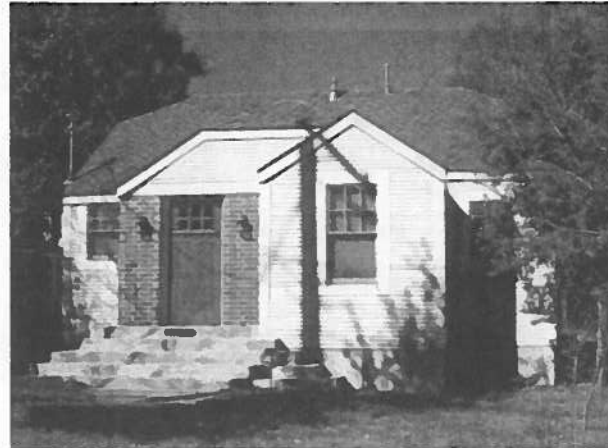
1910 A Newning Ave

Date of Construction 1938
Source: TCAD
Stylistic Influences None
Historic Use Dwelling, single
Current Use Dwelling, single
Stories 1

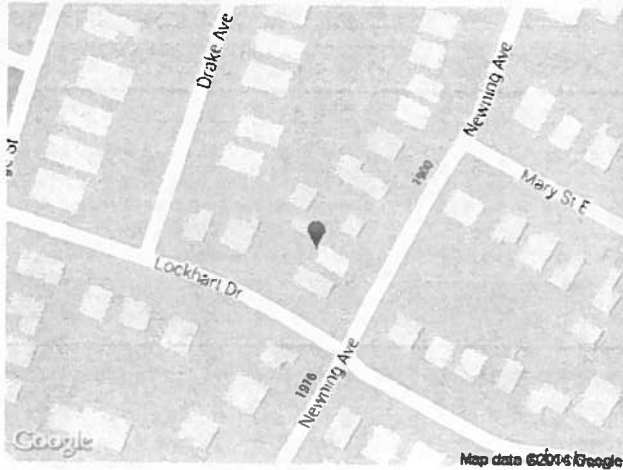
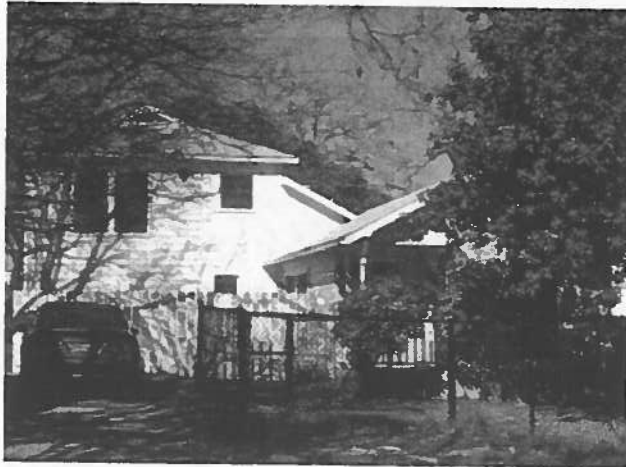
1912 Newning Ave ✓

Date of Construction	1940	Integrity	Circa 1980: 1-story addition on front of original 2-story house.
Source	TCAD		
Stylistic Influences	None		
Historic Use	Dwelling, single		
Current Use	Dwelling, single		
Stories	2		
Moved	Has Not Moved

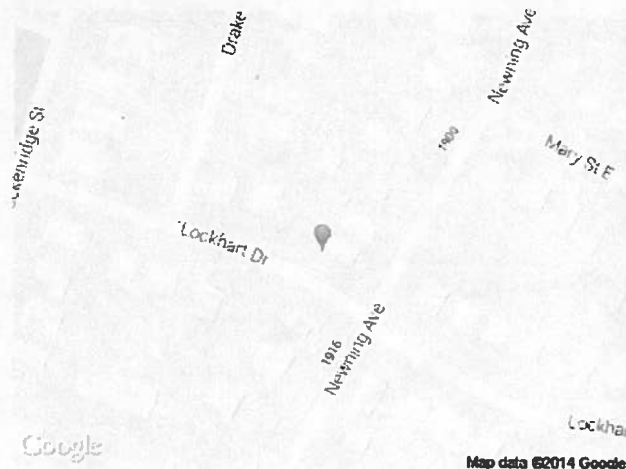
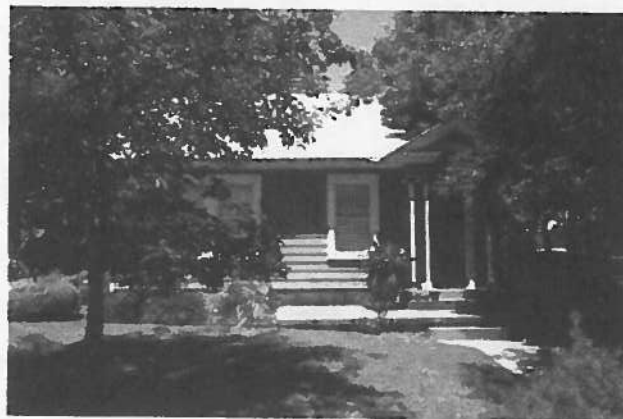
1914 Newning Ave

Date of Construction	1933 Source: City Directories	Roof Type	Side Gable	Porch Supports	Square Full Height Wood, w/classical detailing
Stylistic Influences	Colonial Revival	Roof Materials	Metal	Porch Railings	None
Historic Use	Dwelling, single	Number of Chimneys	Exterior: 0, Interior: 0	Outbuildings	1 Story Detached Garage
Current Use	Dwelling, single	Windows	Wood Double Hung	Moved	Has Not Moved
Stories	1	Door Features	Glazing	Integrity	Porch altered.
Plan	Square or rectangular	Porch Type	Partial Width, Independent		
Foundation	Pier-and-Beam	Porch Roof Types	Gabled		
Exterior Materials	Wood

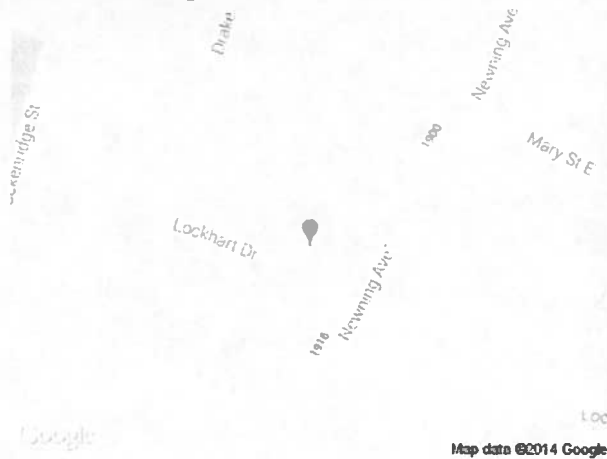
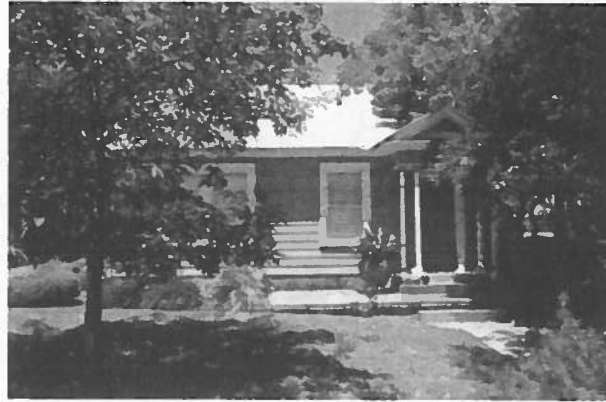
1914 Newning Ave

Date of Construction	1933 Source: City Directories	Roof Type	Side Gable	Porch Supports	Square Full Height Wood, w/classical detailing
Stylistic Influences	Colonial Revival	Roof Materials	Metal	Porch Railings	None
Historic Use	Dwelling, single	Number of Chimneys	Exterior: 0, Interior: 0	Outbuildings	1 Story Detached Garage
Current Use	Dwelling, single	Windows	Wood Double Hung	Moved	Has Not Moved
Stories	1	Door Features	Glazing	Integrity	Porch altered.
Plan	Square or rectangular	Porch Type	Partial Width, Independent		
Foundation	Pier-and-Beam	Porch Roof Types	Gabled		
Exterior Materials	Wood

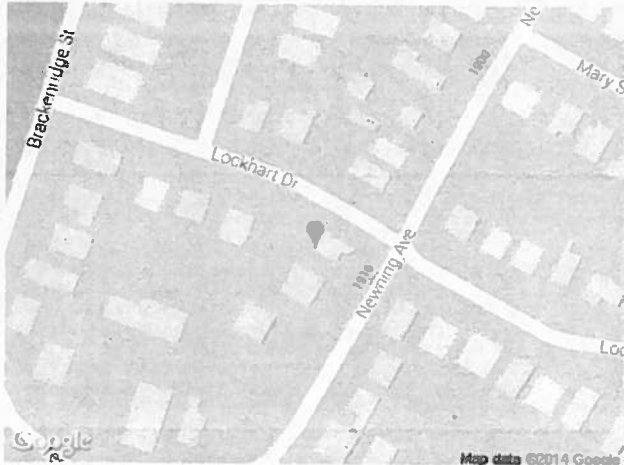
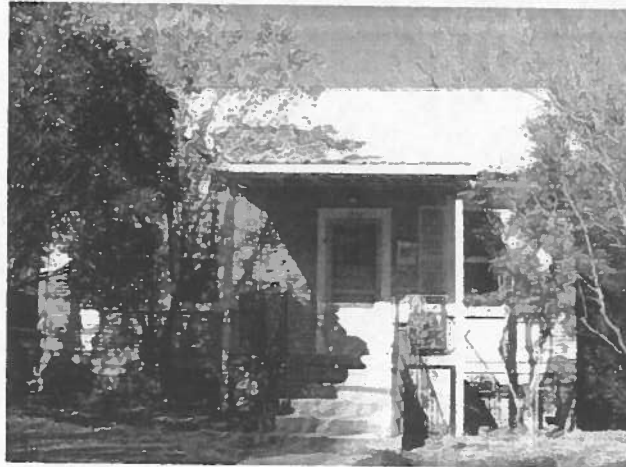
1918 Newning Ave

Date of Construction	1932 Source: TCAD	Roof Type	Side Gable	Porch Supports	Square Full Height Wood
Stylistic Influences	Minimal Traditional	Roof Materials	Metal	Porch Railings	Metal
Historic Use	Dwelling, single	Number of Chimneys	Exterior: 0, Interior: 0	Moved	Has Not Moved
Current Use	Dwelling, single	Windows	Wood Double Hung	Integrity	Porch roof added.
Stories	1	Door Features	Glazing		
Plan	Square or rectangular	Porch Type	Partial Width, Independent		
Foundation	Pier-and-Beam	Porch Roof Types	Shed		
Exterior Materials	Wood

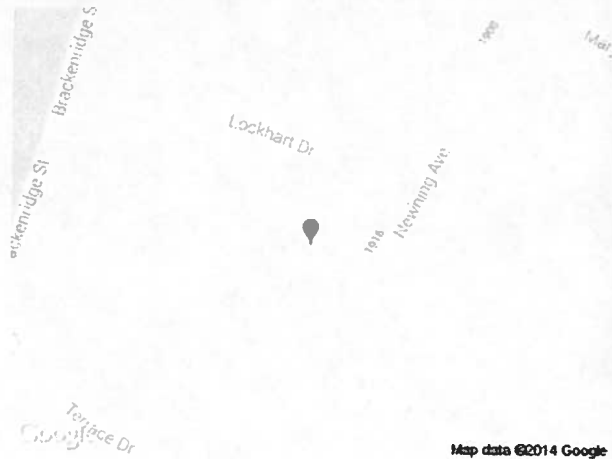
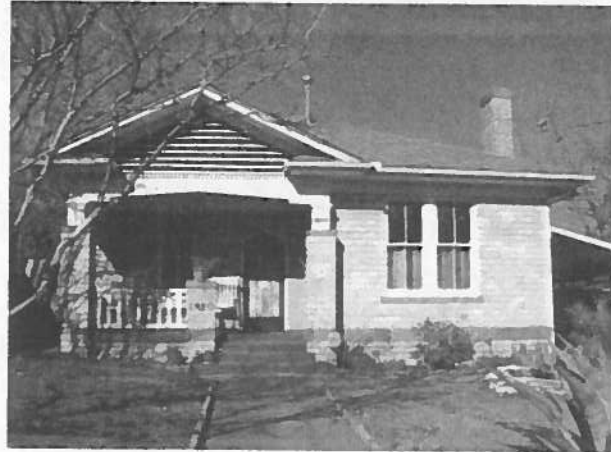
1920 Newning Ave

Date of Construction	1931 Source: City Directories	Roof Materials	Composition shingles	Porch Railings	Square Wood
Stylistic Influences	Prairie	Number of Chimneys	Exterior: 1, Interior: 0	Outbuildings	Attached carport circa 1960.
Historic Use	Dwelling, single	Chimney Materials	Brick	Moved	Has Not Moved
Current Use	Dwelling, single	Windows	Wood Double Hung	Integrity	Carport attached.
Stories	1	Door Features	Glazing, Geometric door and screen door w/pointed top.		
Plan	Square or rectangular	Porch Type	Partial Width, Inset		
Foundation	Perimeter Wall	Porch Roof Types	Gabled, Decorative front gable w/comice return, venting on pediment, and detailed porch header.		
Exterior Materials	Brick, Buff brick w/red brick detailing.	Porch Supports	Square on Pier, Brick Piers		
Roof Type	Hipped with Gable

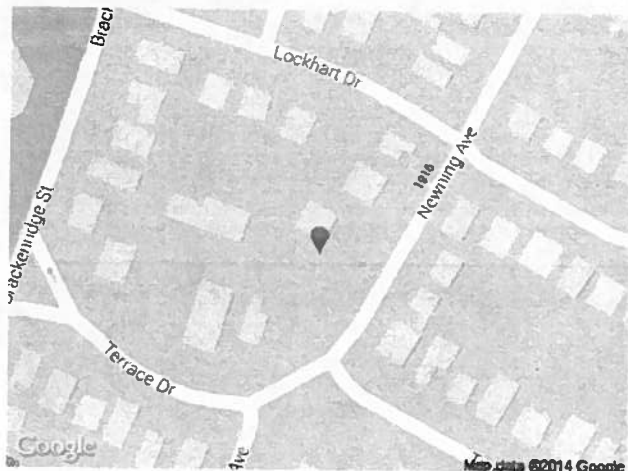
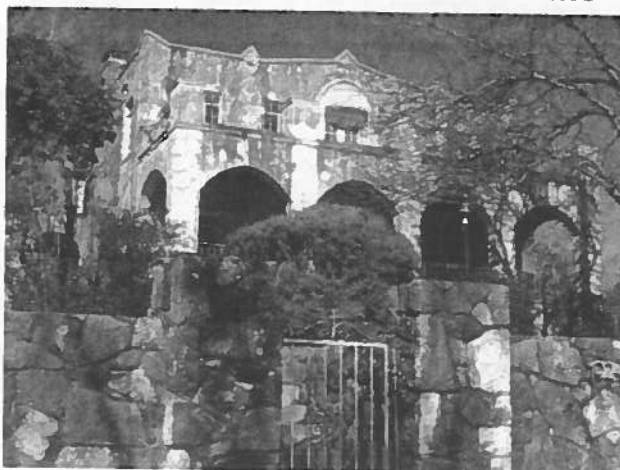
1924 Newning Ave

Date of Construction	1937 Source: TCAD	Exterior Materials	Stone	Porch Type	Full Width, Independent
Stylistic Influences	Revival - Mediterranean	Roof Type	Flat with Parapet	Porch Roof Types	Flat
Historic Use	Dwelling, single	Roof Materials	Built up Tar & Gravel	Porch Supports	Other, Arched stone
Current Use	Dwelling, single	Number of Chimneys	Exterior: 1, Interior: 0	Porch Railings	Metal
Previous Designations	City of Austin Landmark	Chimney Materials	Stone	Outbuildings	Secondary dwelling— see 1926 Newning Ave.
Stories	2	Windows	Metal casement	Landscape Features	4' stone retaining wall. House sits above street on hill.
Plan	Square or rectangular	Door Features	Glazing	Moved	Has Not Moved
Foundation	Perimeter Wall

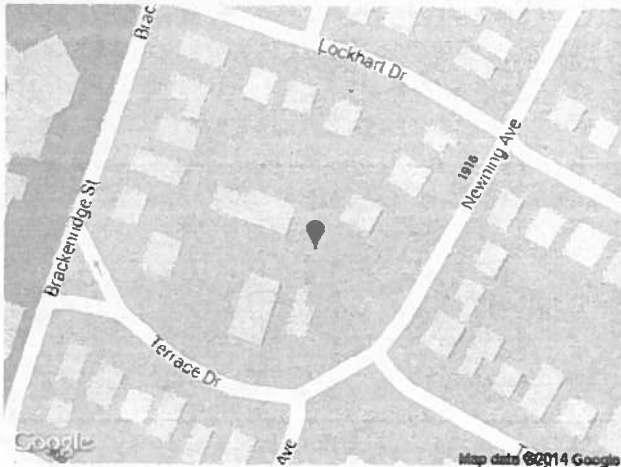
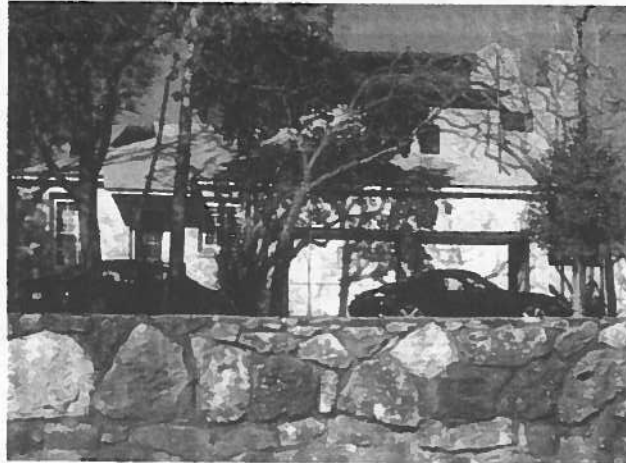
1926 Newning Ave

Date of Construction	Estimated 1939	Roof Materials	Composition shingles	Porch Railings	None
Stylistic Influences	None	Number of Chimneys	Exterior: 0, Interior: 0	Landscape Features	4' stone retaining wall.
Historic Use	Garage Apartment	Windows	Wood Double Hung	Moved	Has Not Moved
Stories	1	Door Features	Glazing	Integrity	Garage doors replaced. Outbuilding to 1924 Newning.
Plan	Square or rectangular	Porch Type	Stoop Roof		
Foundation	Perimeter Wall	Porch Roof Types	Shed, Cantilevered		
Exterior Materials	Stone	Porch Supports	None		
Roof Type	Hipped with Gable

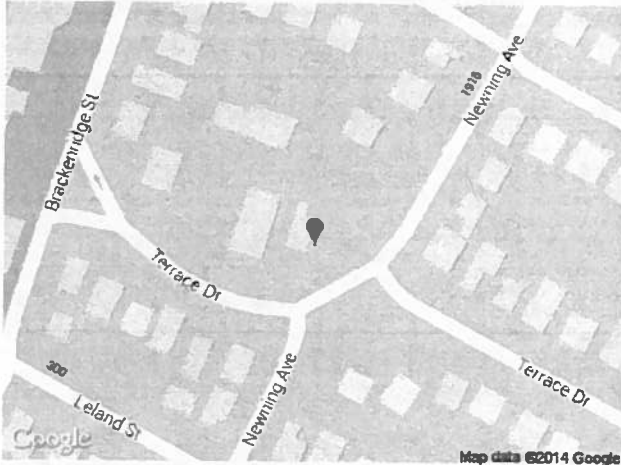
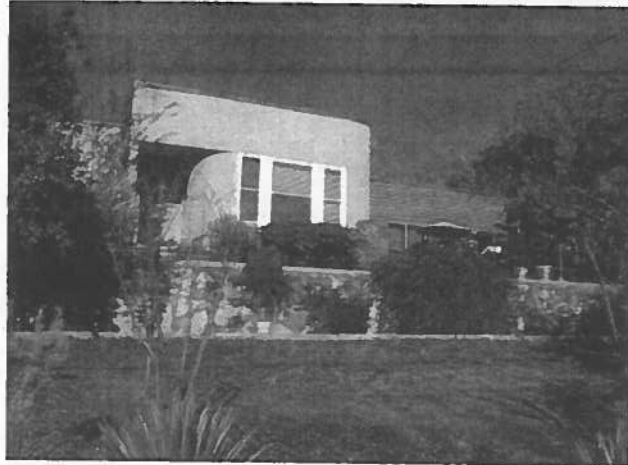
1928 Newning Ave

Date of Construction	1936 Source: TCAD	Roof Type	Flat	Landscape Features	2-5' stone retaining wall. Terraced lot.
Stylistic Influences	Modernistic	Roof Materials	Built up Tar & Gravel	Moved	Has Not Moved
Historic Use	Dwelling, single	Number of Chimneys	Exterior: 0, Interior: 0	Integrity	Modern side addition.
Current Use	Dwelling, single	Windows	Wood Double Hung		
Stones	1	Porch Type	Partial Width, Inset		
Plan	Asymmetrical	Porch Supports	Column Full Height		
Foundation	Perimeter Wall	Porch Railings	None		
Exterior Materials	Stucco, Hardiplank on addition.
