Park Place at Riverside Subdivision and Offsite Channel Improvements

Environmental Commission Briefing
November 4, 2015

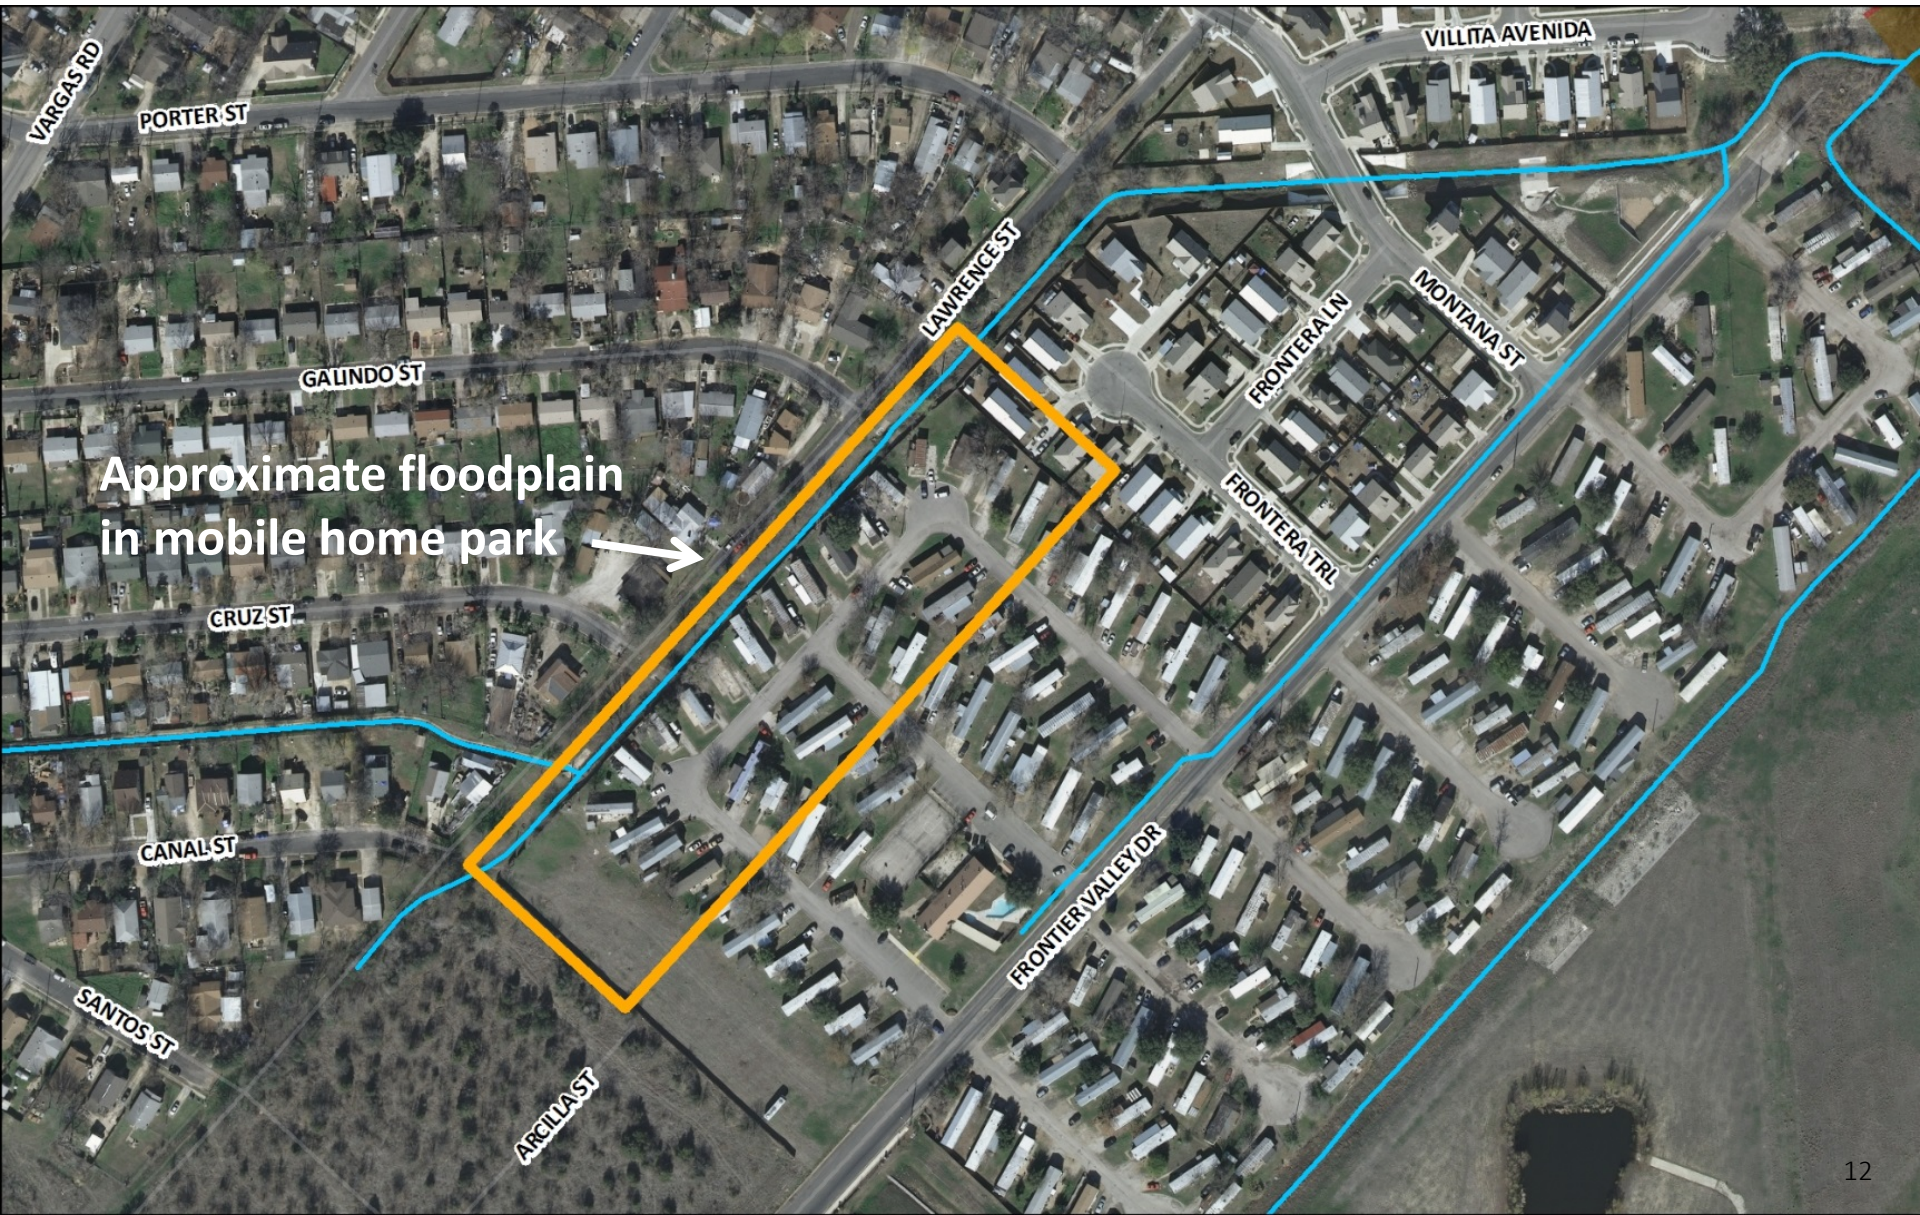
Approximate Floodplain Before Channel Improvements

- Off-site channel improvements provide a number of flood benefits
 - Improved flood conveyance
 - Removed a number of homes from the 100-year flood plain
 - Applicant worked with Watershed staff on channel design and revegetation plan
 - Review similar to current code process and requirements

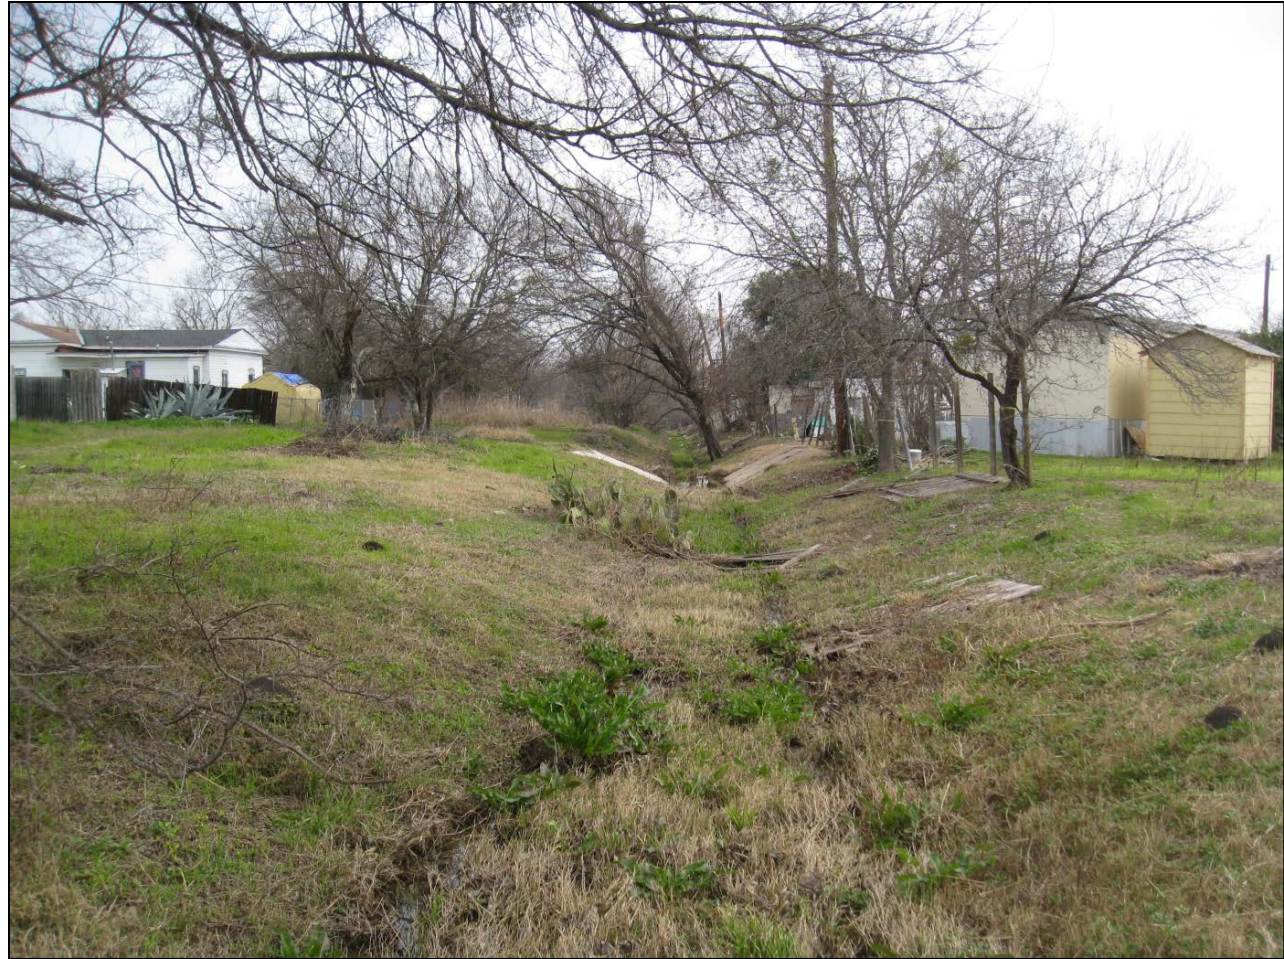
Channel Prior to Construction

- Trapezoidal grass lined channel
- Regularly mowed
- Low stream function
- Limited habitat value

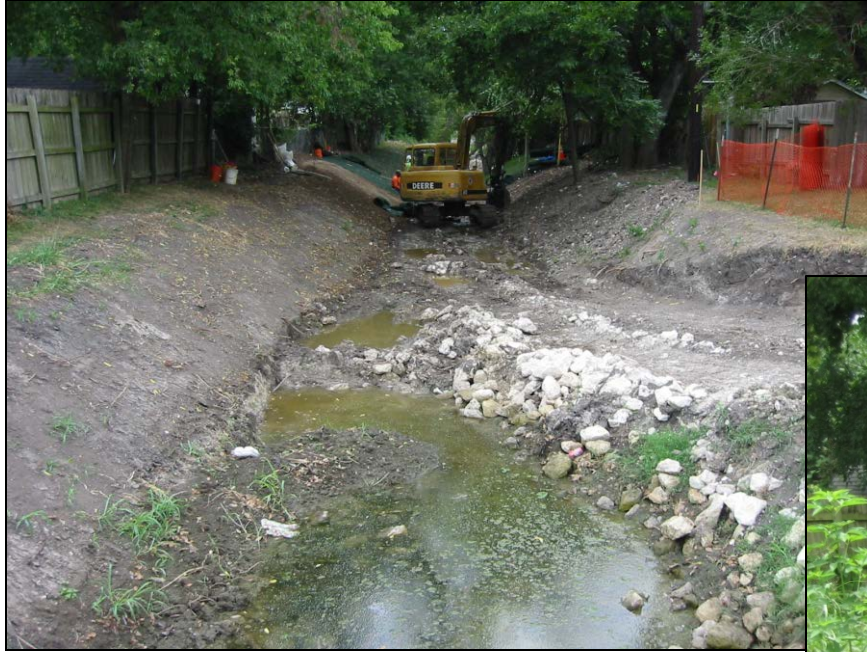
During construction

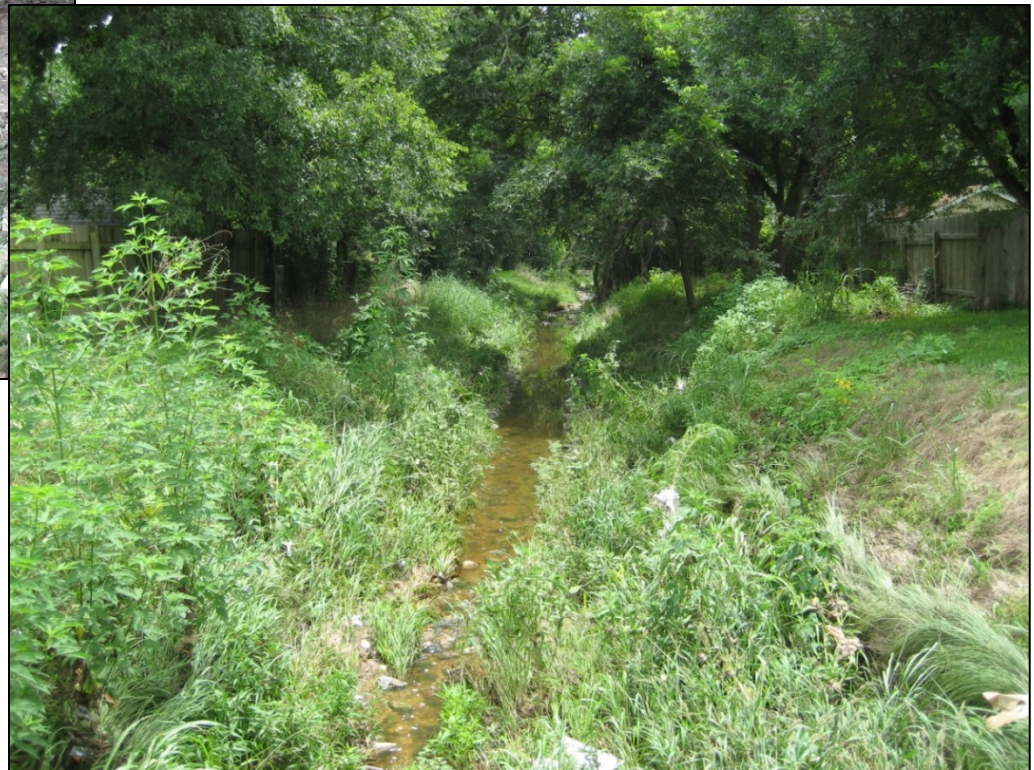
After construction

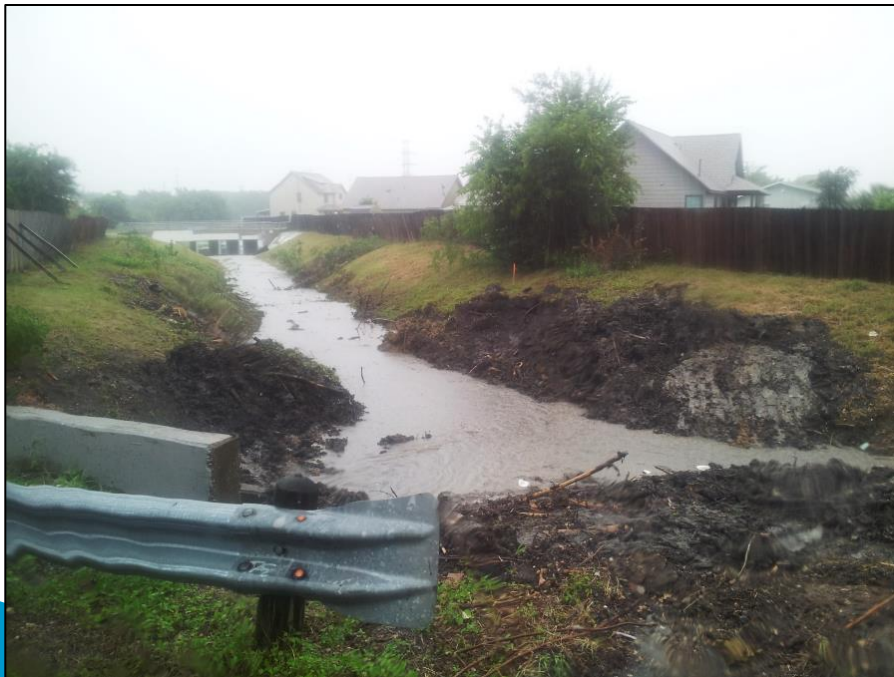
Photo taken June 16 during rain event.
Section of channel shown is within project limits.
Referred to DSD to determine compliance with approved site plan and assignment of corrective actions.

- June 15:** Citizen notifies COA of tree removal and sediment run-off
- June 16: WPD Investigator site visit; compliance action referred to Env. Inspection (DSD)
- June 26: Env. Inspector issues corrective action punch-list to contractor
- June 29: Citizen sends photos of creek washout
- June 30: Env. Inspectors conduct site visit and issue new punch-list

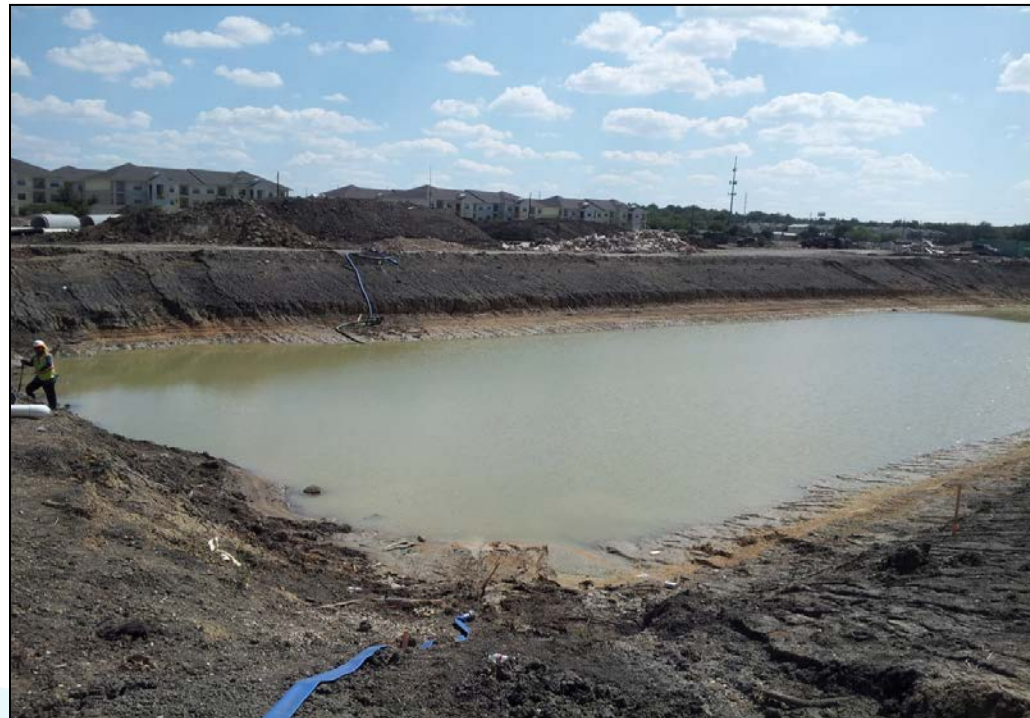
September 18 –
Sedimentation basin being
pumped from bottom,
resulting in silty discharge

- Aug. 20:** Citizen call to Pollution Hotline to report sediment discharge
- Aug. 20: WPD responds to site and finds most controls functioning, some controls failing
- Aug. 21: WPD sends investigation findings to Env. Inspector; DSD finds site in compliance
- Sep. 18: WPD site visit identifies improper dewatering practices
- Sep. 22: DSD conducts site visit and issues new punch-list

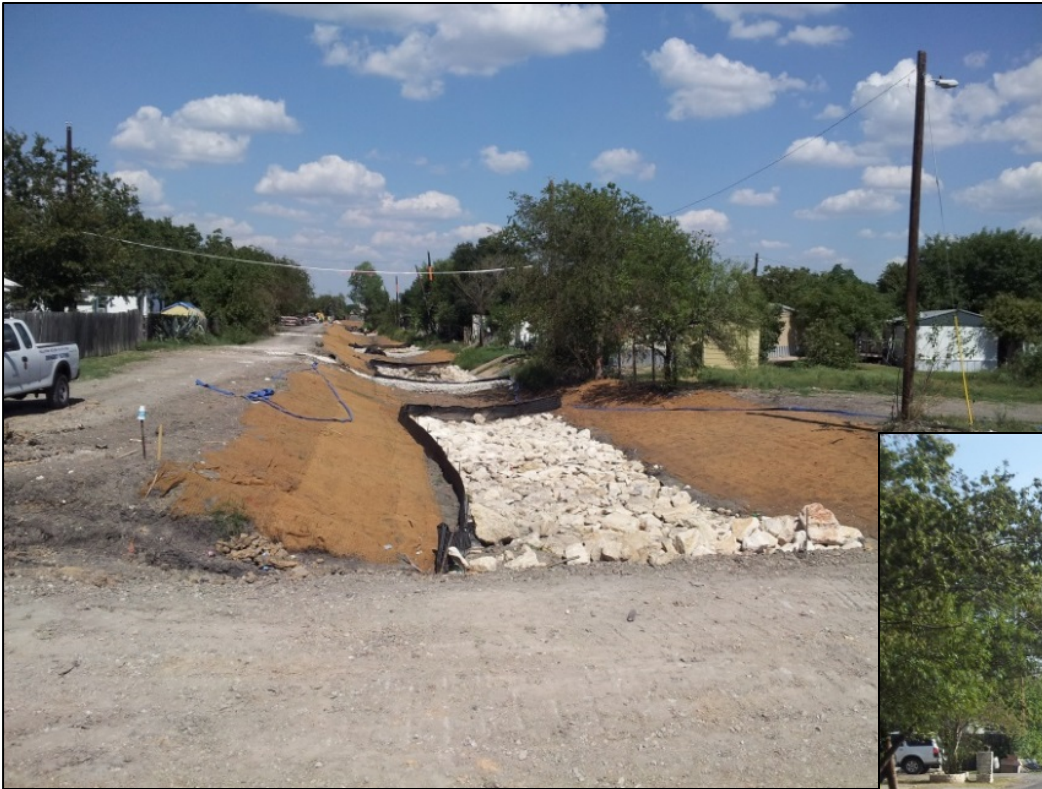
Left: September 23

**Improved site stabilization;
no further discharges.**
