SOUTHCENTRAL SHORE UNIT

AUDITORIUM SHORES UNIT

BUTLER SHORES WOODLAND UNIT

ZILKER EAST UNIT

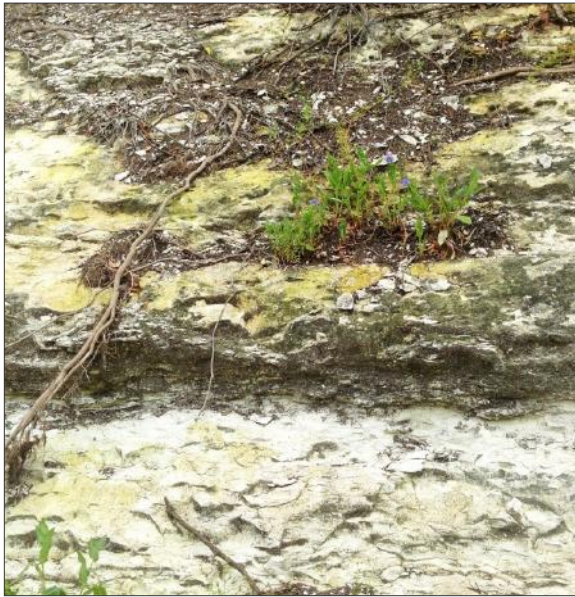
Figure 4.45 (Above, left): The exposed rock cliffs in this unit are unique within the study area. Figure 4.46 (Above, right): Many plantings have recently been added to the wetland surrounding the mouth of Blunn Creek. Figure 4.47 (Below, left): Invasive species, erosion issues, and recommended restoration work in the The Cliffs Unit. Sources: COA, NAIP. Figure 4.48 (Below, right): The largest infestation of catclaw vine in the study area is found in The Cliffs.

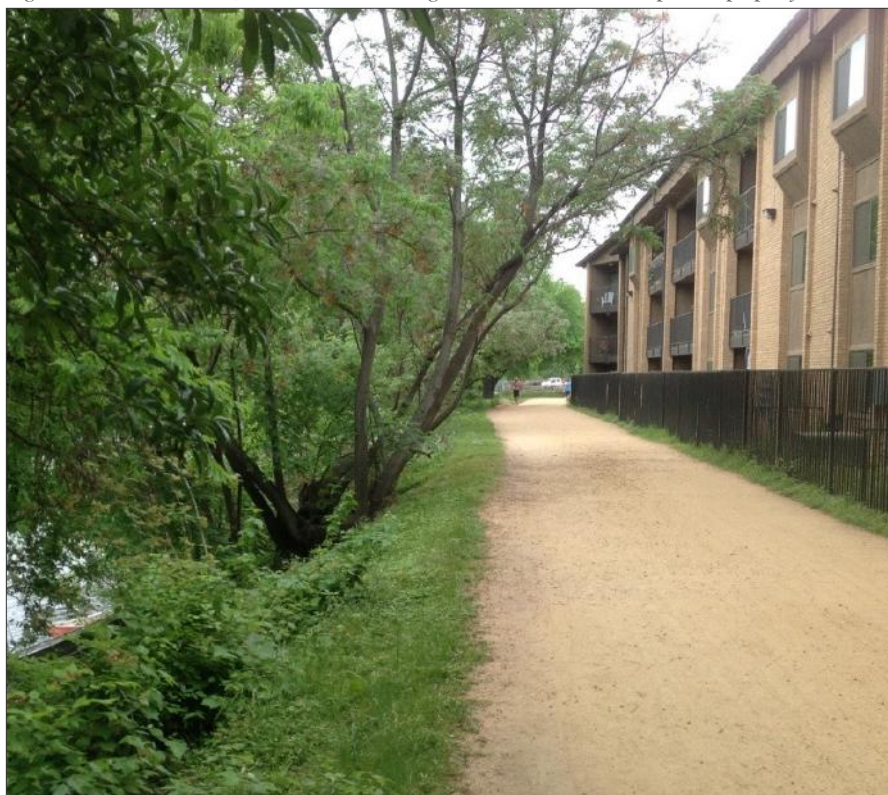
through an easement on private property rather than through public parkland (Figure 4.50). Though it is narrow, the woodland makes up 2 acres. Bald cypress is the dominant overstory tree, making up over half of the trees surveyed. The vast majority of the trees in the unit are considered shoreline trees, for a total of 6.8 trees per 100 ft of shoreline. Though the number of trees in the area is comparable to other units, the basal area is relatively high due to the high number of large bald cypress. The understory in the woodland is variable. There are pockets of comparatively intact native understory and groundcover,

Figure 4.50: In this unit, the Trail runs through a narrow easement on private property.

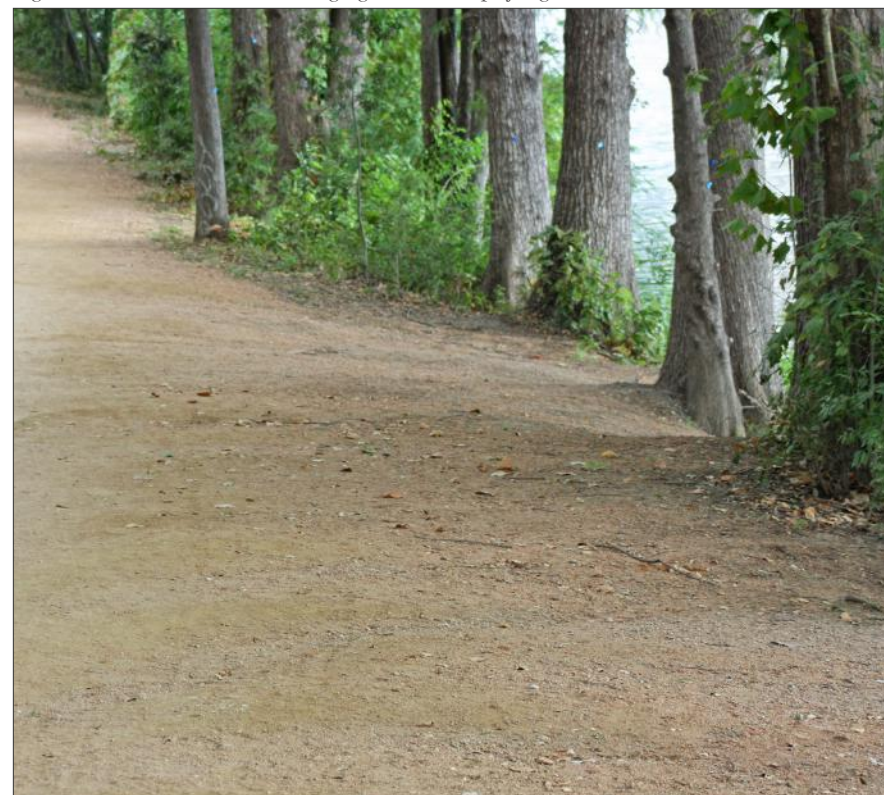
There are several major areas of granite deposition into the riparian area between Congress Avenue and the Boardwalk, like the one shown in Figure 4.51. Informal trails and concrete slabs are scattered throughout the area, with major issues near Congress Avenue, where severe trampling is leading to sheet erosion.

Figure 4.51: Trail erosion is damaging the thin strip of vegetation between the Trail and Lake.

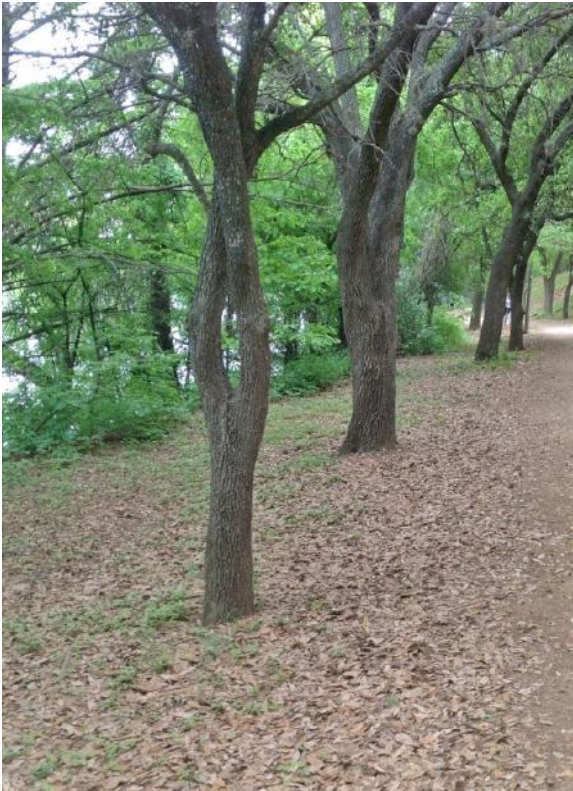
4.52 can be converted to woodland by the City or by landowners. The live oak grove pointed out in Don Gardner's report near and to the east of the Austin American Statesman building should be pruned. Invasive species removal with a focus on Ligustrum, golden rain tree, and Chinaberry as well as planting and seeding are recommended. Trail stabilization is essential for the area from the Boardwalk to Congress.

Figure 4.52: The woodland can be expanded into mowed areas.

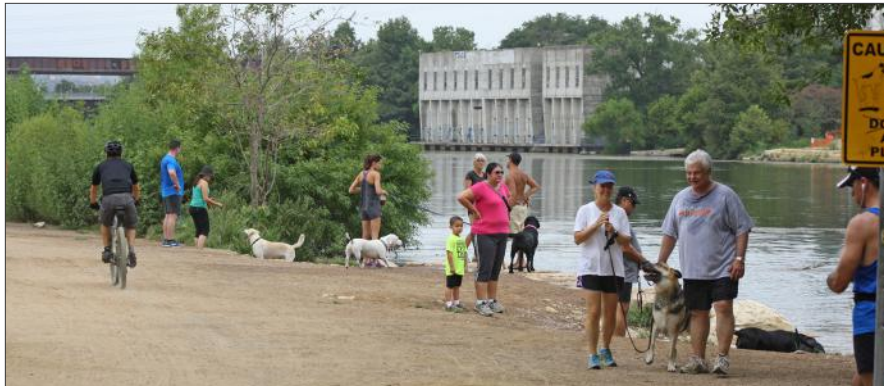
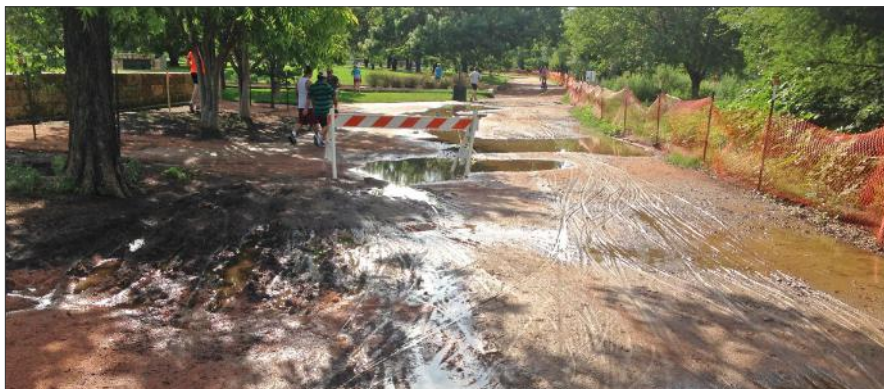
Figure 4.55 (Above): This popular water access point for dogs is badly trampled. Figure 4.56 (Middle): Poor trail drainage leads to visitors taking alternative routes, generally in the mulch around tree roots in the upper-left corner of this photo. Figure 4.57 (Below): Invasive species, erosion issues, and recommended restoration work in the Auditorium Shores Unit. Sources: COA, NAIP.

[R, I, E, & U] Work with City of Austin to ensure the implementation and ongoing maintenance of the Auditorium Shores master plan is successful and natural area management is aligned with these guidelines to the extent feasible. **High priority**

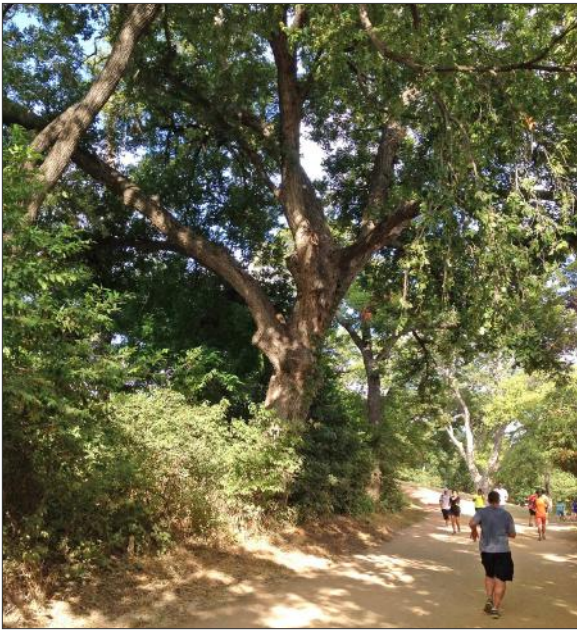
Figure 4.58: Numerous large pecan trees create a cathedral-like canopy and provide shade along the Butler Shores Woodland section of the Trail.

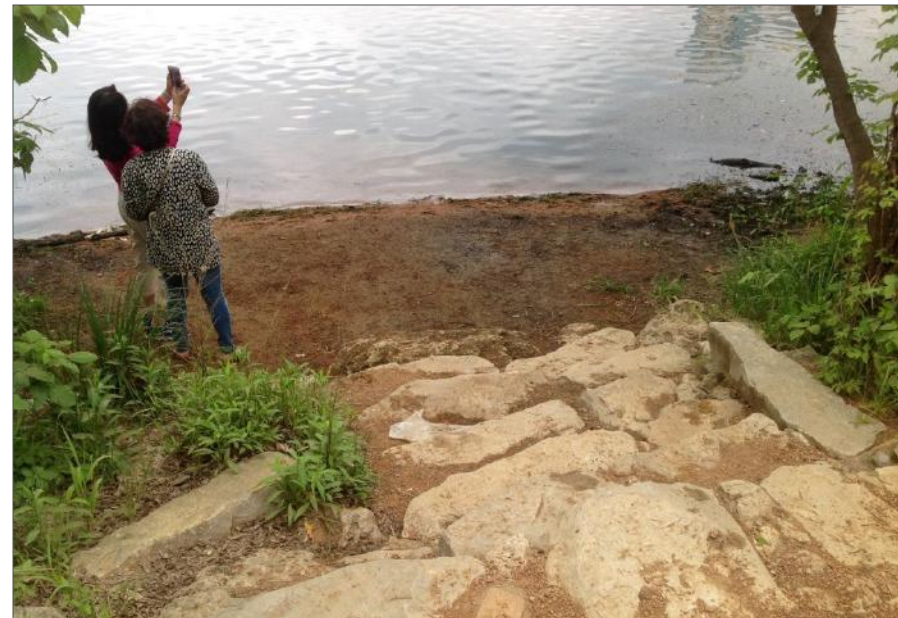
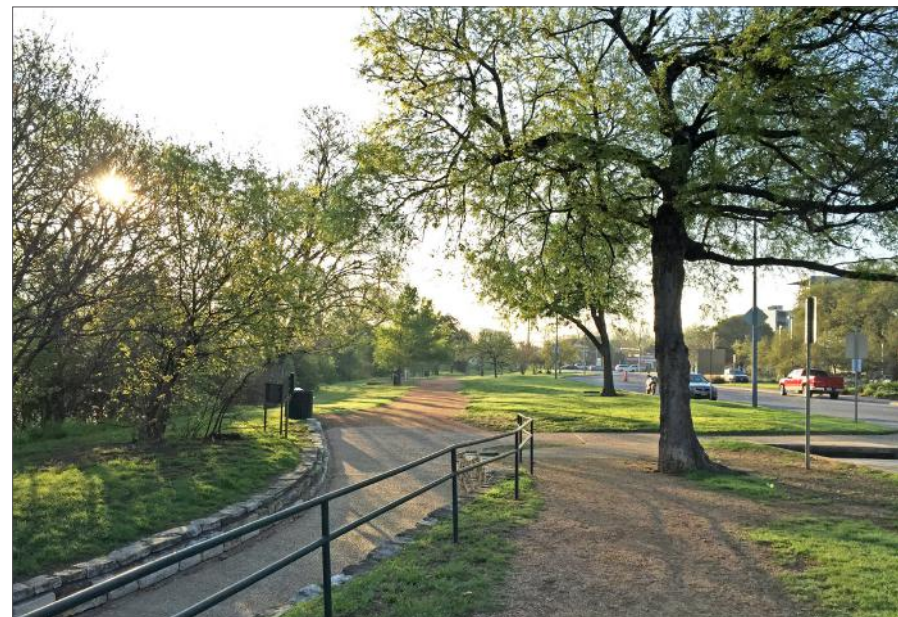
Figure 4.61 (Above): A well used formal water access point has stairs leading users to the shore, the surface below is heavily trampled and eroding into the Lake. Figure 4.62 (Below): The underutilized lawn near PARD offices is recommended for woodland expansion.

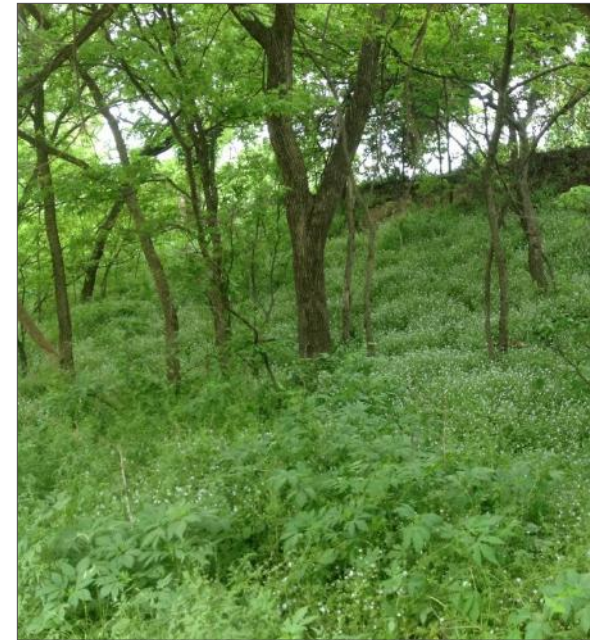
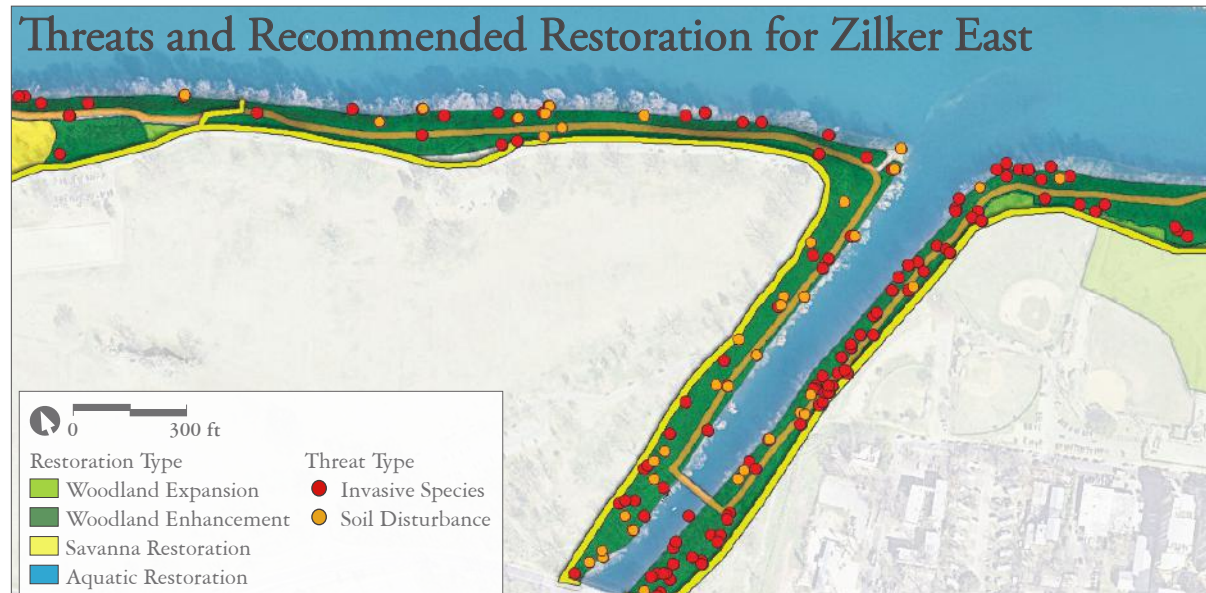
Figure 4.64 (Above, left): This bald cypress in Zilker East is one of the largest trees in the study area and in Austin. Figure 4.65 (Above, right): Young backberry trees dominate the woodland upland of the Trail along Barton Creek. Figure 4.66 (Below): Invasive species, erosion issues, and recommended restoration work in the Zilker East Unit. Sources: COA, NAIP.

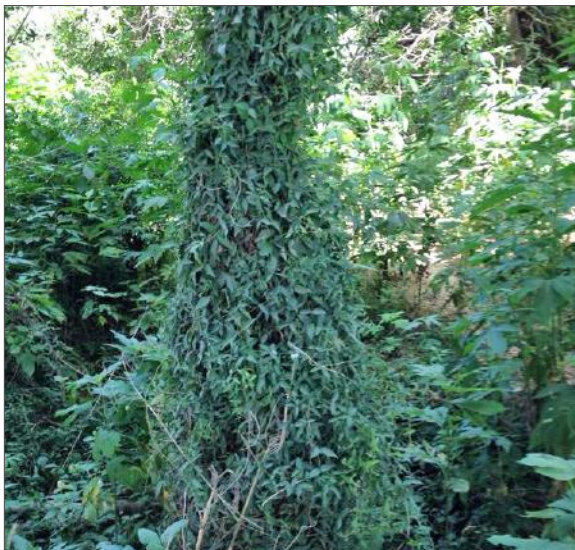
There are two catclaw patches, one just east and one just west of MoPac (Figure 4.69). Both are currently limited in area, but very dense. Two patches of sweet autumn clematis were found right along the Trail 850 ft east of MoPac. This species is abundant in many units but is not currently common in Zilker East or West. Silverberry, *Elaeagnus macrophylla*, was

Figure 4.69: Invasive catclaw vine in Zilker West.

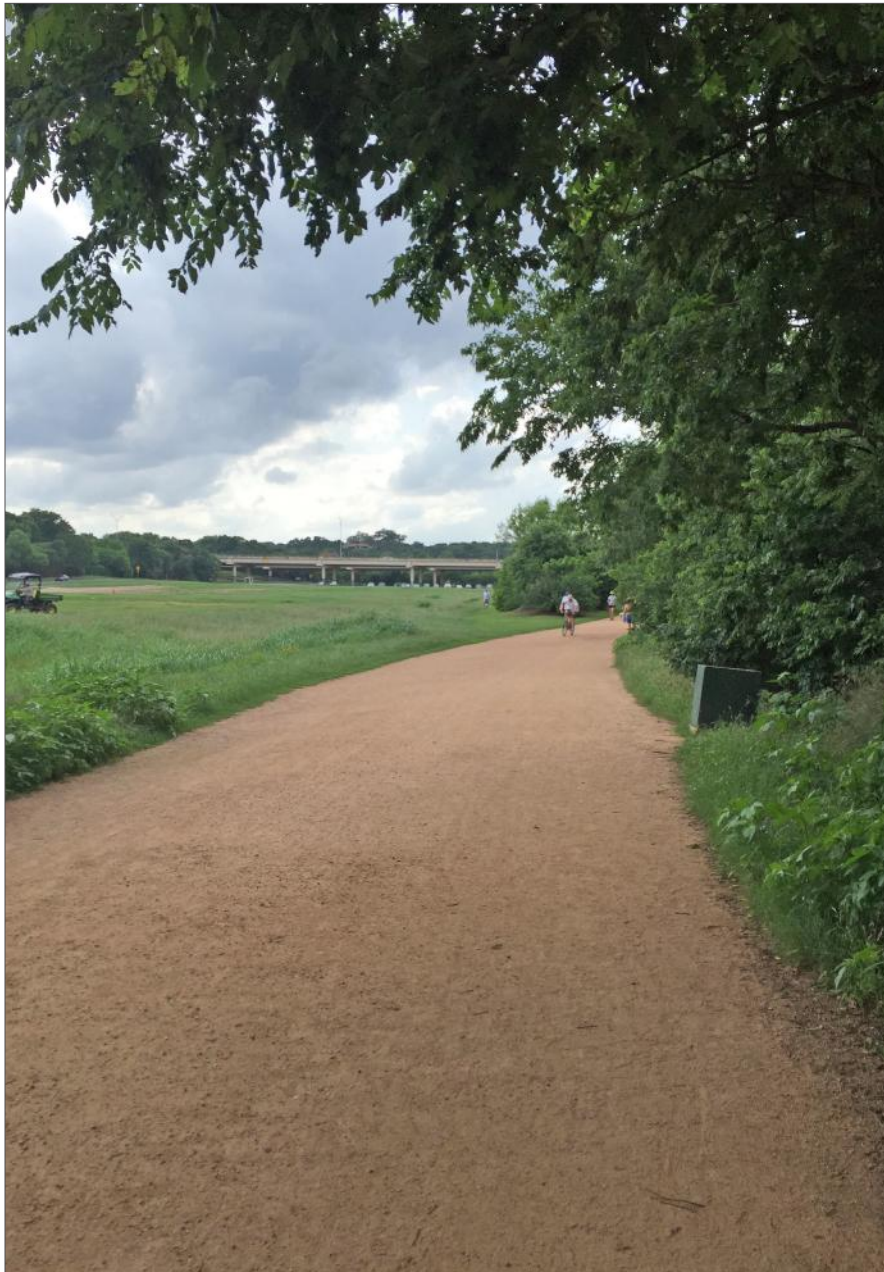
Significant erosion control efforts are needed in this area, both on the Trail itself and downslope from it. To the extent possible, moving the Trail away from the steep slope and stabilizing the crushed granite is recommended. Green infrastructure with a focus on retention is needed between the trail and parking areas with a focus on the compacted overflow parking. Invasive species removal, especially of the aggressive catclaw vine, should occur as soon as possible. Savanna restoration and woodland expansion are recommended in the upland areas along with enhancement of the existing woodlands.

Figure 4.71: The wide Trail throughout much of Zilker West should be narrowed to allow more space between the Trail and the slope.
