# Height Limitations and Setbacks

## According to Code 25-2-1063

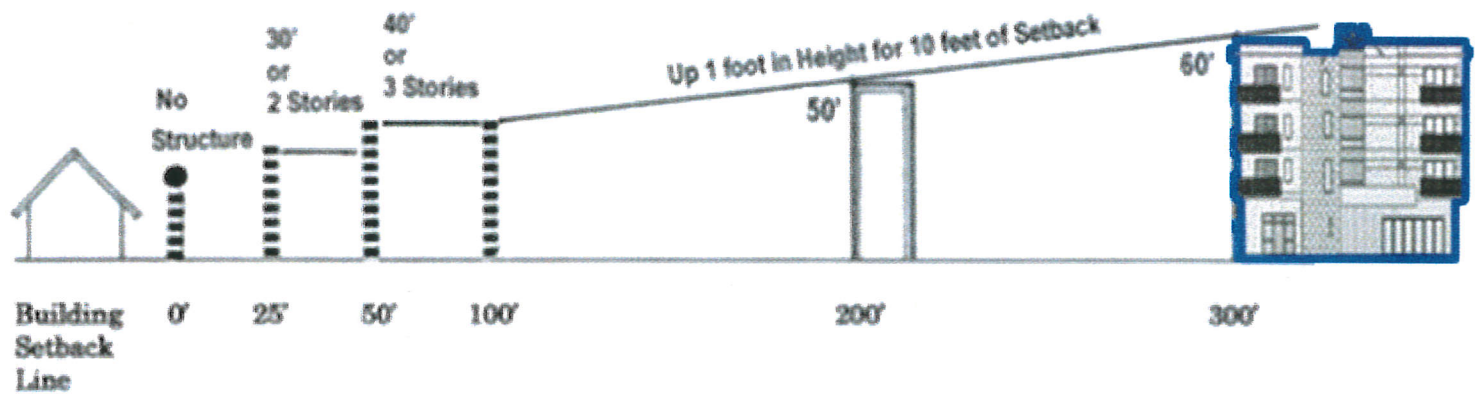
5 stories and 60' setback 300'

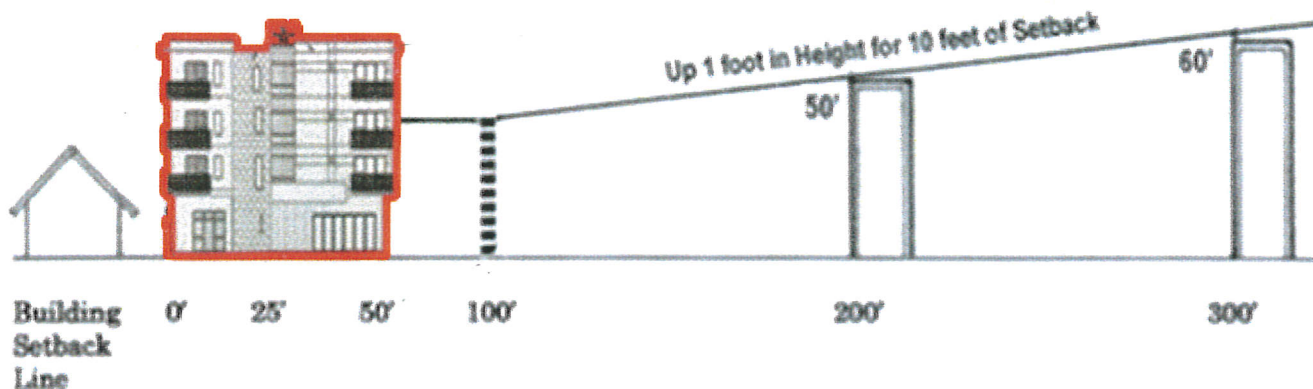
## With Variances

5 stories and 60' setback 0'

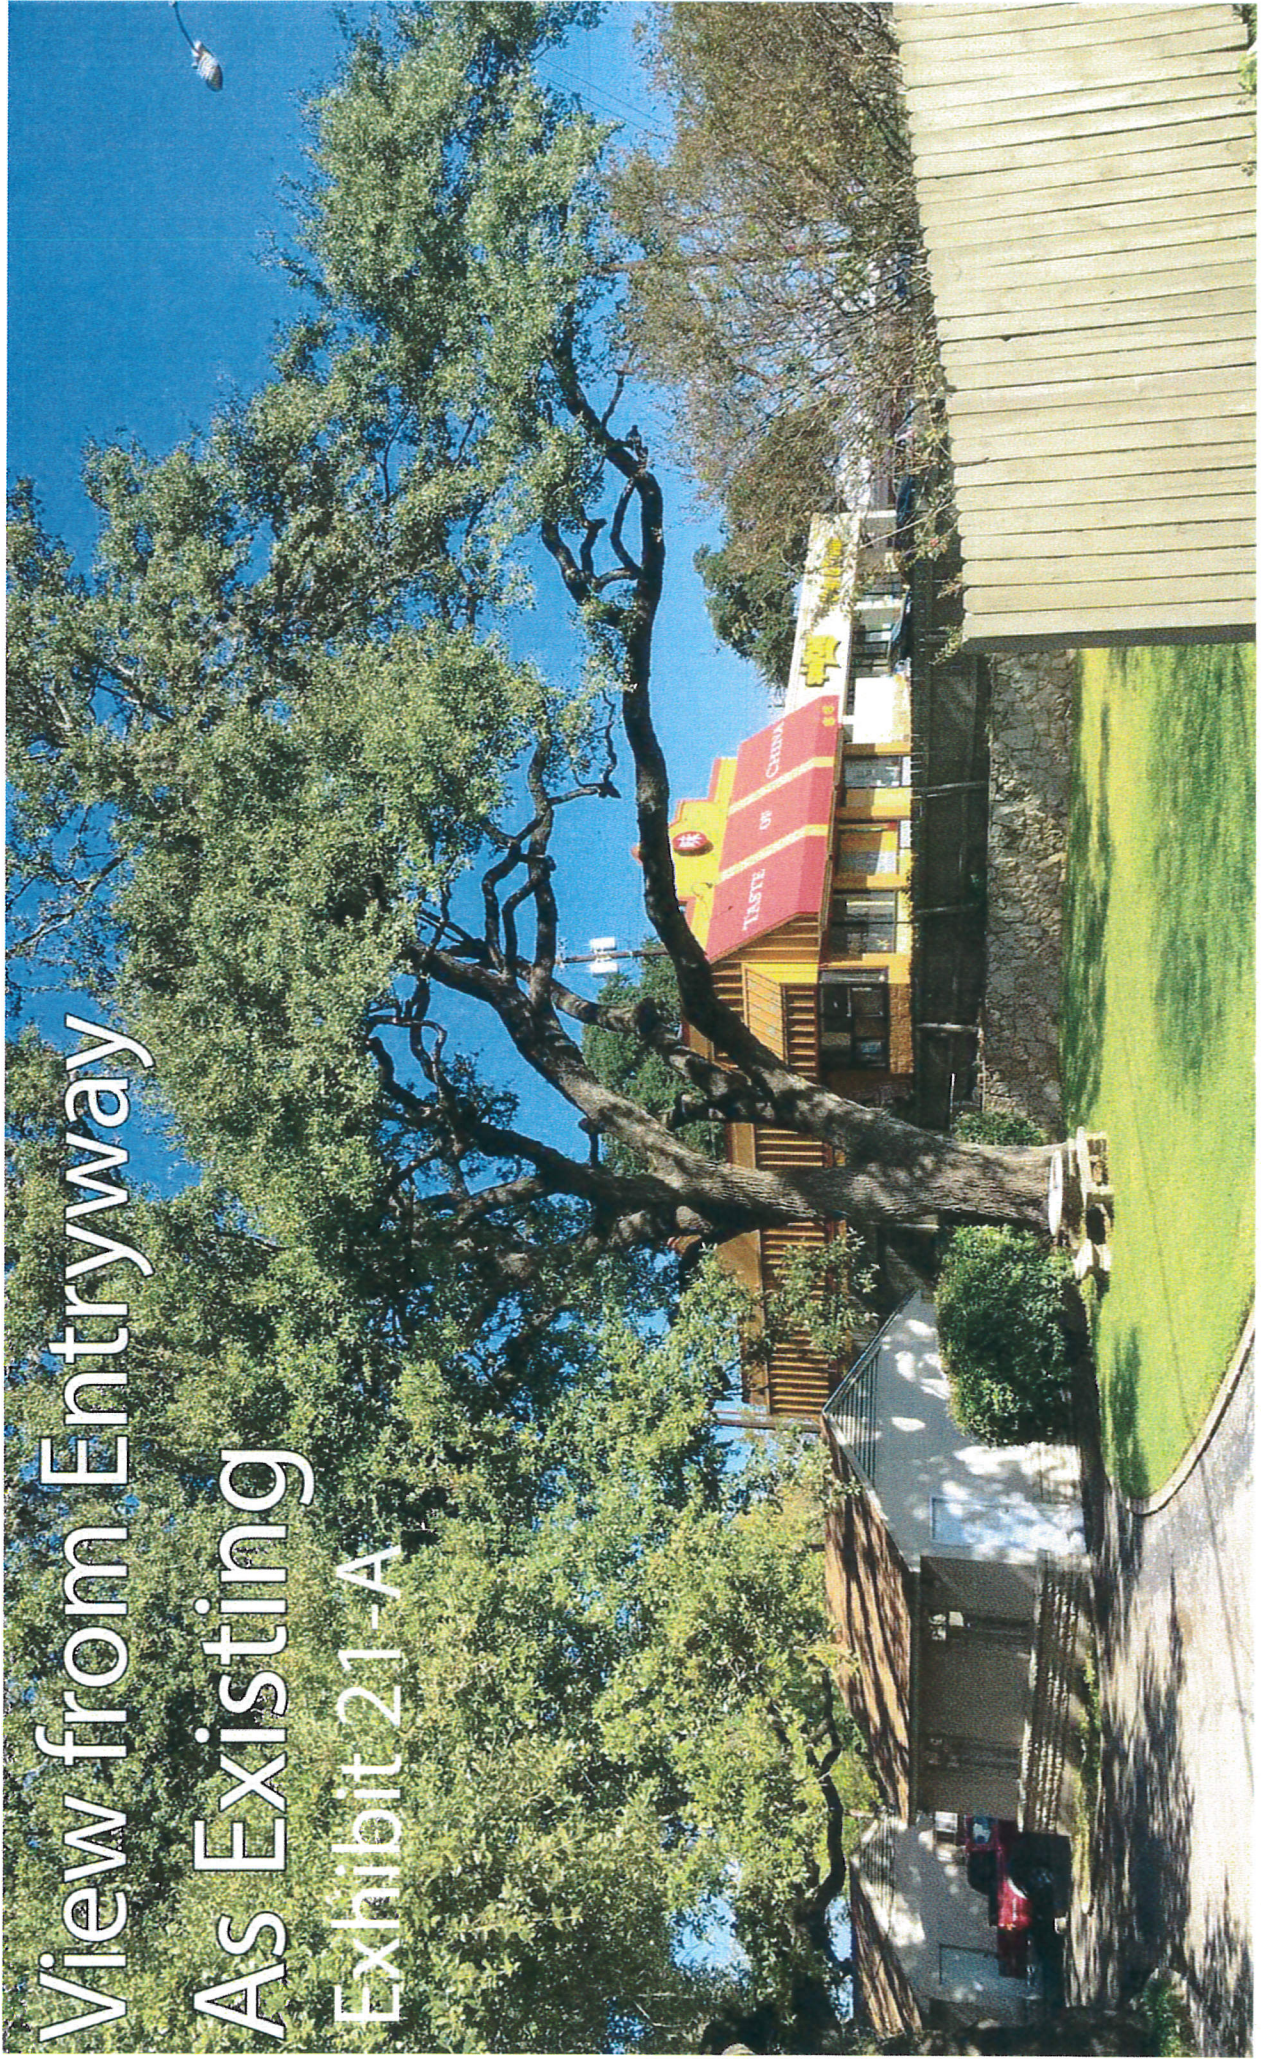
# View from Entryway As Existing Exhibit 21-A

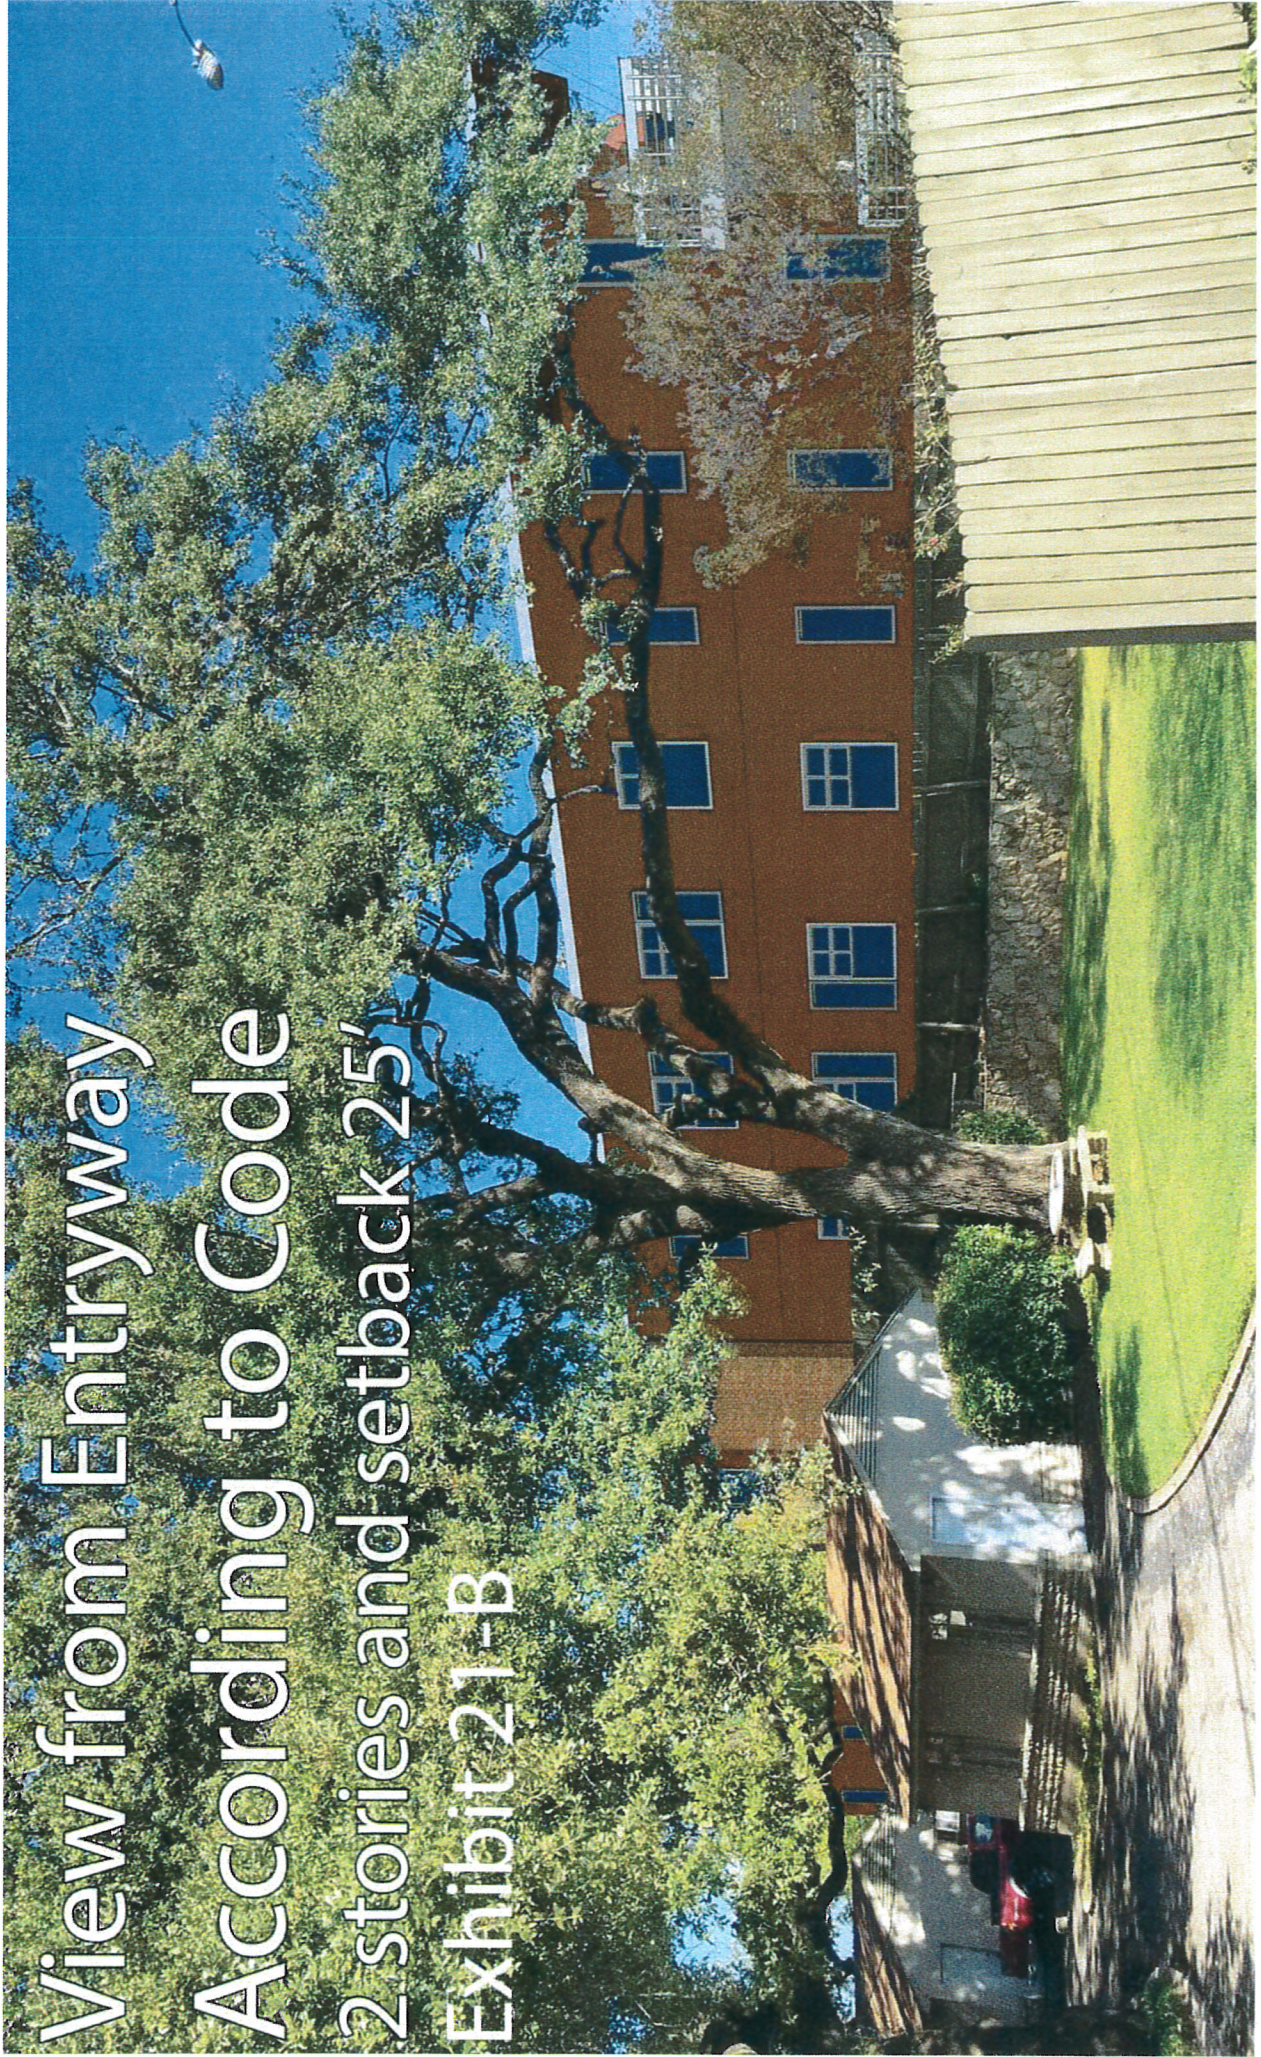
View from Entryway  
According to Code  
2 stories and setback 25'  
Exhibit 21-B

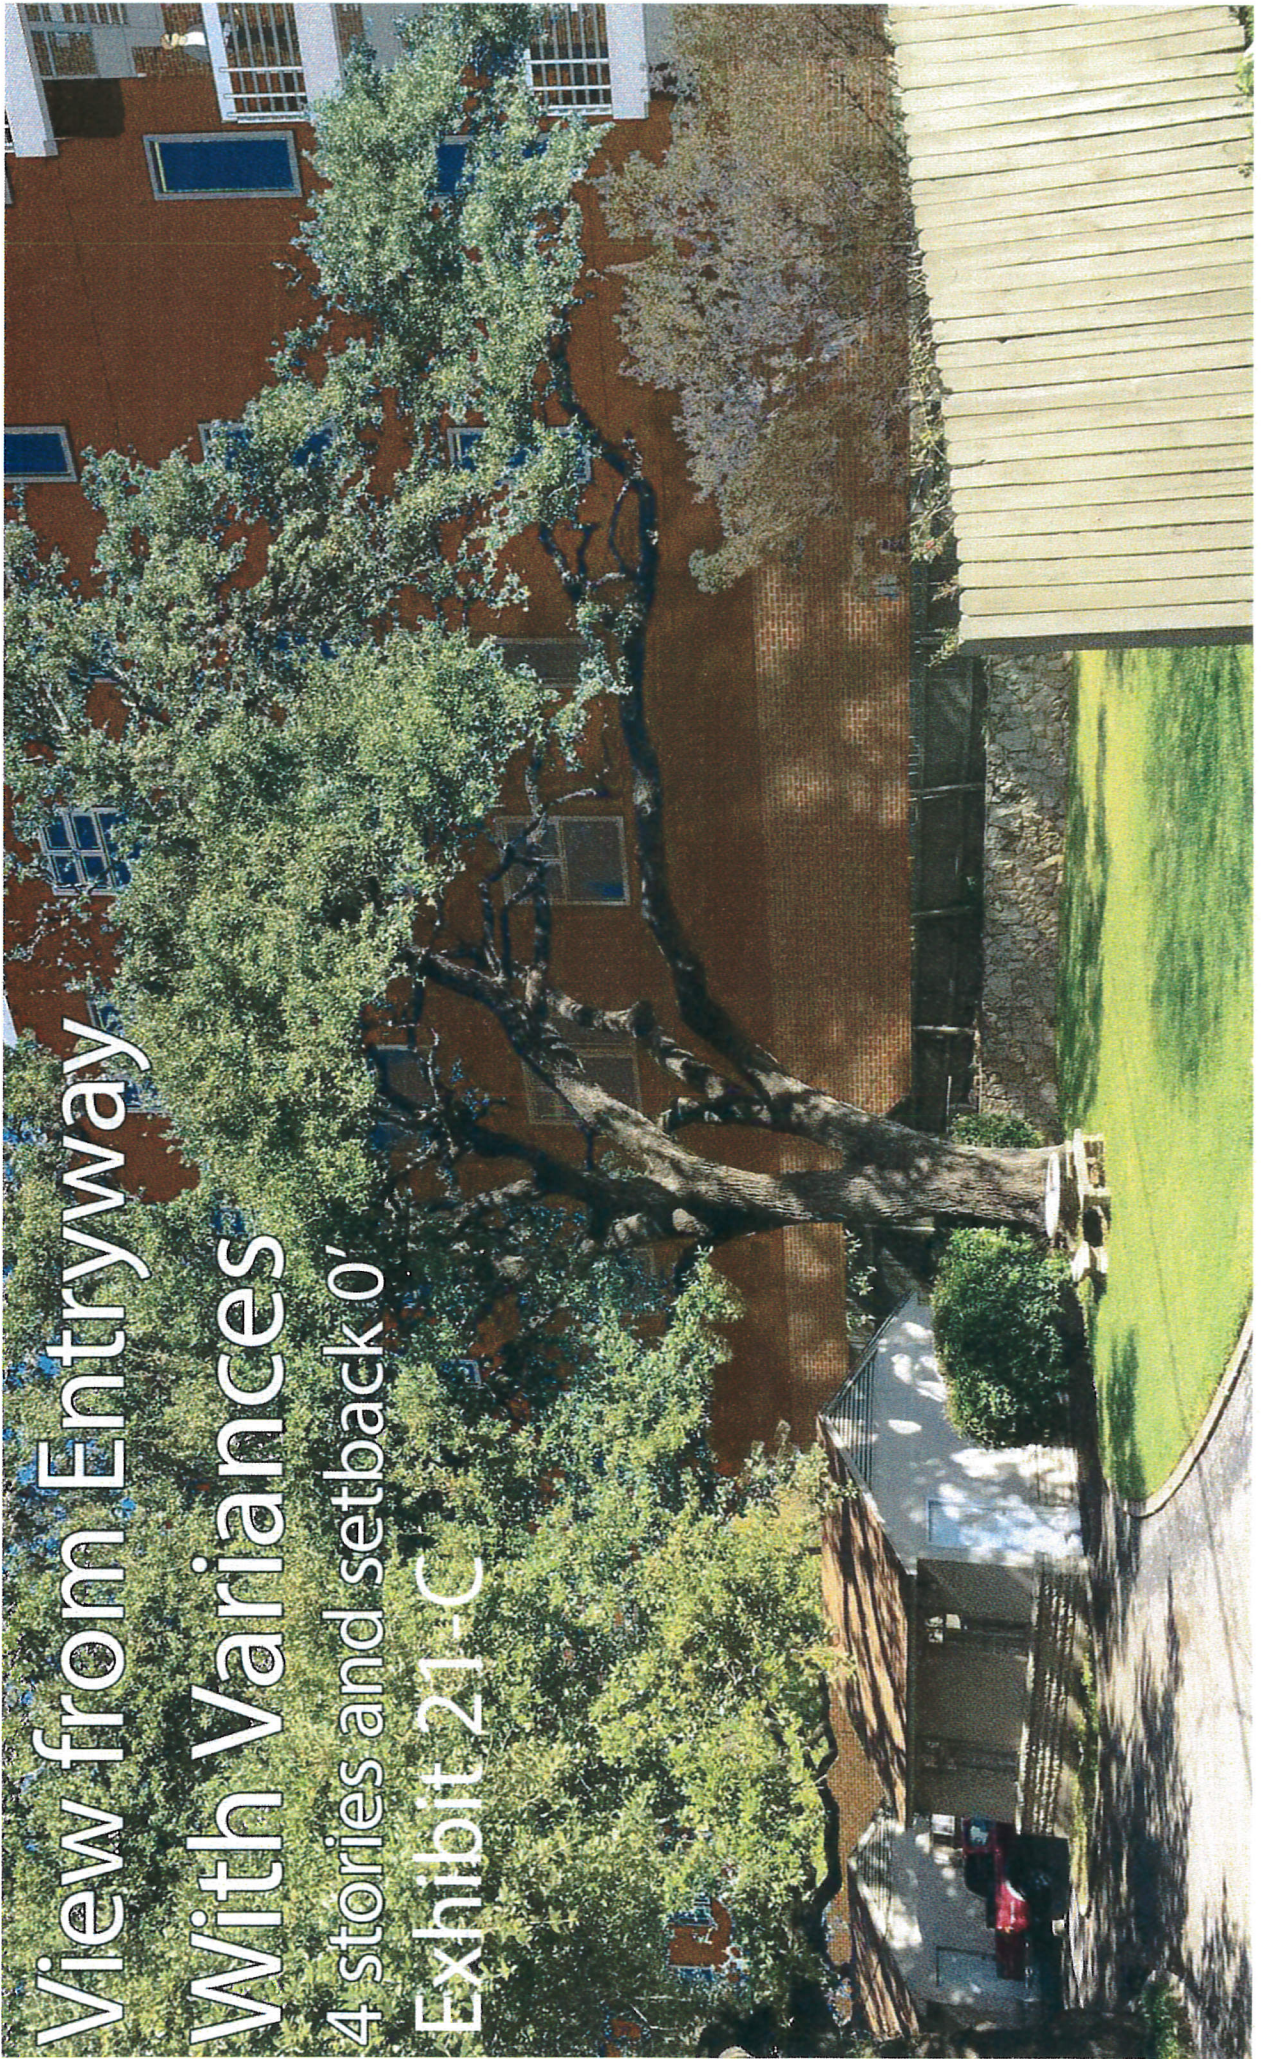
# View from Entryway With Variances 4 stories and setback 0' Exhibit 21-C
