**HISTORIC LANDMARK COMMISSION**  
**FEBRUARY 27, 2017**  
**APPLICATION FOR A CERTIFICATE OF APPROPRIATENESS**  
**LHD-2016-0017**  
**806 Blanco Street**  
**Castle Hill Historic District**

**PROPOSAL**

Remove existing windows on the side of the house and install new windows; demolish the rear wall of the house and replace with a wall of glass.

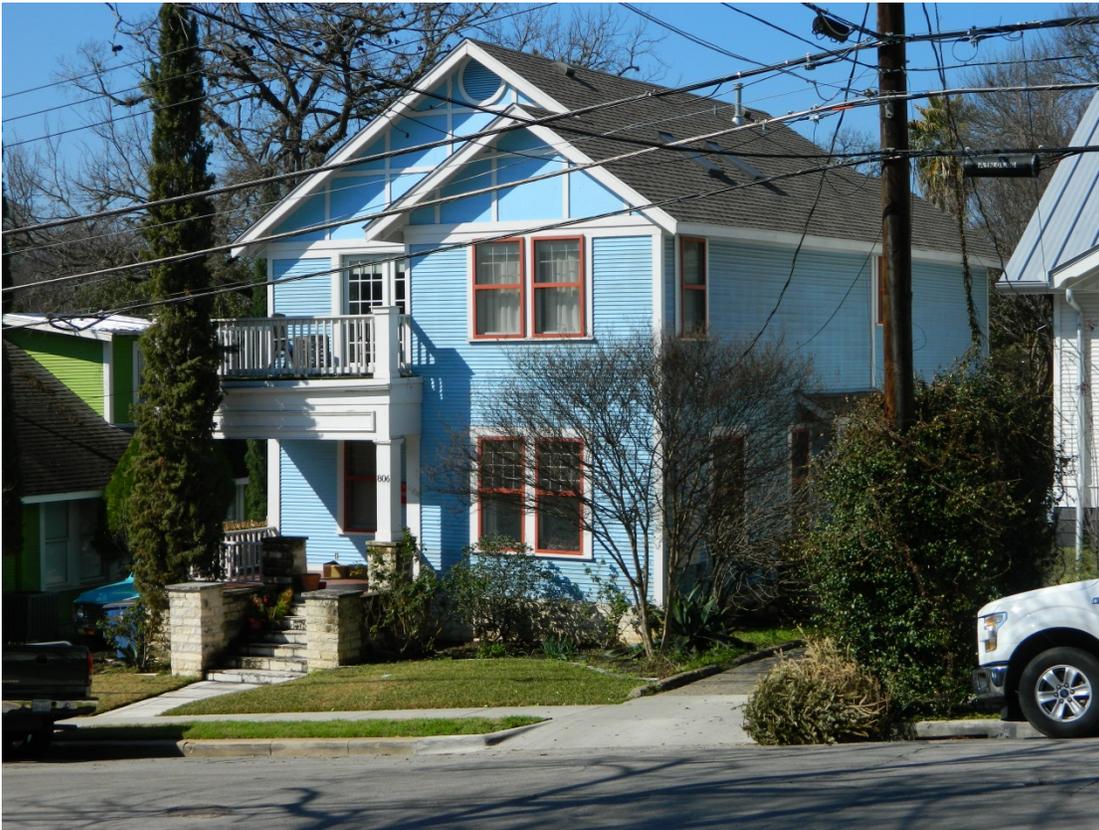
View of the house from W. 9<sup>th</sup> Street, showing the north side of the house.
