This report presents the Critical Environmental Feature (CEF) Assessment and Hydrogeologic report portion of the City of Austin (COA) Environmental Assessment (EA) for Pilot Knob PUD. The purpose of this EA is to satisfy a COA, Land Development Code 25-8-121 Environmental Assessment Requirement, which necessitates that an EA be performed for any development located: (1) over a karst feature; (2) within an area draining to a karst aquifer or reservoir; (3) in a water quality transition zone; (4) in a critical water quality zone; (5) in a flood plain; or (6) on a tract with a gradient of more than 15 percent.

Pilot Knob PUD
Austin, Travis County, Texas
WJXK2203

Site Photographs

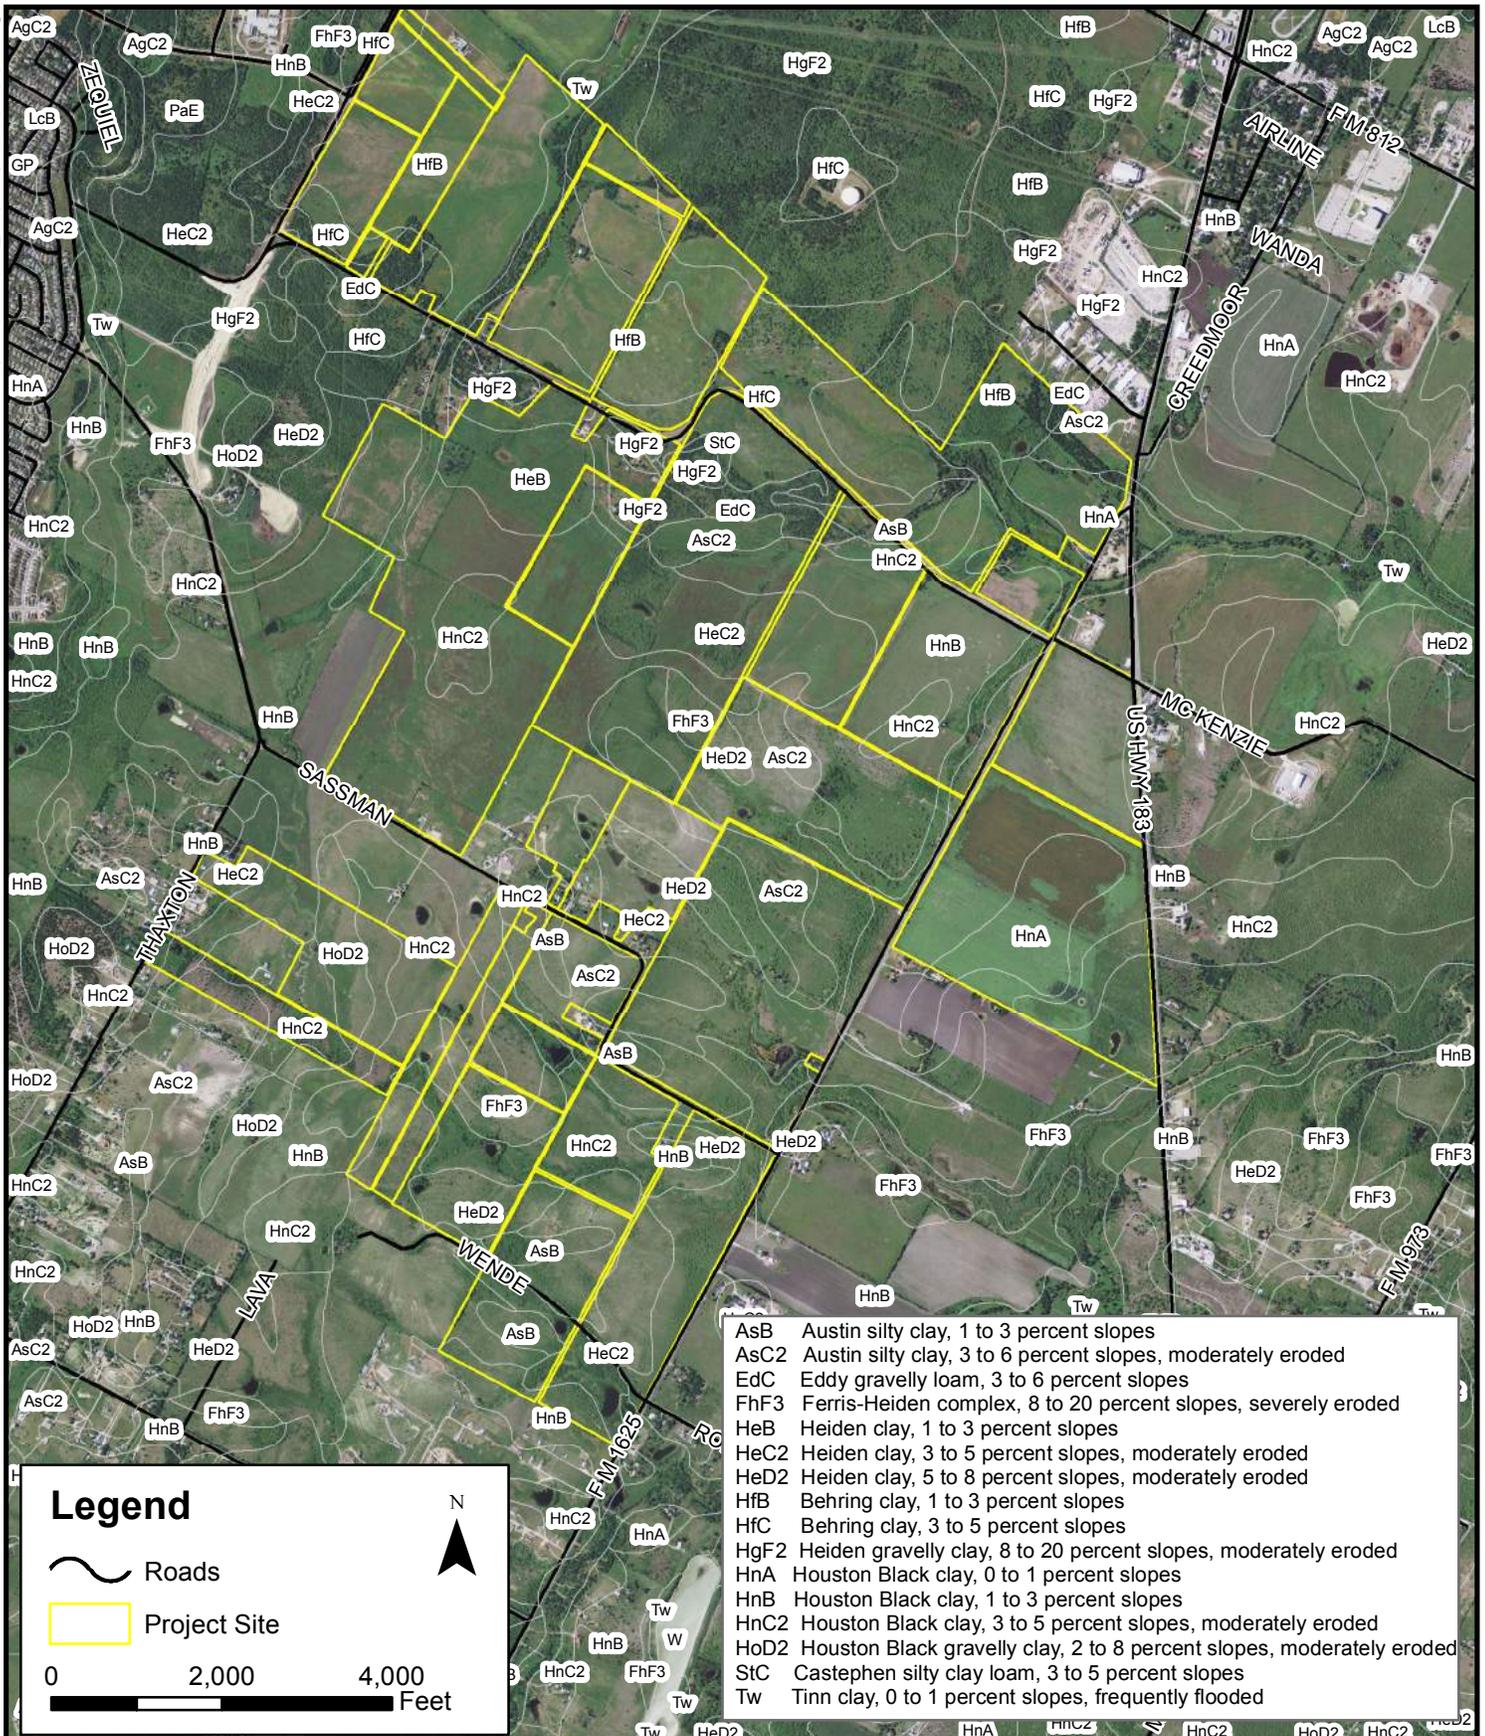
4

Soils in the project site are presented in **Table 1** (NRCS Web Soil Survey of Travis County, 2012) (**Appendix A, Exhibit 4**).

Soil Survey Map

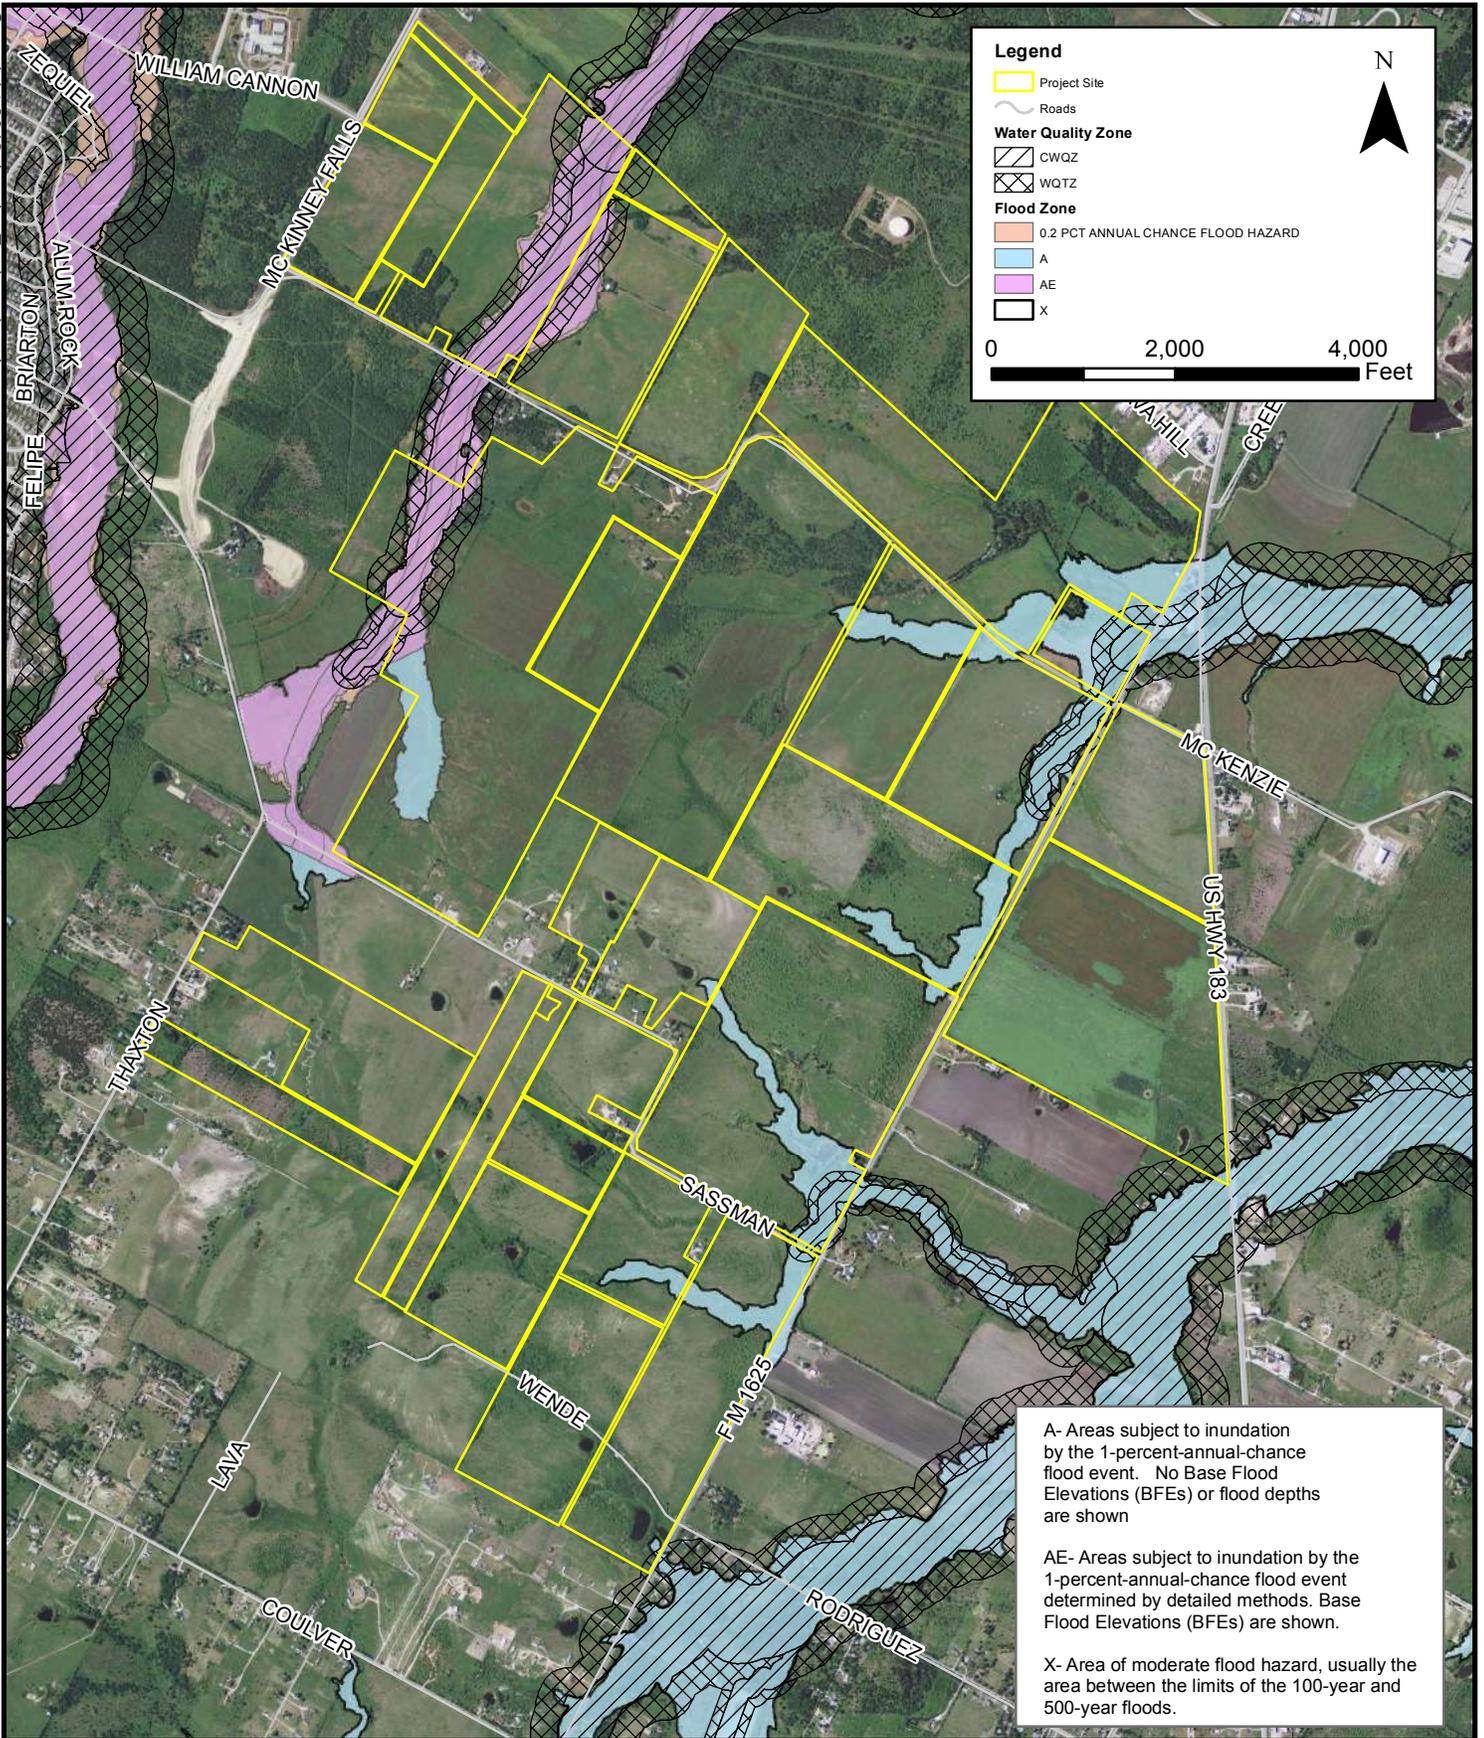
Exhibit
6

According to the Federal Emergency Management Agency (FEMA) Flood Insurance Rate Map panel number 48453C0615H dated September 26, 2008, the site is mapped as Zone A, areas with a 1% annual chance of flooding (no base flood elevations determined), Zone AE, areas with a 1% annual chance of flooding (with base flood elevations determined), and Zone X, areas with a 0.2% annual chance of flood (**Appendix A, Exhibit 6**).

A- Areas subject to inundation by the 1-percent-annual-chance flood event. No Base Flood Elevations (BFEs) or flood depths are shown

AE- Areas subject to inundation by the 1-percent-annual-chance flood event determined by detailed methods. Base Flood Elevations (BFEs) are shown.

X- Area of moderate flood hazard, usually the area between the limits of the 100-year and 500-year floods.

The CWQZ buffer can vary in distance, but will generally be greater than 50 feet and less than 200 feet from the tributary centerline for minor to intermediate waterways, depending on the drainage area. The WQTZ buffer distance can also vary, but will generally be either 100 feet or 200 feet adjacent to the CWQZ, depending on the drainage area. Refer to **Appendix A, Exhibit 6** for the approximate distance of each zone.

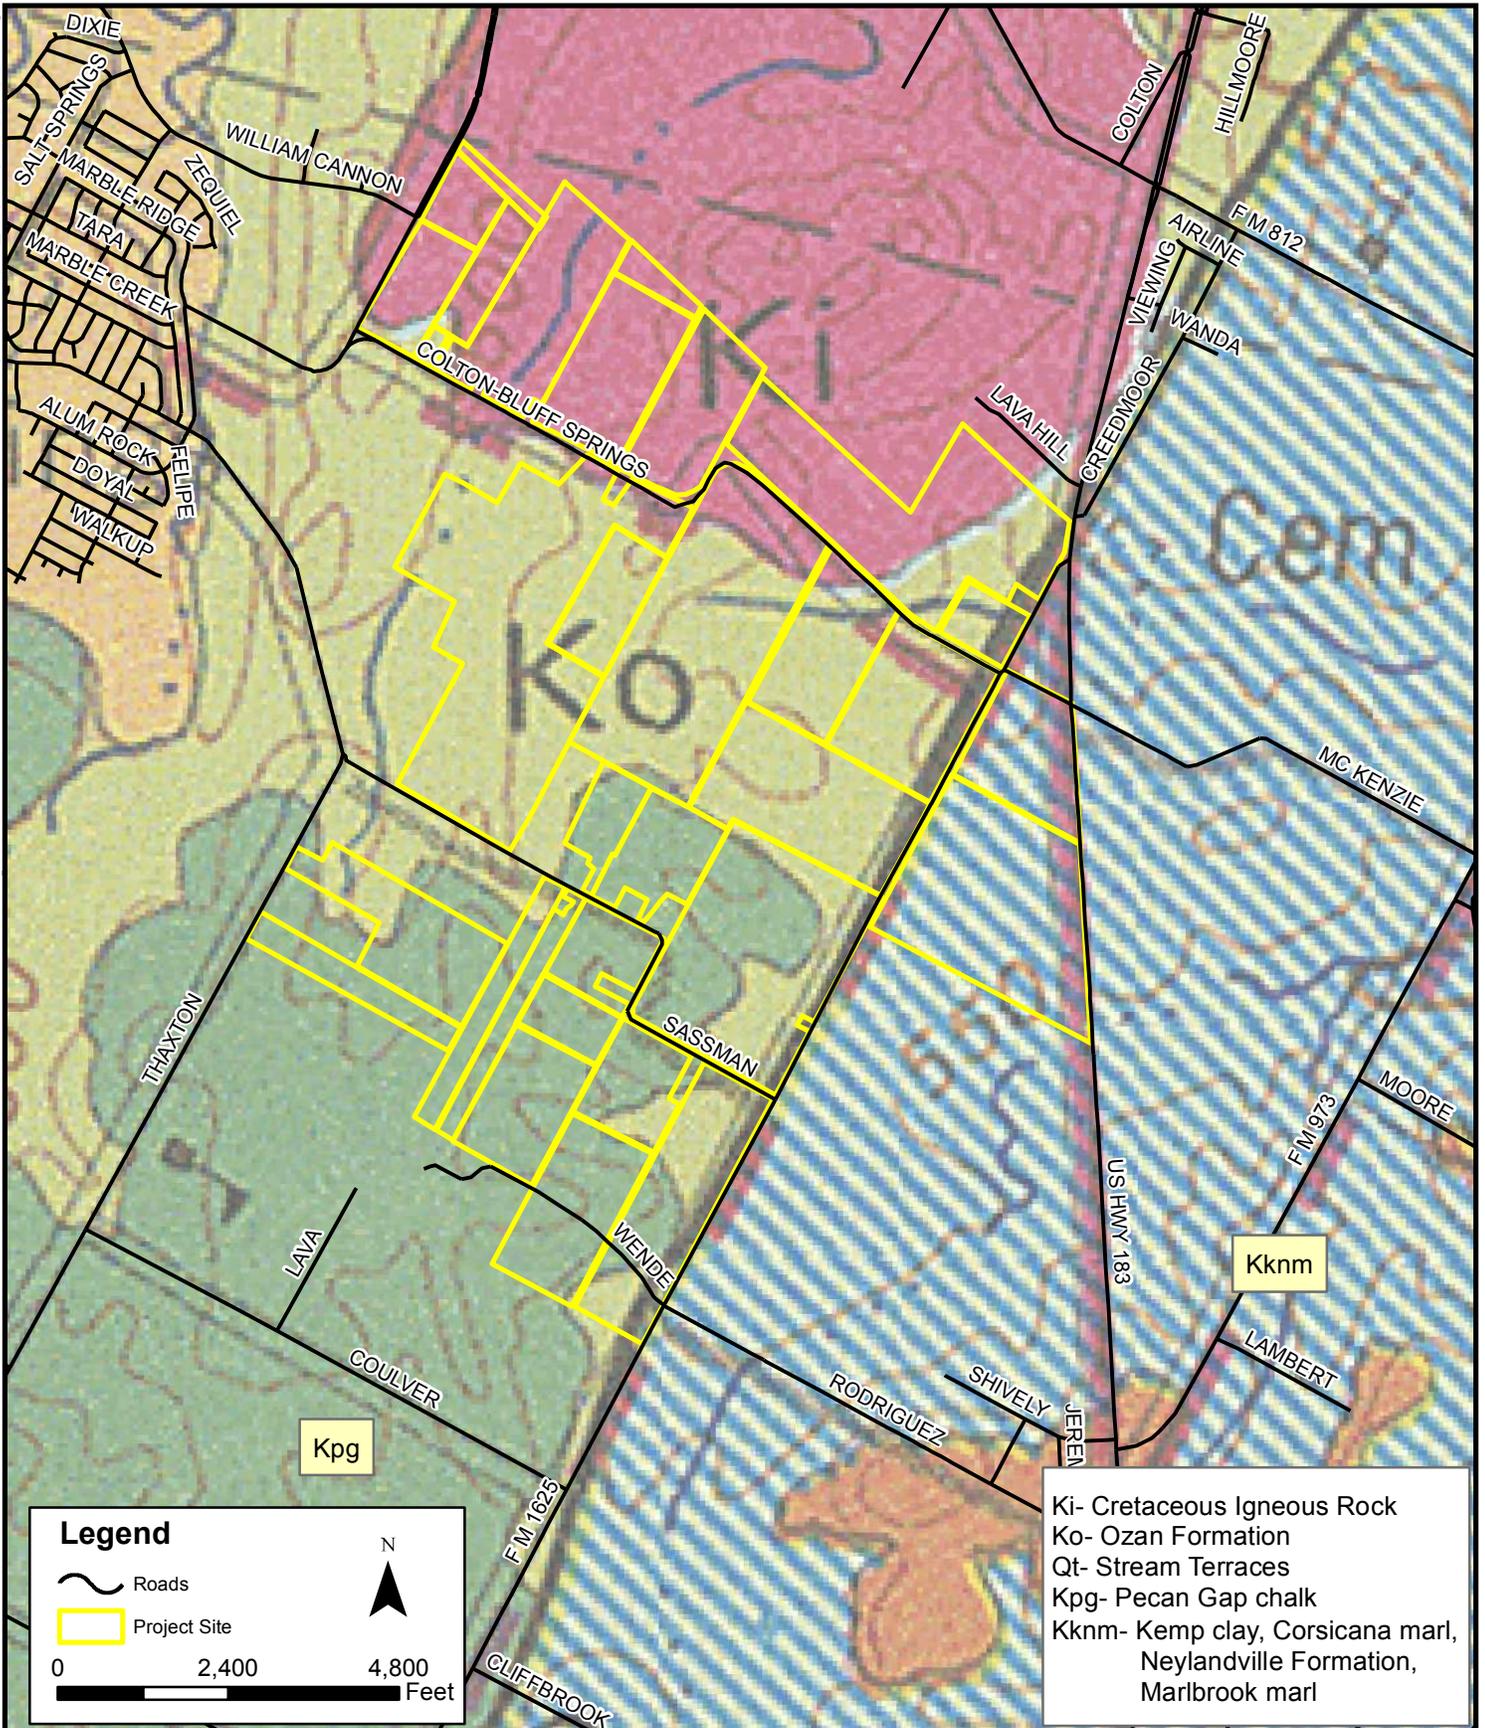
9

Refer to **Appendix A, Exhibit 9** for the Geologic Map.

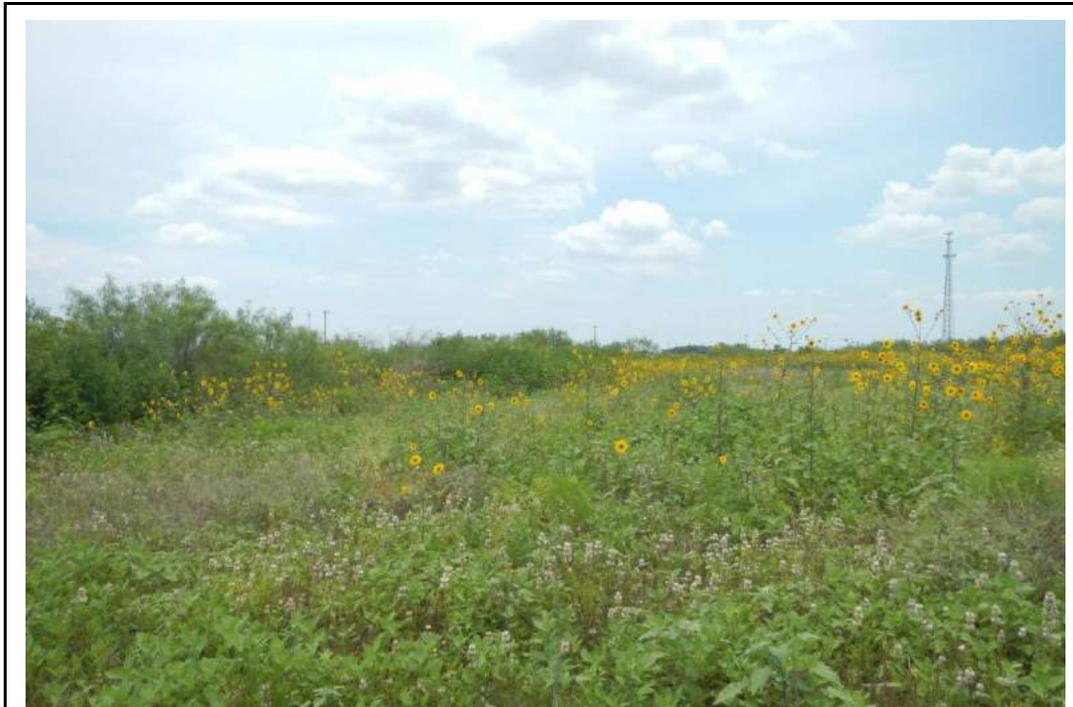
The site predominately consists of cropland primarily used for hay production, native rangeland, and abandoned cropland with wooded corridors along fence rows (**Appendix B, Photograph 1**). Tributaries of Cottonmouth Creek, North Fork Dry Creek, and Dry Creek (locally named "South Fork Dry Creek") traverse throughout portions of the properties.

Photograph 1. Typical view of native rangeland and abandoned cropland with wooded corridors along fencerows.

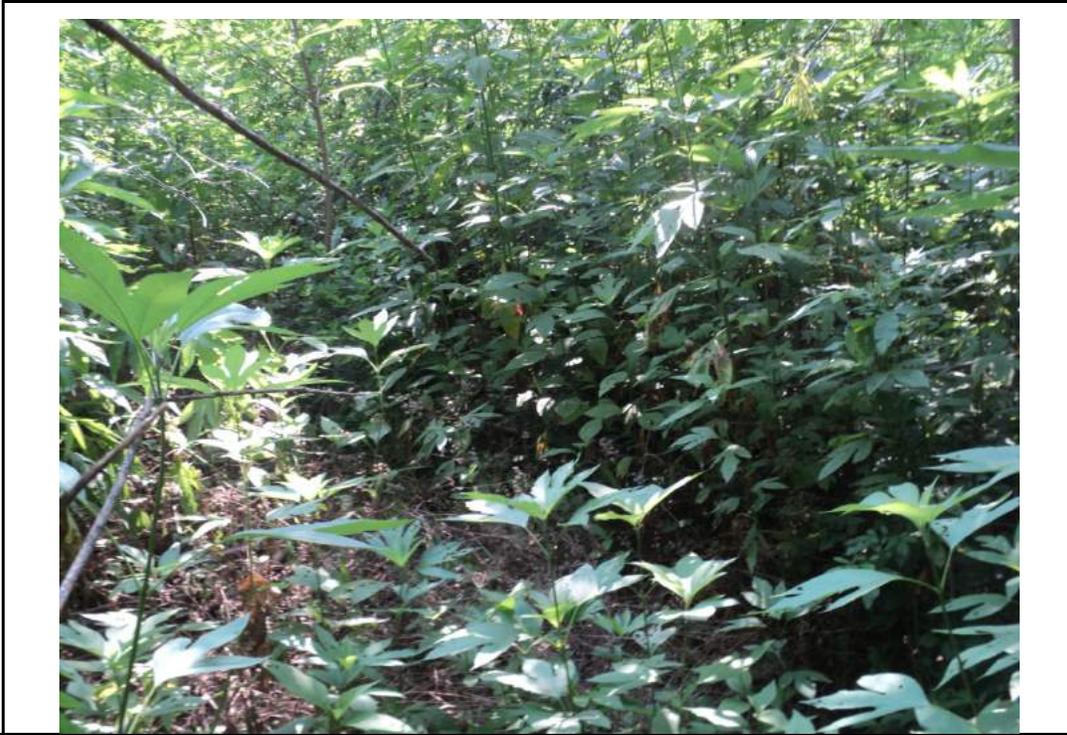
The majority of the project site consisted of upland range vegetation including Japanese brome (*Bromus japonicus*), King Ranch bluestem (*Bothriochloa ischaemum var. songarica*), silver bluestem, horsemint (*Monarda citriodora*), giant ragweed (*Ambrosia trifida*), sumpweed (*Iva annua*), goldenrod (*Solidago virgaurea*), Texas wintergrass, and Johnson grass (*Sorghum halepense*) (**Appendix B, Photograph 3**). Upland woody vegetation observed consisted of hackberry (*Celtis laevigata*), Ashe's juniper (*Juniperus ashei*), mesquite, mustang grape (*Vitis mustangensis*), eastern red cedar (*Juniperus virginiana*), and gum bumelia (*Sideroxylon lanuginosum*) (**Appendix B, Photograph 4**). Bottomland vegetation observed consisted of cottonwood (*Populus deltoids*), chinaberry (*Melia azedarach*), black willow (*Salix nigra*), hackberry, boxelder (*Acer negundo*), and giant ragweed (**Appendix B, Photograph 5**).

Photograph 5. Typical view of bottomland vegetation within North Fork Dry Creek. View to the north.

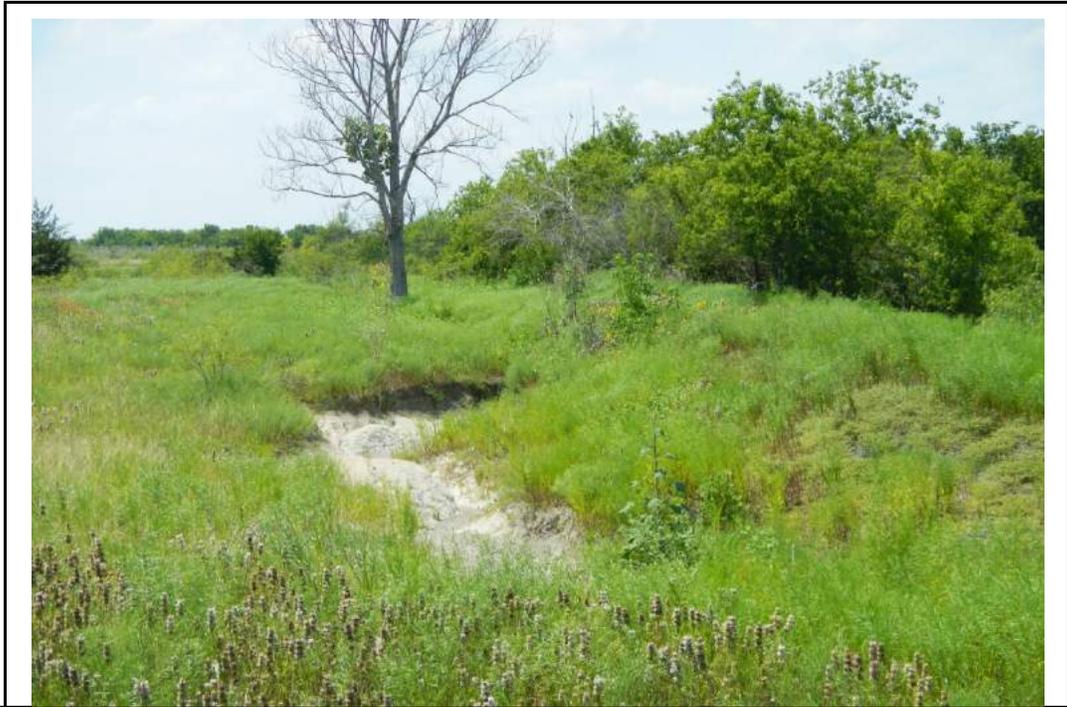
Photograph 6. Typical view of North Fork Dry Creek. View to the west.

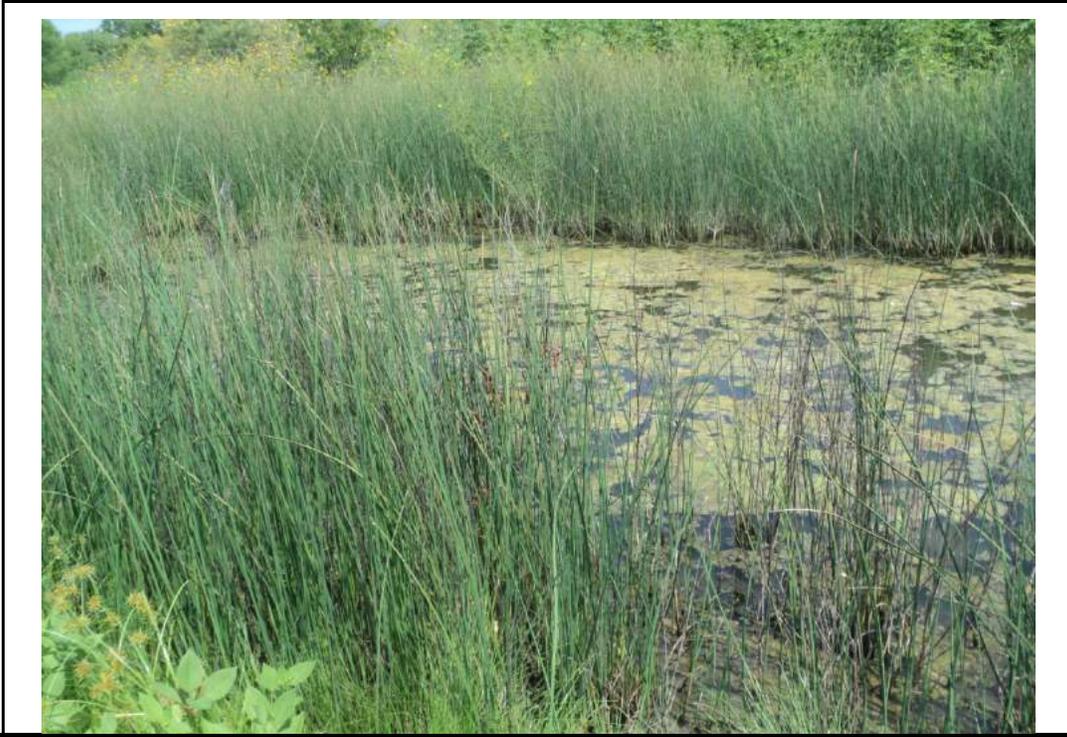
Wetlands were also evaluated within the site. Wetlands are those "areas that are inundated or saturated by surface or ground water at a frequency and duration sufficient to support, and that under normal circumstances do support, a prevalence of vegetation typically adapted for life in saturated soil conditions" as defined by the U.S. Army Corps of Engineers (USACE) and U.S. Environmental Protection Agency. Wetlands were delineated within the site, as described by the criteria in the 1987 USACE Wetland Delineation Manual (USACE 1987). Five wetlands were identified on site. Vegetation within these wetlands consisted of black willow, yellow nutsedge (*Cyperus esculentus*), bald spikerush (*Eleocharis erythropoda*), bulrush (*Scirpus spp.*), cattail (*Typha spp.*), curly dock (*Rumex crispus*), and sumpweed (**Appendix B, Photograph 7 and 8**).

Photograph 7. Typical view of wetland 2 vegetation. View to the north.

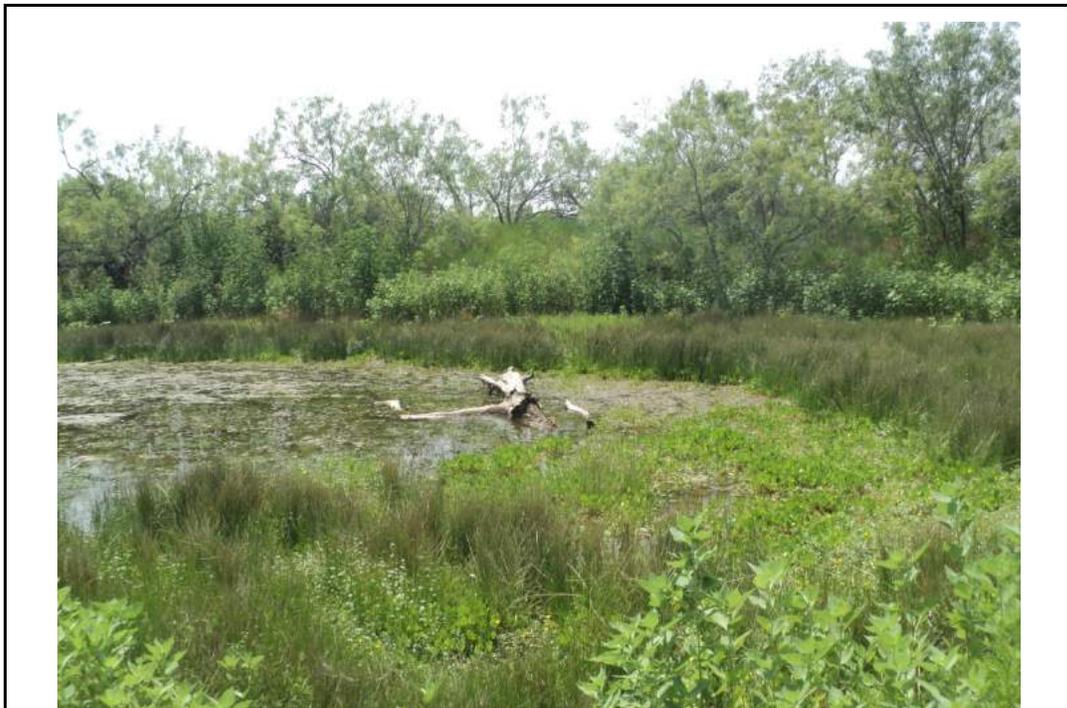
Photograph 8. Typical view of wetland fringe around pond 27. View to the west.

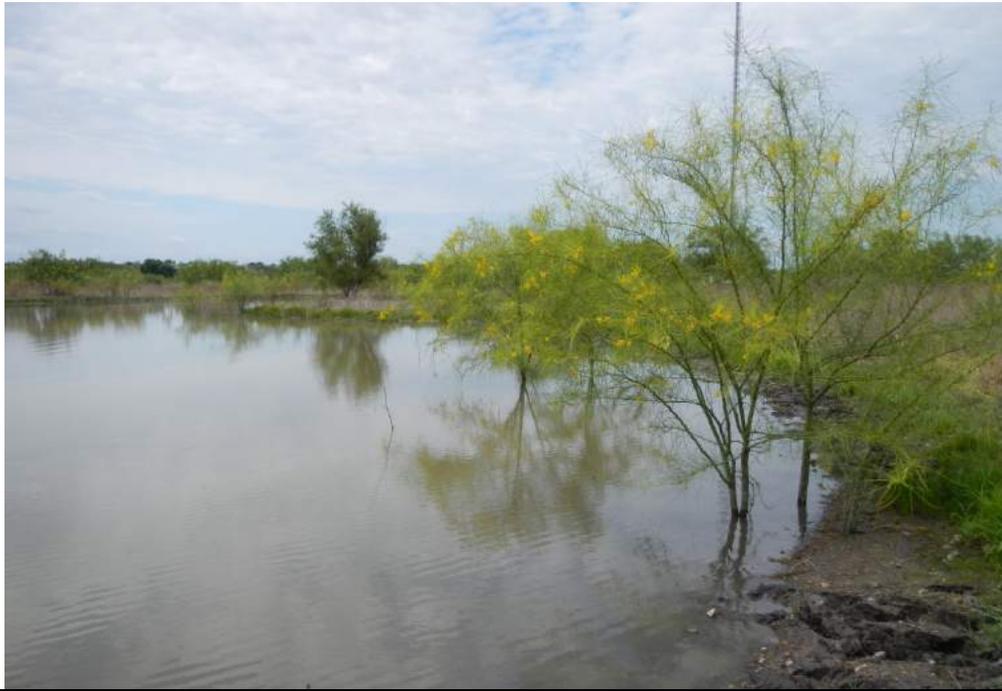
There were also a total of twenty-six ponds (seventeen upland and nine on-channel) located on the project site (**Appendix B, Photograph 9**). The majority of the ponds were barren in vegetation along the banks; some did consist of black willow, hackberry, and Chinese tallow tree (*Triadica sebifera*) (**Appendix B, Photograph**

Photograph 9. Typical view of an upland pond. View to the northeast.

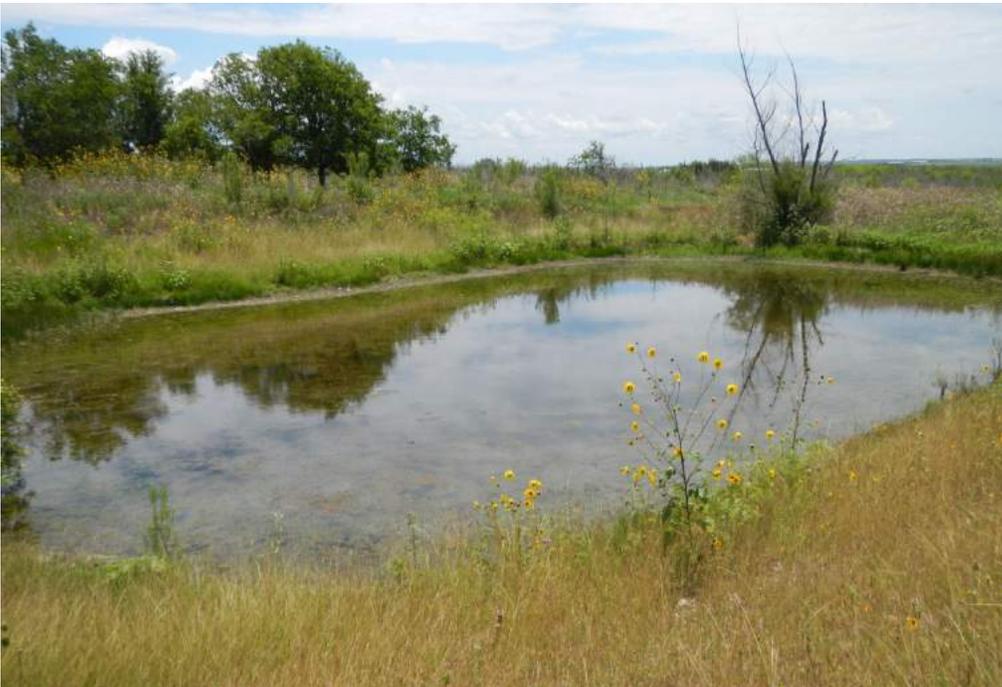
10). Although upland ponds are generally not considered jurisdictional by the USACE, the COA considers them important features due to their relationship with associated wetland fringe along their banks (ten total ponds with associated wetland fringe).

Photograph 10. Typical view of vegetation along banks of pond. View to the north.

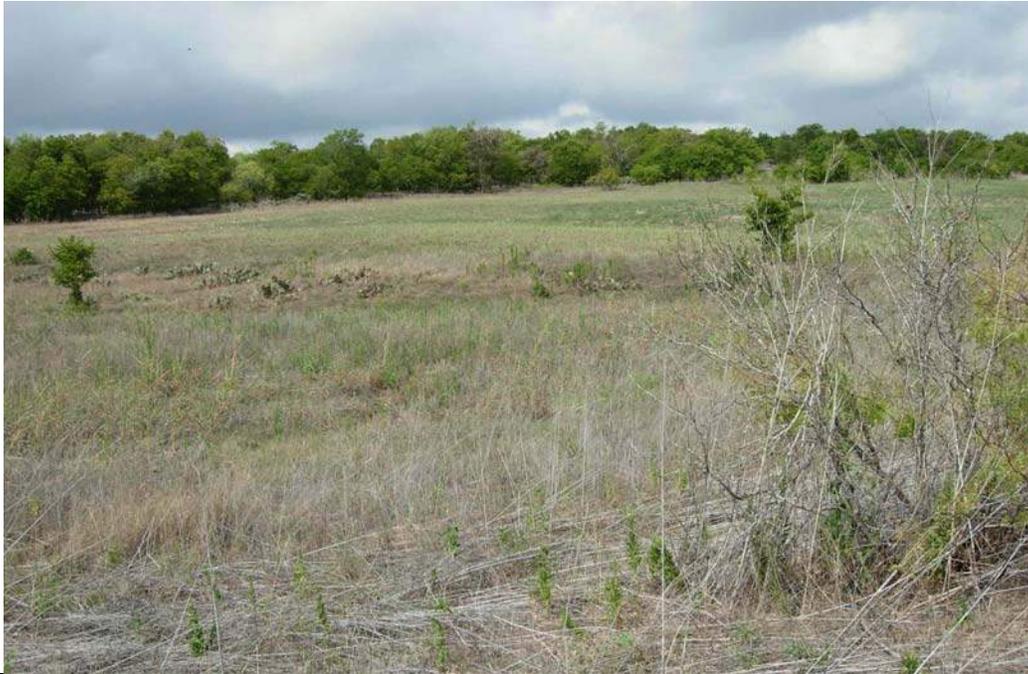
There was an upland pond, located north of Colton Bluff Springs Road and west of Cottonmouth creek, that was determined not a CEF (**Appendix B, Photograph 11**). The upland vegetation growing in the pond borrow area and spoil embankment area was similar to vegetation already described in this report, therefore, it is apparent that the pond does not hold water and does not exhibit any wetland features. The nature of the chalky sub soil layers is not conducive to holding water for extended periods of time. **Table 2** provides a summary of all waters within the site.

Photograph 11. Typical view of dry upland pond. View to the west.

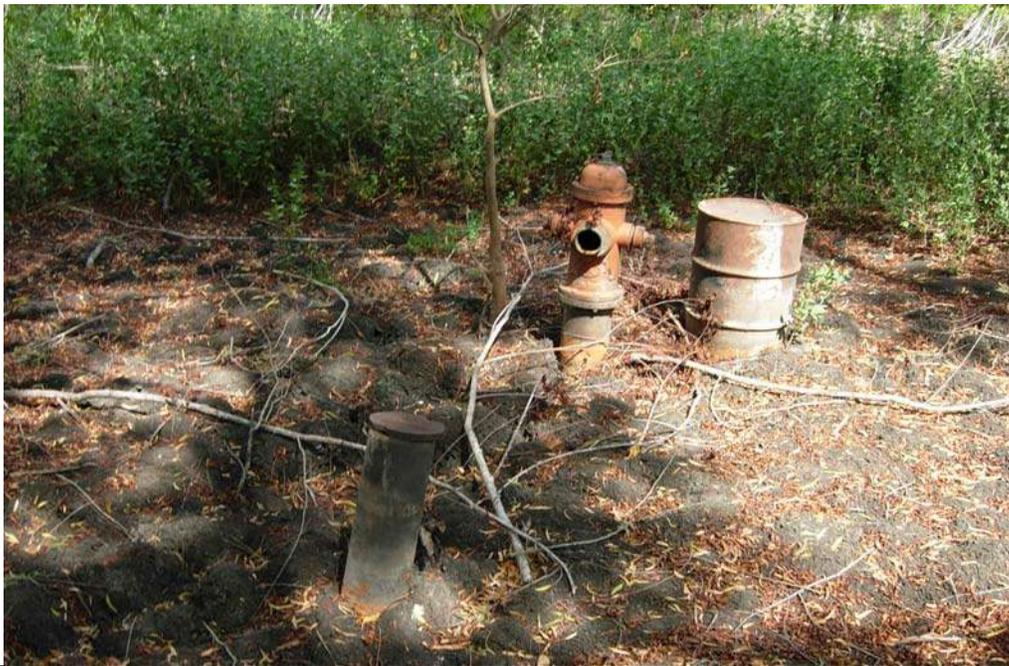
During the site visit, no borings or excavations were observed; however a fire-hydrant and a plugged water well were observed north of Colton Bluff Springs Road on the western edge of Cottonmouth Creek (**Appendix B, Photograph 12**). No other water wells, borings, or excavations were identified within the site by visual reconnaissance.

Photograph 12. Typical view of abandoned fire hydrant and piping. View to the north.
