BARTON SPRINGS POOL MASTER PLAN

Concepts for Preservation and Improvement

Building Condition

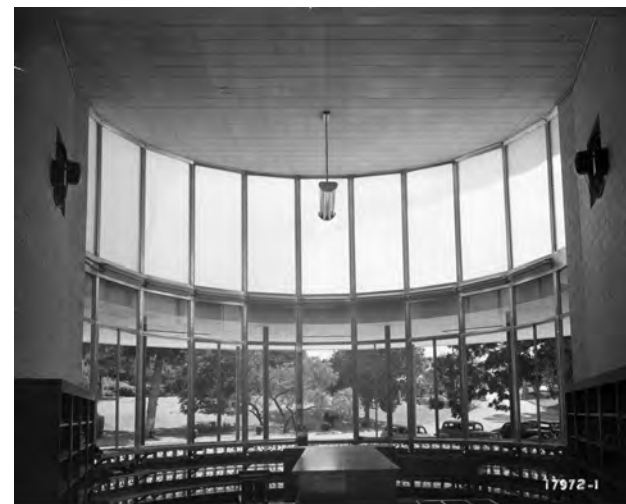
Bathhouse service office, central rotunda, circa 1947. PICA 17393, Austin History Center, Austin Public Library.

The central rotunda was designed as a generous space, intended to accommodate as many as five ticket takers plus a substantial towel and bathing suit rental operation. PICA 17393, Austin History Center, Austin Public Library.

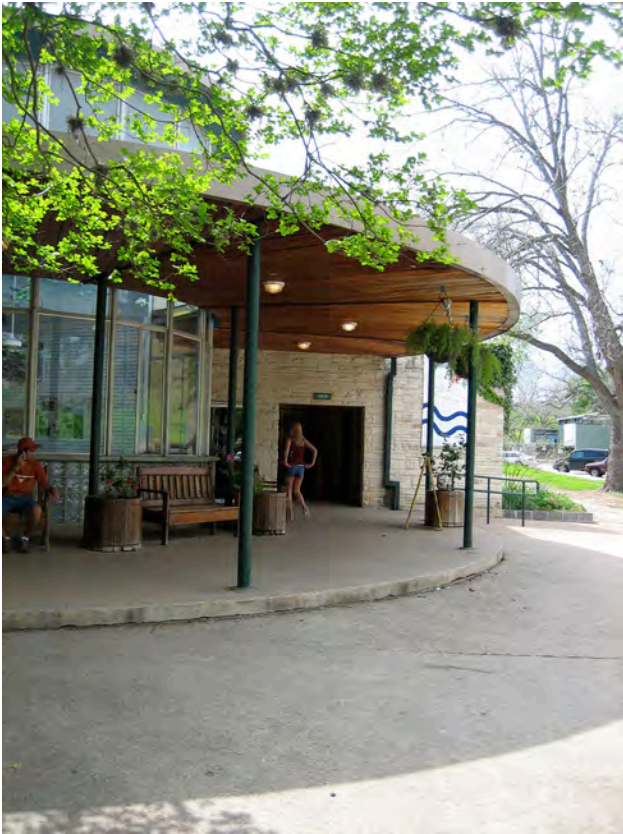
Existing 1947 Bathhouse. Originally, tickets were sold through ticket windows in the glass rotunda.

Originally, tickets were purchased at the central glass rotunda, much the way movie tickets are bought today, with patrons walking up to ticket windows paying the clerks sitting inside. Depending on the size of the crowd, as many as five clerks would be deployed while the waiting patrons were shaded by the deep canopy that still exists today.

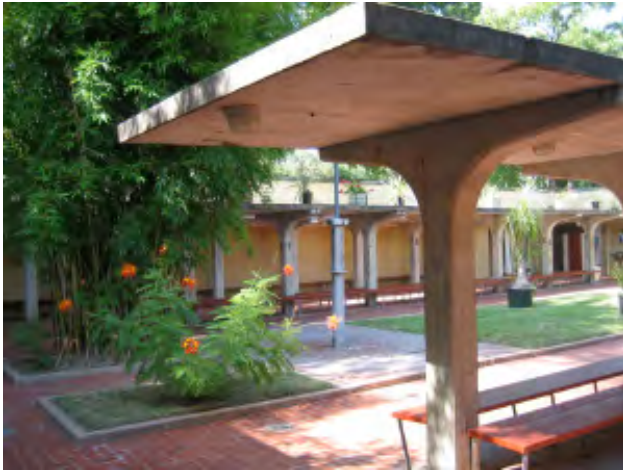
Men's Dressing Area, open and attractively landscaped, should retain its historic character.

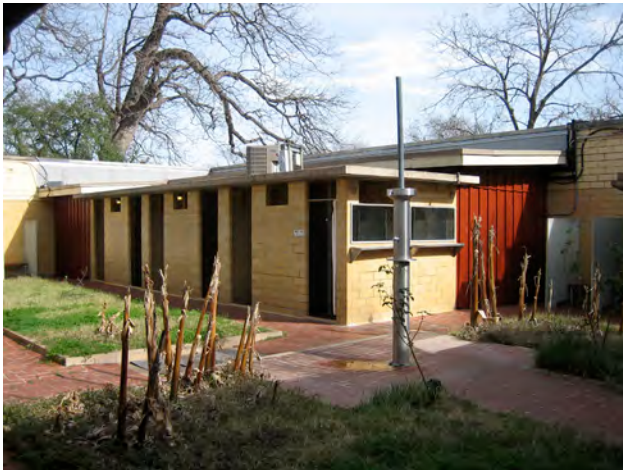
The Women's Dressing Area should be redesigned for a more open feel, while still offering a range of privacy options. This image shows the relocated Lifeguard's Lounge/Manager's Office, and the space it took from the Women's Area.

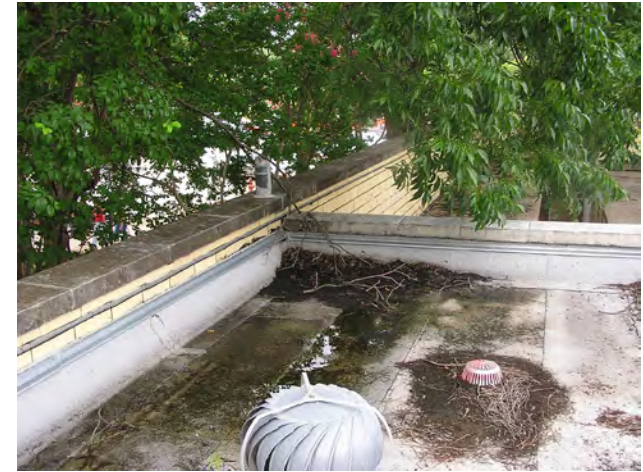
The roof was evaluated by a roofing consultant who observed some leaks and that its general condition is poor. More troubling, several areas of the roof are designed with parapet walls on all sides. These areas have primary drains but not overflow drains, a code violation and a safety hazard. Roof replacement is a short-term recommendation of this plan.

With a single area drain, and no overflow drain, a clog could lead to a catastrophic roof collapse.

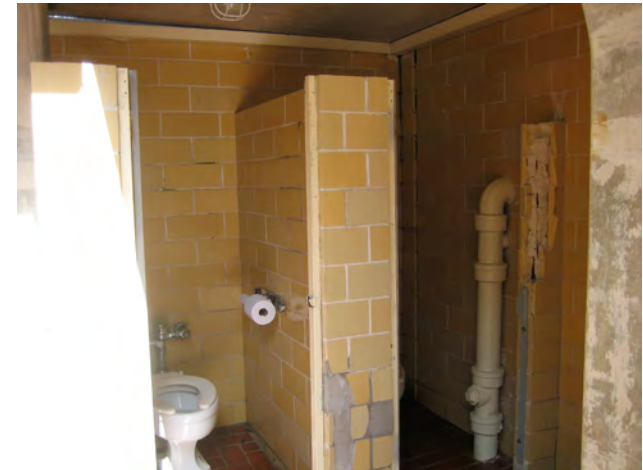
Aside from the deterioration, the preponderance of masonry toilet partitions gives the place a crowded feel. A rehabilitated Bathhouse should include more generous maneuvering clearances throughout.

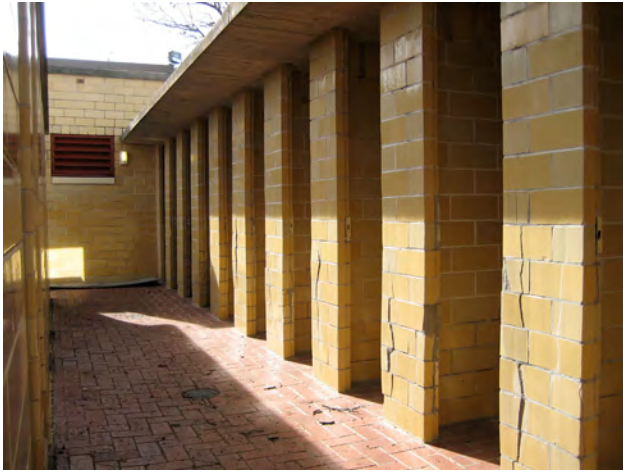
Aside from the masonry deterioration, some of the Women's Dressing area seems cramped and dank. Regular swimmers report that this area is rarely used.

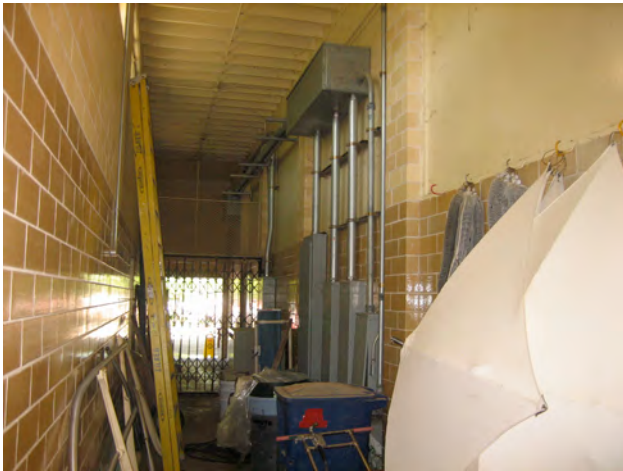
The electrical service appears to be adequate for future needs, but the location of the panels in the outdoor corridor between the rotunda and the Men's Dressing Area is noisy and not convenient to a new design. The electrical fixtures are generally not energy efficient and should be replaced with new, more efficient fixtures. Furthermore, numerous surface-mounted conduits can be seen on the building, suggesting a series of alterations and additions over the life of the building. Removing these and relocating their service in less conspicuous routes should be a part of any rehabilitation effort. From a practical standpoint, this could result in the replacement of all of the electrical service.

Electrical upgrades are installed unattractively, rendering this otherwise usable space good only for storage.

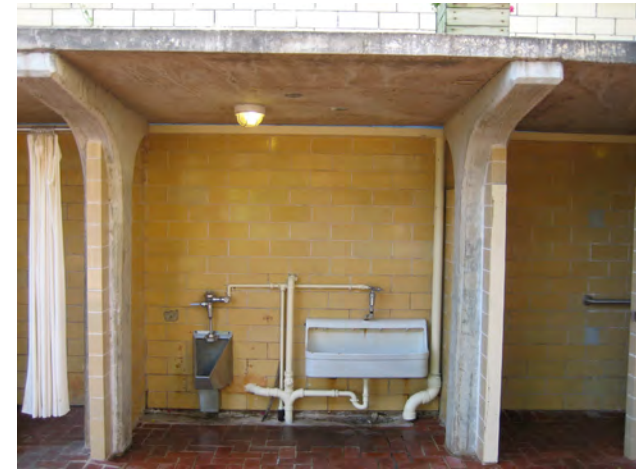
There are a range of ages and types of plumbing fixtures in the building. None of them appear to be water-conserving fixtures. To the extent that this plan will likely involve mov-

Plumbing fixtures vary in age and condition. Trough urinals (right) do not meet current code. None of the fixtures are low water-use fixtures.

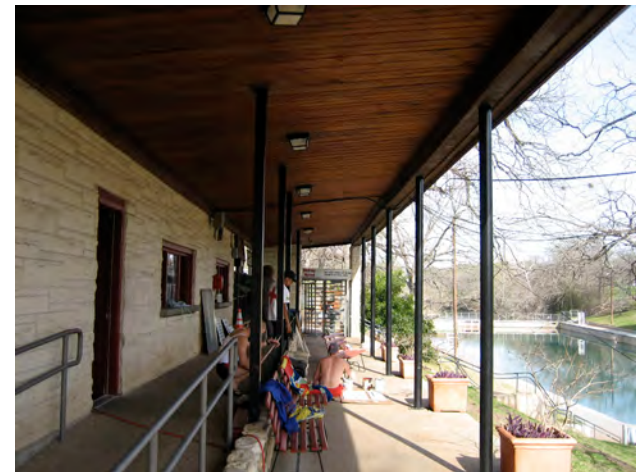
The relocation of the Lifeguard's Lounge/Manager's Office in the 1960s required this elevated passage to account for a level change, changing what was designed to be a shaded social space into more of a passageway.
