300 Colorado Street

Dossier on Architectural and Occupational History

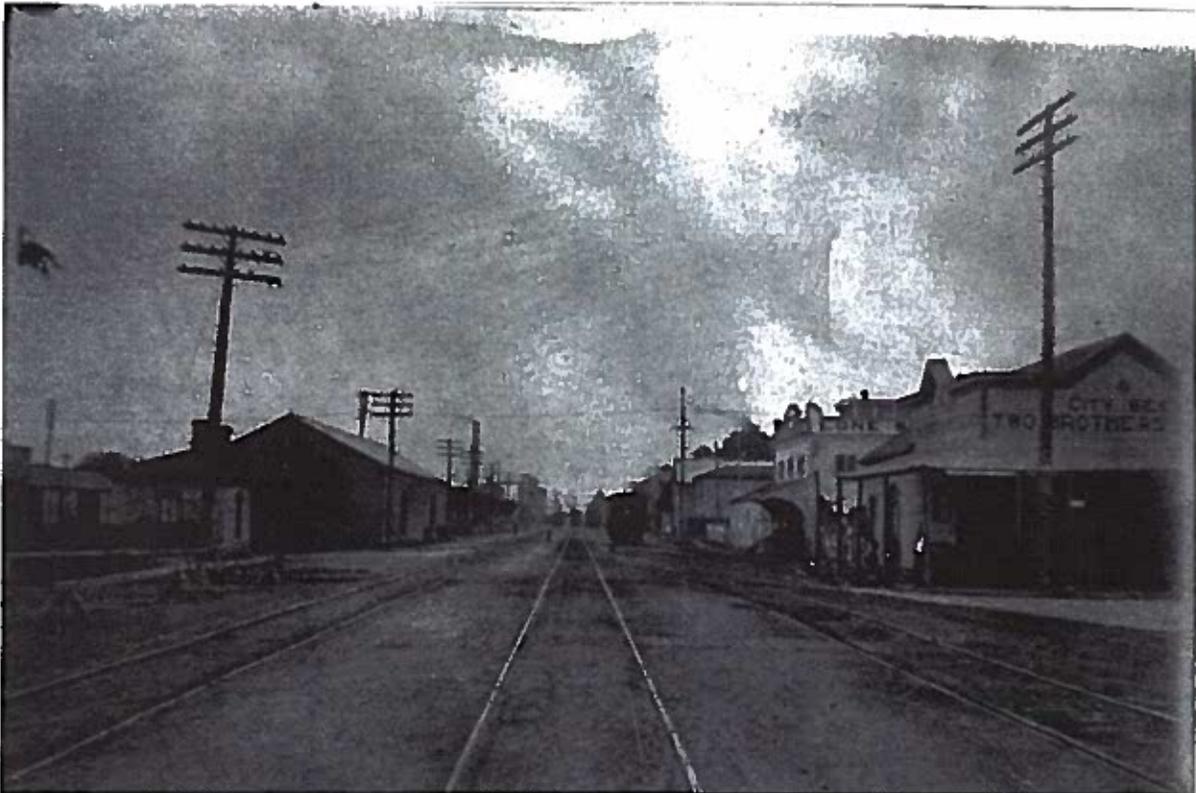
Photo 1: 3rd Street looking East towards Colorado Street. 1905. Austin History Center.¹

The earliest picture we have of the site is from circa 1905. It shows The Two Brothers Saloon.

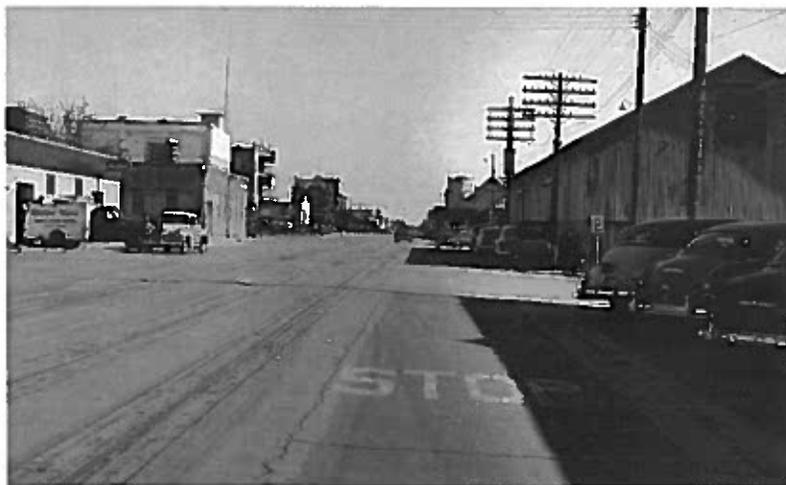
Photo 2: View from Lavaca looking East down 3rd street. 11/20/1952. Austin History Center.

A photo from 1952 shows a view of 3rd street, looking east from Lavaca. The building's south and west elevations can be seen on the left of the frame.

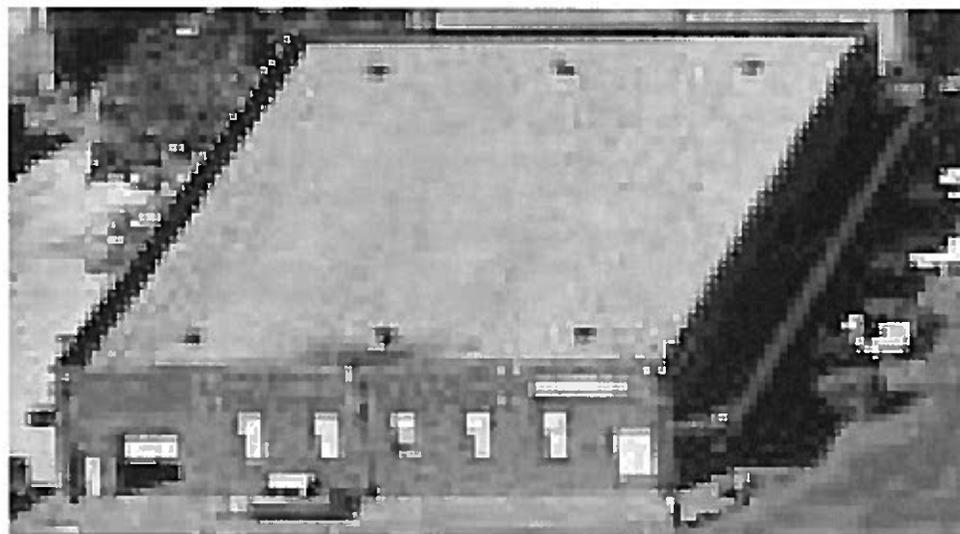
Photo 3: Zoomed-in aerial View of Downtown Austin. 11/7/1959. Neall Douglass Collection.

An aerial photo from 1959 that gives a fairly clear view of 300 Colorado. The side facing the viewer is the south elevation, along 3rd street. The south elevation shows the original fenestration patterns along with a garage door on the western corner which probably served as a loading area. On the east elevation, the outline of a canopy can be seen.

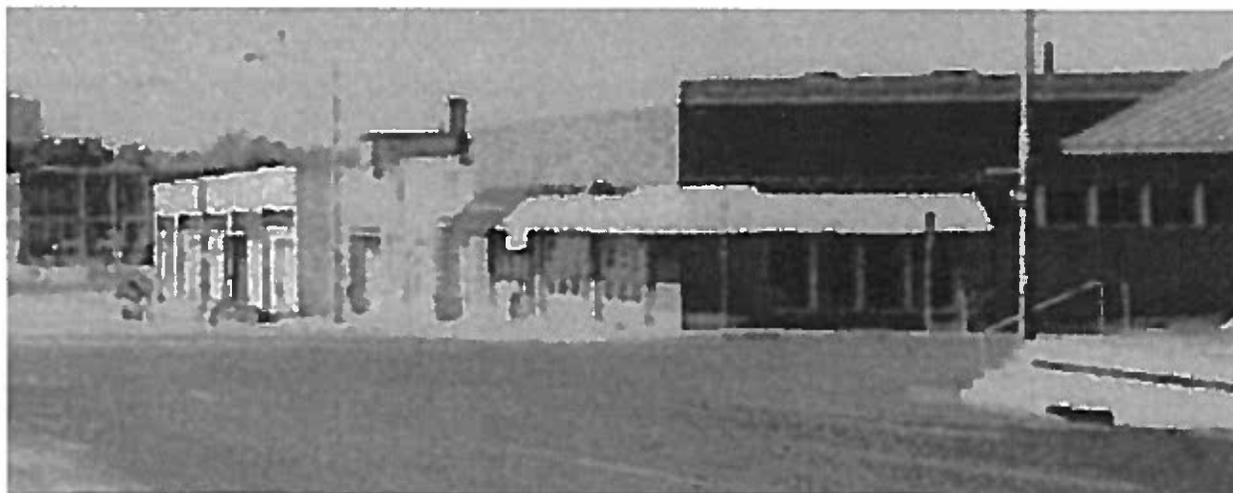
Photo 5: A view of Colorado Street looking South from 5th and Colorado. 1985. Austin History Center.

In Photo 5, 300 Colorado is the white building at end of frame. The building has been painted white and the canopy removed. Compare to Photo 3.

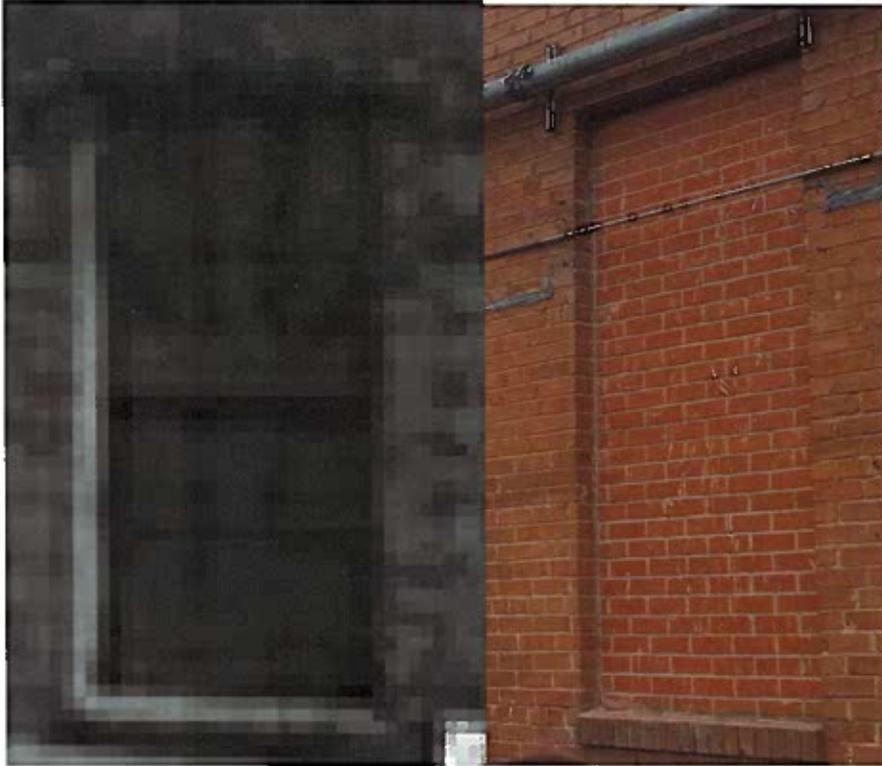
Photo 7: (left) close-up of West Fenestration from 1952. 11/20/1952. Neall Douglas Collection.

Photo 8: (right): West fenestration of Sullivan’s Steakhouse. 8/5/2017 John Laycock.

The original, rear fenestration (left) and the current fenestration (right), reflects the complete alteration of the window pattern – with windows walled in.

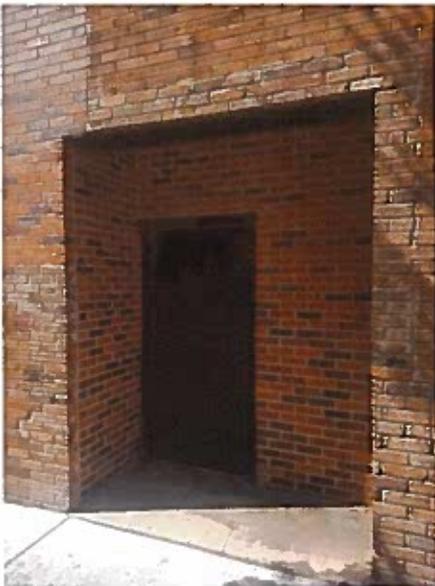
Photo 9: Door, formerly garage door, on Sullivan’s south elevation. 8/5/2017. John Laycock.

The original loading dock has been bricked up and turned into a door.

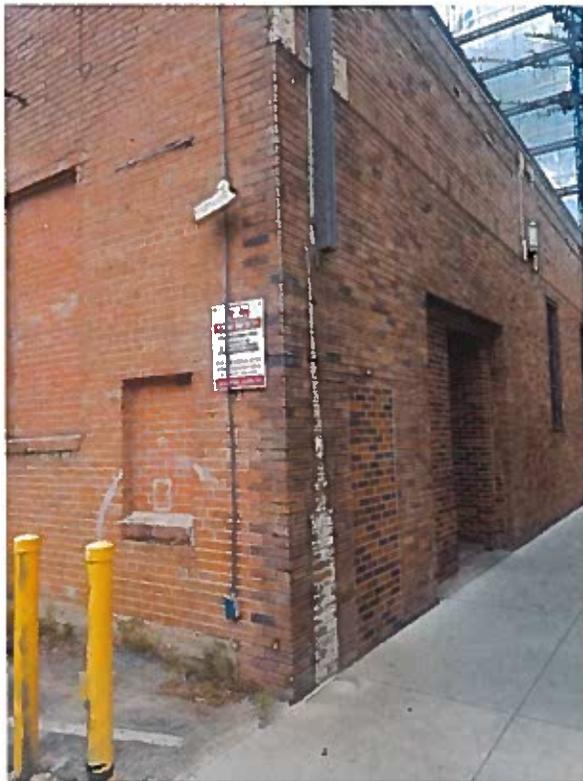
Photo 10: Southwest Corner of Sullivan's. 8/5/2017. John Laycock.

Conclusion: 4 different kinds of brick in a single shot reveal extensive alterations since the building was constructed in 1925. The site contains little of its integrity or original brick, fenestration, or door pattern.
