HISTORIC LANDMARK COMMISSION
OCTOBER 23, 2017
DEMOLITION AND RELOCATION PERMITS
HDP-2017-0513
919 VALDEZ STREET

Demolish a 1939 church building.

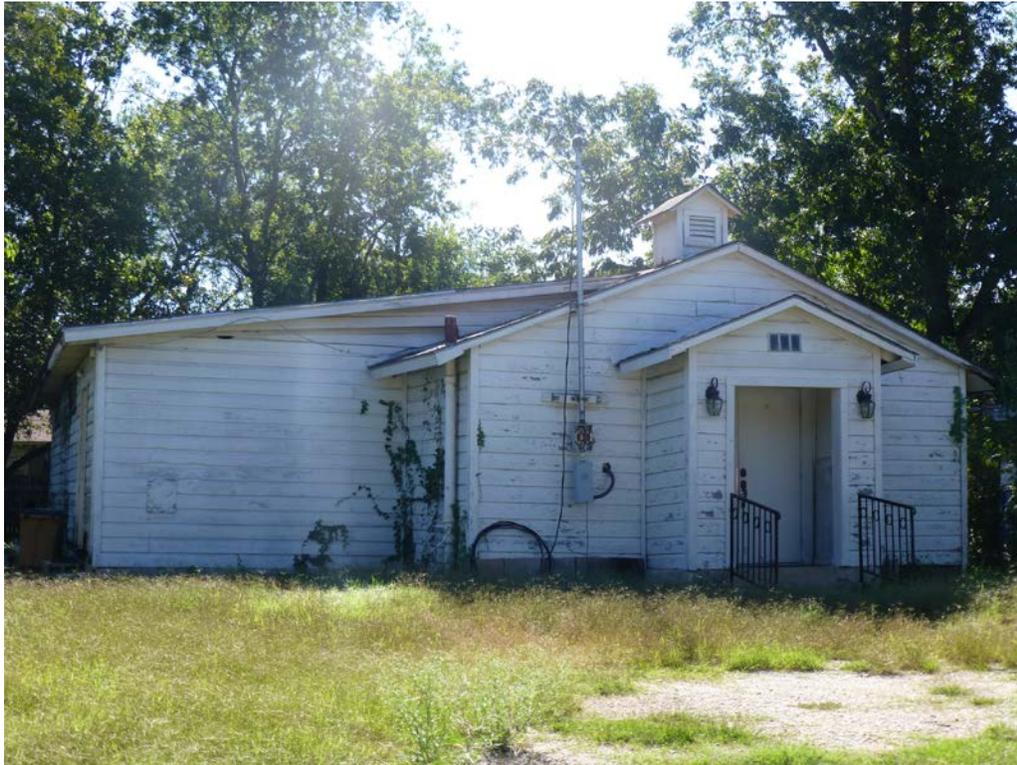
Primary (west) façade of 919 Valdez Street

One-story, rectangular-plan, front-gabled wood-frame building constructed in a vernacular style with a shed-roofed addition. The building is clad in shiplap wood siding and features 8-light wood-sash windows and a partially enclosed entry porch. A small gable-roofed bell tower sits atop the ridge line.

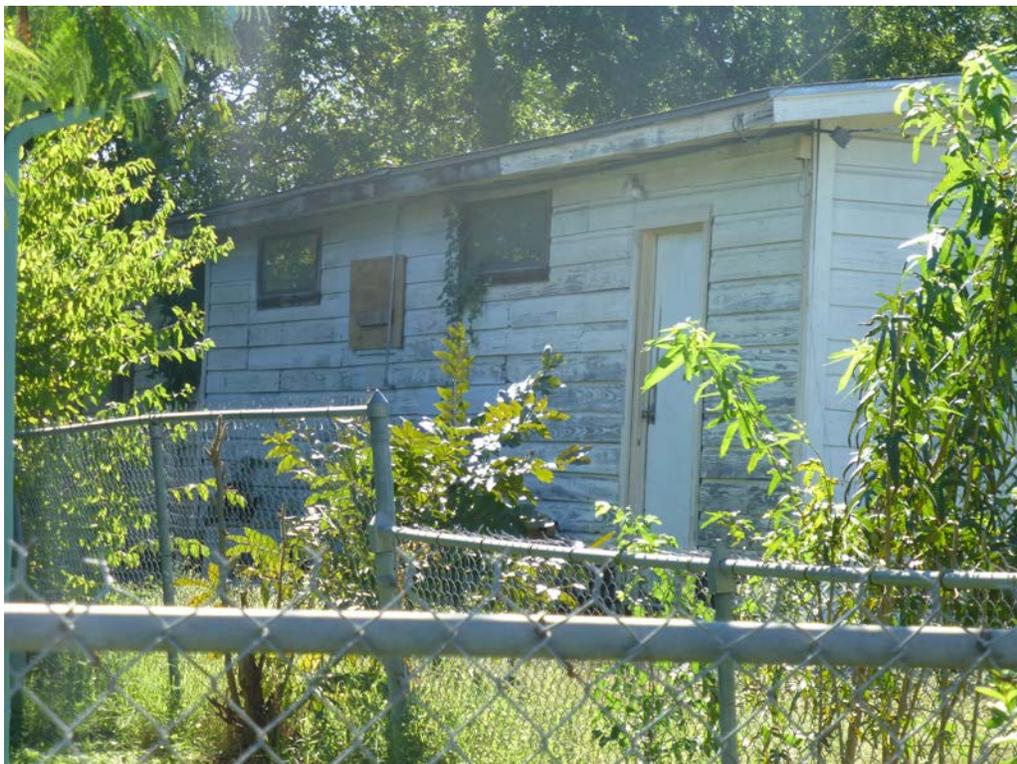
Detail of north elevation

In 1961, a one-story frame addition was constructed on the north side of the building to house a kitchen and dining room. A one-story masonry addition at the northeast corner was proposed in 1977-78. However, it is not clear if it was built, as the entire building appears to be of wood-frame construction.

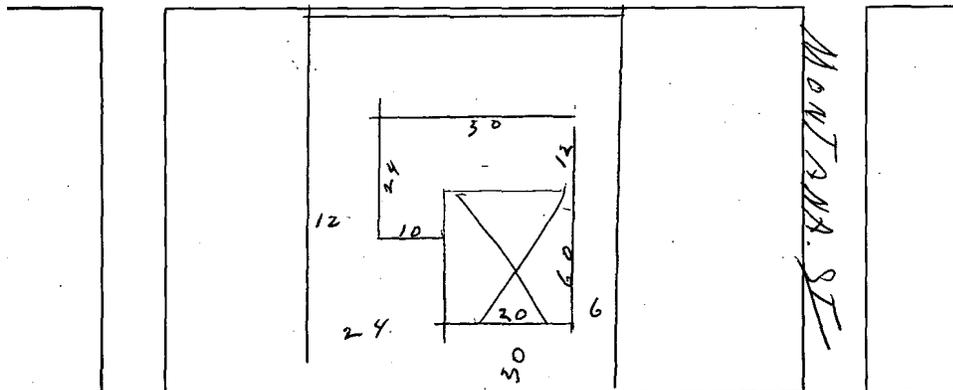
Inspection form for wood-frame addition, 5/18/1961.

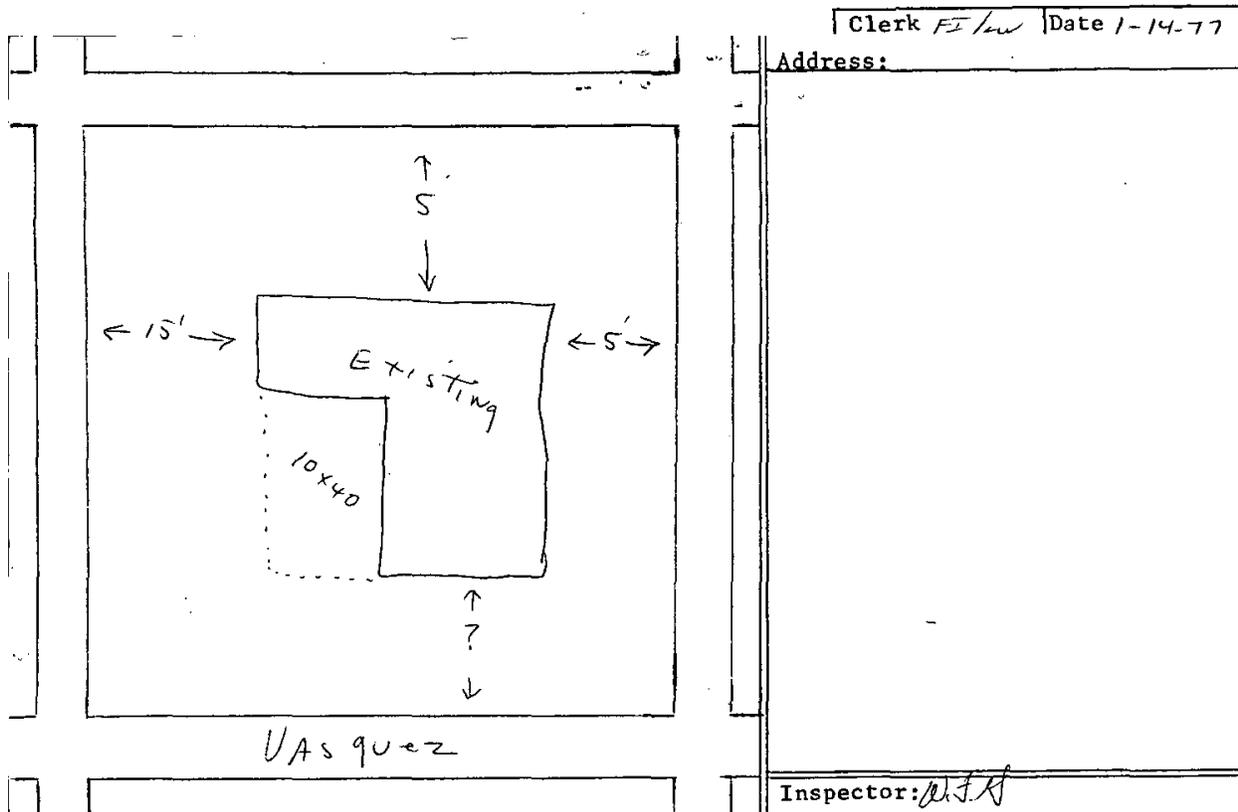
Inspection form for masonry addition, 3/7/1978. It is not clear if the addition was constructed.
