Tannehill Branch Creek at Givens Park Erosion Repair Project

MICHELLE ADLONG, P.E. | CITY OF AUSTIN WATERSHED
PROTECTION DEPARTMENT

PRESENTATION TO PARKS BOARD

1/23/2018

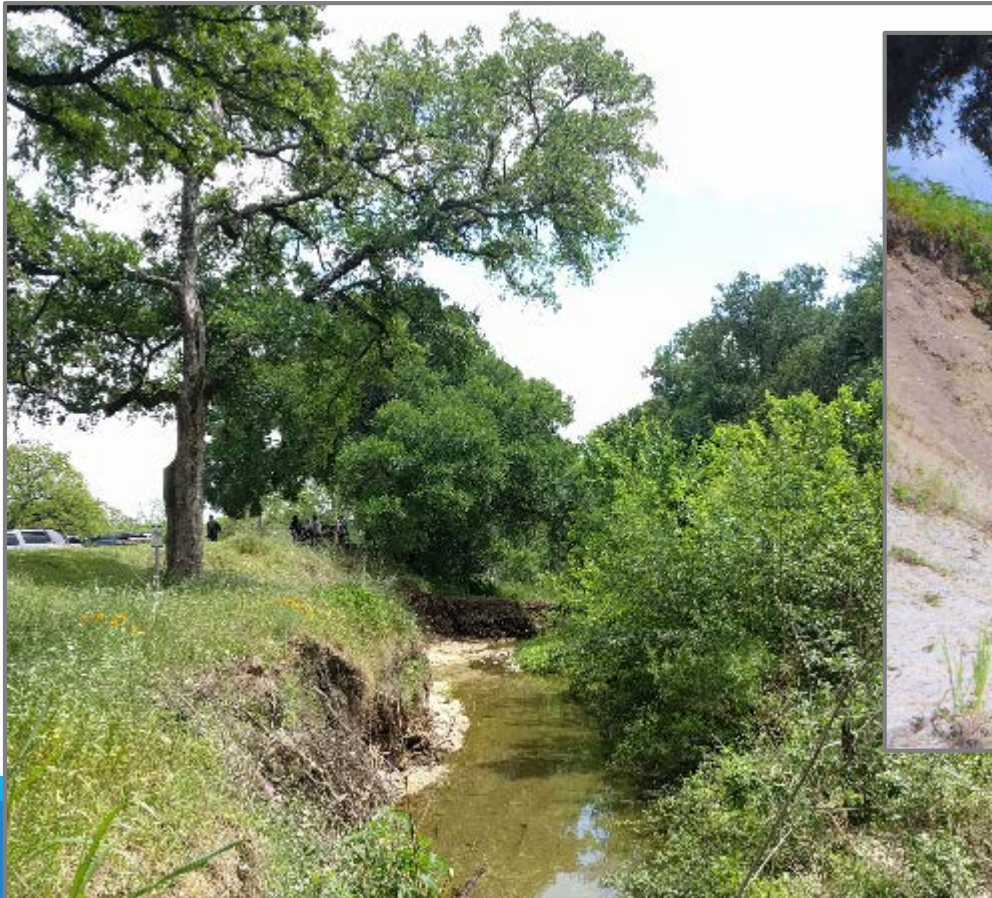
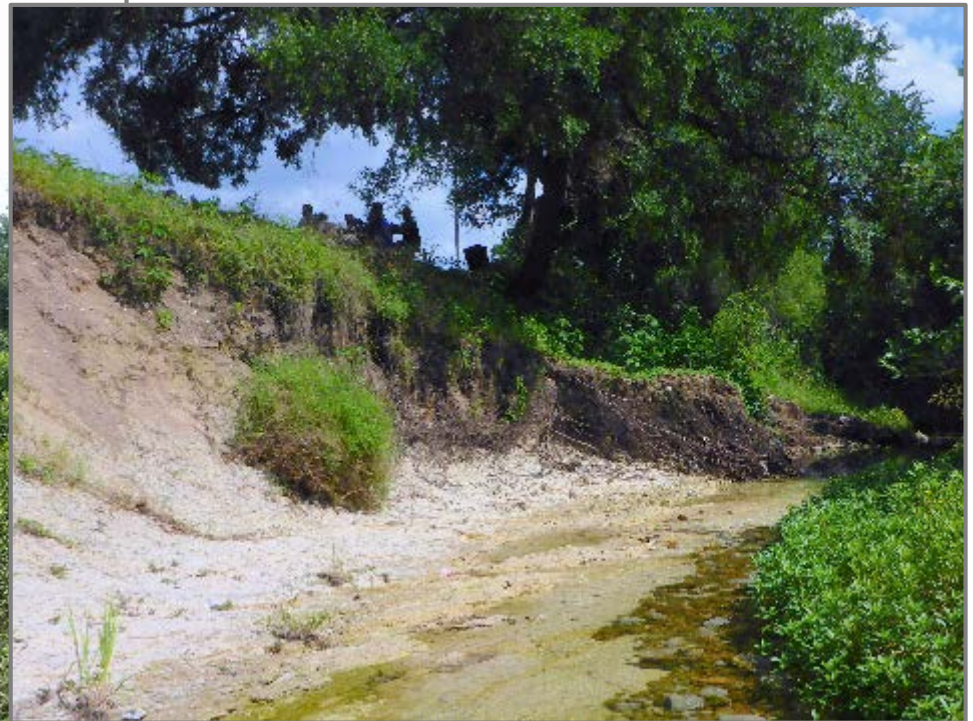
- ★ Protect park land, trees, and picnic bench from erosion

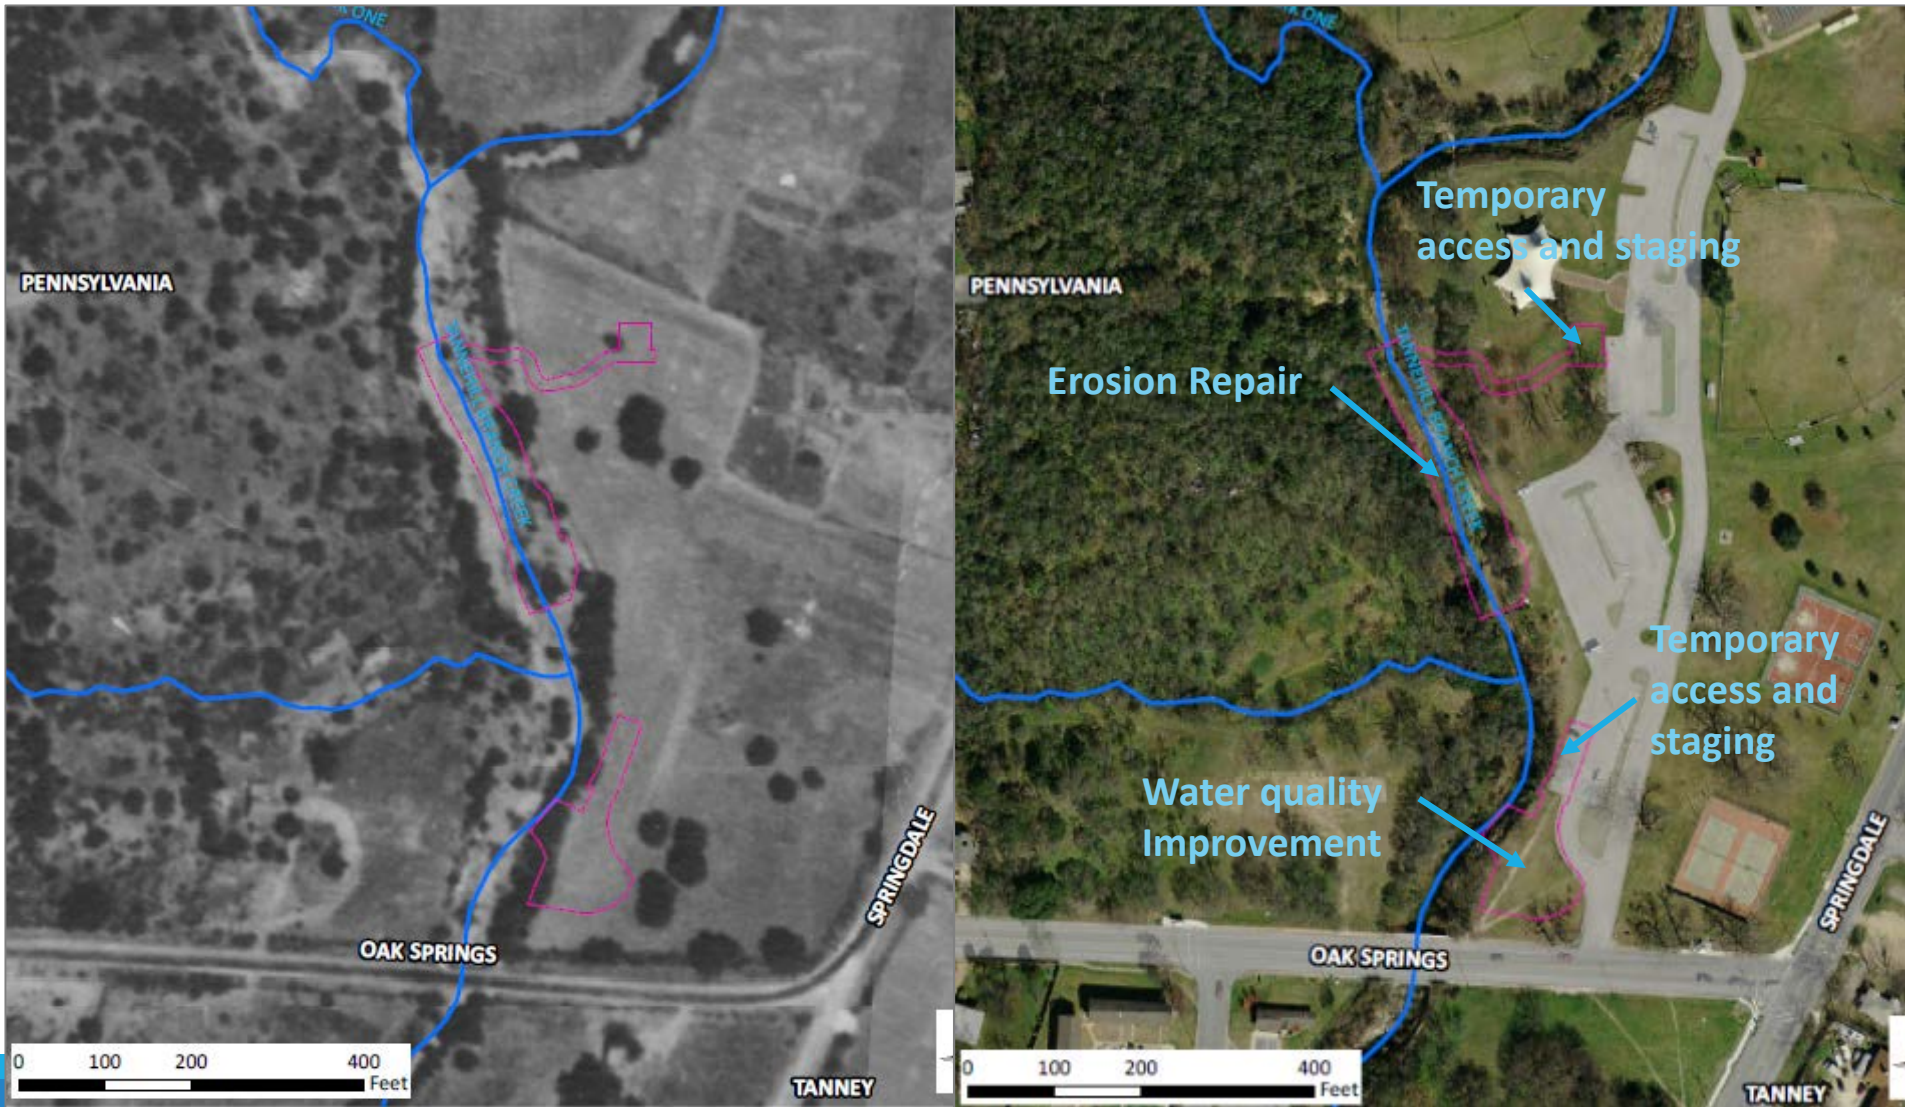
Tannehill Branch at Givens Park: 1940 vs 2017

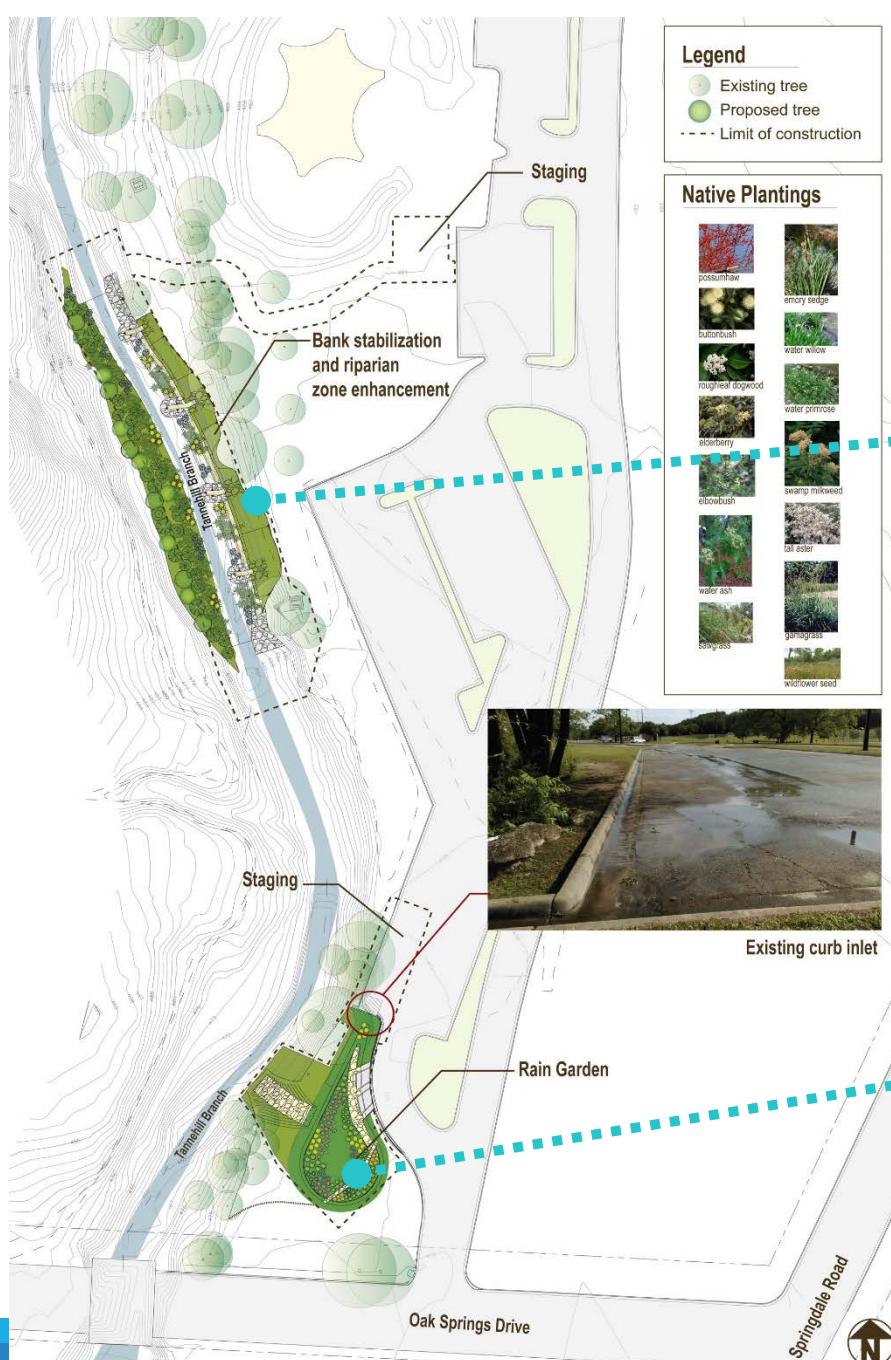
Proposed Solutions

- Stabilize the eroding stream bank and restore the natural stream

- Construct a landscaped rain garden to capture and filter erosive, polluted parking lot runoff

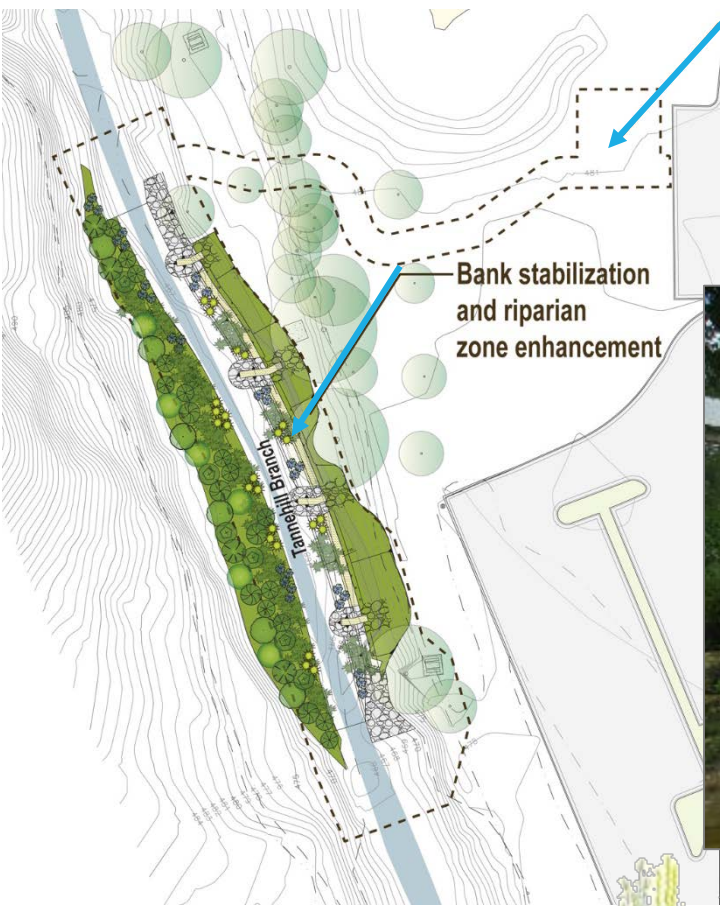
Proposed stream restoration

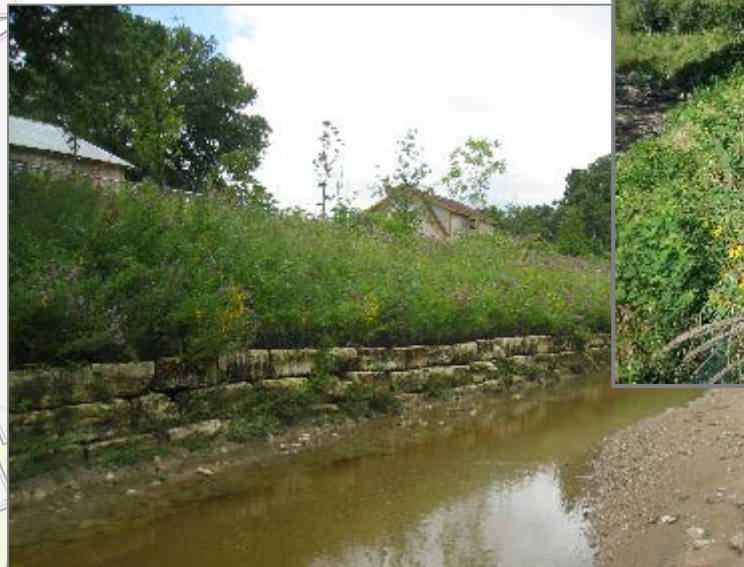
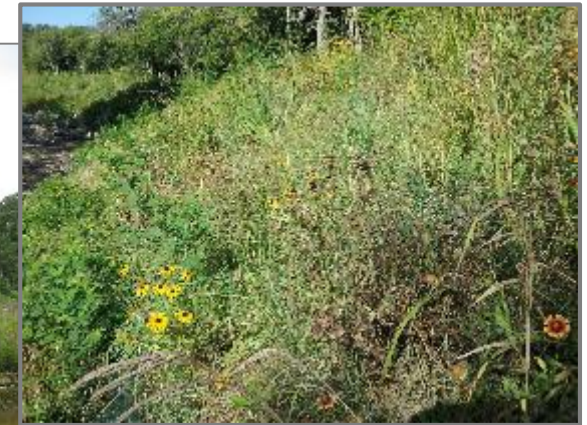
Temporary access and staging

- ❑ 300 LF (13,500 SF) of stream channel restored
- ❑ Including park access & staging, 32,000 SF of parkland temporarily used

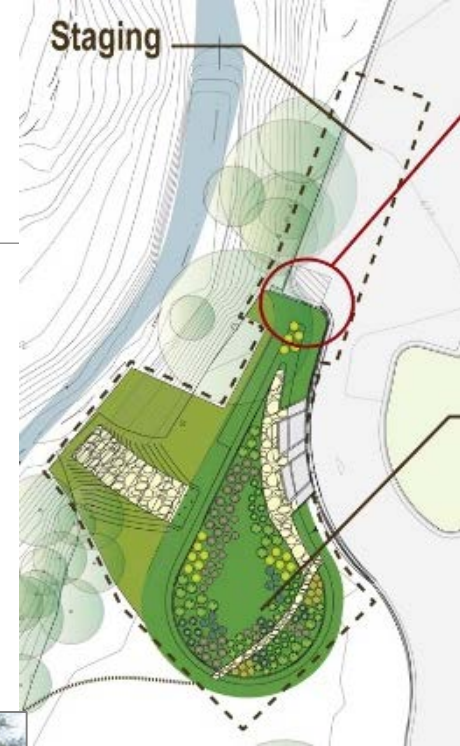
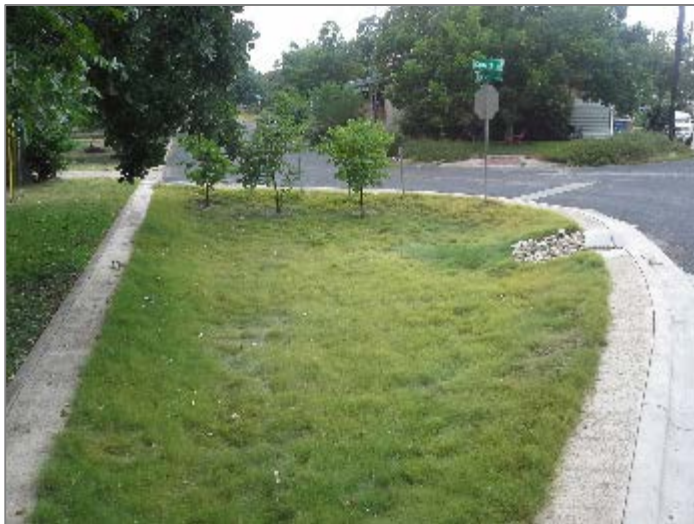
Proposed rain garden

- ❑ 6200 SF rain garden
- ❑ Rebuild about 90 LF of curb & gutter and stabilize about 20 LF of streambank
- ❑ Total of 15,000 SF of parkland temporarily used

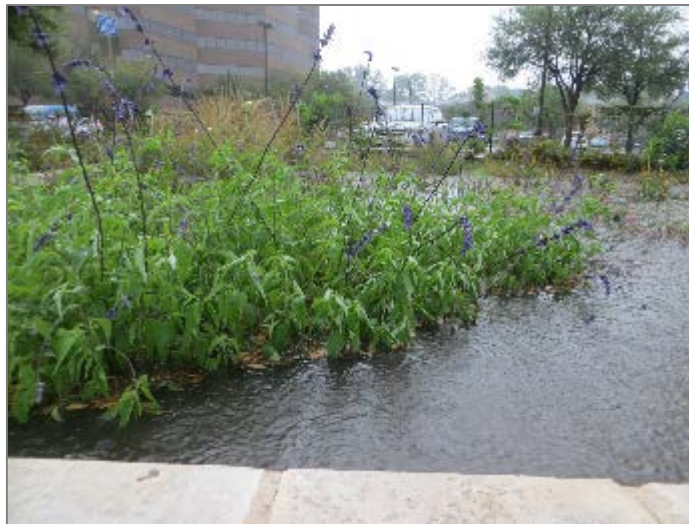
Example – sod only - dry

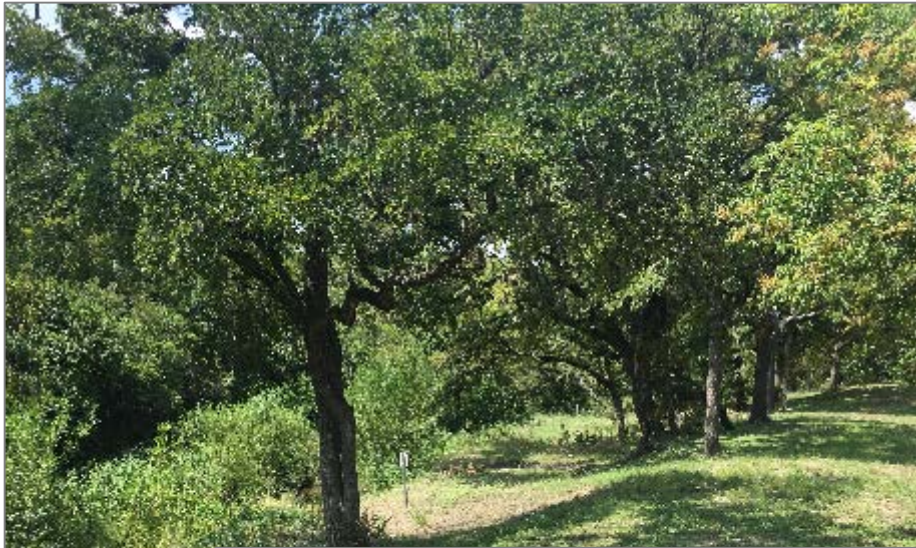
Example – native plants - during rain

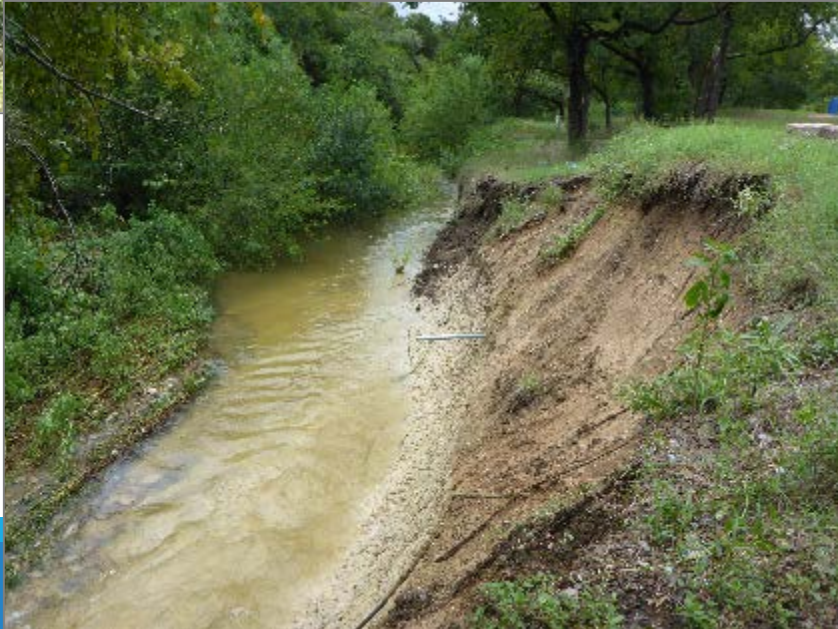
Trees

- ❑ 1 tree (10" crape myrtle) to be removed
- ❑ Park has already lost large trees due to erosion; stabilizing streambank will protect existing trees
- ❑ Trees in or near Limit of Construction will receive tree protection during construction
- ❑ Tree seedlings will be planted in channel revegetation areas
