12th Street Bridge at Shoal Creek

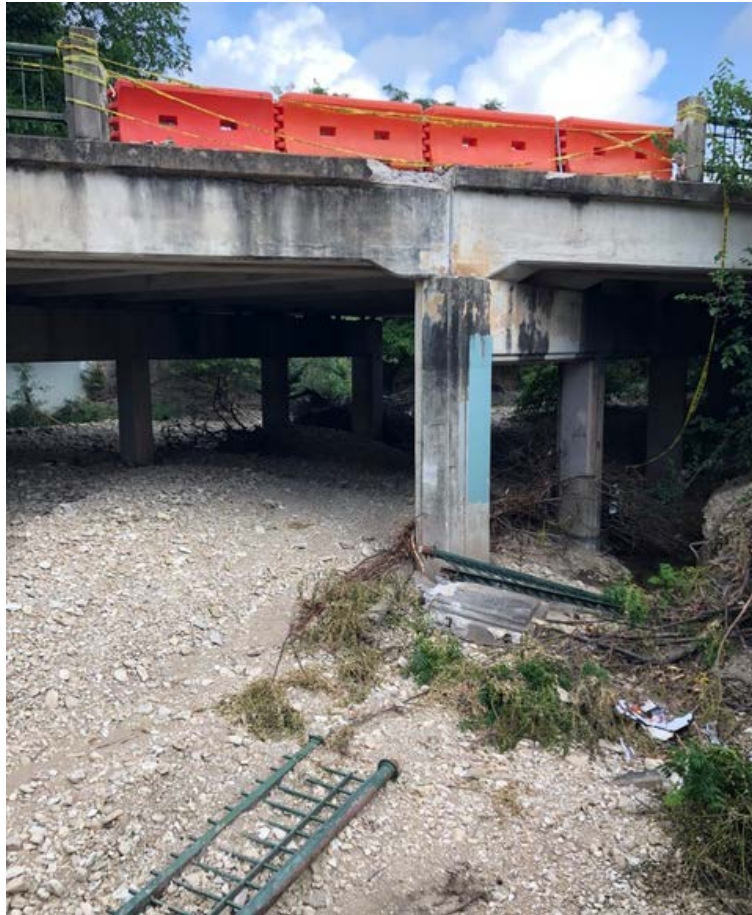
12th Street Bridge over Shoal Creek was damaged by a vehicle in June 2018. As a result, two sets of rails fell to the ground, as shown in Figure 1. Temporary water barriers have been installed for public safety, as shown in Figure 2.

Figure 1. Damaged Rail

Construction plans from November 2001 and revision plans from April 2002 can be found in Figures 5 and 6, respectively. These plans indicate that railing posts were retrofitted in 2002. We propose repairing damaged posts and railings with in-kind material and repainting them to look similar to the original silver color.

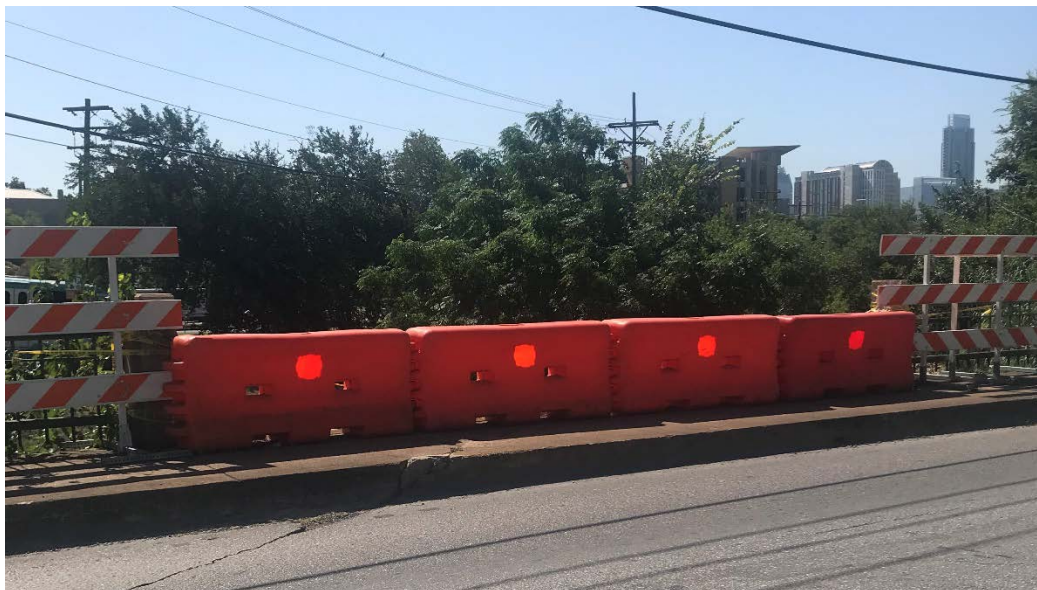
Figure 2. Temporary Barriers

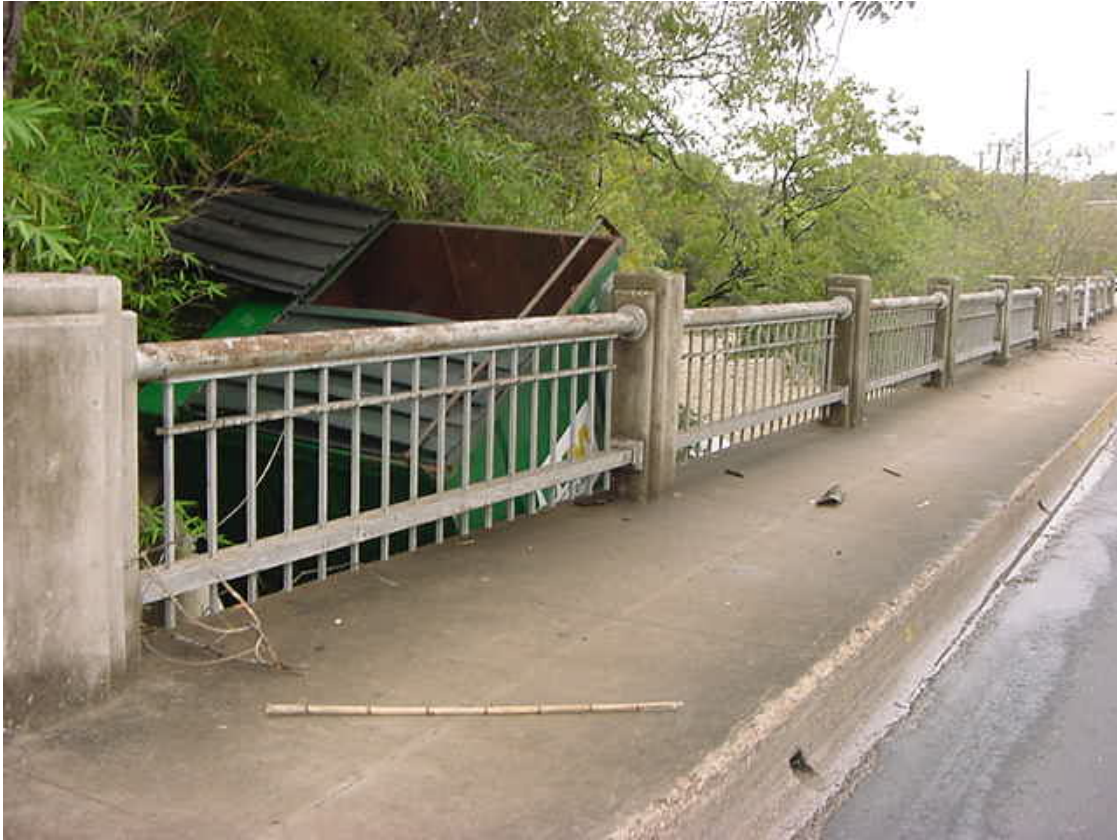
This railing is a standard section that has been installed at multiple locations throughout the city. Figures 3 and 4 show that the concrete surfaces and railings have been tagged and painted over numerous times in previous years: Figure 3 is a picture from November 2001, showing silver paint (galvanized) on railing and gray concrete, whereas figure 4, a Google Street View from August 2013, shows green paint on railing with painted/tagged concrete pedestals.

Figure 3. Silver Painted Rail with Gray Concrete (Dated November 16, 2001)

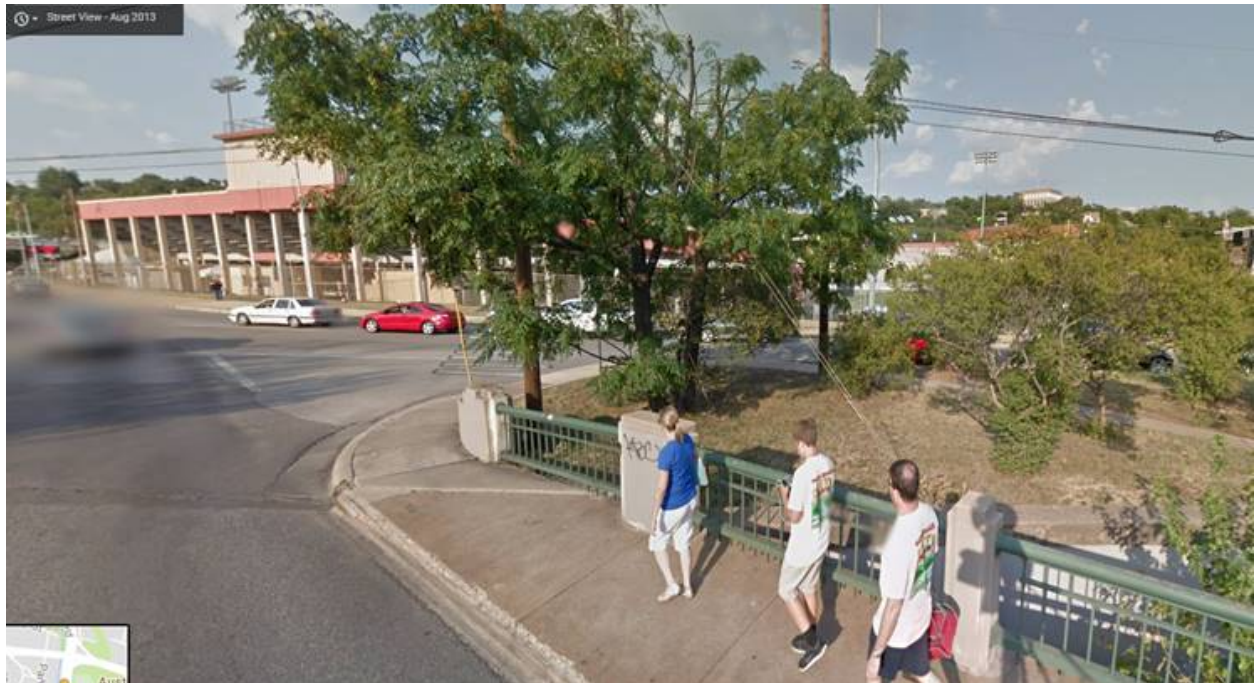
Figure 4. Google Street View (Dated August 2013)

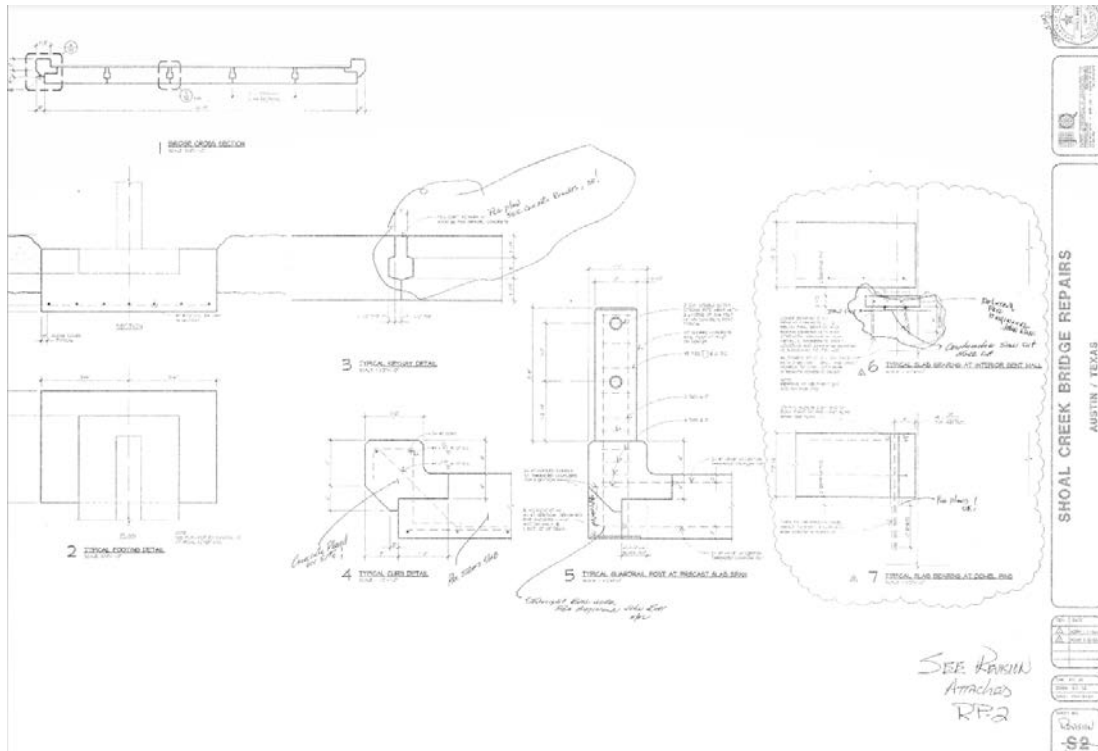
Figure 5. Construction Plan (Dated November 2001)

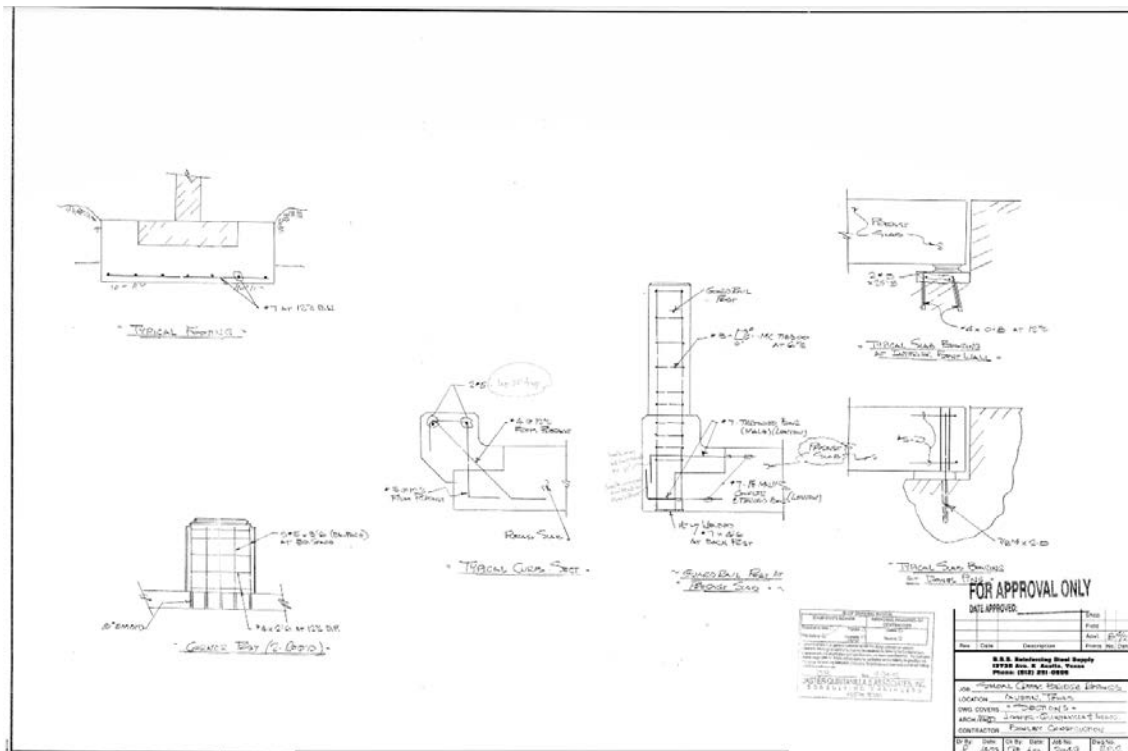
Figure 6. Revision of Construction Plan (Dated April 2002)
