TEXAS OFFICIAL WOOD DESTROYING INSECT REPORT

4200 WINDWOOD RD.

AUSTIN

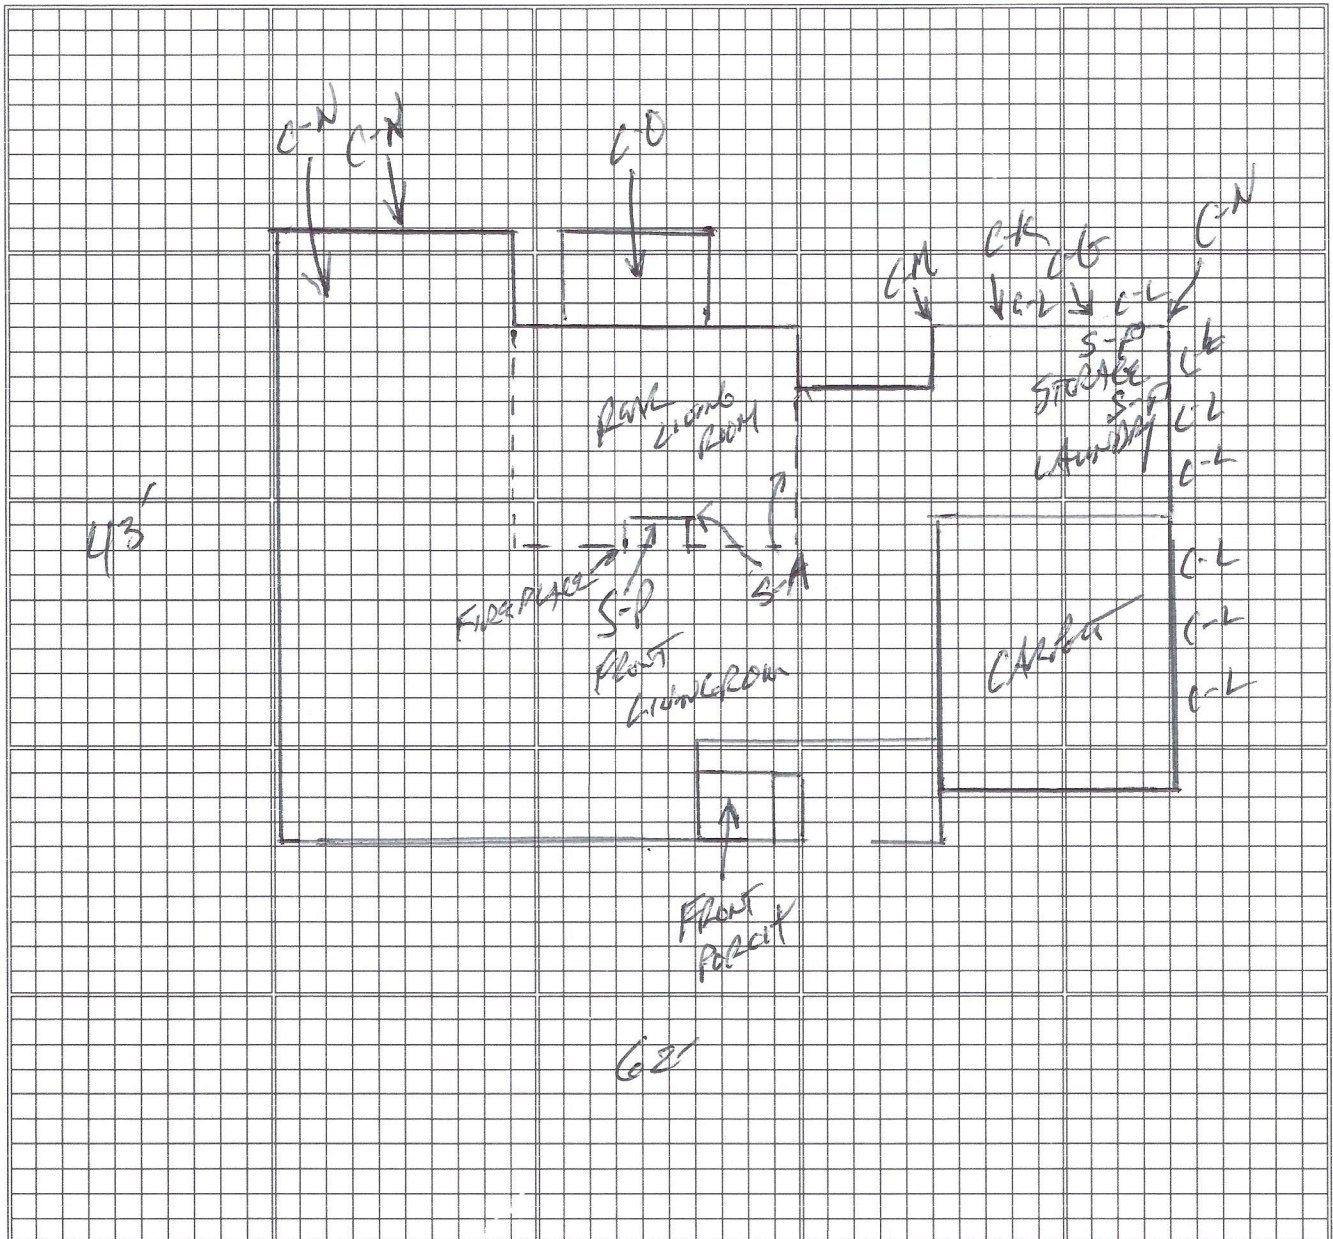
8G. Visible evidence of: SUB. TERMITES has been observed in the following areas: PREVIOUS - RIGHT REAR STORAGE ROOM SILL, W/ FLOOR, UNDER FIREPLACE. ACTIVE - UNDER REAR LIVING ROOM AT A PIER, S/ UNDER THE FIREPLACE  
If there is visible evidence of active or previous infestation, it must be noted. The type of insect(s) must be listed in the first blank and all identified infested areas of the property inspected must be noted in the second blank. (Refer to Part D, E & F, Scope of Inspection)

The inspector must draw a diagram including approximate perimeter measurements and indicate active or previous infestation and type of insect by using the following codes: E-Evidence of Infestation, A-Active; P-Previous; D-Drywood Termites; S-Subterranean Termites; F-Formosan Termites; C-Conducive Conditions; B-Wood Boring Beetles;

Specify reason: CONCRETE SOIL AT THE SCARS, PUT THE TREES AWAY ELIOT WIFE WOOD/GROUND  
Refer to Scope of Inspection Part J CONTRACT. READ WILHELM HOUSE FOR SUB. TERTILES - OBTAIN A RENEWABLE
