Addenda to Variance Application

West Harbour Marina

**RE: Pre-Construction Notification for Regional General Permit 8 Request
SWF-2018-00267
G4 Interests LLC
West Harbour Marina
2503 Westlake Drive
Austin, Texas 78704**

**Wetland Delineation Report
West Harbour Marina
2503 Westlake Drive
Travis County, Texas**

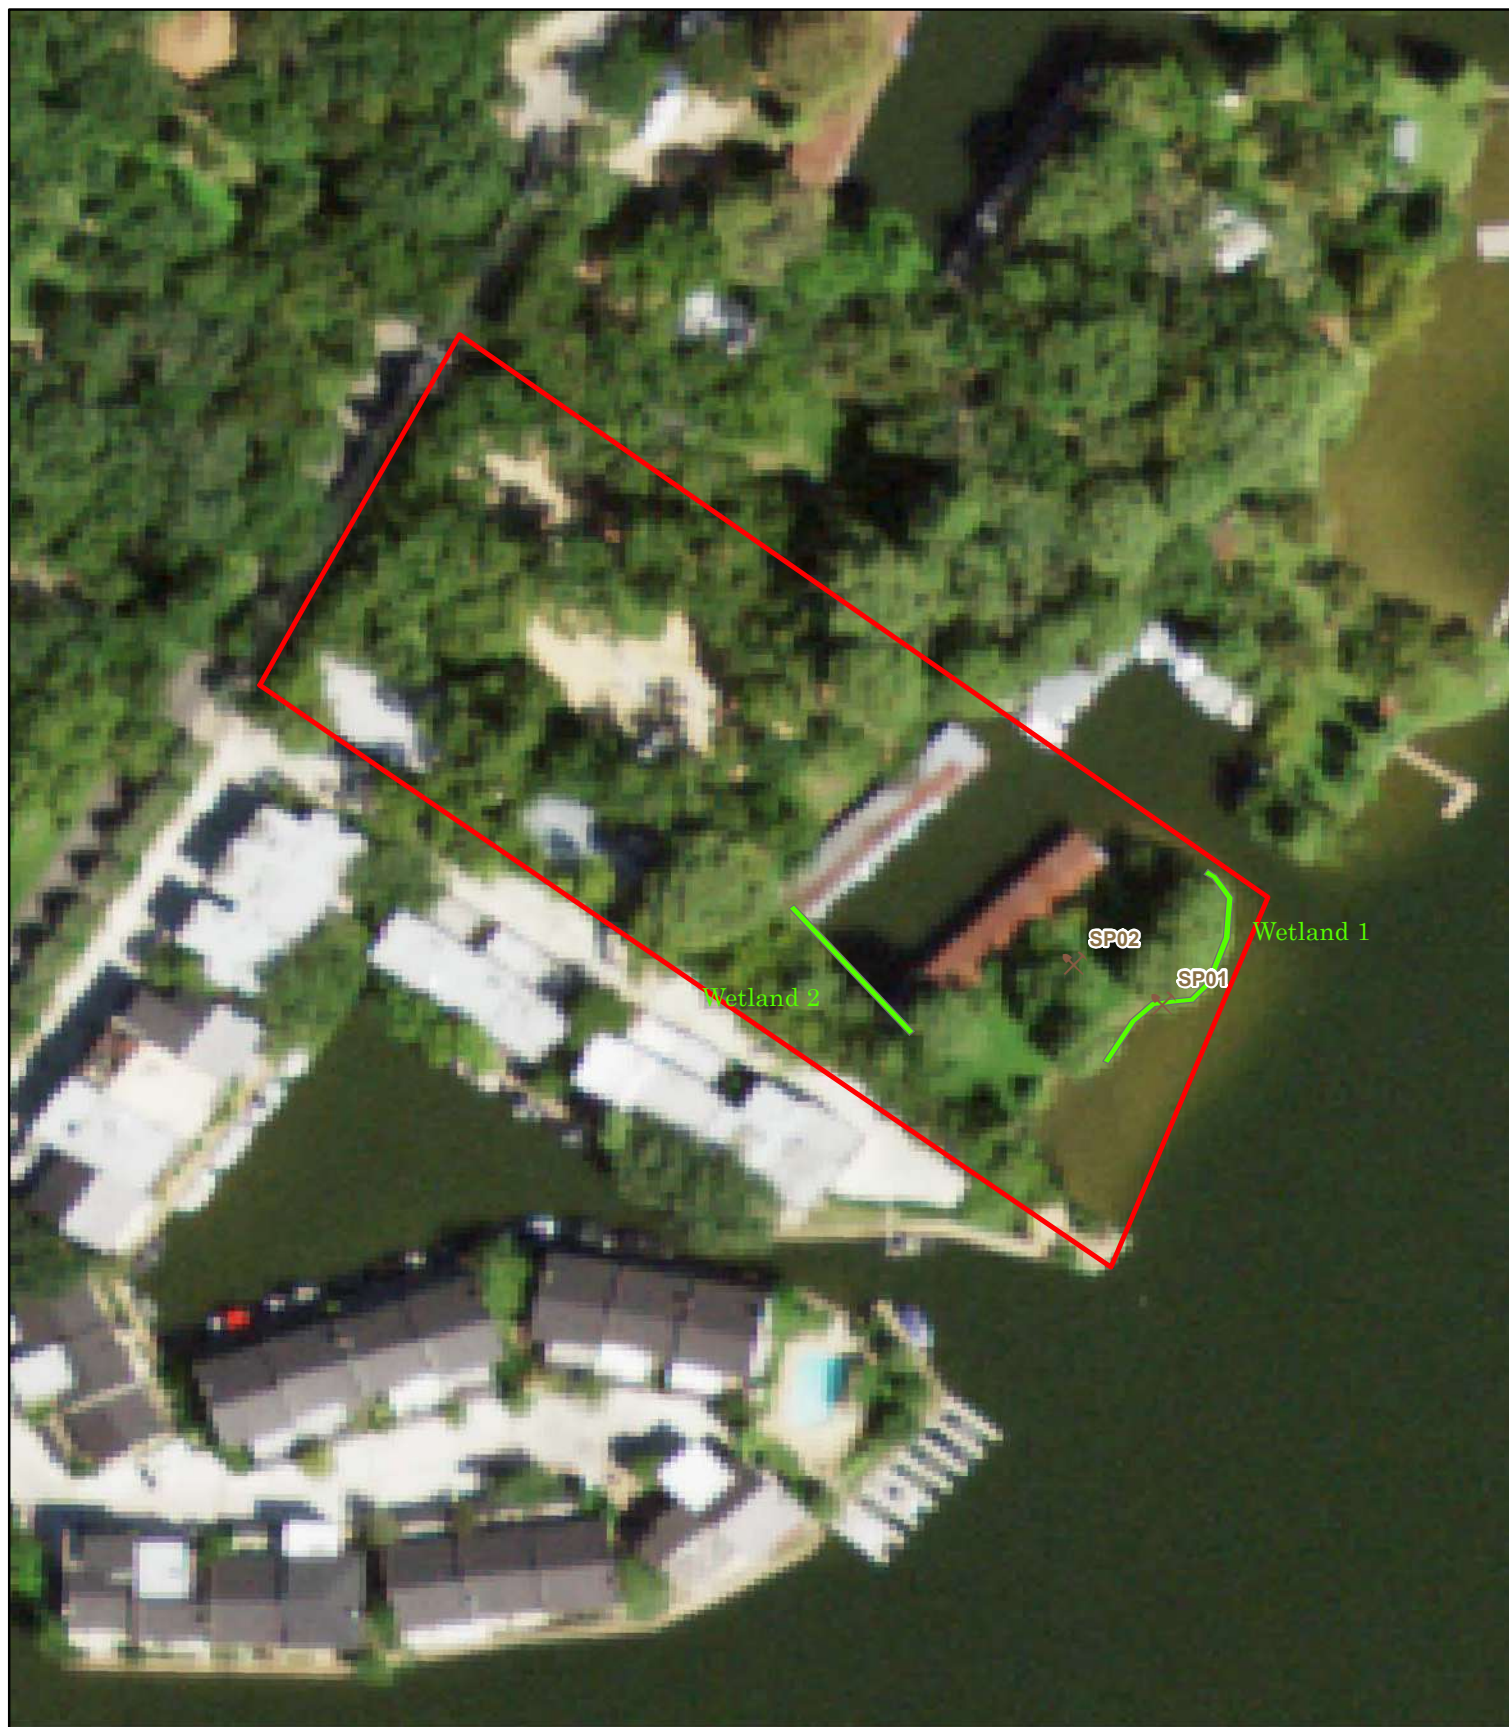
Figure 2: Wetland Delineation Data - Natural Color Map

Fringe Wetlands - 0.015 acres
-

DESCO biologists identified two fringe wetland areas (**Wetland 1 and 2**) within the assessment area as a result of wetland delineation efforts. **Wetland 1** is 0.009 acres (136 feet by 3 feet) in size and **Wetland 2** is 0.006 acres (88 feet by 3 feet). DESCO believes that **Wetland 1 and 2** are potentially jurisdictional because they abut Lake Austin, a dammed portion of the Colorado River.

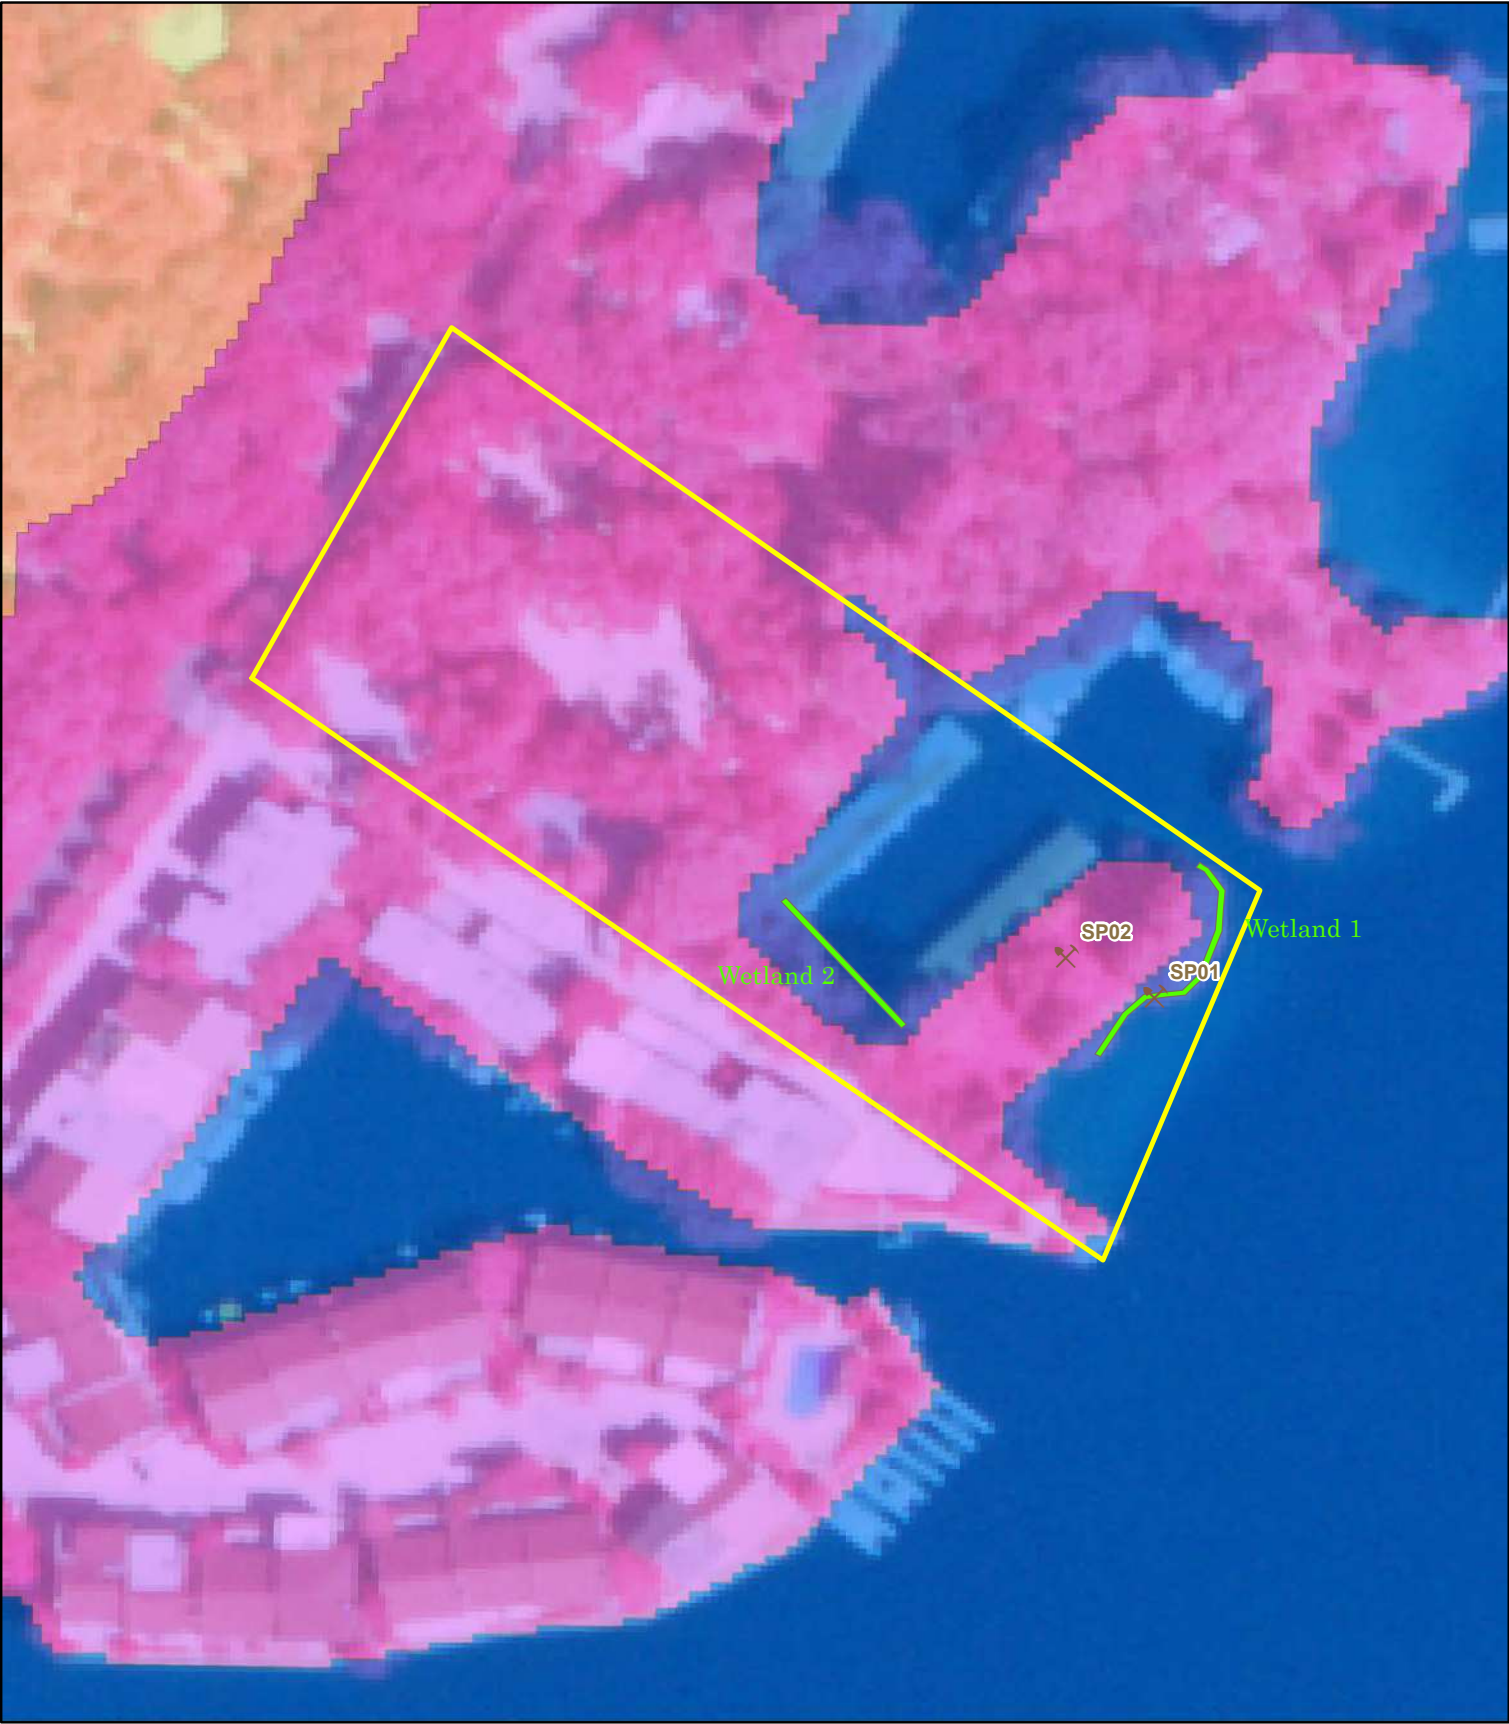
Figure 5: Wetland Delineation Data with FEMA Data - Color Infrared Map

0.2 PCT Annual Chance Flood Hazard

1 PCT Annual Chance Flood Hazard

Area of Minimal Flood Hazard

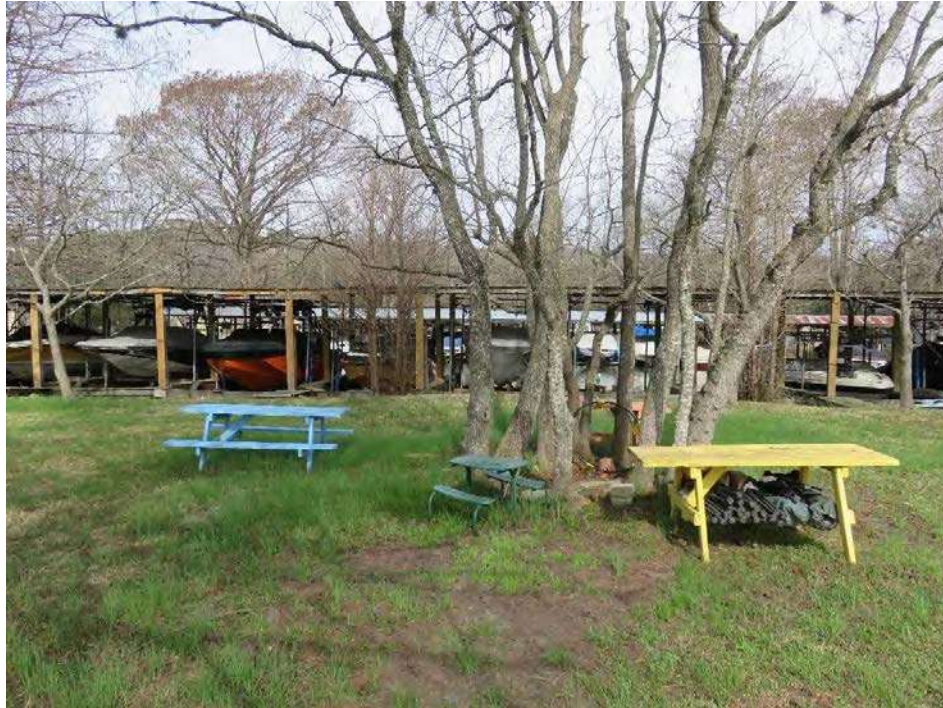
Photo 5: Photo was taken on the southeastern portion of the property, facing northwest towards SP02 in upland habitat and the boat slips.

DESCO established this sample point in an upland habitat west of **Wetland 1**. Data collected at this sample point contains hydrophytic vegetation but does not exhibit hydric soils and wetland hydrology indicators.

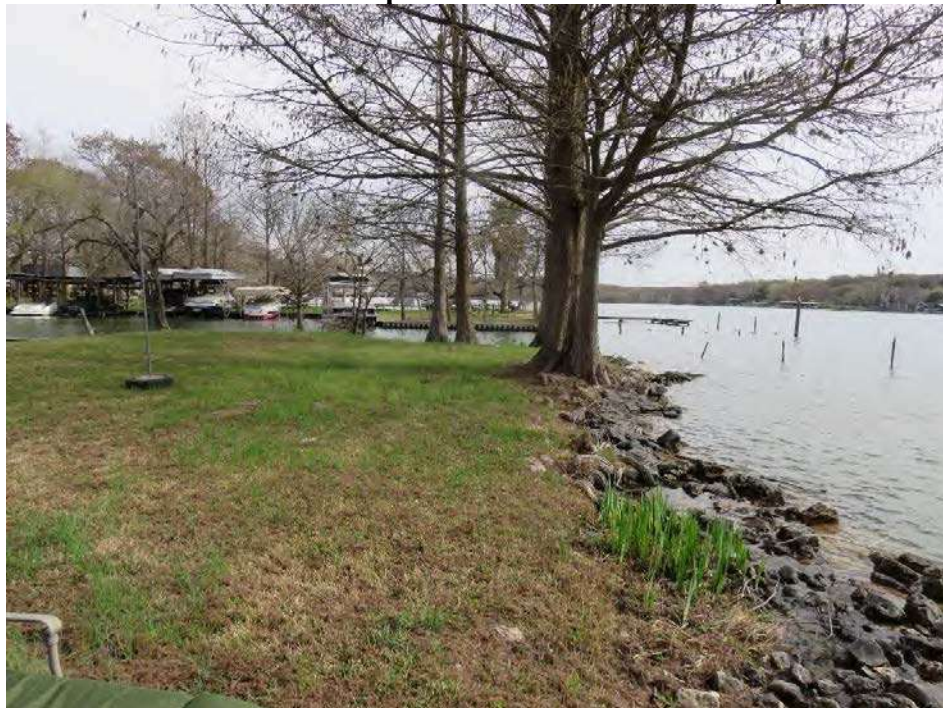
Photo 6: Photo was taken of Wetland 1 and SP01 on the southeastern portion of the property, facing northeast down the fringe wetland shoreline.

DESCO established this sample point in a fringe wetland habitat (**Wetland 1**) on the southeastern boundary of the property abutting Lake Austin. Data collected at this sample point contains hydrophytic vegetation, hydric soils, and wetland hydrology.

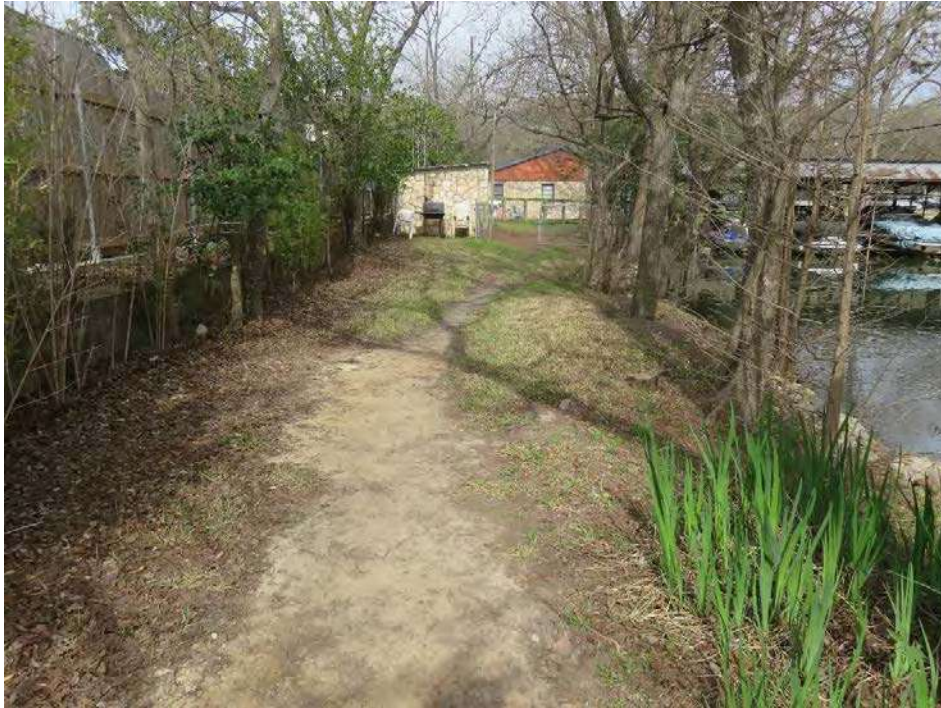
Photo 7: Photo was taken of Wetland 2 on the southeastern portion of the property, facing northwest towards Westlake Drive with fringe wetland shoreline on the right side of the photo.

Two potentially jurisdictional fringe wetlands totaling 0.015 acres and abutting Lake Austin are present within the property (**Wetland 1 and 2**). **Wetland 1** is 0.009 acres in size and **Wetland 2** is 0.006 acres in size.
