Austin Water Climate and Environmental Update

Austin Environmental Commission
February 20, 2019

**Daryl Slusher and
Mehrdad Morabbi**
Austin Water

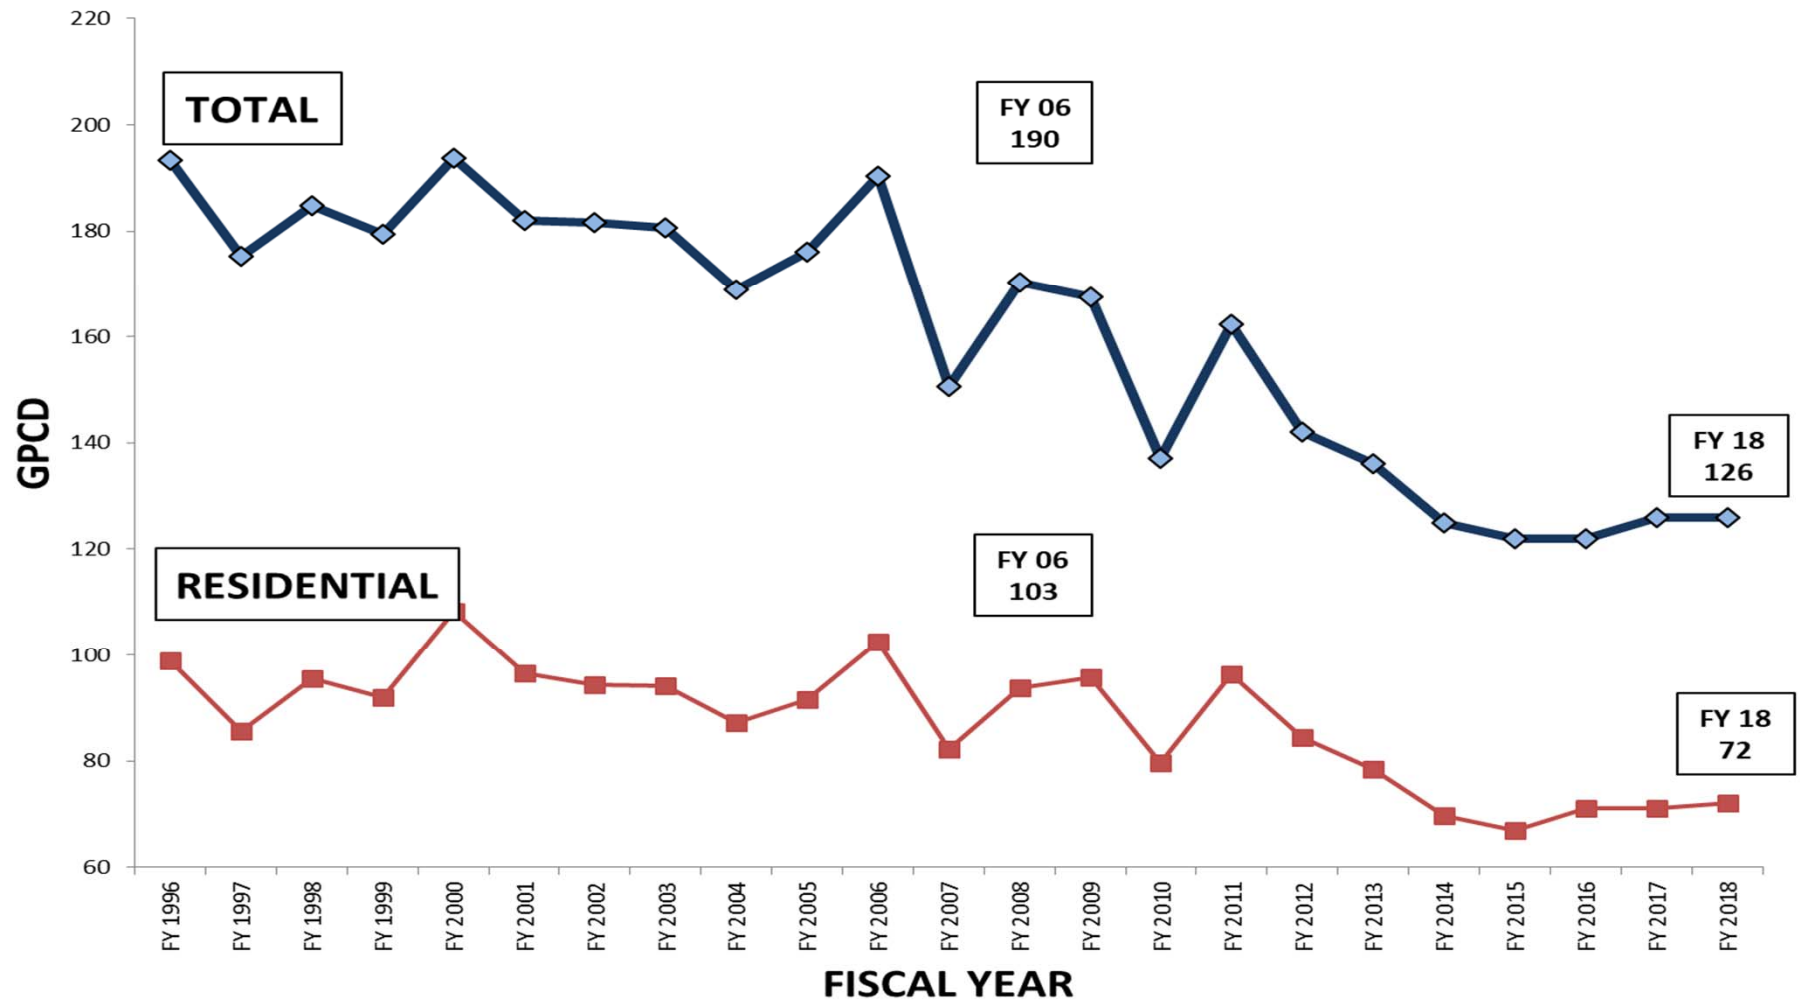
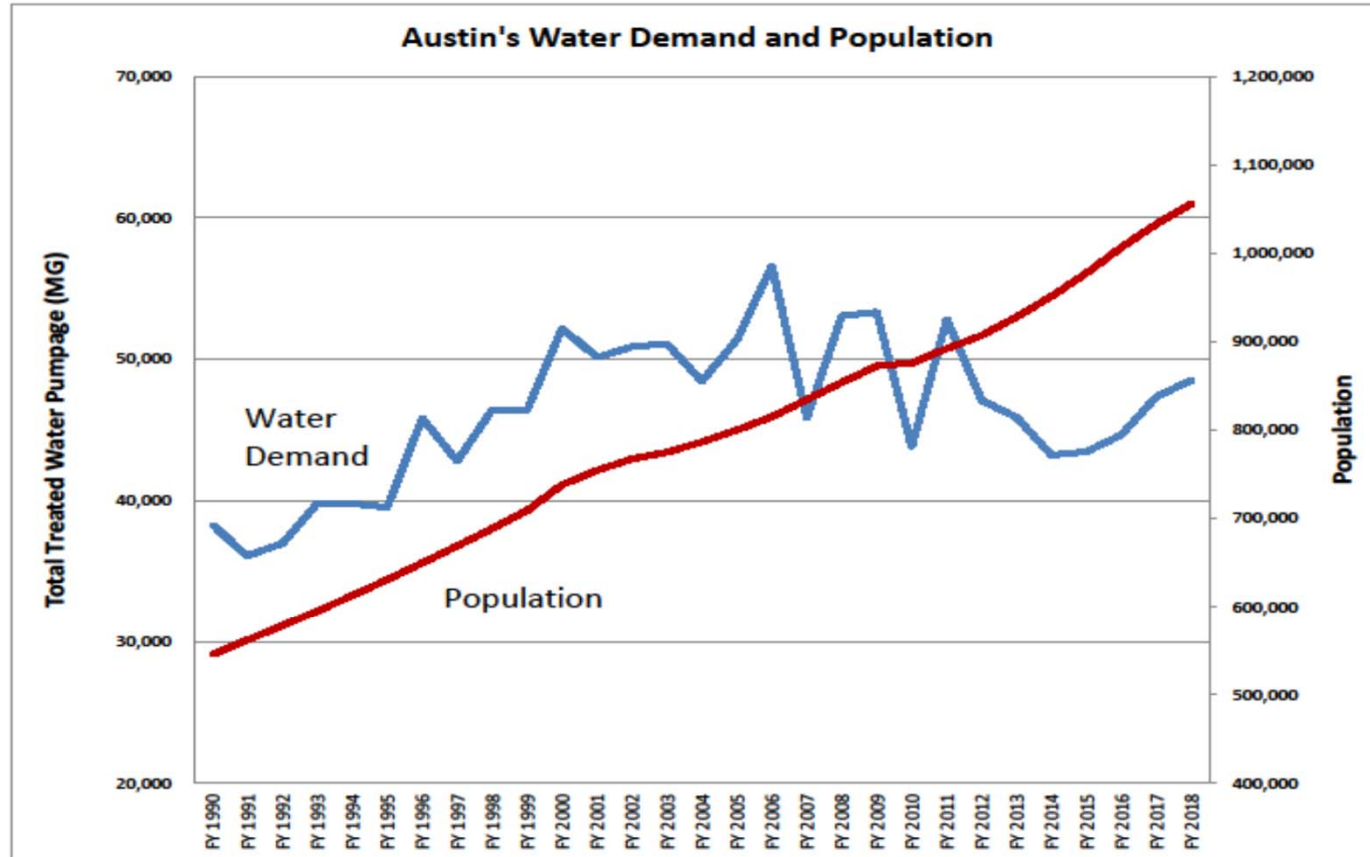
WATER USE - GALLONS PER CAPITA PER DAY (GPCD)

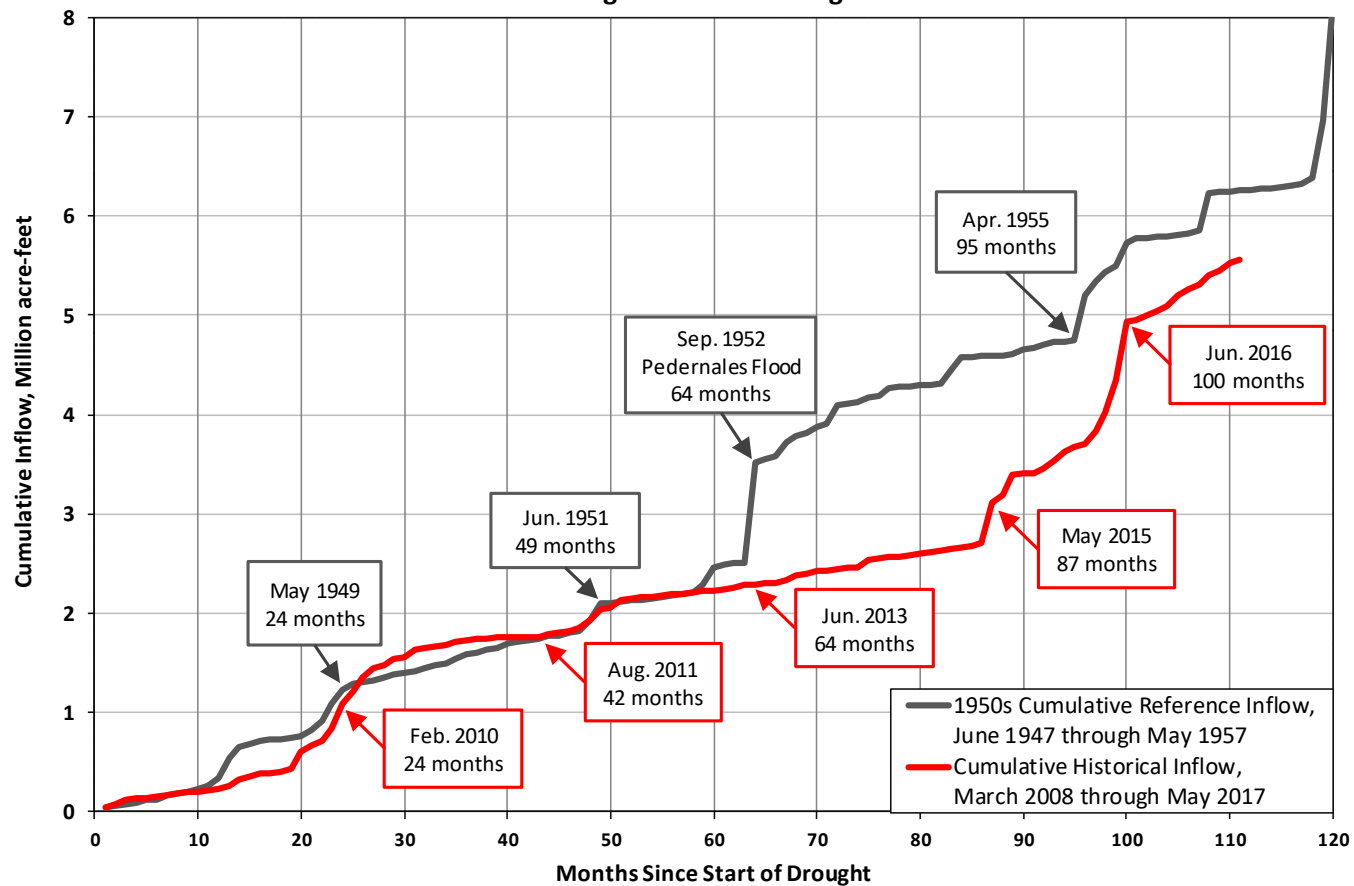
Cumulative Inflows to Lakes Buchanan and Travis 1950's Drought vs Recent Drought

Top 5 all-time lowest reservoir inflows have occurred since 2006

9 of the 12 lowest inflow years have all occurred since 1999

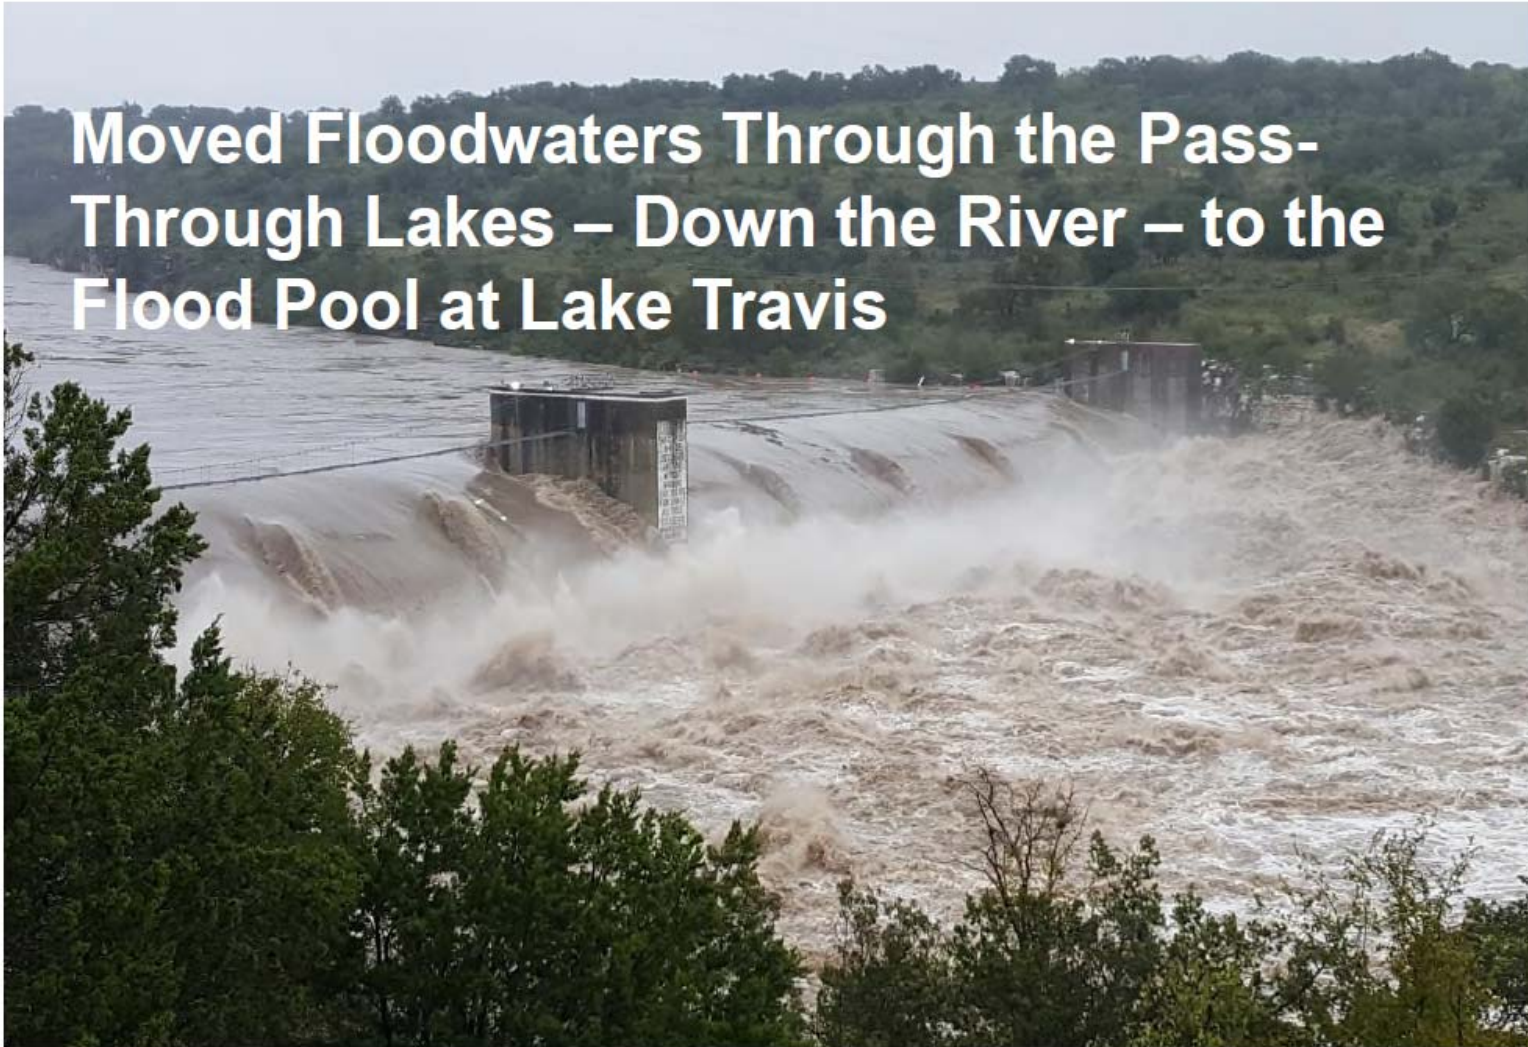
Moved Floodwaters Through the Pass-Through Lakes – Down the River – to the Flood Pool at Lake Travis

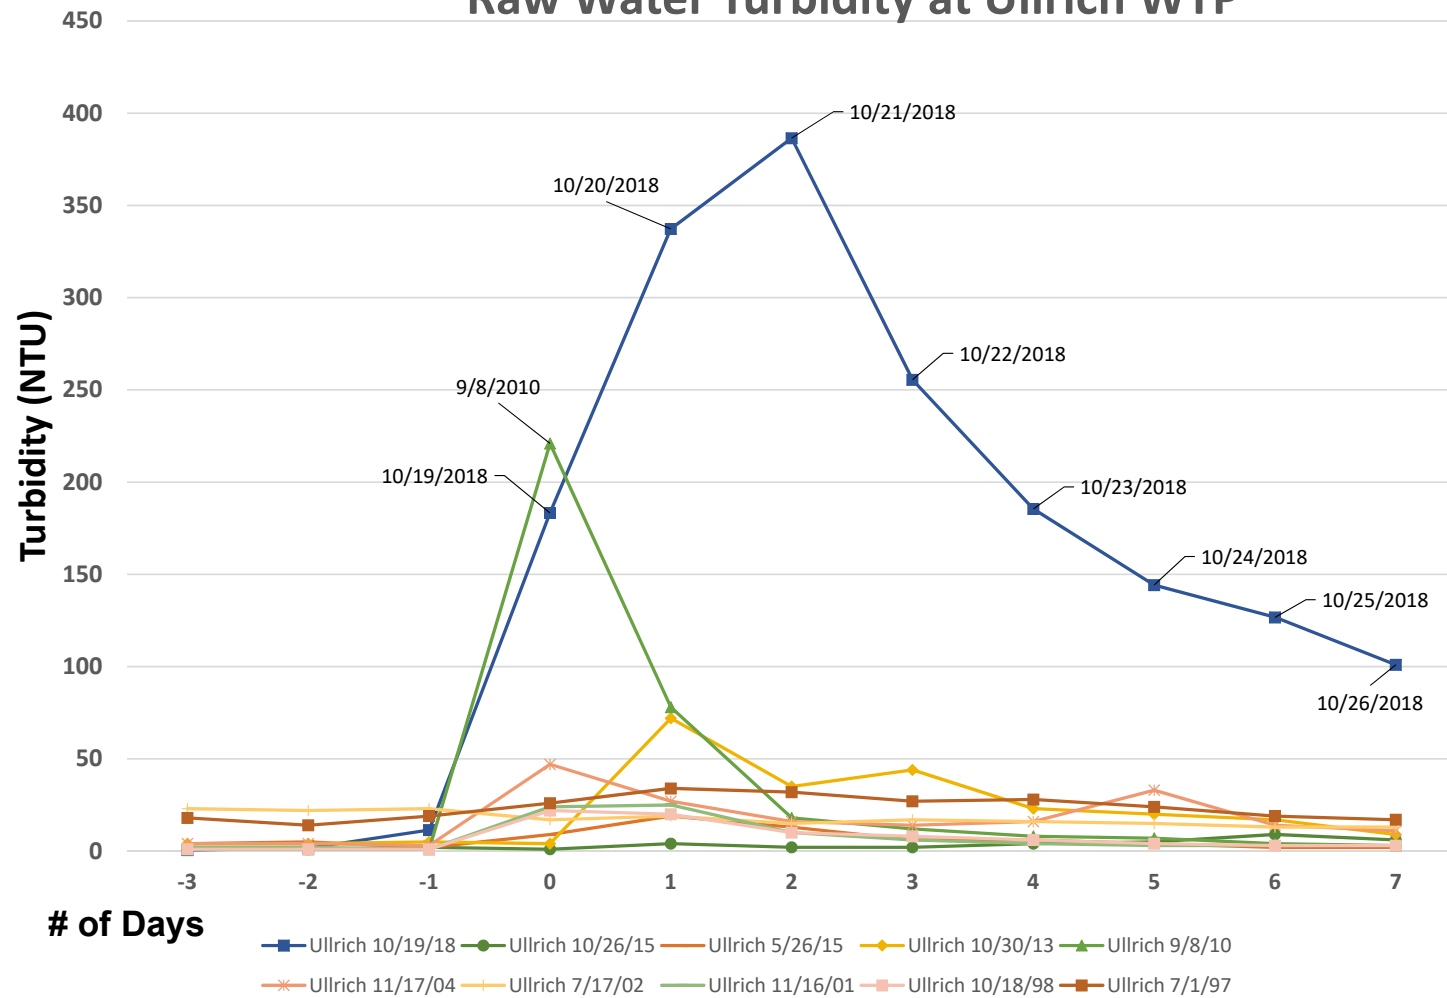
Raw Water Turbidity at Ullrich WTP

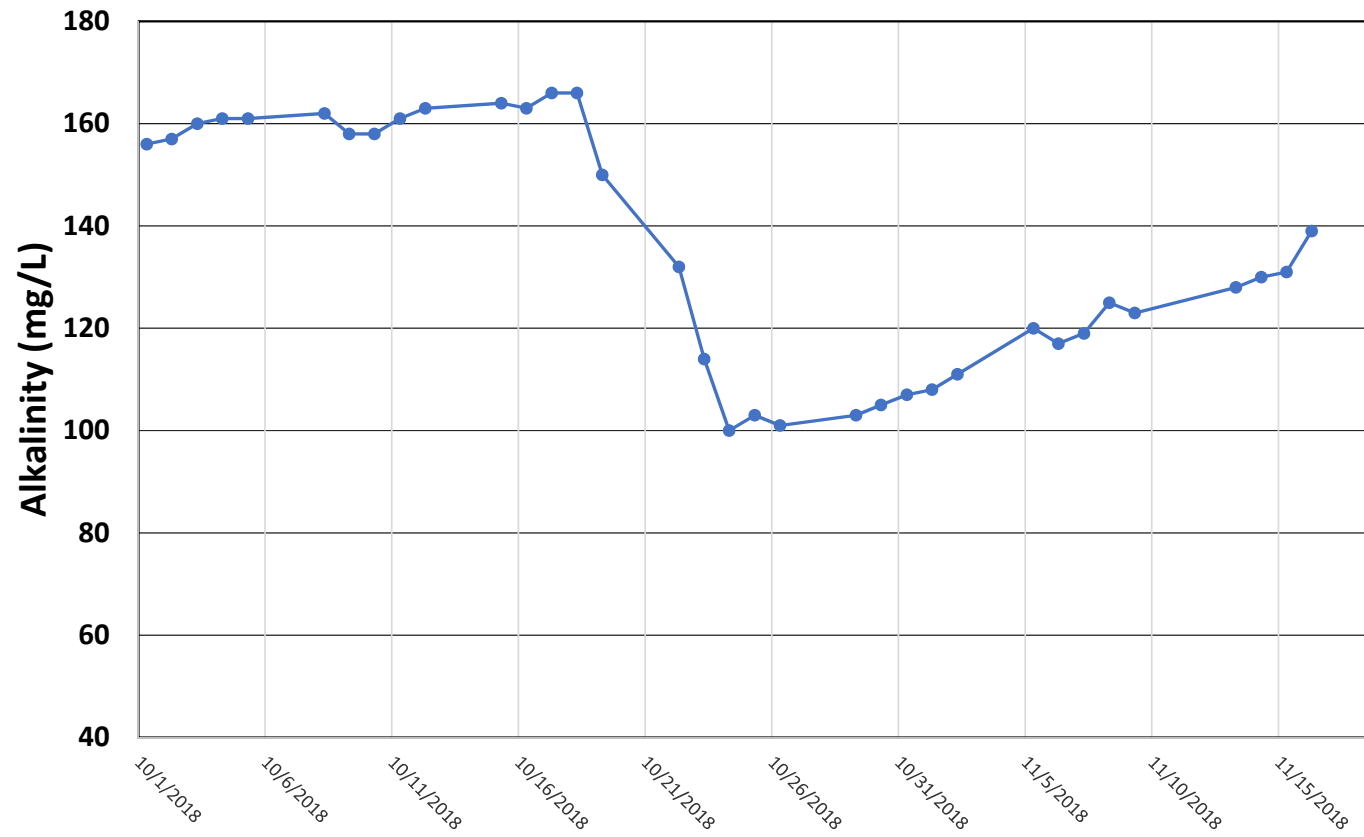
Ullrich Raw Water Alkalinity

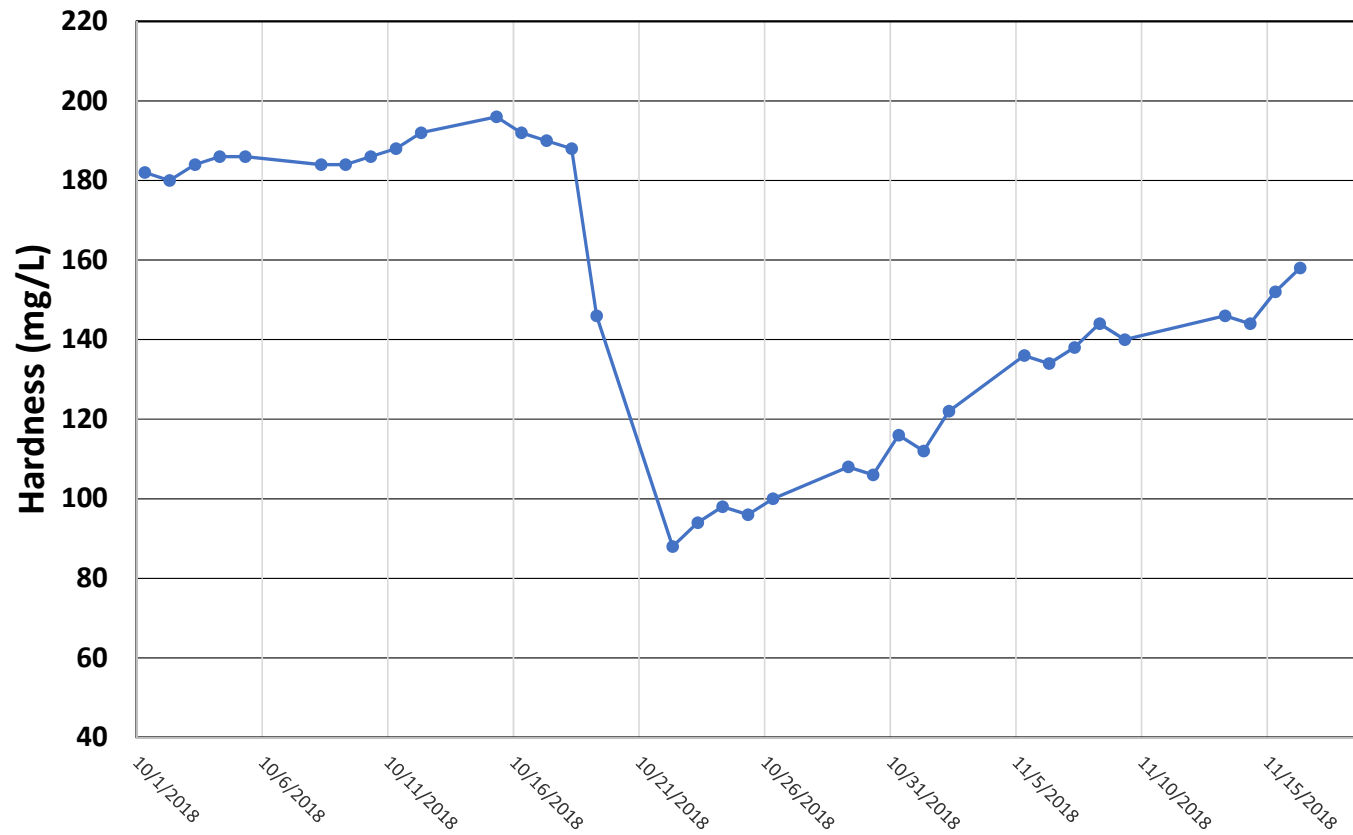
Ullrich Raw Water Hardness

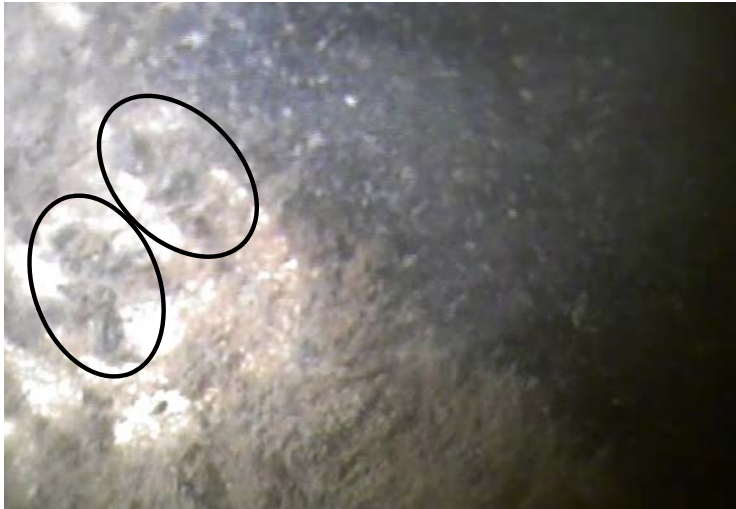
Handcox WTP Upper Intake Rim
November 28, 2017

Jun 2017	Mussels Detected in Lake Travis
Aug 2017	Lake Travis Declared Infested Mussels Detected in Lake Austin
Sep 2017	Initial Presentation to W&WW Commission http://www.austintexas.gov/edims/document.cfm?id=283697
Nov 2017	Inspected All Intakes No Mussels at Ullrich or Davis WTPs Few Mussels on the Upper Screen of Handcox WTP

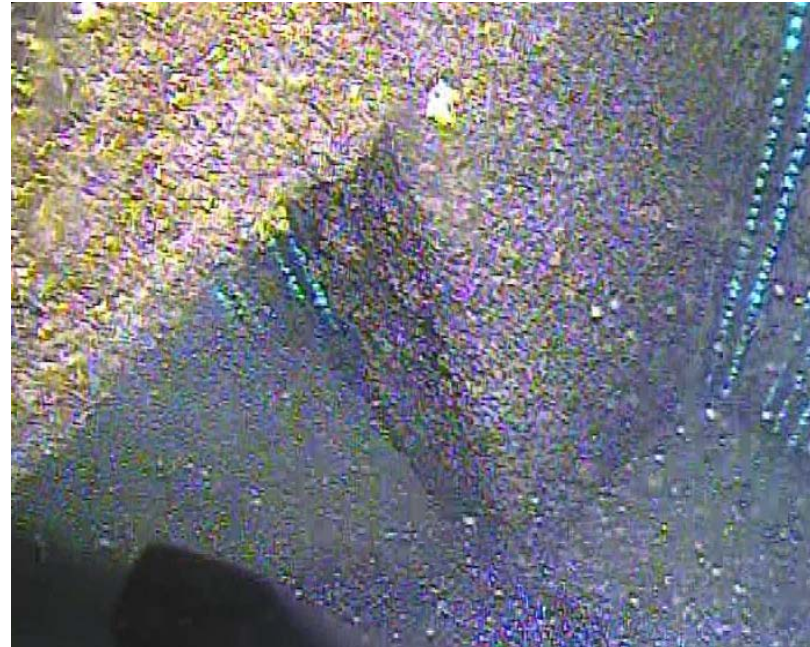
Handcox WTP Upper Intake Screen
September 2018

Feb 2018	Lake Austin Declared Infested
Mar 2018	Issued NTP to Black & Veatch to Investigate Zebra Mussels Mitigation Techniques
May 2018	Contract With Underwater Construction Corporation to Inspect & Clean All Intakes
Oct 2018	Stakeholder Workshop With B&V Boil Water Notice
Sep 2018	Handcox WTP Top Intake Screen 100% Covered

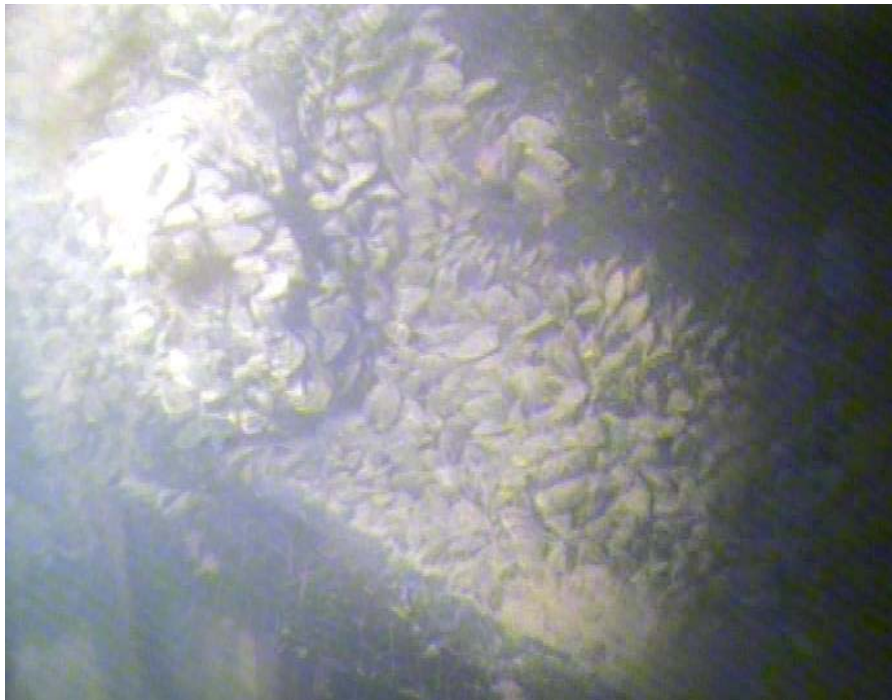
Ullrich WTP Pump Isolation Gate
January 7, 2019

Discovered Mussels in the Ullrich Raw Water Pipeline

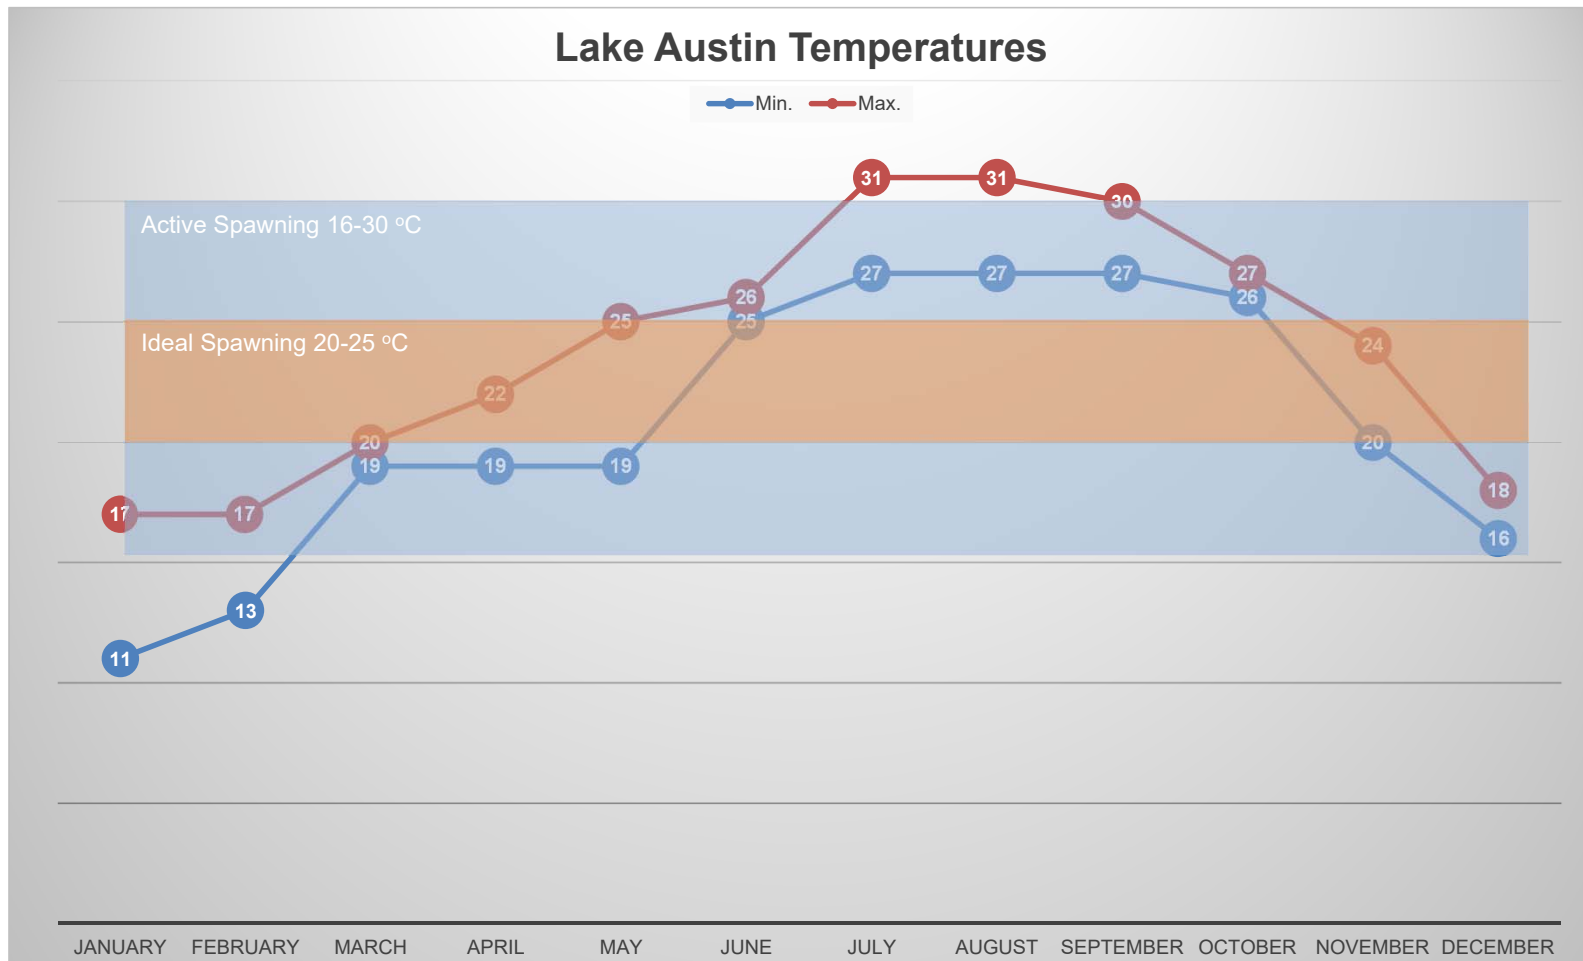
Spawning Temperatures

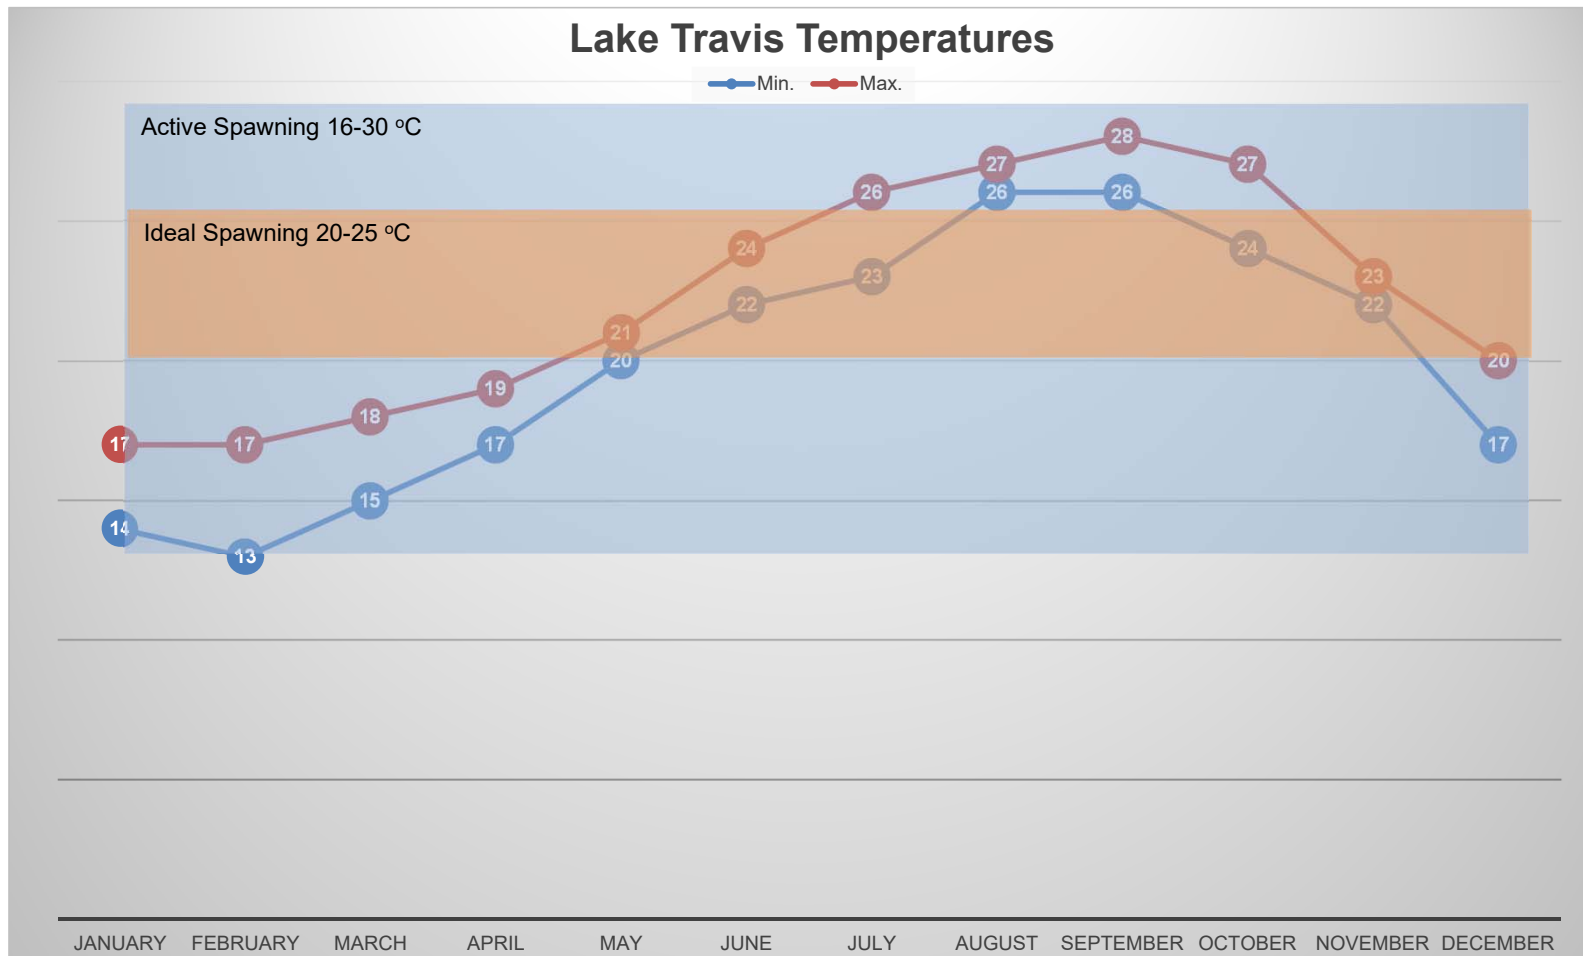
Spawning Temperatures

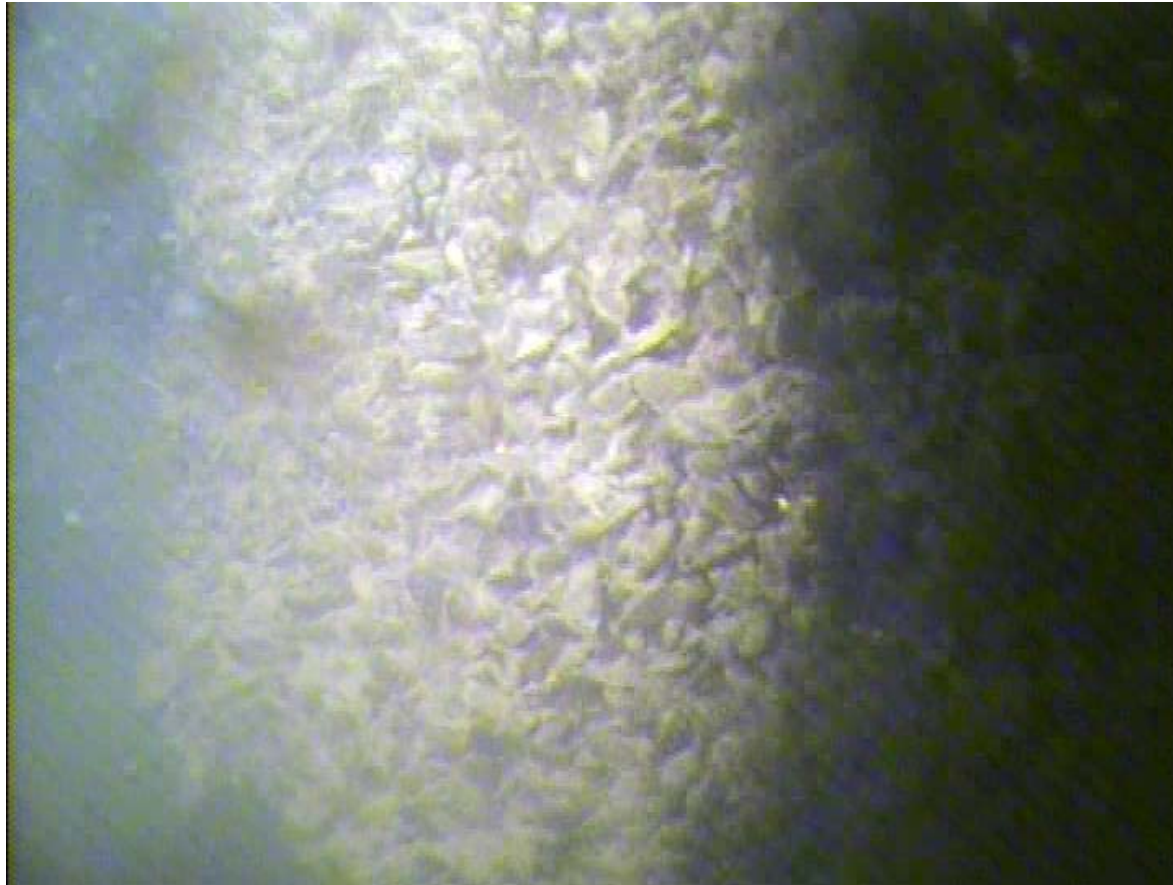
Davis WTP Pump Casing
January 7, 2019

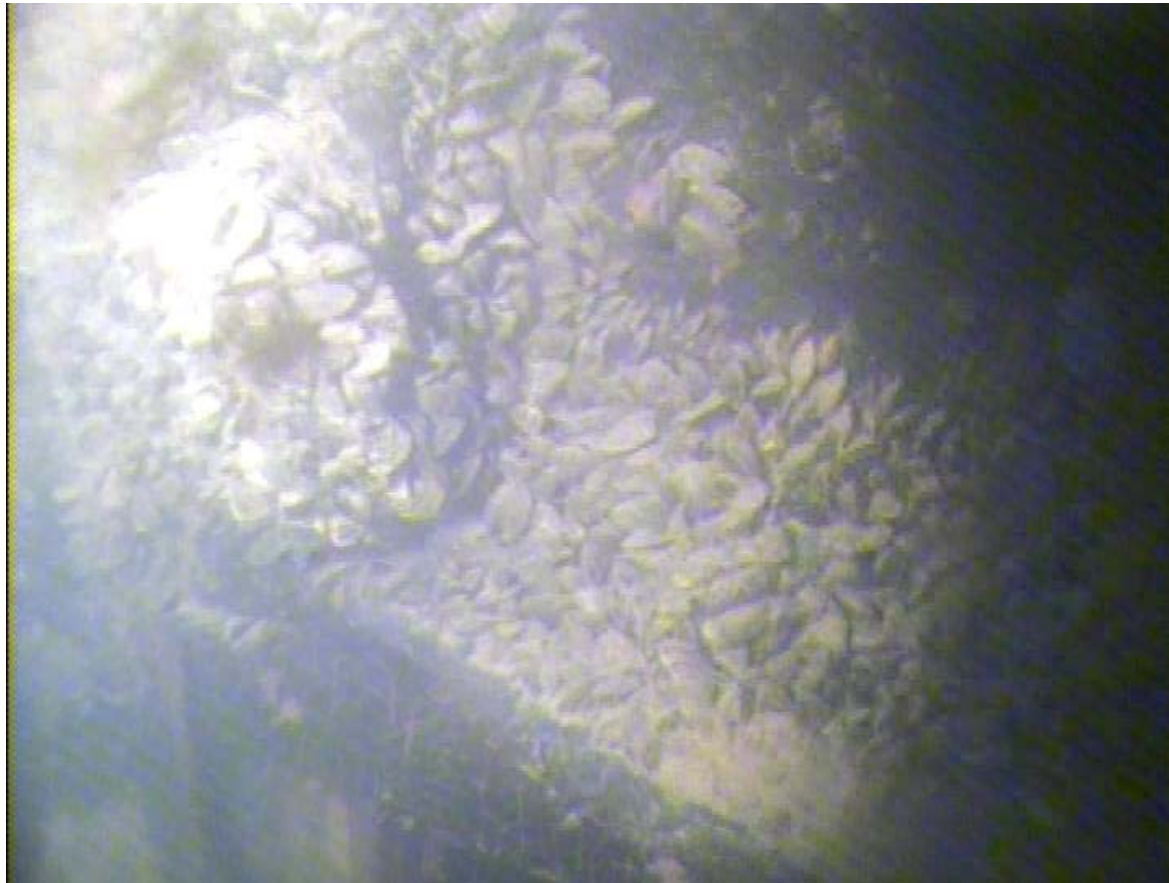
Ullrich WTP Pump Isolation Gate
January 7, 2019

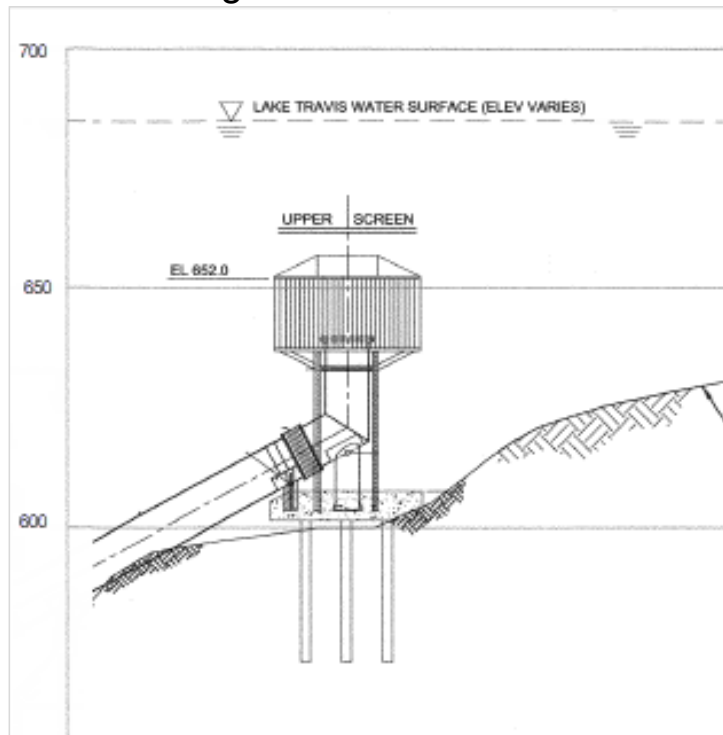
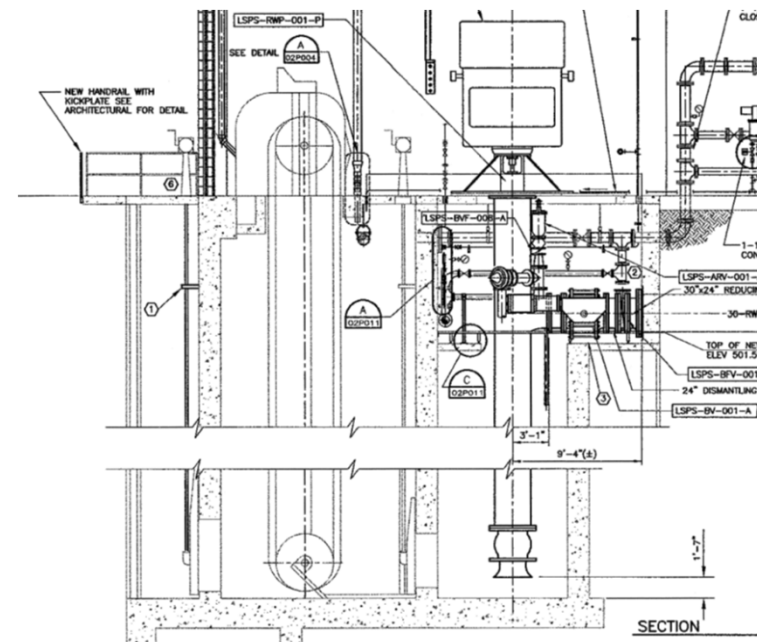
Intake Cleaning & Inspection

- Targeted Service every 3-6 months
 - Davis WTP
 - Ullrich WTP
 - Handcox WTP
 - Emma Long WTP
 - River Place Intake
 - Longhorn Dam
