Country Club Creek West at Roy G Guerrero Park

*Environmental Commission
May 1, 2018*

Janna Renfro
Engineer
Watershed Protection Department

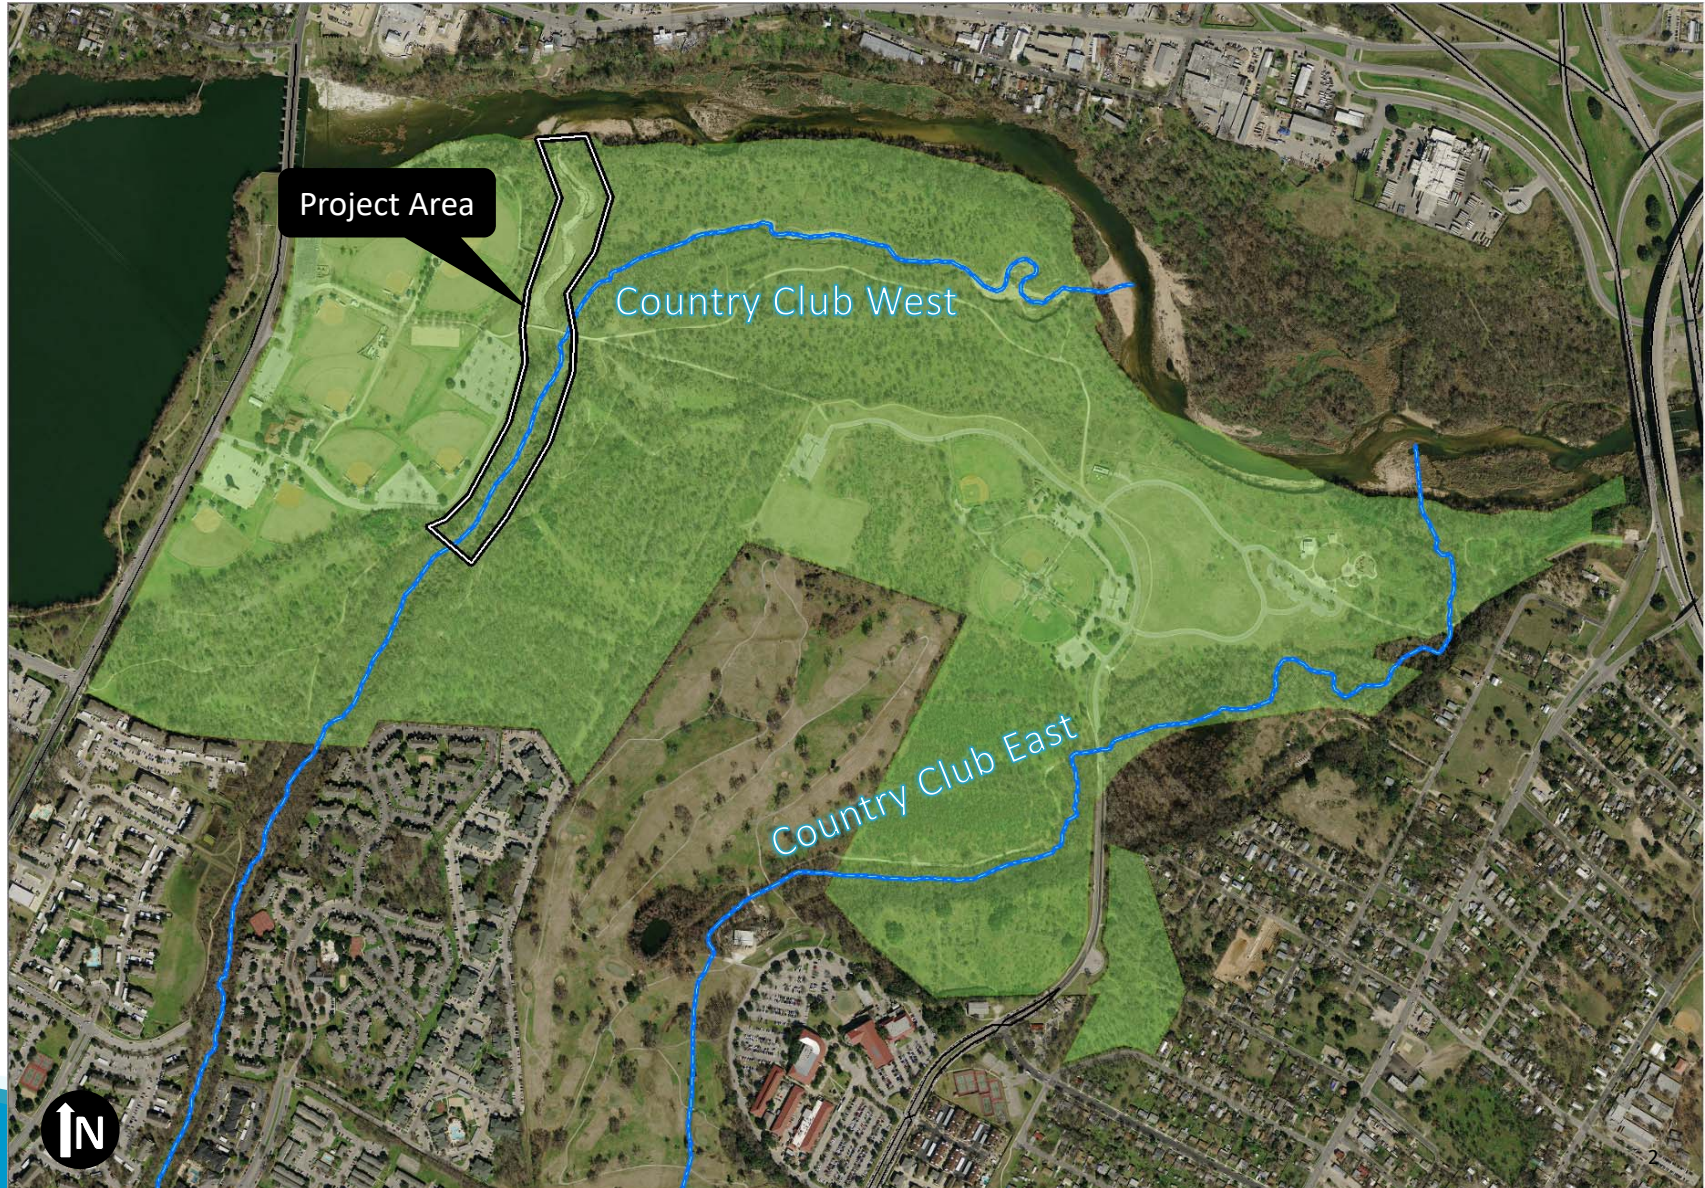
Erosion Damage

- 2015 Floods
- Severe erosion created a shorter path to the river.
- Pedestrian bridge collapsed
- May 2015 - December 2017: Erosion damaged ~1500 feet (5 acres) of drainage channel
- 100s of trees lost
- 2500 dump truck loads of sand and soil (~37,000 cubic yards)

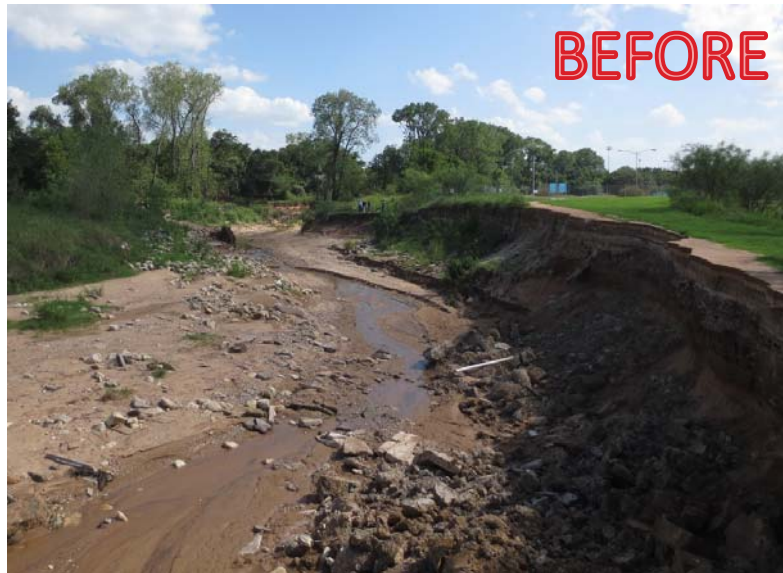
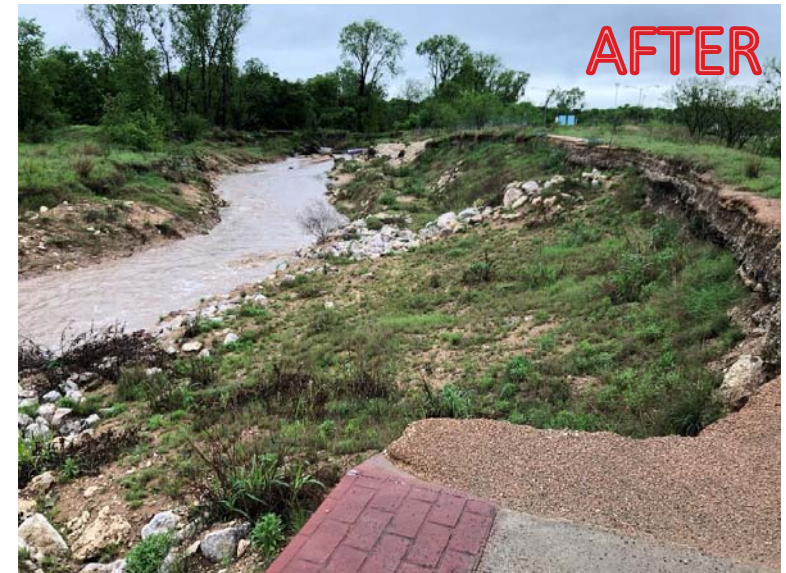
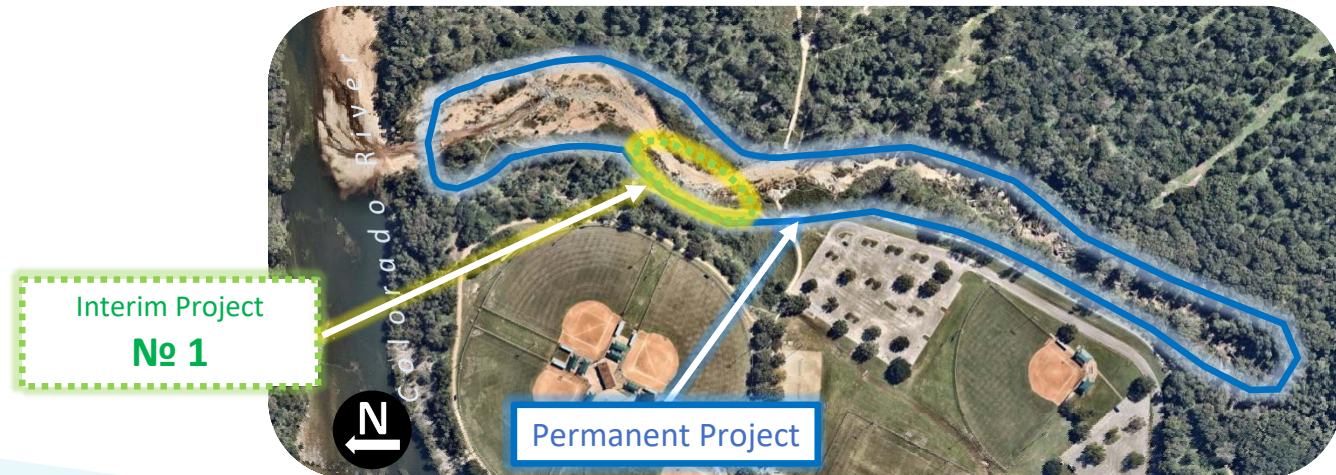
Temporary Repairs

- Project No. 1
- 2017
- Stabilized bank near ballfields

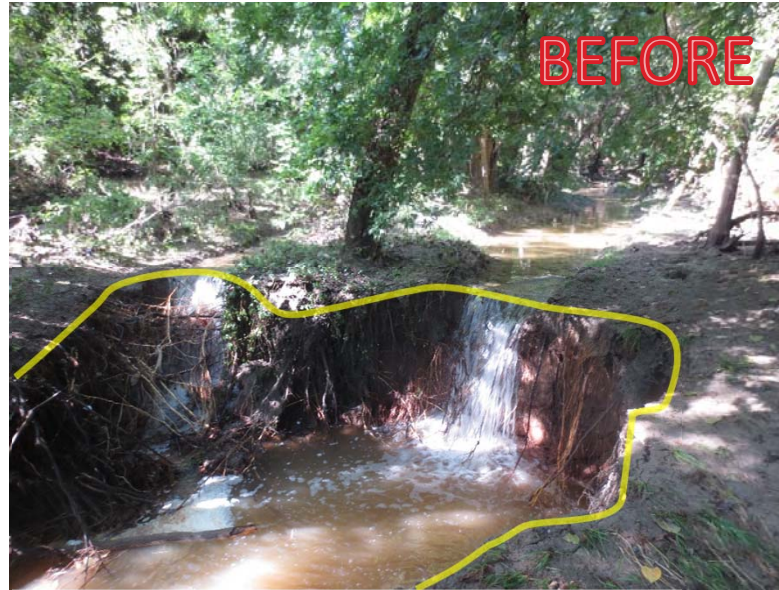
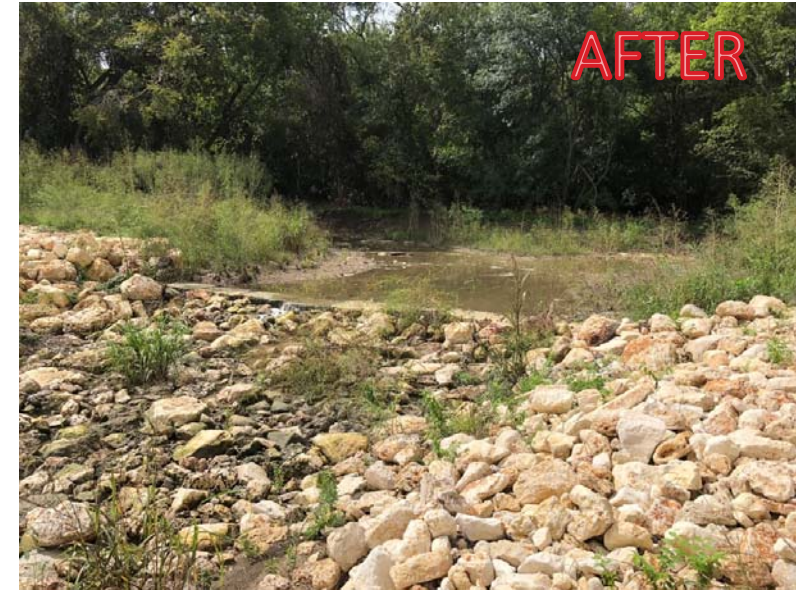
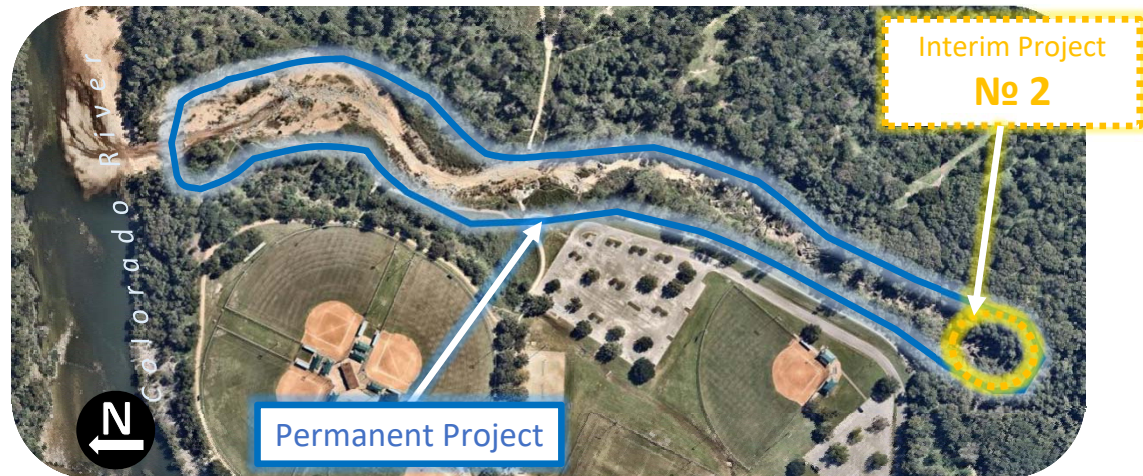
Temporary Repairs

- Project No. 2:
- 2018
- Stabilized headcut

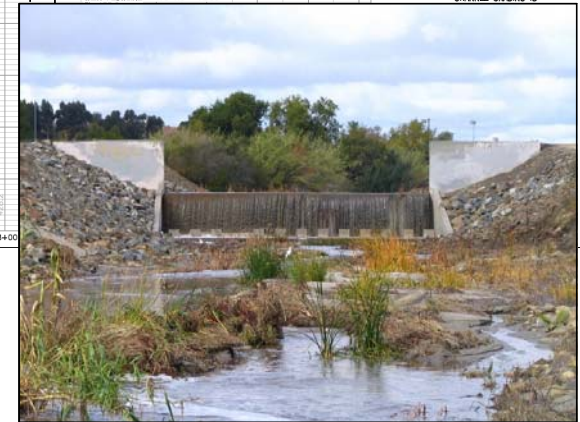
Permanent Solution

- ~2,000 linear feet of channel stabilization
- Three concrete “drop structures”
- Natural channel between structures
- Bridge over middle structure above 500-year flood elevation

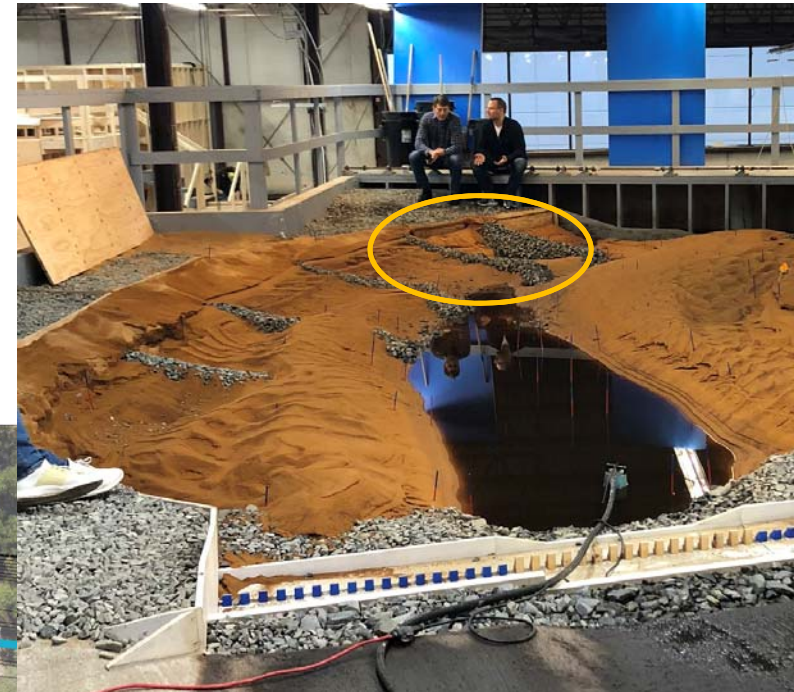
Model Findings

- 💧 Revise channel alignment
- 💧 Maximize width
- 💧 Structure modifications

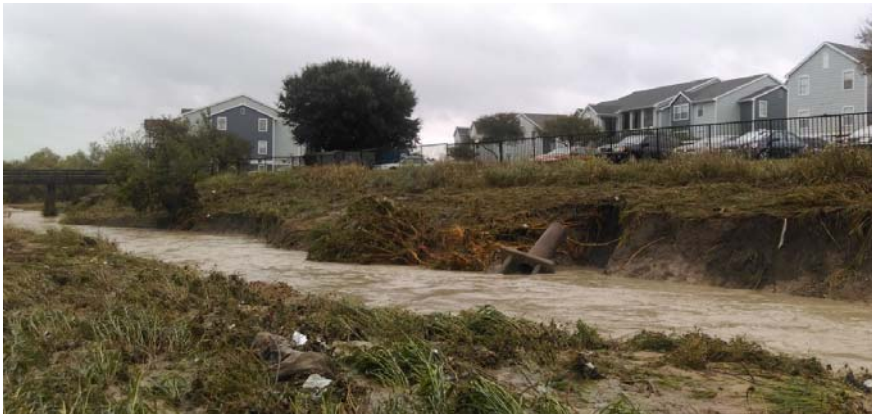
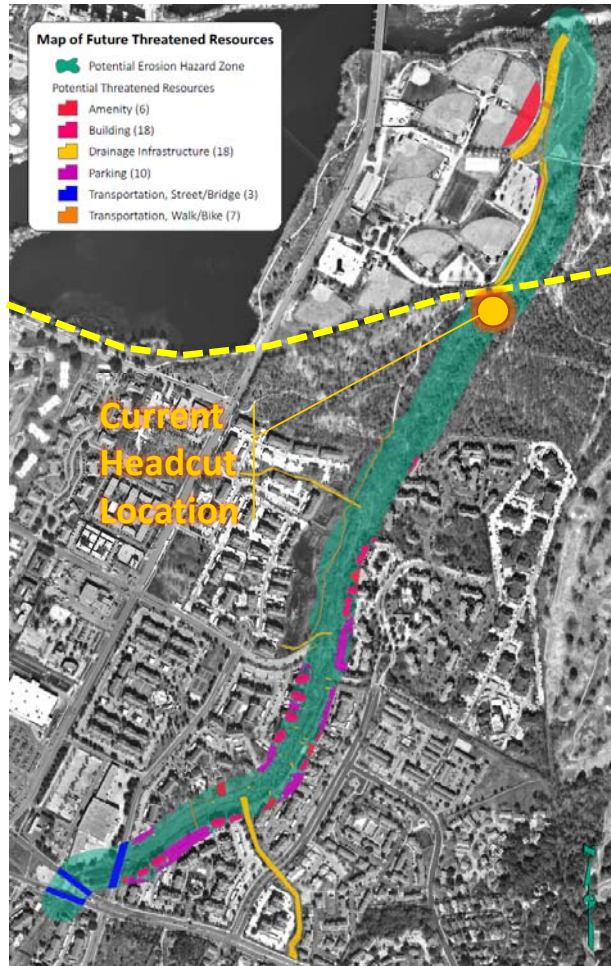
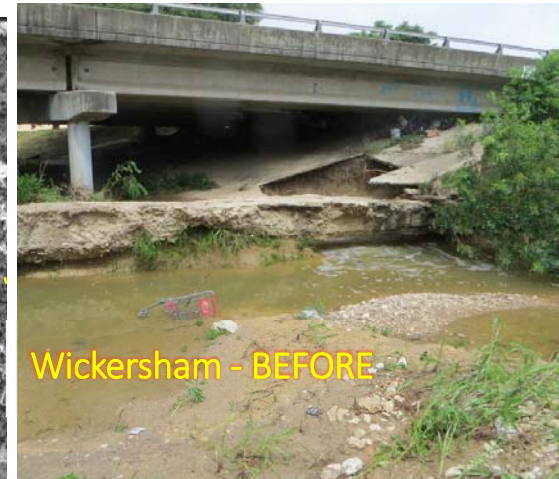
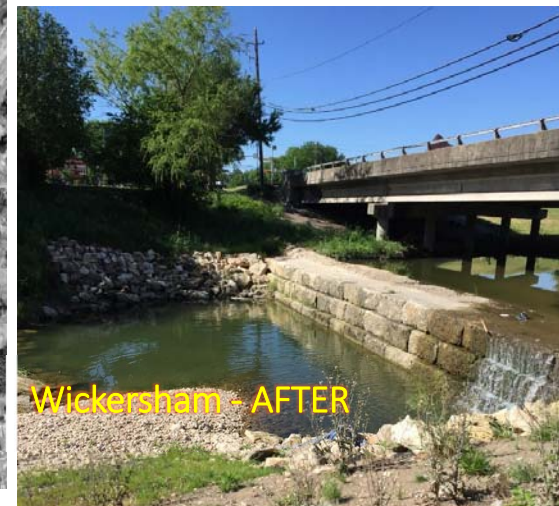
Do nothing?

- Headcut will continue to move upstream.
- High confidence of threats upstream
- Increasingly expensive project
