City Of Austin Historic Landmark  
Commission

NRD-2019-0033 3206 GLENVIEW AVENUE

Construct a second-story addition to a one-story  
contributing house

WORKSHOP

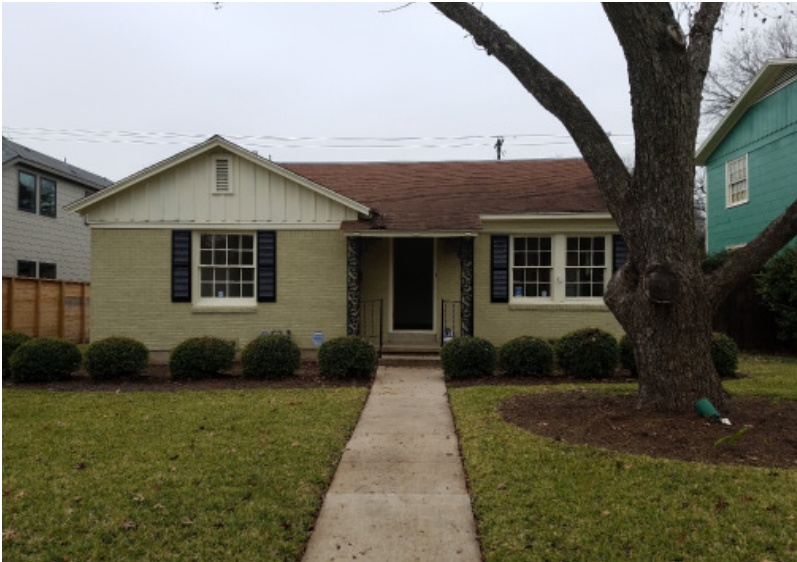
FRONT OF RESIDENCE

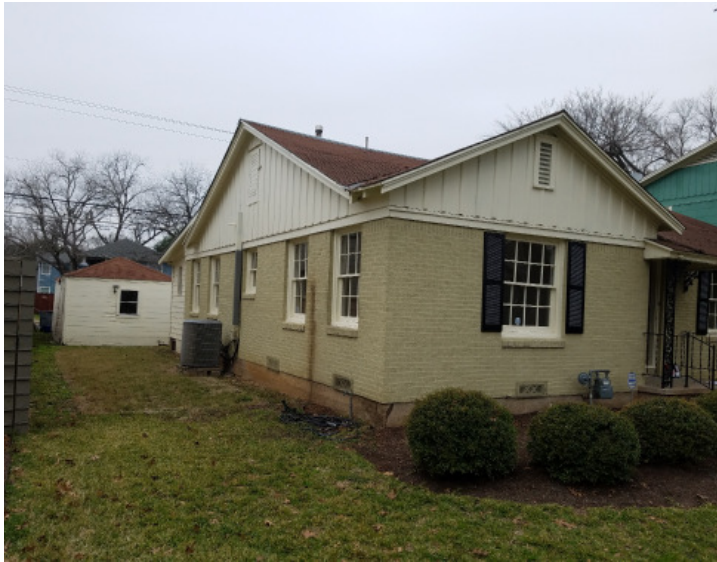
LEFT SIDE OF RESIDENCE

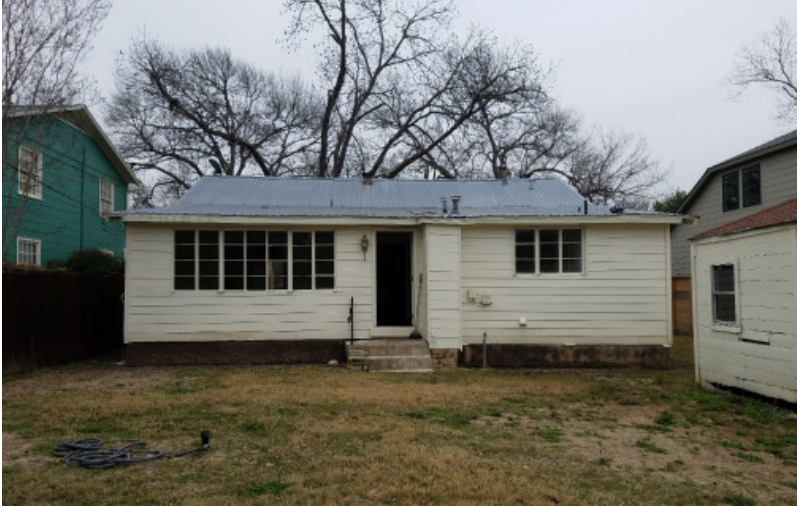
REAR OF RESIDENCE

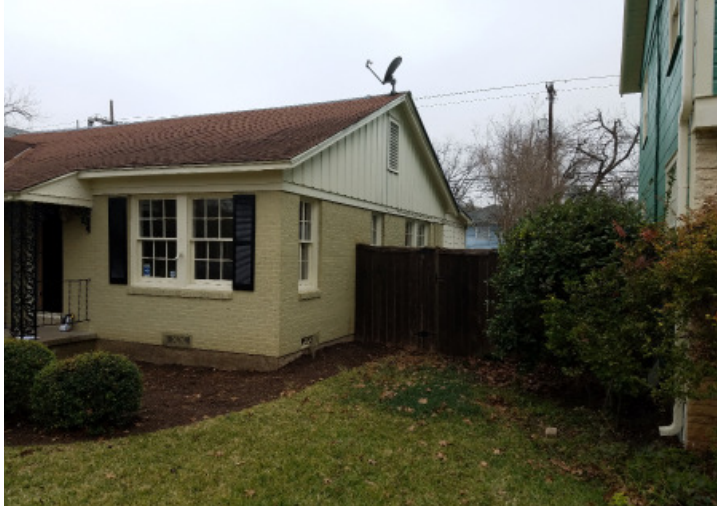
RIGHT SIDE OF RESIDENCE

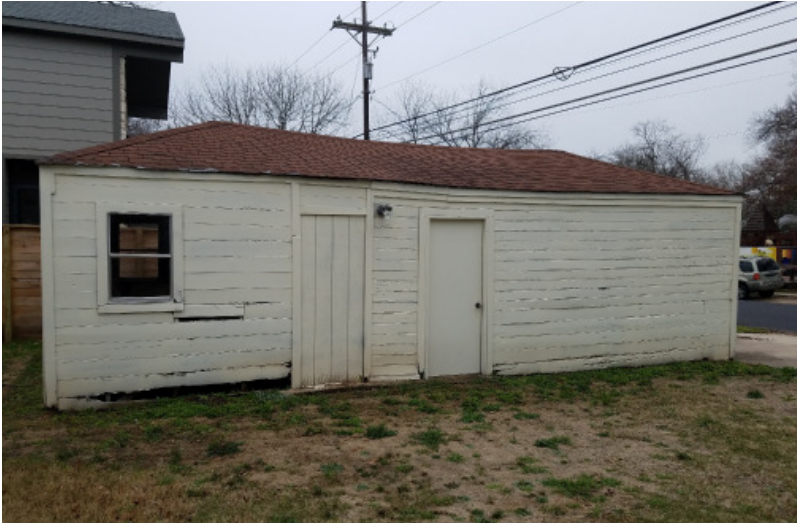
SIDE OF GARAGE

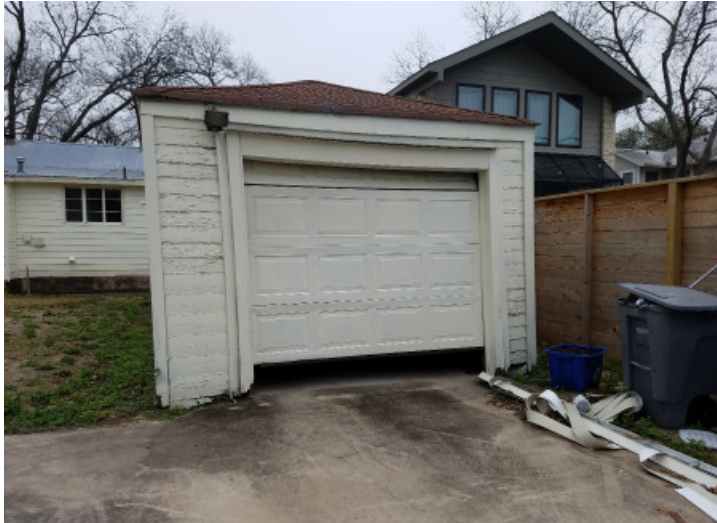
FRONT OF GARAGE

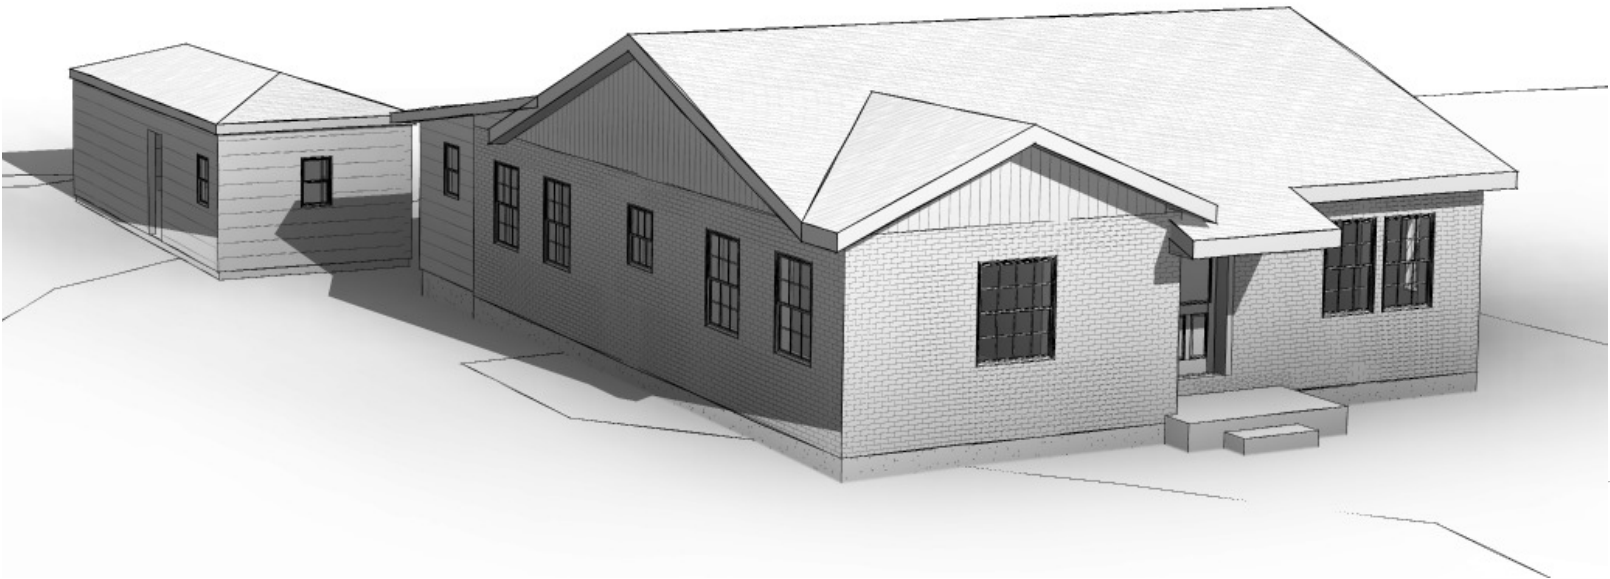
EXISTING RESIDENCE ISSUES/ CONCERNS

- 1. FOUNDATION IN POOR CONDITION
- 2. REAR ADDITION SHOWING EVIDENCE OF ACTIVE WOOD DESTROYING INSECTS
- 3. WATER LEAKS IN ROOF
- 4. WINDOWS IN POOR CONDITION WITH WATER INFILTRATION
- 5. ORGANIC GROWTH UNDER VANITY IN BATH 2
- 6. SUN ROOM FLOORING CONTAINS ASBESTOS
- 7. WOOD ROT

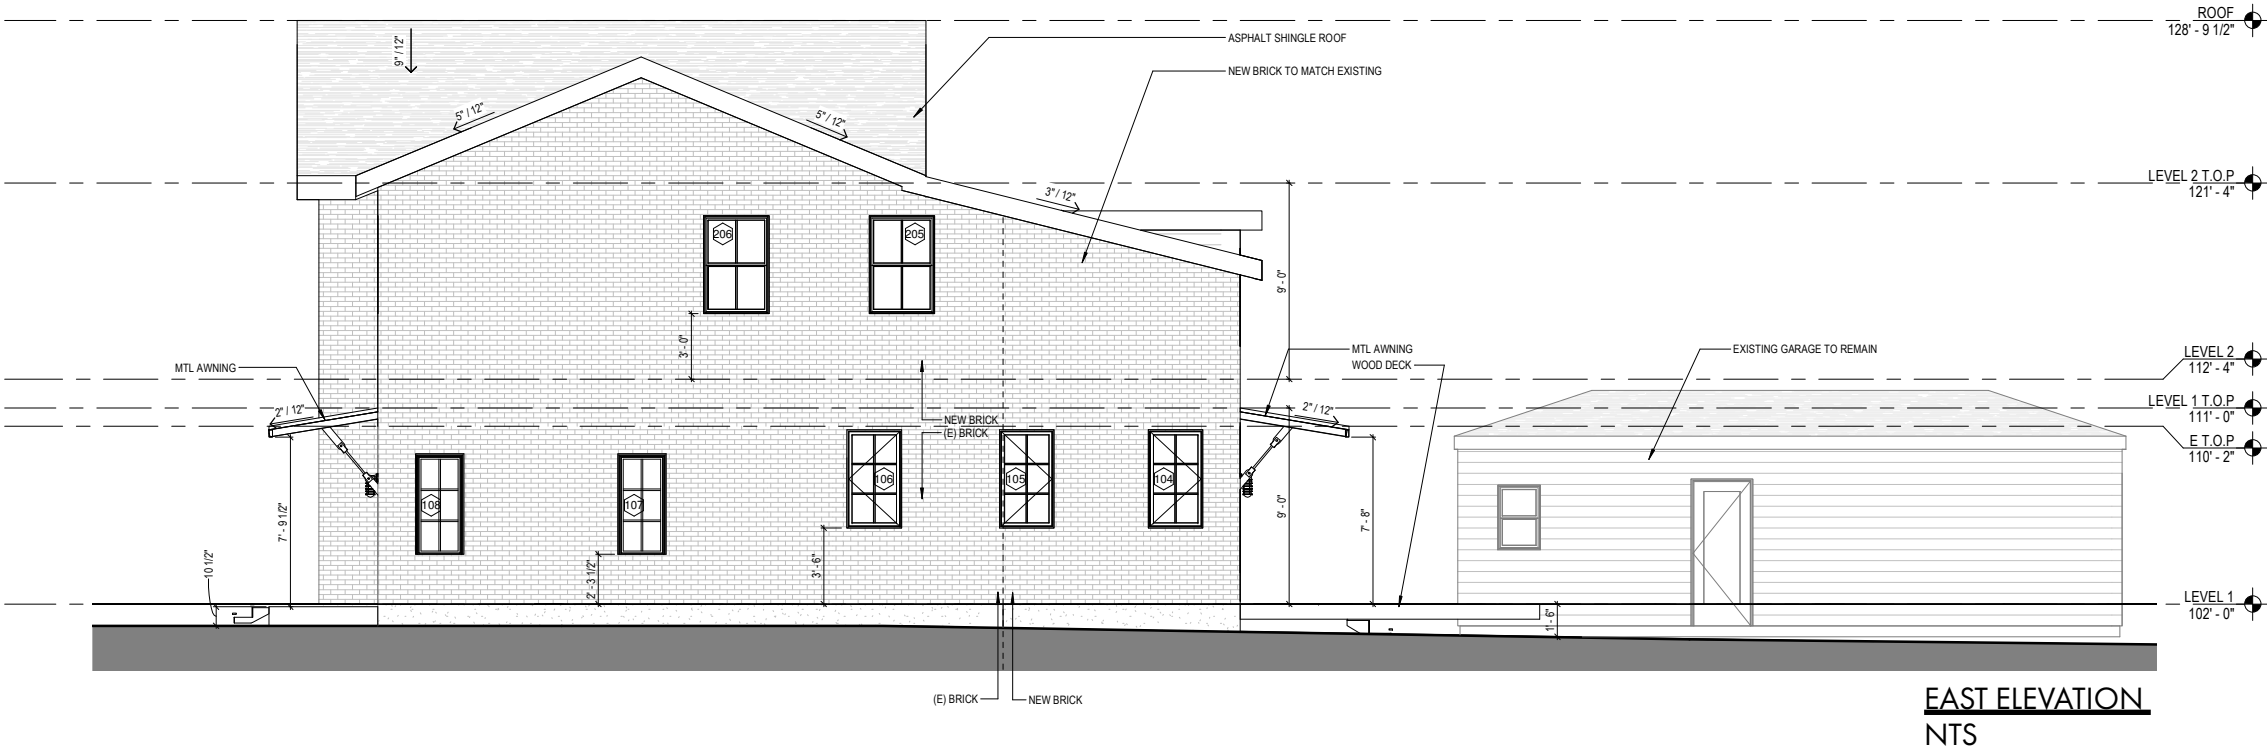
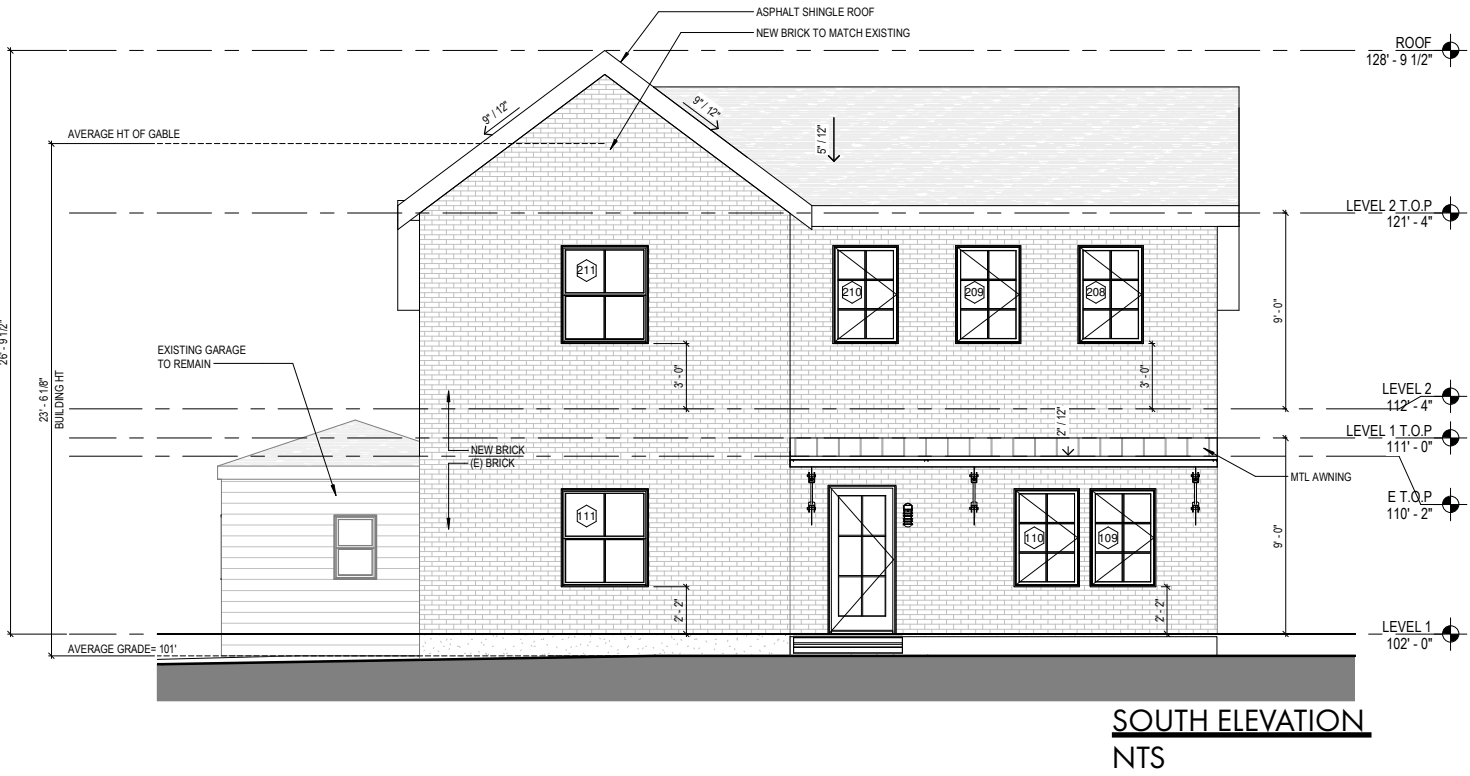
PROPOSED ELEVATIONS SUBMITTED FOR PERMIT

BRICK FACADE ON ALL FOUR ELEVATIONS. EXISTING BRICK TO REMAIN AND NEW BRICK TO MATCH EXISTING BRICK SIZE AND COLOR

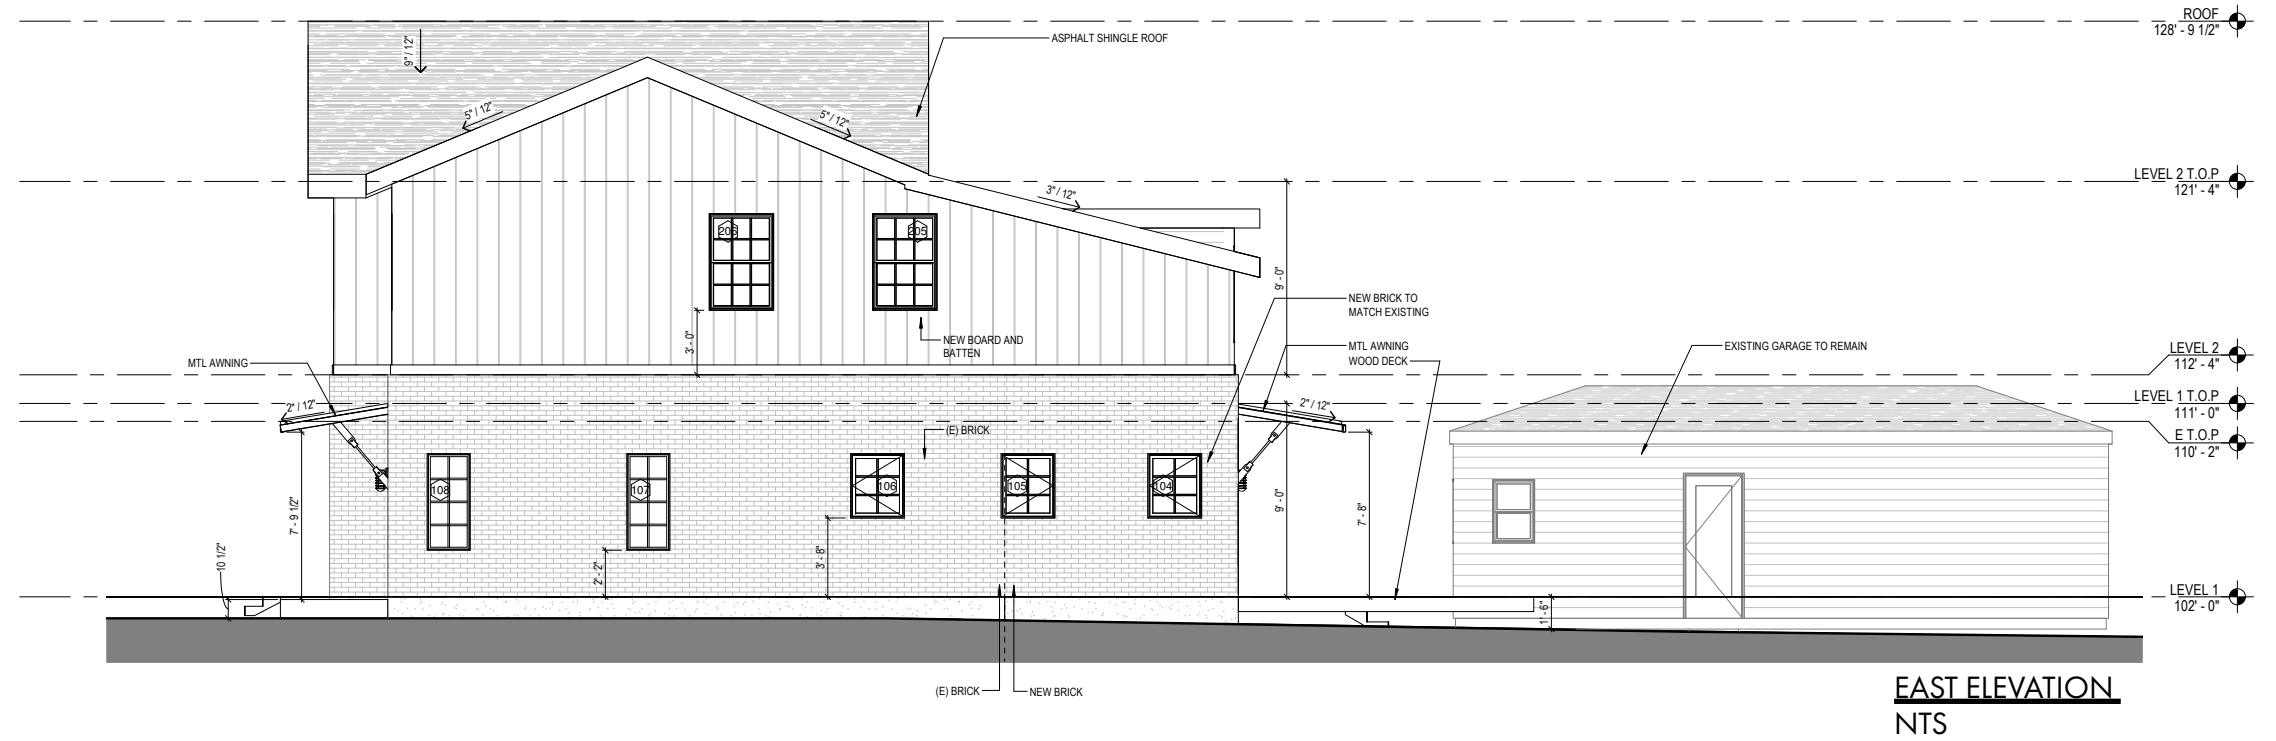
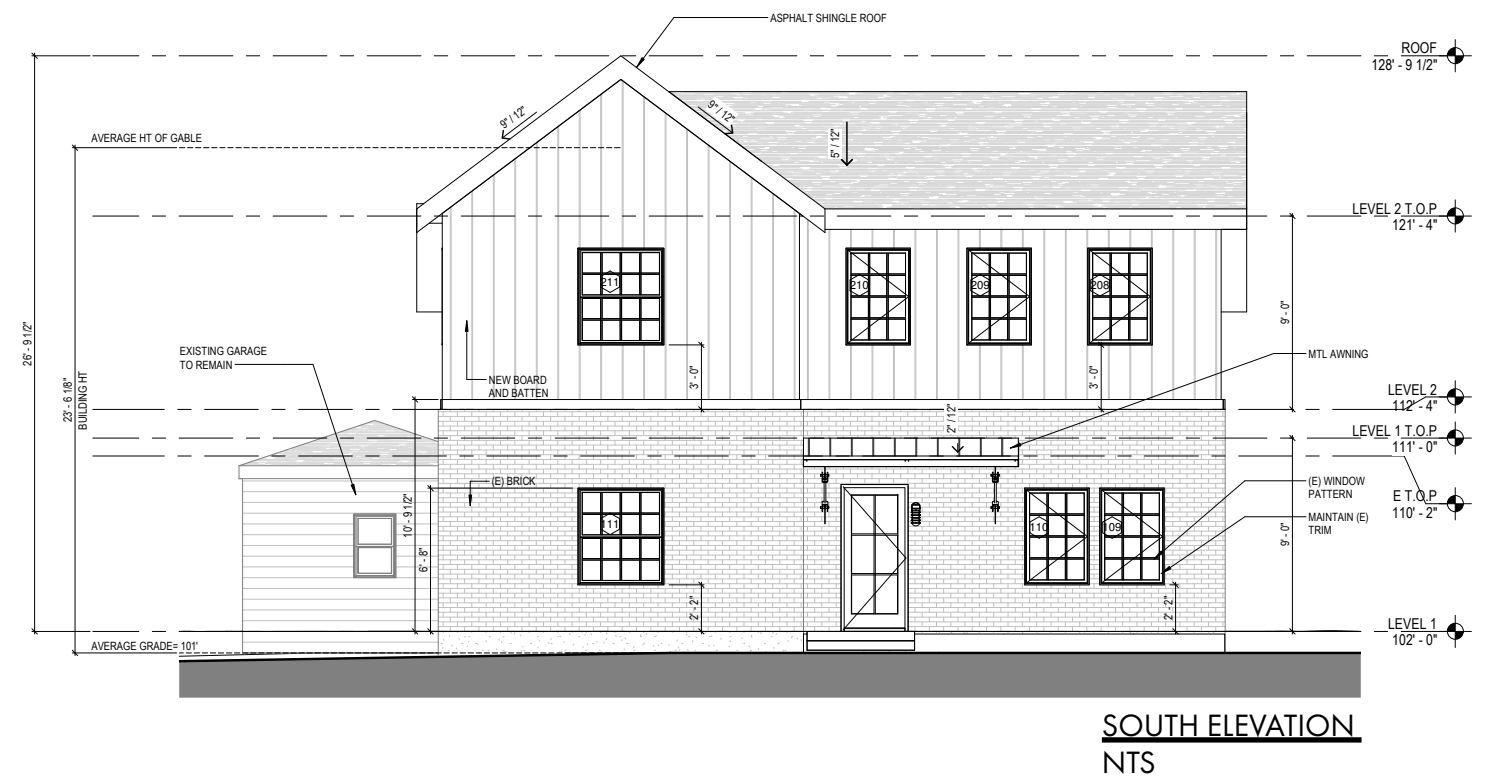
# PROPOSED ELEVATIONS WITH DELINEATION

BRICK FACADE ON ALL FOUR ELEVATIONS ON FIRST LEVEL ONLY . EXISTING BRICK TO REMAIN, AND SECOND FLOOR TO BE BOARD AND BATTEN WITH A TRIM PIECE CLEARLY DELINEATING BETWEEN THE ORIGINAL AND THE NEW.
