### **ITEM FOR ENVIRONMENTAL COMMISSION AGENDA**

**NAME & NUMBER OF  
PROJECT:** Albert H. Ullrich Water Treatment Plant  
SPC-03-0005C(R1)

**REQUEST:** Variance request is as follows:  
Request to vary from LDC 25-8-281(C)(2)(b) to allow the construction  
within 150-foot Critical Environmental Feature (CEF) buffer for a Rimrock  
CEF.

CITY OF AUSTIN  
ZEBRA MUSSEL MITIGATION TECHNIQUES  
ULLRICH WTP

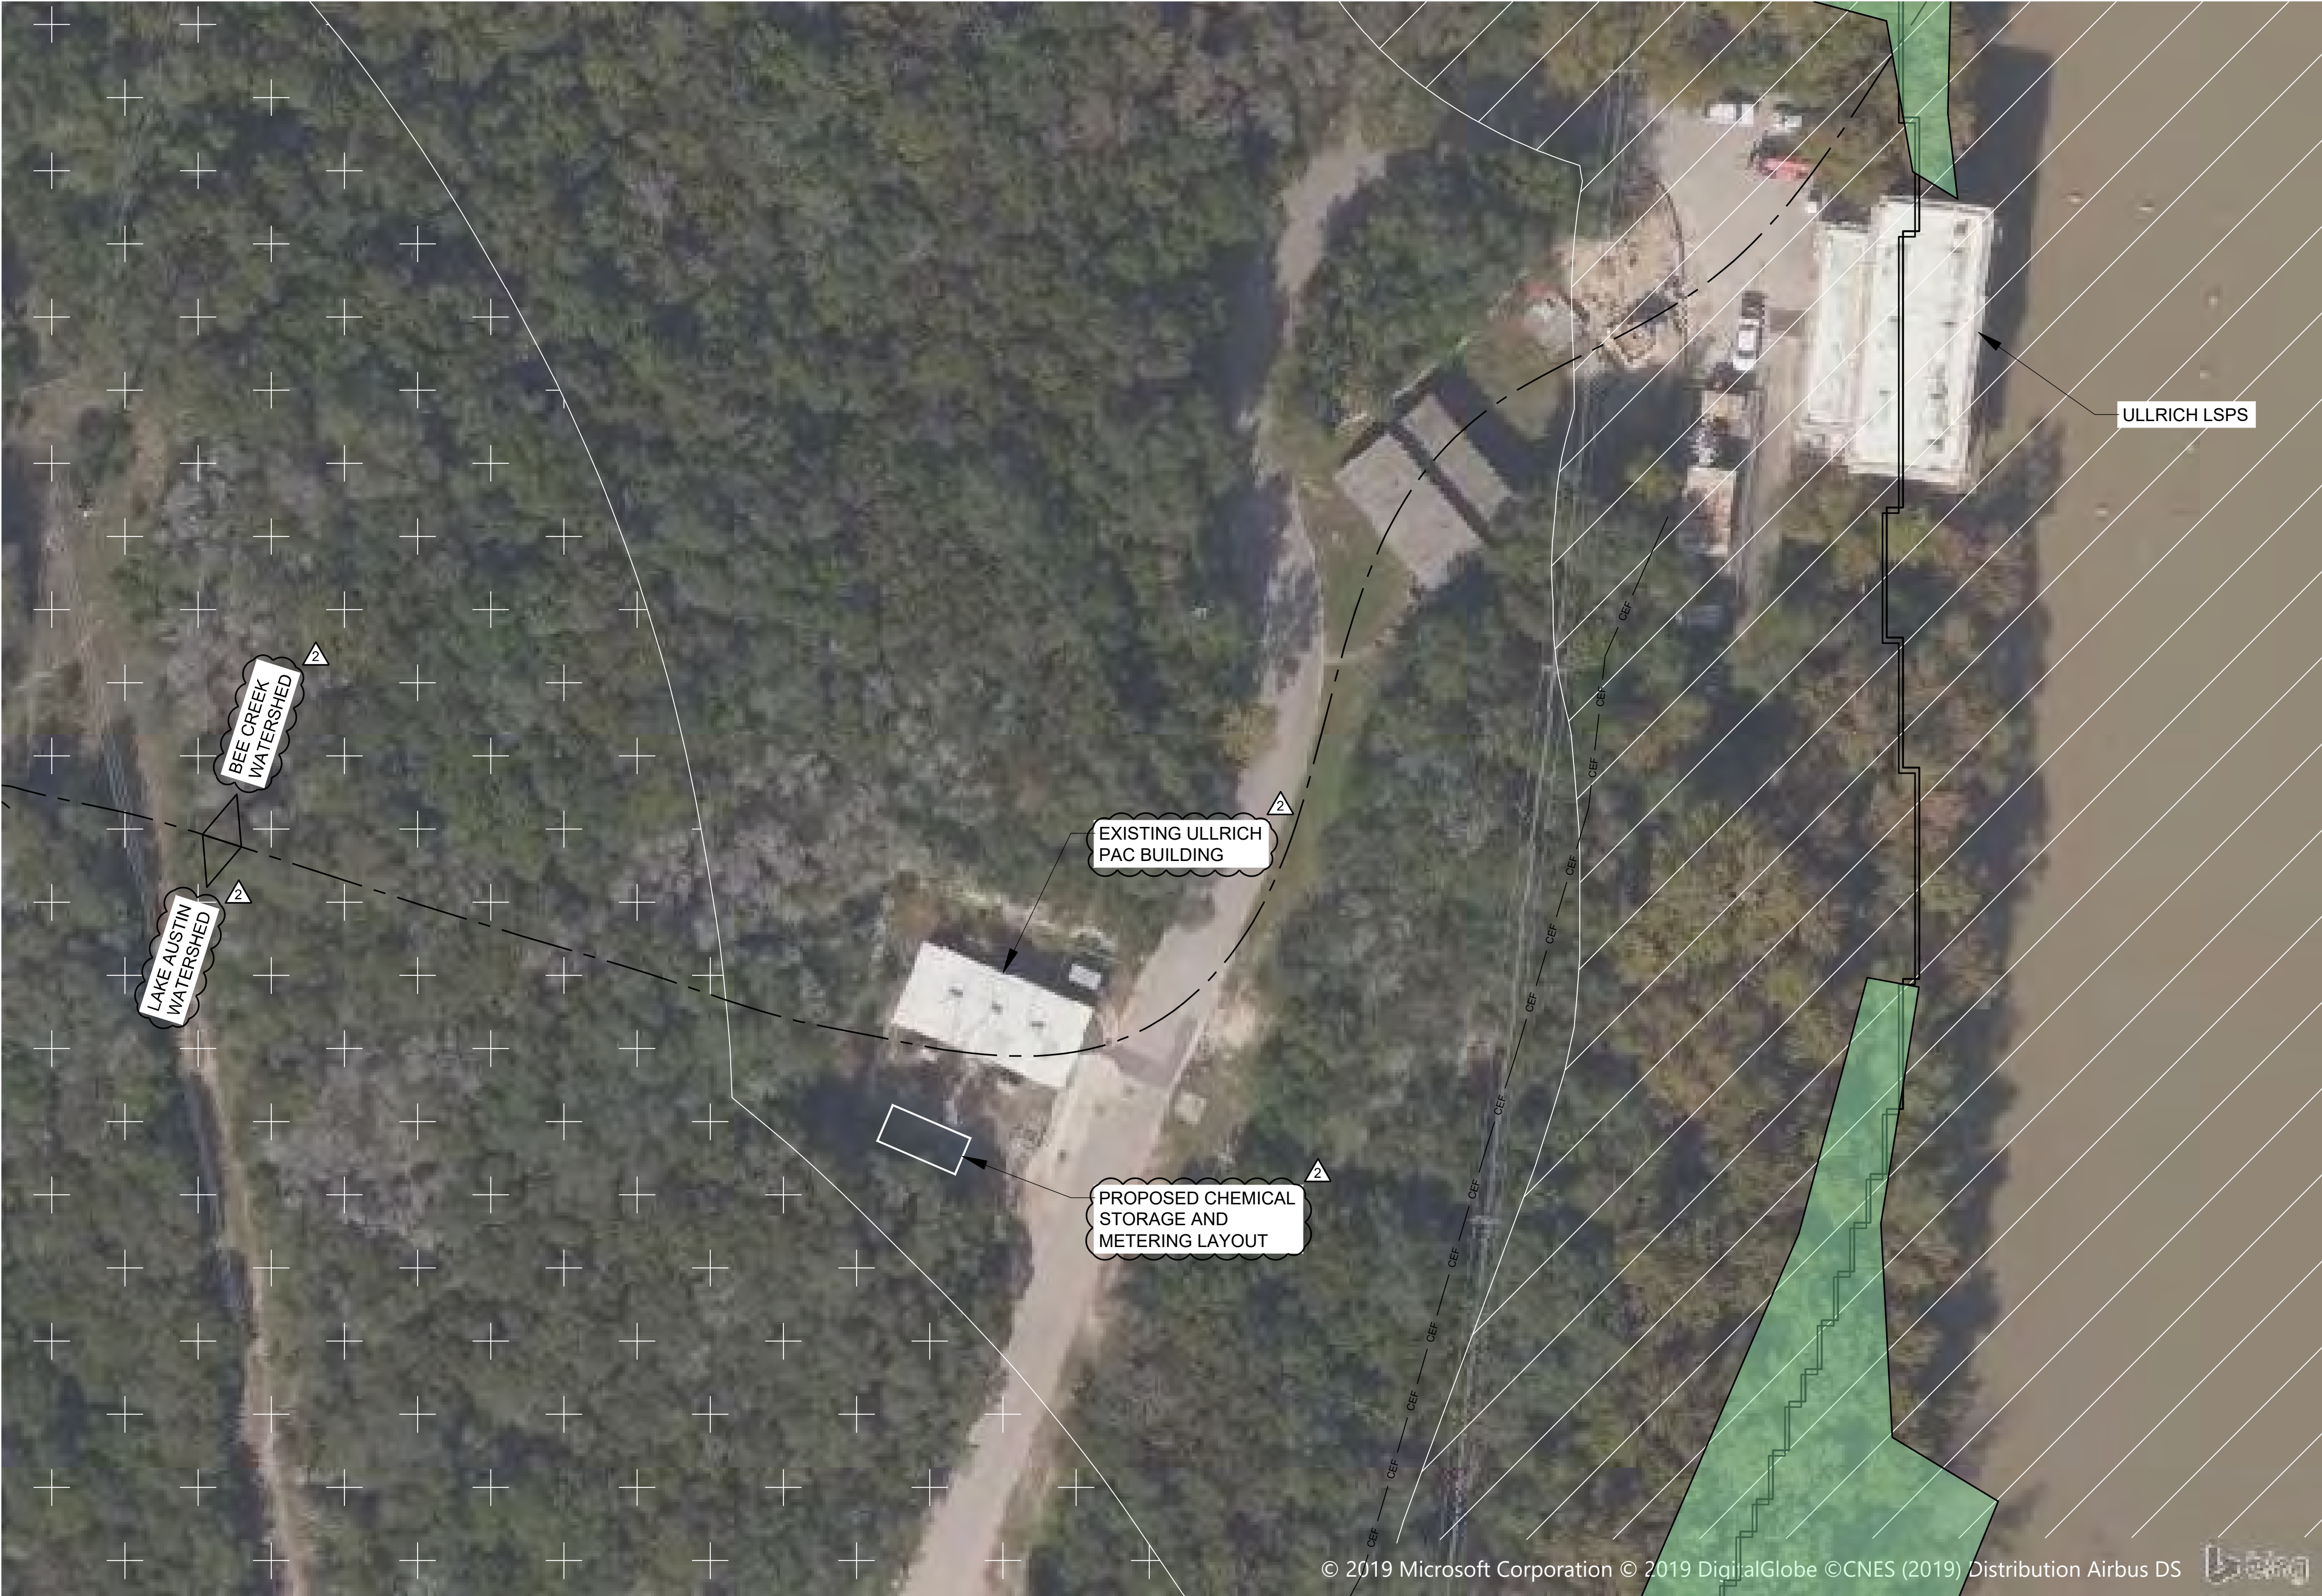
- CRITICAL WATER QUALITY ZONE
- WATER QUALITY TRANSITION ZONE
- CRITICAL ENVIRONMENTAL FEATURE: WETLANDS
- CEF CRITICAL ENVIRONMENTAL FEATURE (CANYON RIMROCK)\*

GENERAL  
SITE LAYOUT

Clearly indicate in what way the proposed project does not comply with current Code (include maps and exhibits)	<ul style="list-style-type: none"><li>• Construction will be performed within the 150' rimrock CEF buffer and within 150' wetlands CEF buffer.</li></ul>

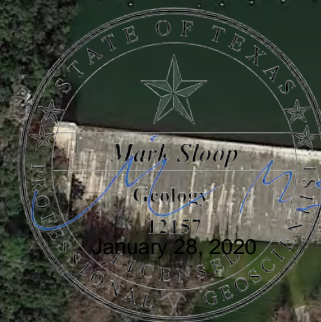
WETLAND CRITICAL  
ENVIRONMENTAL  
FEATURE (W-1)

APPROX. 3,500 SF OF  
DISTURBANCE

**Wetland, W-1:** This wetland was observed along the eastern edge of the assessment area, at the shore of the Colorado River. The river bank was dominated by bald cypress (*Taxodium distichum*, OBL), with some glossy privet (*Ligustrum lucidum*, UPL), green ash (*Fraxinus pennsylvanica*, FAC), and American sycamore (*Platanus occidentalis*, FAC). Jamaican sawgrass (*Cladium mariscus*, OBL) and taro (*Colocasia esculenta*, OBL) were observed beyond the fence line at the shore, but inaccessible. The wetland was approximately 5 to 60 feet wide, observed from the edge of the water, and approximately 250 feet long. Please see

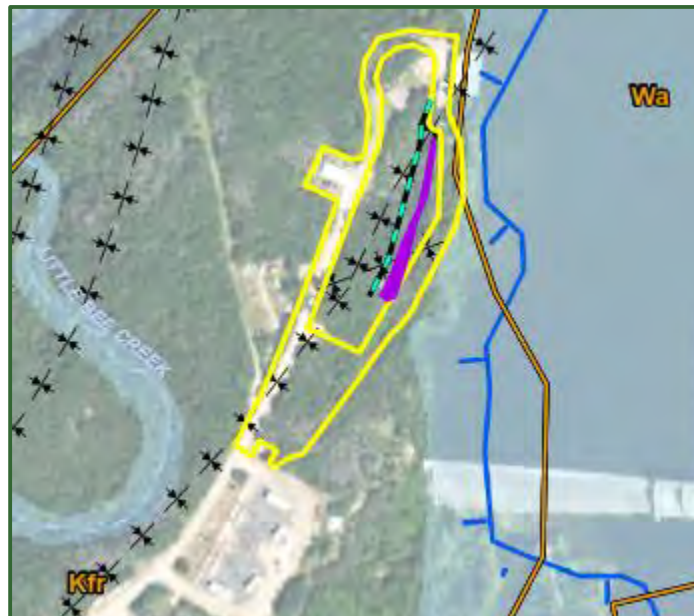
**Photograph 6:** Ullrich Rimrock, Solution Recharge Feature – The figure below depicts the location of the feature in blue.

**\*\*City of Austin does not consider the depression identified during the site visit to be a recharge feature per the January 30, 2020 email from Minda Sarmiento.**

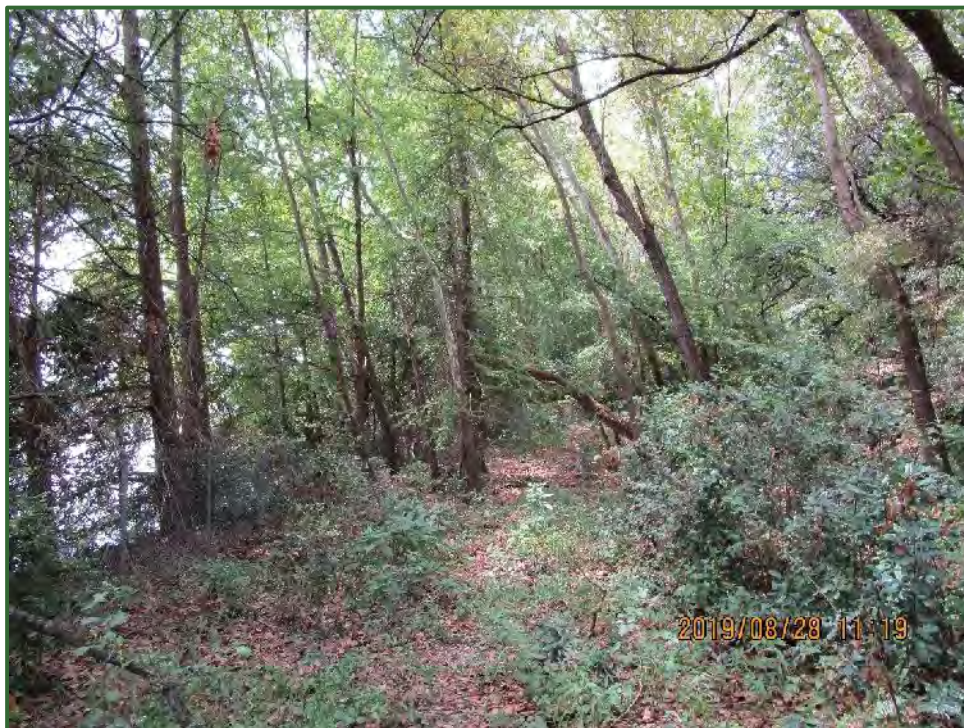
**Photograph 10:** Example of **Deciduous Floodplain Forest** between the river bank and Ullrich Rimrock.

The **Deciduous Floodplain Forest** was observed below the bluff, east of the paved driveway. Canopy cover was dense, with cottonwood (*Populus deltoides*), bald cypress, American sycamore, and glossy privet as overstory. Smaller woody vegetation included ash species (*Fraxinus* sp.) and chinaberry (*Melia azedarach*), with some groundcover from poison ivy (*Toxicodendron radicans*), frostweed (*Verbesina virginica*), and Virginia wild rye (*Elymus virginicus*). The understory vegetation had relatively low density. The previously-

described wetlands occurred along the river bank on the edges of this habitat. Please see **Photograph 10**.
