## Environmental Resource Inventory

Ullrich Water Treatment Plant  
Low Service Pump Station Improvements  
1000 Forest View Drive Austin, Texas 78746

# Ullrich LSPS

Ullrich Water Treatment  
 Plant Process Efficiency and  
 Rehabilitation

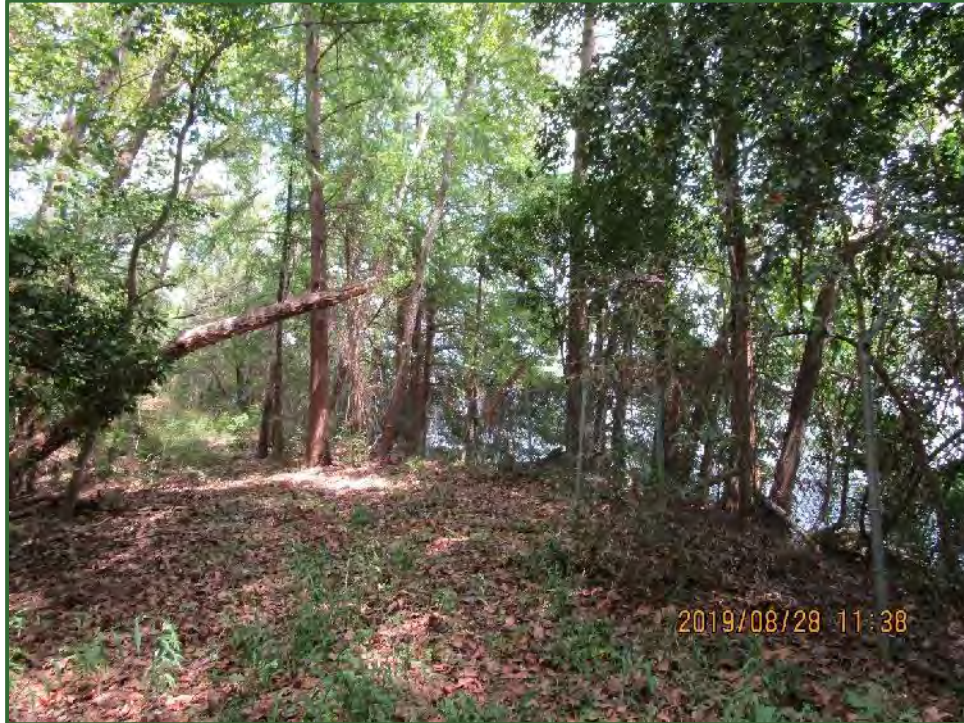
**Wetland, W-1:** This wetland was observed along the eastern edge of the assessment area, at the shore of the Colorado River. The river bank was dominated by bald cypress (*Taxodium distichum*, OBL), with some glossy privet (*Ligustrum lucidum*, UPL), green ash (*Fraxinus pennsylvanica*, FAC), and American sycamore (*Platanus occidentalis*, FAC). Jamaican sawgrass (*Cladium mariscus*, OBL) and taro (*Colocasia esculenta*, OBL) were observed beyond the fence line at the shore, but inaccessible. The wetland was approximately 5 to 60 feet wide, observed from the edge of the water, and approximately 250 feet long. Please see

**Photograph 1:** Wetland W-1 – A view of the wetland, dominated by bald cypress along the bank of the Colorado River.

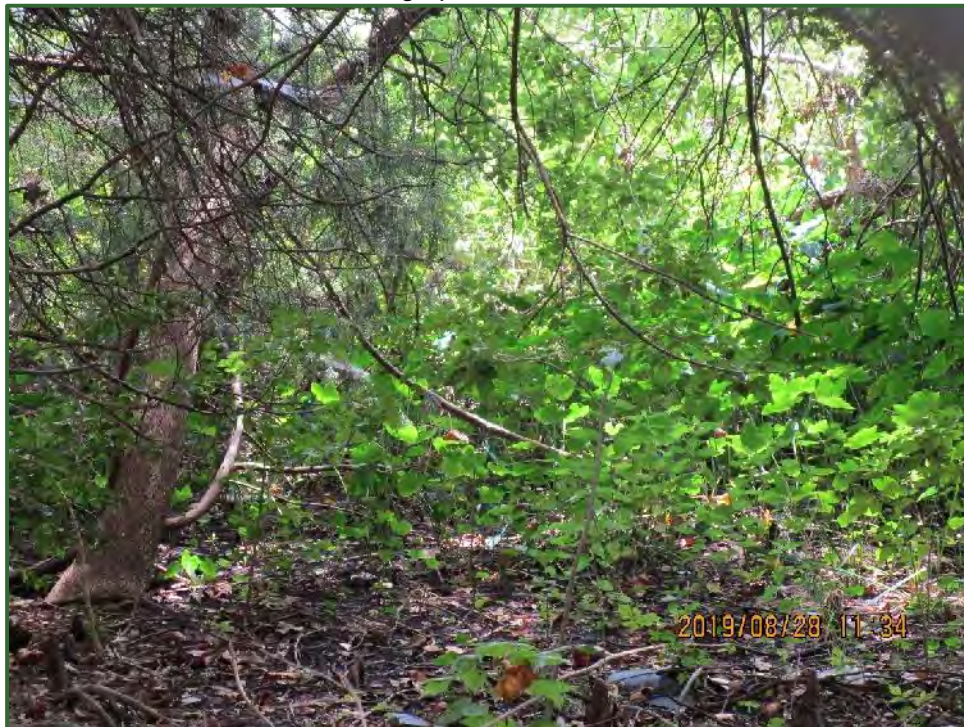
**Photograph 2:** Wetland W-1 – Photo through perimeter fence of taro at river bank.

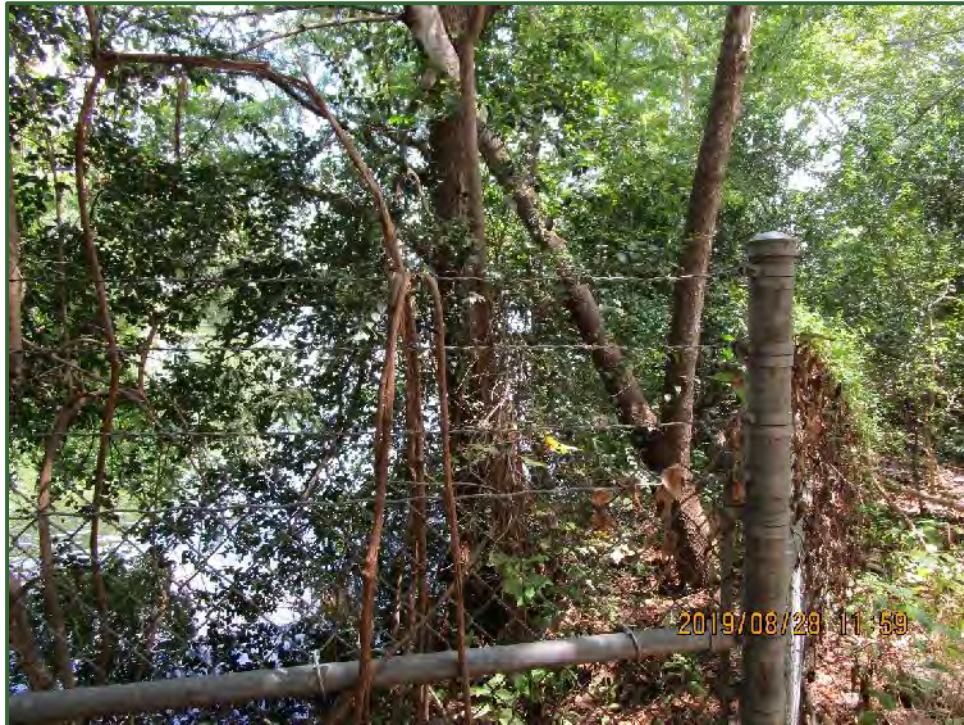
**Wetland, W-2:** This wetland was observed northwest of the facility at the bank of the Colorado River, at the north end of the assessment area. Bald cypress, smallspike false nettle (*Boehmeria cylindrica*, FACW), and Emory sedge (*Carex emoryii*, FACW) dominated the area, along with some glossy privet and American sycamore. The wetland was approximately 15 feet wide from the edge of the water and 140 feet long following the shoreline. Please see

**Photograph 3:** Wetland W-2 – Wetland observed on northern side of assessment area along bank of the Colorado River, outside of perimeter fence. Bald cypress and American sycamore can be seen.

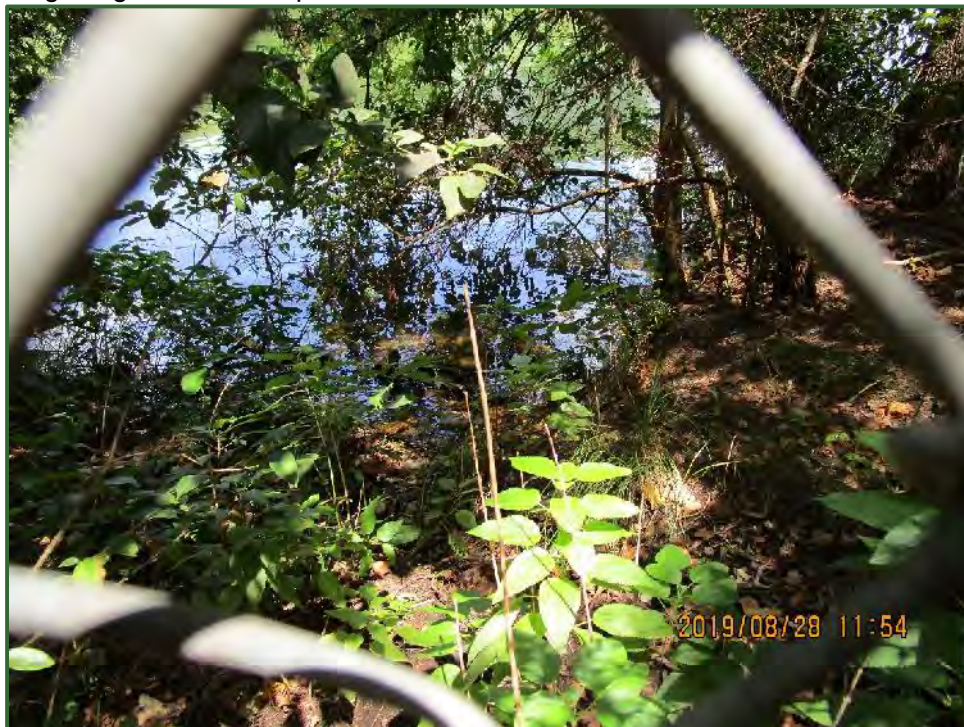
**Photograph 4:** Wetland W-2 – View of wetland vegetation at the river bank outside of perimeter fence, including sedges and shortspike false nettle.

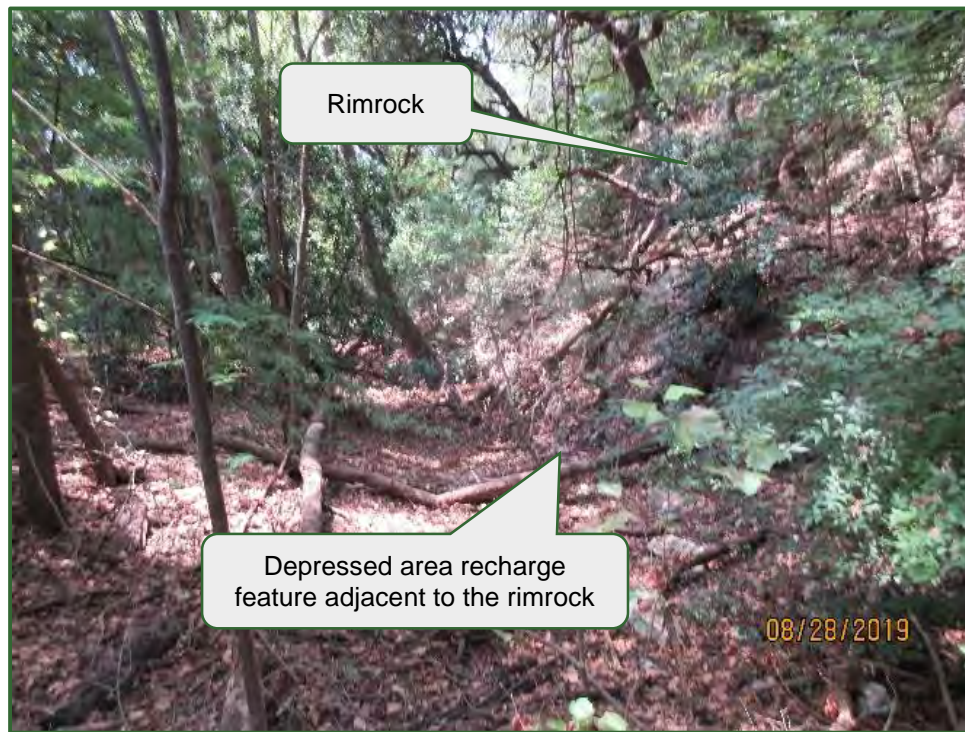
**Rimrock, Ullrich Rimrock:** Rimrock was observed at the center of the assessment area, northwest of the proposed roadway and southeast of the proposed work adjacent to the existing roadway. The rim rock extends northeast to southwest for approximately 430 feet. The estimated height of the rimrock is 30 feet from the base to the upper edge. Please see

**Recharge Feature, Solution Recharge Feature:** A recharge feature was observed within a depression that is approximately five to six feet below the nearby footpath surface and approximately three to four feet below the level of the nearby Colorado River. The depression contained several inches of leaf litter and detritus. The initial site visit was conducted after a rain event the evening before and little to no water was observed in the depression. Comparing the depression and rimrock discussed above to geologic maps of the area, these features appear to

correlate with a mapped fault depicted on the site. The feature was approximately 350 long, 20 feet wide, and 4 feet below the surrounding grade. Please see **Photographs 5-6**.

**Photograph 5:** Ullrich Rimrock, Solution Recharge Feature – This depression was observed east of the paved driveway and at the foot of the rimrock.

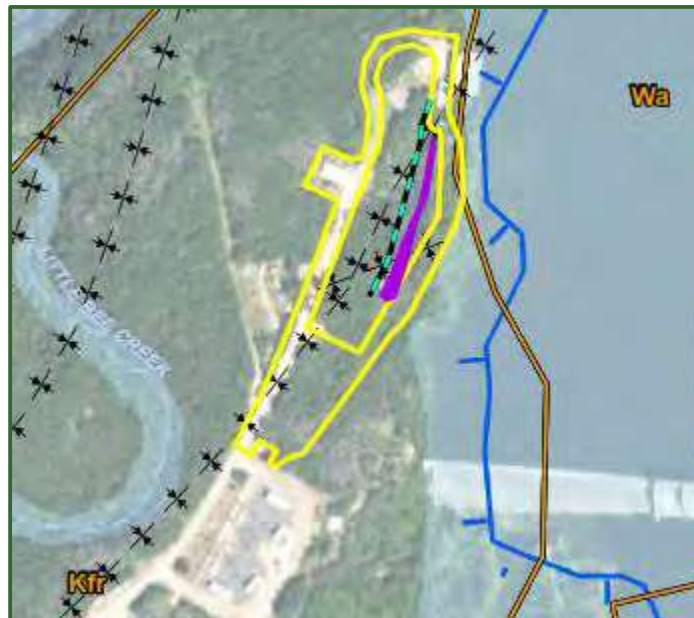
**Photograph 6:** Ullrich Rimrock, Solution Recharge Feature – The figure below depicts the location of the feature in blue.

**\*\*City of Austin does not consider the depression identified during the site visit to be a recharge feature per the January 30, 2020 email from Minda Sarmiento.**

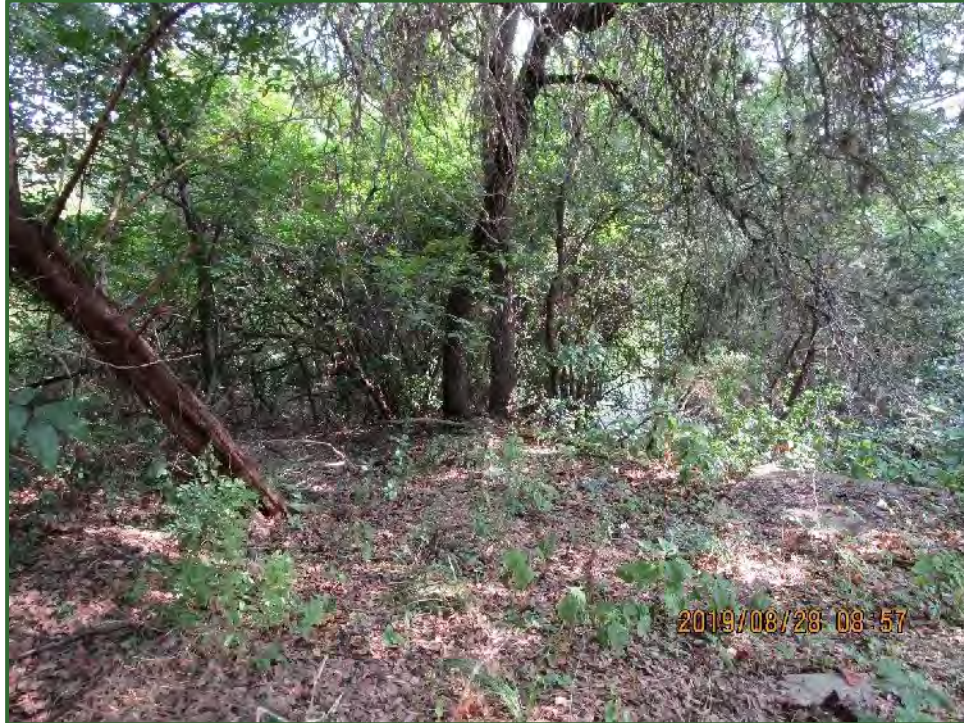
The **Juniper Woodland** occupied the upland portions of the project area adjacent to the driveway. Canopy cover was mostly dense, with some open grassy areas on the eastern side. Trees were predominantly ashe juniper (*Juniperus ashei*) with some cedar elm (*Ulmus crassifolia*) and live oak (*Quercus fusiformis*). The moderately dense midstory included Texas persimmon (*Diospyrus texana*), Texas mountain laurel (*Sephora secundiflora*), agarita (*Mahonia trifoliolata*), yaupon (*Ilex vomitoria*), and elbowbush (*Forestiera pubescens*). Shrubby boneset (*Ageratina havanensis*) and cedar sedge (*Carex planostachys*) dominated the wooded understory. The grassy opening vegetation predominantly consisted of silver bluestem (*Bothriochloa laguroides*), doveweed (*Croton monanthaginus*), prairie coneflower (*Ratibida columnifera*), and other grasses and forbs as groundcover. Additionally, evergreen and flameleaf sumac (*Rhus virens*, *Rhus lanceolata*) and Texas kidneywood (*Eysenhardtia texana*) grew as a midstory with some prickly pear species (*Opuntia* sp.). Please see **Photographs 7-9**.

**Photograph 7:** Example of **Juniper Woodland**, west of paved driveway.

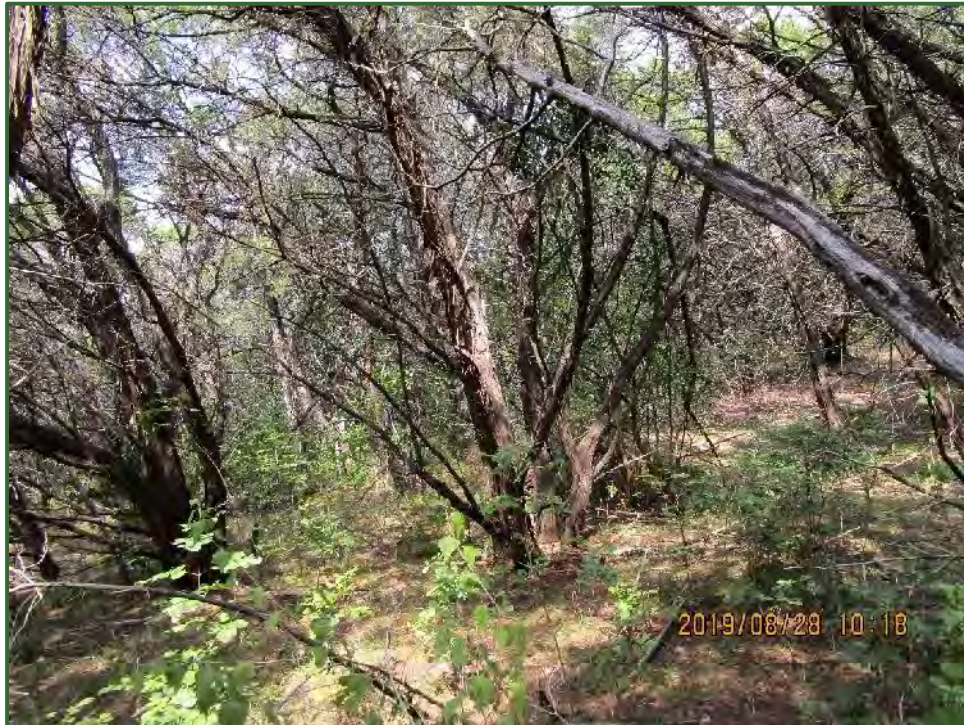
**Photograph 8:** Example of **Juniper Woodland**, east of paved driveway and above floodplain bluff.

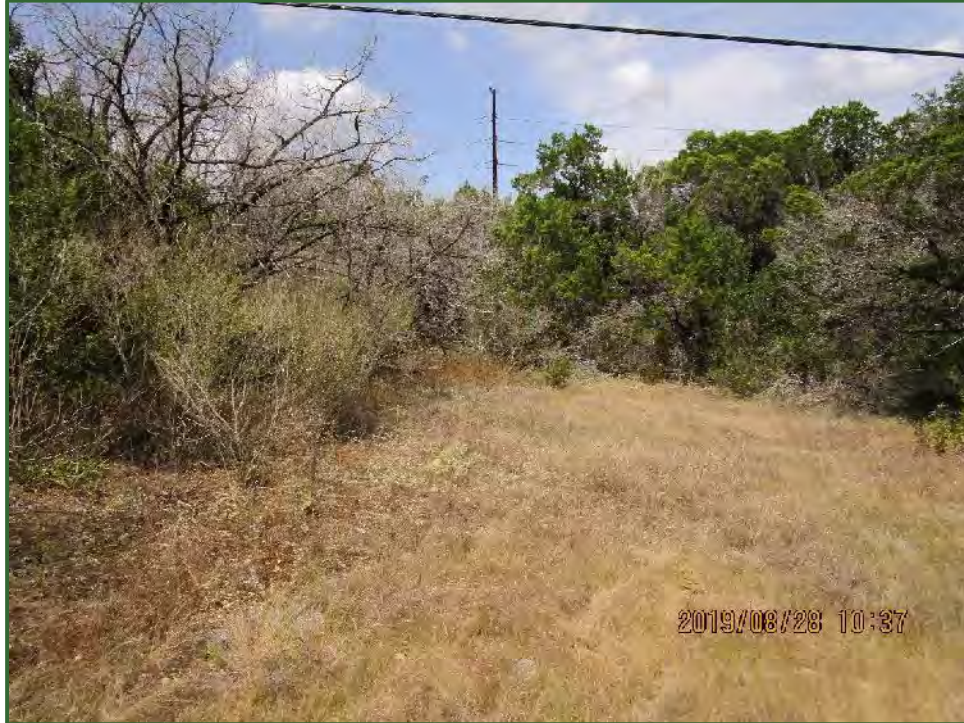
**Photograph 9:** Grassy opening in **Juniper Woodland**, east of paved driveway.

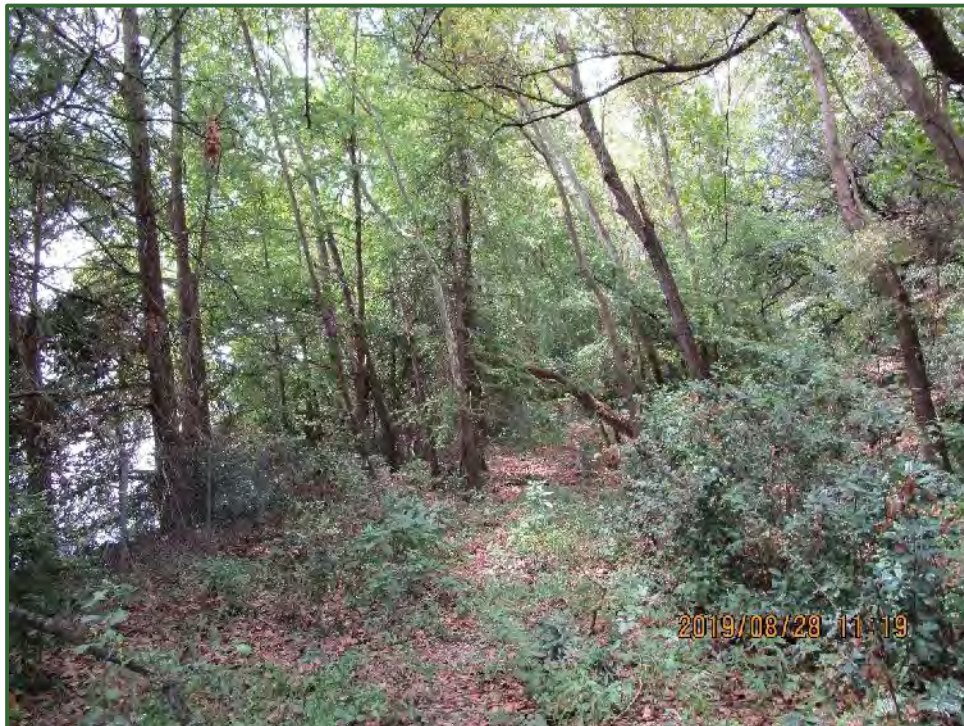
The **Deciduous Floodplain Forest** was observed below the bluff, east of the paved driveway. Canopy cover was dense, with cottonwood (*Populus deltoides*), bald cypress, American sycamore, and glossy privet as overstory. Smaller woody vegetation included ash species (*Fraxinus* sp.) and chinaberry (*Melia azedarach*), with some groundcover from poison ivy (*Toxicodendron radicans*), frostweed (*Verbesina virginica*), and Virginia wild rye (*Elymus virginicus*). The understory vegetation had relatively low density. The previously-

described wetlands occurred along the river bank on the edges of this habitat. Please see **Photograph 10**.

**Photograph 10:** Example of **Deciduous Floodplain Forest** between the river bank and Ullrich Rimrock.

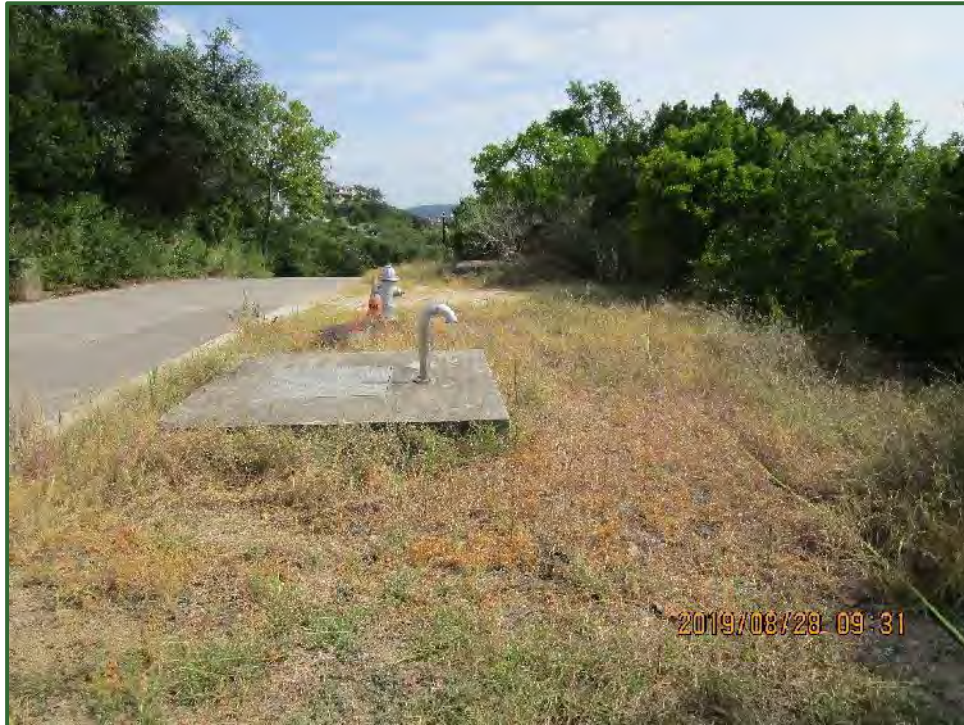
**Mowed Grasses** were observed along the paved driveway within the project area. Identifiable grasses included silver bluestem and perennial rye (*Lolium perenne*), and forbs included lemon beebalm (*Monarda citriodora*), tie vine (*Ipomoea cordatotriloba*), western ragweed (*Ambrosia psilostachya*), Indian Blanket (*Gaillardia pulchella*), maretail weed (*Erigeron canadensis*), as well as plants as found in the wooded openings in the Juniper Woodland, described above. Please see **Photograph 11**.

**Photograph 11:** Example of **Mowed Grasses** along paved driveway.

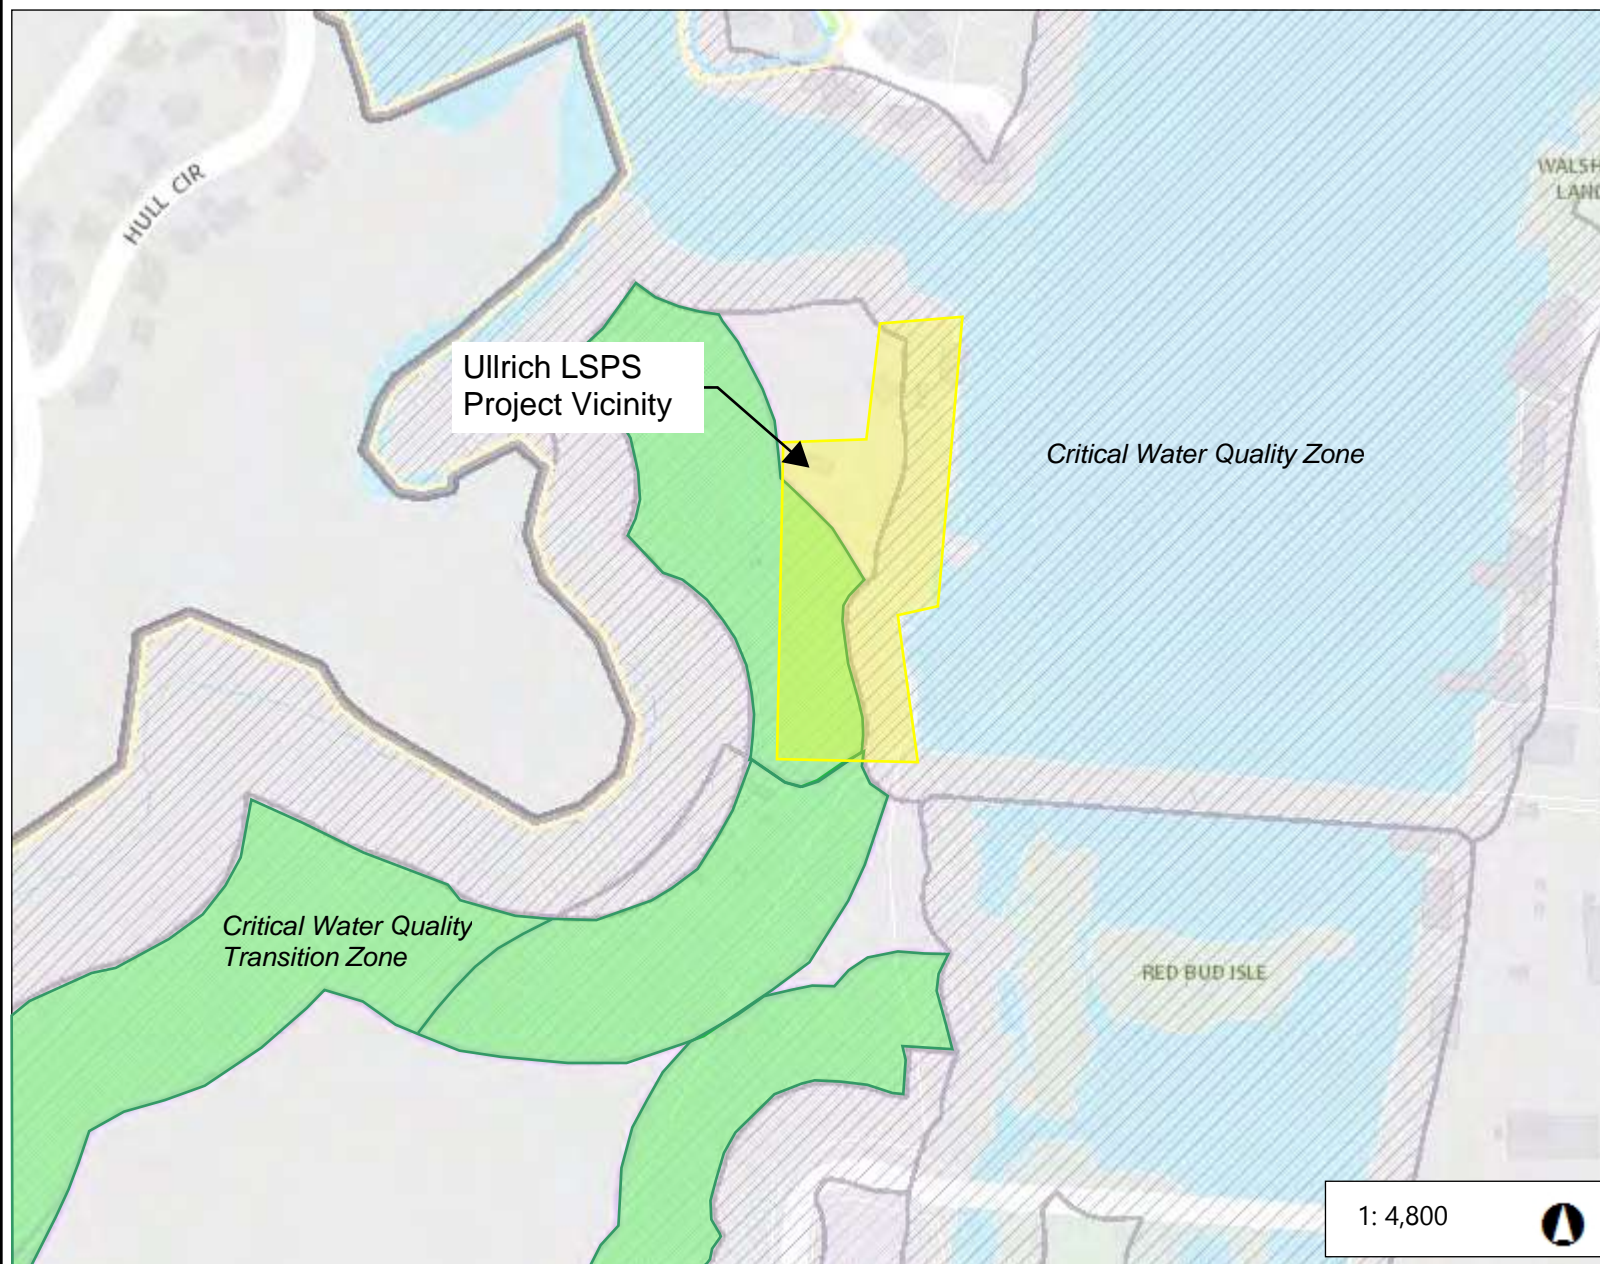
## ATTACHMENT 9.6 - WQTZ AND CWQZ MAP

This project is in the CWQZ and CWTZ.

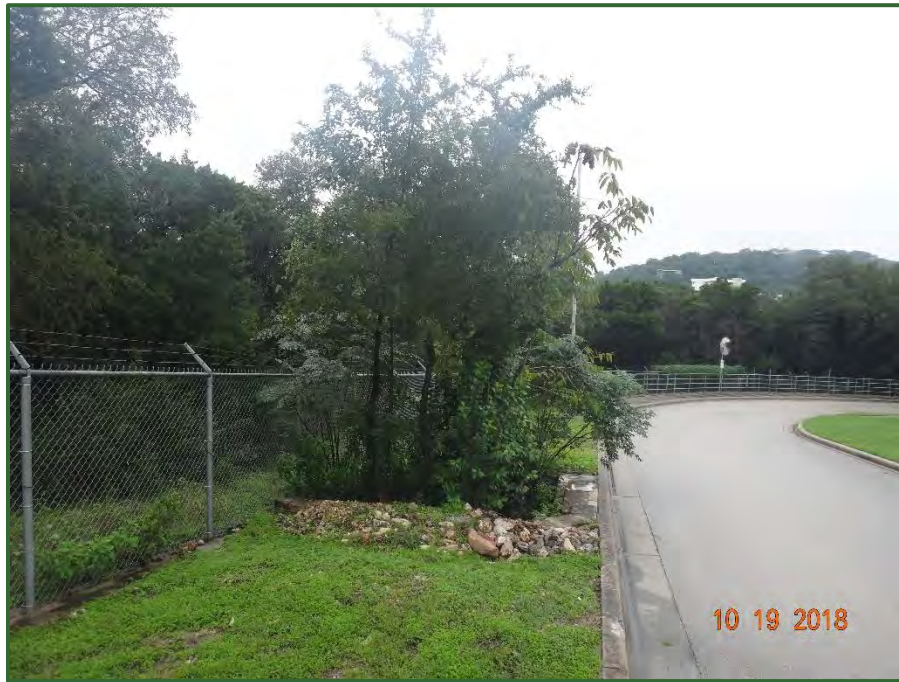
**Photograph #1**

A view of Sinkhole, **SH-1**. This karst recharge feature lies between the paved perimeter road and the perimeter fence on the southwest edge of the facility. A berm has been constructed on the topographical up-gradient side of the sinkhole to prevent overland flow from entering the feature. The photographer is facing northwest.

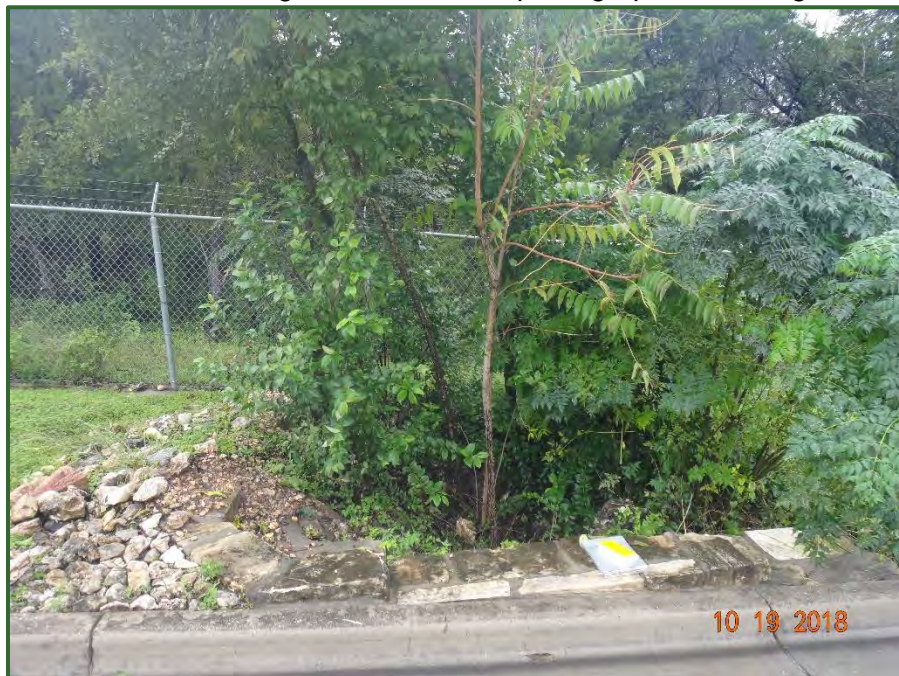
**Photograph #2**

Additional view of **SH-1**. This view shows the topographical up-gradient berm on the left, the curb along the roadway, and blocks set in concrete between the curb and the sinkhole, to prevent overland flow from entering the feature. The photographer is facing southwest.

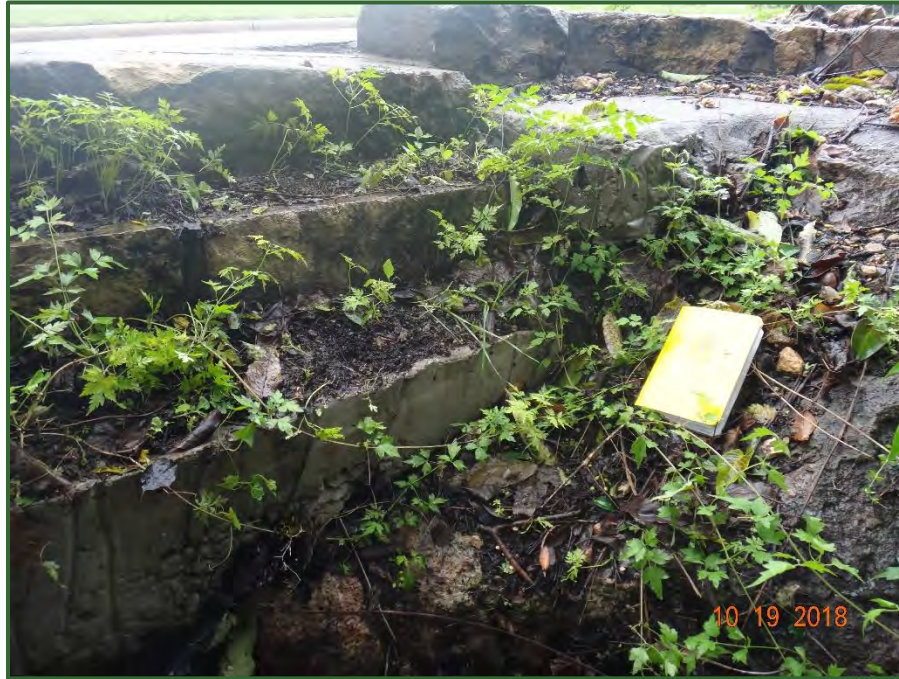
**Photograph #3**

The northeast wall of Sinkhole SH-1 is shown with concrete reinforcement above Edwards Limestone bedrock. The photographer is facing east.

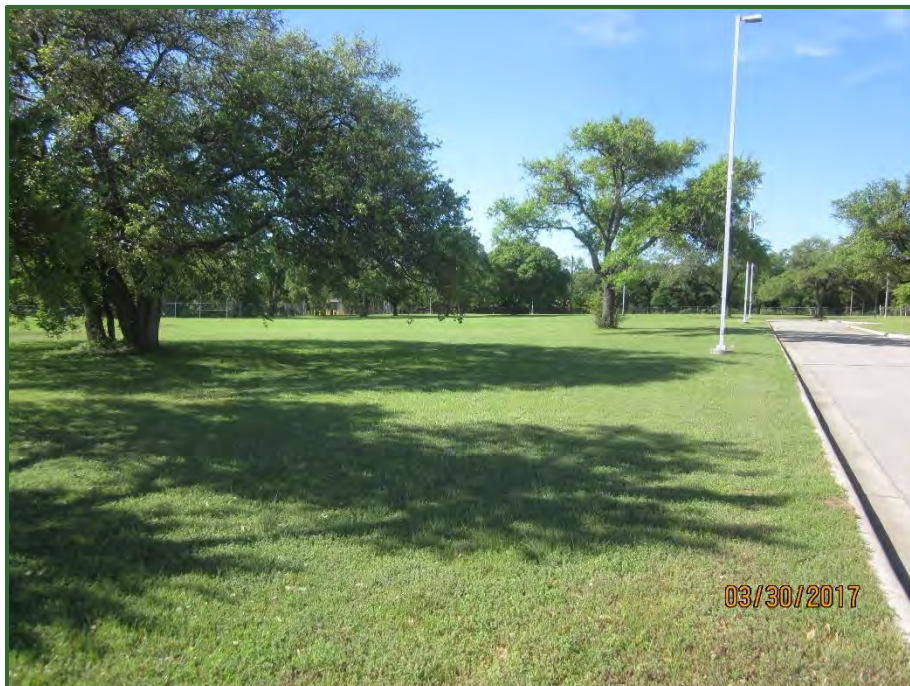
**Photograph #4**

A view of Mowed Landscape on project site. This shows manicured grasses and stand-alone trees.

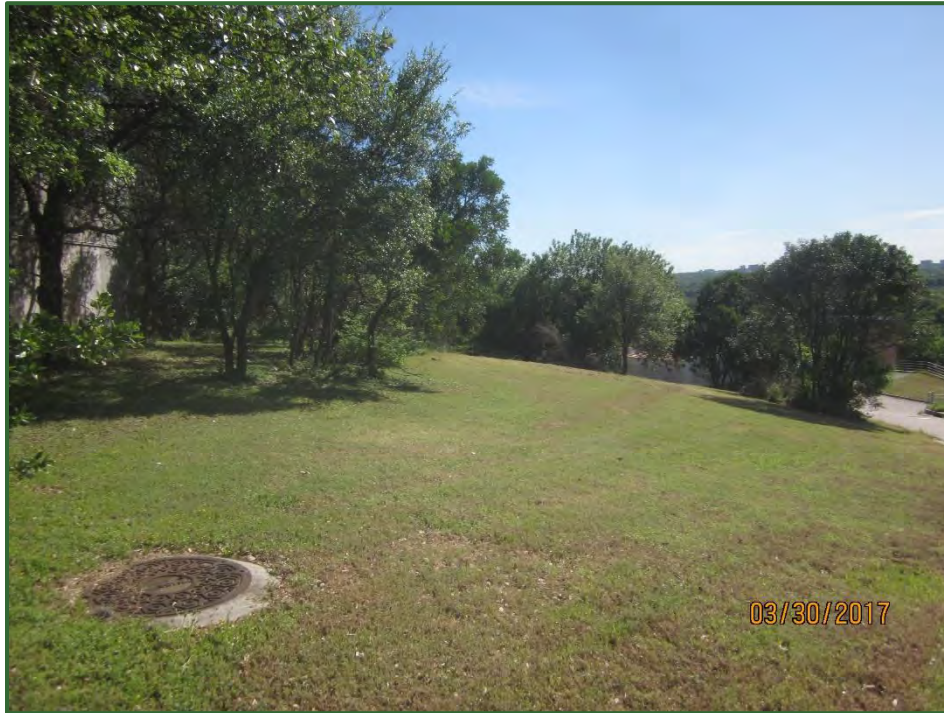
**Photograph #5**

Another view of Mowed Landscape with clusters of stand-alone trees.

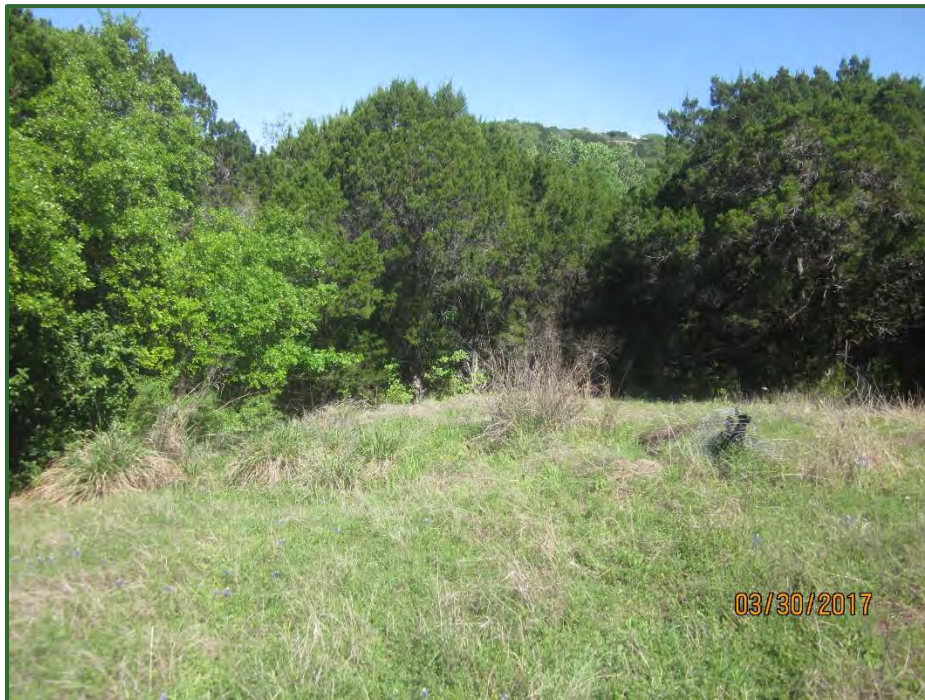
**Photograph #6**

This is a view of the edge between the Juniper Oak Woodland and the wild grown landscape.

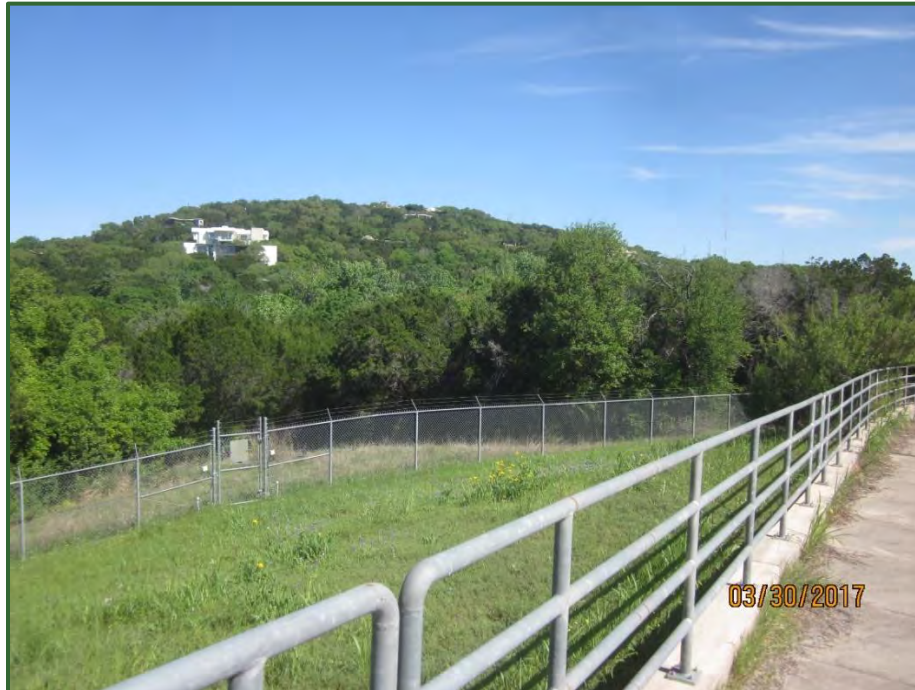
**Photograph #7**

A view of the Juniper Oak Woodland on the edges of the project site.

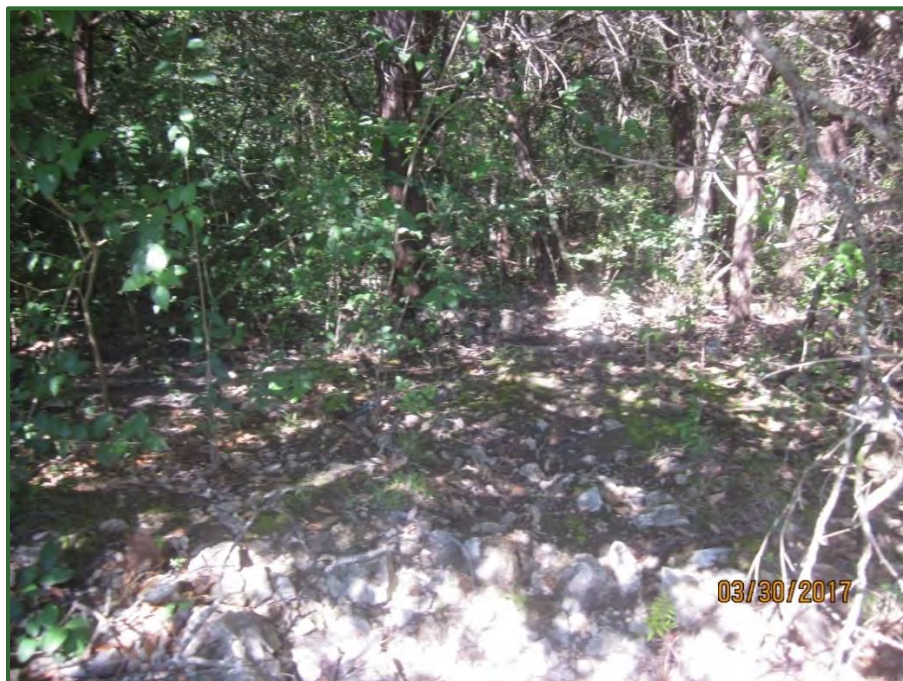
**Photograph #8**

A view of the understory of the Juniper Oak Woodland. This shows the bare ground, as well as some of the plant growth underneath the canopy.
