**HISTORIC LANDMARK COMMISSION
JANUARY 25, 2021
DEMOLITION AND RELOCATION PERMITS
GF 2020 191578
518 EAST 40TH STREET**

PROPOSAL

Partially demolish a ca. 1910-1920 house and construct an addition.

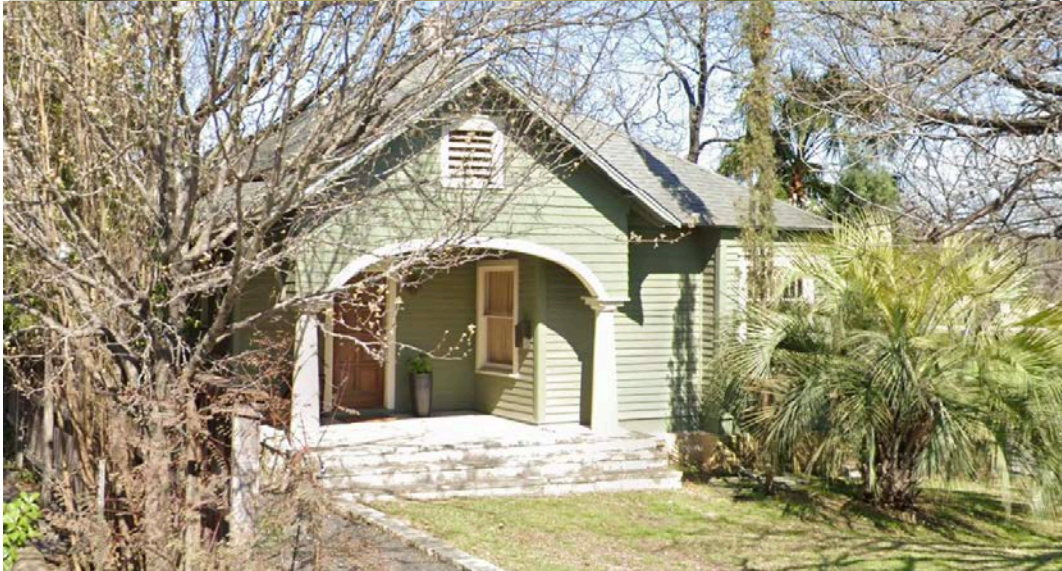
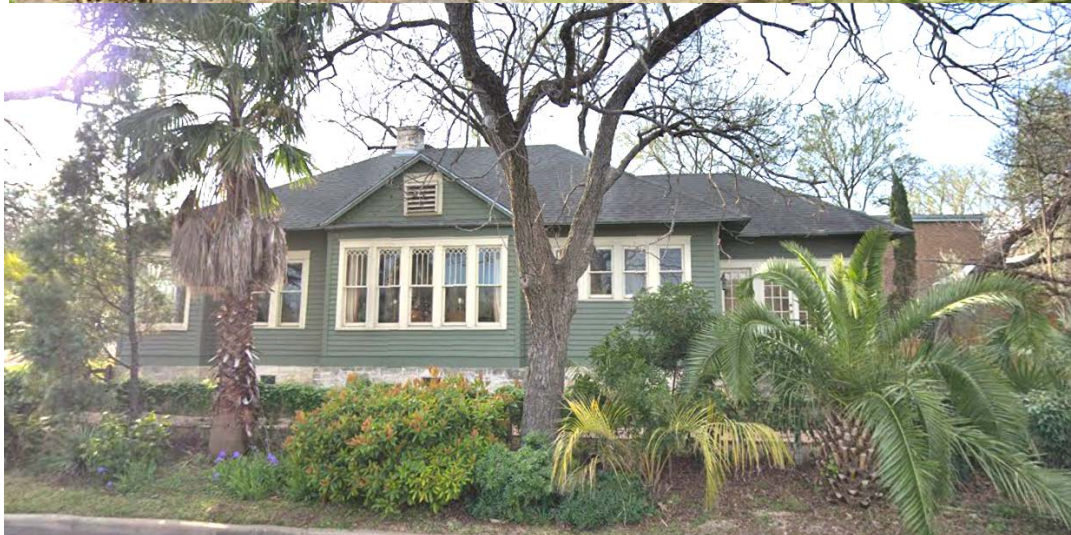
Photos

One-story house with compound hipped roof; partial-width, gabled front porch supported by Classical columns; horizontal wood siding; and single and mulled wood windows with 4:1, 1:1, and multi-light configurations.
