## Memo

**Re:** Court of Three Sisters Reasonable Use Memorandum

The 0.43-acre piece of property located at 504 W 24<sup>th</sup> St. and 2405 Nueces Street in Austin, Travis County, Texas 78705 (the "Property").

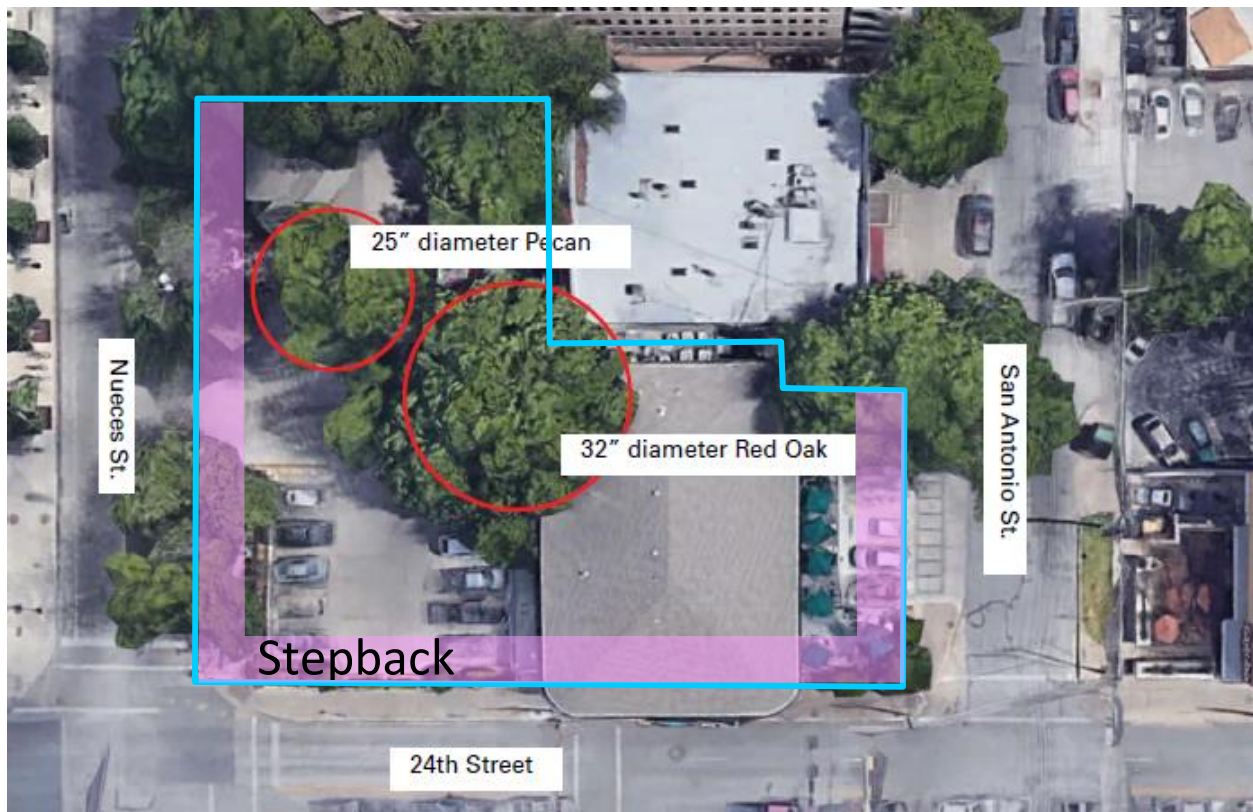
## EXHIBIT A: Site Constraints Exhibit

Tree locations of 25" Pecan (#911) and 32" Red Oak (#913) with 12-foot stepback around site.

There are two heritage trees on the site – one (1) 25" Pecan and one (1) 32" Red Oak – that are being requested for removal. Both trees are centrally located on the Property. See Exhibit A for tree locations.

Per § 25-2-758 (B)(1), Building Wall Height, Stepbacks, and Envelope, a 12-foot stepback on West 24<sup>th</sup> Street, Nueces Street and San Antonio Street is required. This stepback impedes the footprint of the site thereby limiting the development and reducing the developable footprint by approximately 20%.

The trees requested for removal on the site are located in the middle of the site. Given their location and existing canopy, the trees impact approximately 25% of the site.

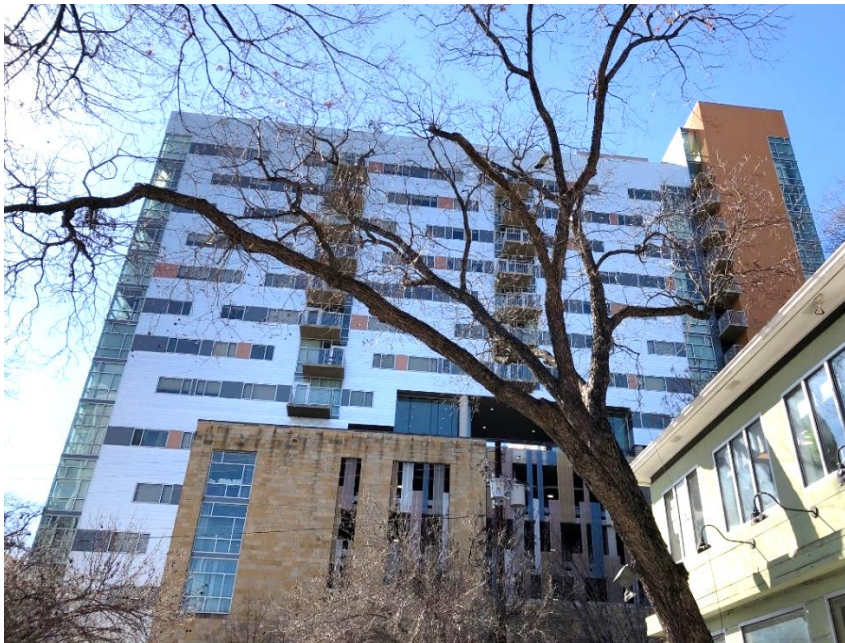
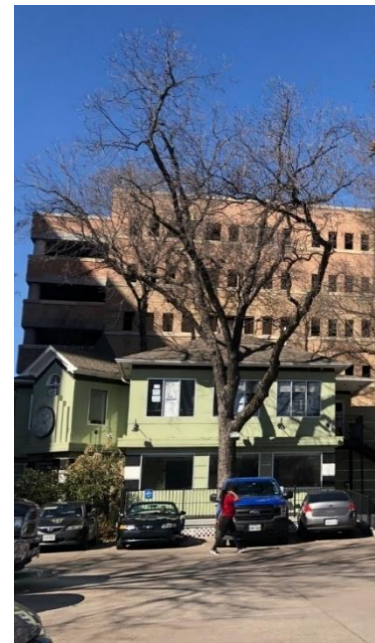
## **EXHIBIT D: Pecan #911 – Over Pruning Exhibit**

A tree evaluation of the 25" Pecan (#911), Exhibit D, was completed by Tree Mann Solutions. The tree is listed in poor condition. The tree has a significantly weak canopy, with the trunk against the building with roots covered by pavement for many years, and there is evidence of significant past failures within the canopy, either for clearance or due to past canopy failures in storms. There is also evidence of over pruning. Because of these reasons, it is a candidate for removal.

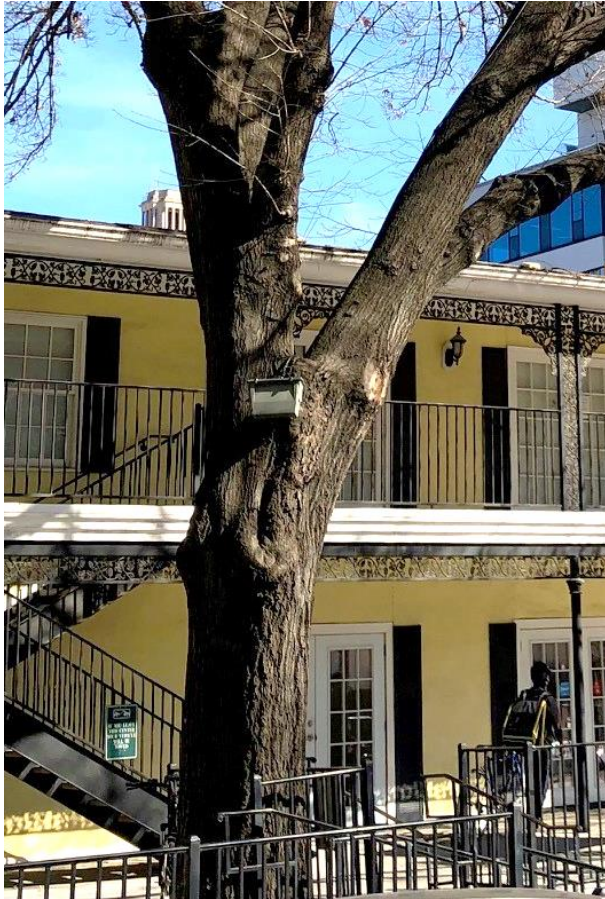
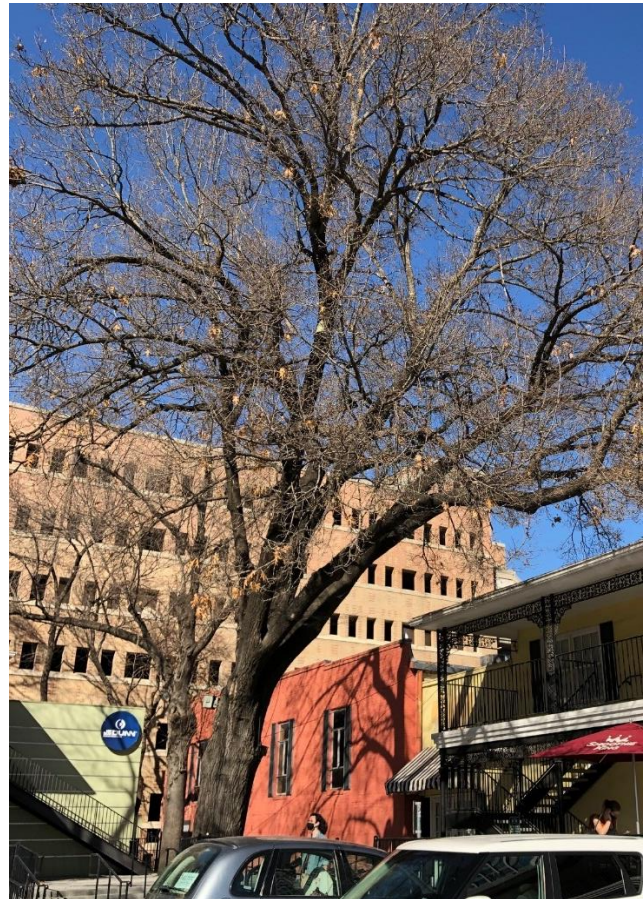
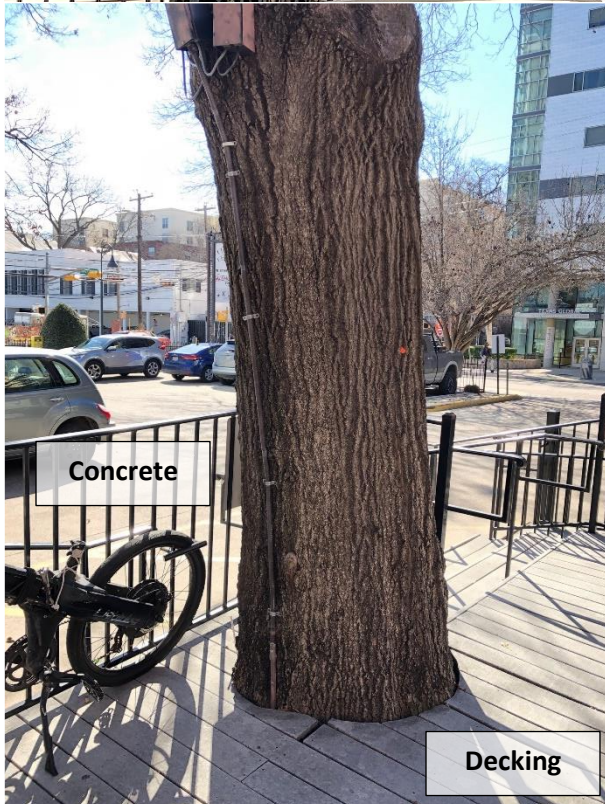
## EXHIBIT E: Red Oak #913 – Weak Unions and Unbalanced

A tree evaluation of the 32" Red Oak (#913), Exhibit E, was completed by Tree Mann Solutions. The tree is listed in fair condition. The tree has weak unions and is unbalanced to the south, all which could possibly present future structural issues, as well as potential root damage due to extensive impervious coverage over this large tree's critical root zone. Because of these reasons, it is a candidate for removal and replacement with thorough mitigation.
