Country Club Creek West at Roy G Guerrero Park

Environmental Commission May 19, 2021

Janna Renfro, P.E. Project Sponsor Watershed Protection Department

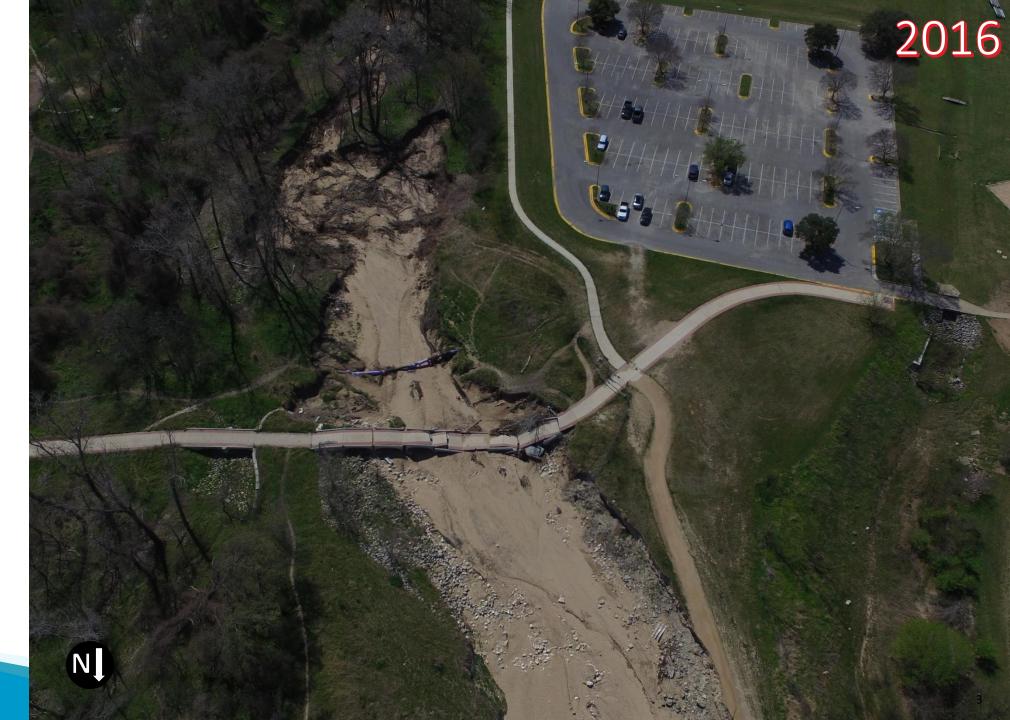
RECAP: Erosion Damage

- 2015 Floods
- Severe erosion created a shorter path to the river.
- Pedestrian bridge collapsed
- May 2015 -December 2017: Erosion damaged
 ~1500 feet (5 acres) of drainage channel
- 100s of trees lost
- 2500 dump truck loads of sand and soil (~37,000 cubic yards)

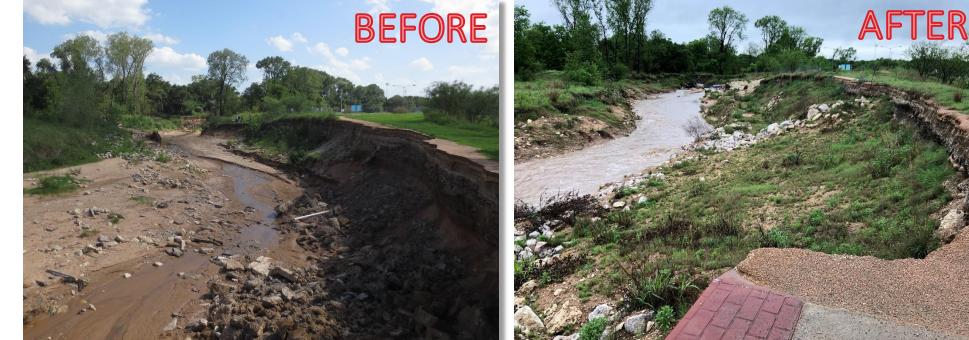
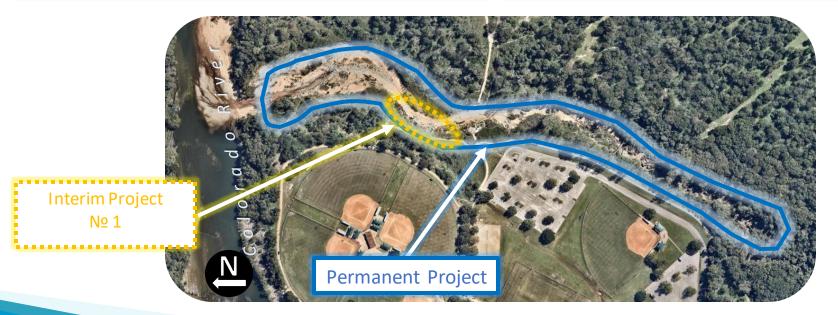
RECAP: Temporary Repairs

- Project No. 1
- 2017
- Protect Ballfields

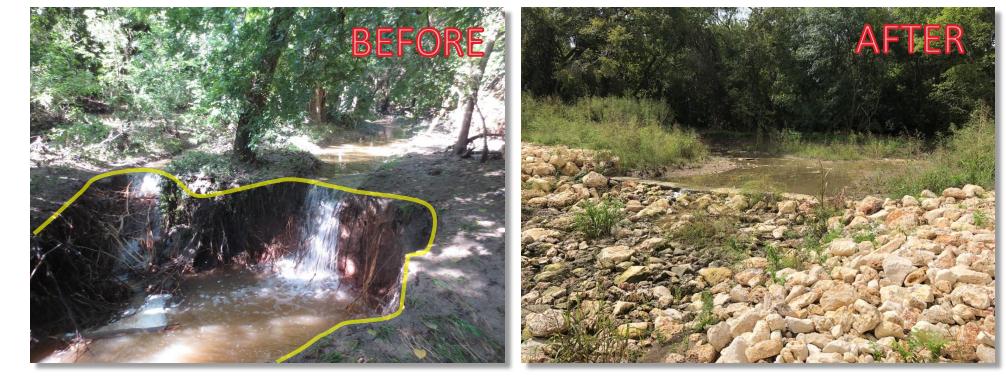
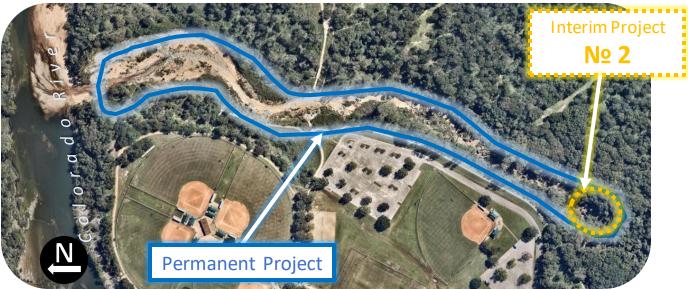
RECAP: Temporary Repairs

- Project No. 2:
- 2018
- Stop headcut from moving upstream

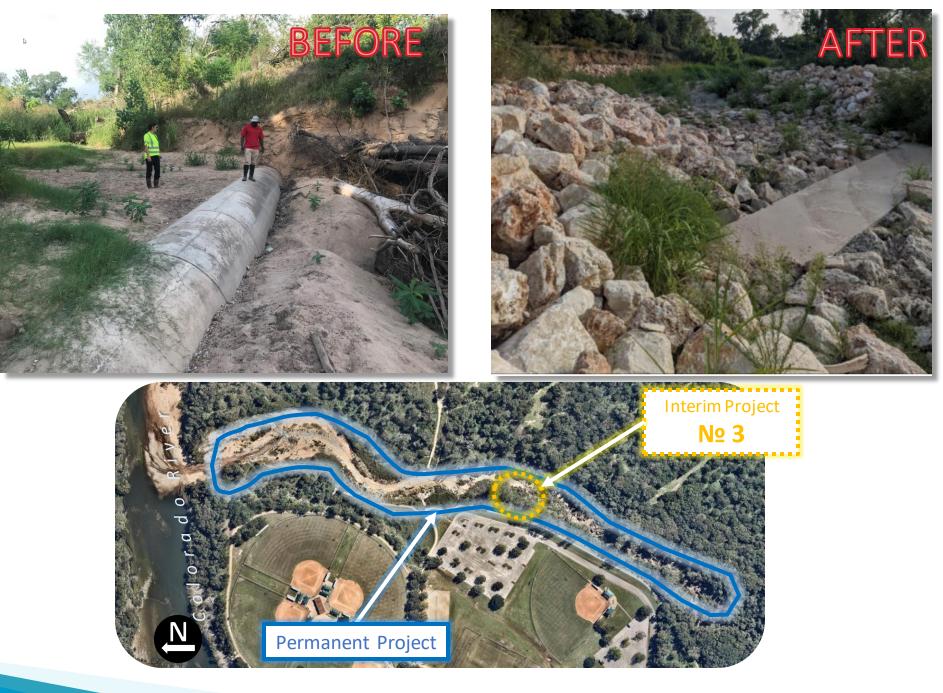
UPDATE: Temporary Repairs

- Project No. 3:
- 2019-20
- Protect 54" Active Wastewater Line

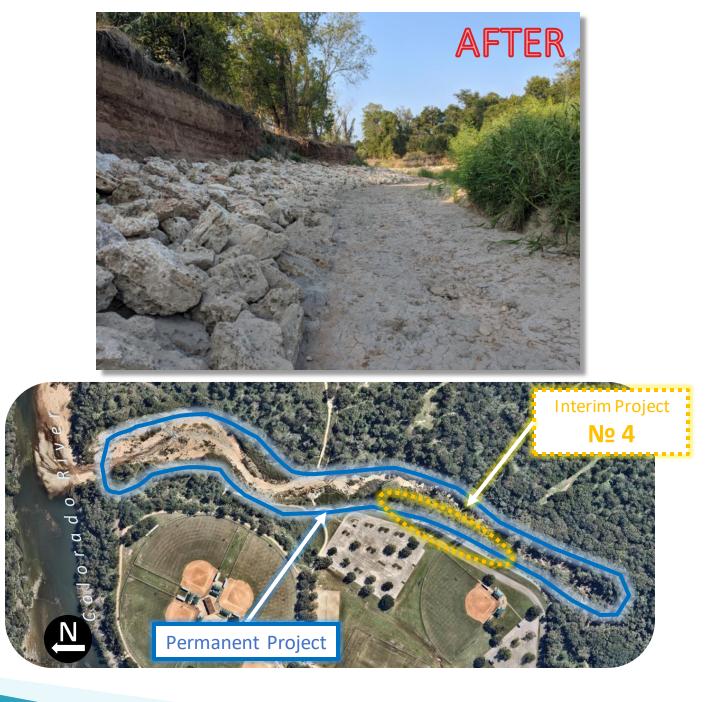
UPDATE: Temporary Repairs

- Project No. 4:
- 2020
- Protect Park Road

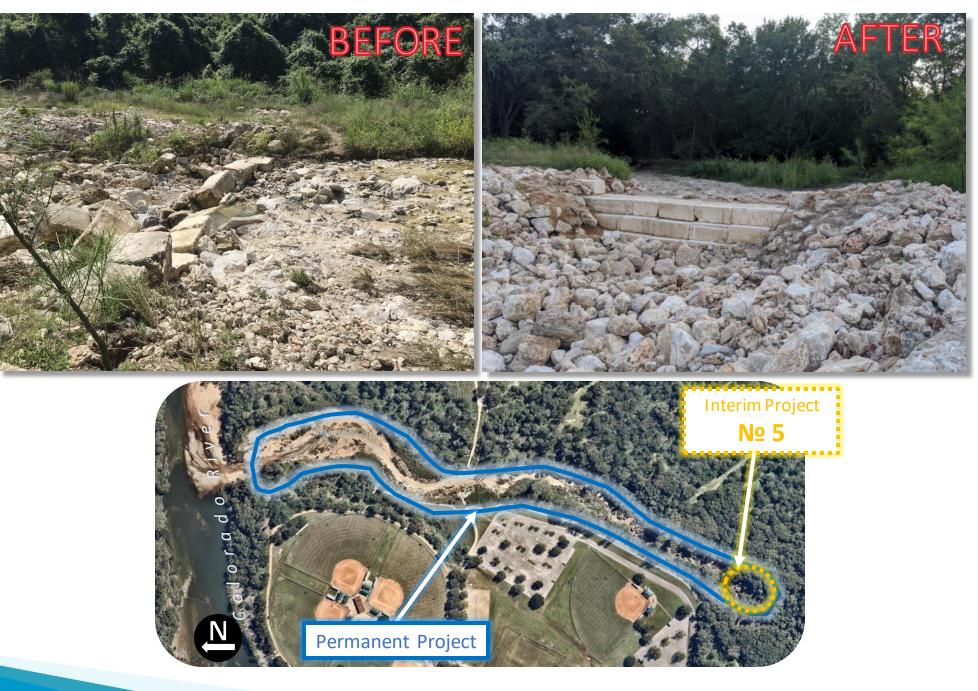
UPDATE: Temporary Repairs

- Project No. 5:
- 2020
- Repair failed temporary headcut stabilization
