**HISTORIC LANDMARK COMMISSION**  
**DEMOLITION AND RELOCATION PERMITS**  
**JUNE 28, 2021**  
**GF-2021-085651; DA-2021-094730**  
**AUSTIN CENTRAL FIRE STATION #1**  
**401 E. 5<sup>TH</sup> ST.**

Construct an addition to a 1938 fire station, which is listed in the National Register of Historic Places; and perform additional repairs and modifications to accommodate ongoing use.

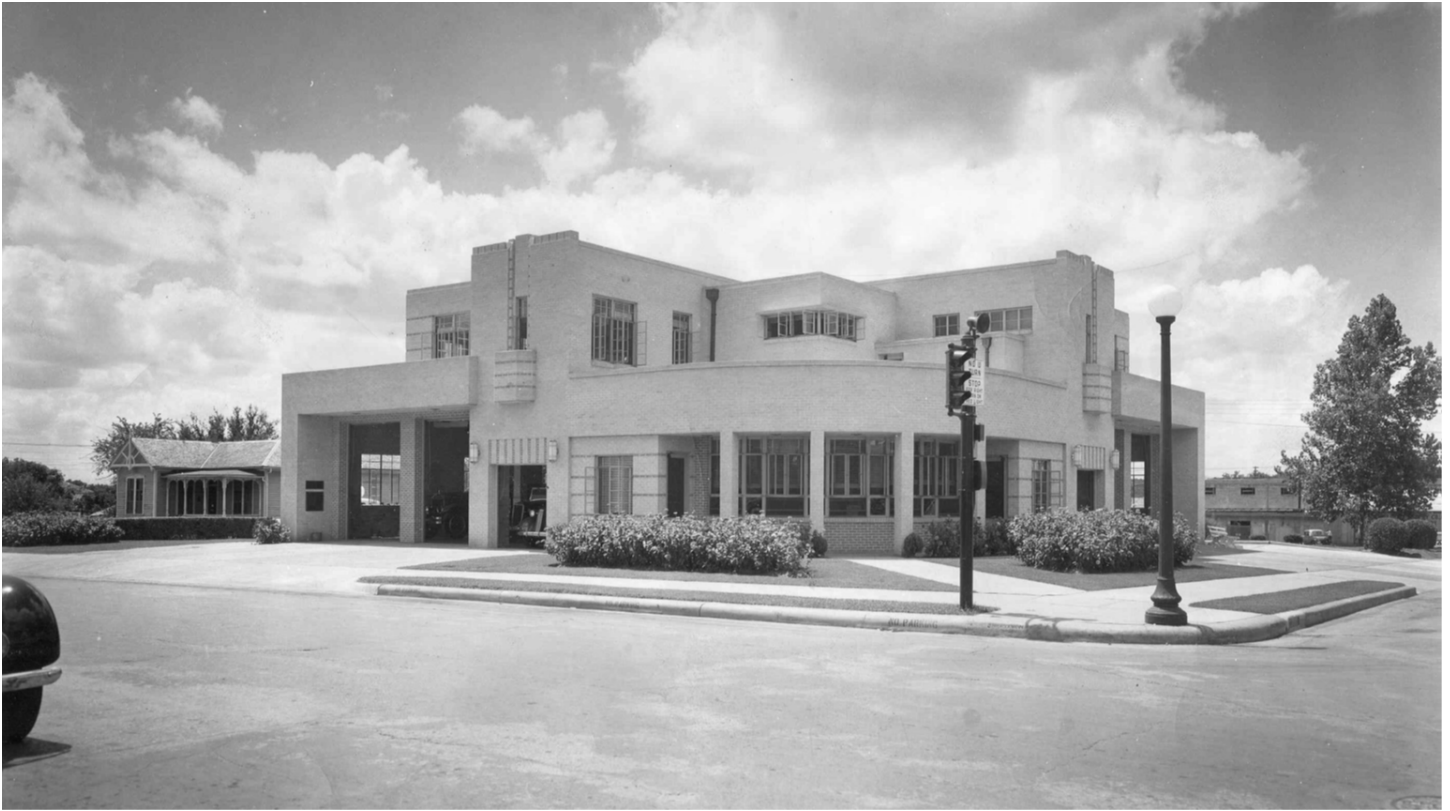
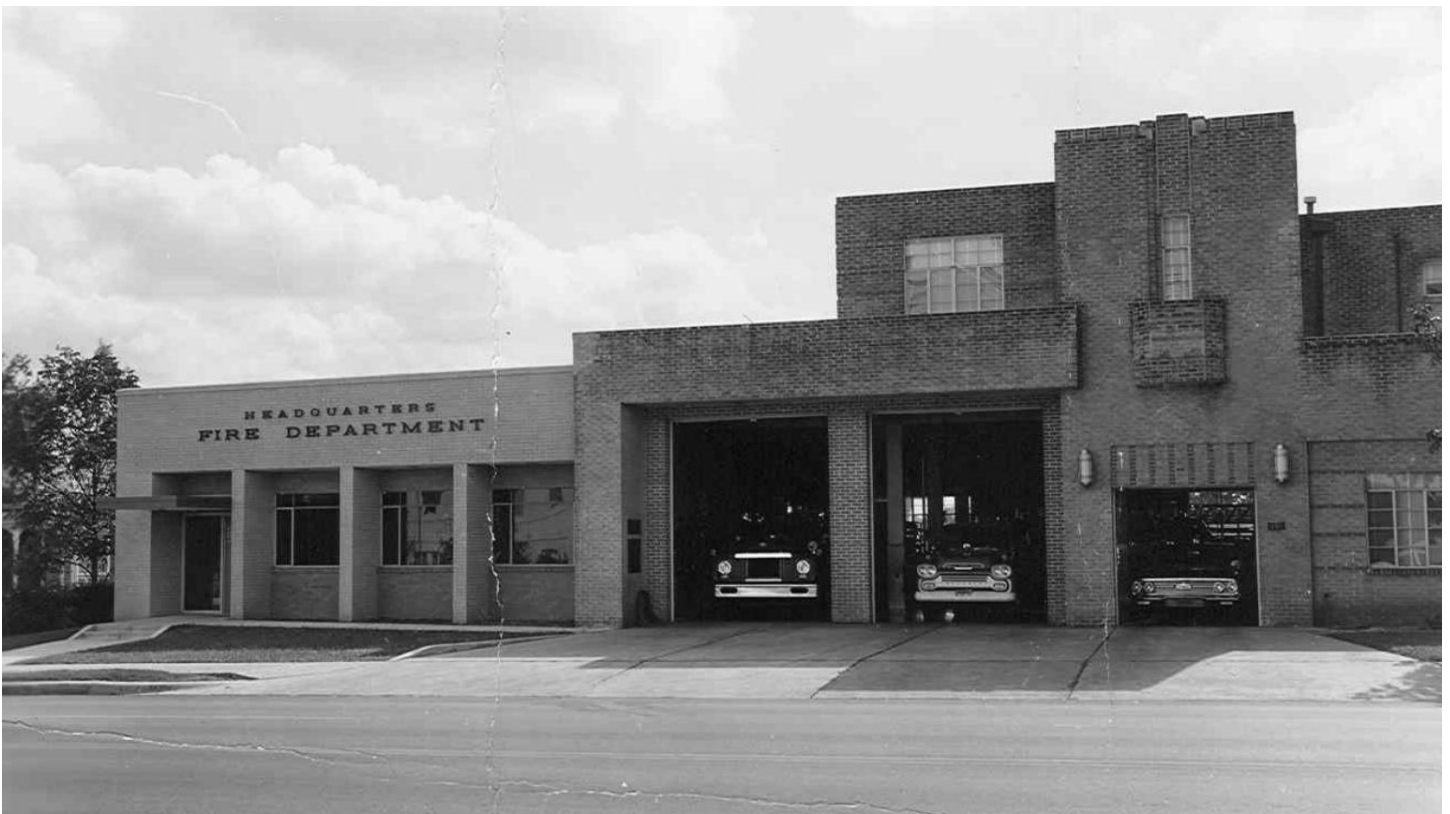
*Historic images of Fire Station #1, before and after construction of the 1962 addition. Provided by applicant.*

The north wing of the building includes a 1-story addition, originally housing the administration offices for the department. Constructed in 1962 (outside of the period of significance for the nomination), this addition is constructed of similar materials. It is characterized by a series of four recessed bays between vertical brick fins.

Though not noted in the nomination, the 1962 annex was designed by architect Eugene Wukasch, known primarily for his ecclesiastical and residential designs and for his involvement in historic preservation.

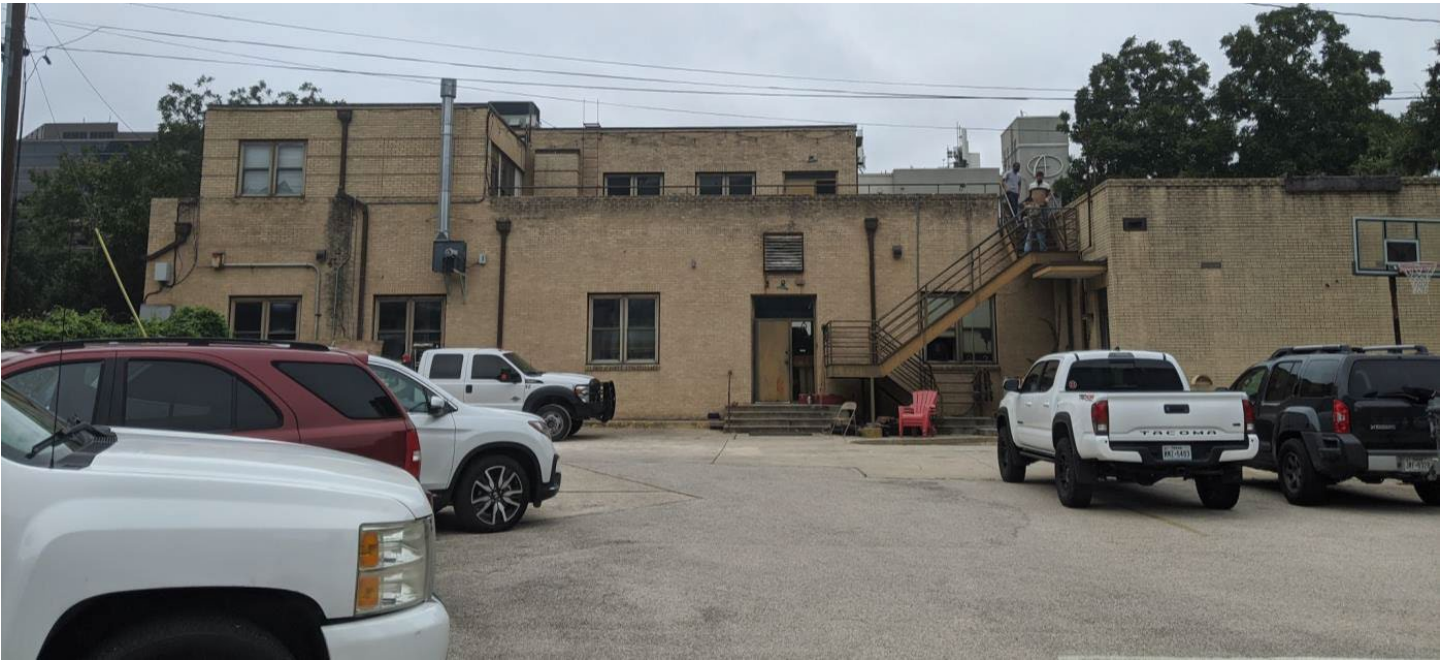
*Rear (south) elevation of the fire station where the addition will be constructed, photograph provided by applicant, 2020.*

The addition is at the back of the building at an inside corner formed by the original footprint and 1962 addition. This allows for the creation of an accessible entrance adjacent to parking, in a location where the addition does not detract from the architecturally significant street-facing elevations. Construction of the addition will not entail removal of an appreciable amount of historic masonry.
