Harmful Algal Blooms

July Water / Wastewater Commission

Brian Haws, P.E.
Operations Manager

July 14, 2021

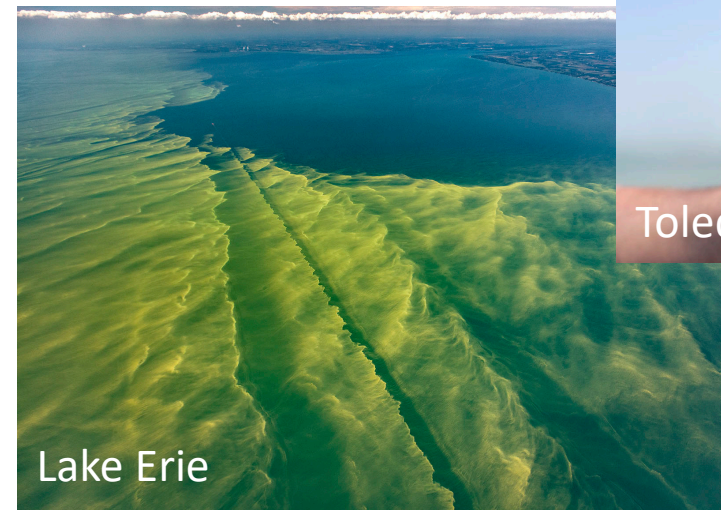
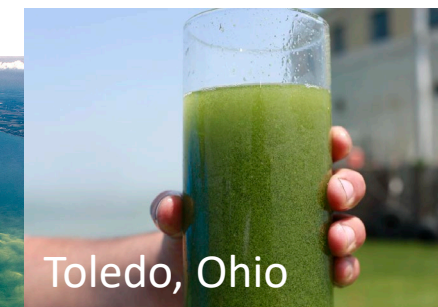
💧 Planktonic blooms

- Free floating microscopic cells
- Suspended in the water column or floating as scum on surface

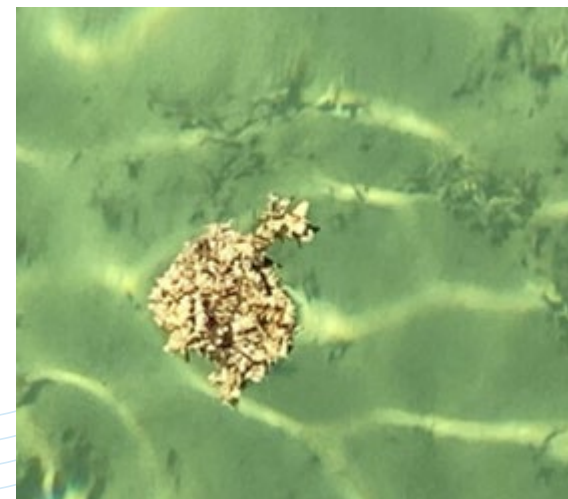
💧 Benthic proliferations

- Originate on bottom of lake in shallow water
- Globbs or mats remain on the bottom or float to the surface

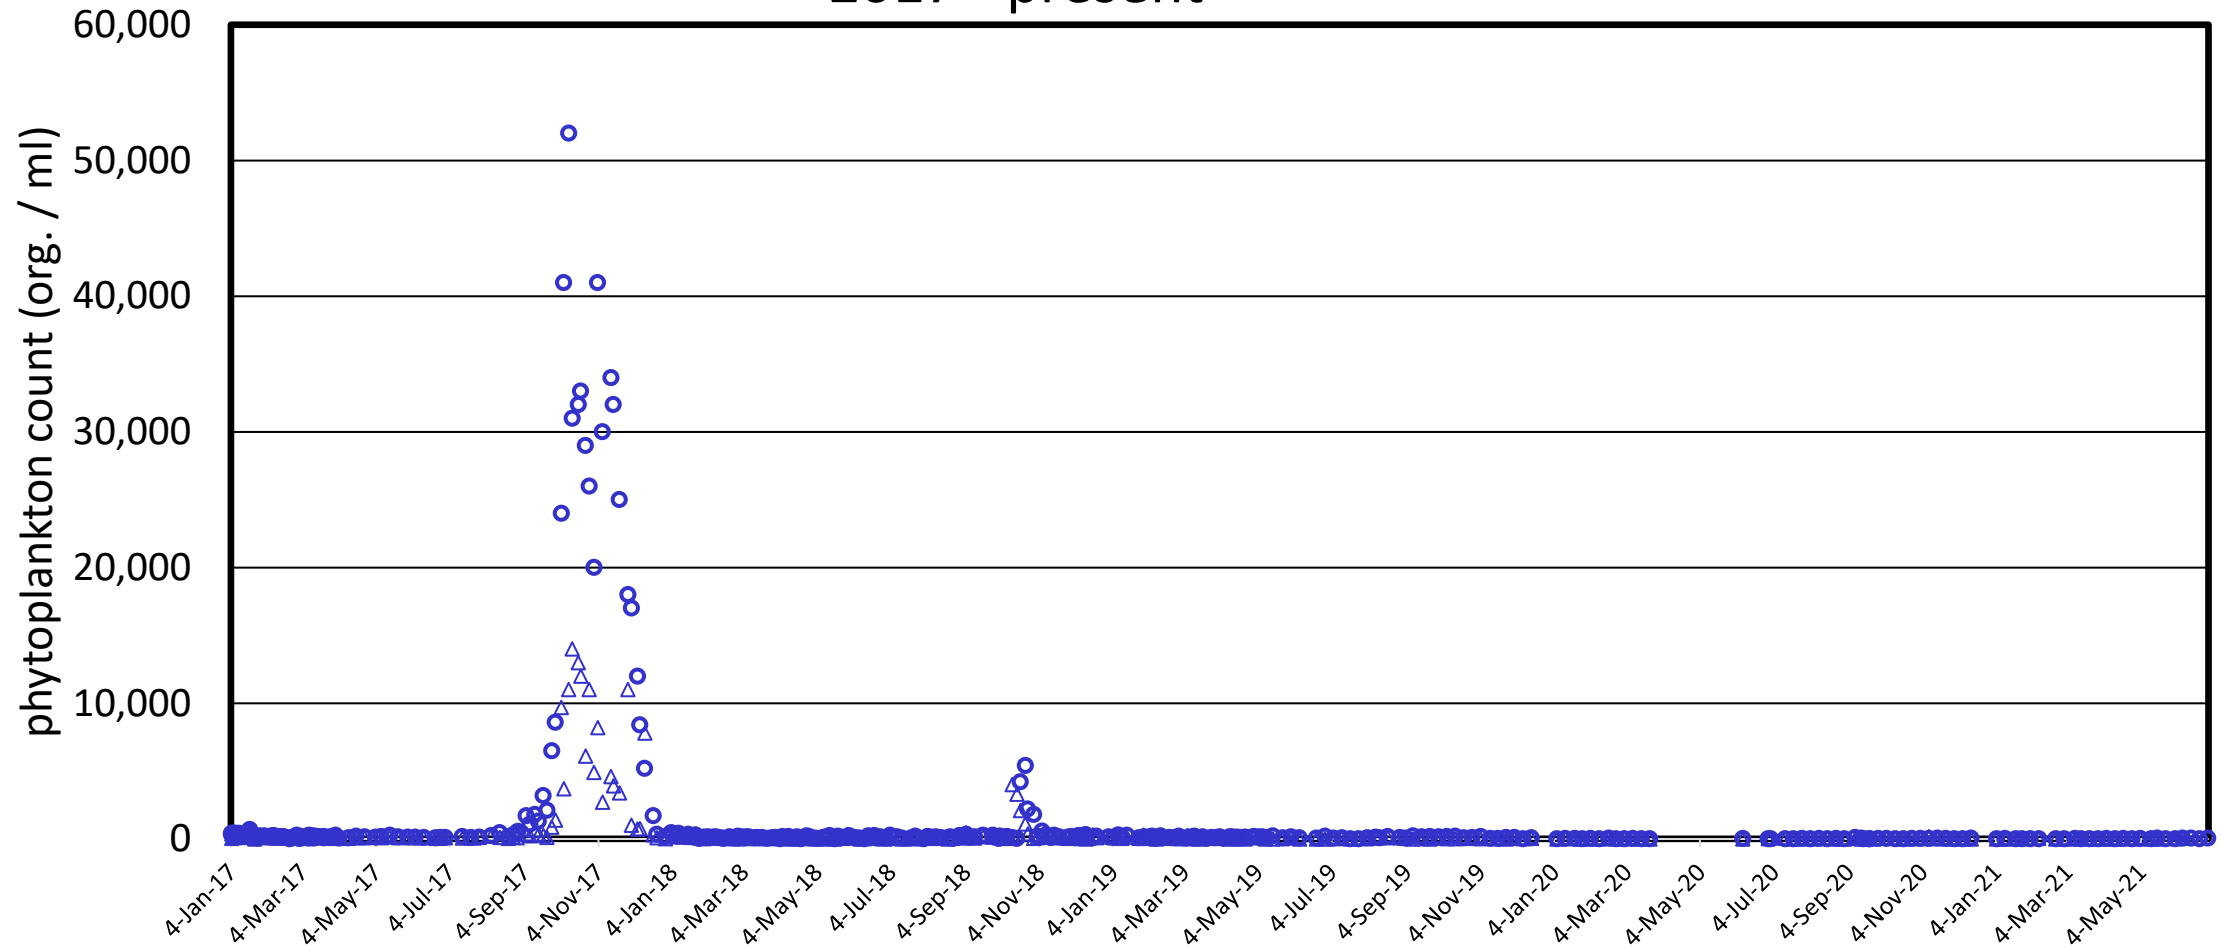
Blue Green Phytoplankton Count 2017 - present

- Routine plankton counts at WTP intakes
 - Focus on blue / green totals
 - Observe trending
 - Adjust monitoring frequency based on current conditions
- Continuous exchange of information
 - Watershed Protection Department
 - Lower Colorado River Authority

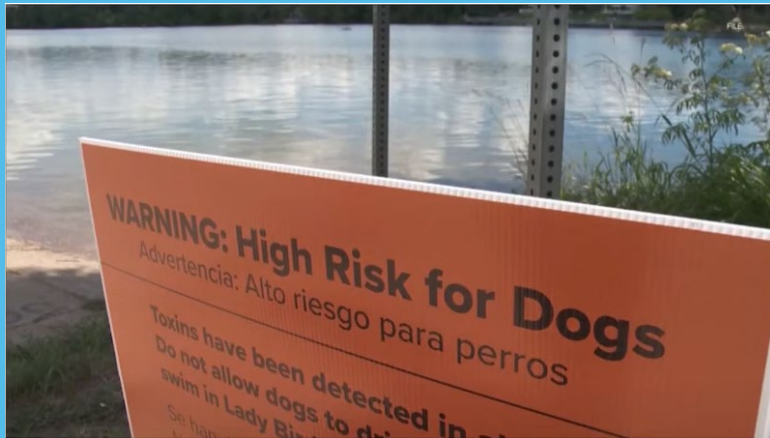
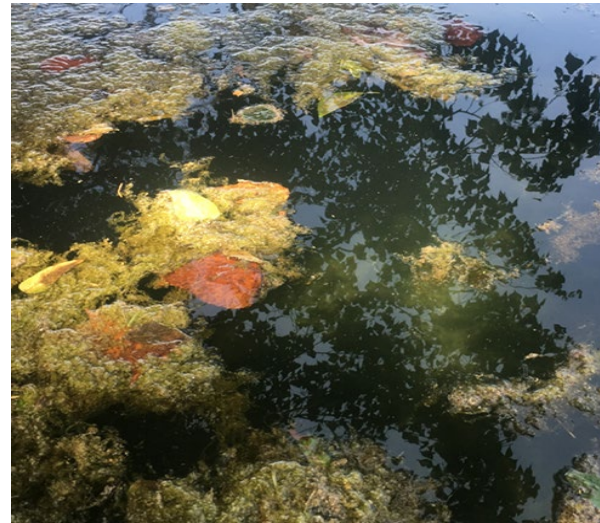
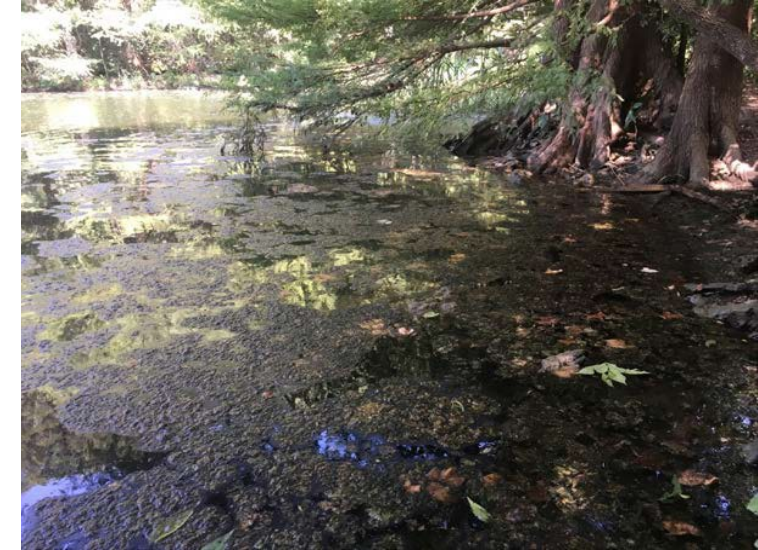
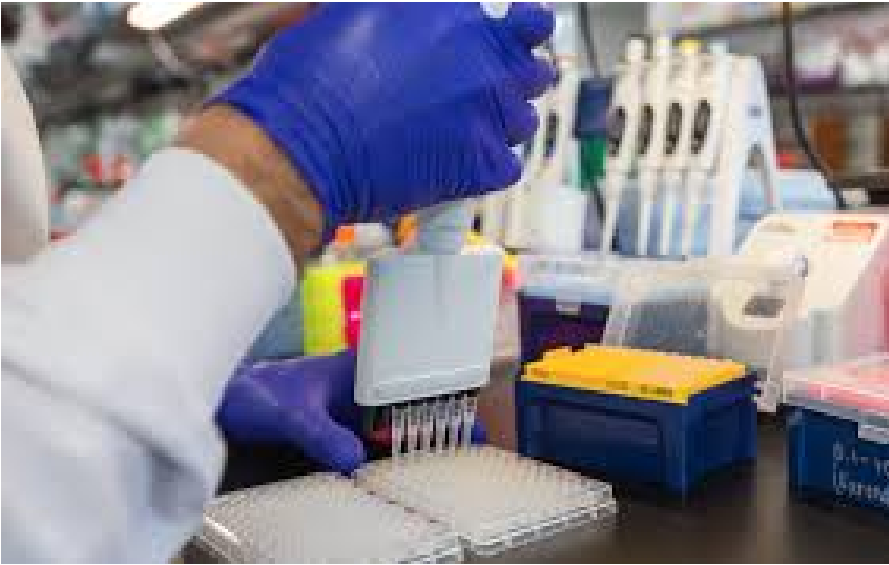
Watershed Protection Department Monitoring

- Biweekly sampling
 - Ladybird Lake (3 sites)
 - Lake Austin (3 sites)
 - Cyanotoxins detected in algae only

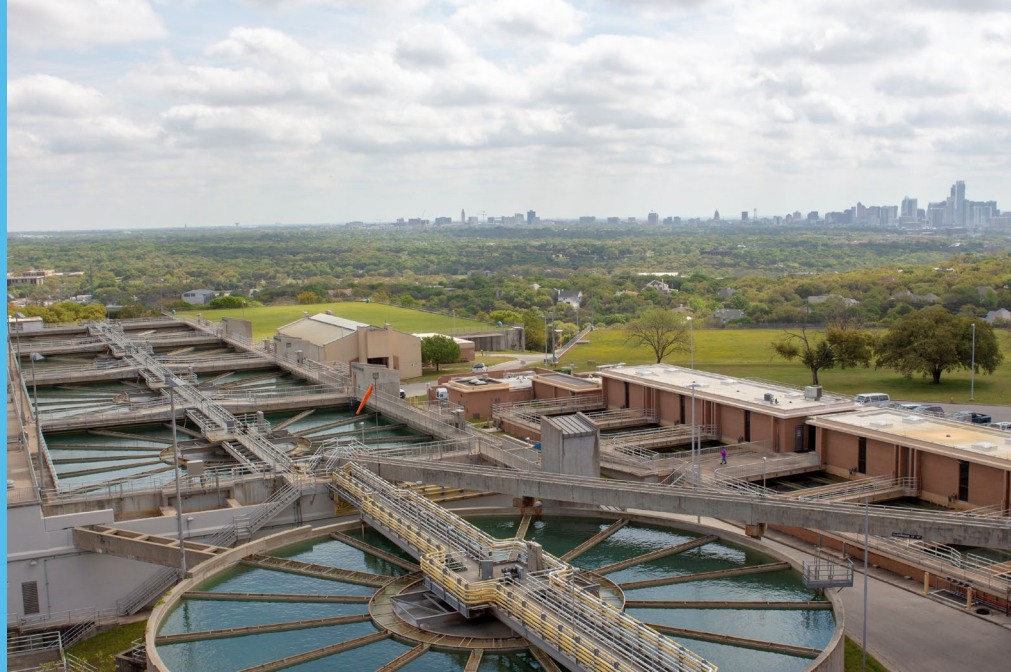
Water Treatment Plant Readiness

- EPA preferred method – conventional treatment
- Additional treatment methods – PAC and oxidation
- Retrofitting for additional chemical capabilities
- Ongoing testing to confirm effectiveness of treatment methods
- Engage consultants for guidance and broader perspective
