MEMORANDUM

CASE: Tree Permit ROW ID 12709593

REQUEST: Right-of-Way Protected Tree Removal Appeal

Re: Denial of request to remove –20-inch Cottonwood in the Right-of-Way (ROW) located at

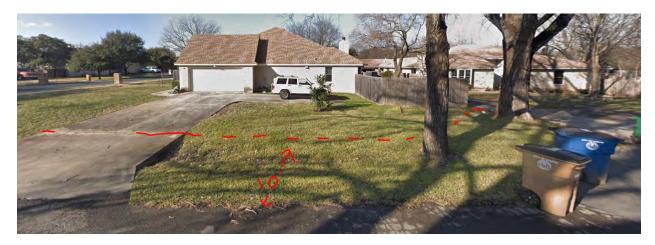
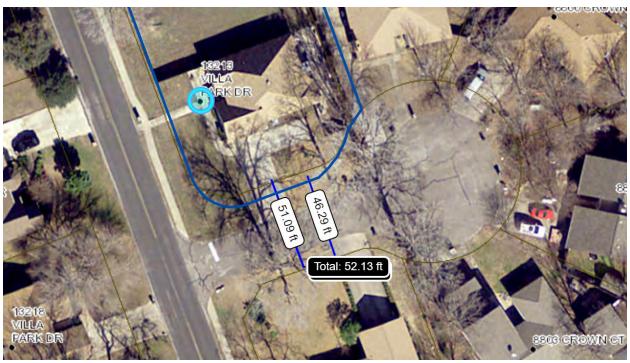
On August 26, 2020 the Program Manager visited the site with another PWF Arborist. A conditional assessment was performed on the 20-inch Cottonwood. This tree had tight bark, good scaffold structure, and no evidence of insects or fungal conks. The canopy was moderately dense with healthy green leaves and no evidence of any large branch failure. For these reasons, PWF again denied permission to remove the 20-inch Cottonwood.

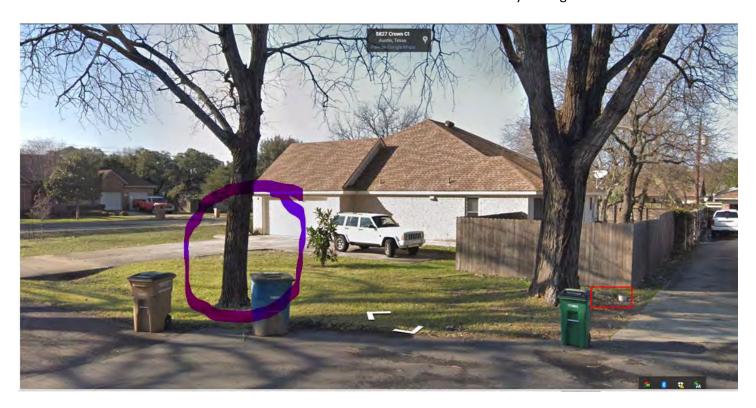
Good morning. I did an on-site assessment of the now 21" diameter cottonwood in the City of Austin right of way adjacent to your property on March 15, 2021. I made note of the tree's condition as the growing season is beginning. I observed the canopy full of catkins and noted of the number and size of the broken branches within the canopy. This tree is in very good condition and assessed to be a low risk tree. My assessment worksheet is attached so that you can see how a Tree Risk Assessment Qualified arborist systematically comes to this conclusion. This system is recognized worldwide as a means to assess a tree's risk to pedestrians, vehicles and stationary structures like houses.

I measured the distance from the water meter (red box next to drive) to the trunk of the 21"diameter tree, circled in purple, as approximately 28 feet. The invoice that you provided from your contractor made no mention of the break in the pipe resulting from a tree root. I have no photos to document your claim that a root caused the break. Hence, I cannot conclude that this tree 28 feet away is the reason for the break in the pipe next to your water meter. I am sorry for the inconvenience this leak caused but the tree will not be removed based on my findings.

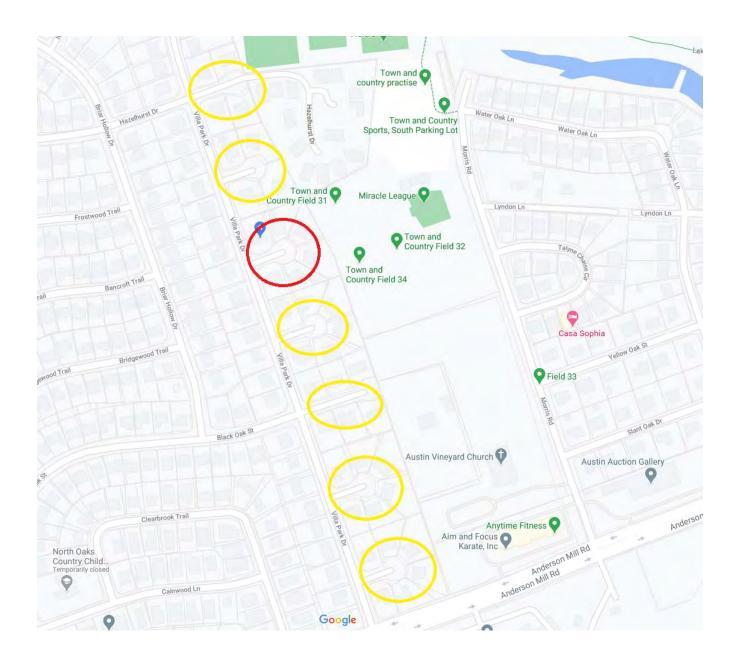
- Michael Alvis, from Austin Water, provided repair details for water main repairs from 2000-2020. The City of Austin incurred over \$61,000 in water main repairs in the last 20 years due to these trees.
- The work order dates indicate that at least 8 repairs have been done in the last 20 years.
- Urban Forester has been provided this data directly from Mr. Alvis.

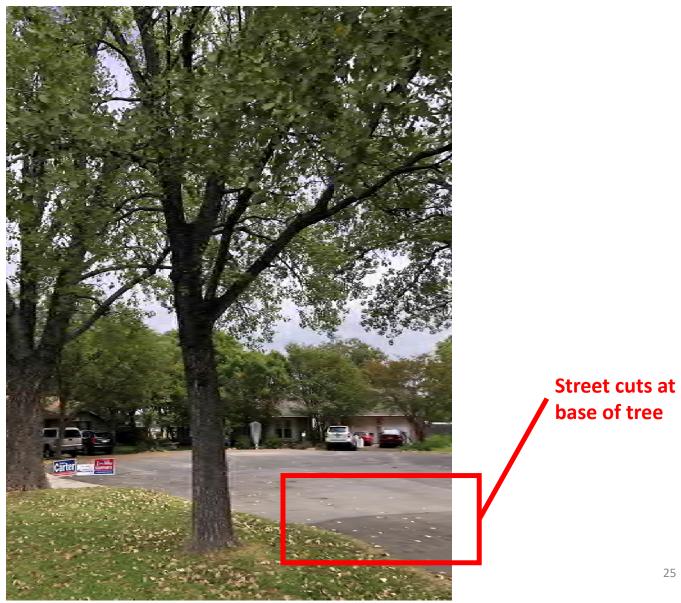
- Base of tree is within inches of the street pavement.
- Street cuts from water main repairs are at the tree.
- Street cuts directly adjacent to this tree indicate that this tree is at least responsible for some of the damage to the water mains.

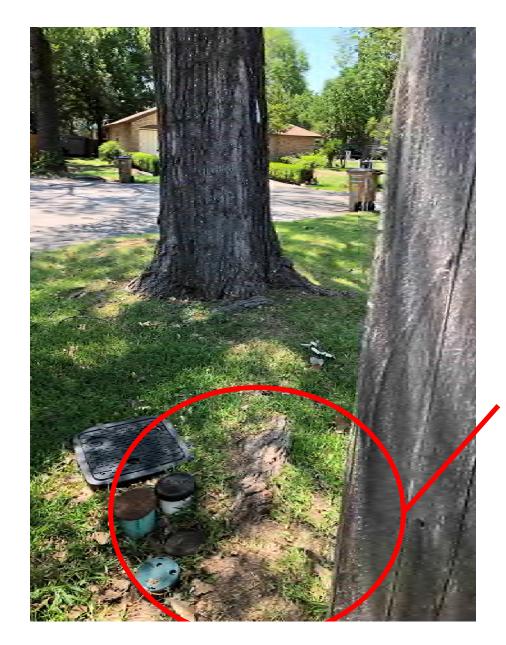
34" Tree – roots visibly bending water valves on the surface. Urban Forester refused to acknowledge this fact. B-8 51 of 73

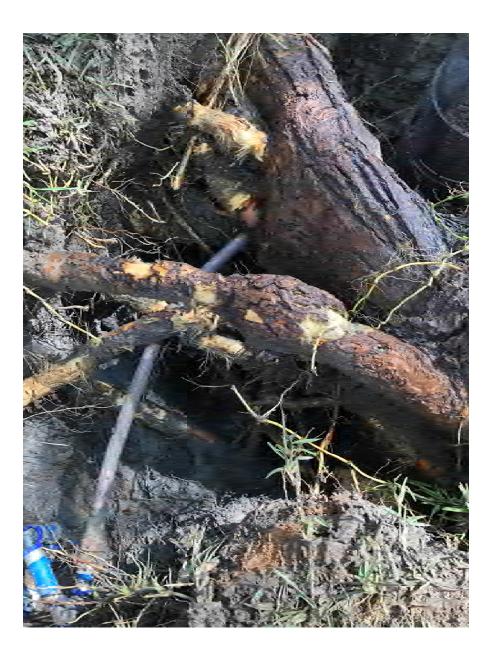
Root was excavated by Austin Water – Roots are clearly destroying pipes. 52 of 73

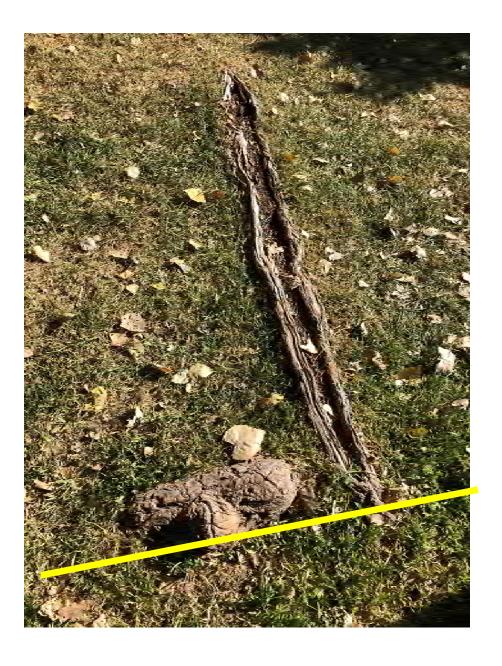
Large root from 20"
Cottonwood tree over
my water main. Has
previously caused
damage to my pipes.
Yellow line indicates
approximate location of
water line.
