**1104 Charlotte St**

**Kindra Welch and family**

**9/13/2021**

**Clarksville Cottage constructed approx 1920**

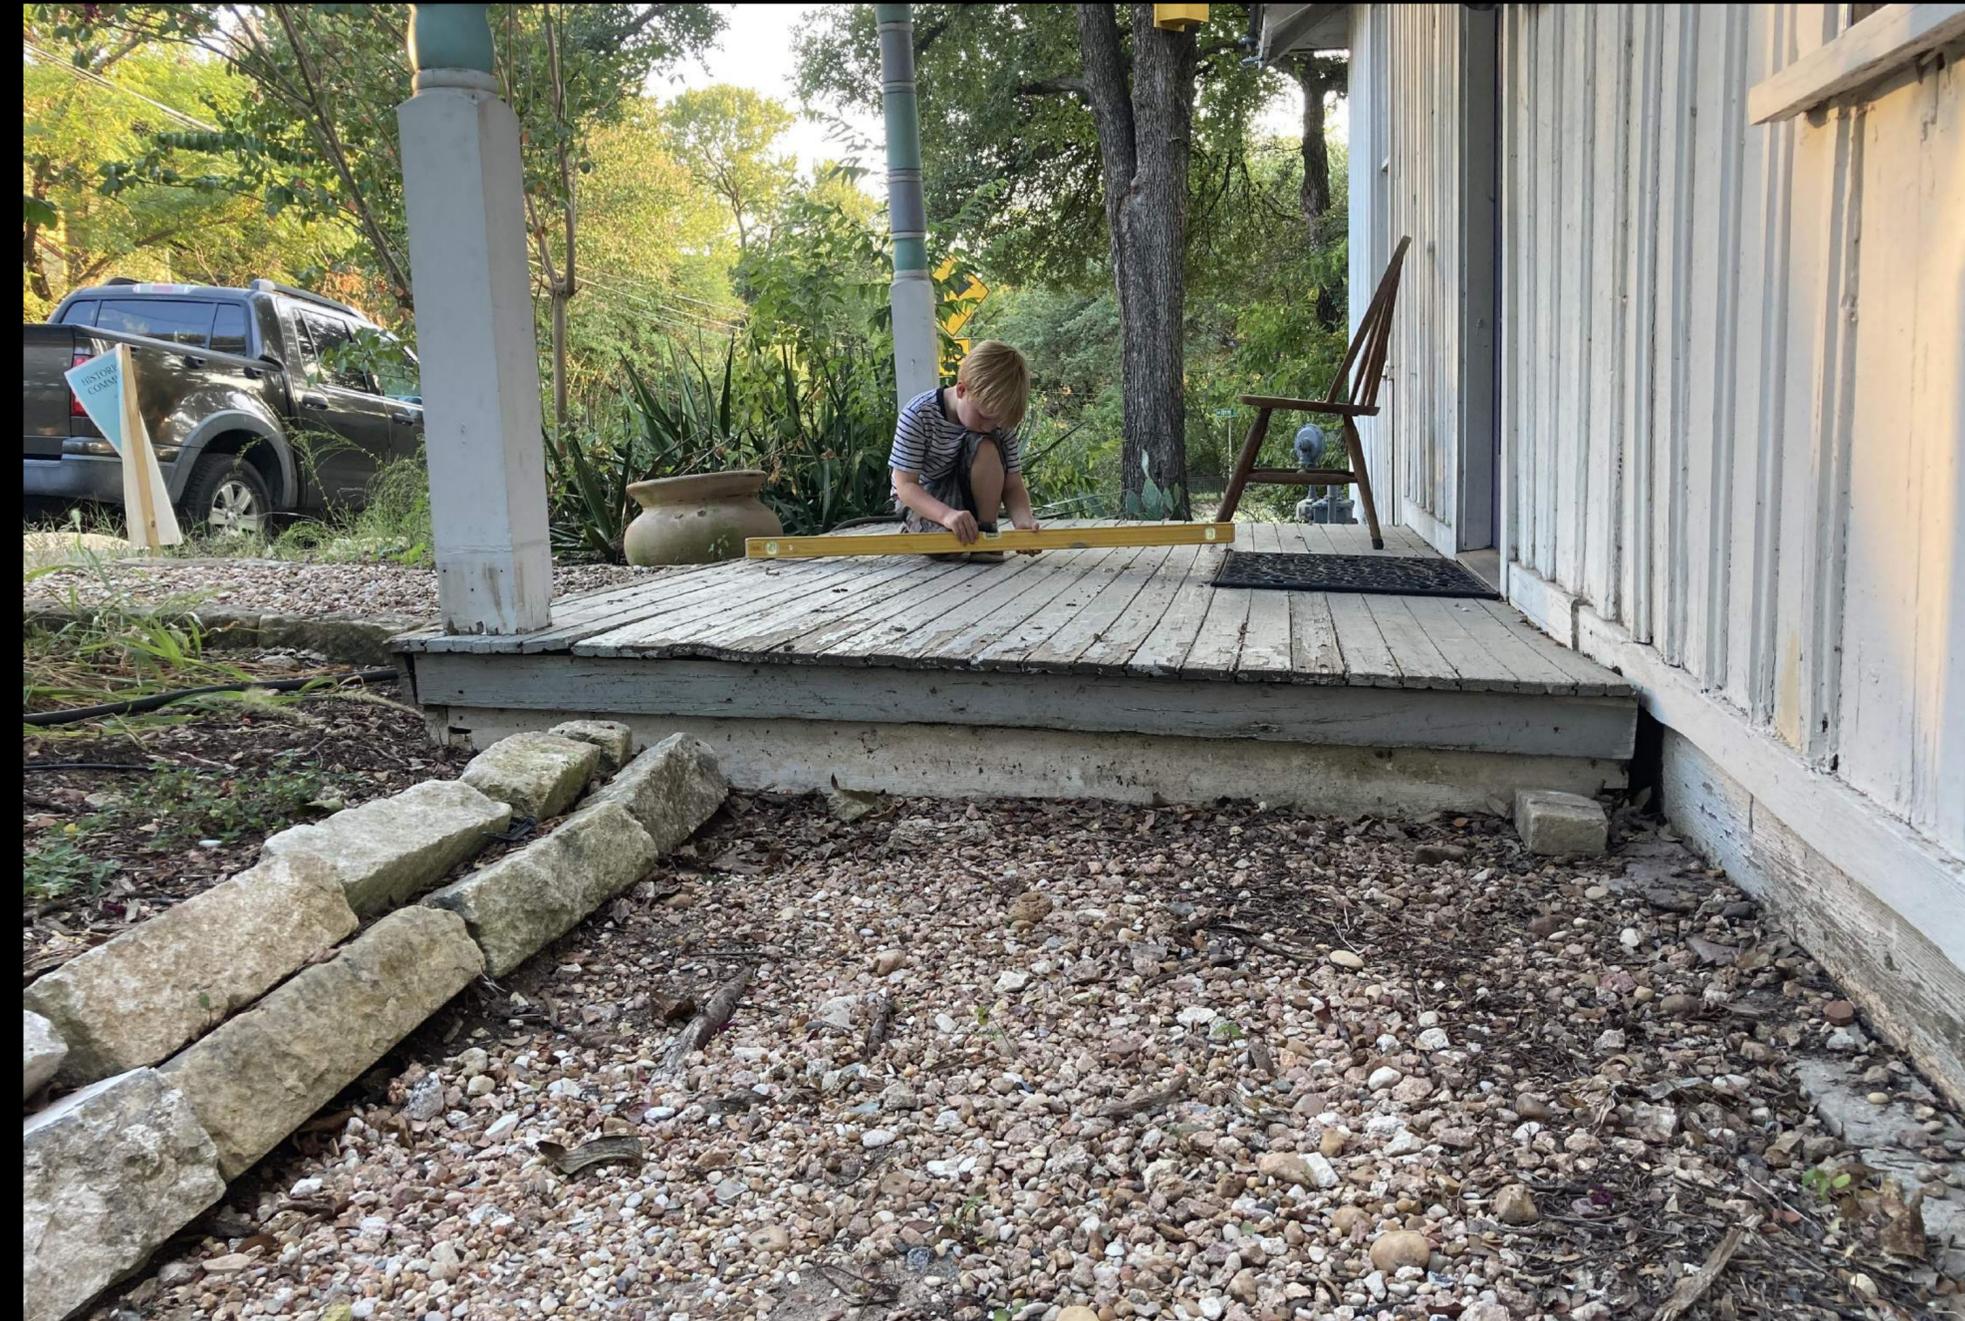
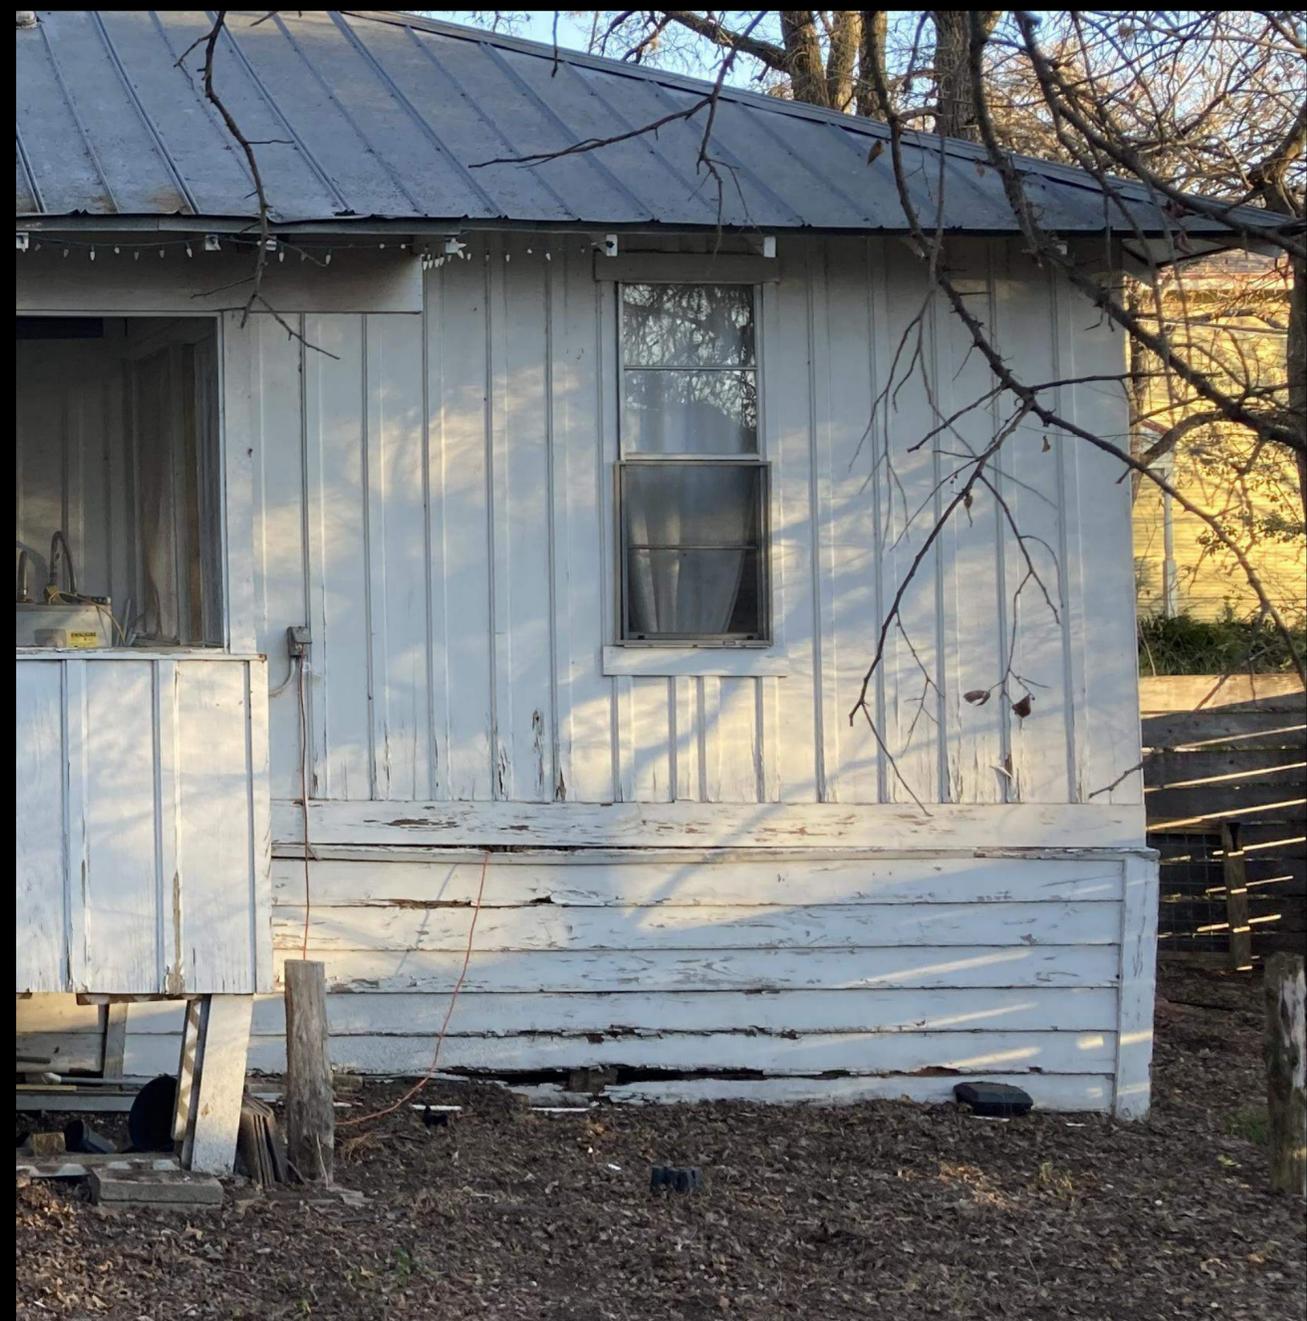
**minor structural issues with original Juniper piers**

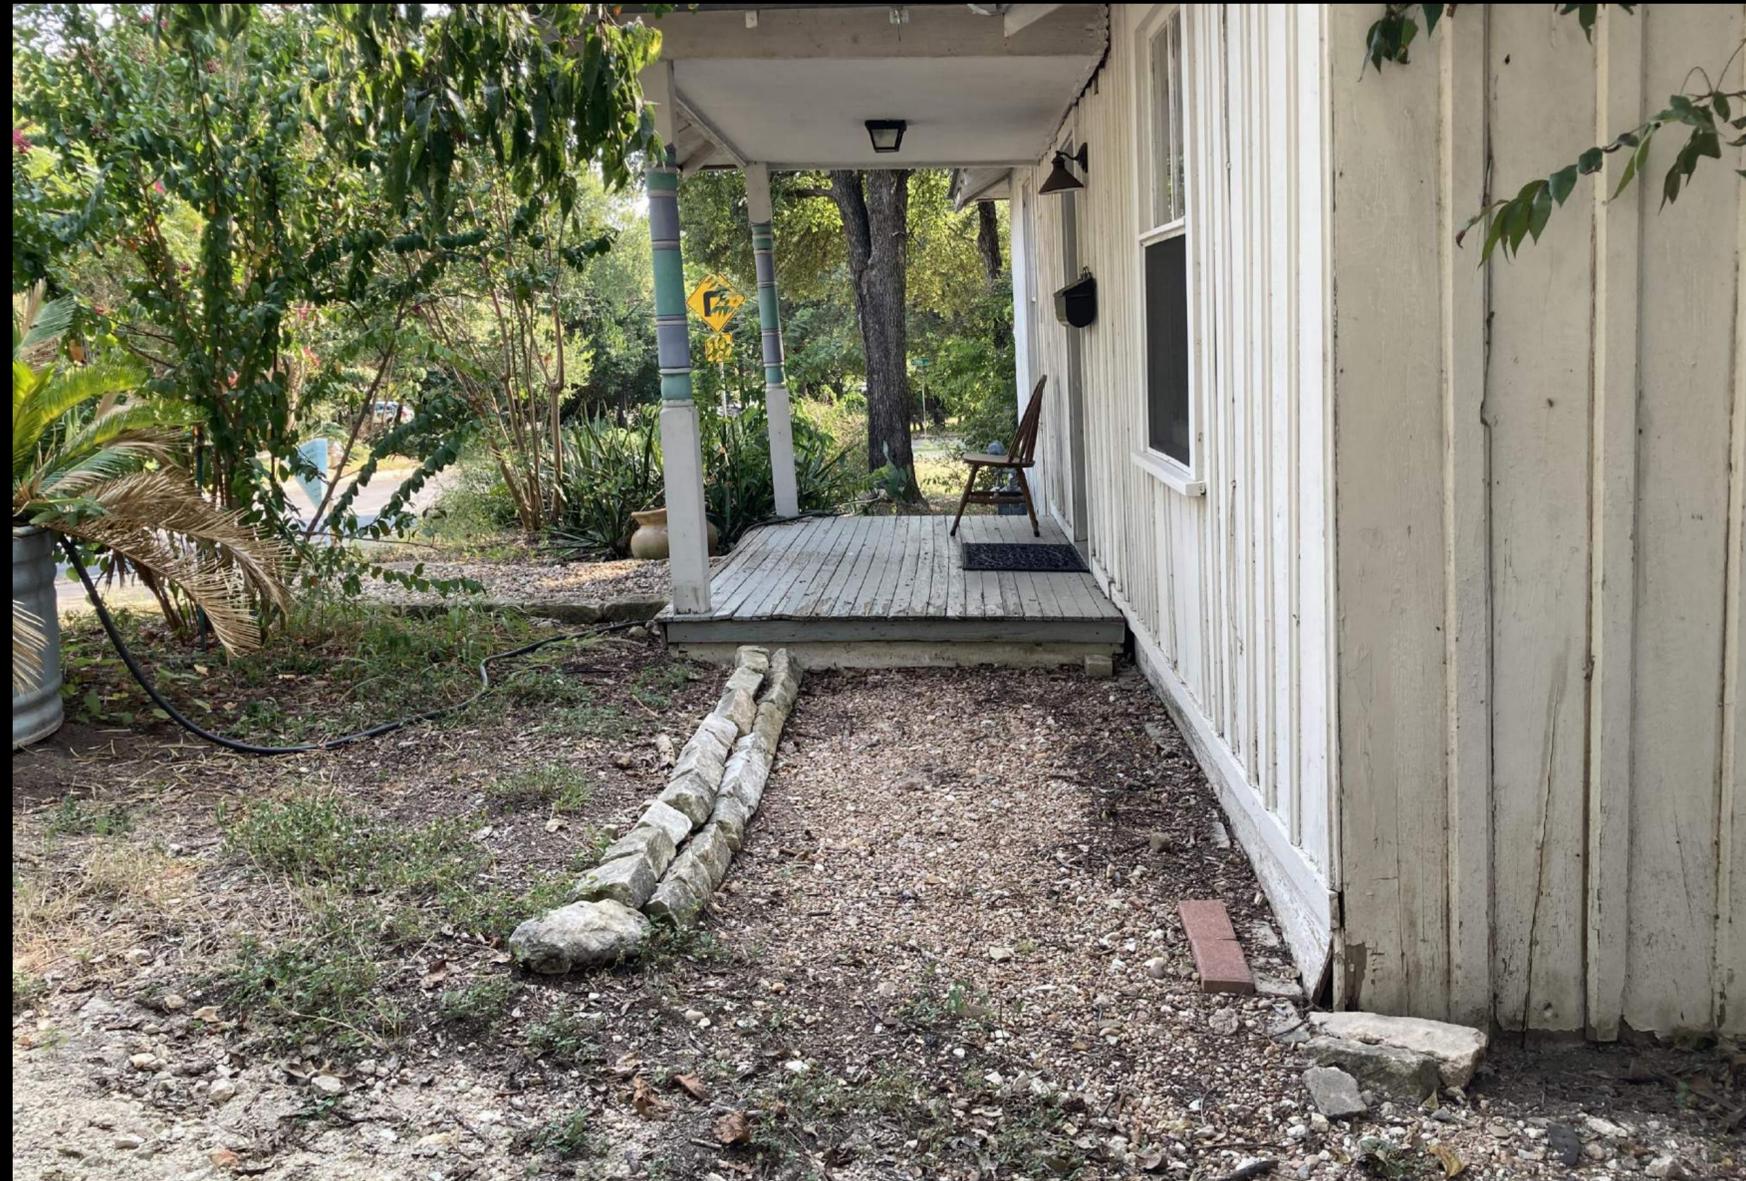
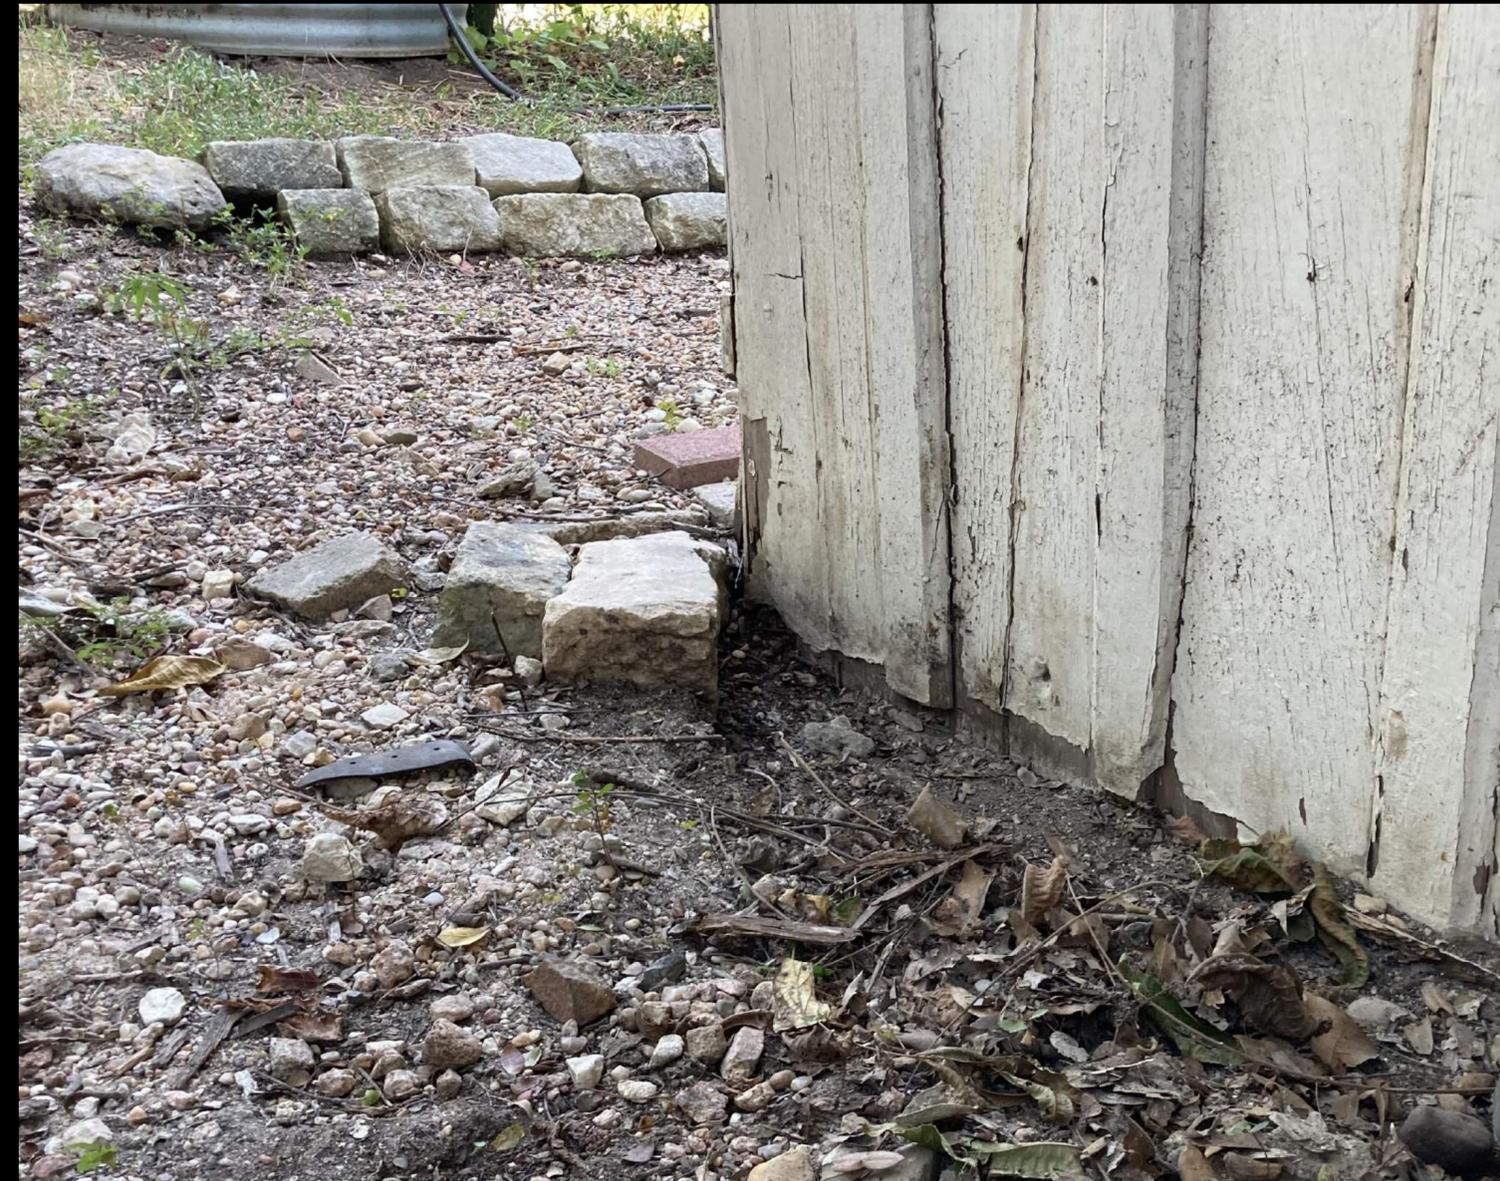
# Threats to the House:

1. Eastern front corner sits directly on the ground enabling deterioration of wood structure and a near constant termite invasion

- 1. One corner sits directly in contact with the ground.**
- 2. Driveway slopes towards the house**
- 3. The house is the focal point of 12th street traffic.**

**Significantly Raise the House**

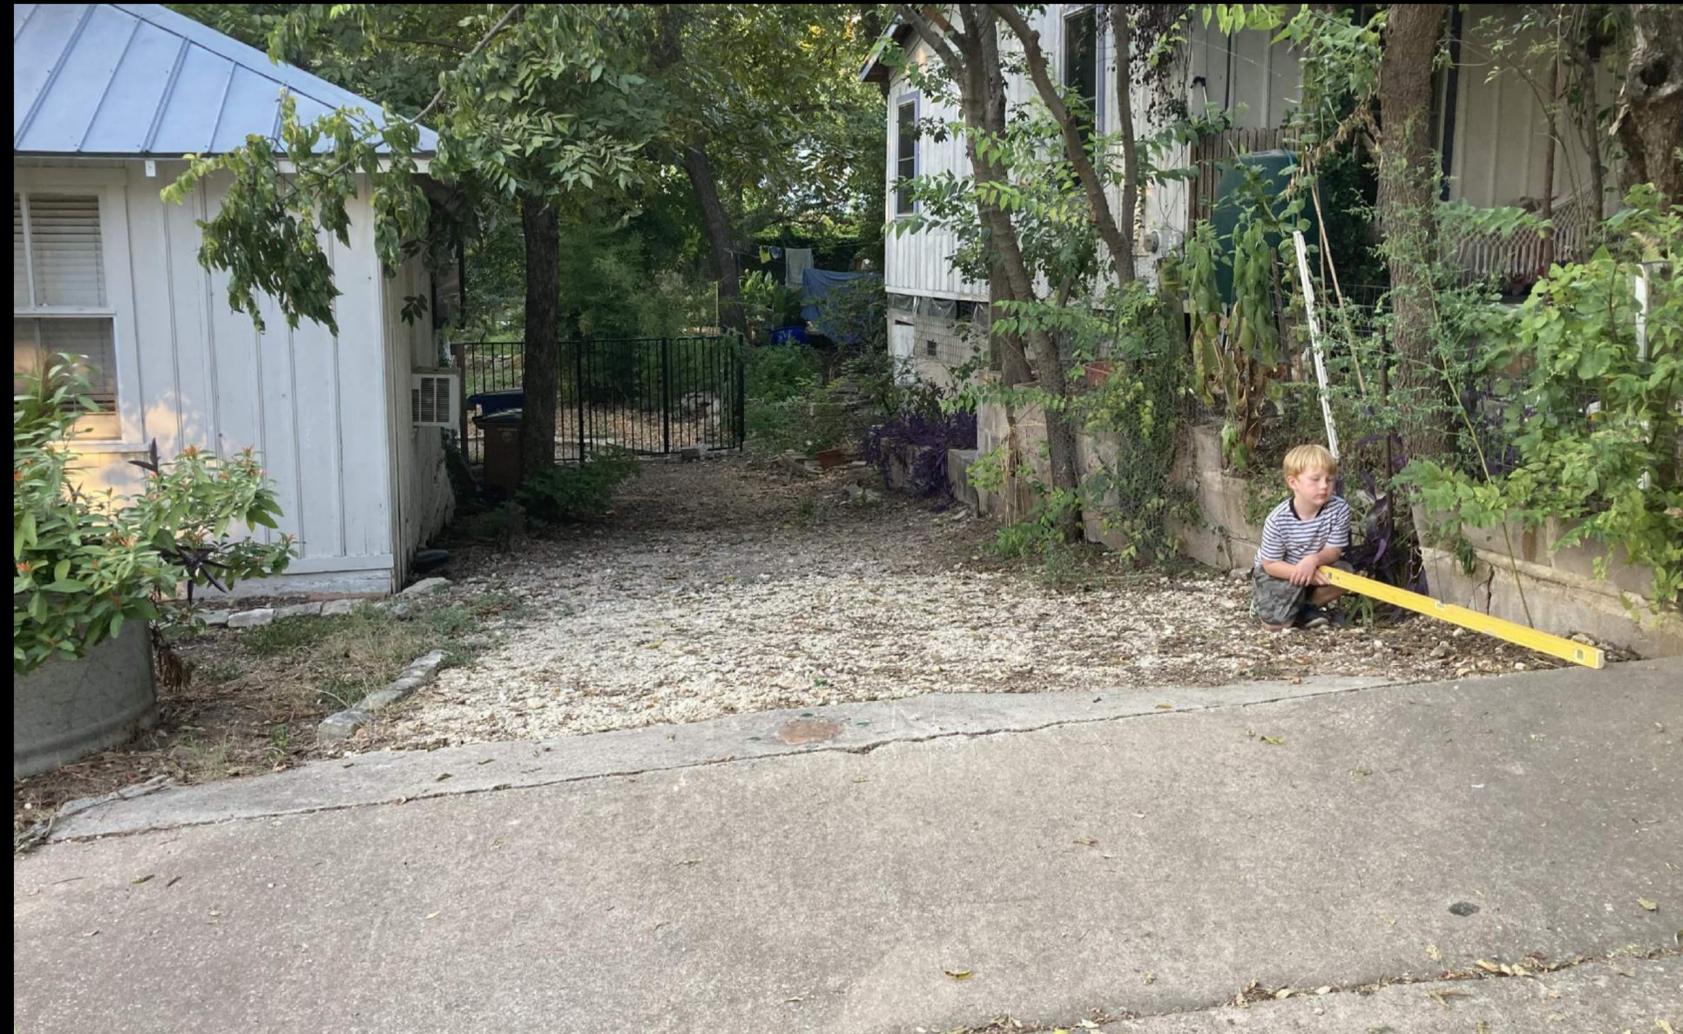
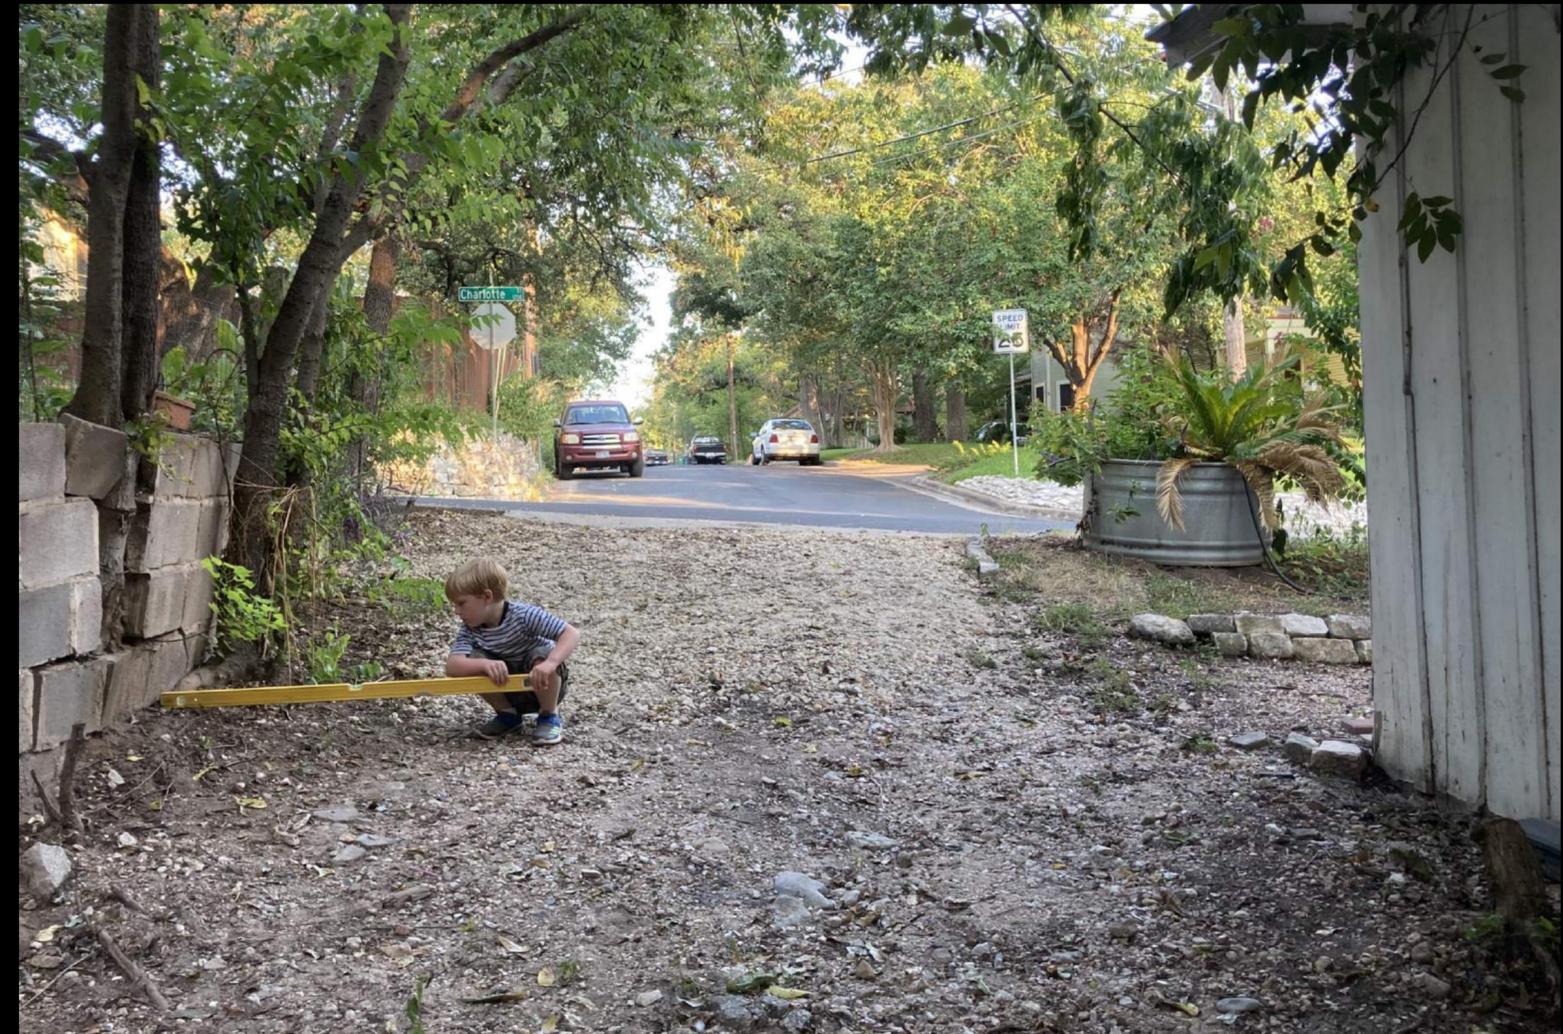
# Threats to the House:

## 2. Driveway slopes towards the house

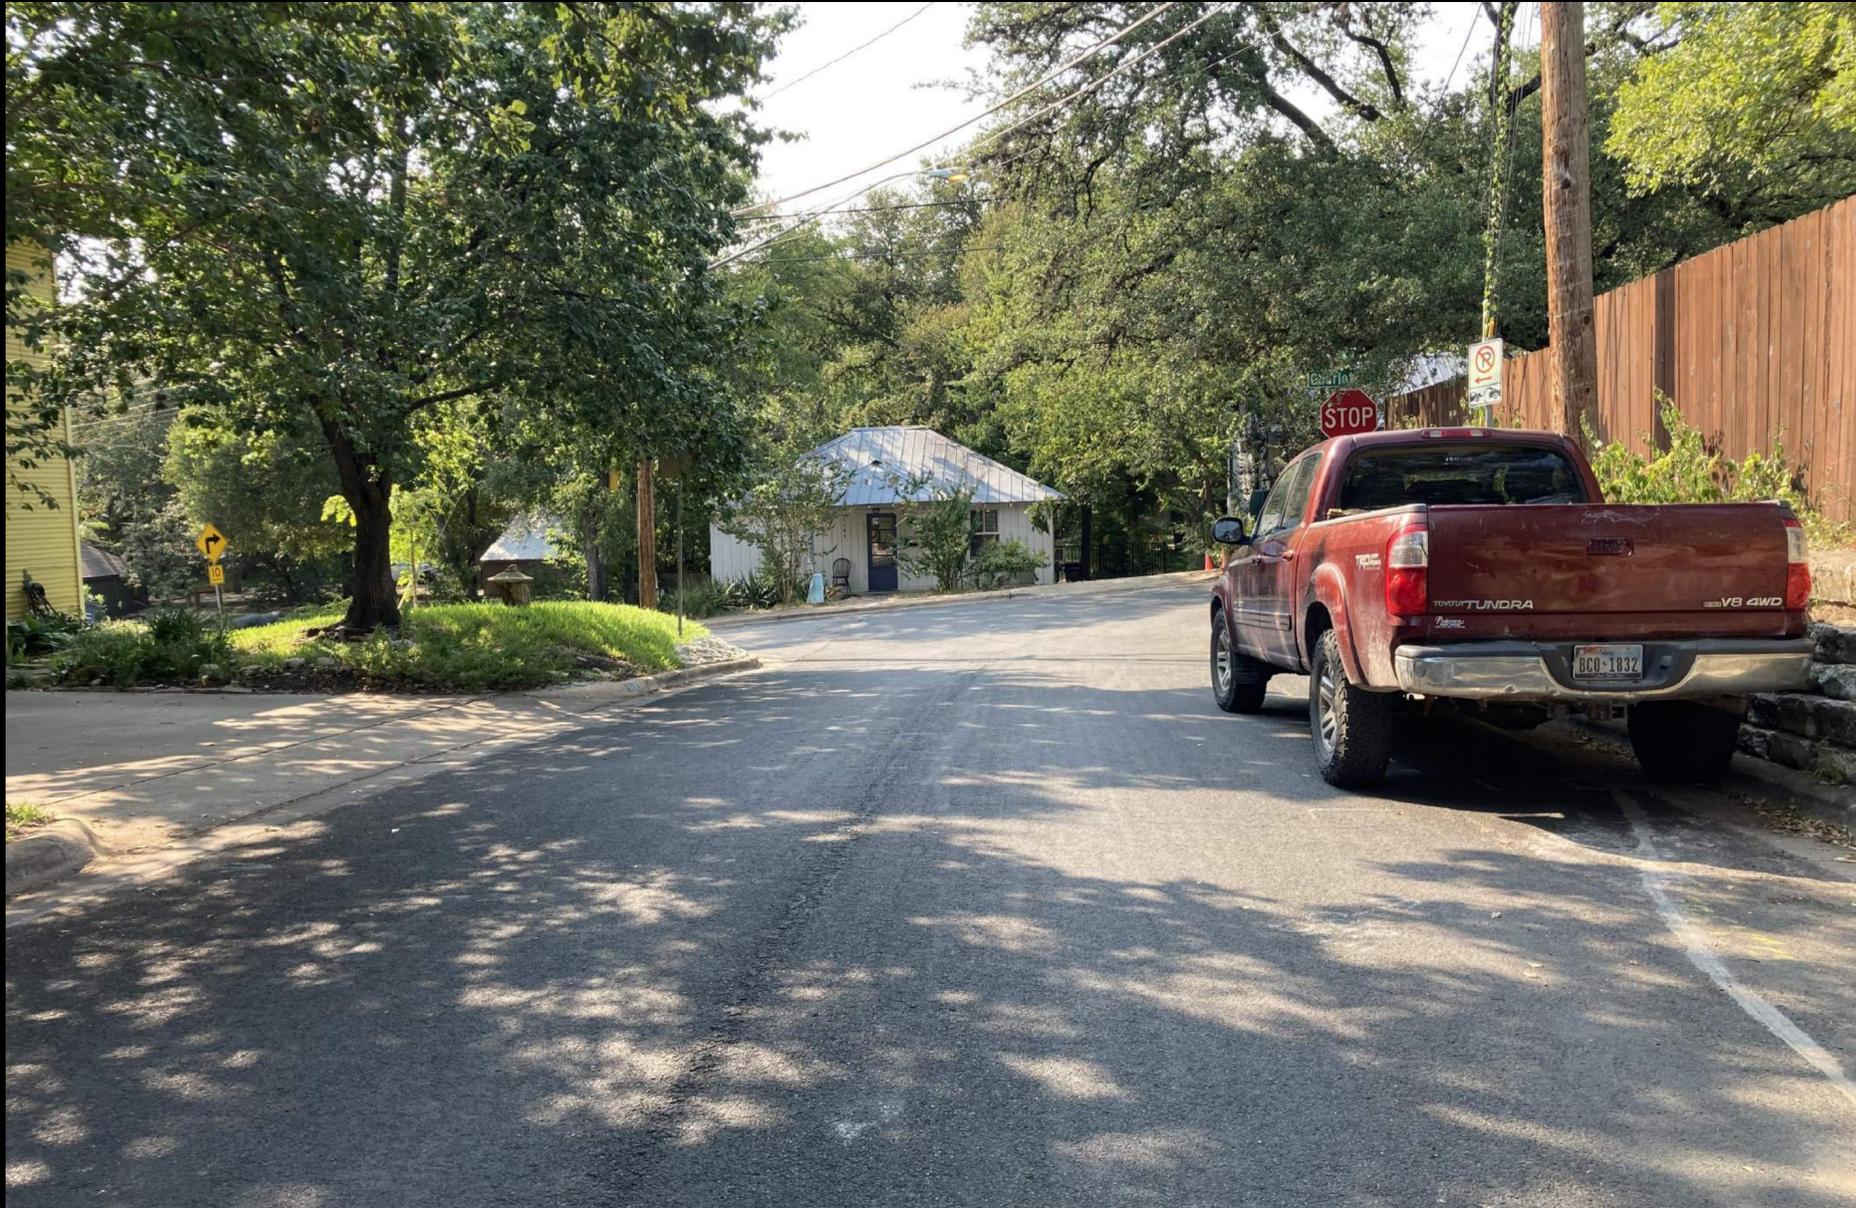
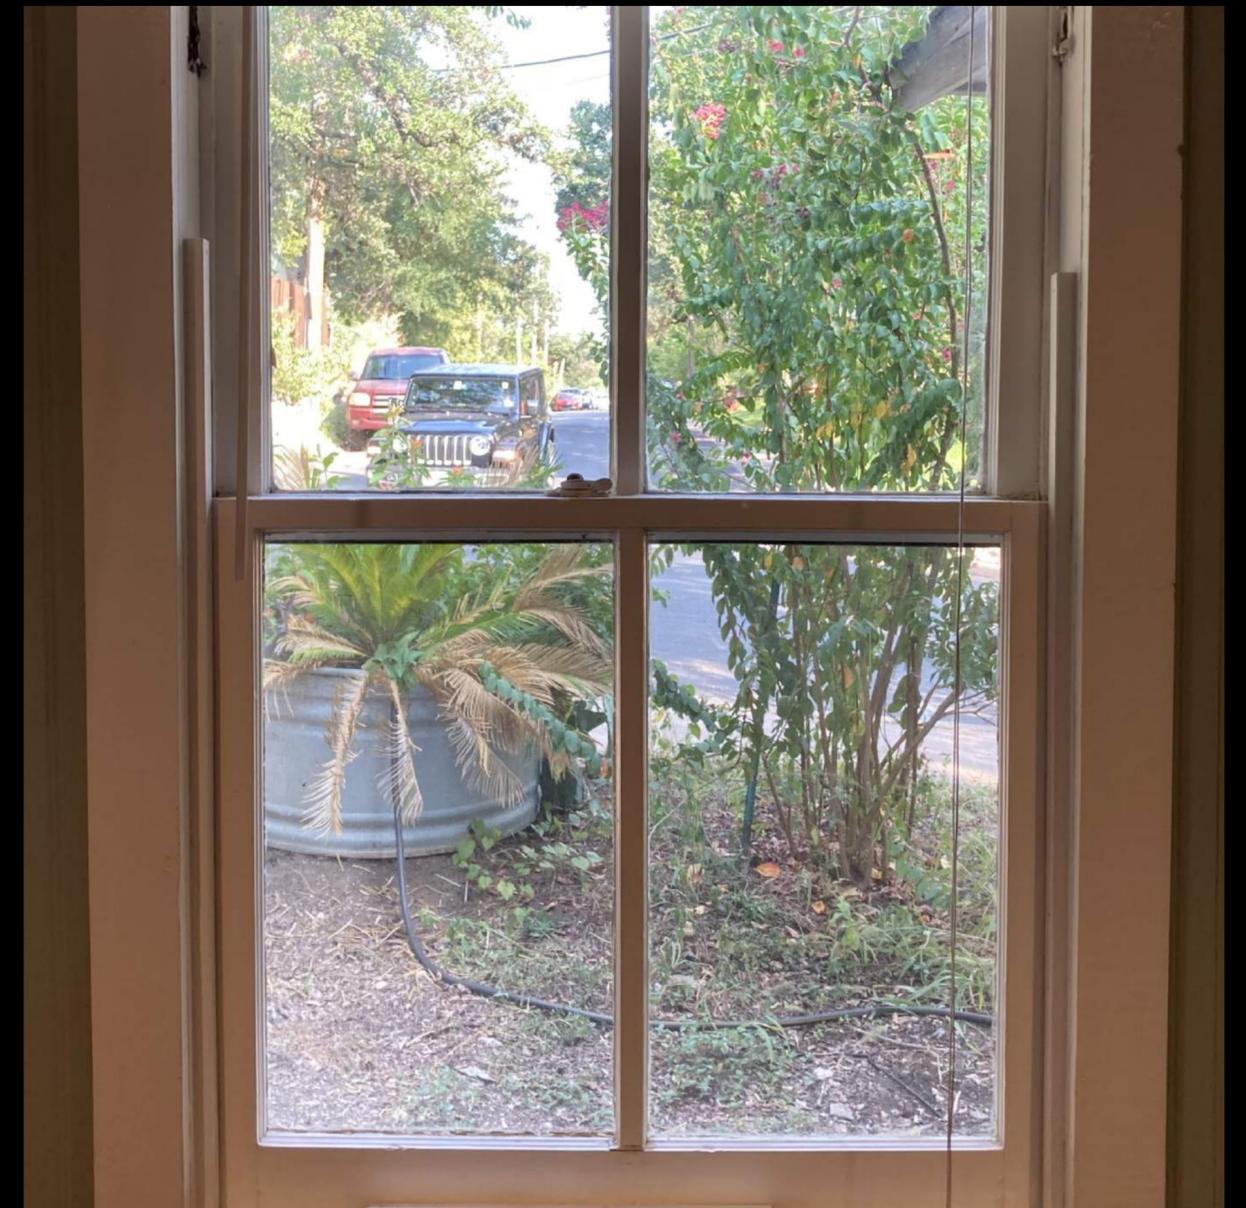
## Threats to the House:

3. The house is the focal point of 12th street traffic, including restaurant and retail traffic from commercial area 1 block away. New Years Eve '03-'04 a driver crashed his truck through the front wall and into the living room.

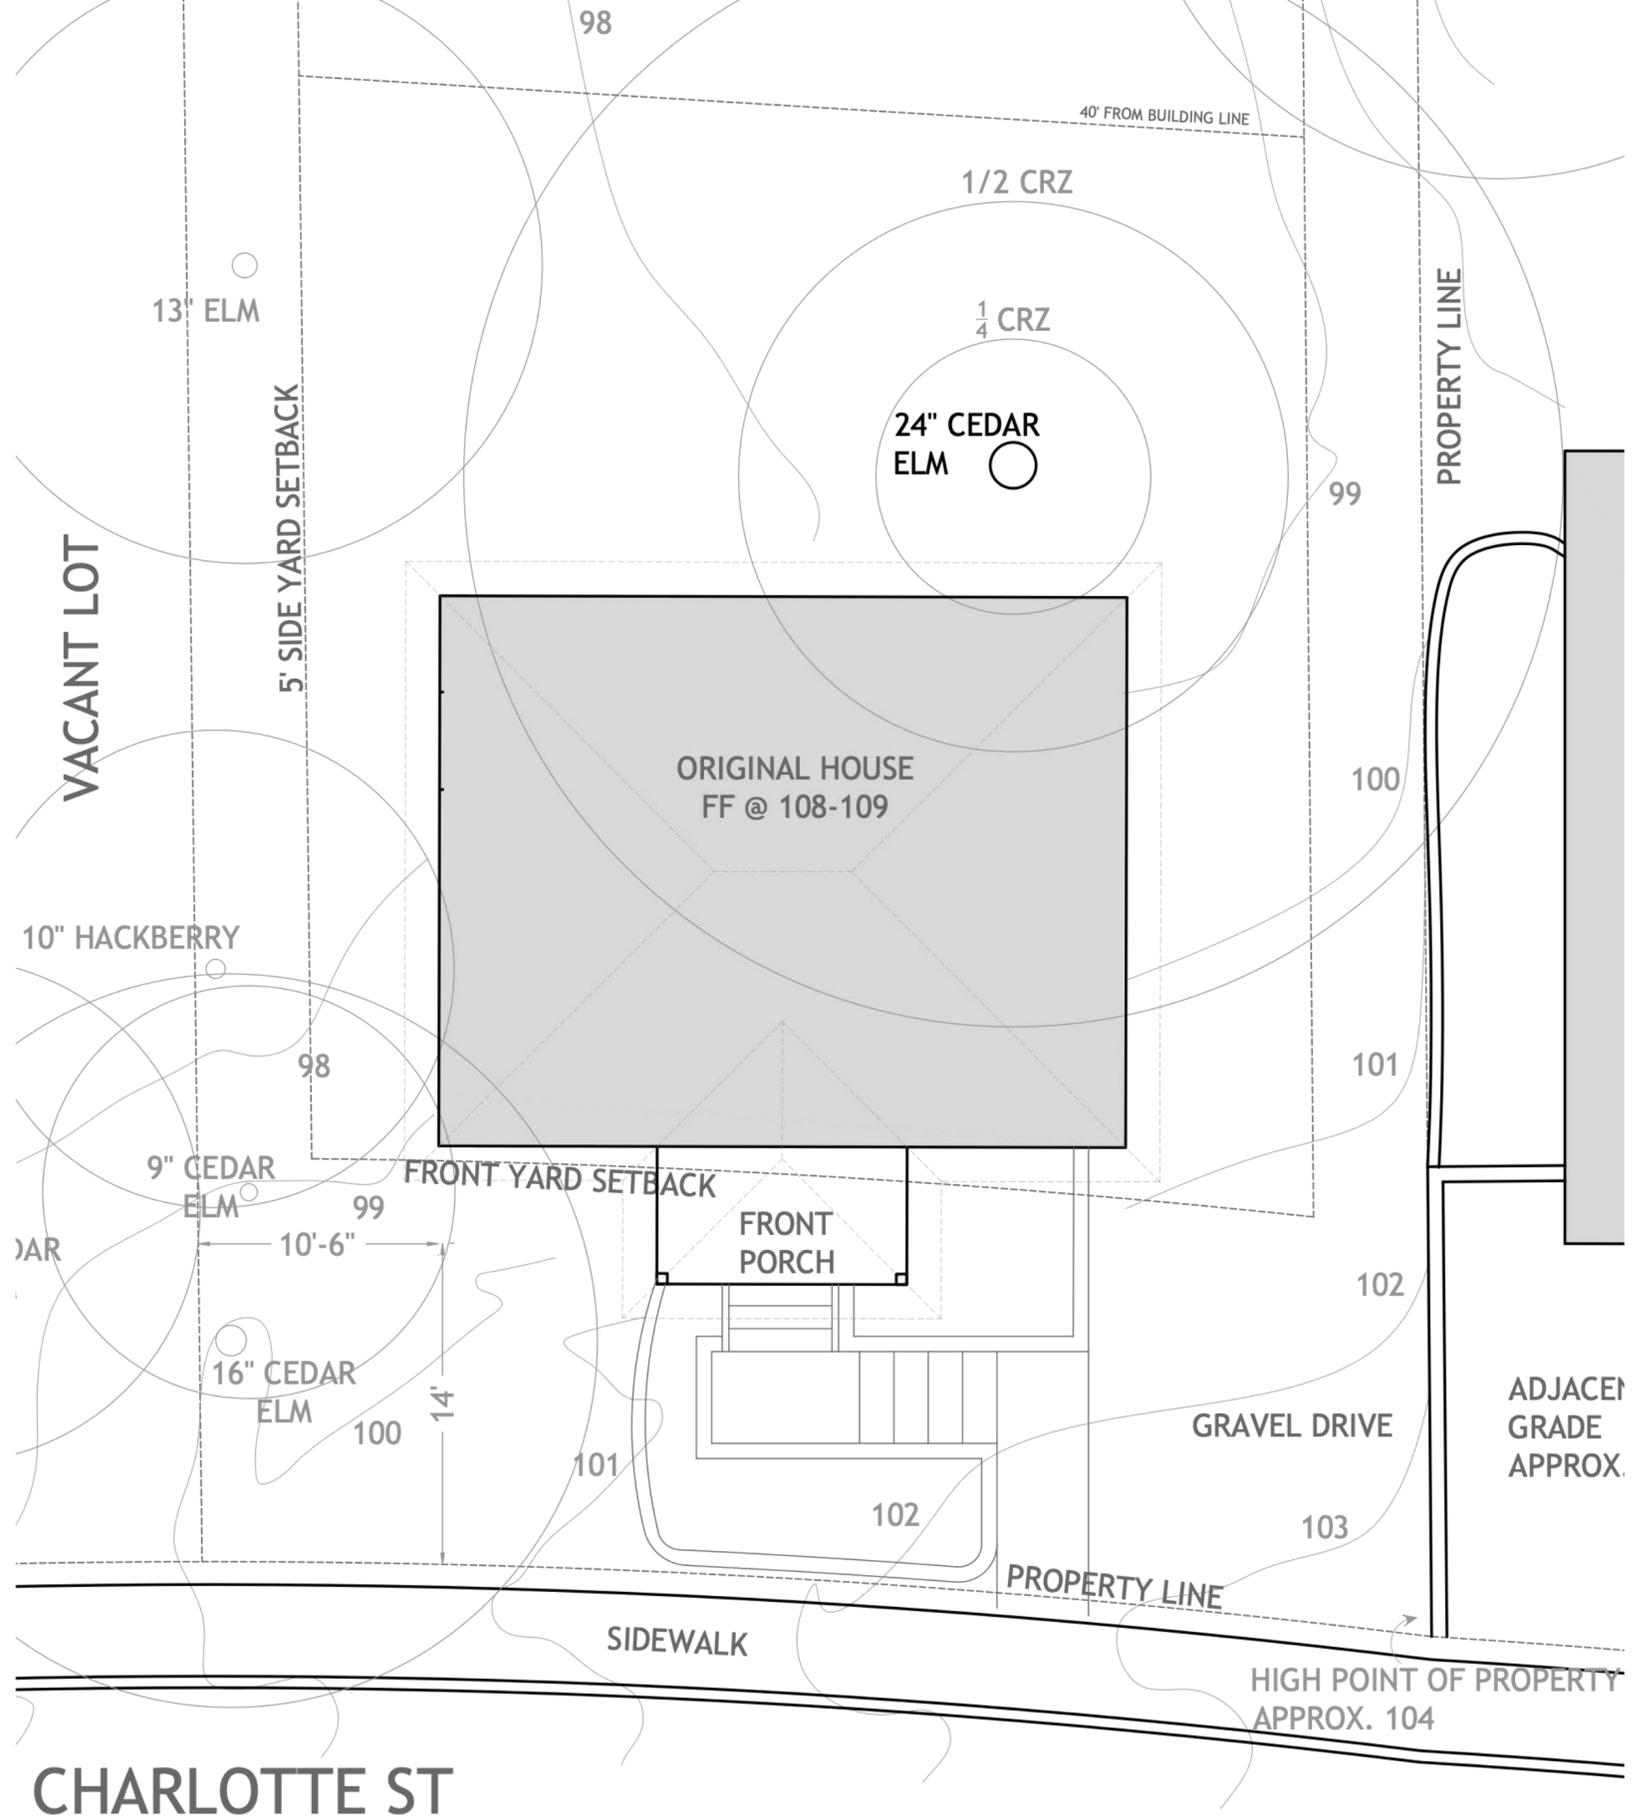
# DEMO BACK PORCH

**PUSH HOUSE AWAY FROM THE STREET APPROX. 4'-4" AND RAISE UP 6'-7'**
