Historic Precedents - Austin Landmarks: W. 32nd St., Austin, TX

1519 W. 32nd St. Existing House

Proposed Improvements

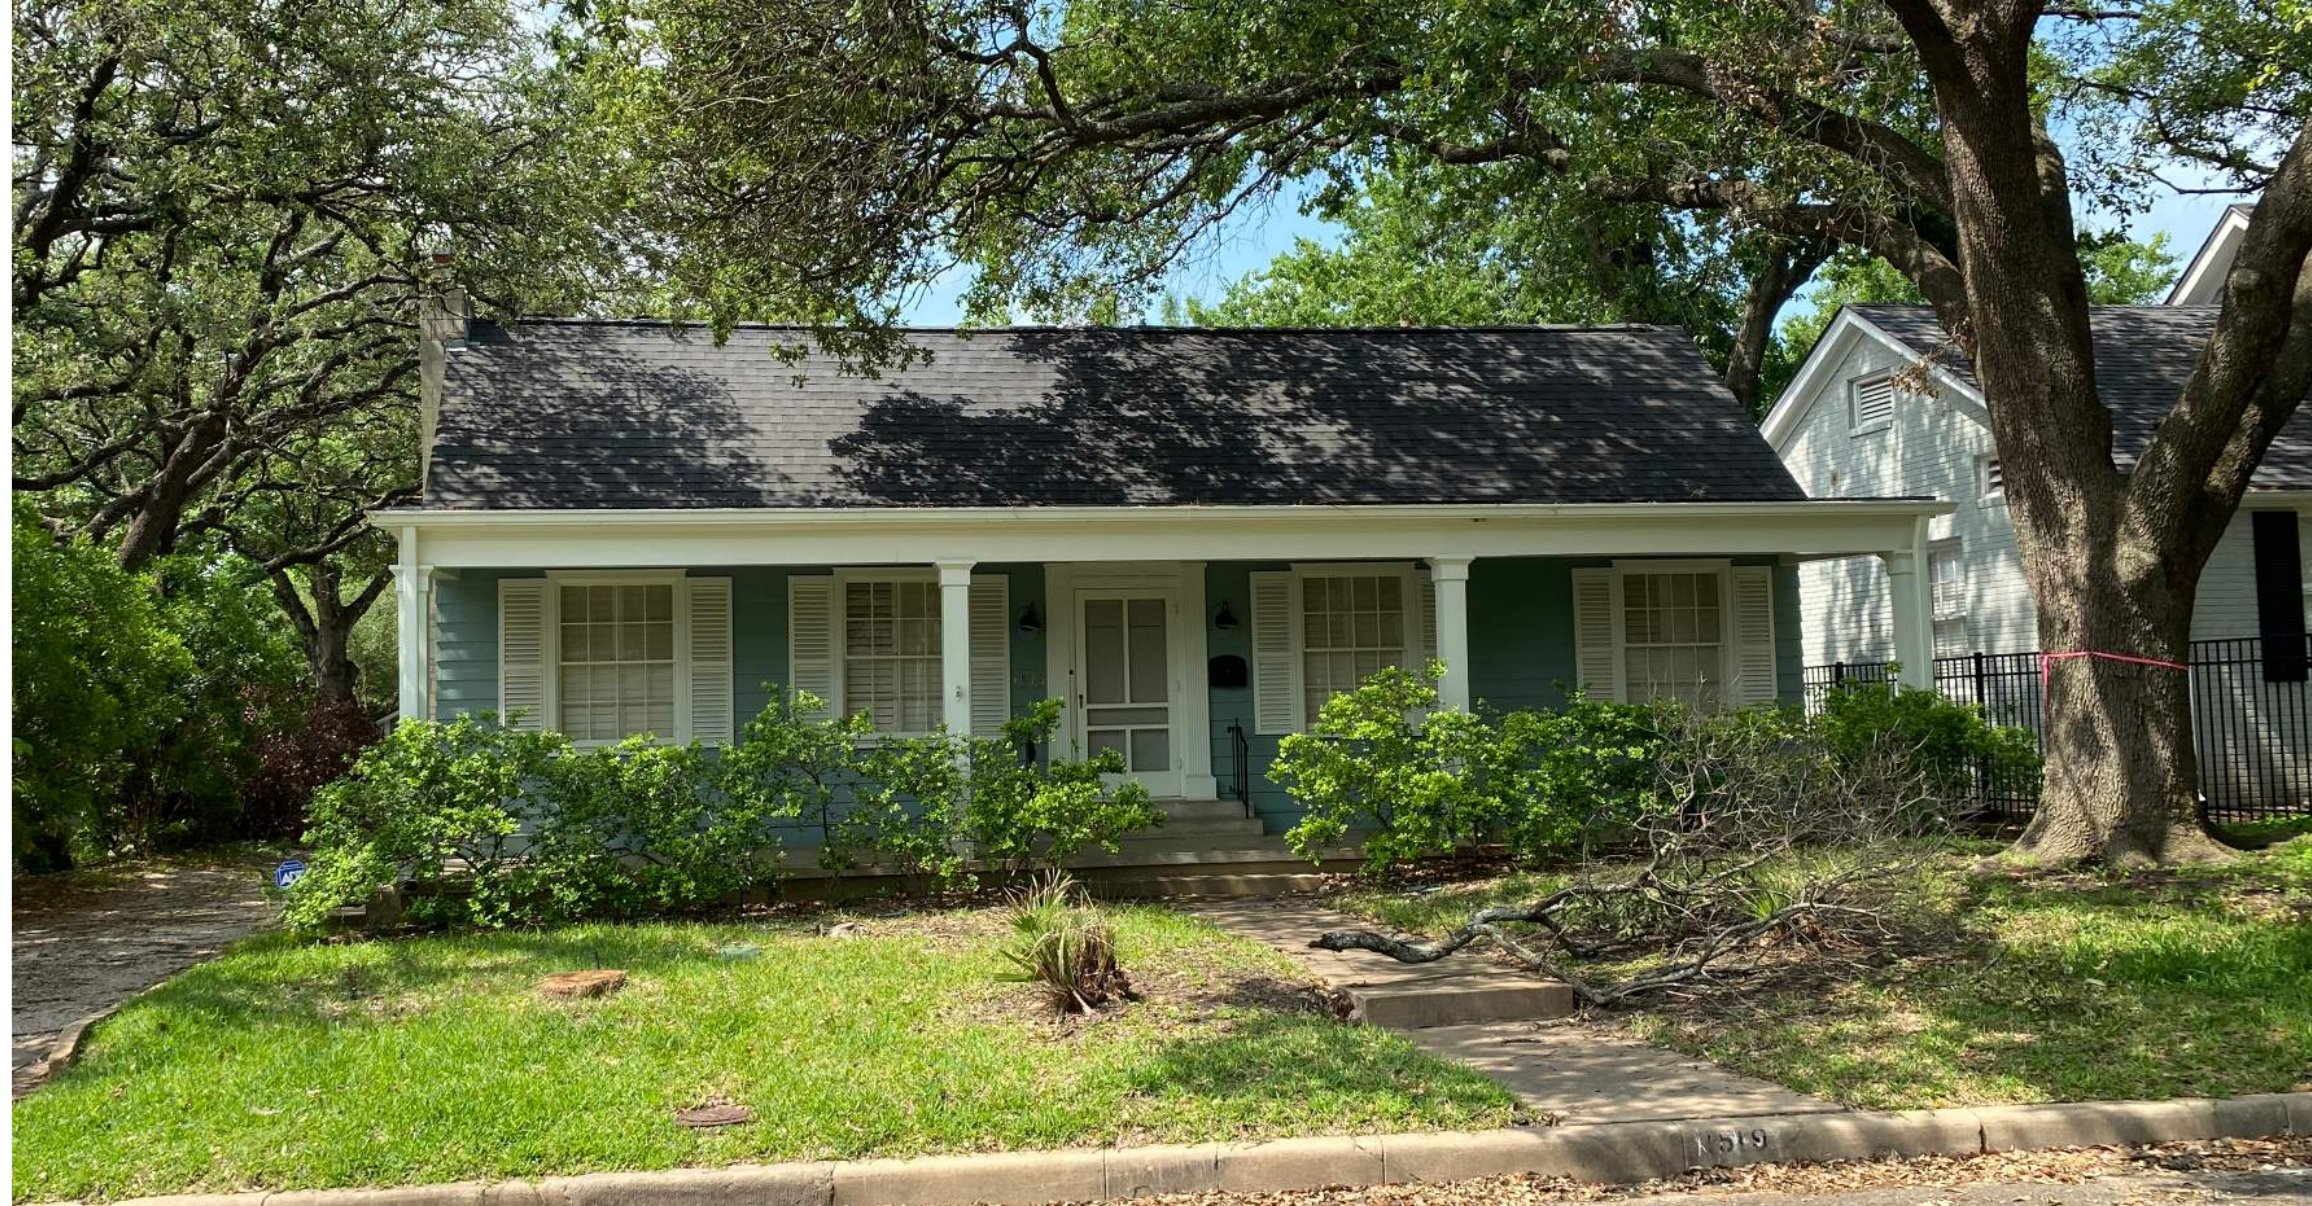
- Post & Beam, Rectangular footprint
- Side gable roof
- Little ornamentation
- Painted Lap Siding with Mitered Corners
- Front facade symmetrical about the entry
- Evenly spaced, double hung windows with divided lites
- Painted wood columns and beams with rectilinear trim

- No significant landscape features or prominent front approach
- Concrete porches
- K-Style gutters and downspouts

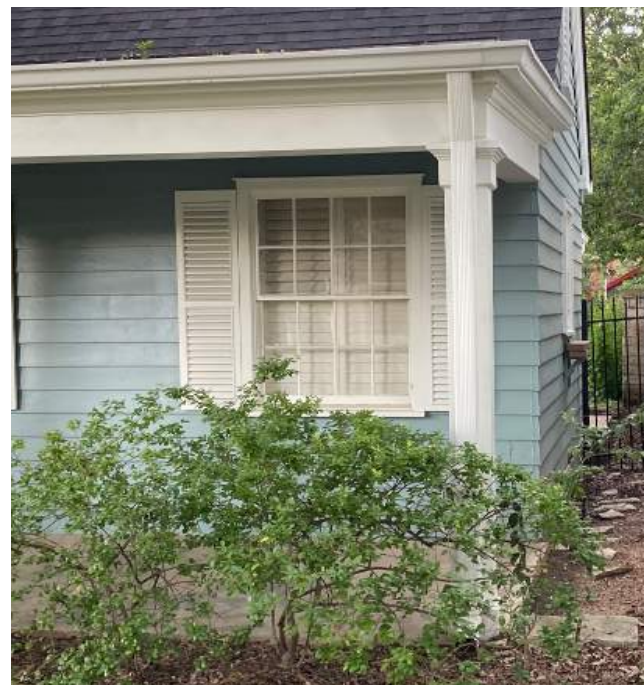
Painted Double Hung Windows
with Divided Lites

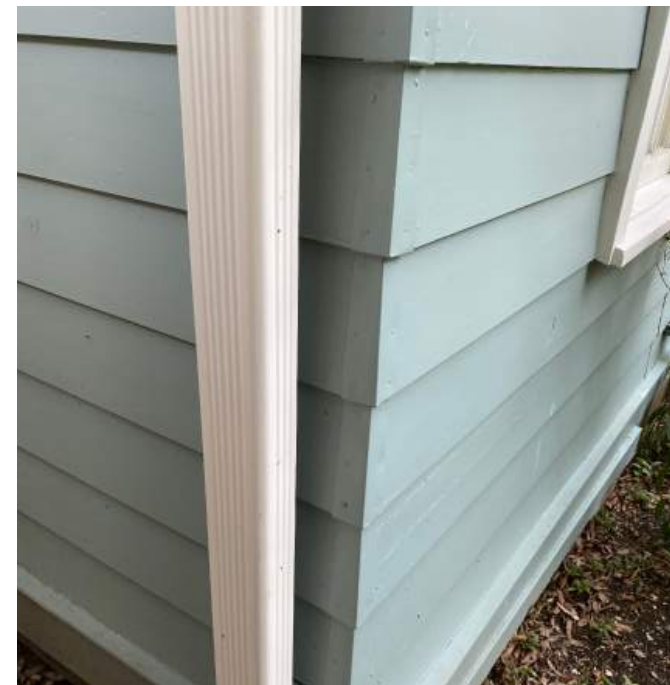
Painted lap siding with mitered
corners.

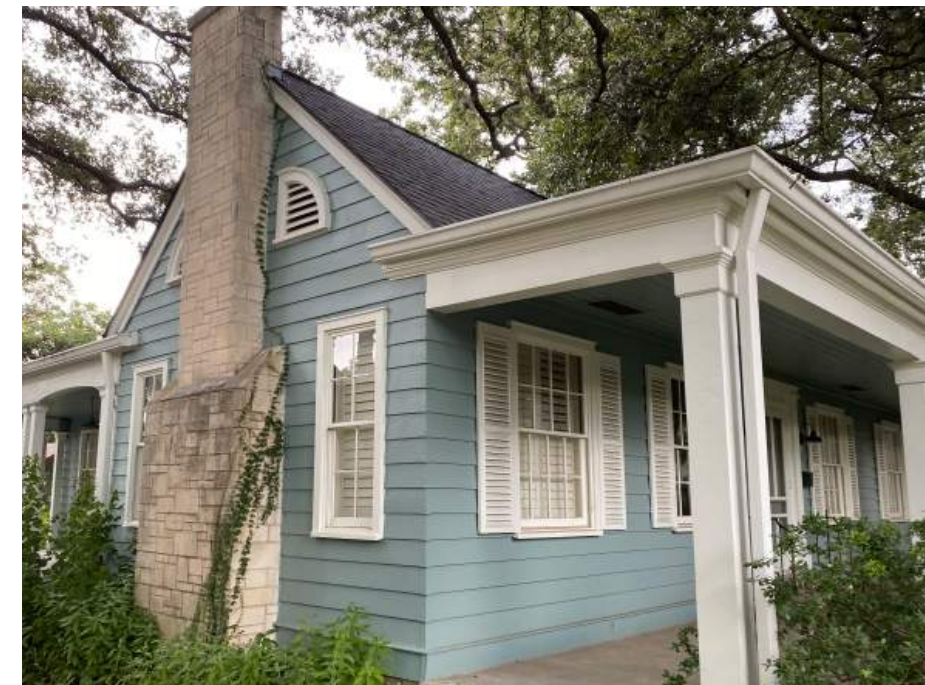
Painted columns and beams w/ minimal trim. Concrete
patio. K-Style gutters and downspouts. Side gable w/ steep
roof.

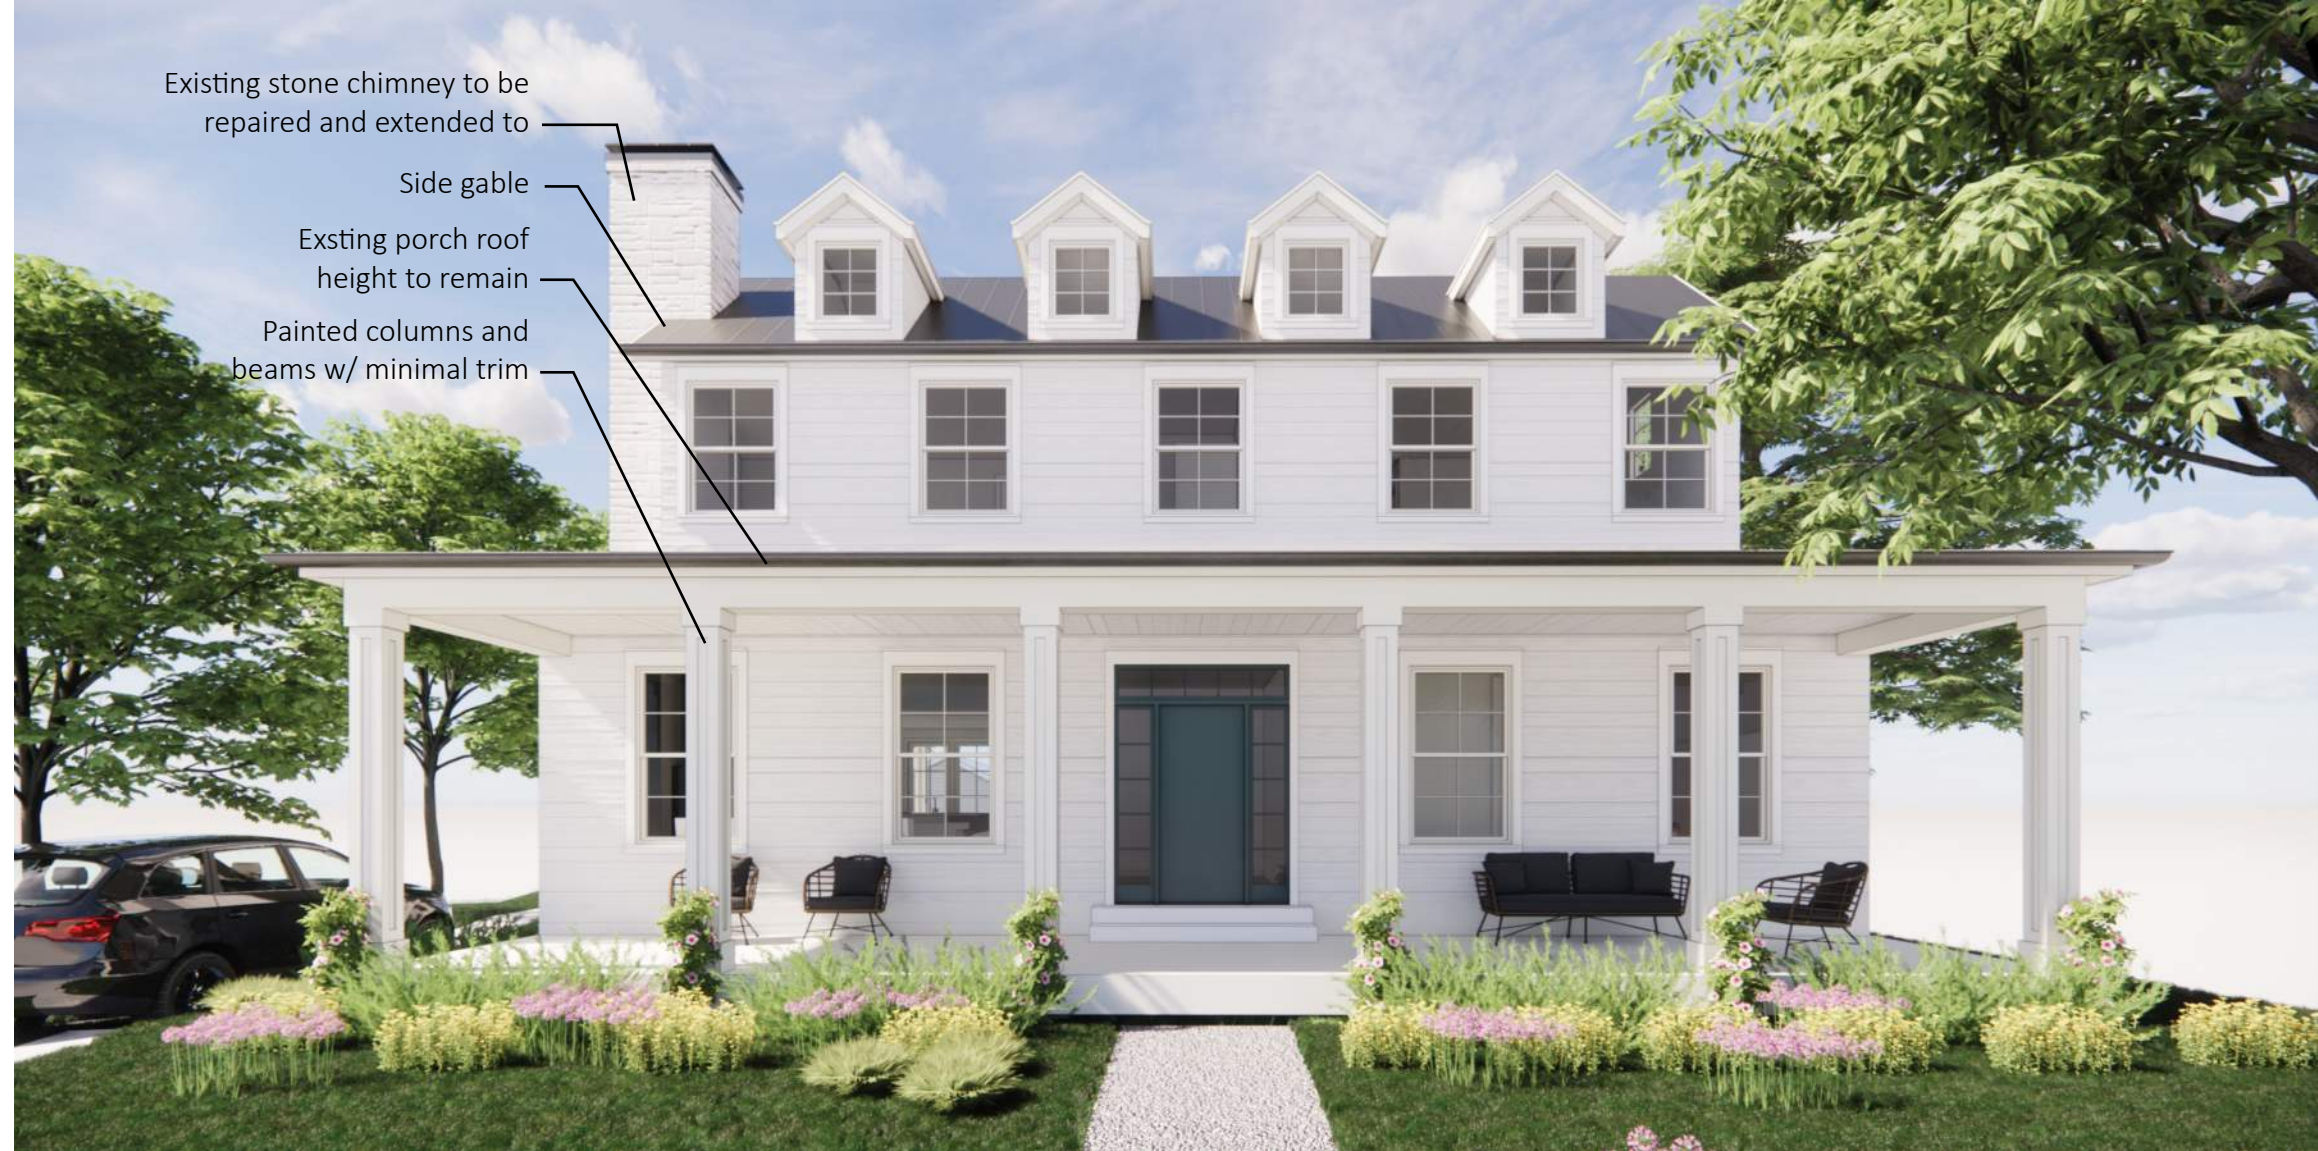
- Post & Beam, Rectangular footprint
 - Existing Structure being repaired and reused; rectangular footprint remains in proposed design
- Side gable roof
 - Remains expressed in proposed improvements
- Minimal ornamentation
- Painted Lap Siding with Mitered Corners
 - Existing to be replaced with Artisan Lap Siding with mitered corners
- Front facade symmetrical about the entrance
- Evenly spaced, double hung windows with divided lites on both levels with symmetrical dormers
- Painted wood columns and beams with rectilinear trim
- Concrete Porches to remain
- New Half-Round Gutters and downspouts

Existing stone chimney to be repaired and extended to
Side gable
Existing porch roof height to remain
Painted columns and beams w/ minimal trim

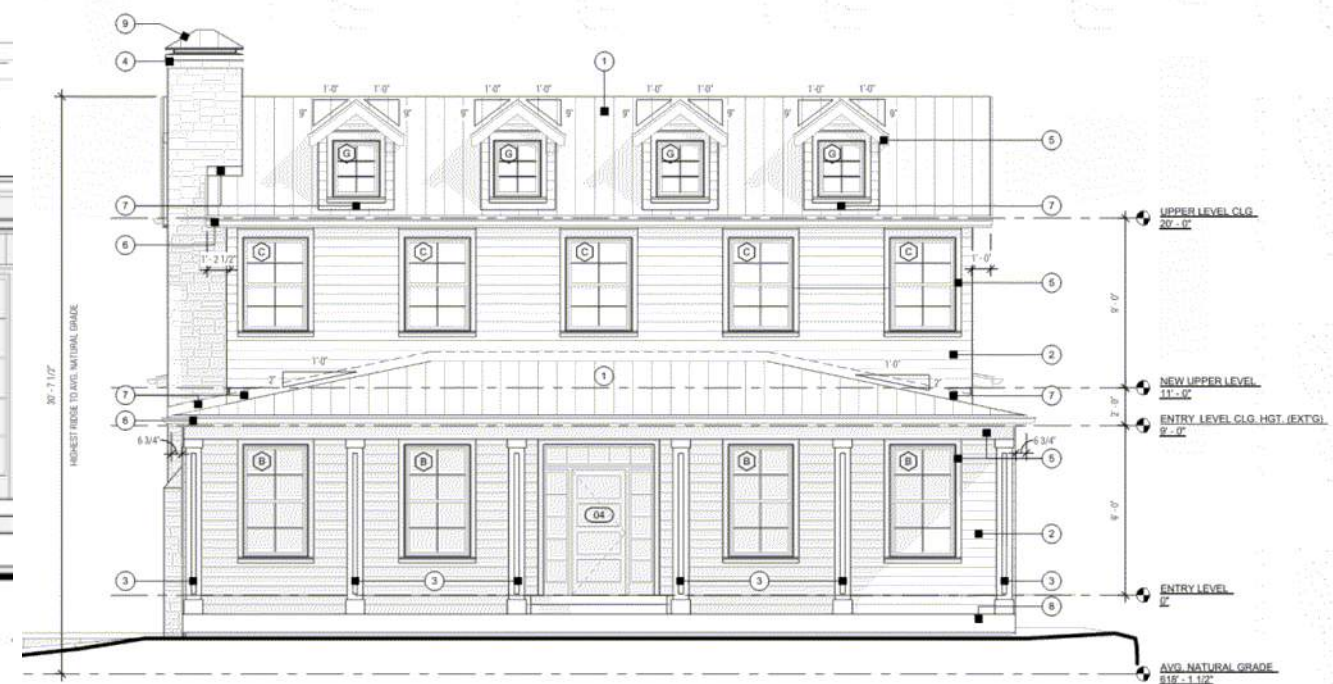
Symmetry about the front entry with evenly spaced columns and windows
