1104 Charlotte St

Kindra Welch and family

10/25/2021

Clarksville Cottage constructed 1915

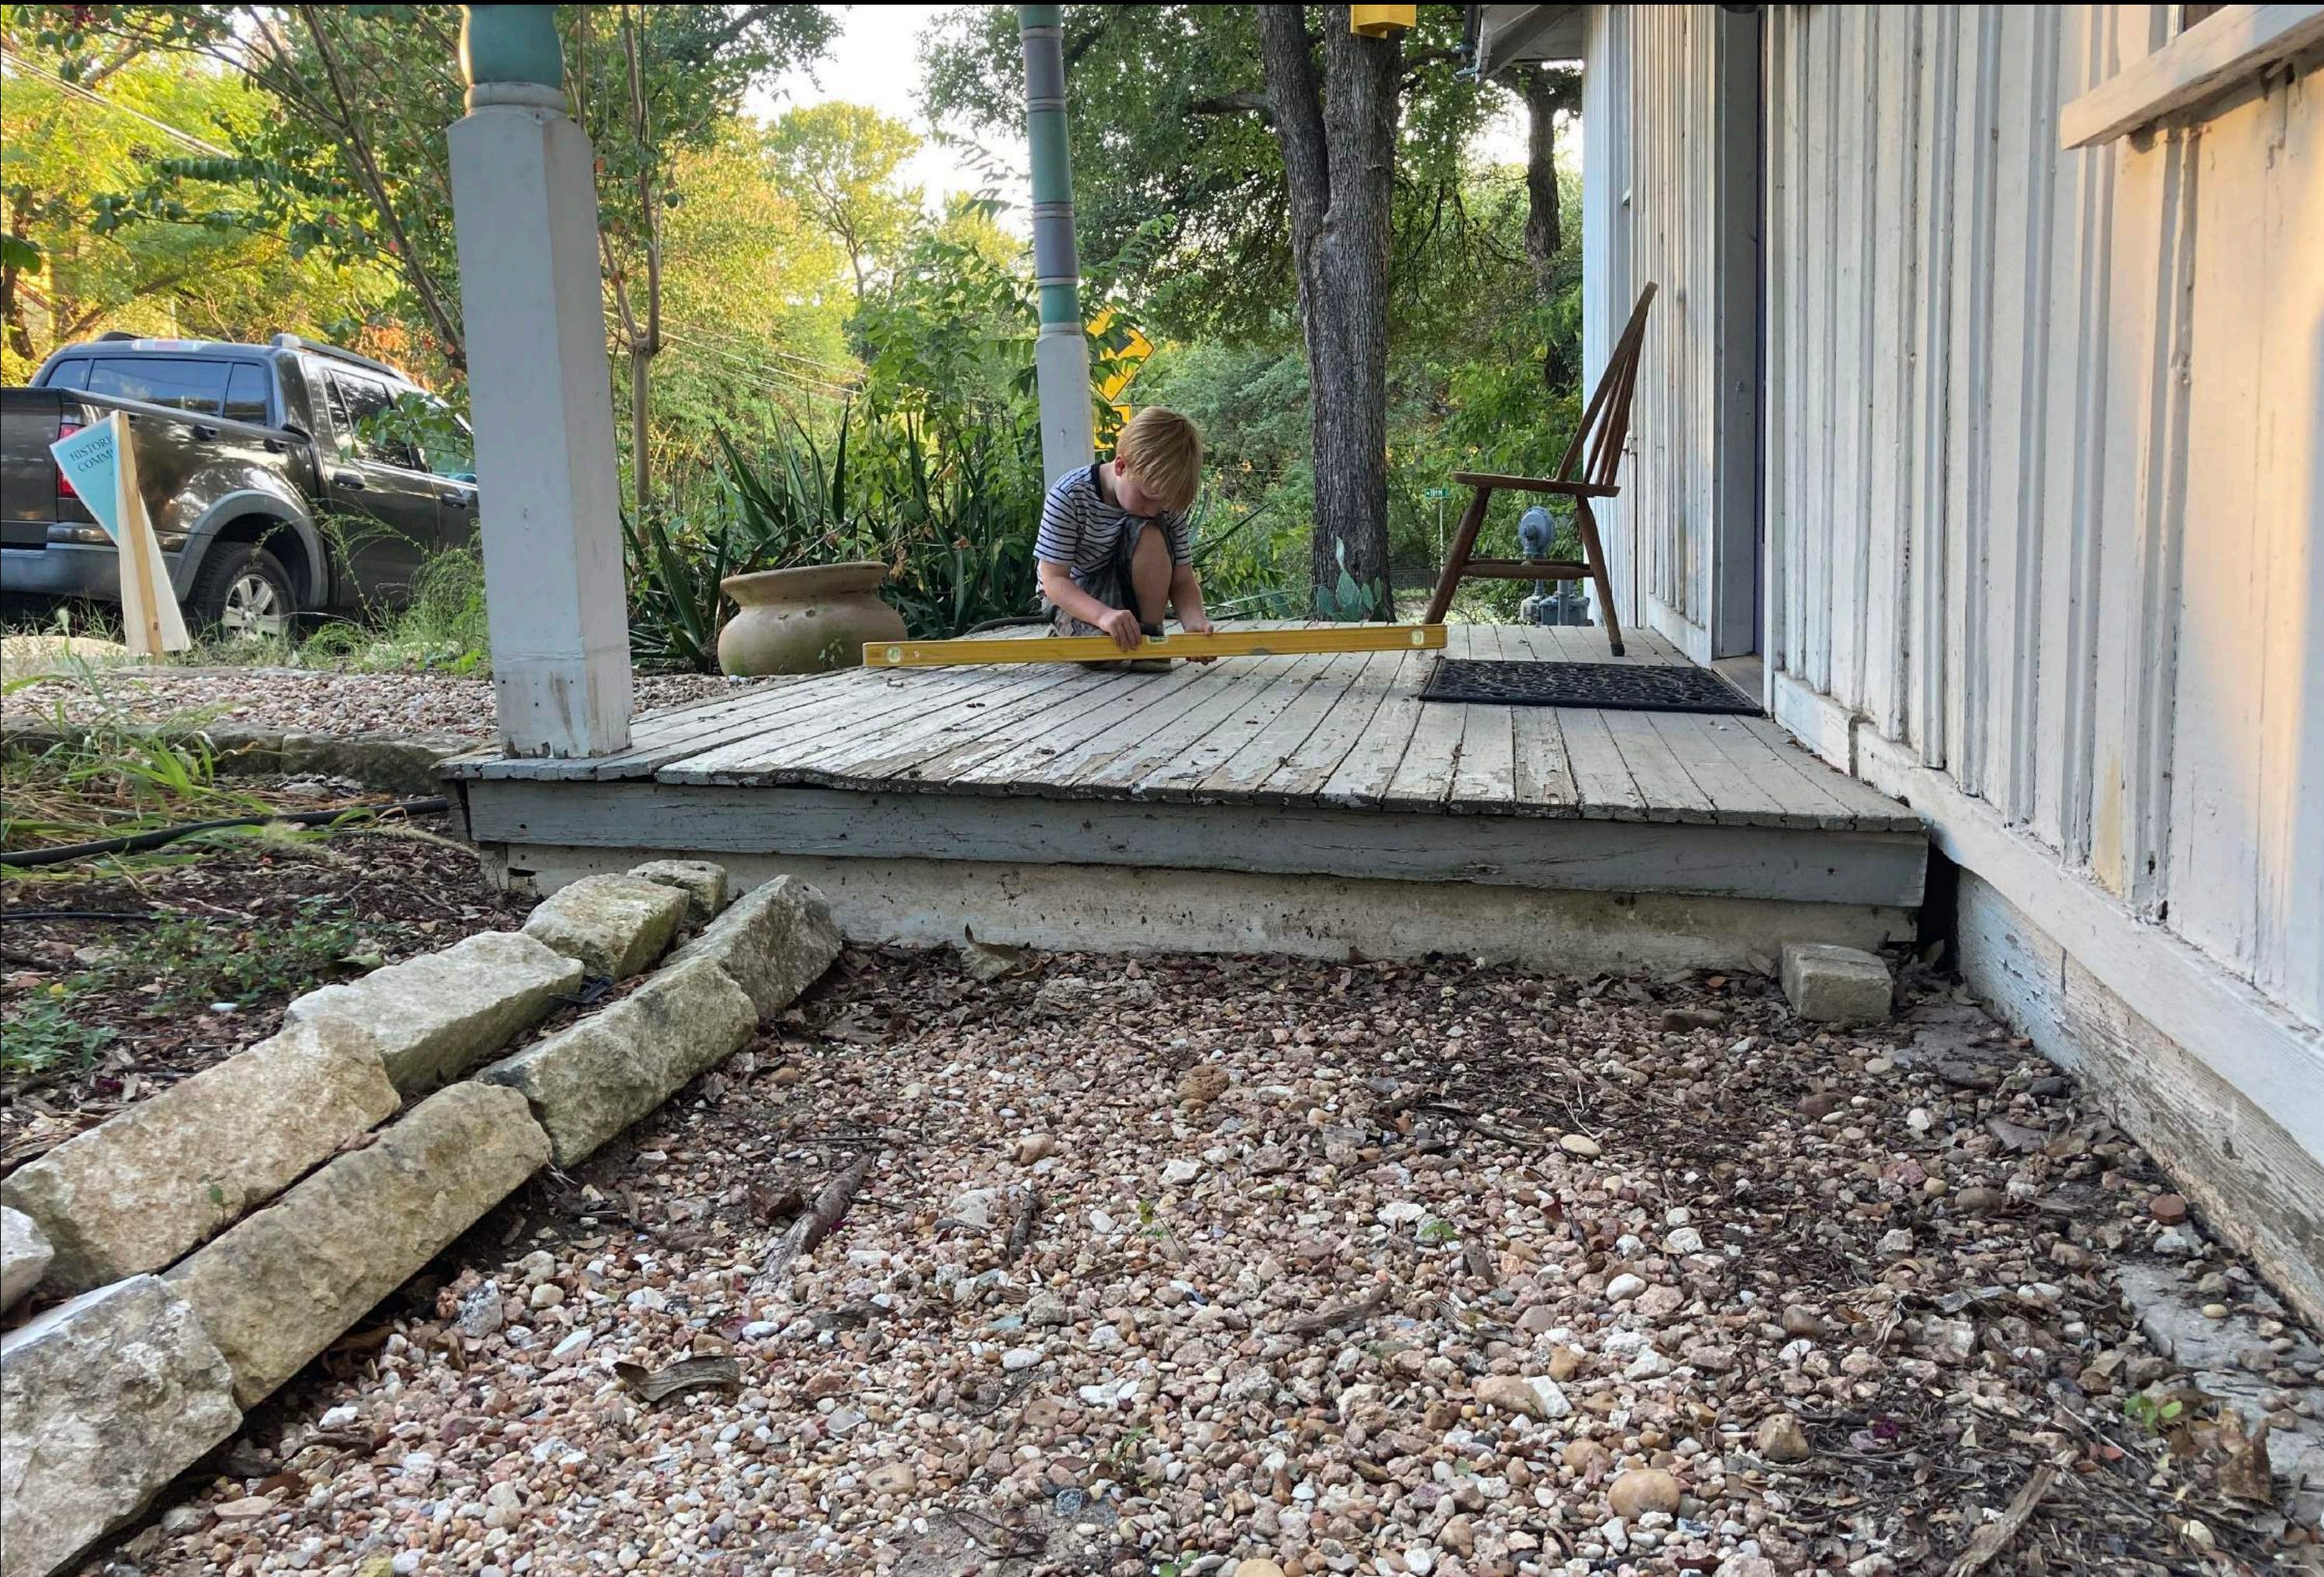
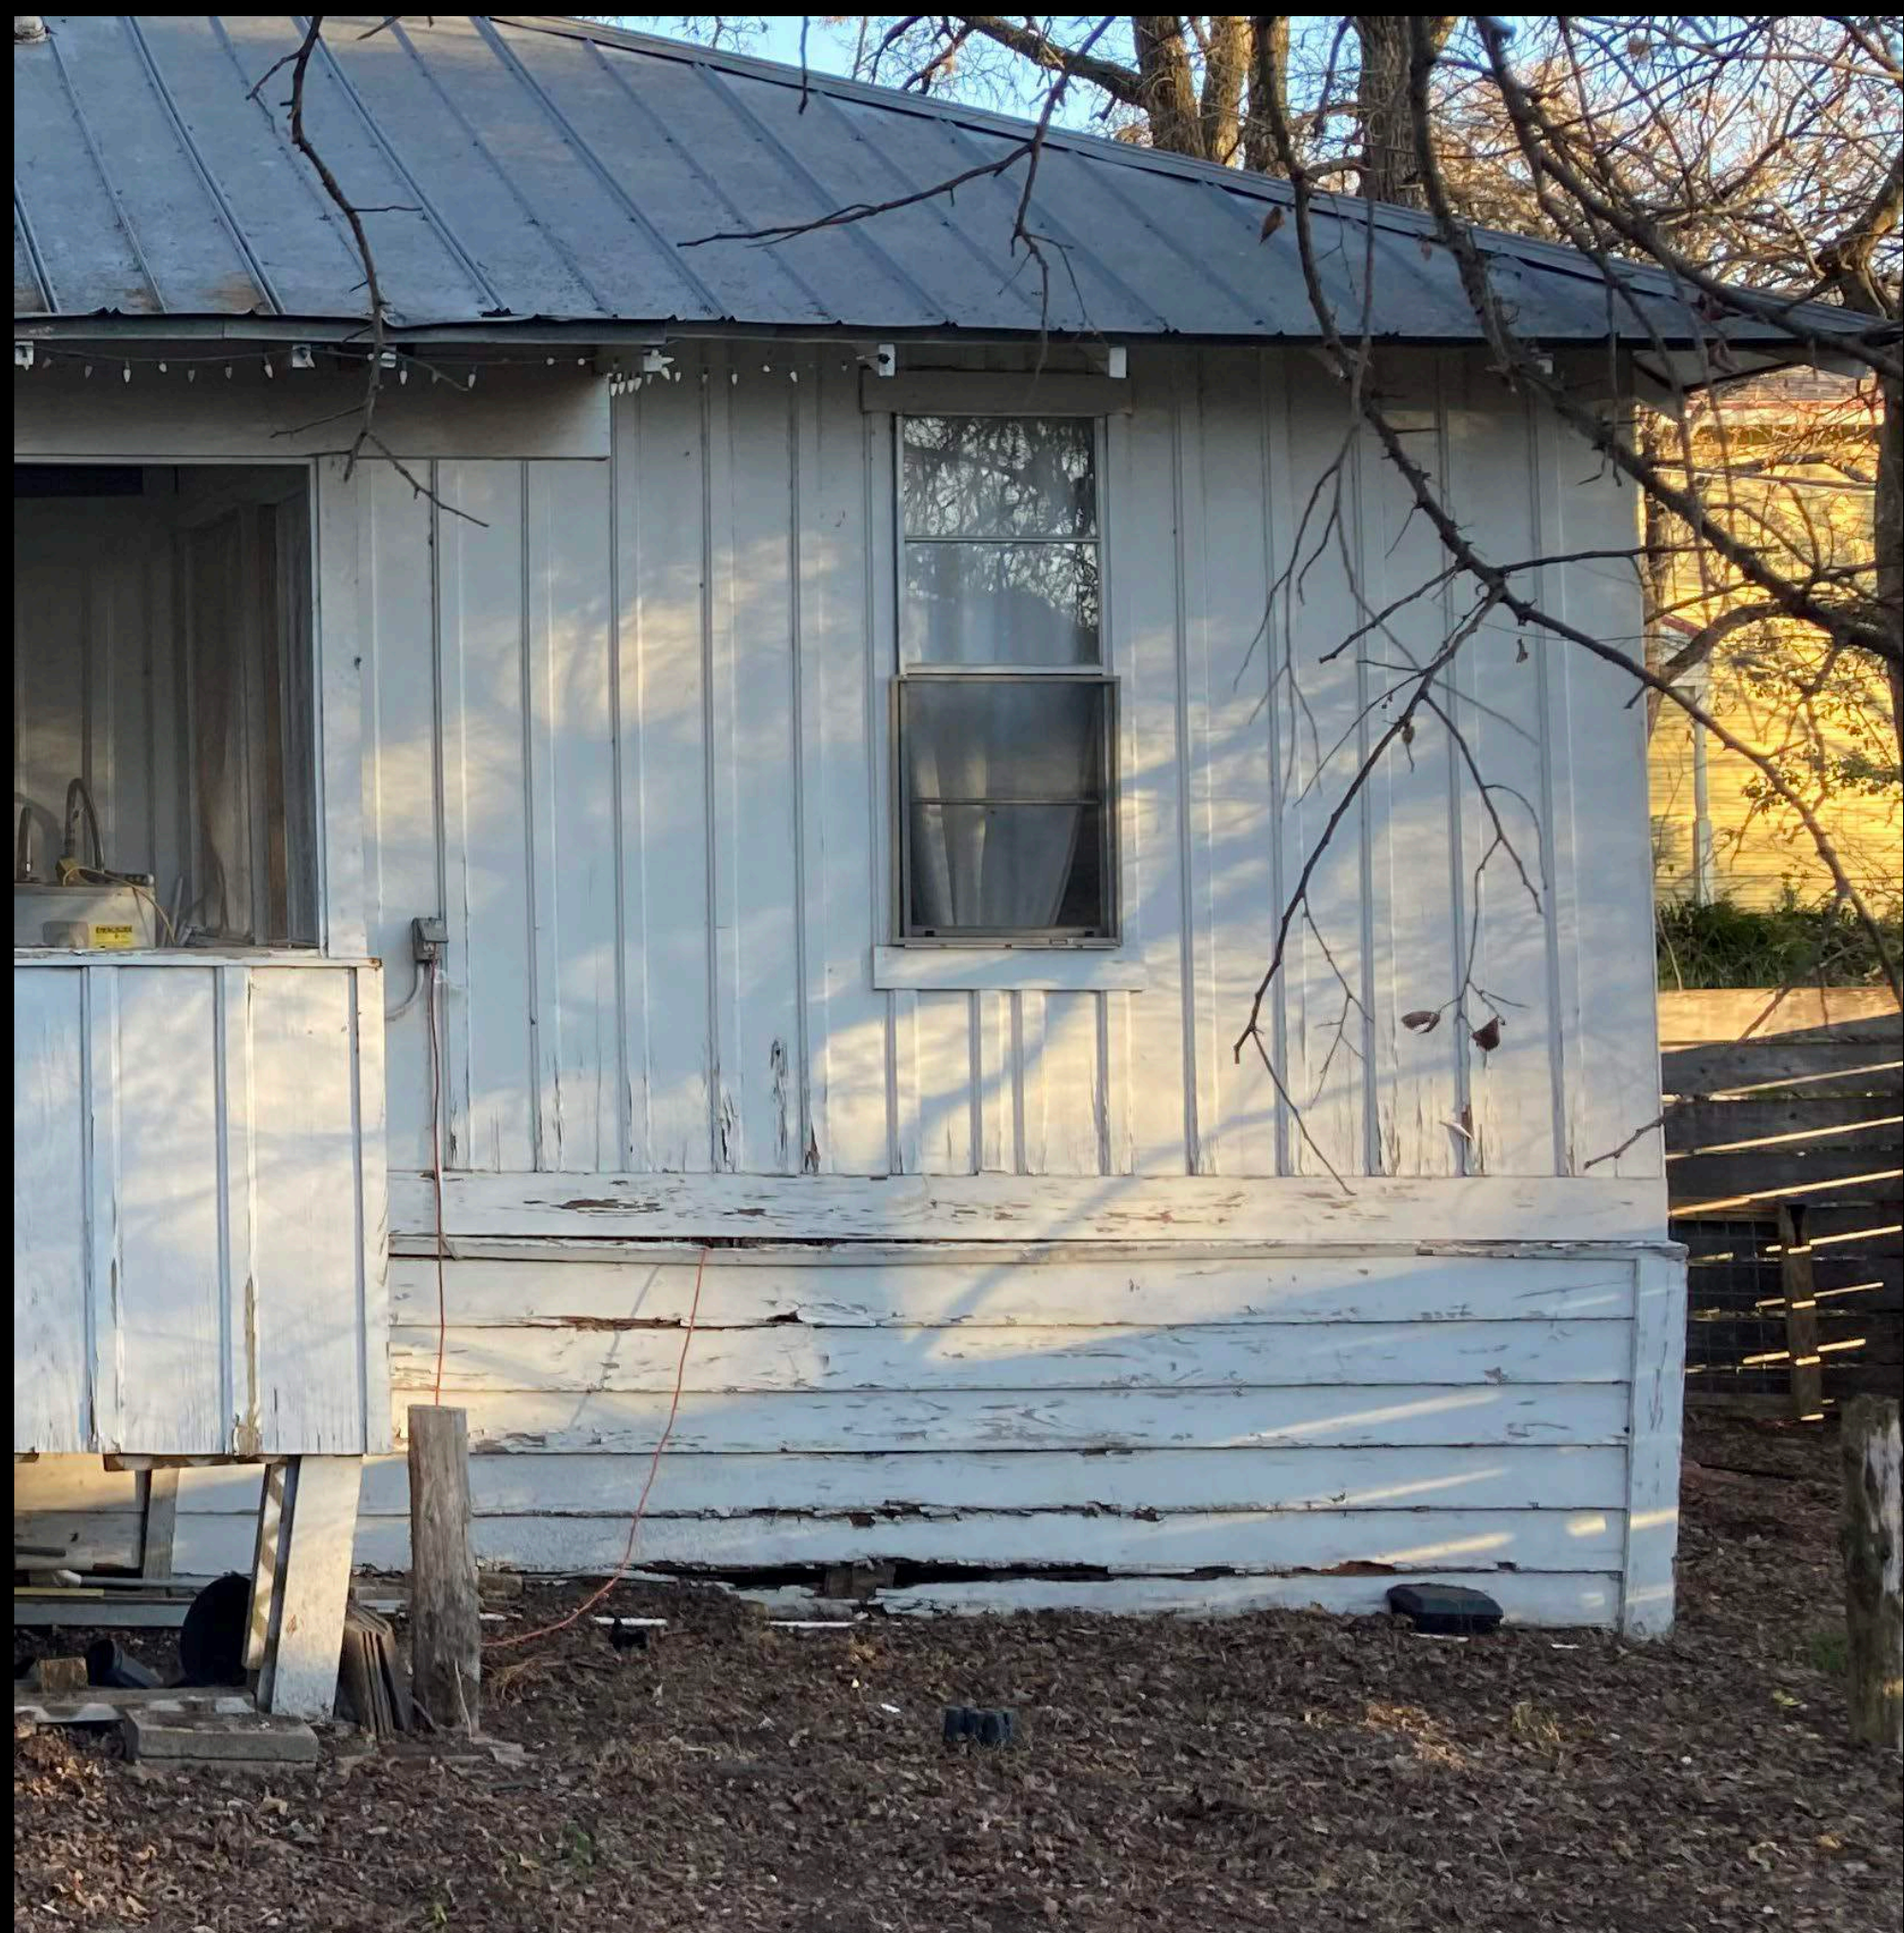
minor structural issues with original Juniper piers

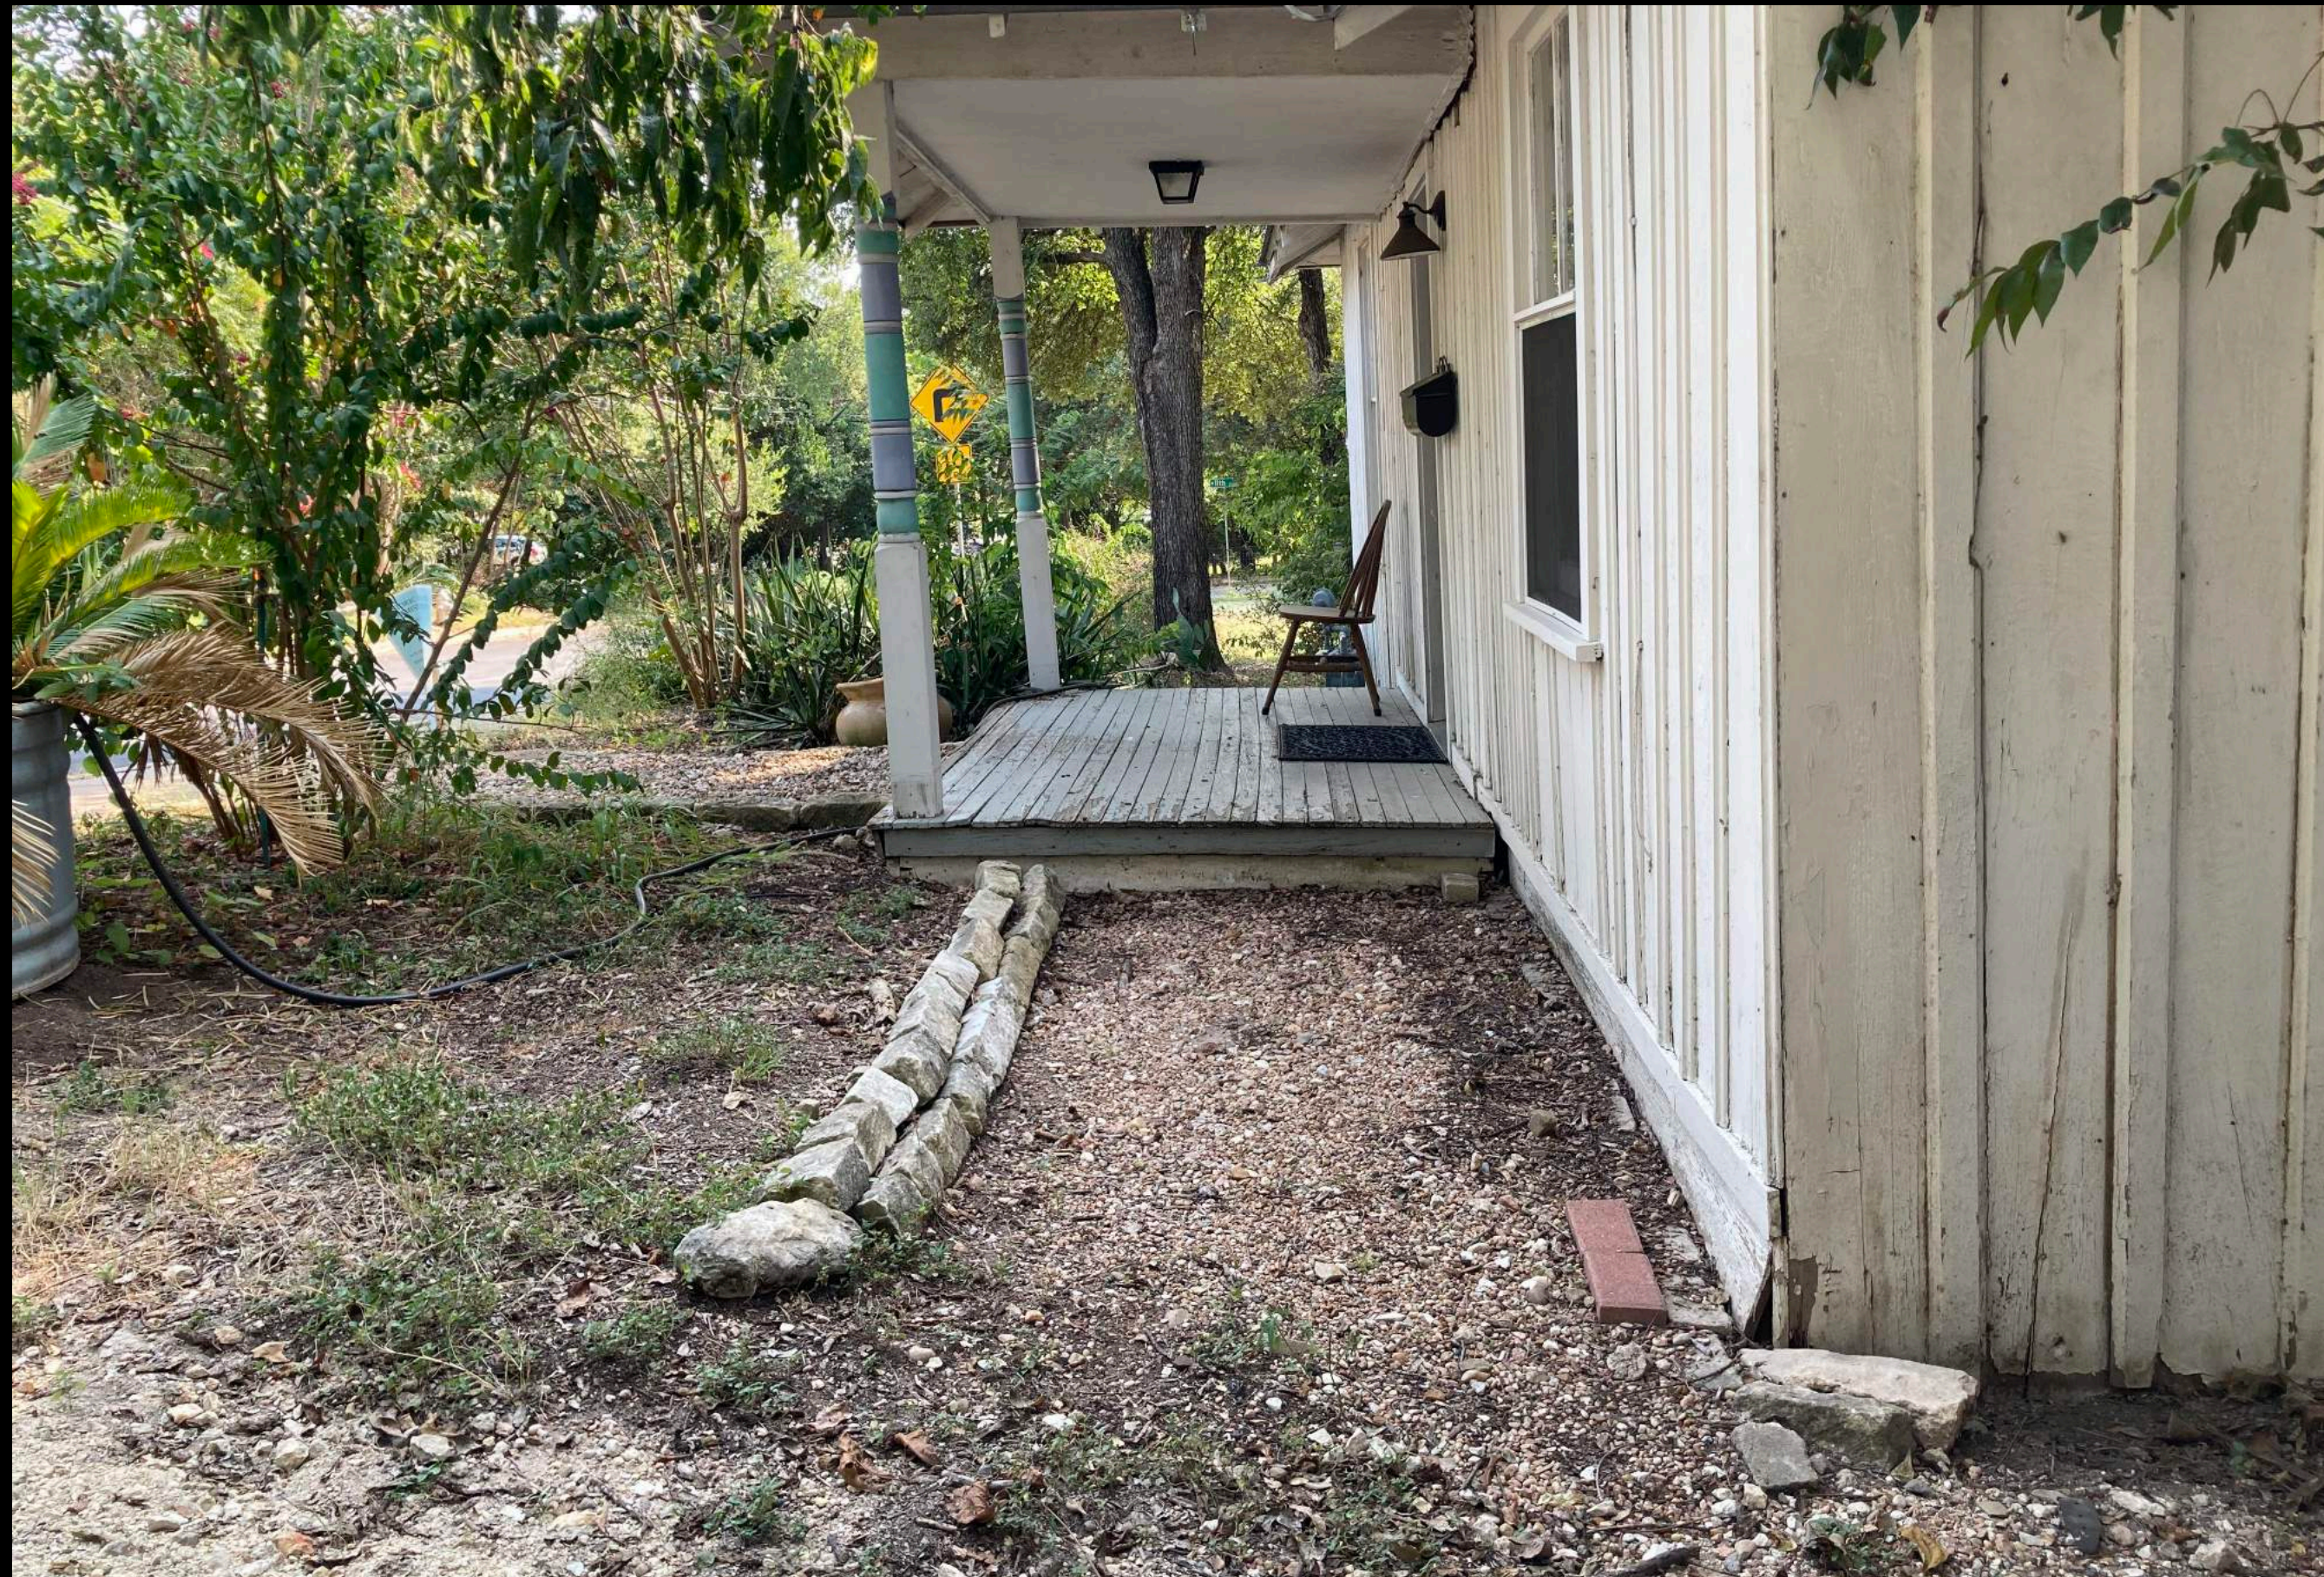
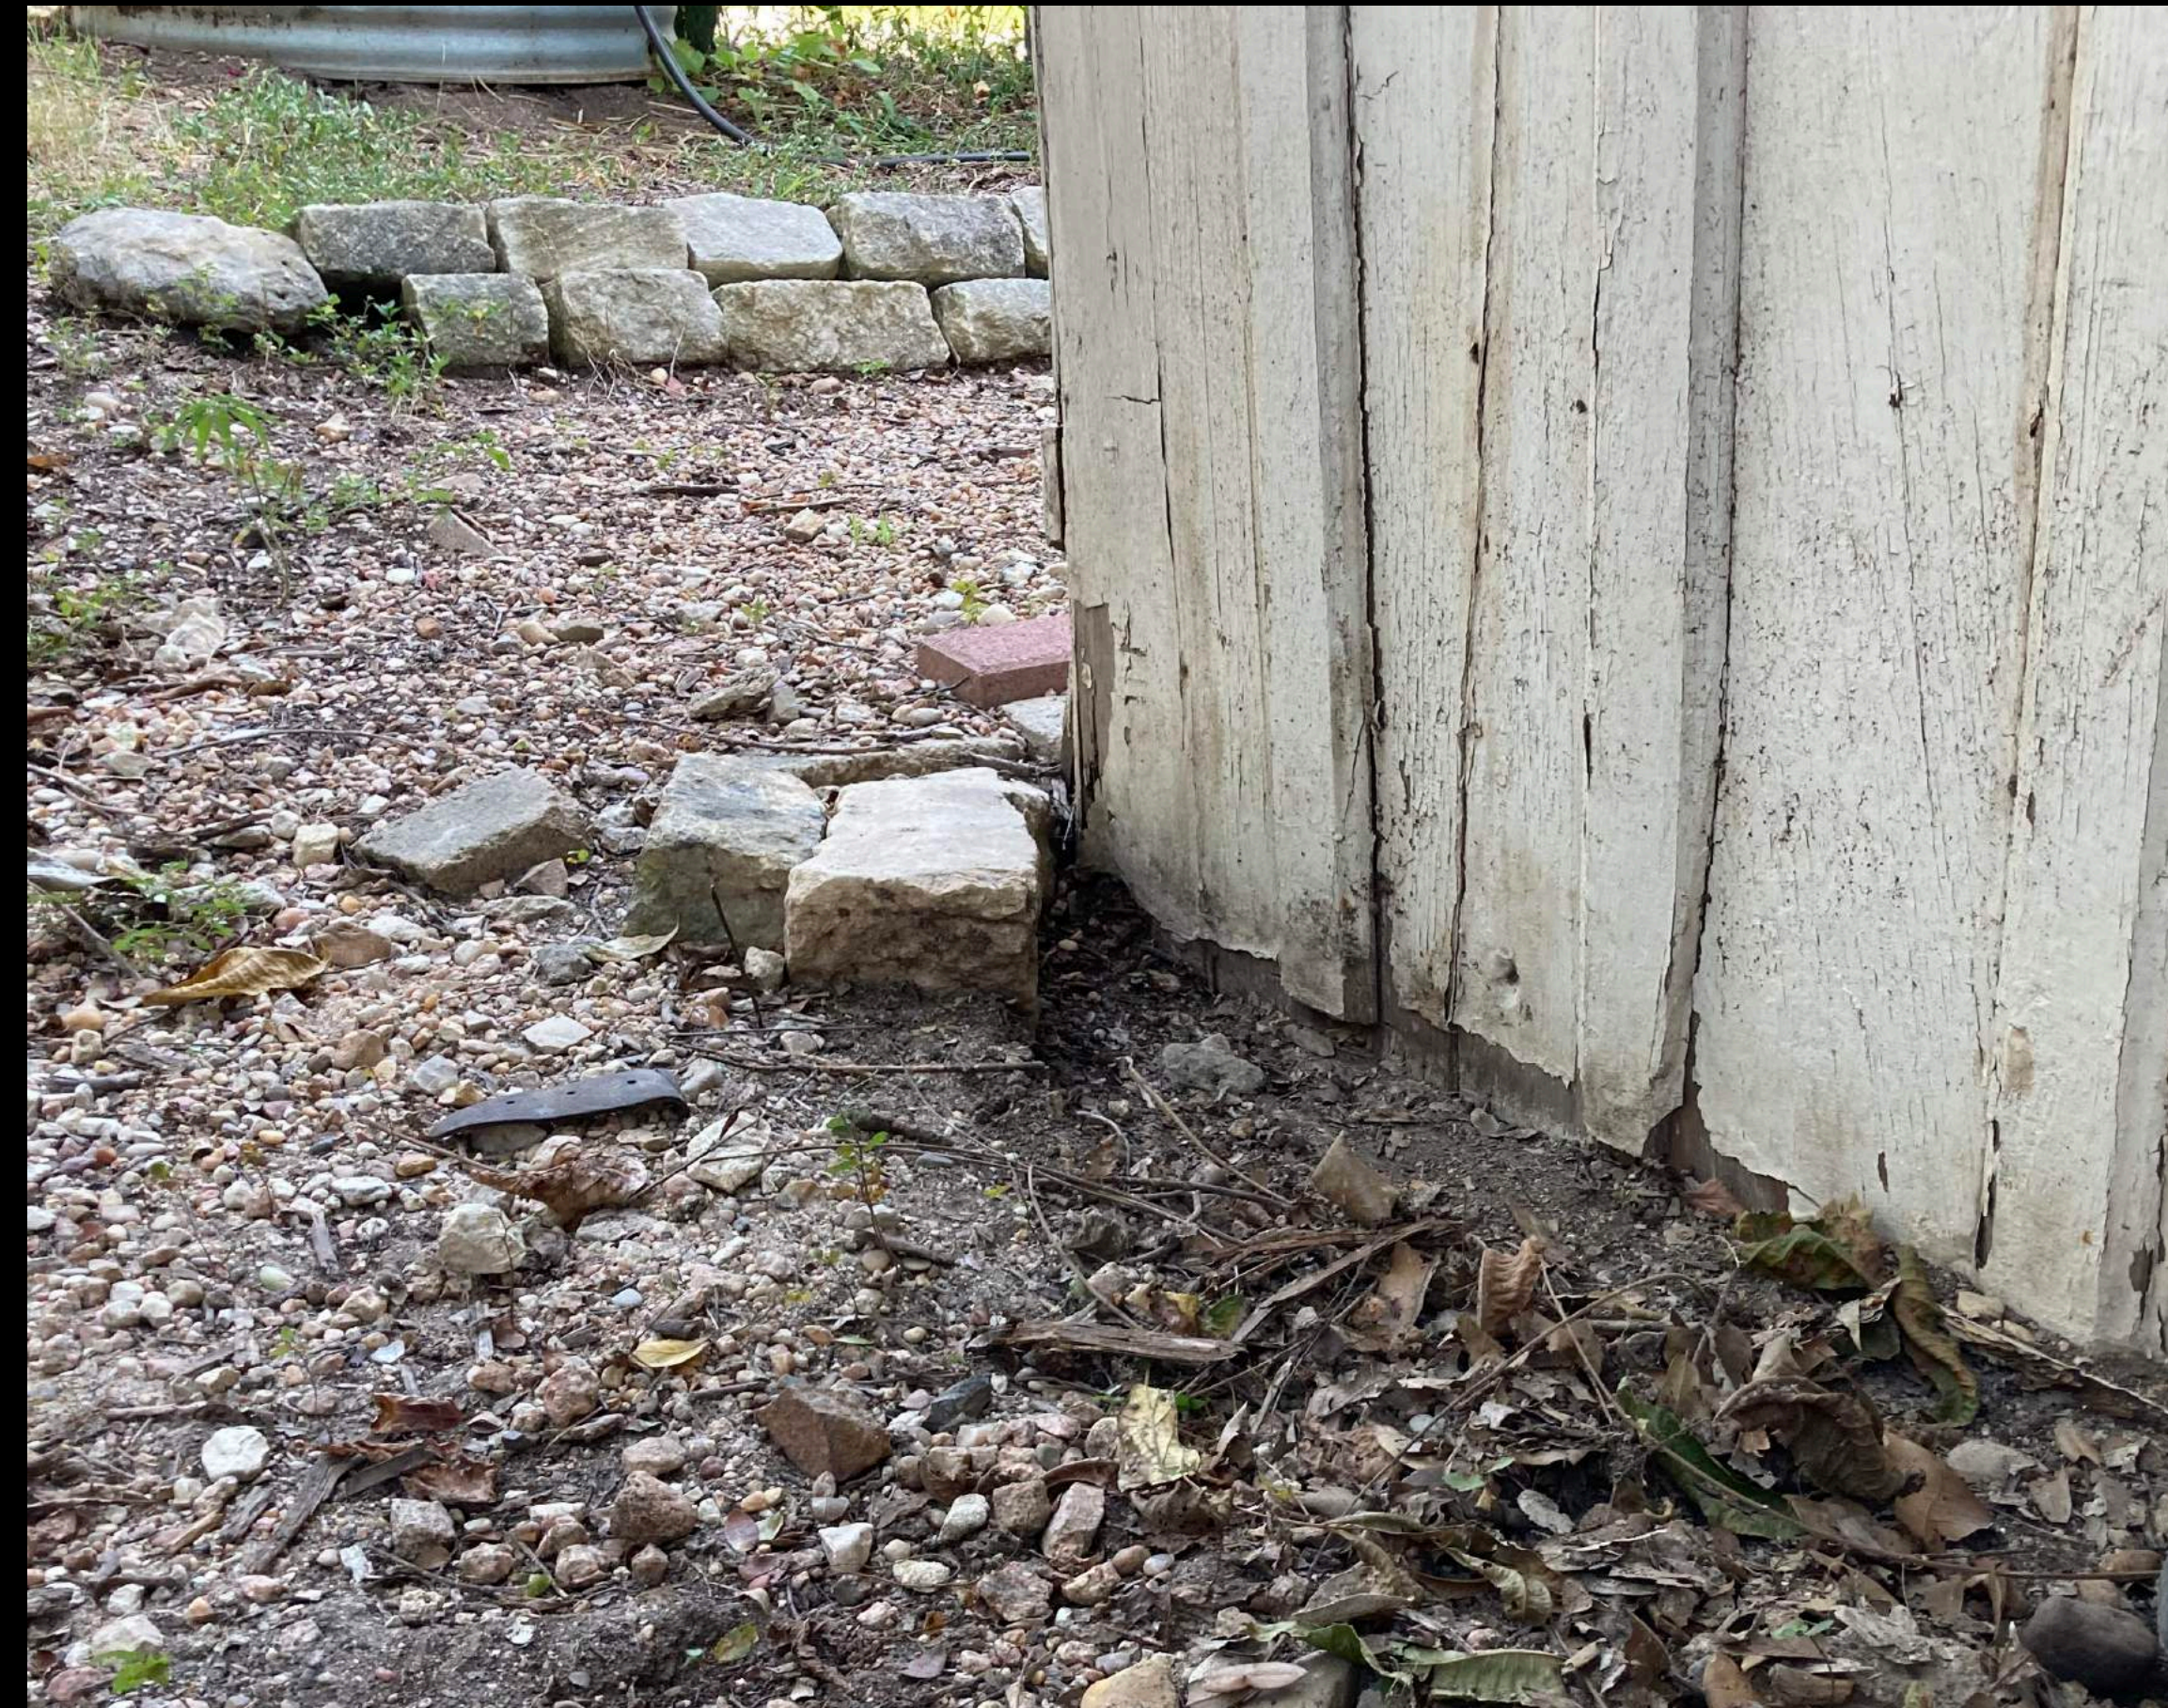
1. Eastern front corner sits directly on the ground enabling deterioration of wood structure and a near constant termite invasion

- 1. One corner sits directly in contact with the ground.**
- 2. Driveway slopes towards the house**
- 3. The house is the focal point of 12th street traffic.**

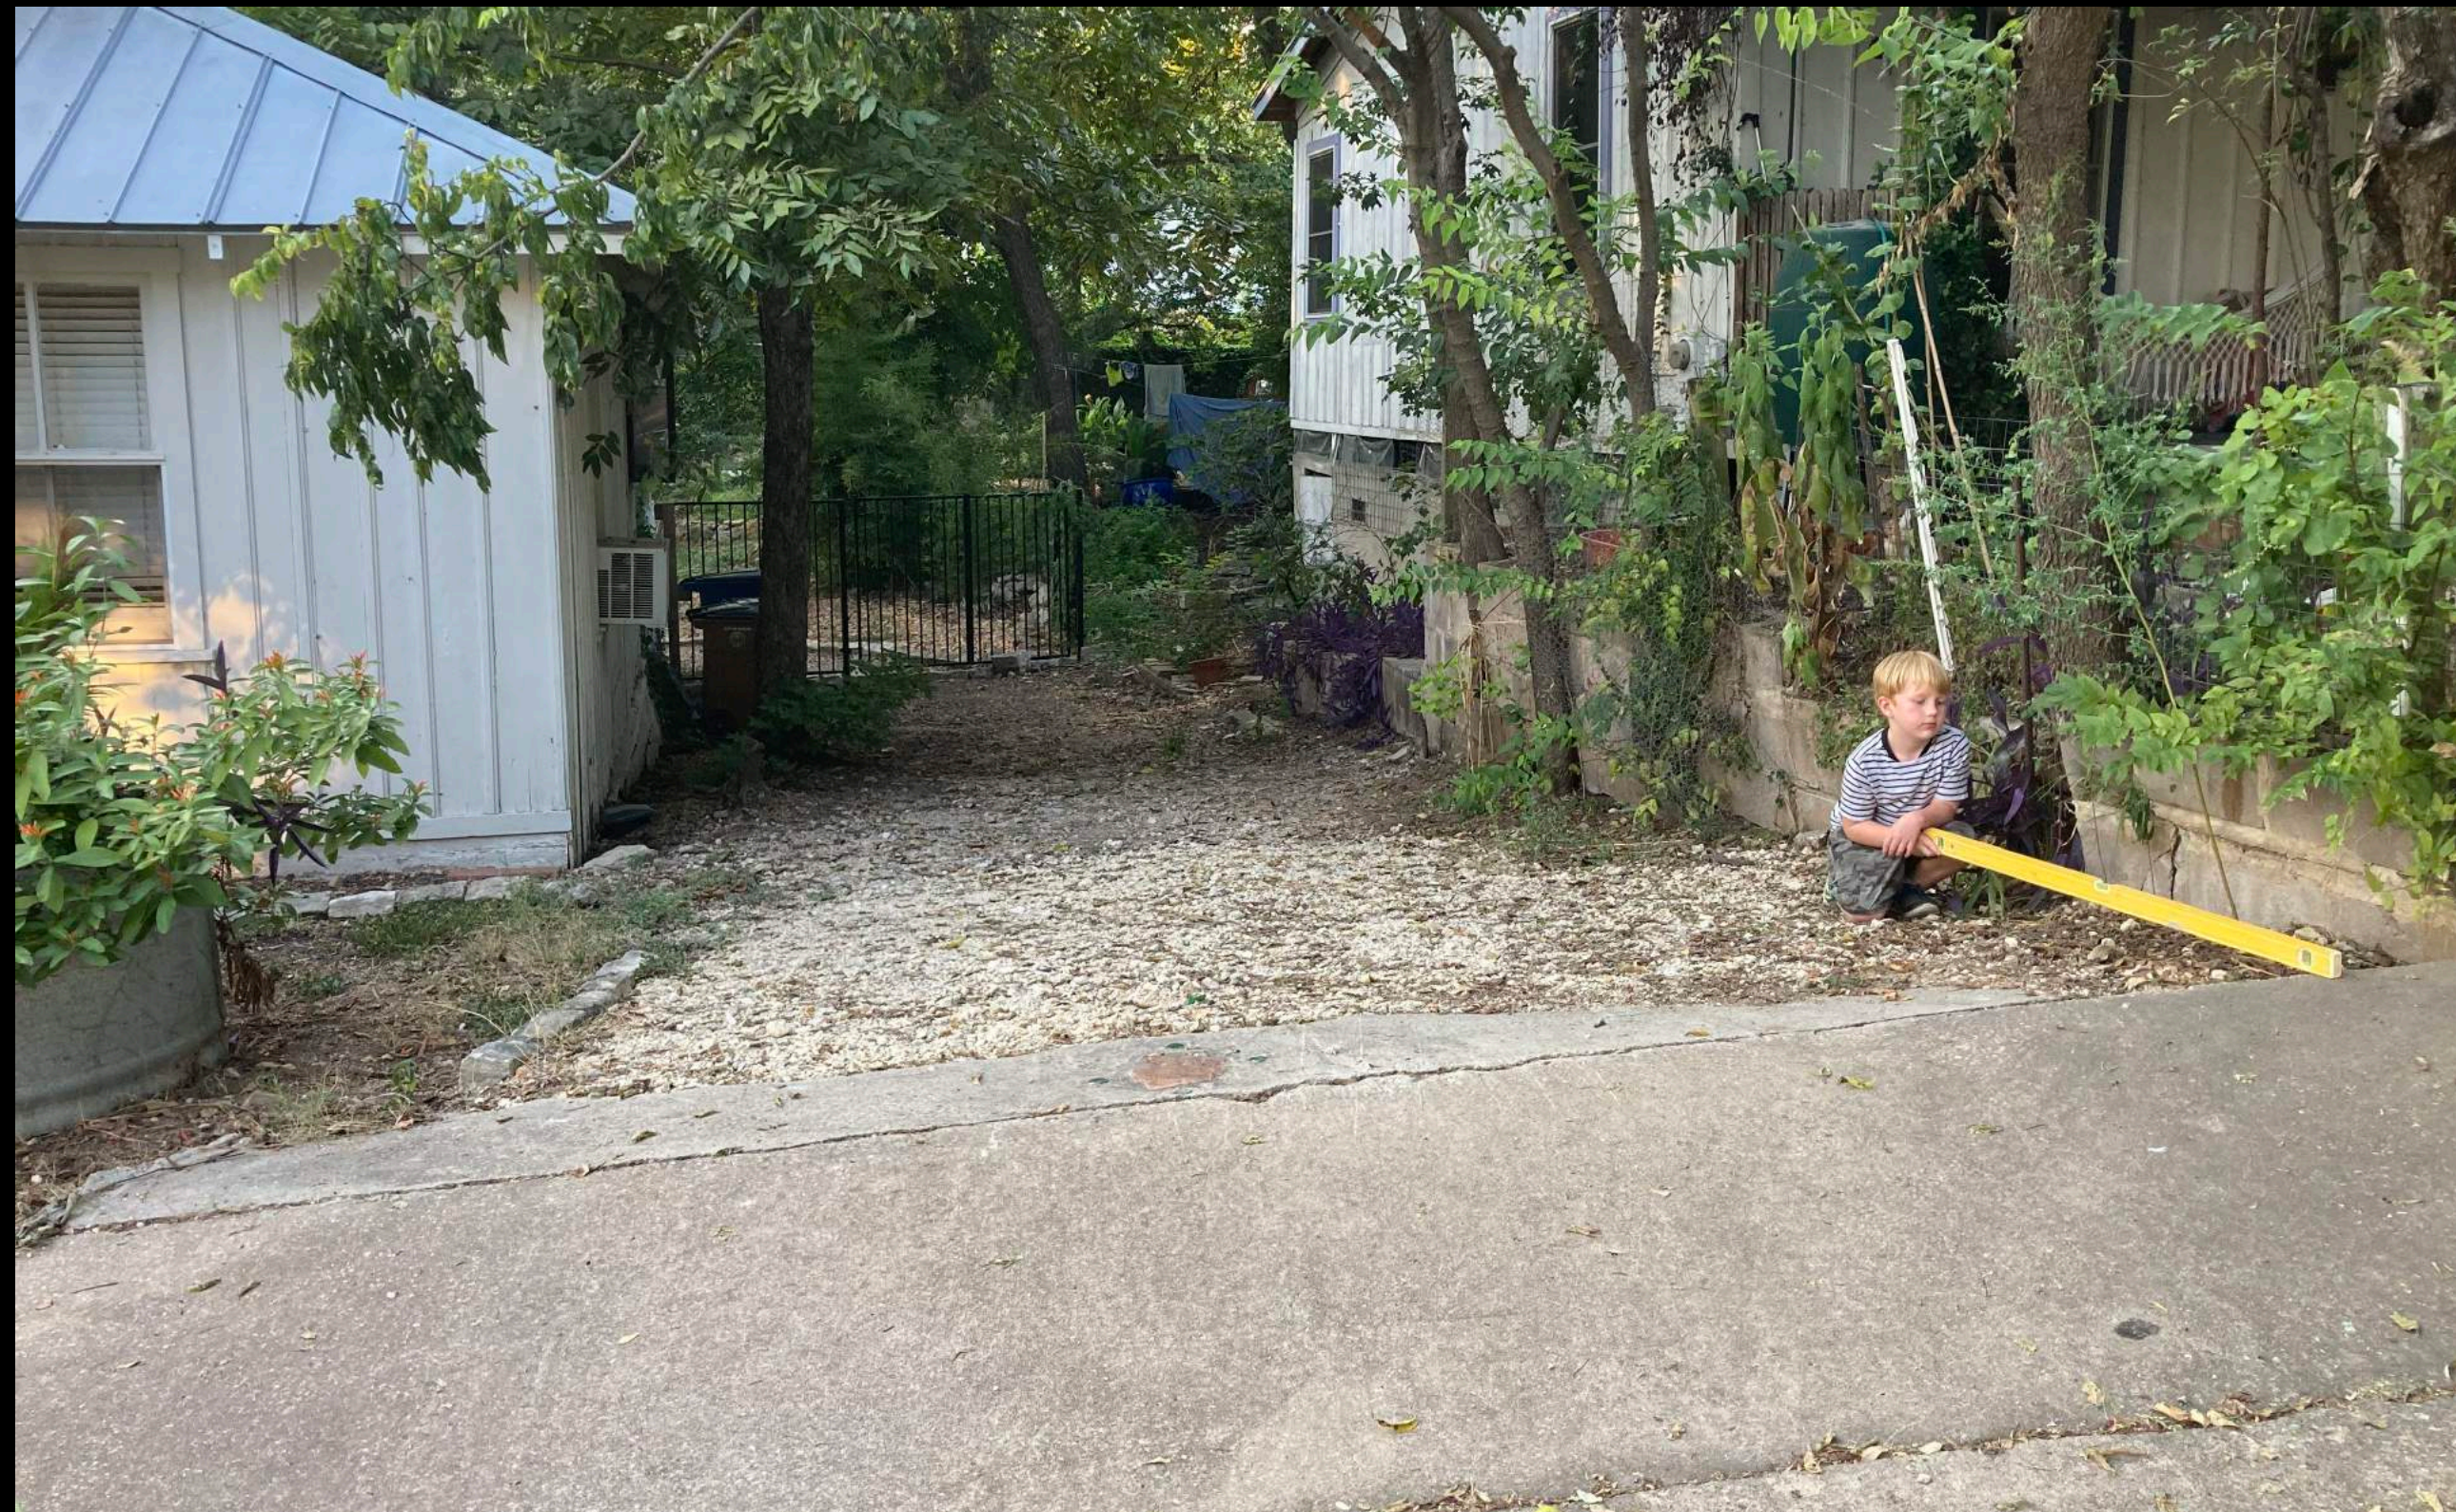
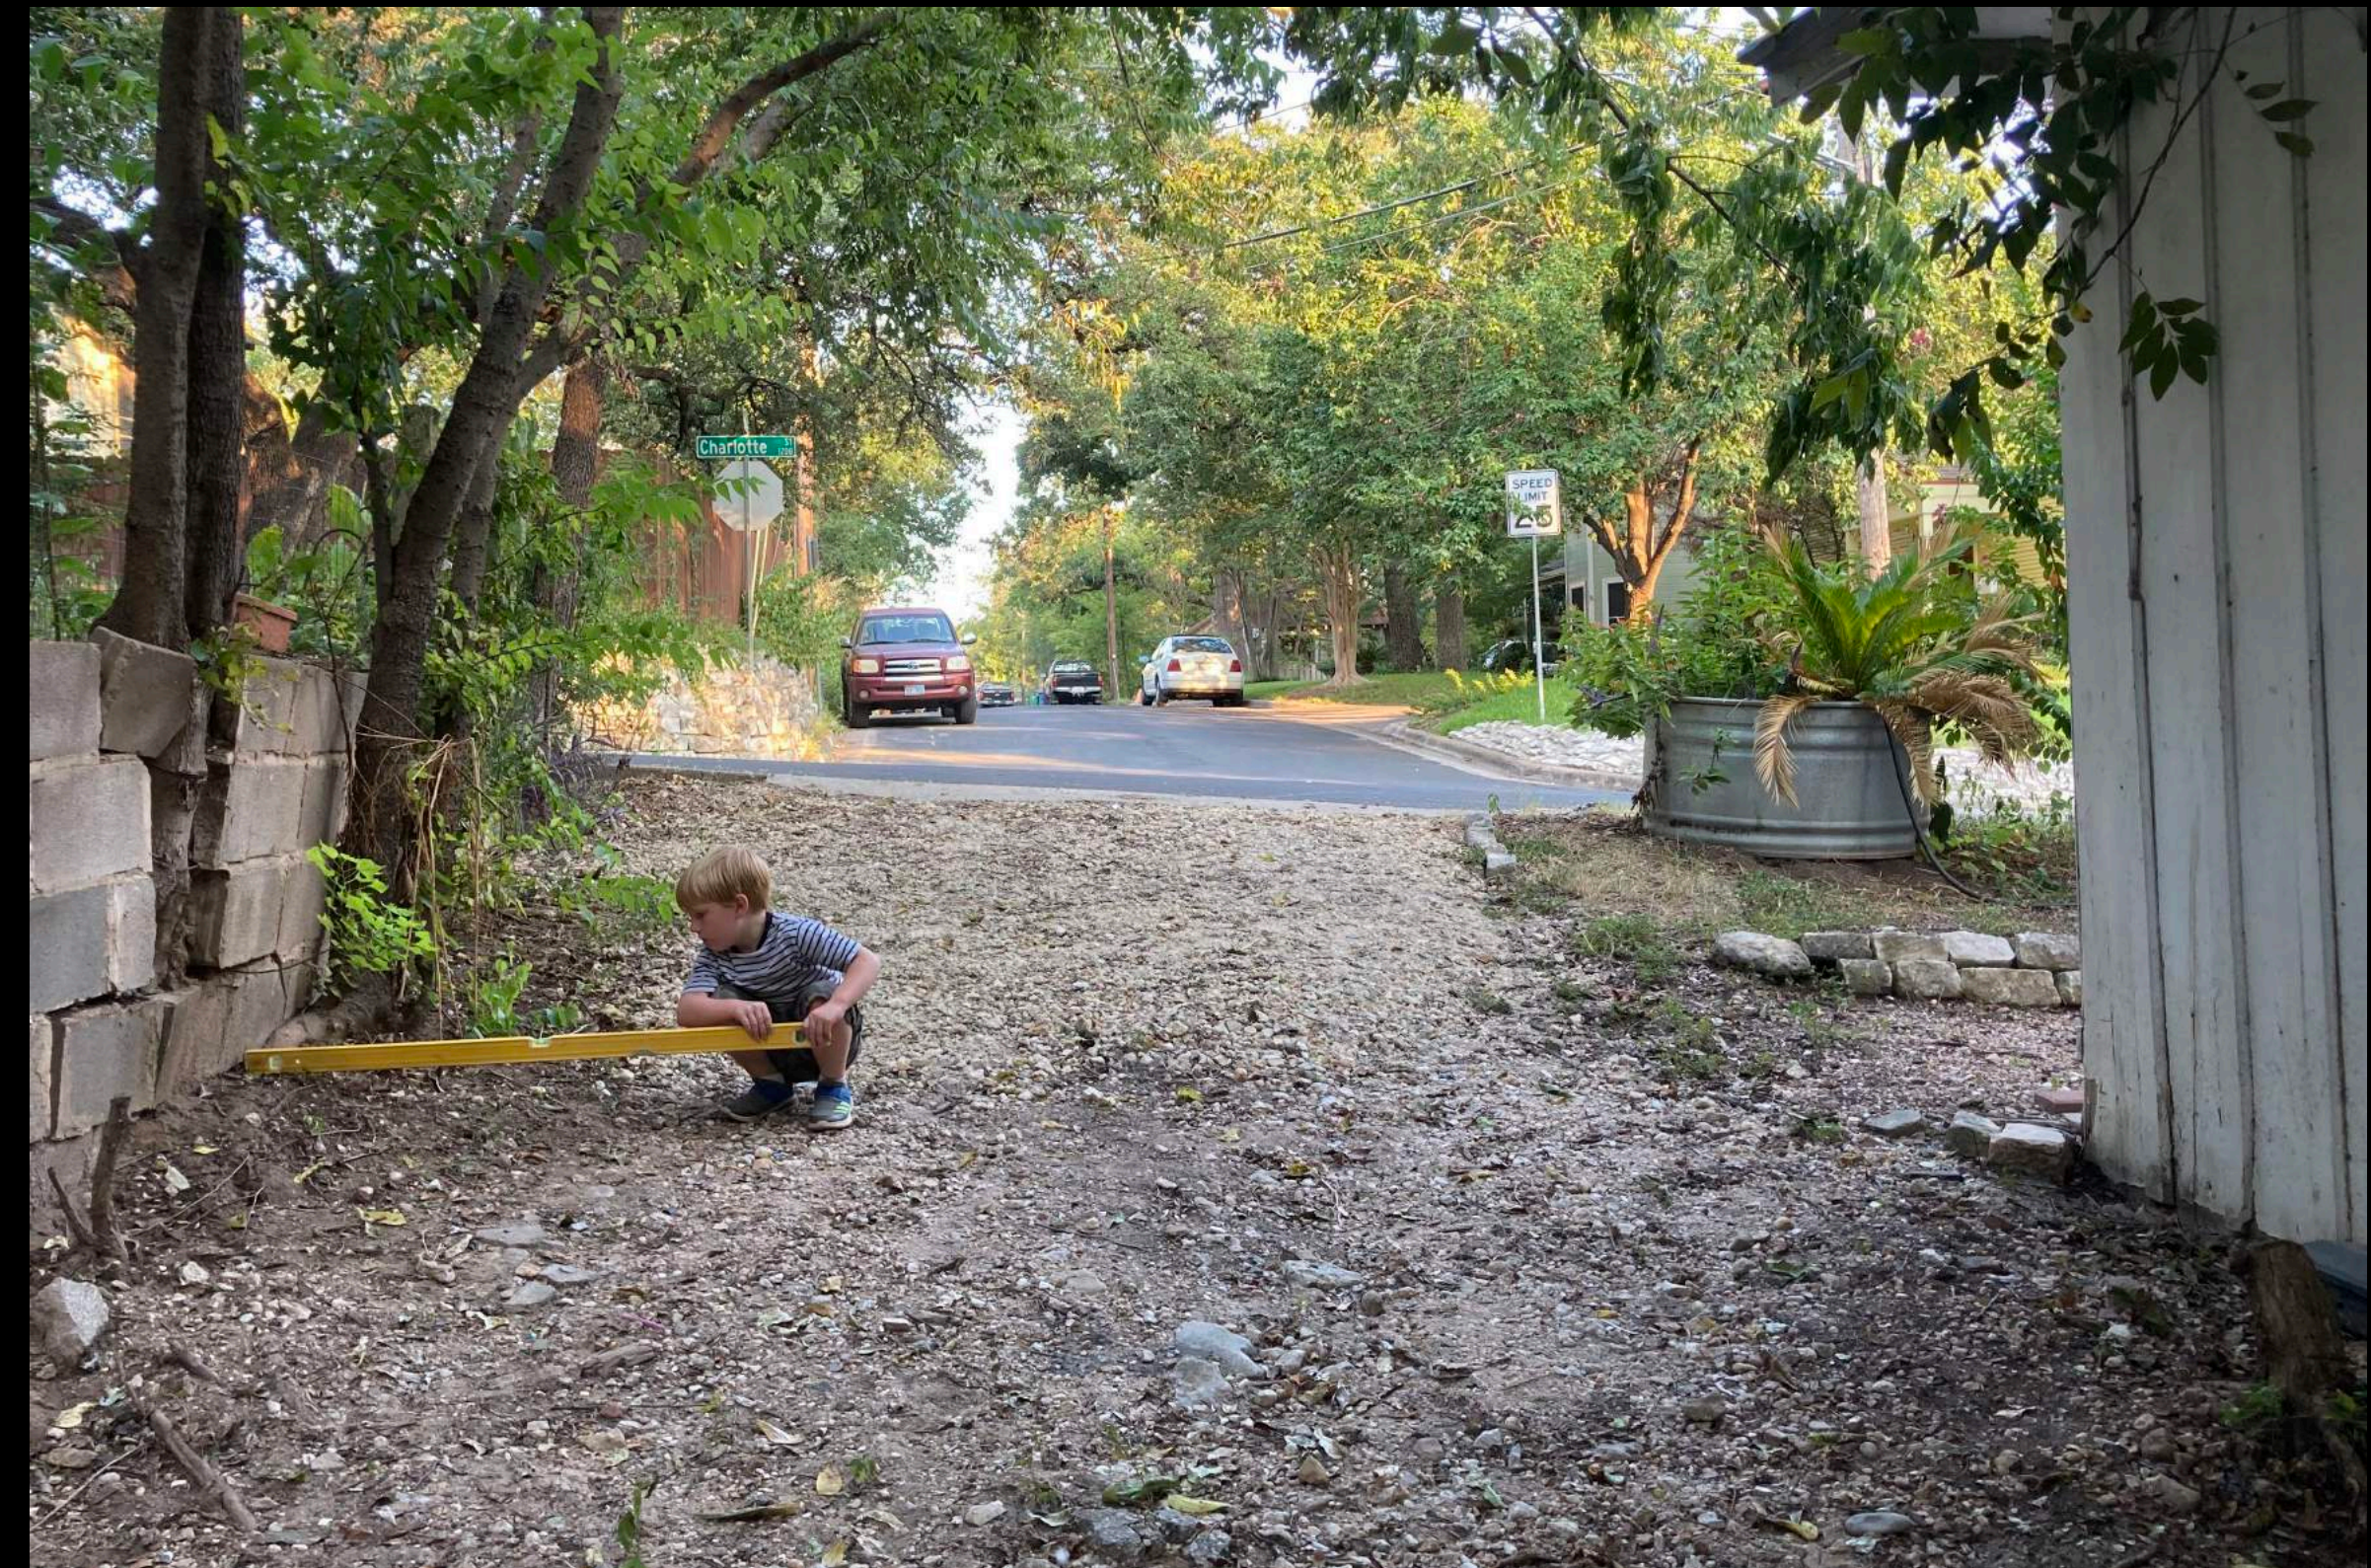
2. Driveway slopes towards the house
