1104 Charlotte St

Kindra Welch and family

10/25/2021

Clarksville Cottage constructed 1915

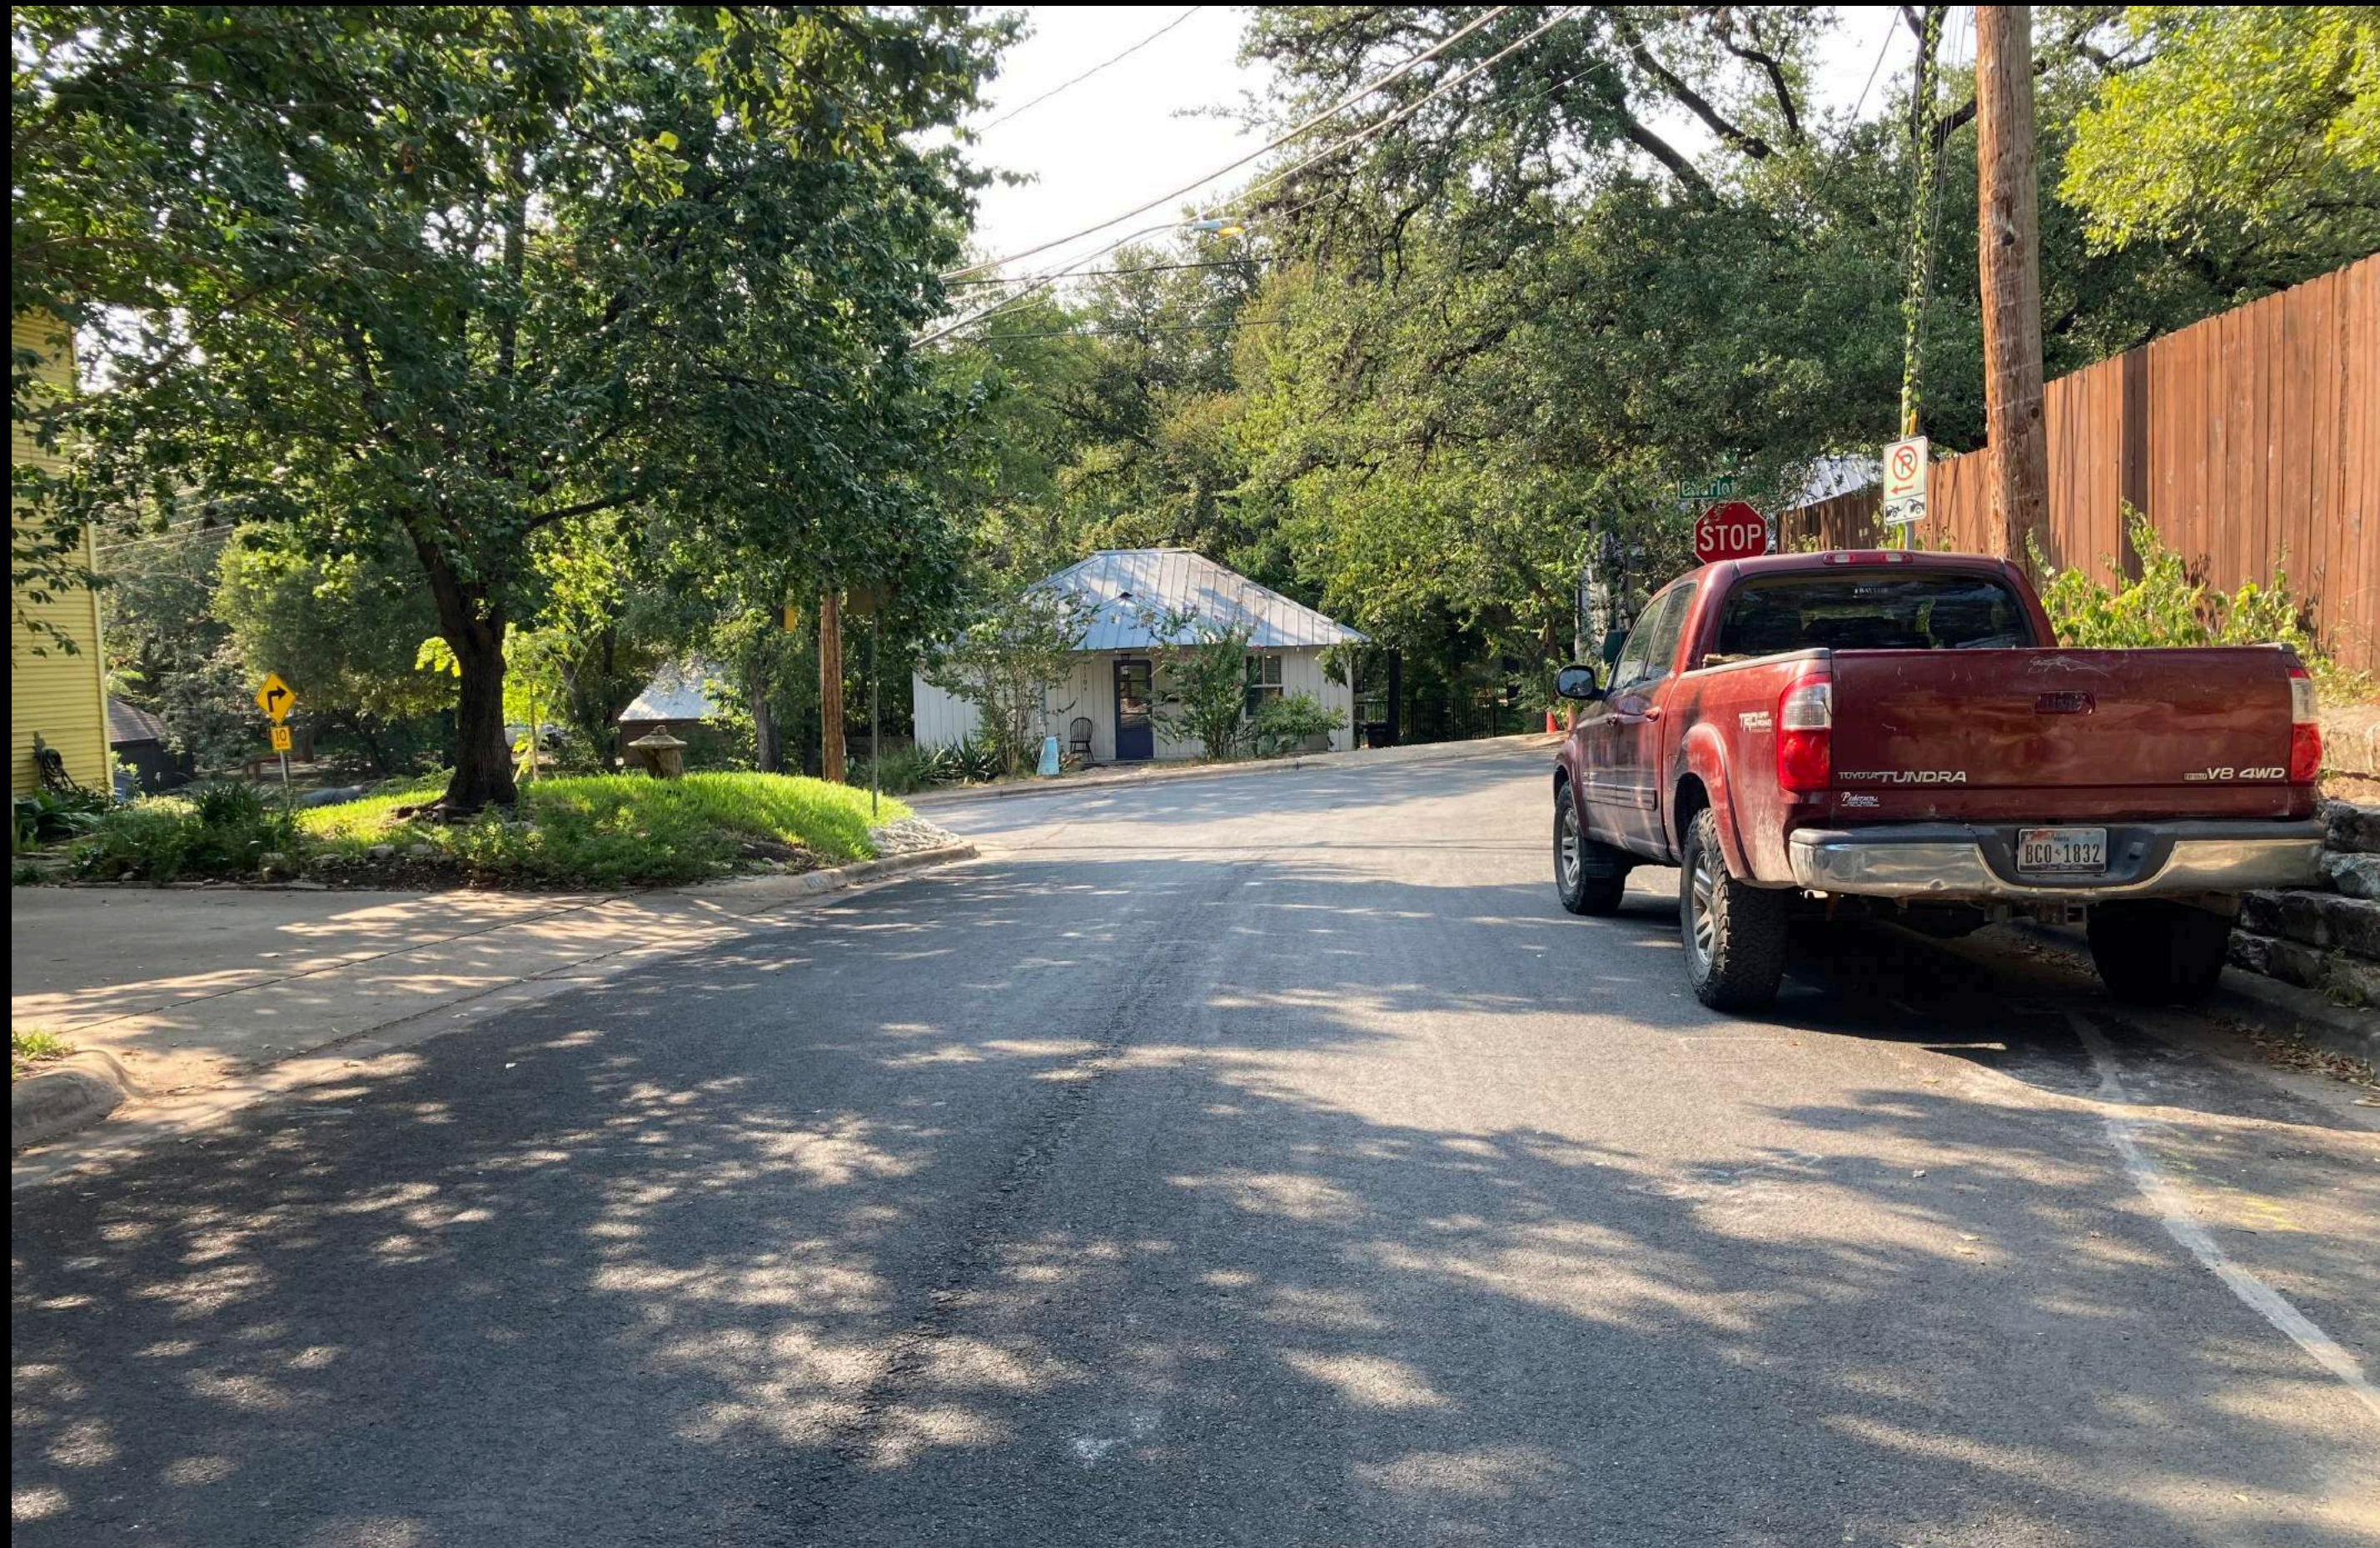
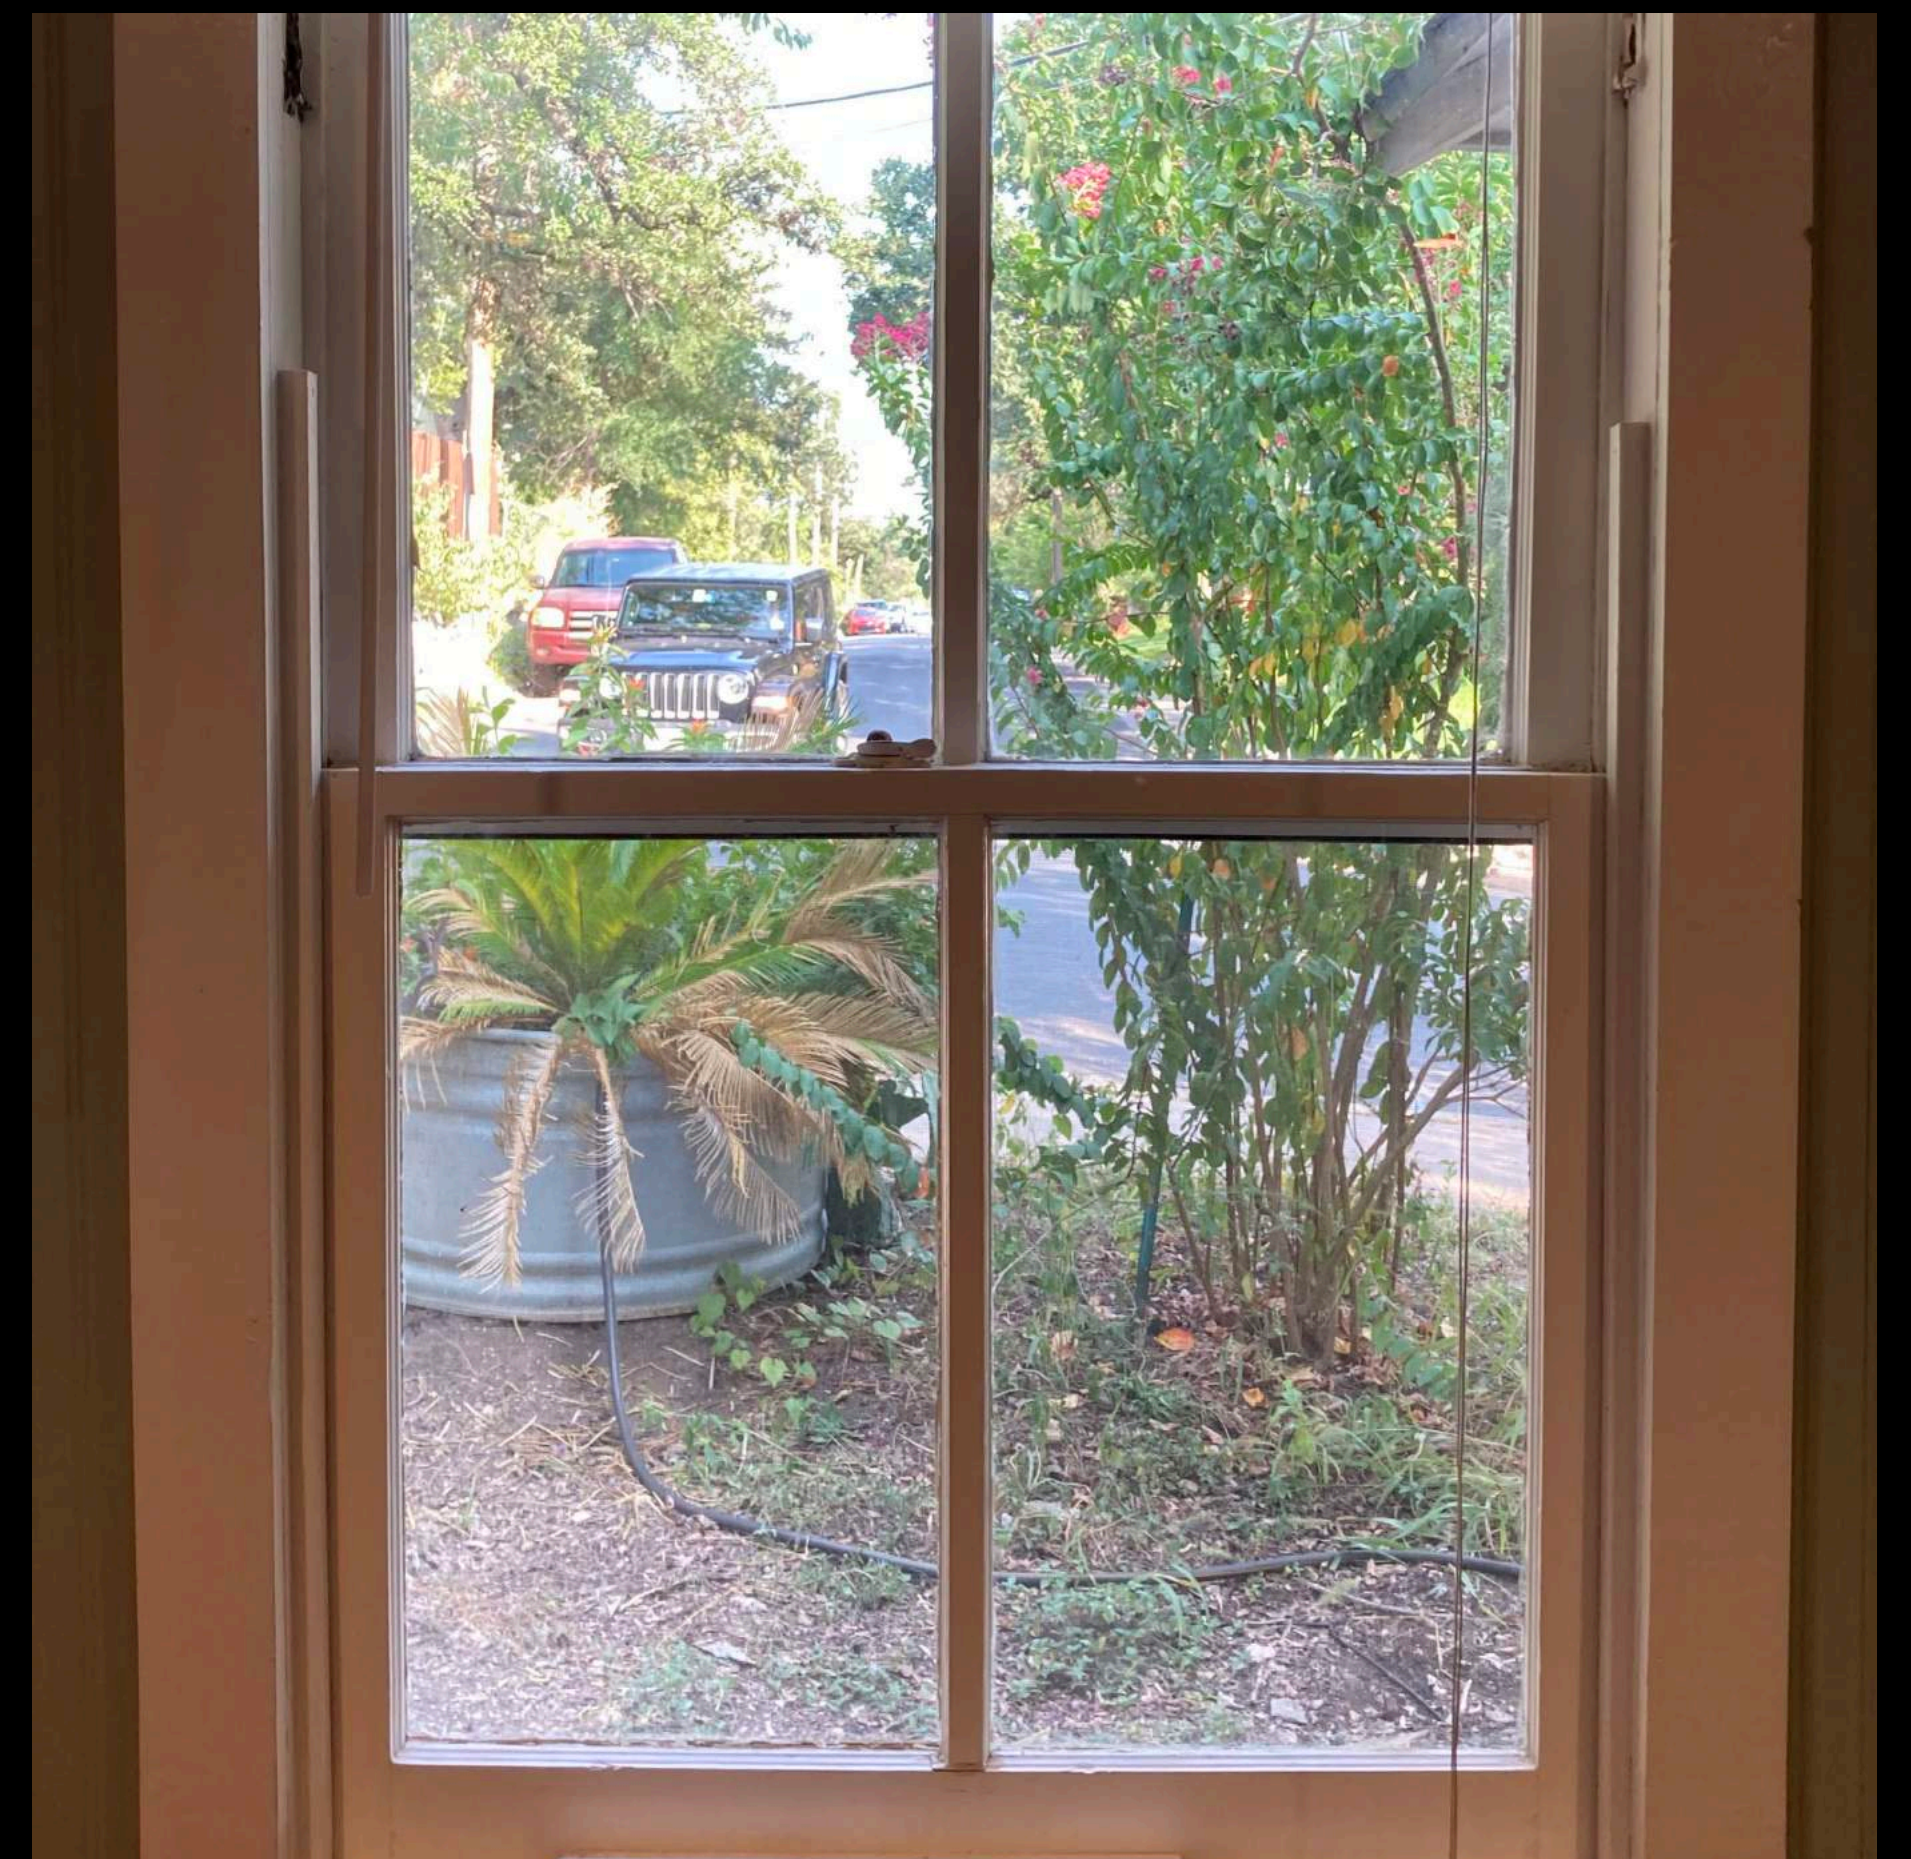
3. The house is the focal point of 12th street traffic, including restaurant and retail traffic from commercial area 1 block away. New Years Eve '03-'04 a driver crashed his truck through the front wall and into the living room.

- 1. One corner sits directly in contact with the ground.**
- 2. Driveway slopes towards the house**
- 3. The house is the focal point of 12th street traffic.**
