## Third Coast Home Inspection

1601 Cedar Ave  
Austin, TX 78702

## PROPERTY INSPECTION REPORT

**By:** Craig A Boarini, Lic #10498 10/22/2021  
(Name and License Number of Inspector) (Date)

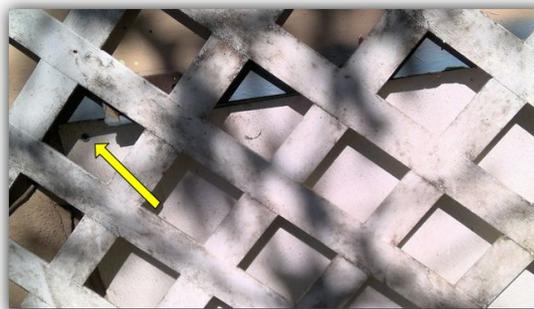
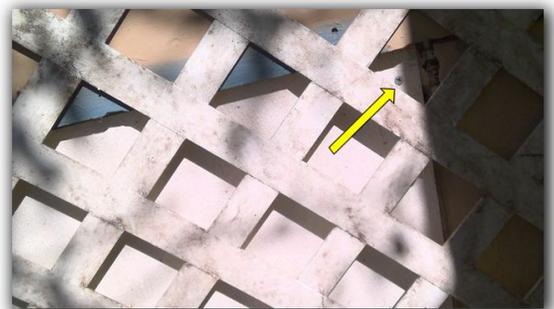
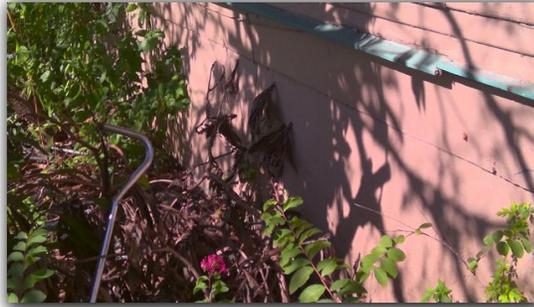
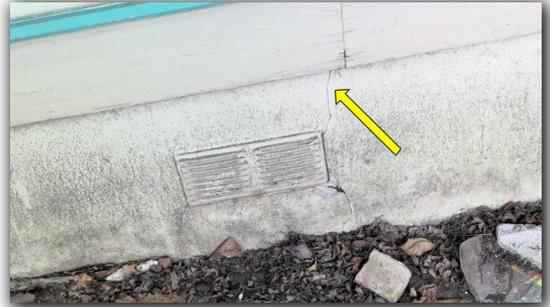
- Foundation Pier and beam crawlspace entry screwed shut, remainder of skirting sealed up . Not inspected.
- Floors not level
- .
- Cracks in foundation skirting
- Cracks in wall(s) and / or ceiling, twisted float joints.

- Signs of structural movement noted; suggest that an expert in this field be consulted for further evaluation of the structure and to provide suggestions as to what, if any, corrective actions should be taken.

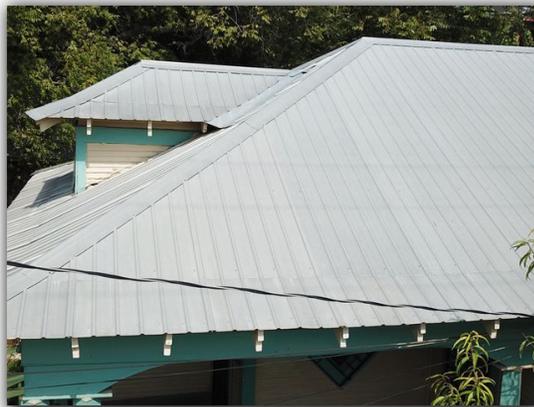
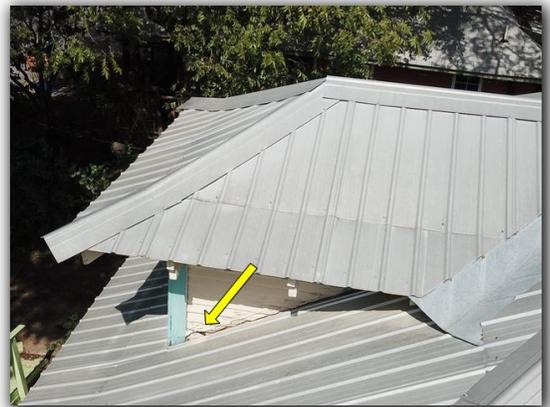
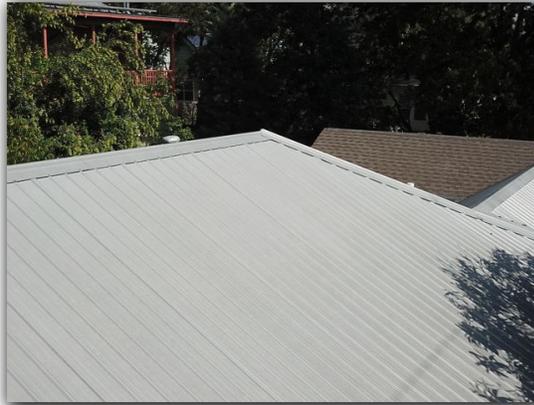
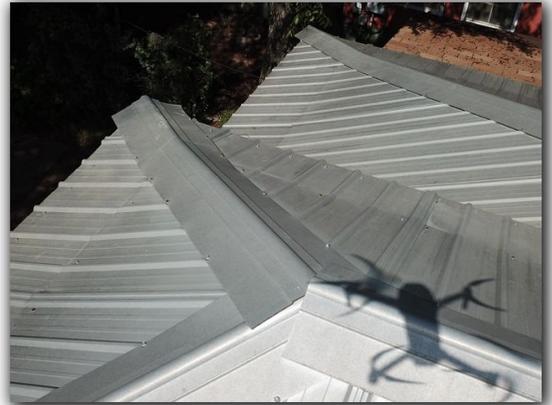
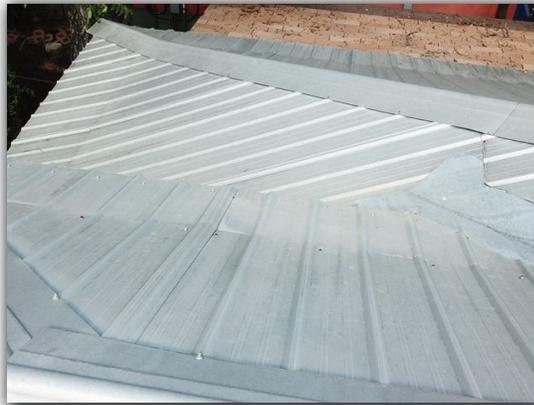
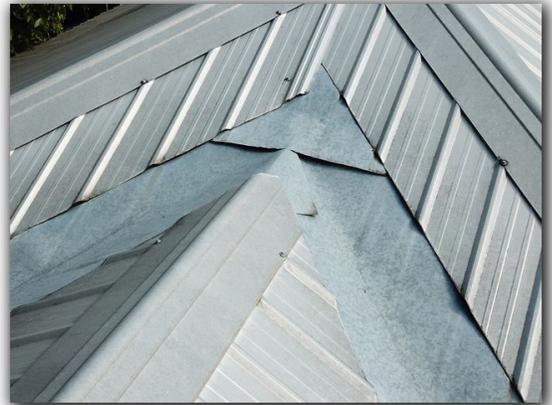
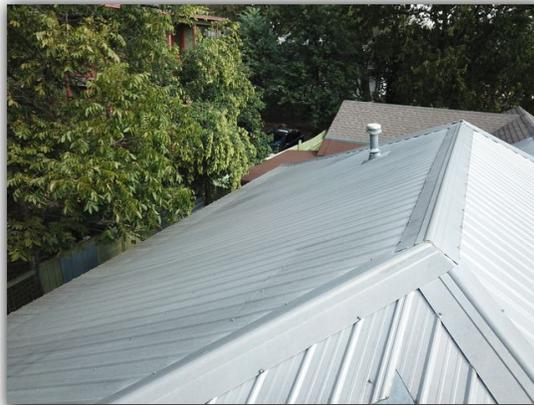
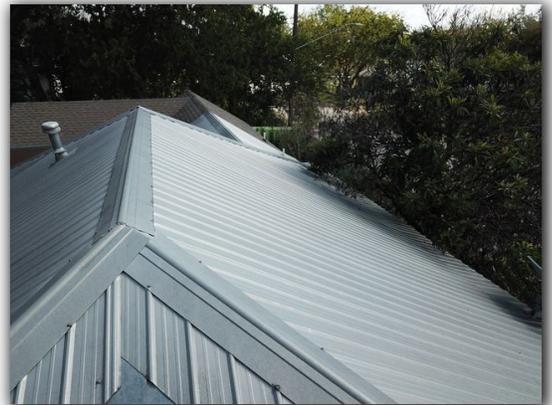
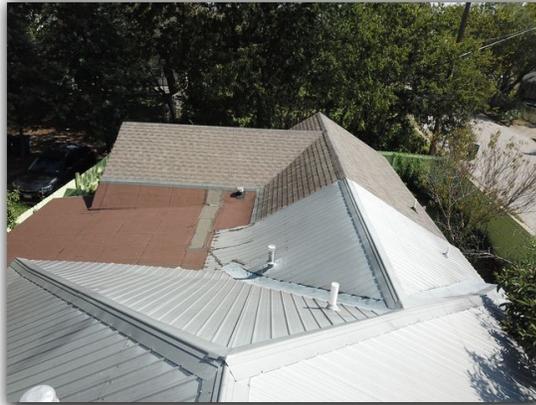
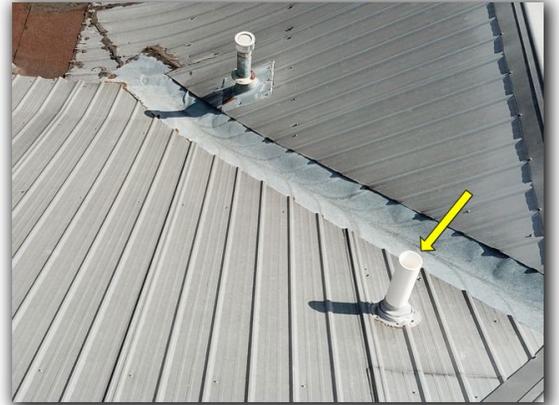
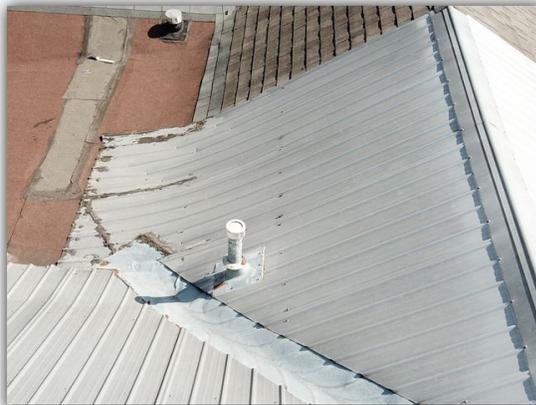
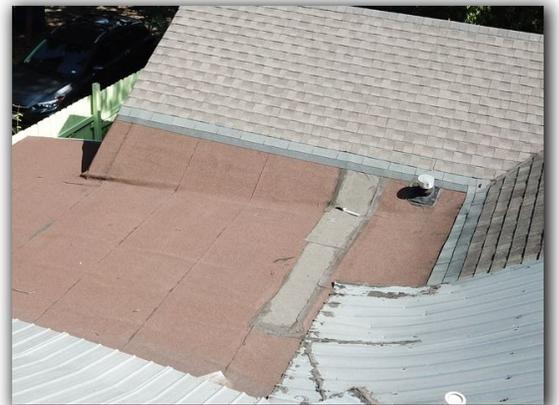
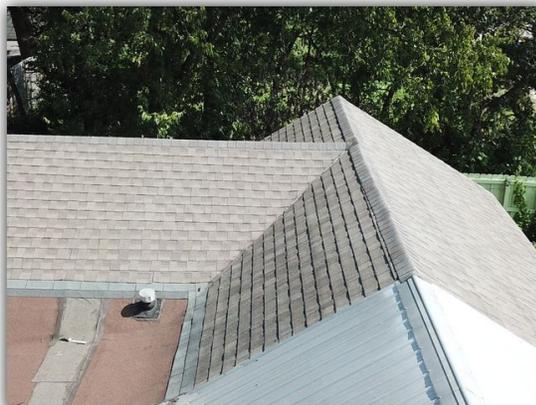
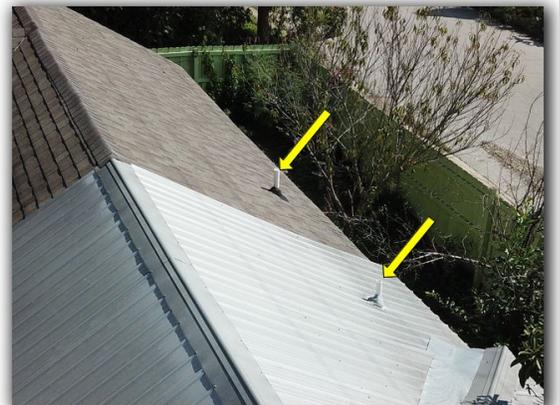
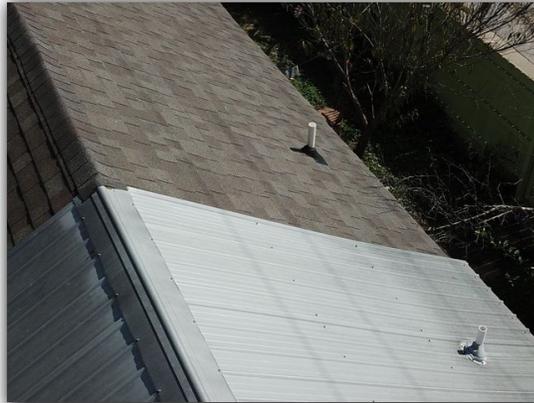
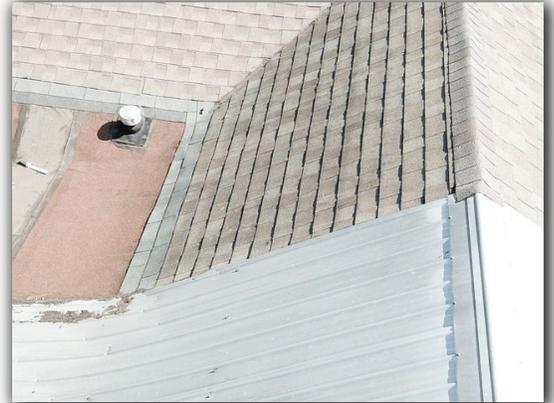
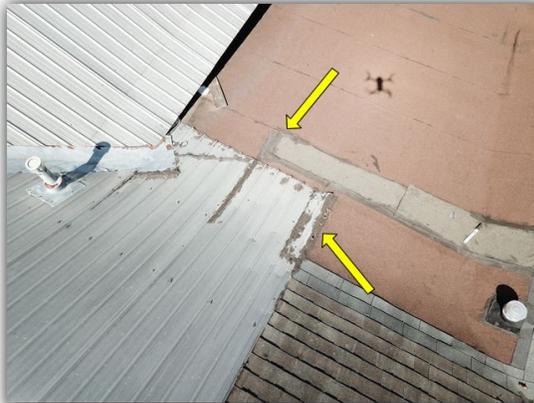
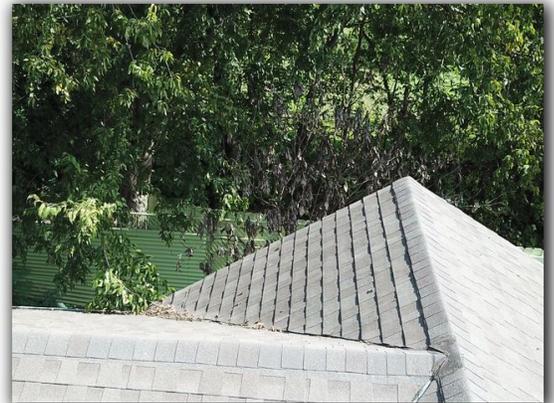
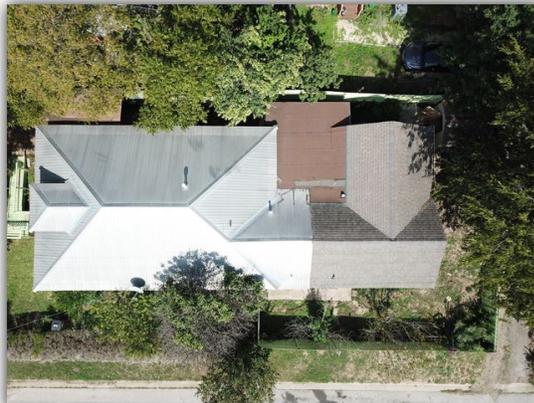
- For total condition and longevity, have roof inspected by a certified Roofer.
- Roof shows signs of patching - Have checked by a certified roofer for total condition and longevity.
- Plumbing vents on the roof are white PVC and are susceptible to deterioration from the sun's rays. (Should be painted with a latex paint.)

Roof shows signs of patching - Have checked by a certified roofer for total condition and longevity.  
Plumbing vents on the roof are white PVC and are susceptible to deterioration from the sun's rays. (Should be painted with a latex paint.)

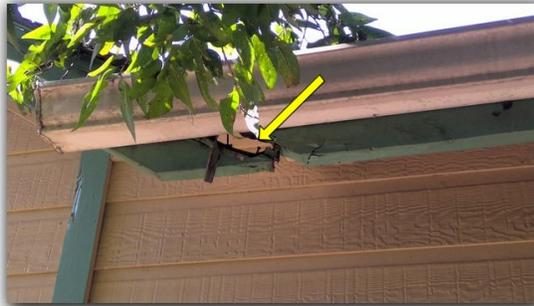
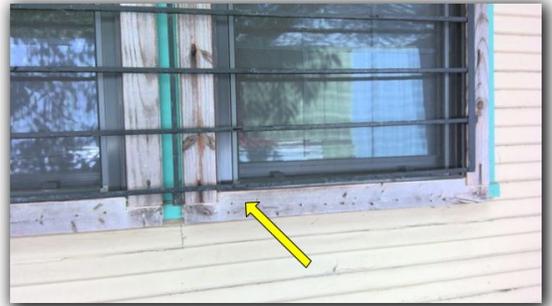
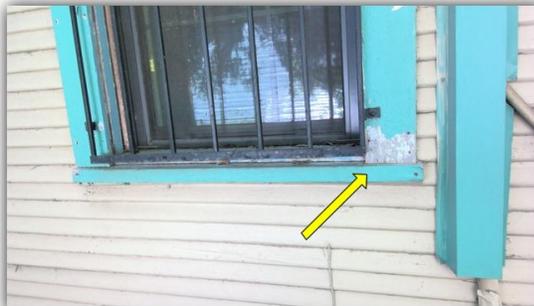
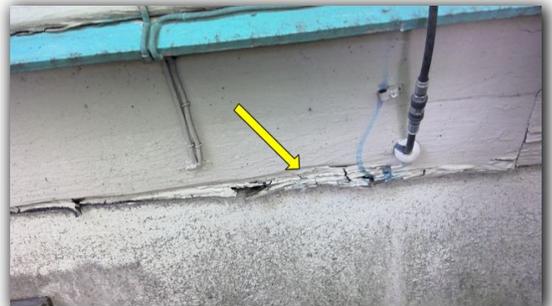
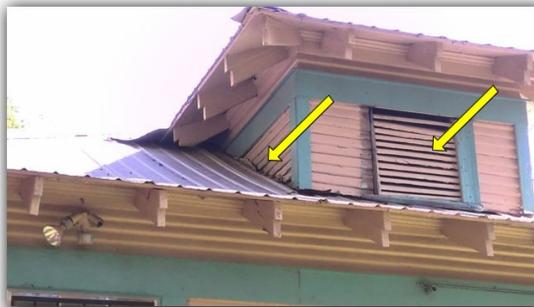
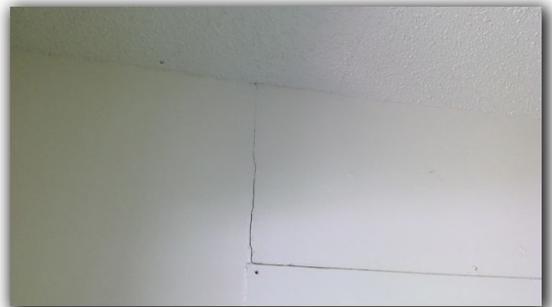
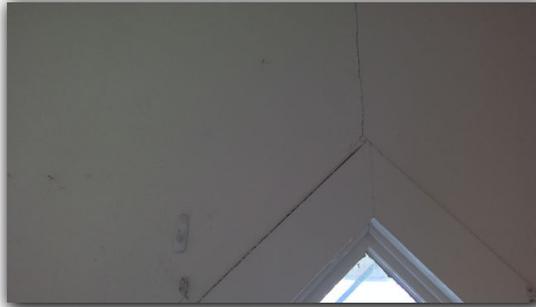
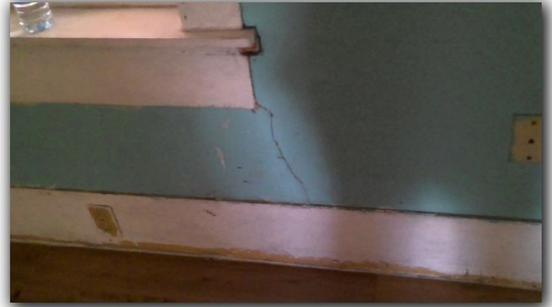
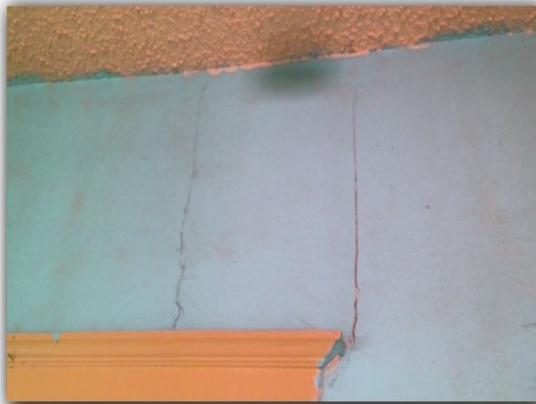
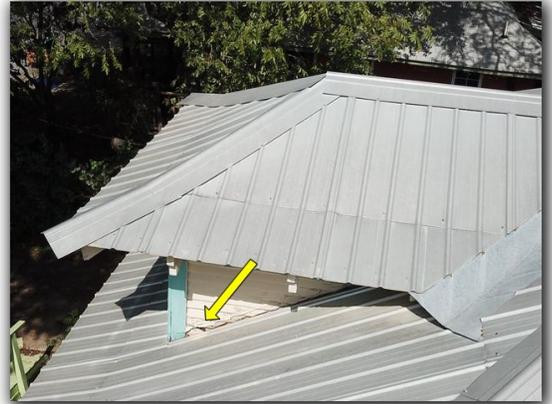
- Settlement cracks in interior walls /twisted float joints in various locations.

- Exterior walls in poor condition, handy man repairs in various locations.

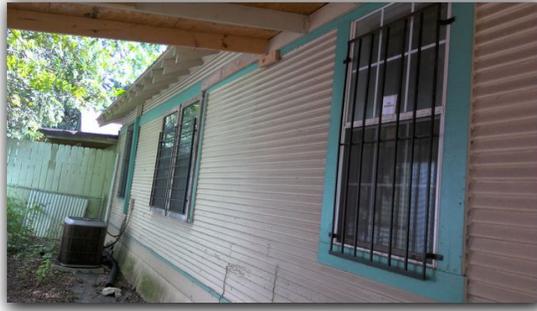
Burglar bars present , fire escape safety hazard.

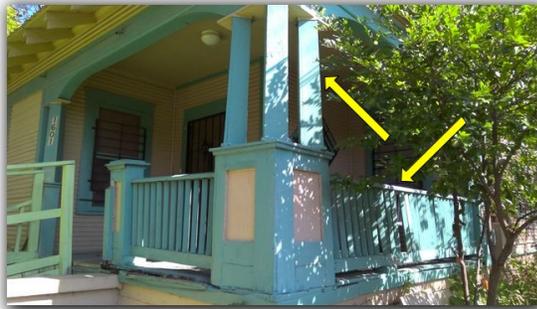
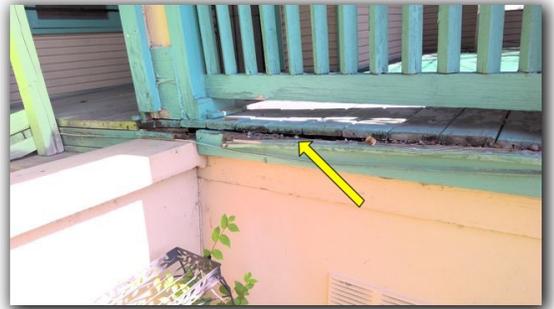
Porch and support columns and railing appear unstable.

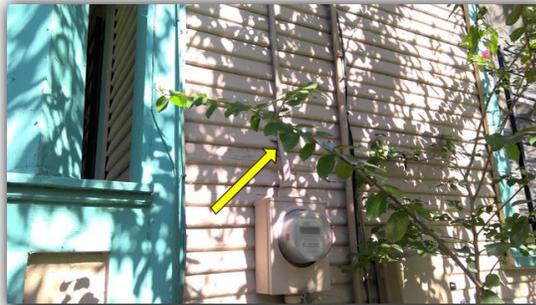
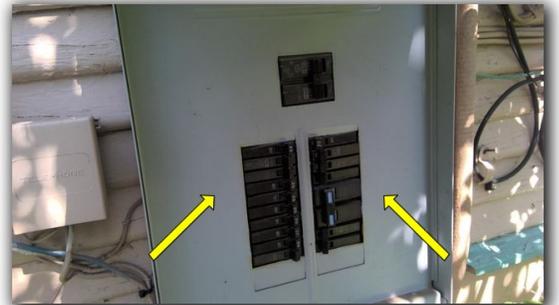
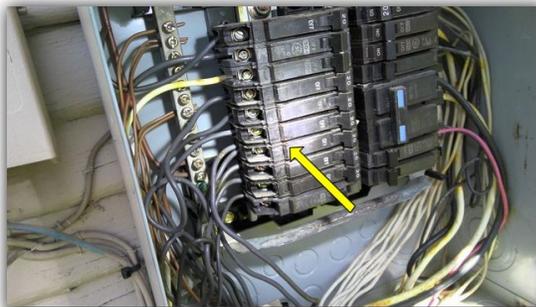
- 125 Amp
- Main power supply wire to the electric meter is unprotected. - Safety hazard (Suggest the installation of a proper mast)
- Main electrical panel is not labeled - Safety hazard
- Doubled tapped breakers / Fuses in the main / only electrical panel - Safety hazard
- A/C condensing unit #1:  
Specifies max amp breaker of 40 amp and a ??? amp breaker is in use

- No ARC fault breakers present for the bedroom - Not required at the time of construction.

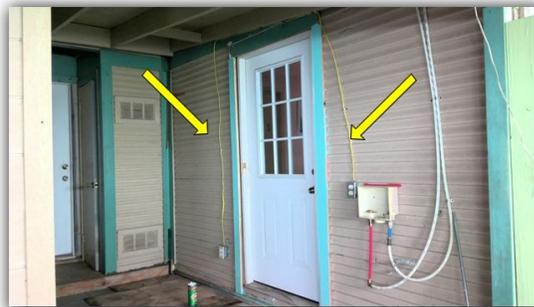
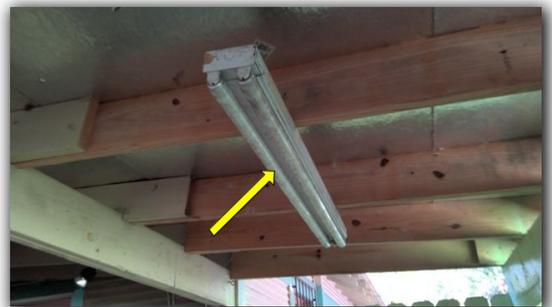
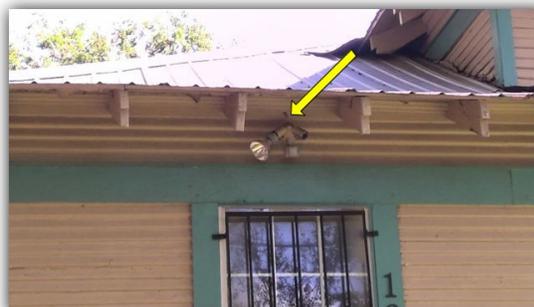
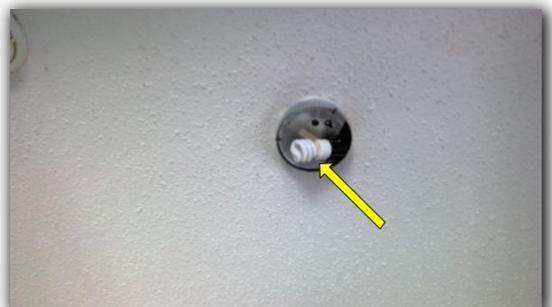
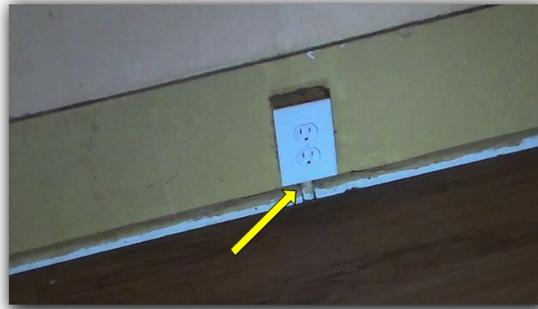
- Light bulbs missing protective covers in various locations. - Safety hazard

- Smoke alarms are not present in each sleeping area
- No smoke alarm in hallway
- Missing Carbon Monoxide detectors when gas supply is present on the property - Safety Hazard

- Unprotected wires interior/exterior of the structure in various locations - Safety hazard

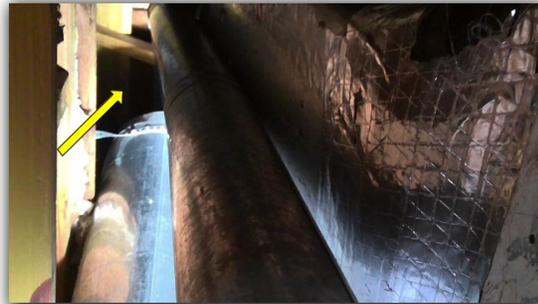
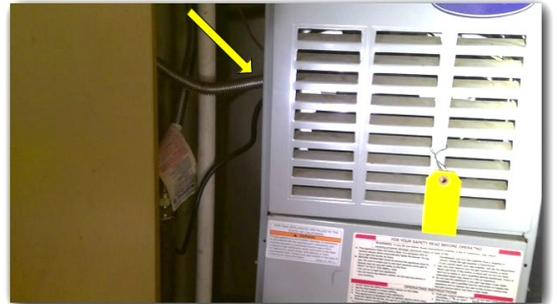
Furnace closet is open to the attic - Safety hazard

Furnace has flex gas line going through the furnace housing, should be rigid pipe going through the housing then flex line to the supply. - Safety hazard

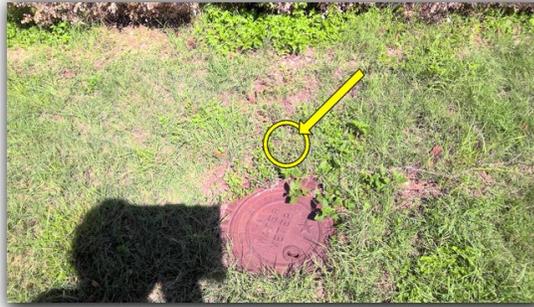
*Comments:* Water not turned off, unable to check any plumbing or drain fixtures.

Home owners water shut off valve is buried or missing. Have plumber locate and clean out for in case of an emergency

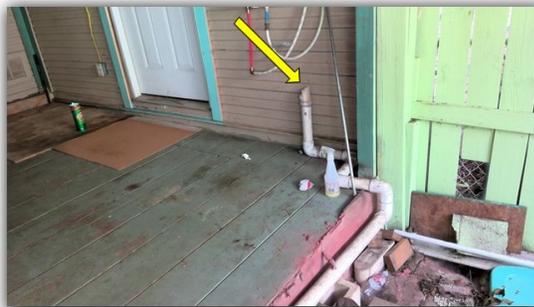
- Broken plumbing in various locations
- Sewer clean out was not located have located or installed by a certified plumber
- Strong Sewer smell in various location - Potential health safety hazard.

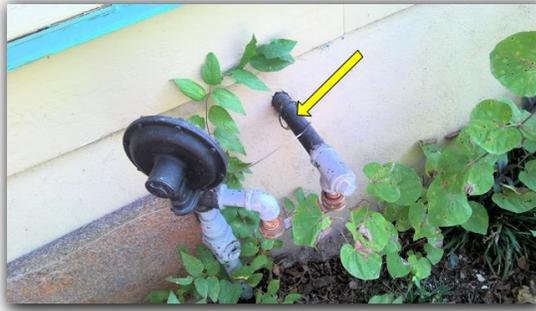
- Water heater pressure relief drain line is not plumbed to the exterior -goes to under the house  
Safety hazard

- Gas meter is not grounded - Safety hazard

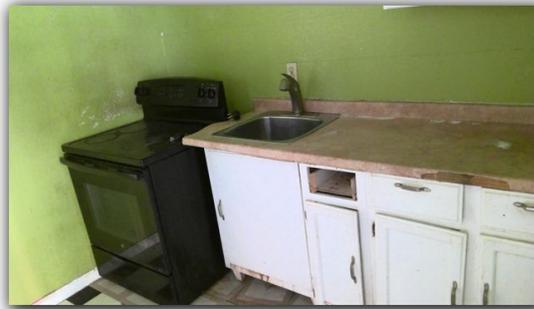
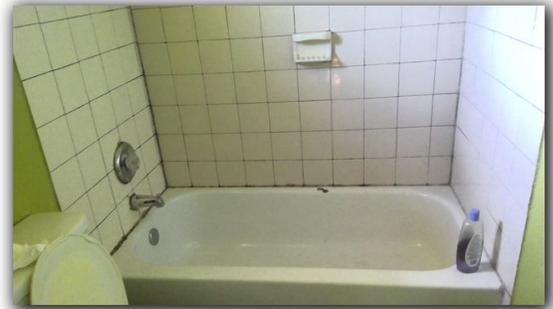
*Comments:* Second structure out back, not inspected. In very poor shape and smell inside is unhealthy.
