McCrummen-Wroe House 2300 WINDSOR ROAD, AUSTIN, TEXAS 78703

## SHEET INDEX:

APRIL 8, 2022

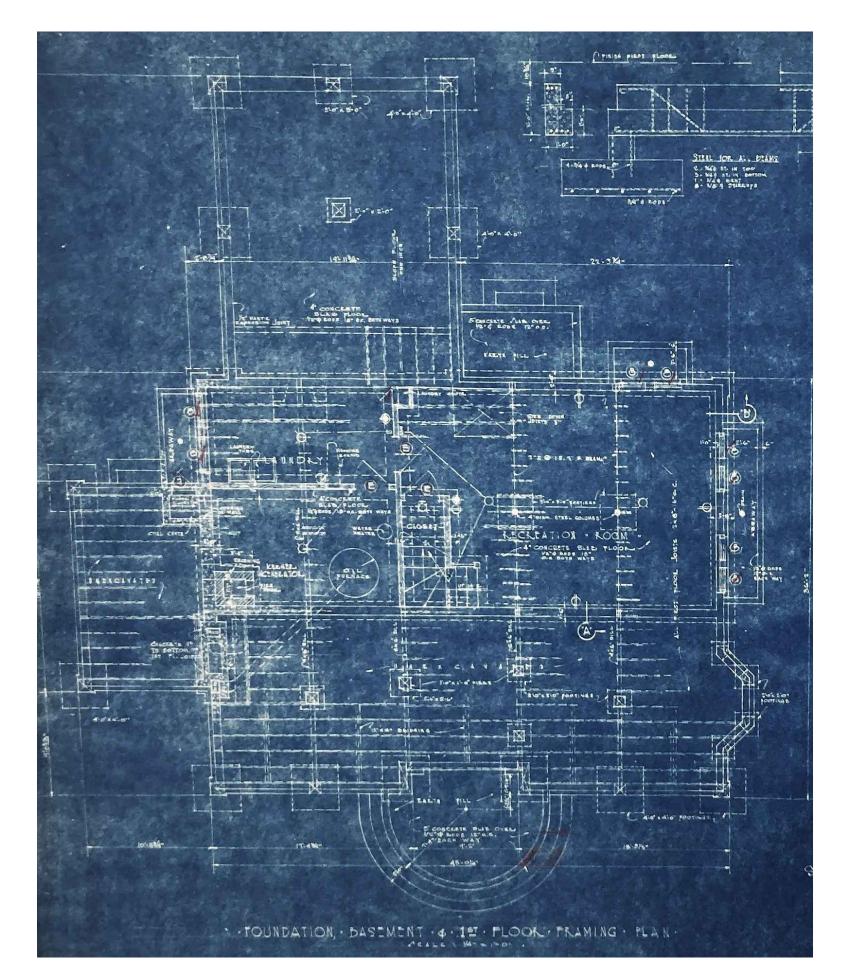
HISTORIC - BASMENT FLOOR PLAN

HISTORIC BASEMENT DRAWING.
Illustrates: Original hand drafted historic basement plan. Plan matches as-built drawings. No changes proposed to exterior envelope of plan.
Image cannot be reproduced or utilized for any other purpose but for Historical Review.

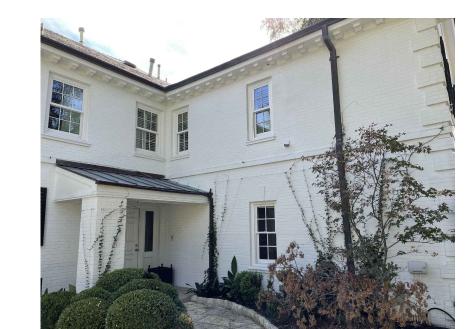
HISTORIC STRUCTURE WITH PORCH ADDITION, BRICK IN-FILLED WALL & DOOR SYSTEM.

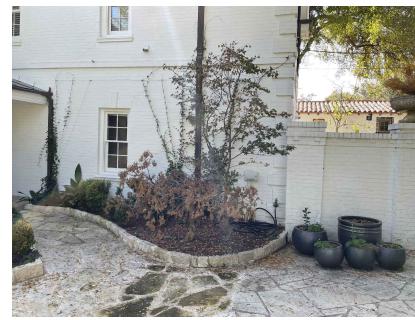
HISTORIC STRUCTURE WITH BRICK FENCE WALL.

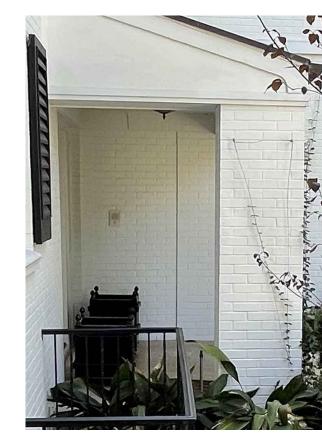
EXISTING PORCH CORNER NORTH ELEVATION Illustrates: Existing decorative brick header. Above brick infill (brick infill to be demolished a replaced with a steel door painted to match existing window color to show it is new in material but blend in with color.) re: Cad Exterior elevations and Historical plan for

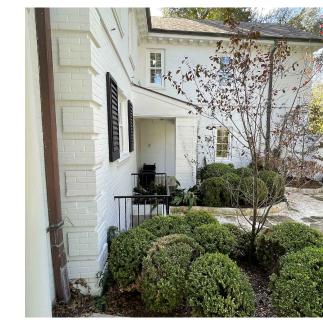
HISTORIC STRUCTURE OVERALL VIEW OF BRICK IN-FILLED WALL.

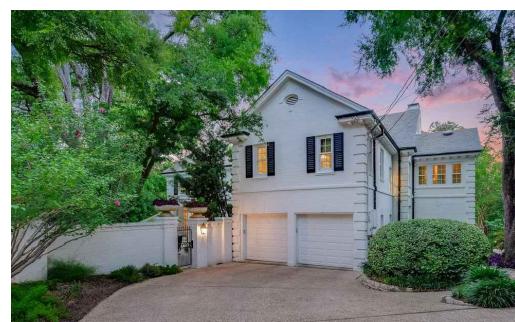
EXISTING WEST ELEVATION AT GARAGE Illustrates: Existing non-historic garage doors to be demolished and

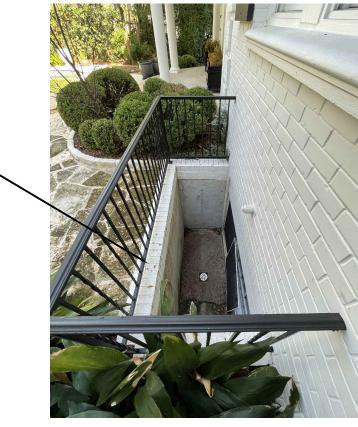
WINDOW WELL DETAIL IMAGE Illustrates: brick at window well NOT HISTORIC per window well detail on this sheet.

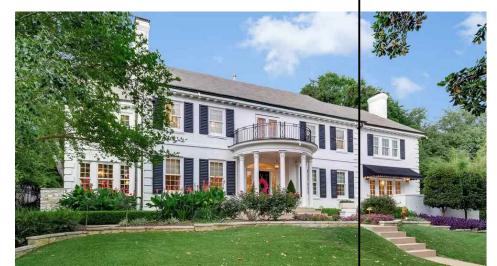
EAST ELEVATION OF HISTORIC PORTION OF ELEVATION WITH ADDITION ON RIGHT.

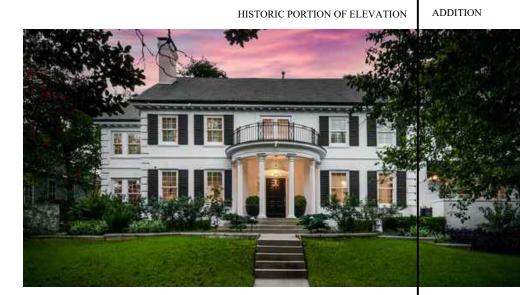
EAST ELEVATION OF HISTORIC PORTION OF ELEVATION SHOWING LEFT WING.
