ITEM FOR ENVIRONMENTAL COMMISSION AGENDA

NAME & NUMBER OF PROJECT: Sky Mountain
SP-2021-0079C

REQUEST: Variance request is as follows:
Request to vary from LDC 25-8-341 to allow cut over 4 feet to 16
feet.

SKY MOUNTAIN
PLANS FOR SITE DEVELOPMENT
CUT / FILL ANALYSIS CROSS-SECTIONS

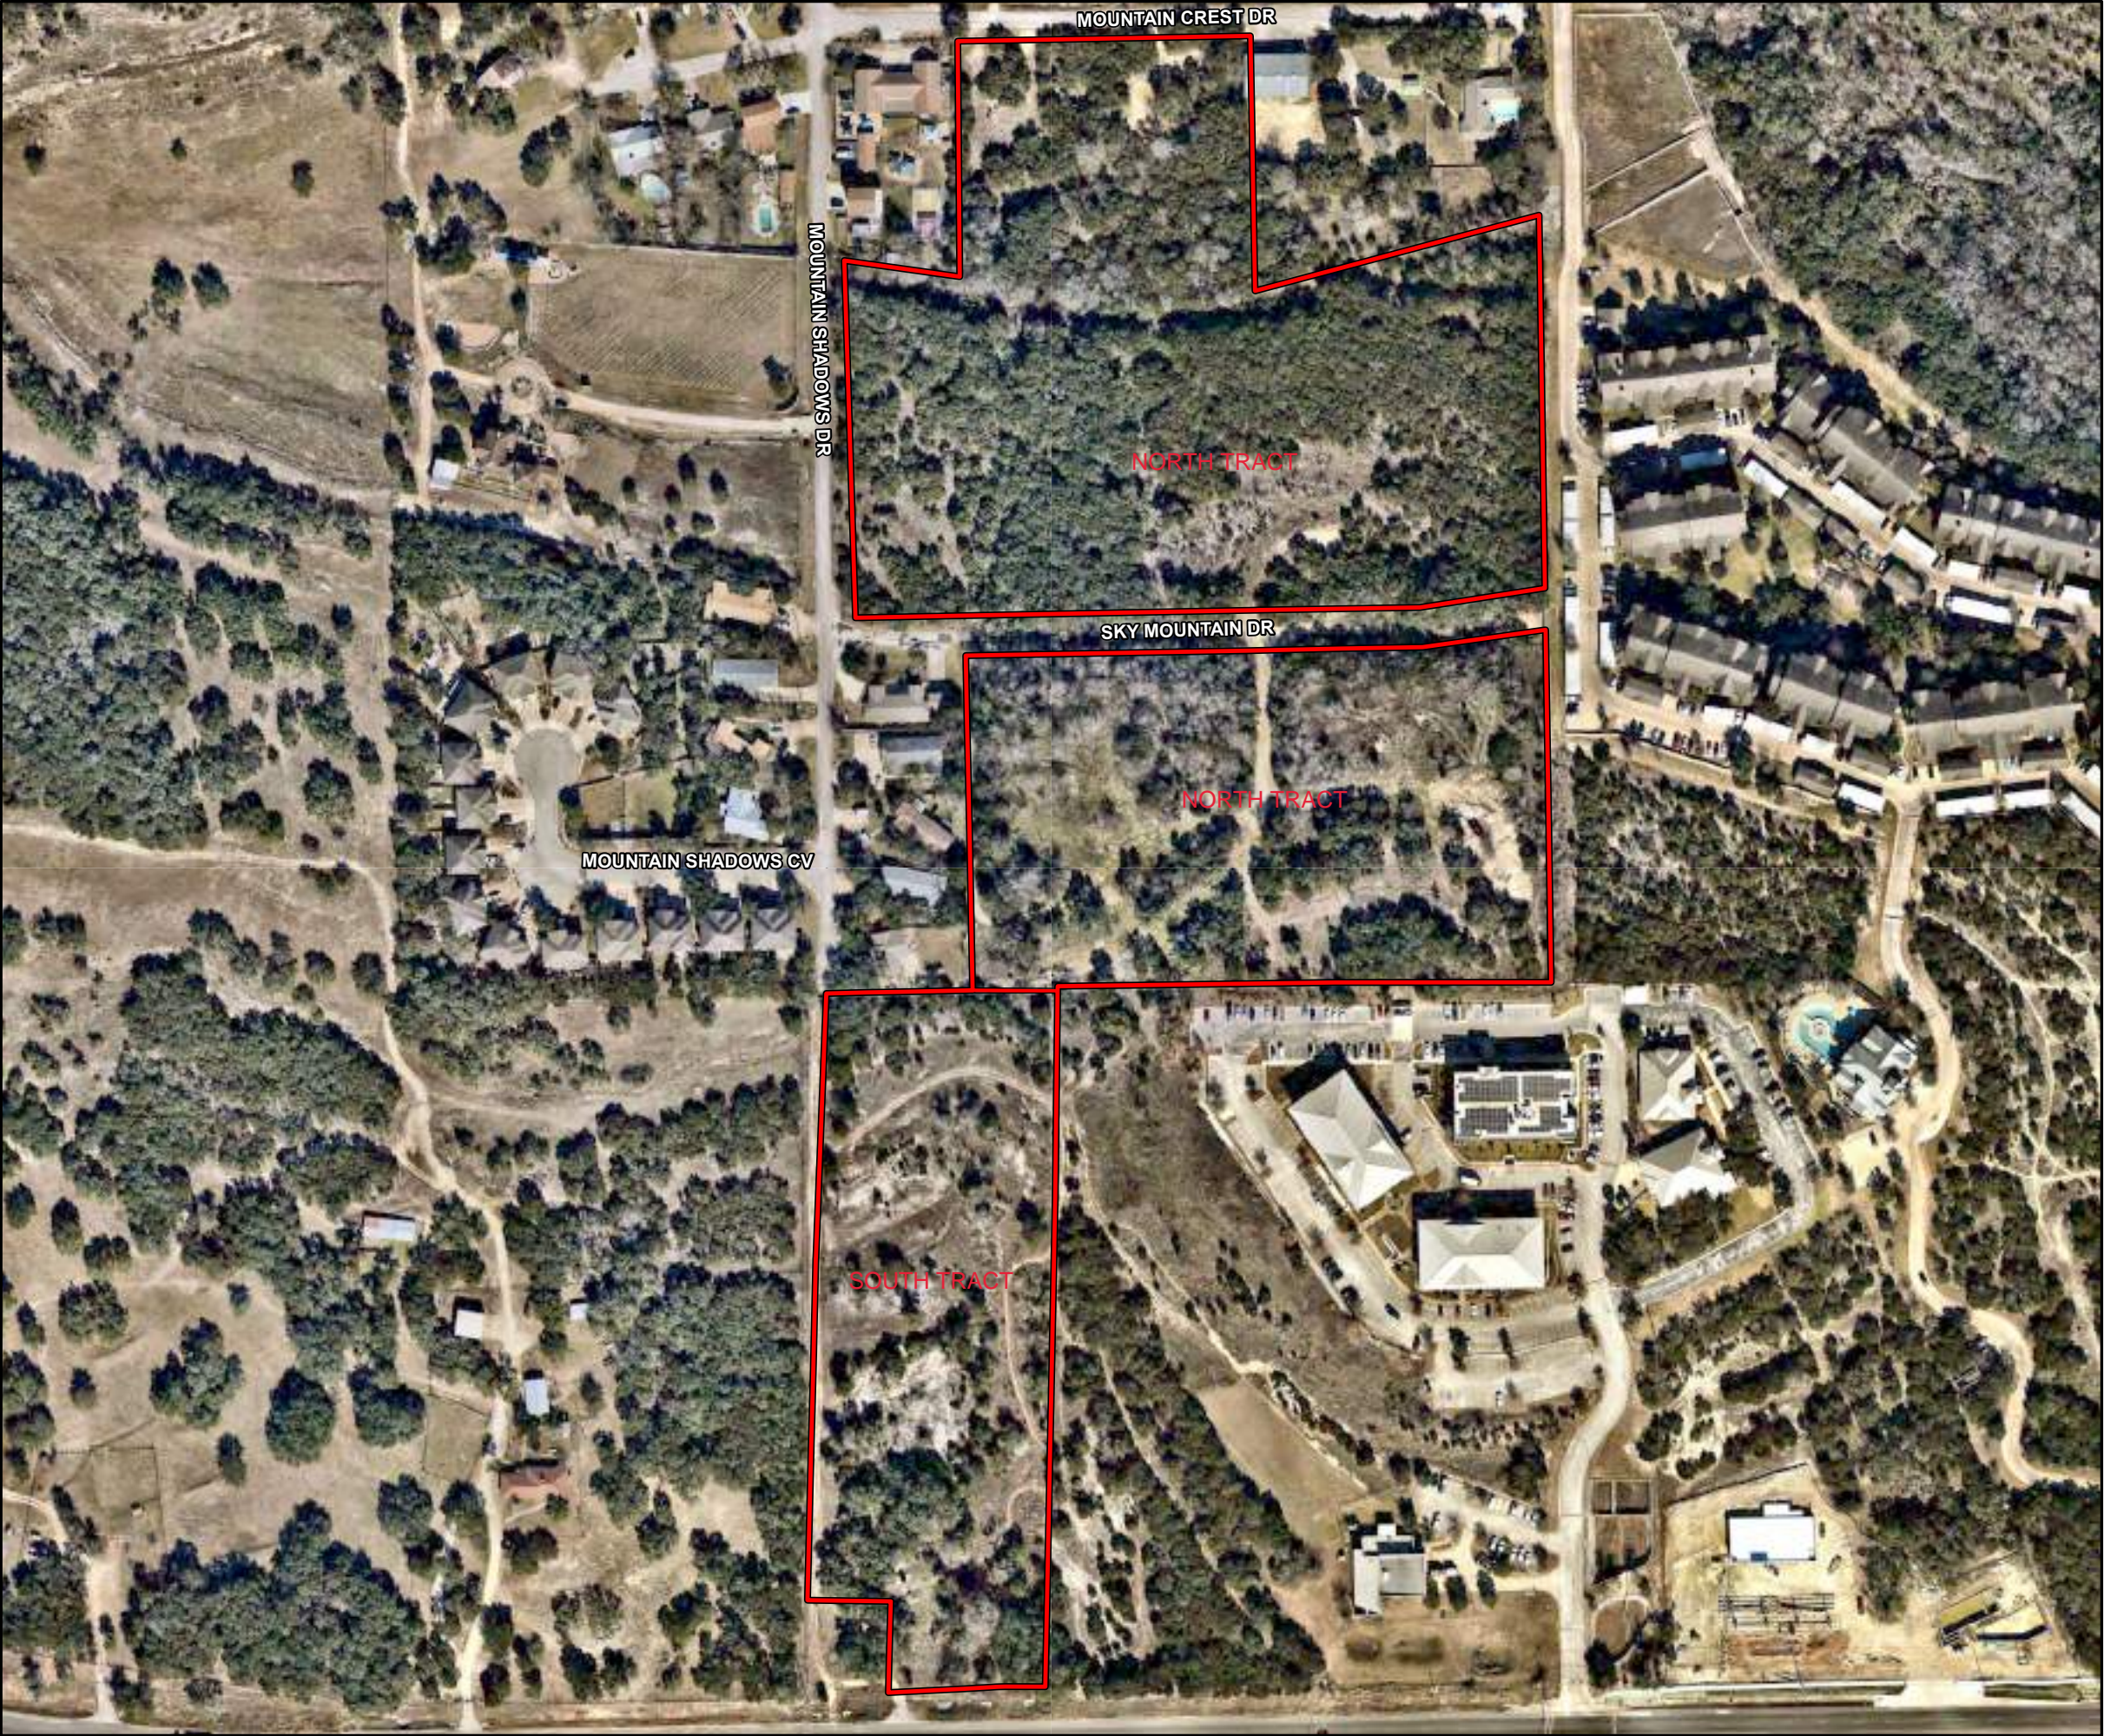
Existing Site conditions Exhibit

Yes The existing site conditions include areas of previously imported fill material that occurred prior to the adoption of developmental regulations requiring site plan applications. According to aerial information, the fill dates back to the early 1980s. As such the existing conditions do not represent the grades that would have occurred naturally. Because the fill has very steep slopes and is not compacted, it is not suitable for building on. This is why the applicant proposes to cut back the fill to such a degree.

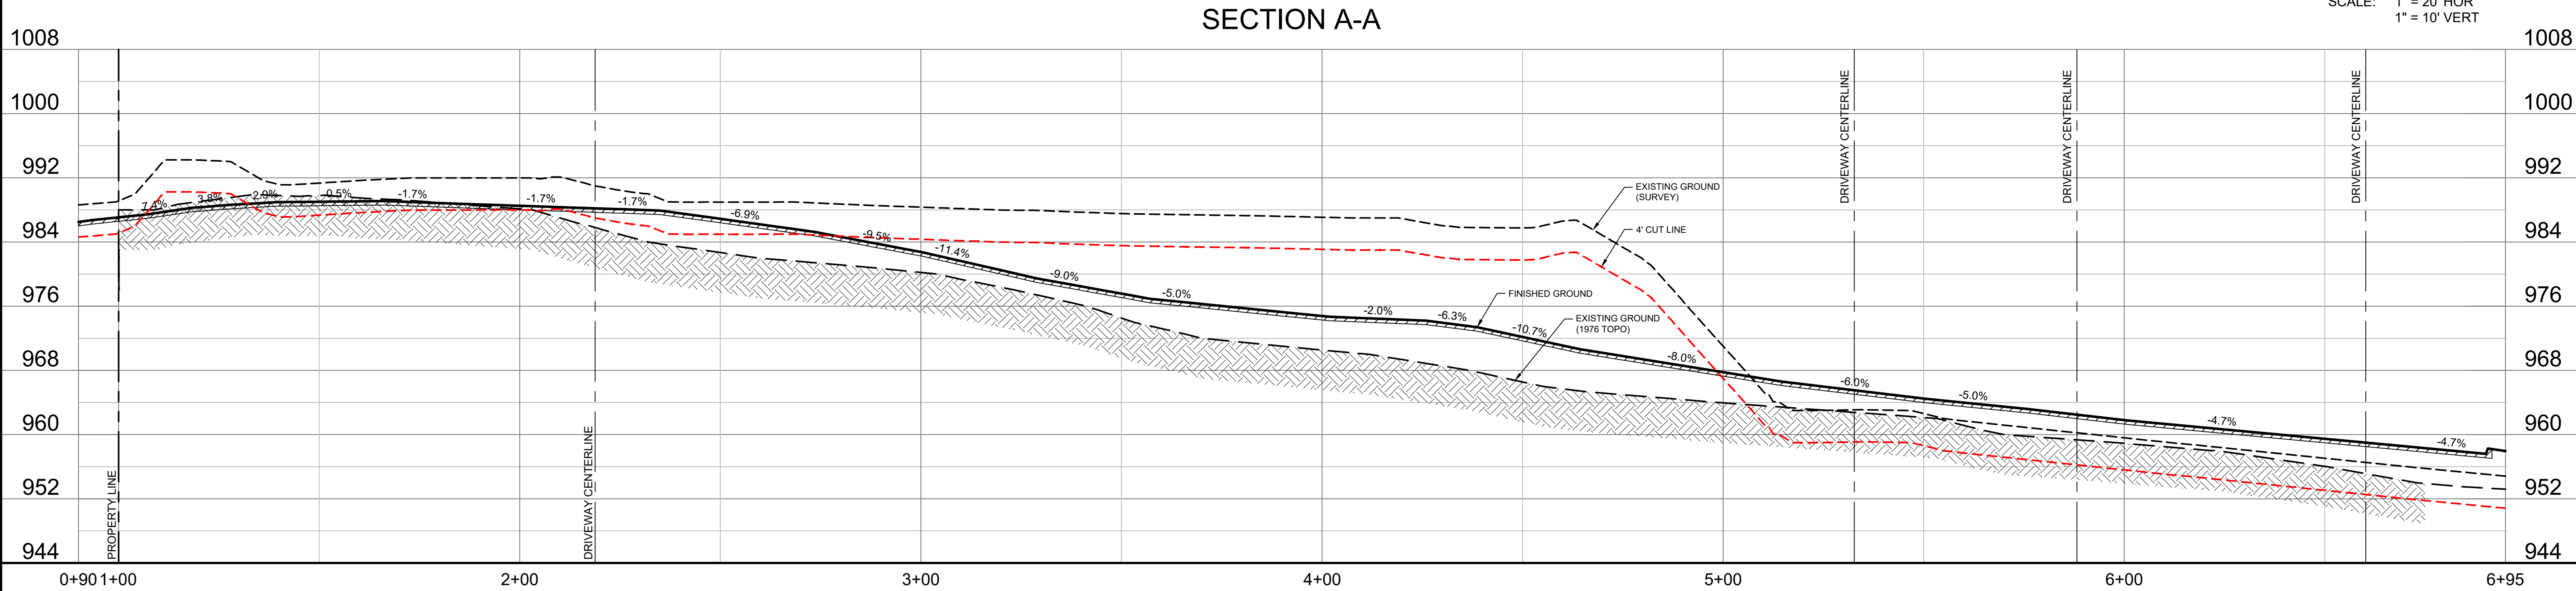
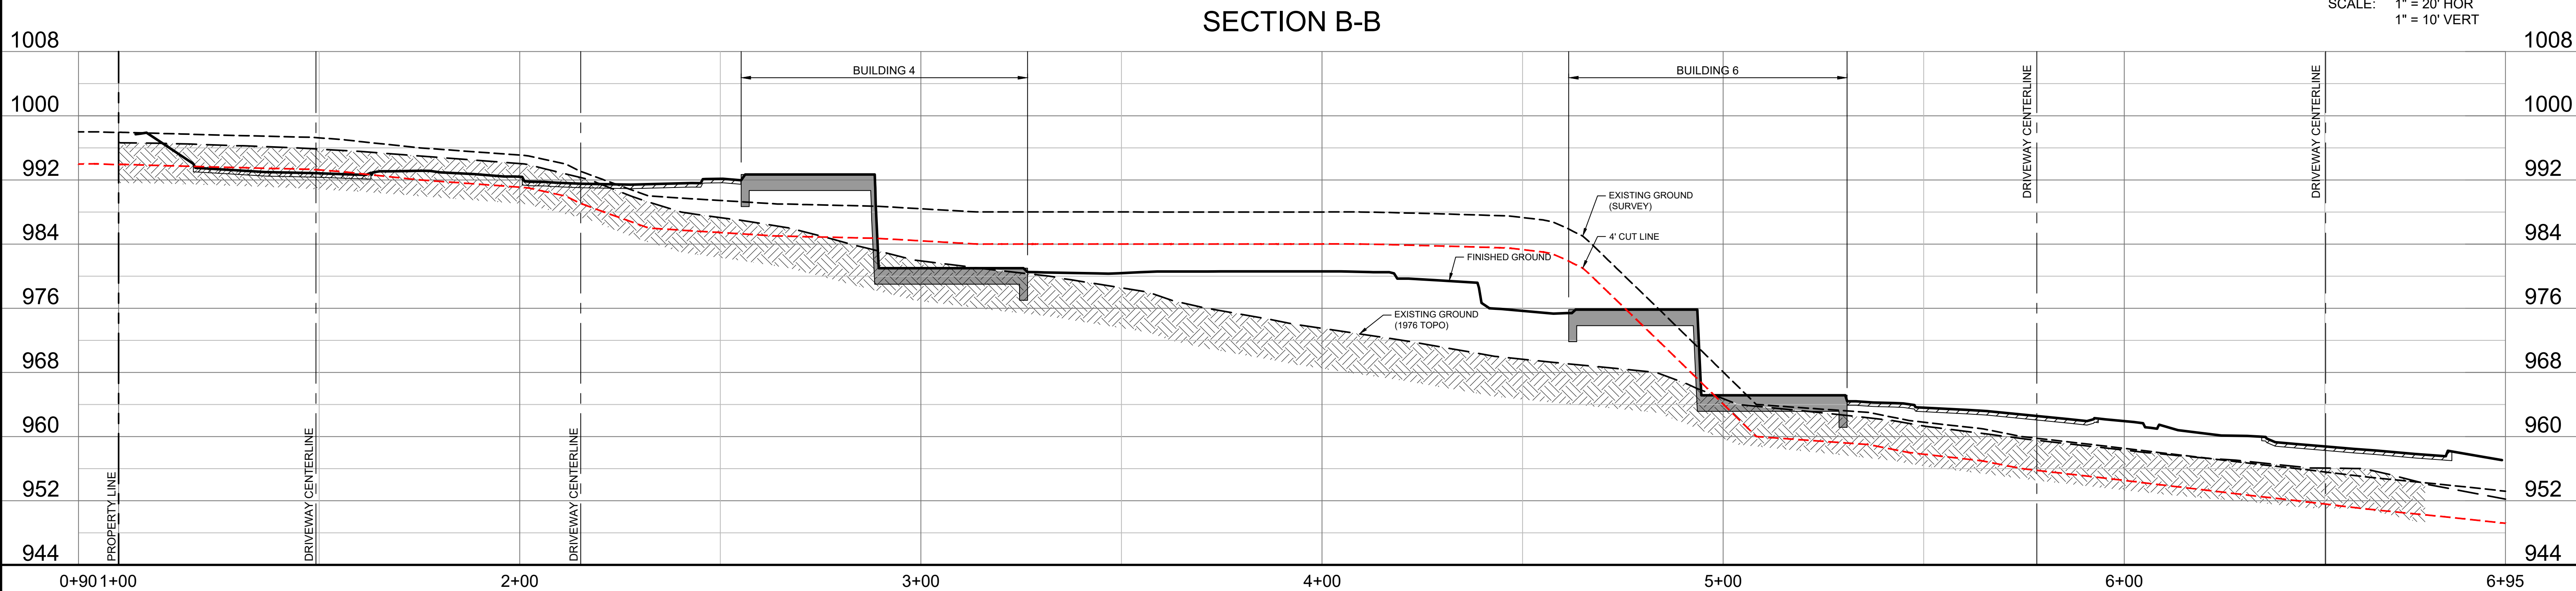
I:\A439 (Lunar) \Mtl\Fam\1\Sky Mountain\Conbits\A439-040-cut fill analysis & survey topow.dwg
User: jfontac
Date: 04/21/2022
Plot Date: 04/21/2022
Plot Time: 04/21/2022 10:30:17

Yes, because the placement of uncompacted fill in the subject area created unnatural embankments with fills up to approximately 20' in the worst-case areas that were not the result of any action performed by the current landowner, thus causing a condition that makes it infeasible to develop the property without removing up to 20' of fill material in the worst-case areas. Additionally, this material was placed in an uncontrolled manner that is not viable to build on.

Yes, the placement of fill on the property within the subject area created an unnatural embankment and associated slopes in the subject area that cannot be developed upon. The property is to be developed with multifamily apartments and associated site improvements. If the variance is not approved the site becomes undevelopable due to a private restrictive covenant with the adjacent community that prohibits access to Mountain Shadows Drive. Non approval of the variance would require disturbance of existing natural area rather than previously disturbed area.

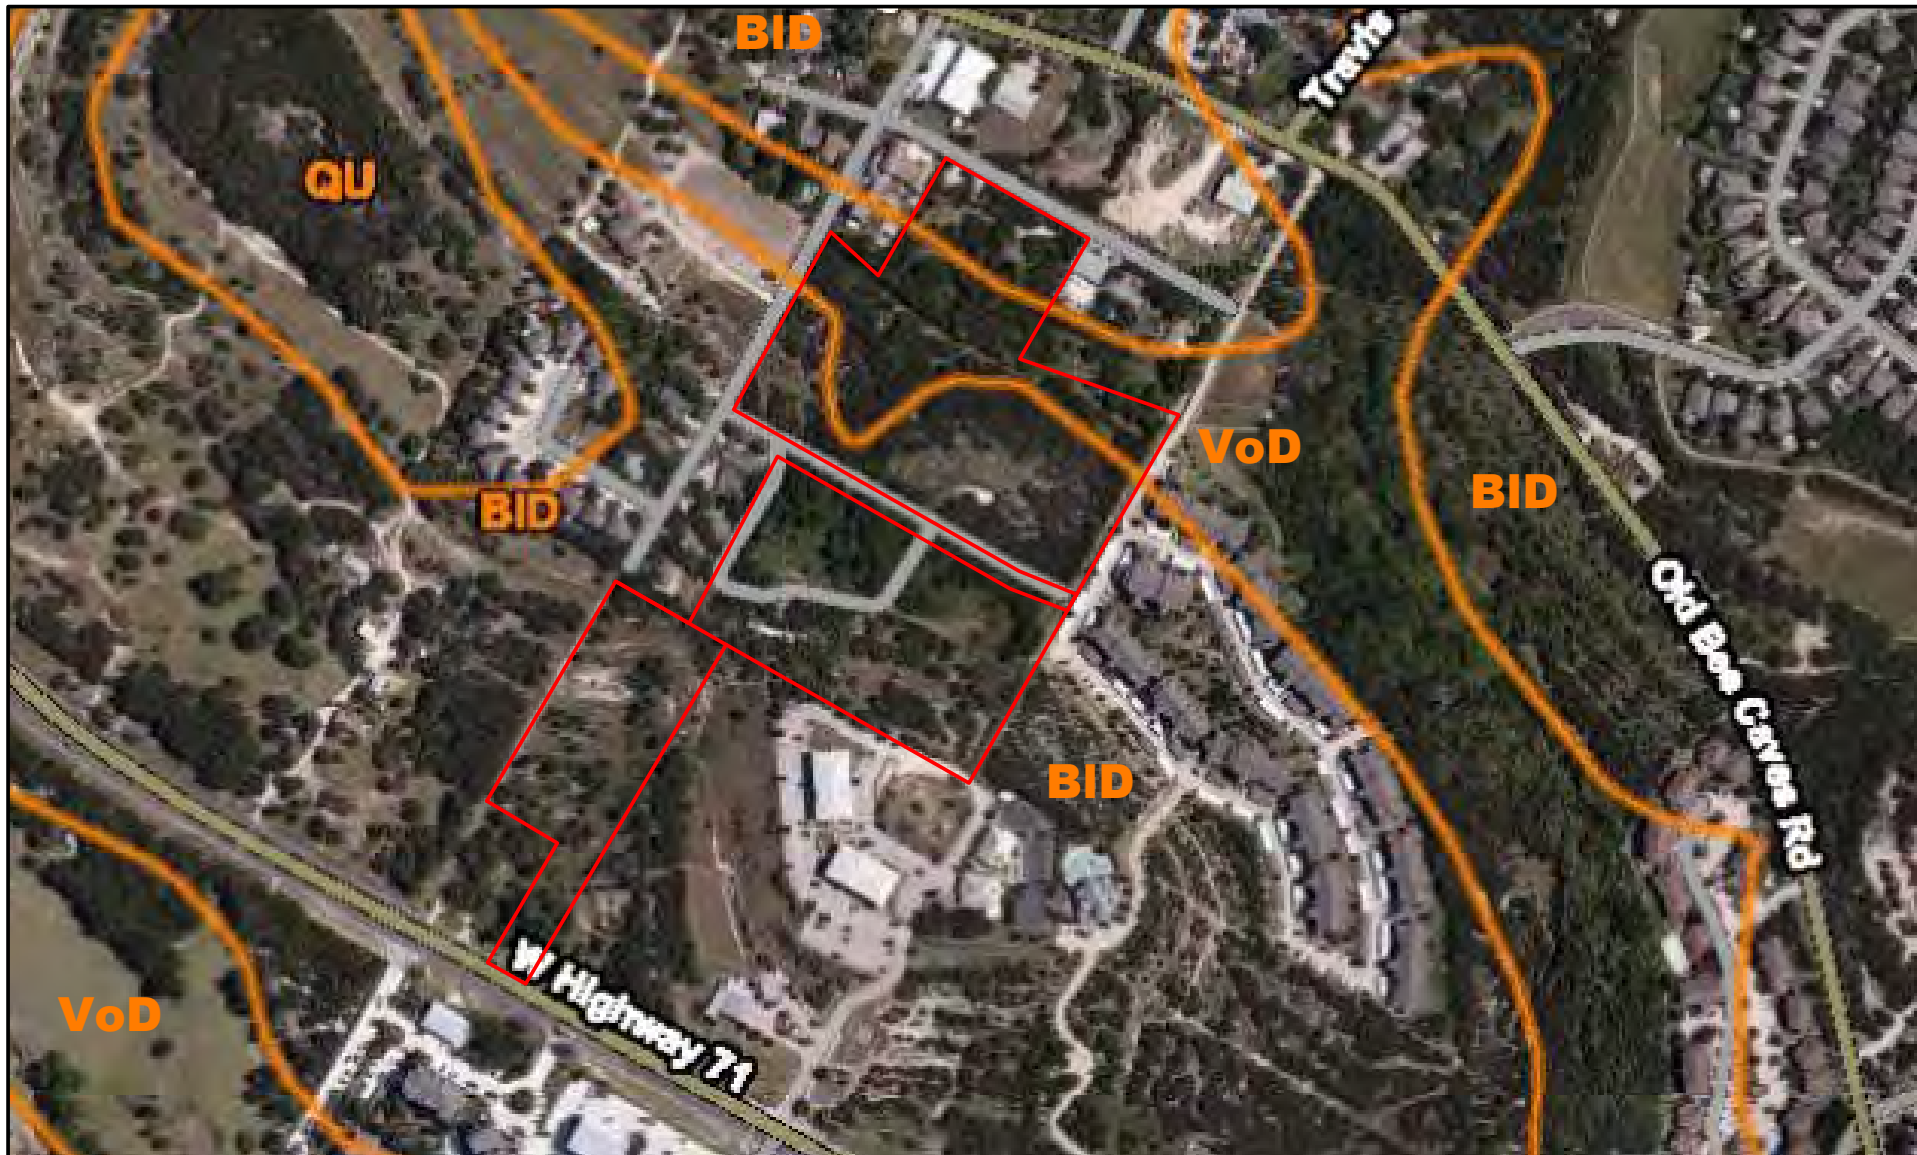
- SUBJECT PROPERTY BOUNDARIES, APPROXIMATE
- SOIL BOUNDARY
- BID - BRACKETT-ROCK OUTCROP COMPLEX, CLAY LOAM, 1-12% SLOPES, VERY SLOW INFILTRATION RATE, UP TO 18 INCHES THICK
- VoD - VOLENTE SILTY CLAY LOAM, 1-8% SLOPES, SLOW INFILTRATION RATE, UP TO 59 INCHES THICK
- QU - QUARRY PIT

Soil Series Unit Names, Infiltration Characteristics & Thickness		
Soil Series Unit Name & Subgroup**	Group*	Thickness (feet)
BID - Brackett-Rock Outcrop	D	1.5
VoD - Volente Silty Clay Loam	C	5

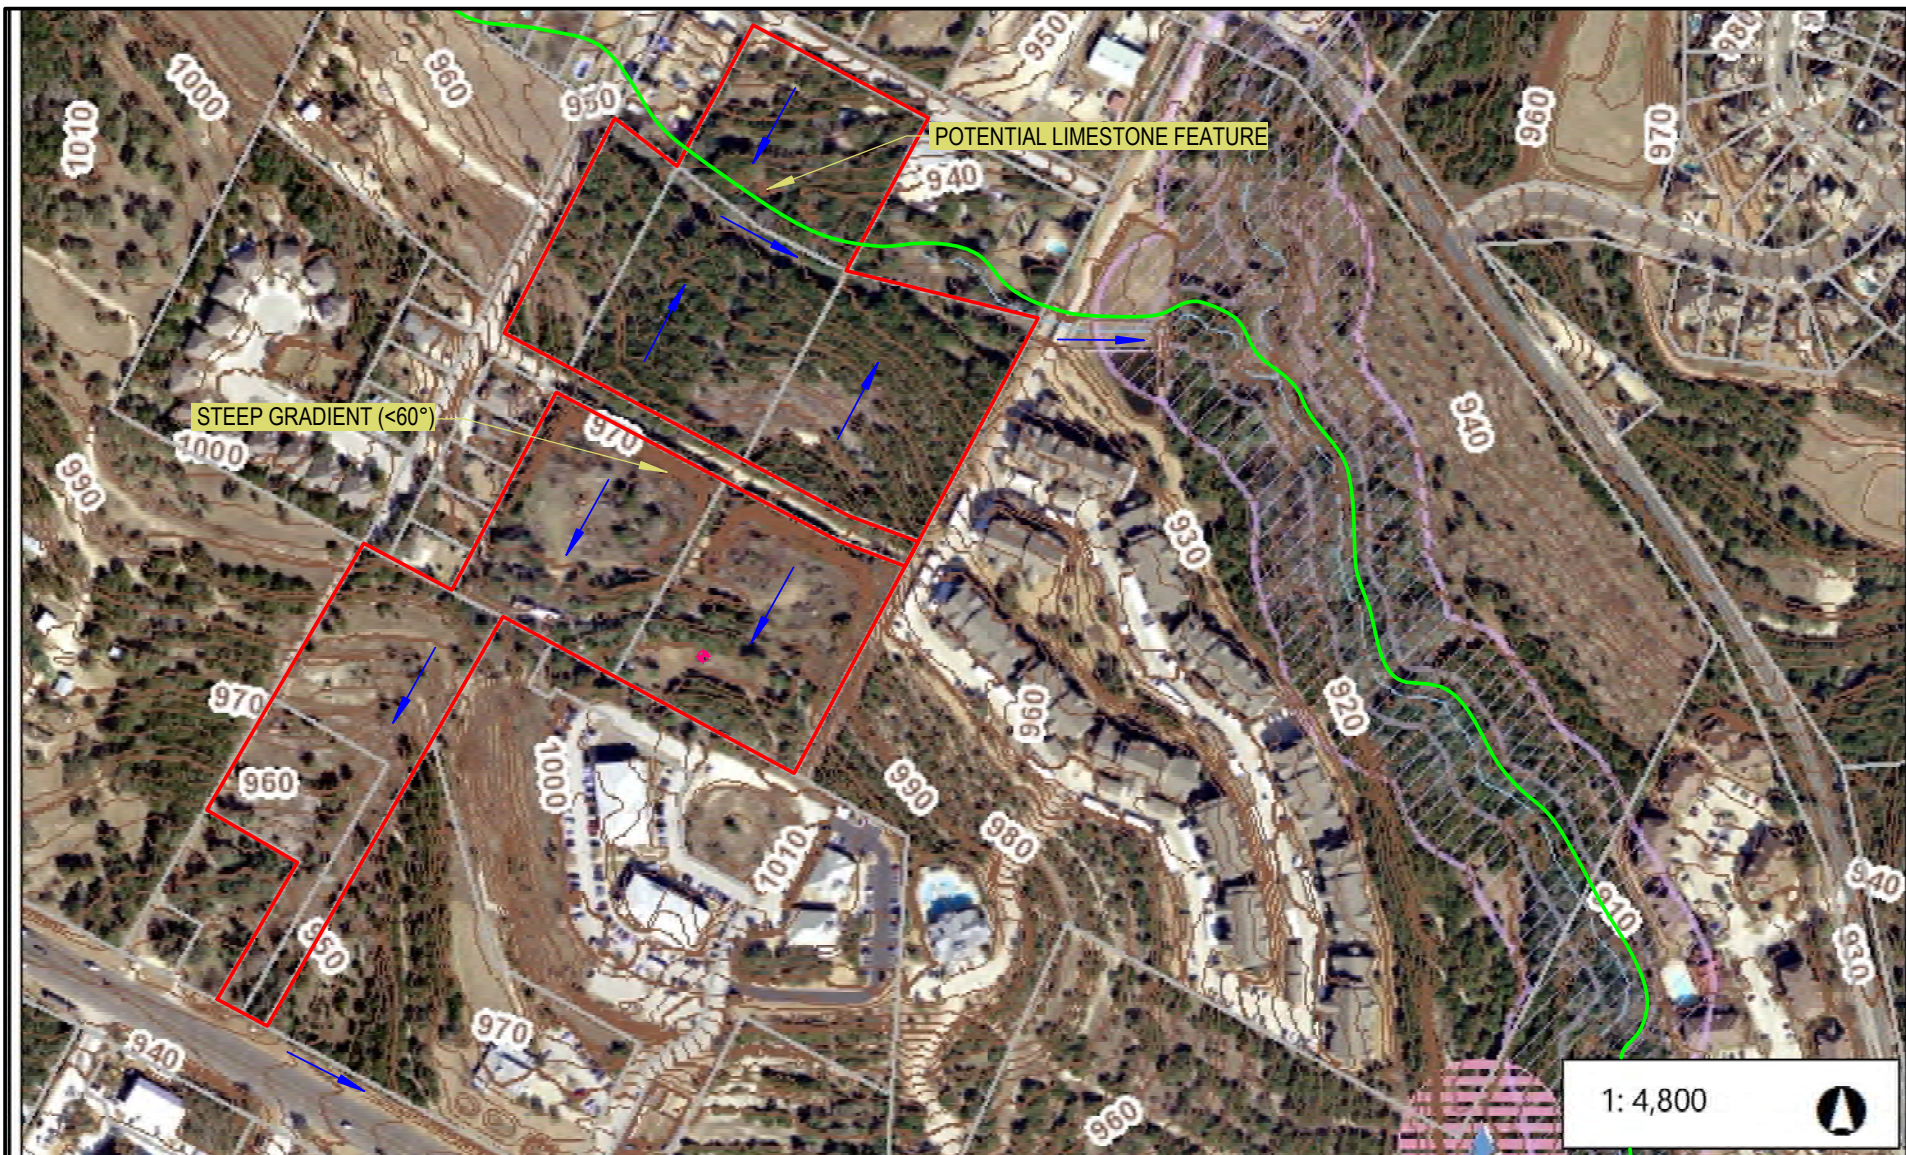
- SUBJECT PROPERTY BOUNDARIES, APPROXIMATE
- + WATER WELL
- CREEK CENTERLINE
- 2-FT TOPOGRAPHIC CONTOUR
- ▨ CRITICAL WATER QUALITY ZONE (CWQZ)
- ▨ CRITICAL ENVIRONMENTAL FEATURE (CEF) SETBACK
- SPRING
- WETLAND; RIVERINE, USFWS NATIONAL WETLAND INVENTORY (NOT OBSERVED)
- STORMWATER FLOW DIRECTION
