The Reservoir Update - 2021

Brent Bellinger, Ph.D.
Environmental Scientist Senior
Watershed Protection Department
June 15, 2022

2021/2022 Projects

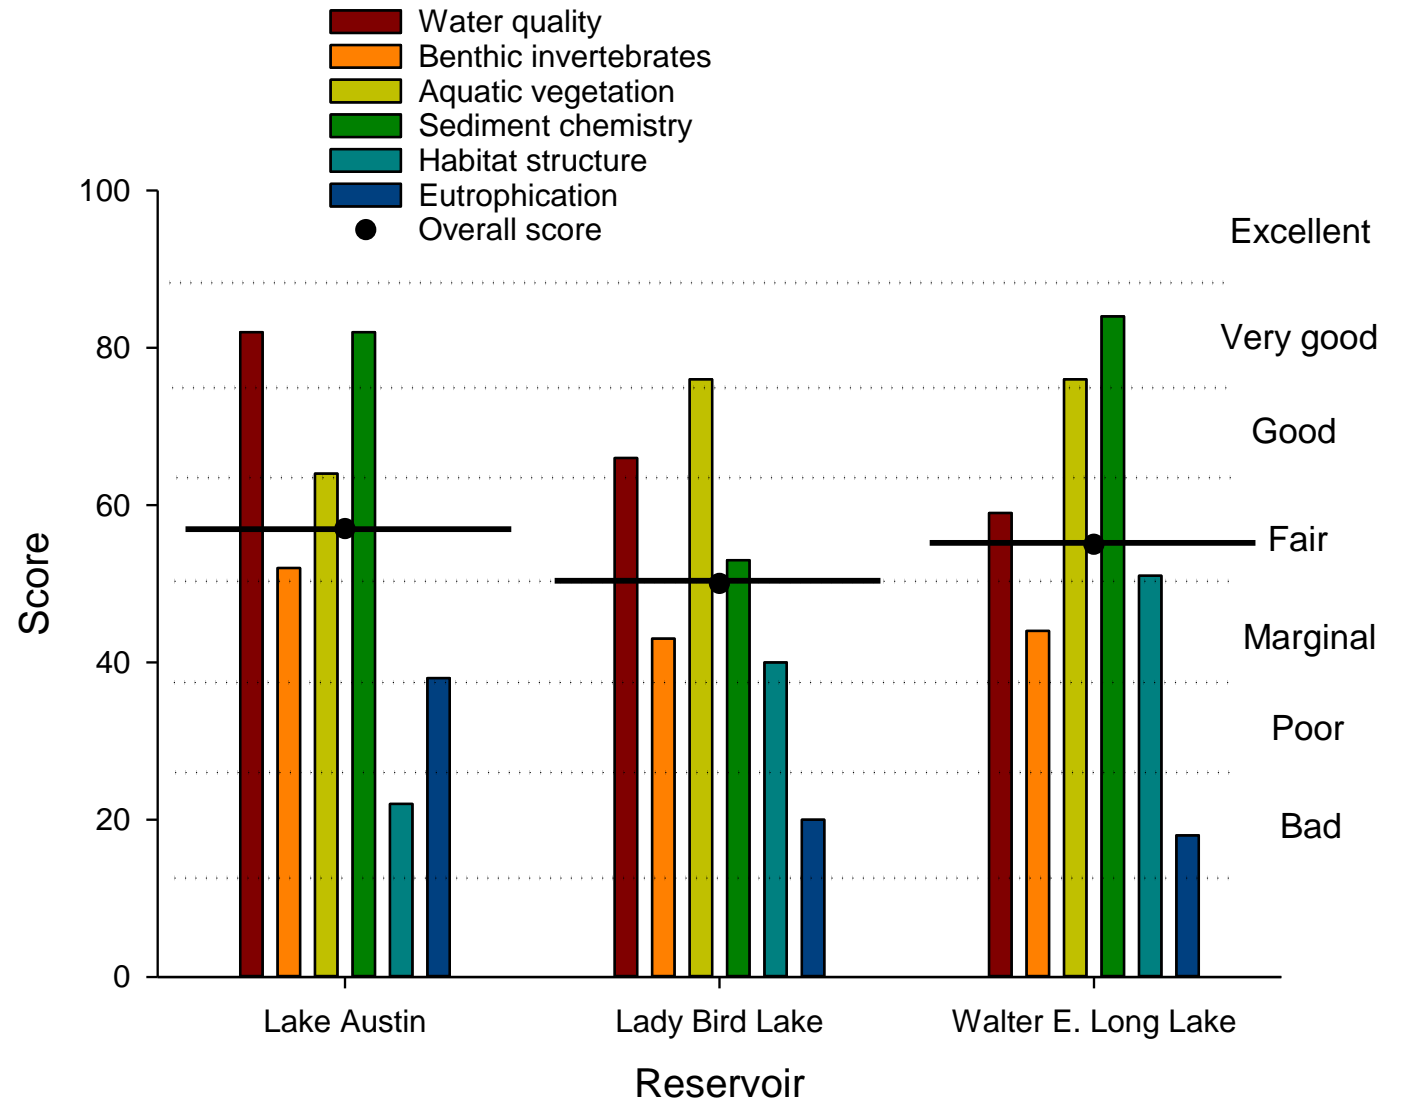
Austin Lakes Index (ALI)

Current reservoir condition

- Water quality, sediments, aquatic vegetation generally above average
- Benthic invertebrates, habitat, eutrophication generally below average

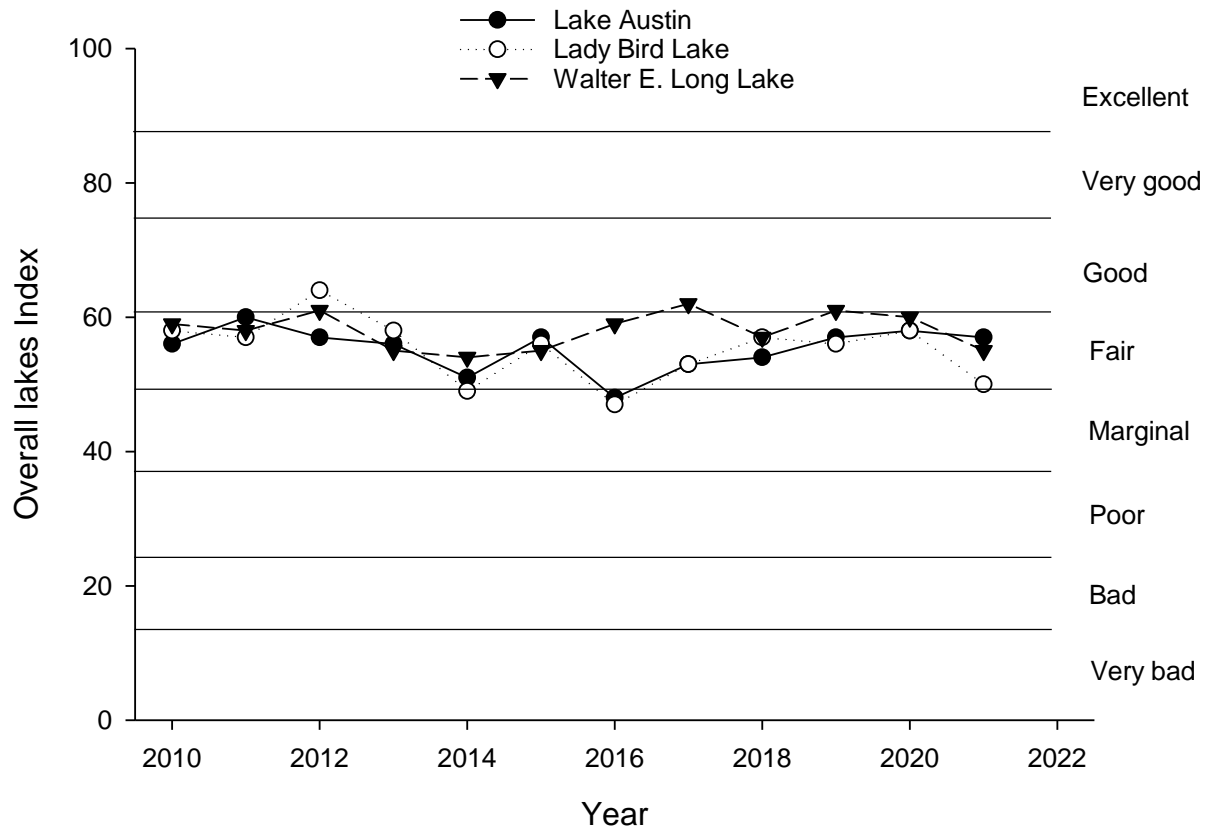
Temporal Trends

- Although overall scores appear steady, sub-index components can have large variability

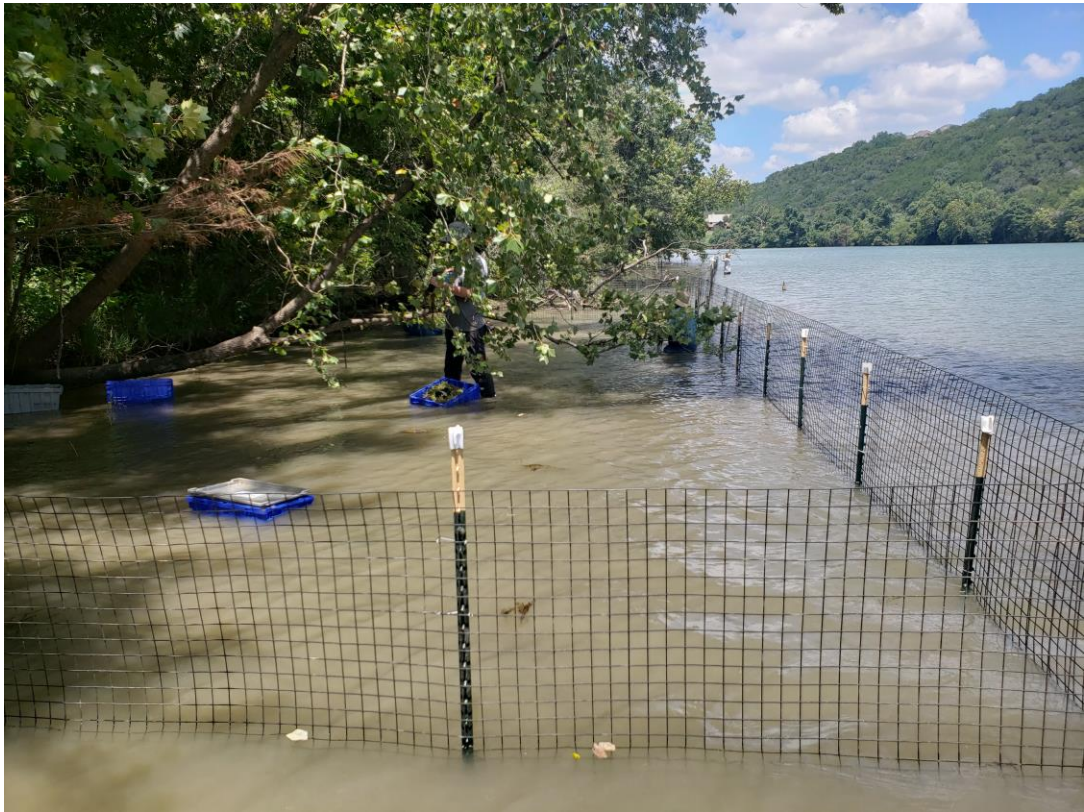
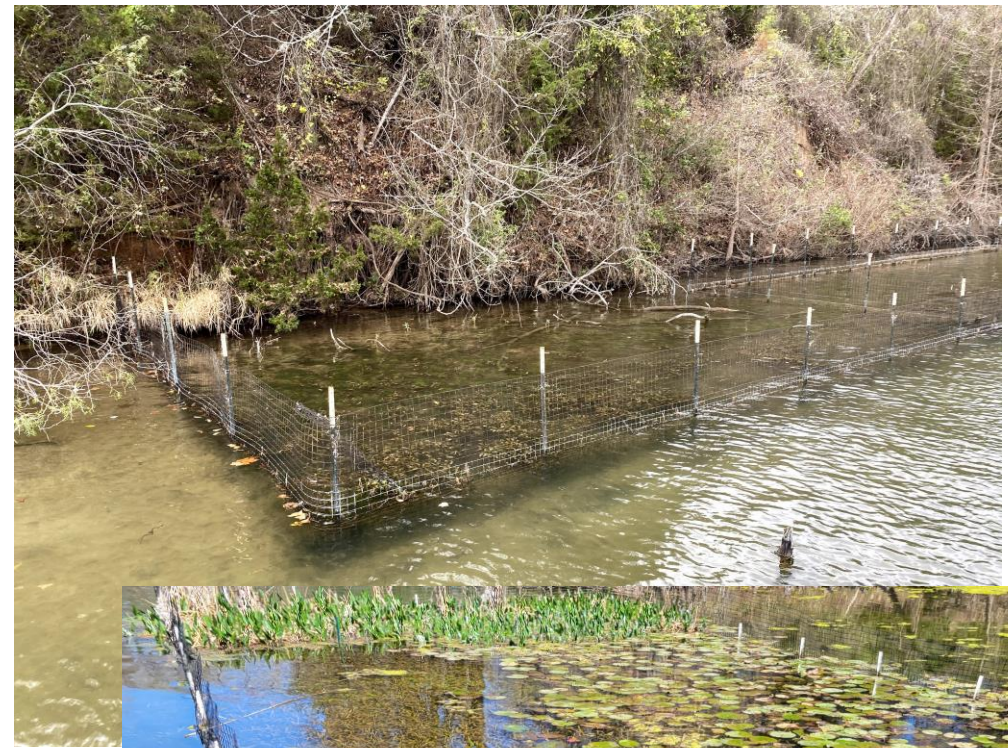
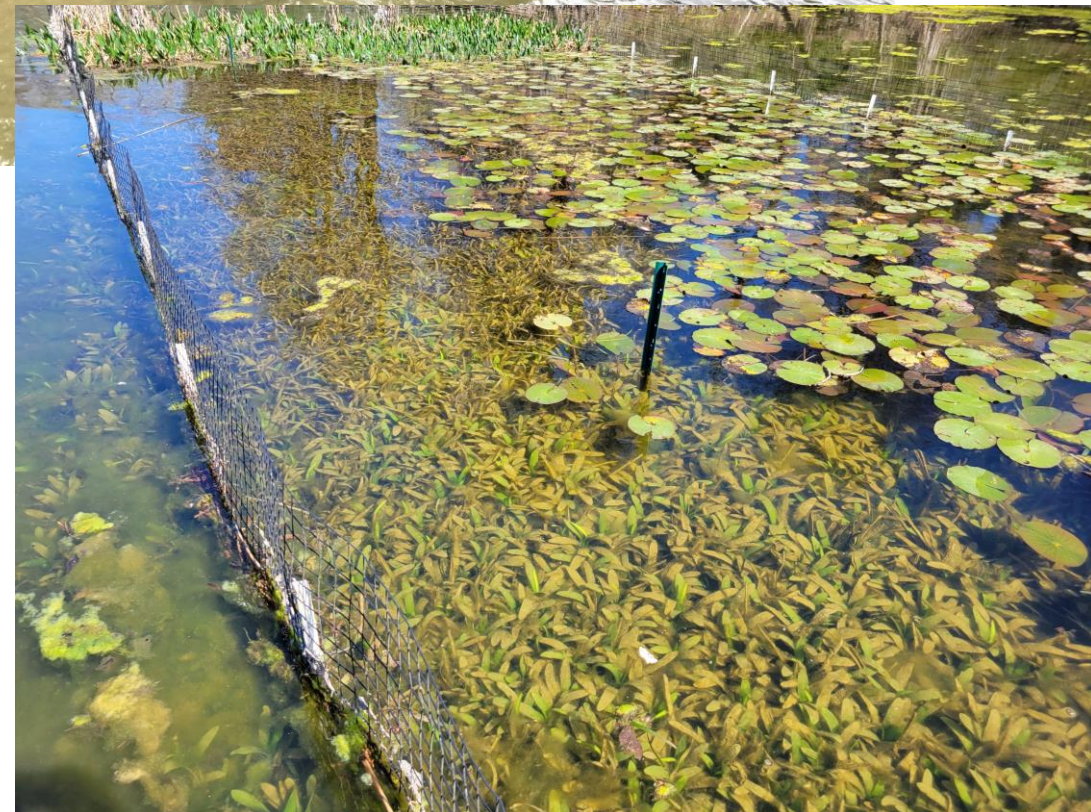
Re-vegetation Efforts

- Macrophytes doing well in cages in both reservoirs, thriving outside of cages in LBL
 - Maintained existing pens in both reservoirs, added new pens to Lake Austin

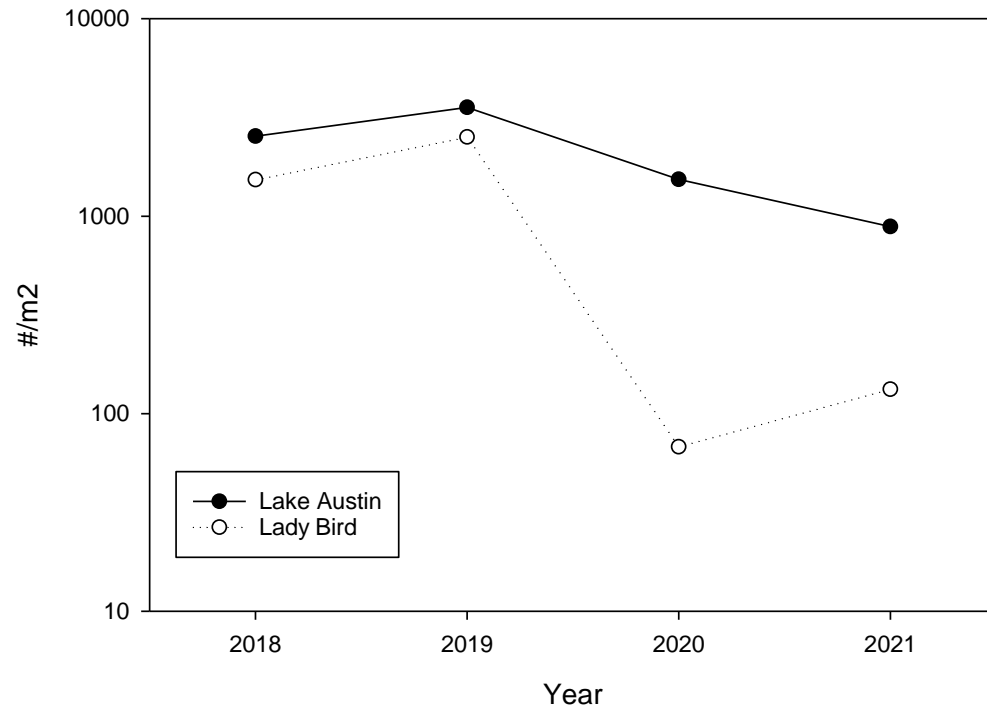
L. Austin

Zebra Mussel Populations

- “Ecosystem engineers” that have altered water quality, alter food webs
 - For example, water clarity correlated with densities

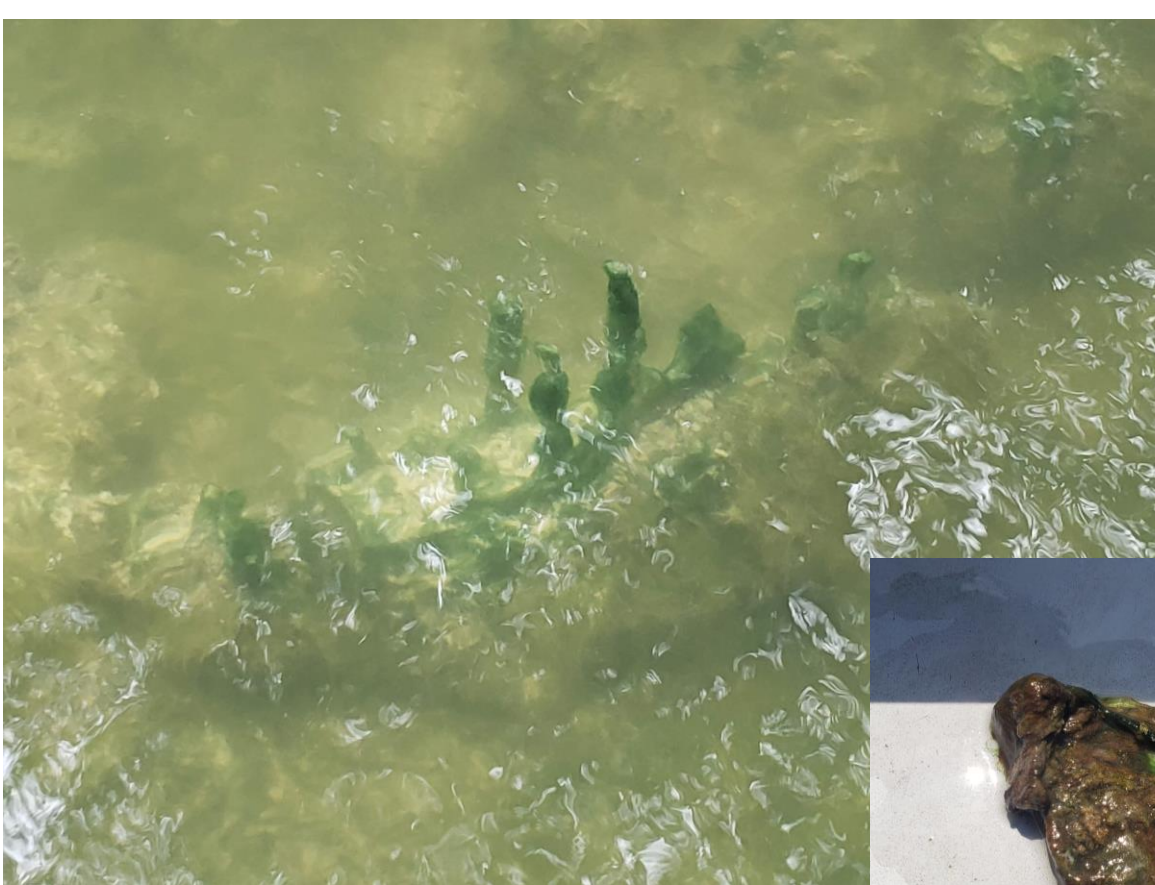
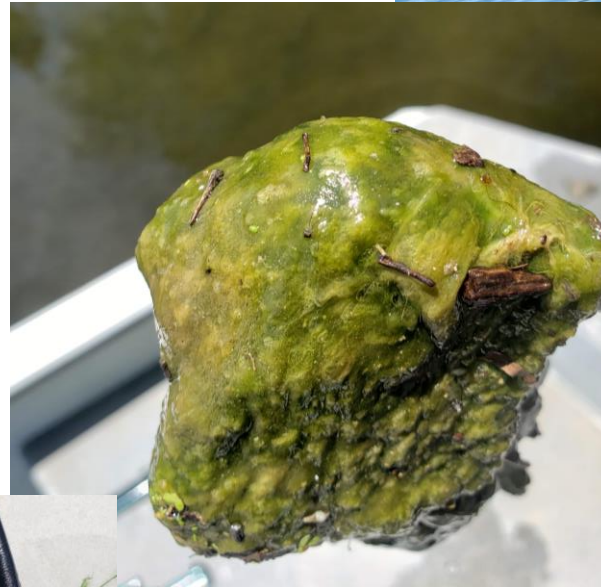
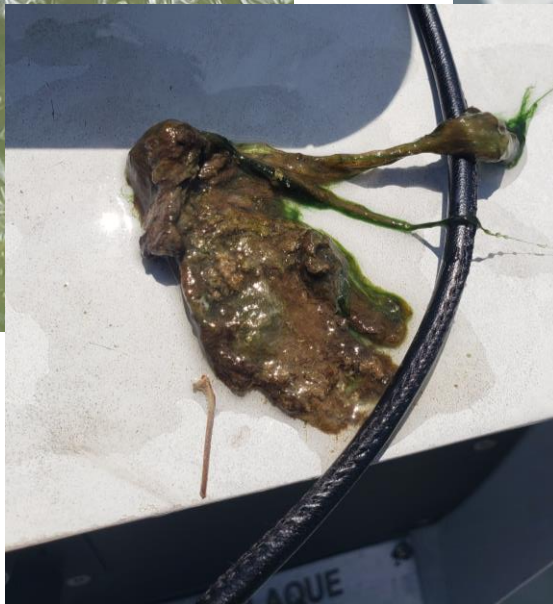
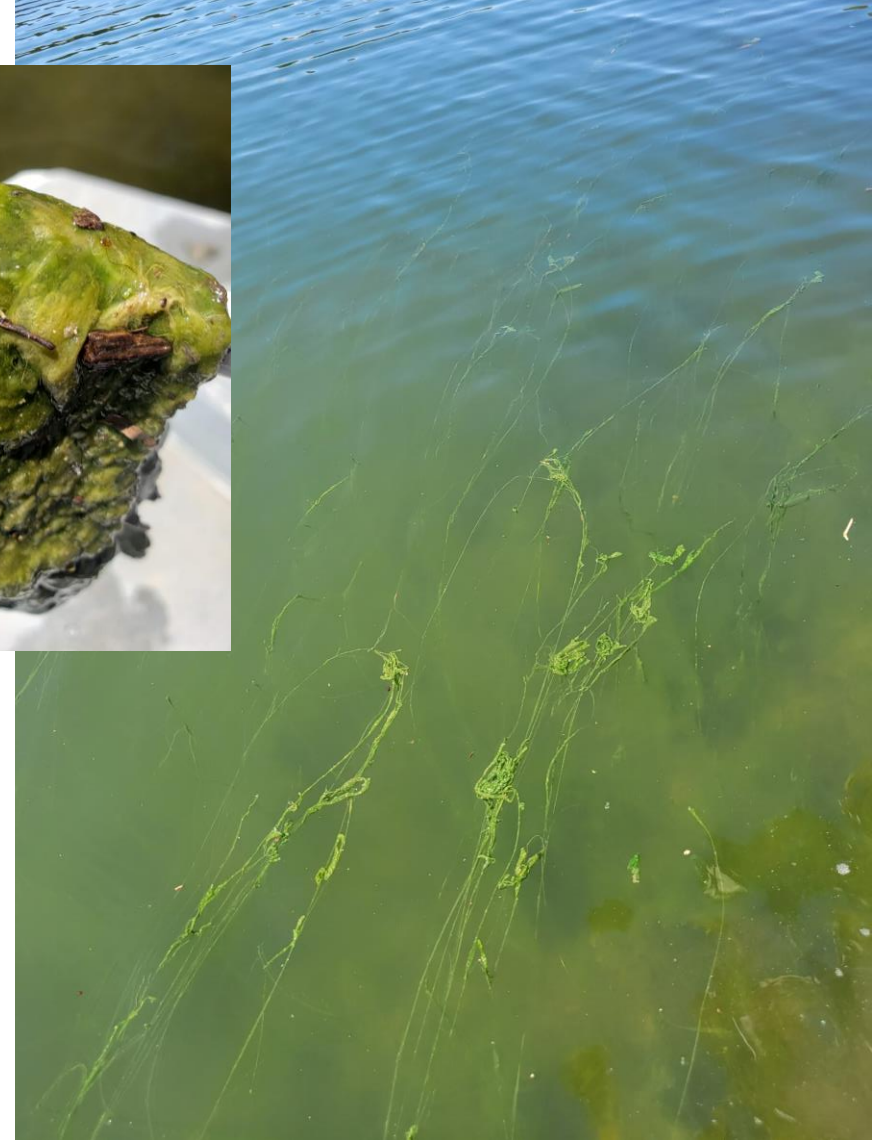
Harmful Algal Proliferations (HAPs)

Jessica Hollis Park – 3 positives

Emma Long – 0 positives

Walsh Ramp – 3 positives

Red Bud – 9 positives

Auditorium Shores – 3 positives

Festival Beach – 3 positives

Jessica Hollis Park = 0.06 ± 0.03 mg ATX/kg

Walsh Ramp = 1.56 ± 3.03 mg ATX/kg

Red Bud = 0.11 ± 0.13 mg ATX/kg

Aud. shores = 0.007 ± 0.013 mg ATX/kg

Festival Ramp = 0.002 ± 0.004 mg ATX/kg
 19.68 ± 34.53 mg CYN/kg

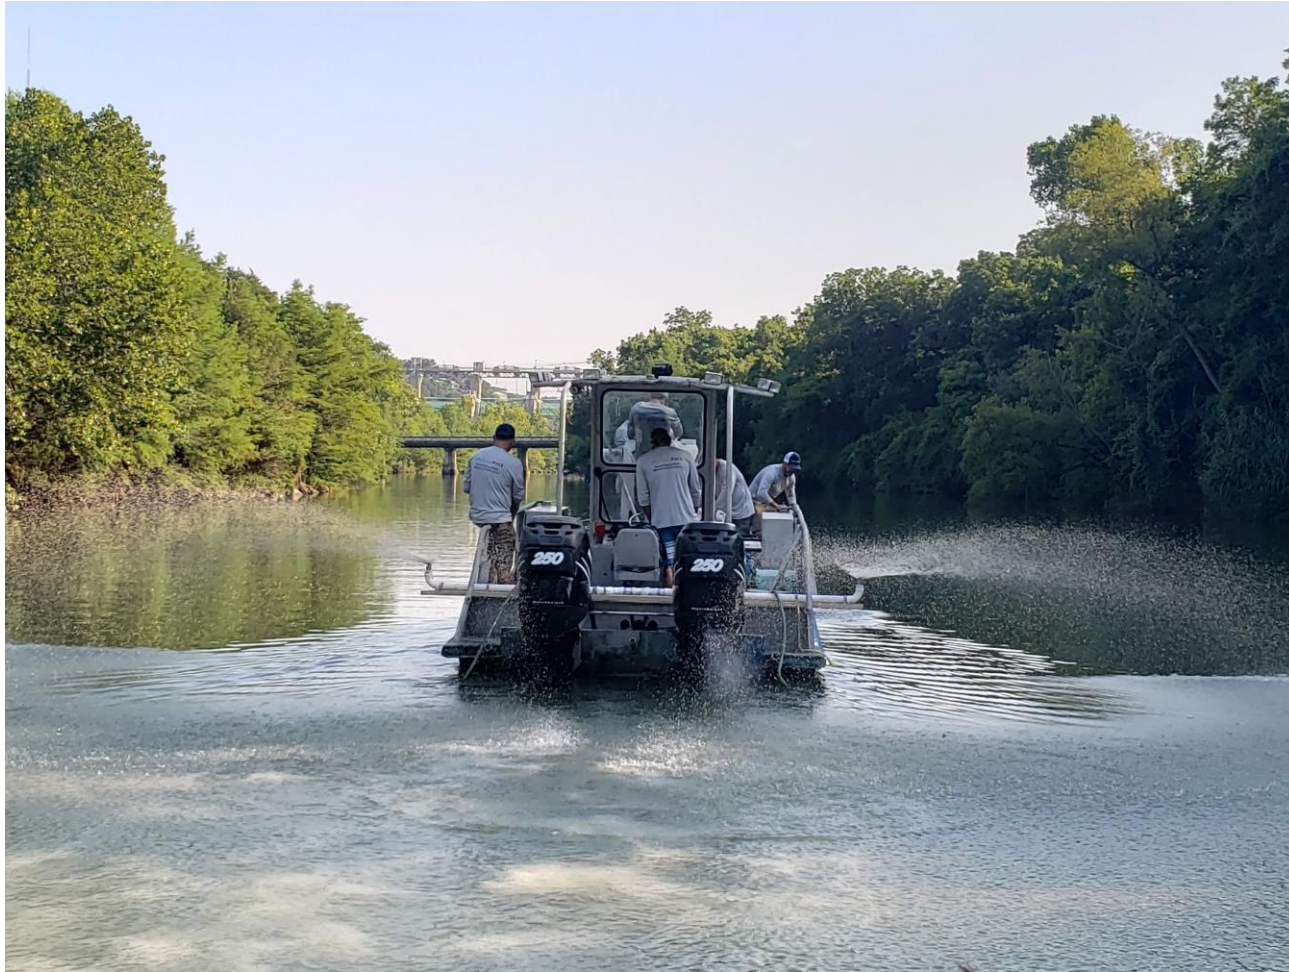
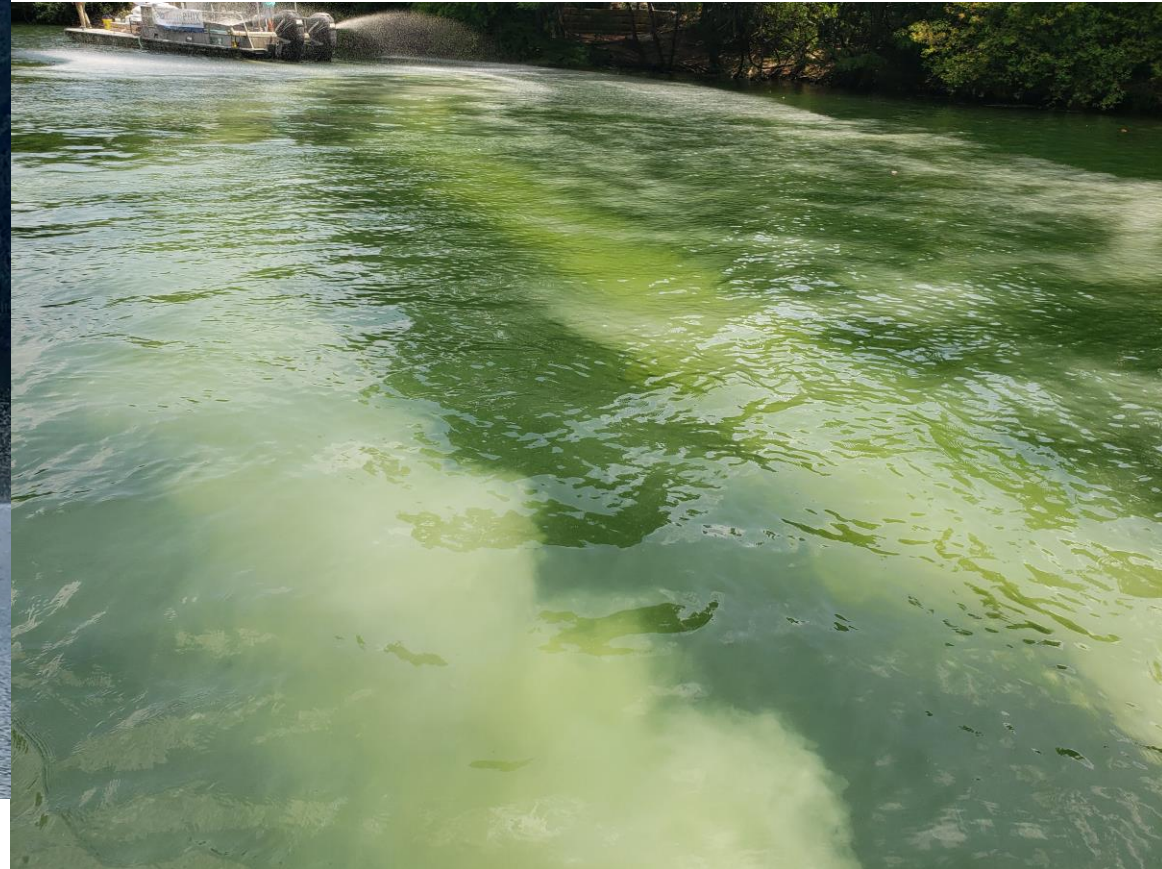
Application

- Toward that end, we secured a multi-year contract with SePRO to apply lanthanum-modified bentonite toward sediment P management
- Phoslock utilized globally to mitigate excess P that may be released from the sediments
- Year 1 – applied 120,000 lbs of Phoslock around Red Bud Isle
 - For year 2 planning on “maintenance” application around Red Bud, targeting new area

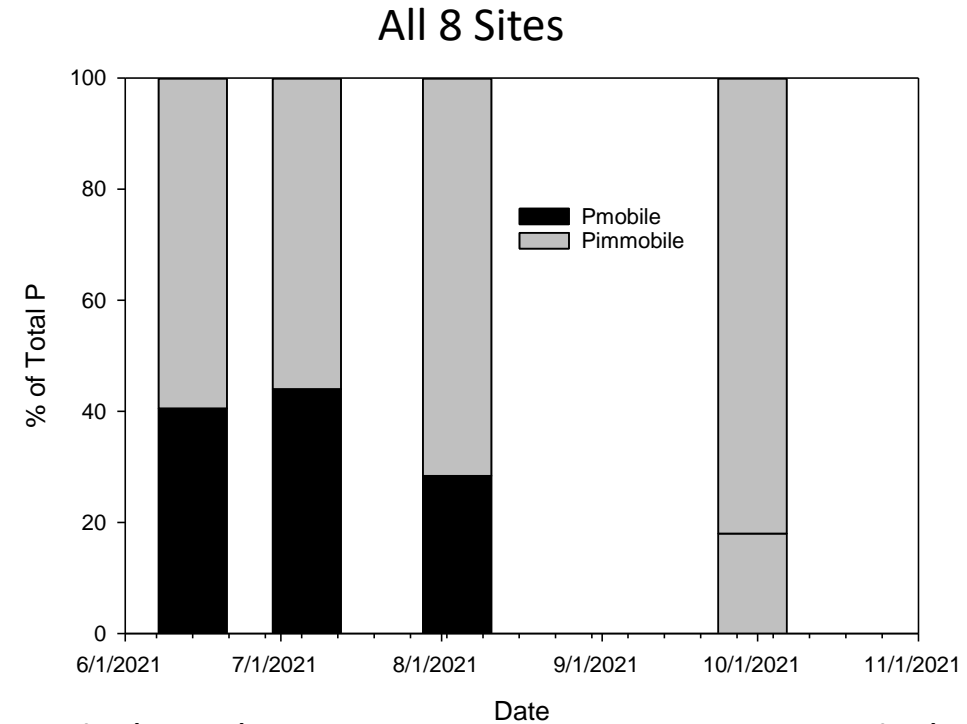
Sediment P Results

- Across all sites:
 - 40% decline in P-mobile fraction (good!)
 - >70% increase in P-immobile (very good!)

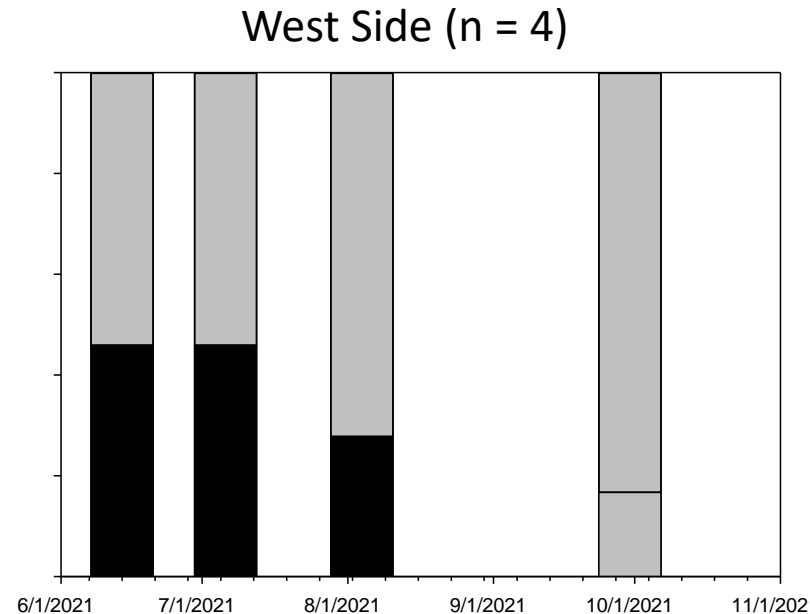
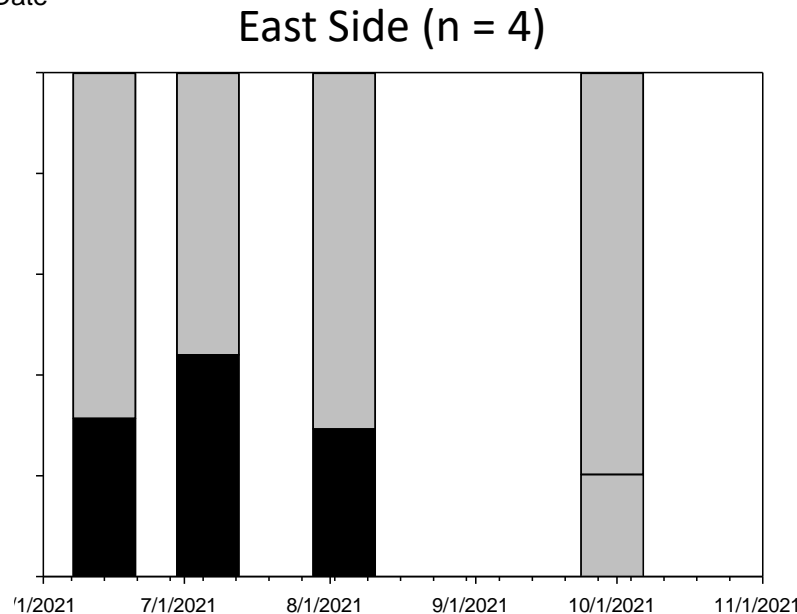
- Larger changes on west side due to greater content of organic sediments

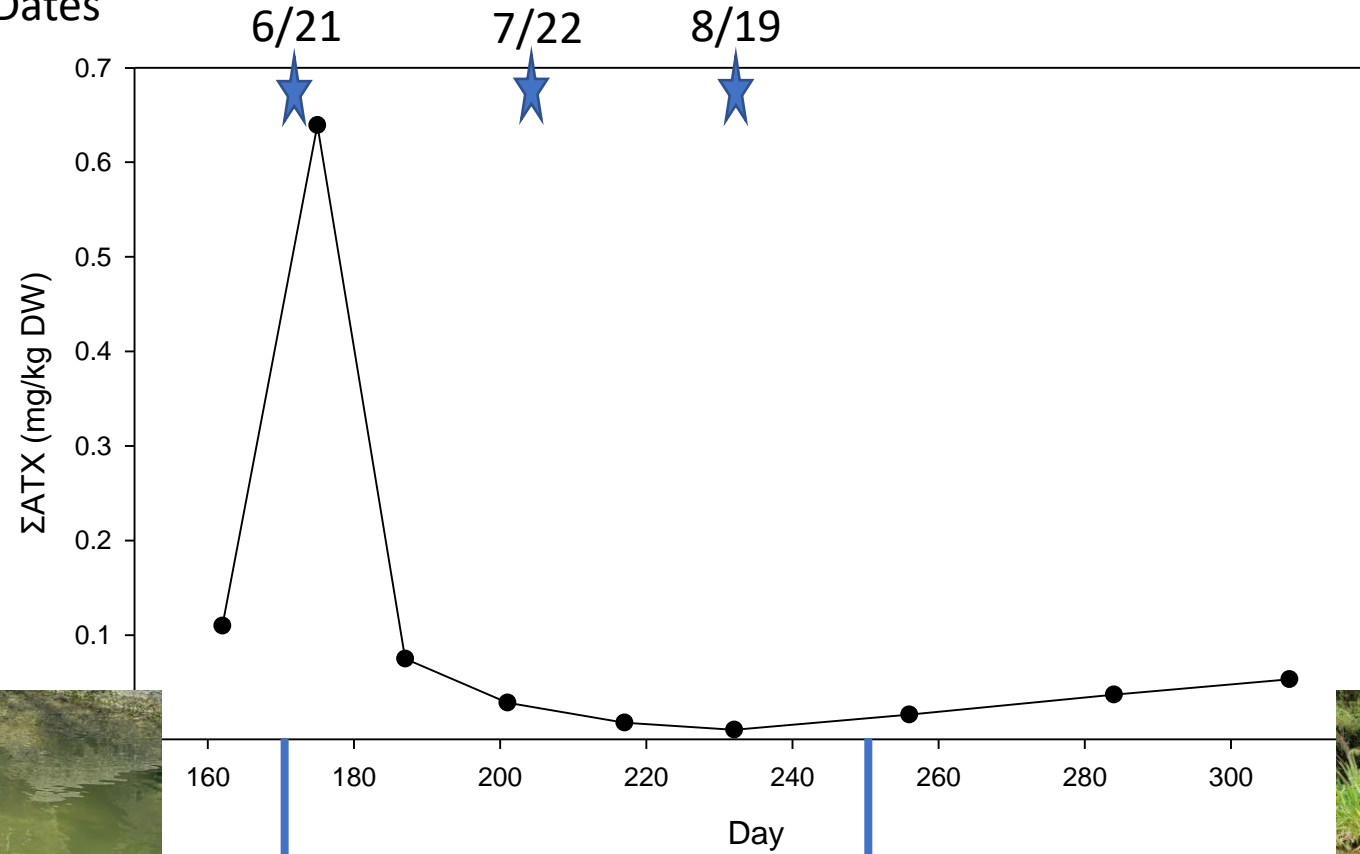
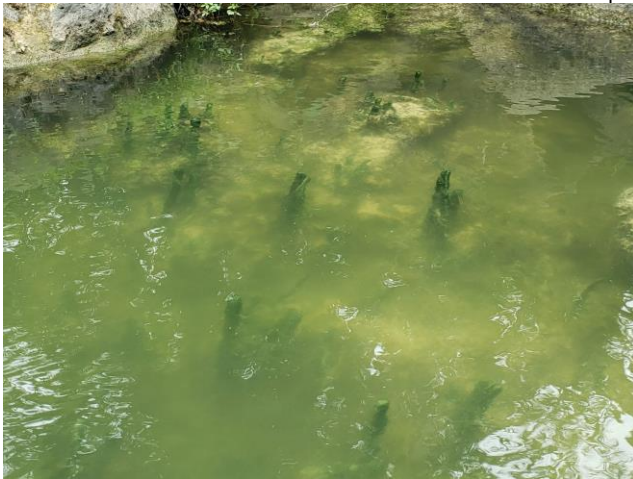
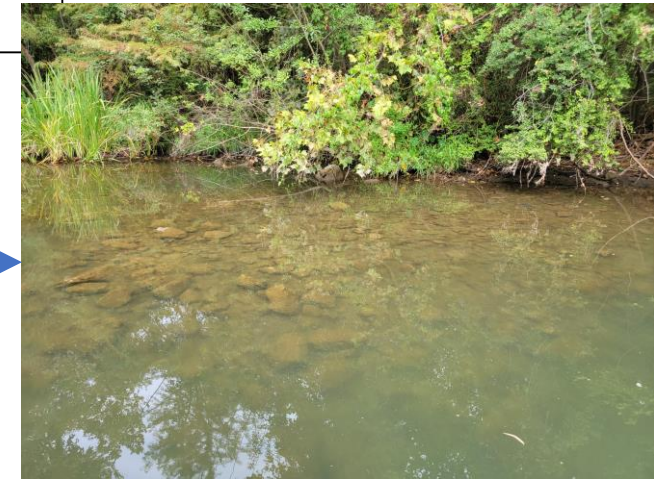
Influence on Algal mats and Toxicity?

Application Dates

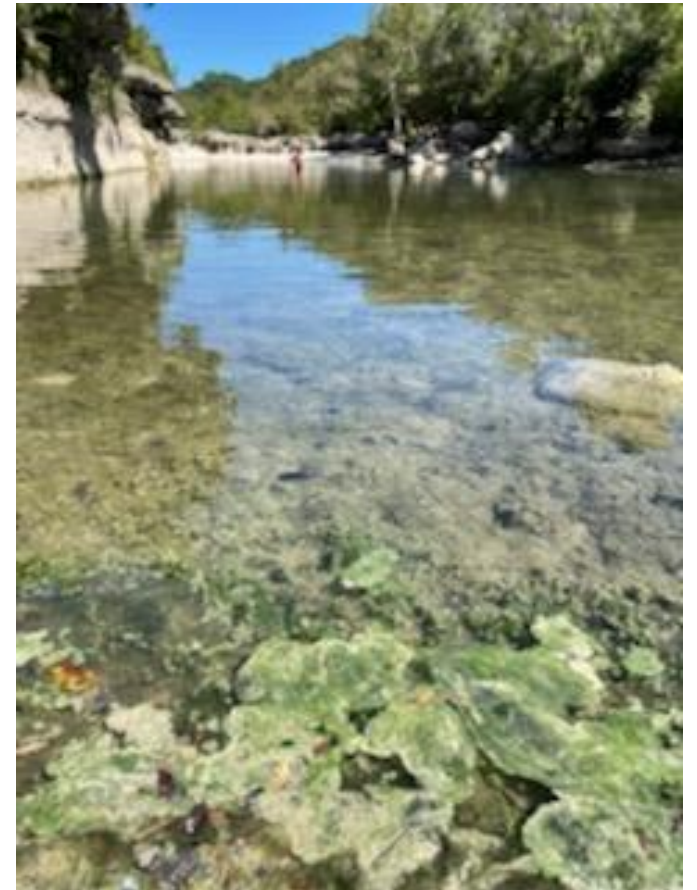
Sculpture Falls

- Samples taken from the popular spot in Barton Creek after a 3-1-1 call of a possible illness
 - At the time almost no flow, observed algal mats in the pool
 - Illness not believed to have been cyanotoxin driven; however, we did measure Cylindrospermopsin in the water
 - Once flows returned to the creek, algae and toxin were not observed
- Sculpture falls – Cylindrospermopsin = toxin that impacts liver and kidney (carcinogenic) over long period of drinking water ingestion, or massive ingestion of toxin for acute impact
