HEIERMAN - HISTORIC LANDMARK COMMISSION REVIEW

The Heierman Building

115 E. 5th Street
Austin, TX 78701
Travis County

Renovation, Selective Demolition of Non-Historic Elements,
New Construction, and Addition to Existing Structure.

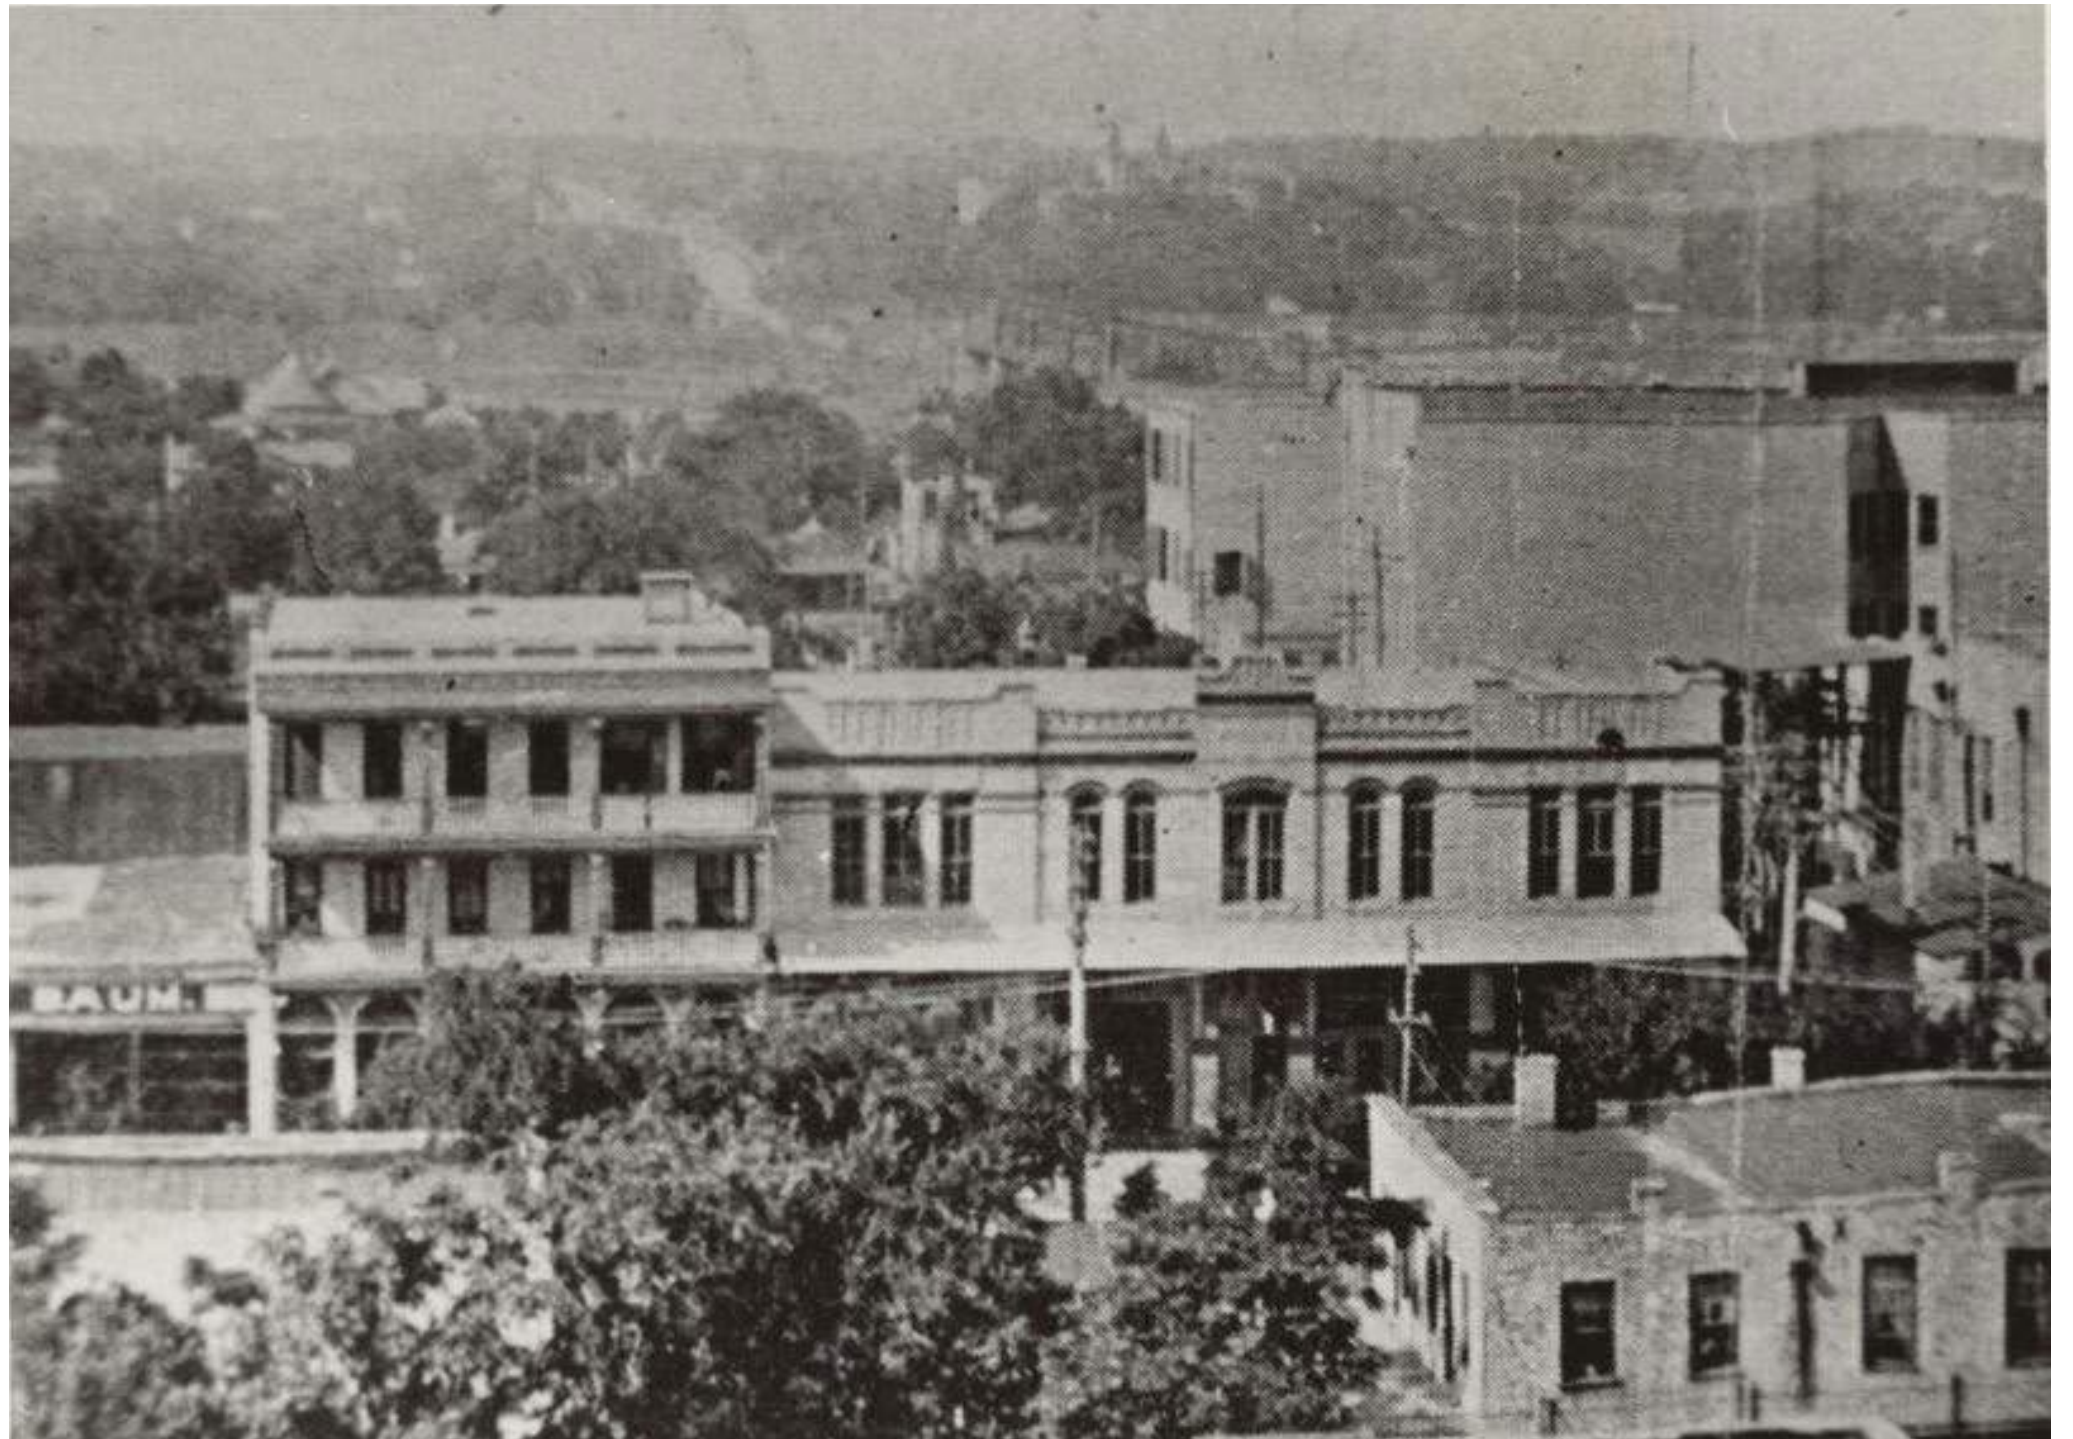
c. 1925

Aside from changes in color and signage, the facade stayed fairly similar to this until the 1970's.

Modifications to the 1887 design:

- Double wood gallery and six-bay arched openings removed.
- Most upper level door openings converted to windows.
- 1920's era storefront added at the ground level with two recessed entries.
- Plaster finish added over masonry at upper levels.
- Metal fire escape added.

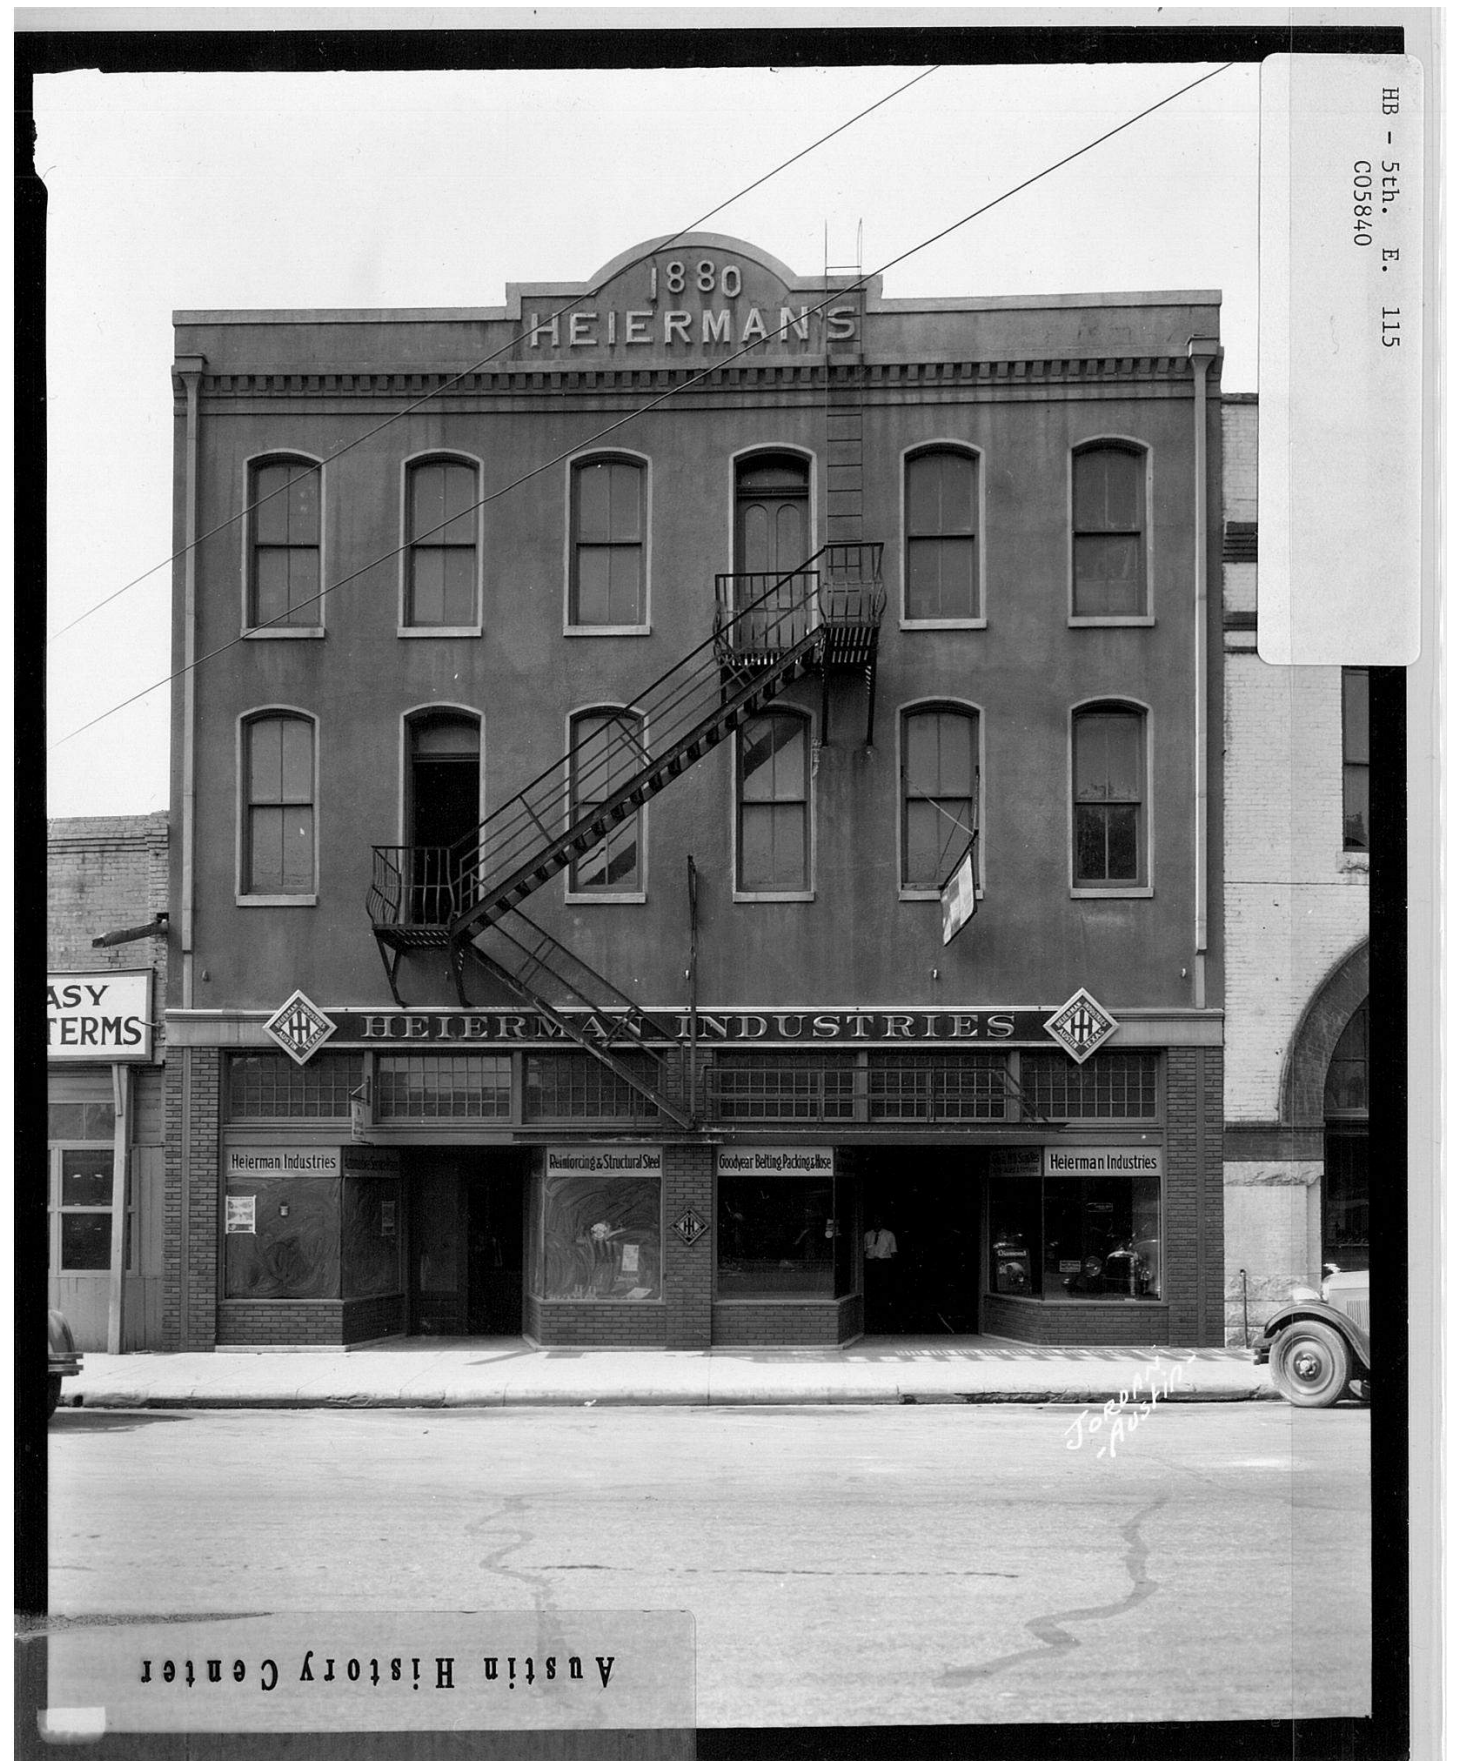
C. 1972

Same design as the 1925 photo, with changes in paint color, mechanical equipment additions, and signage removal.

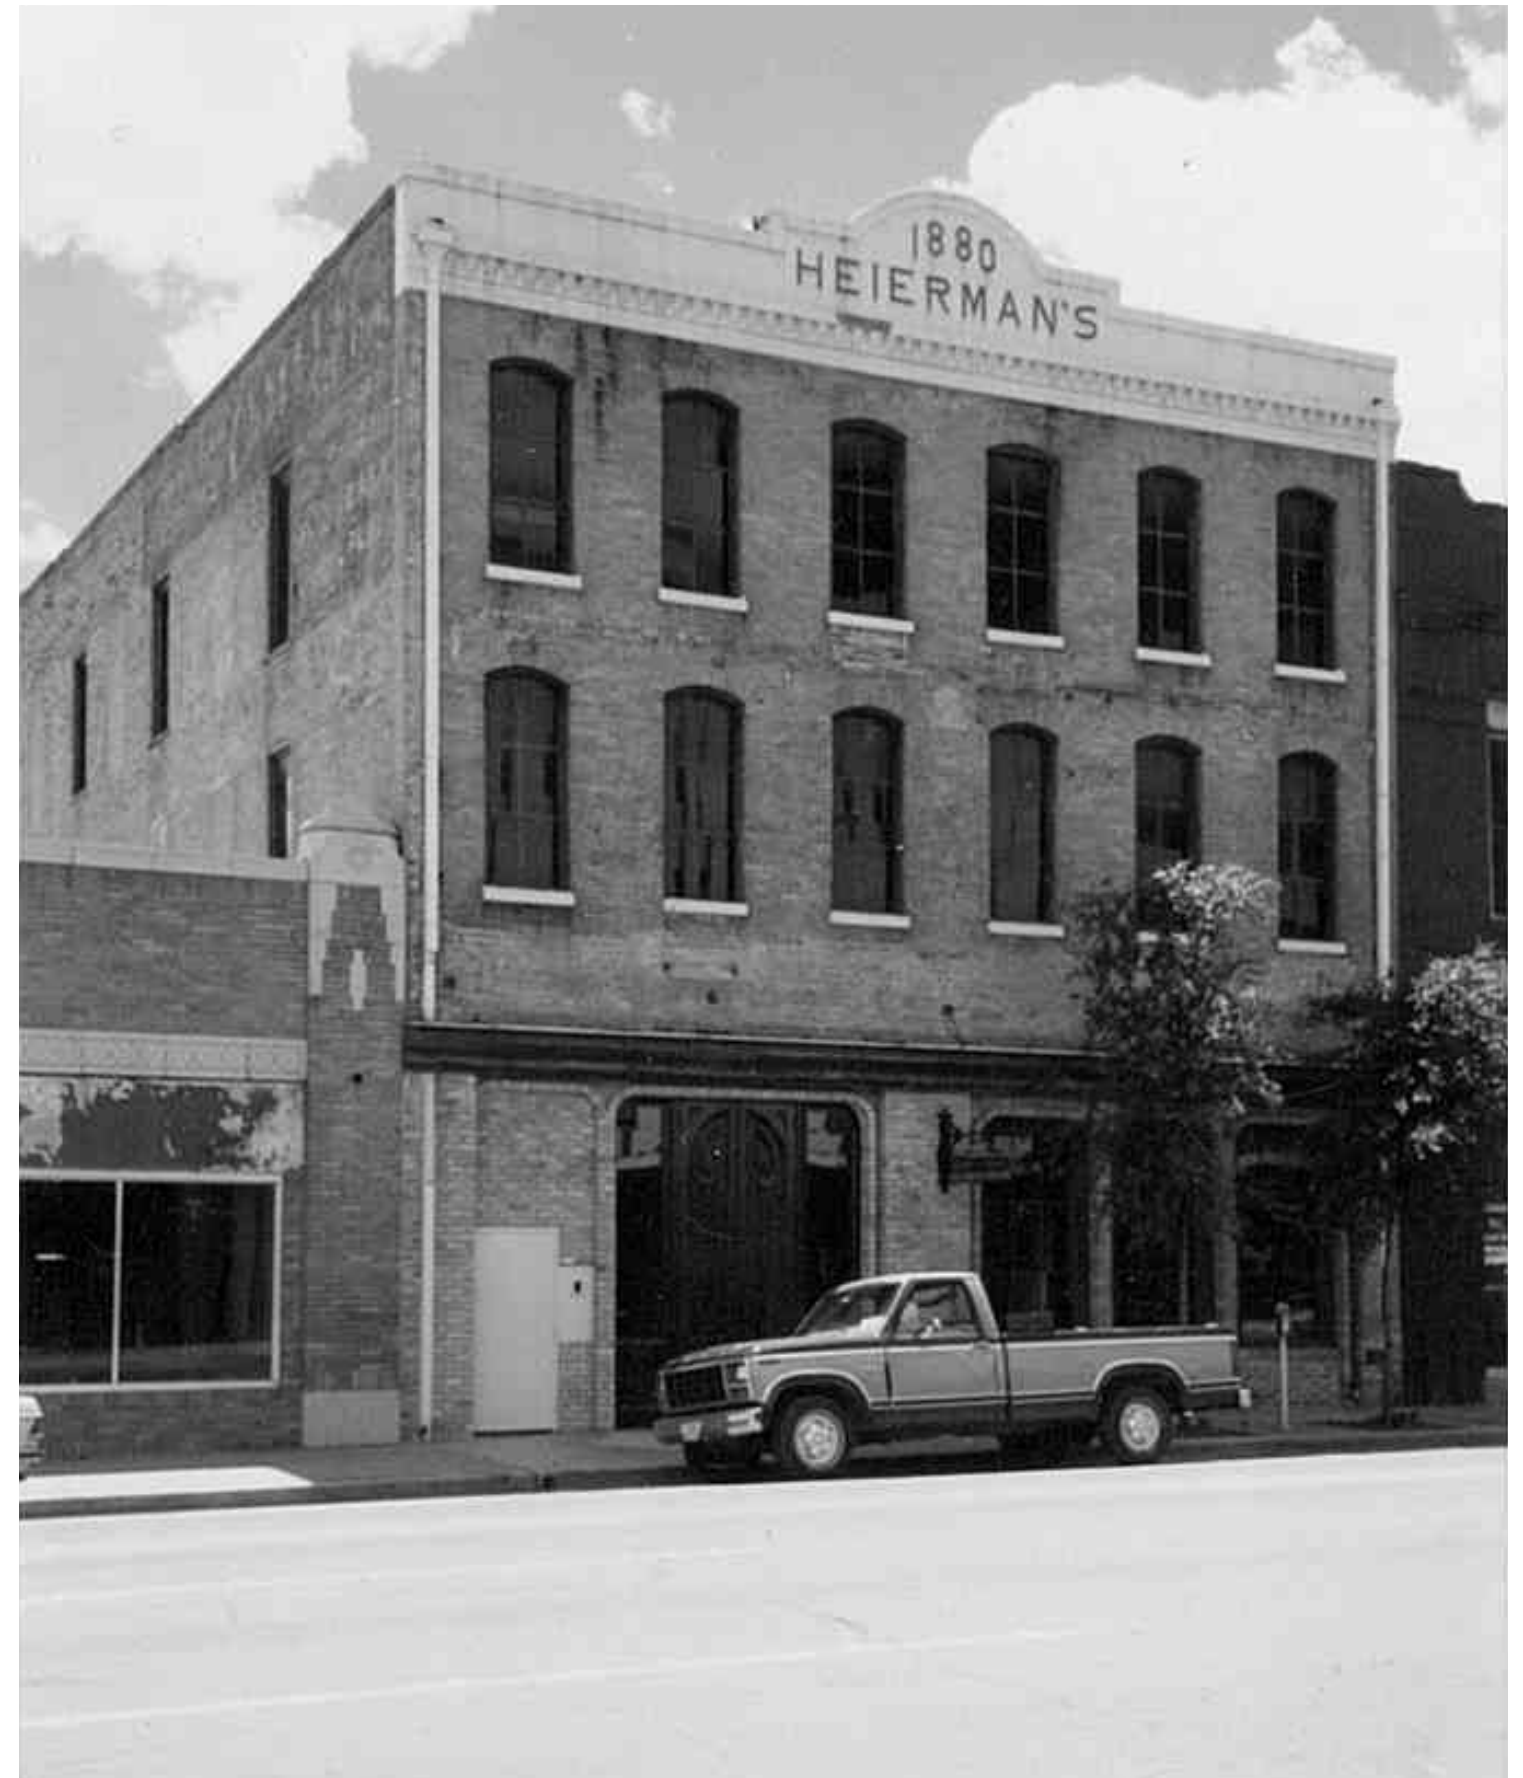
C. 2022

Frost Tower Garage Visible Beyond

Based on the surviving documentation and historical data available, as well as accounting the existing physical conditions of the building; we are proposing the following:

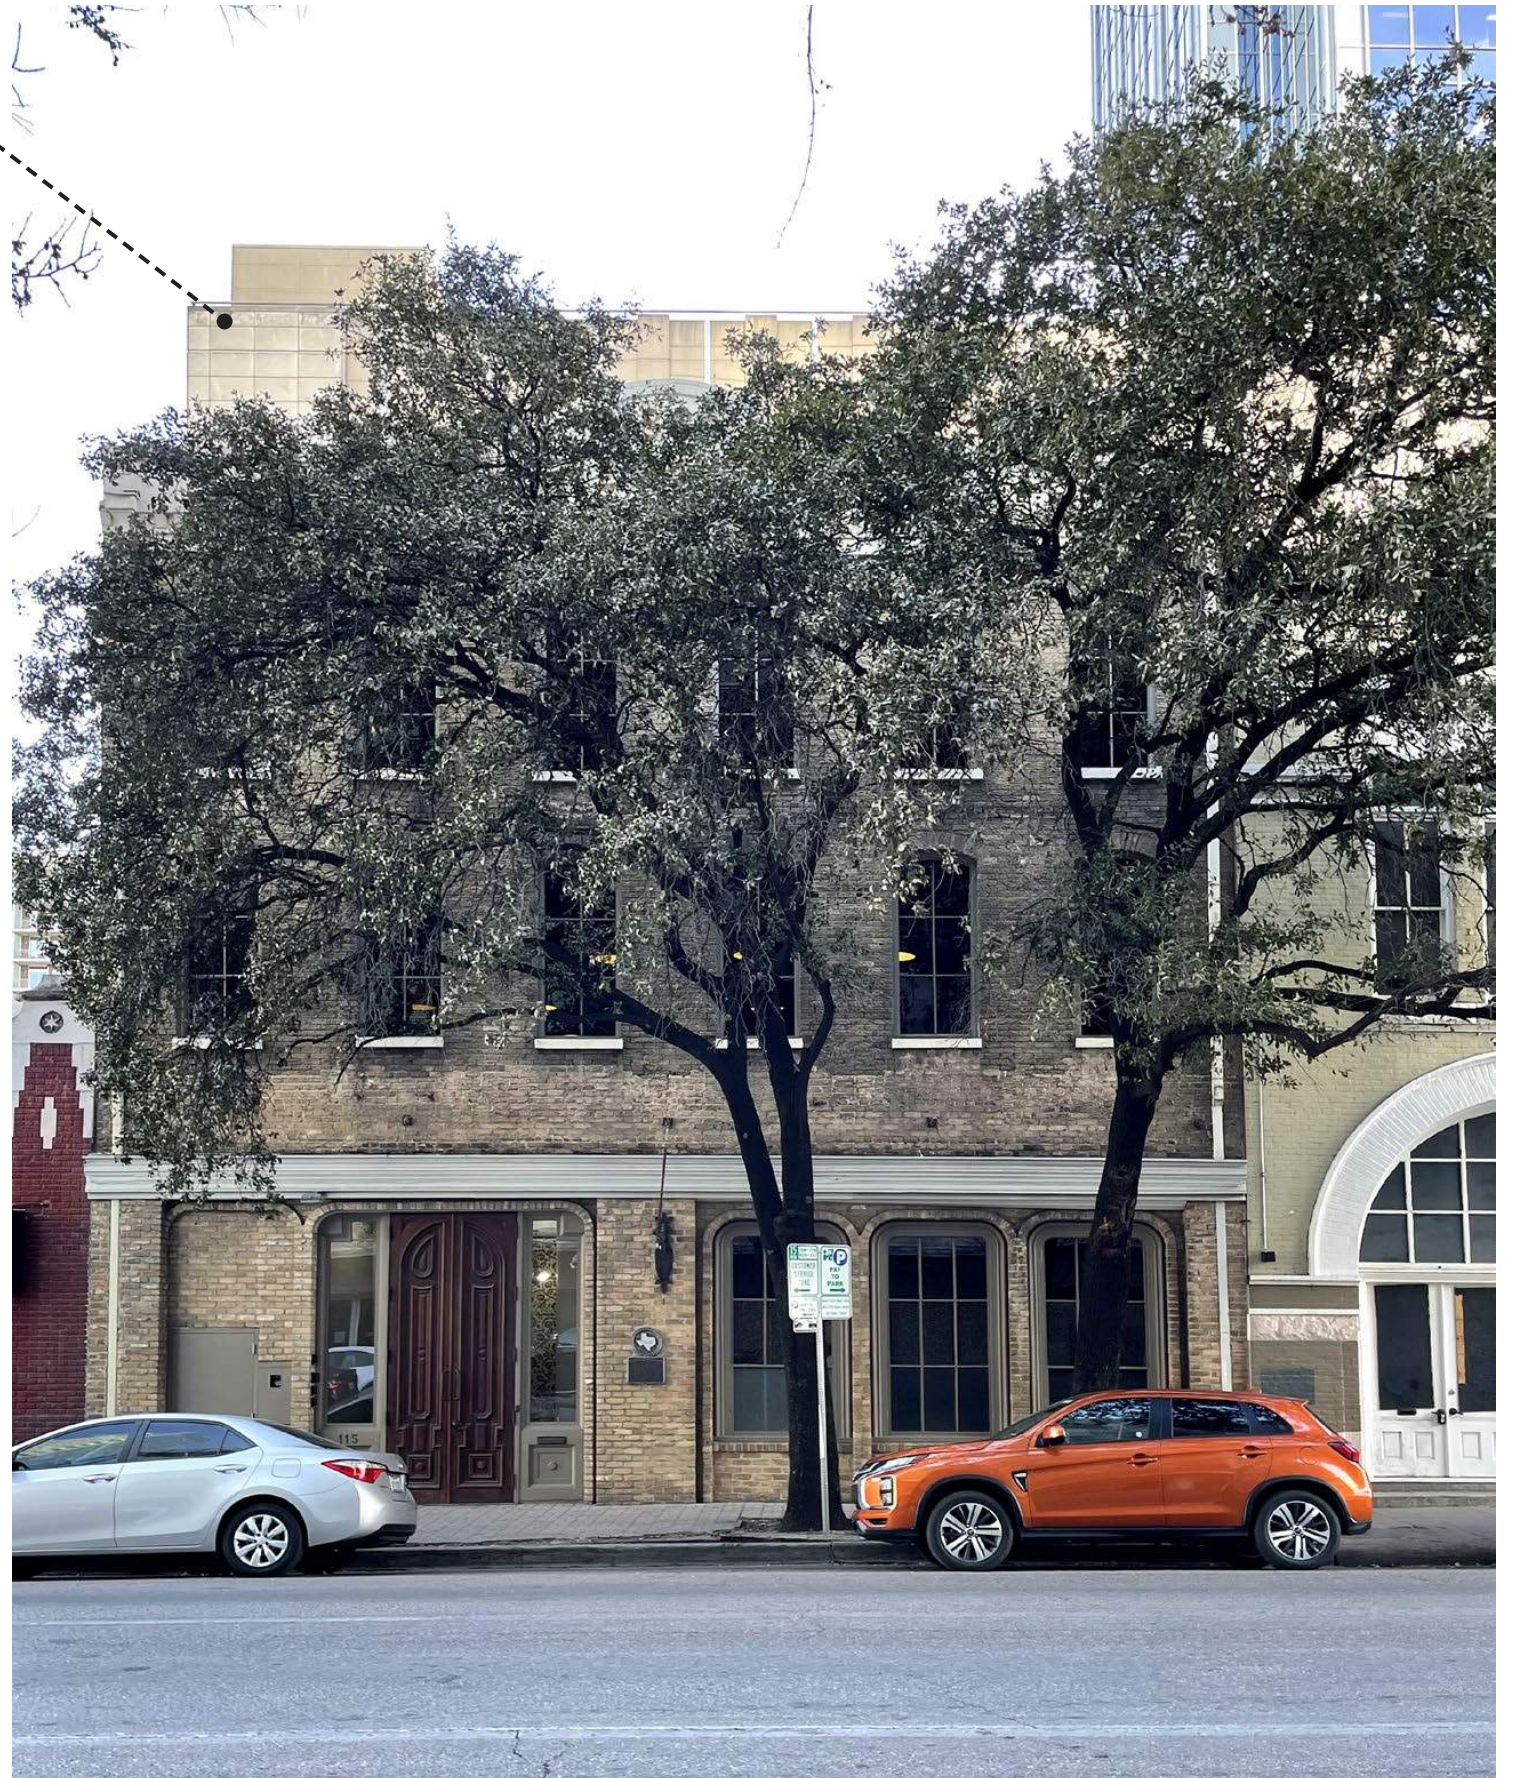
Section Diagram showing limited visibility of the rooftop addition from accross the street. Reference image fig. 24 from National Park Service - Preservation Brief 14 - Rooftop Additions.

Regarding the proposed rooftop addition, our staff appreciates the architect providing the sight line diagram and accordingly setting the associated new construction twenty feet back from the primary façade’s parapet to reduce visibility of the new addition from the principal perspective across 5th Street. Yet, our staff recommends the new addition being lowered in height to be more commensurate to the approximately 12’-13’ heights of the historic second and third stories of the building. Furthermore, our staff recommends and expects the proposed steel paneling of the new addition to be painted a lighter color to blend in more with the existing buff colored historic brick of the Heierman Building and the light grey concrete color of the parking garage directly behind the building to the south.

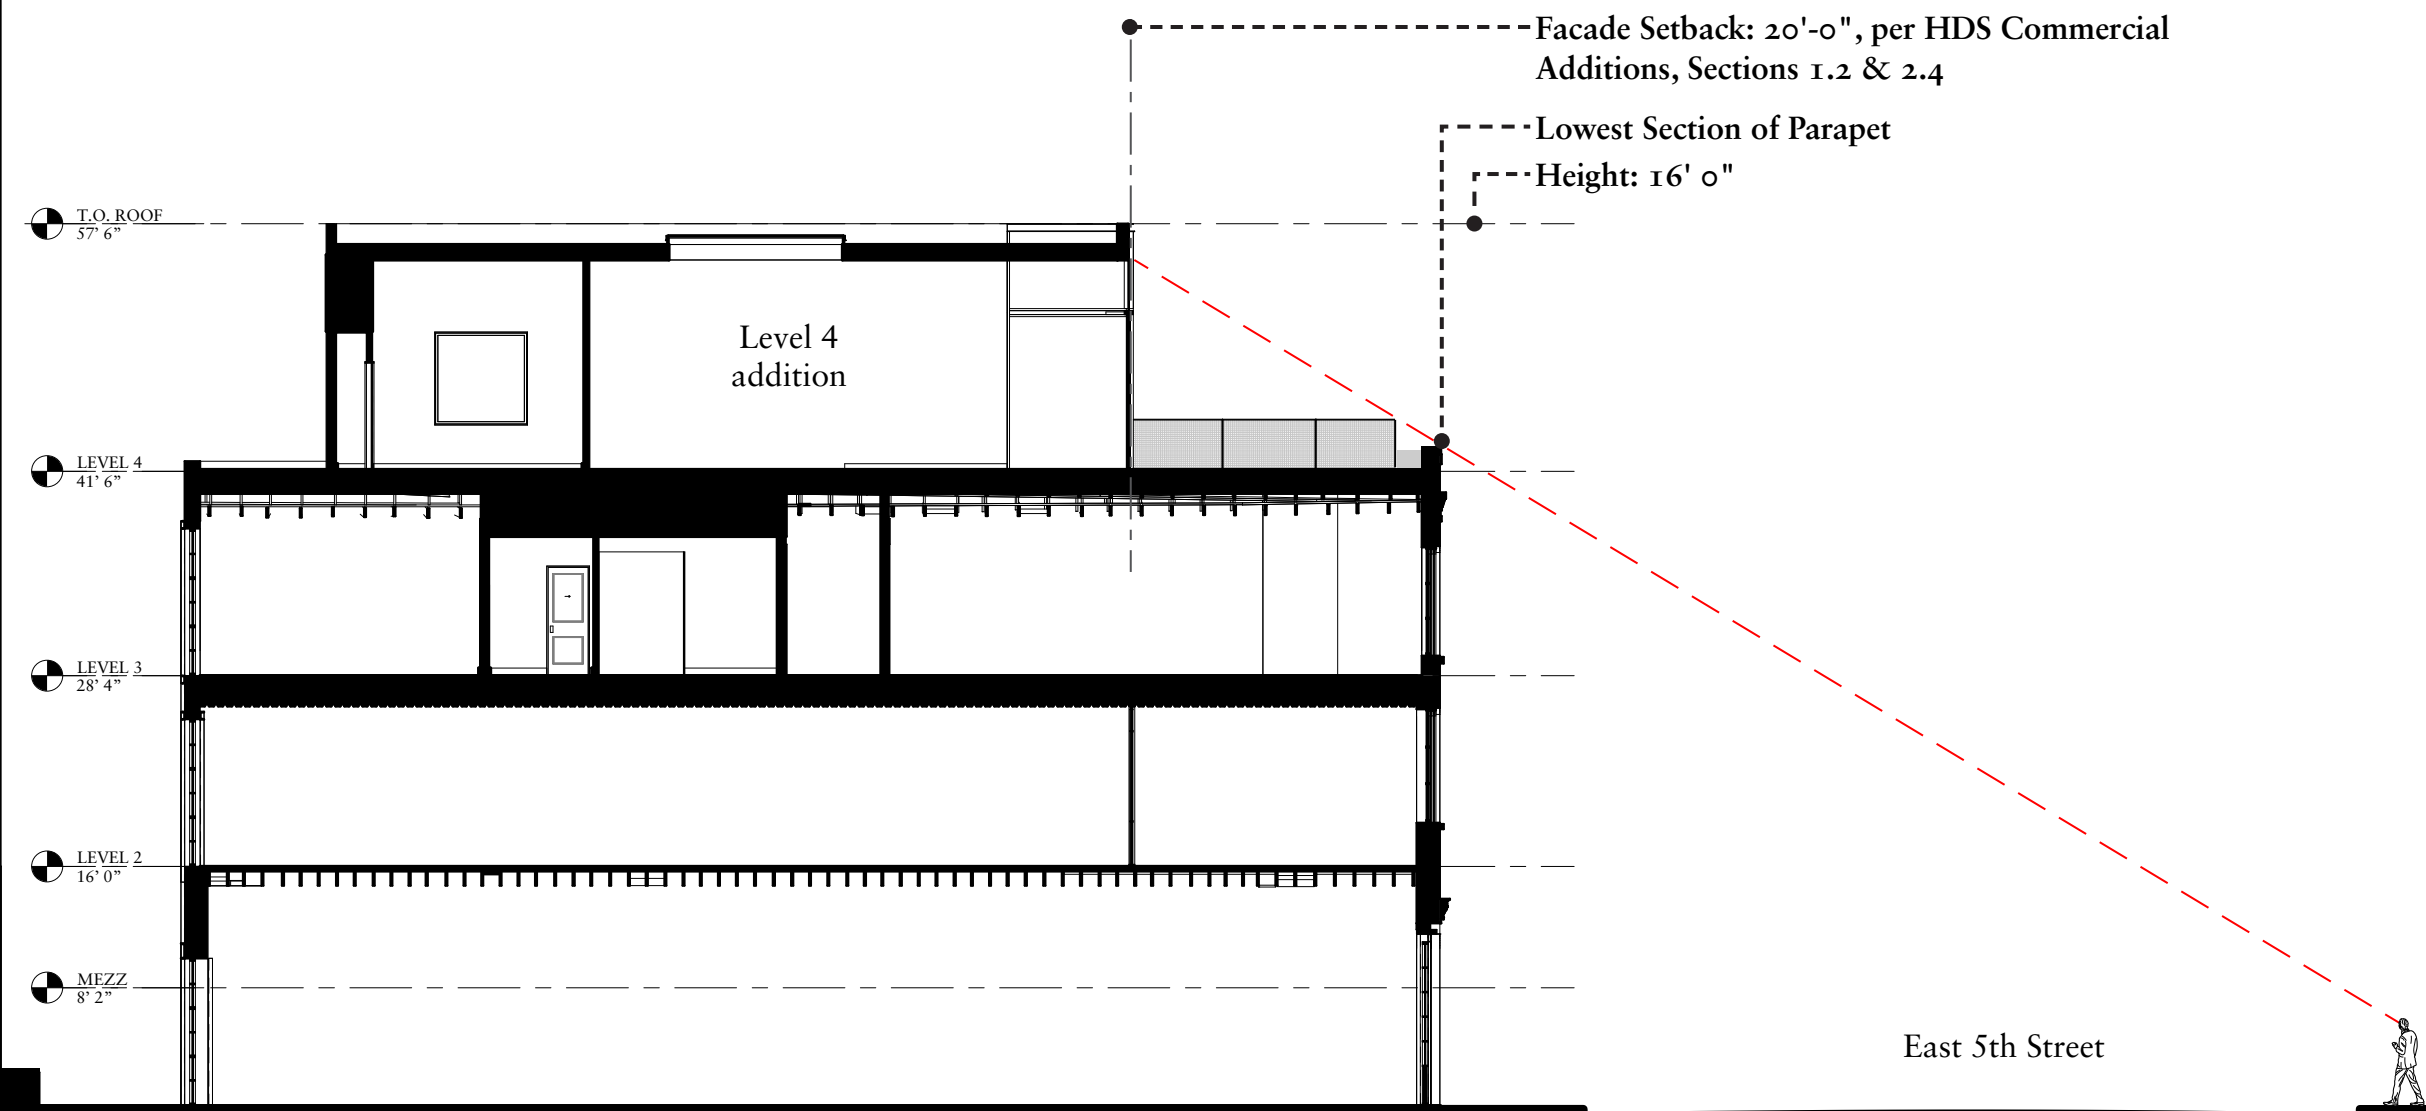
Section through 5th Street

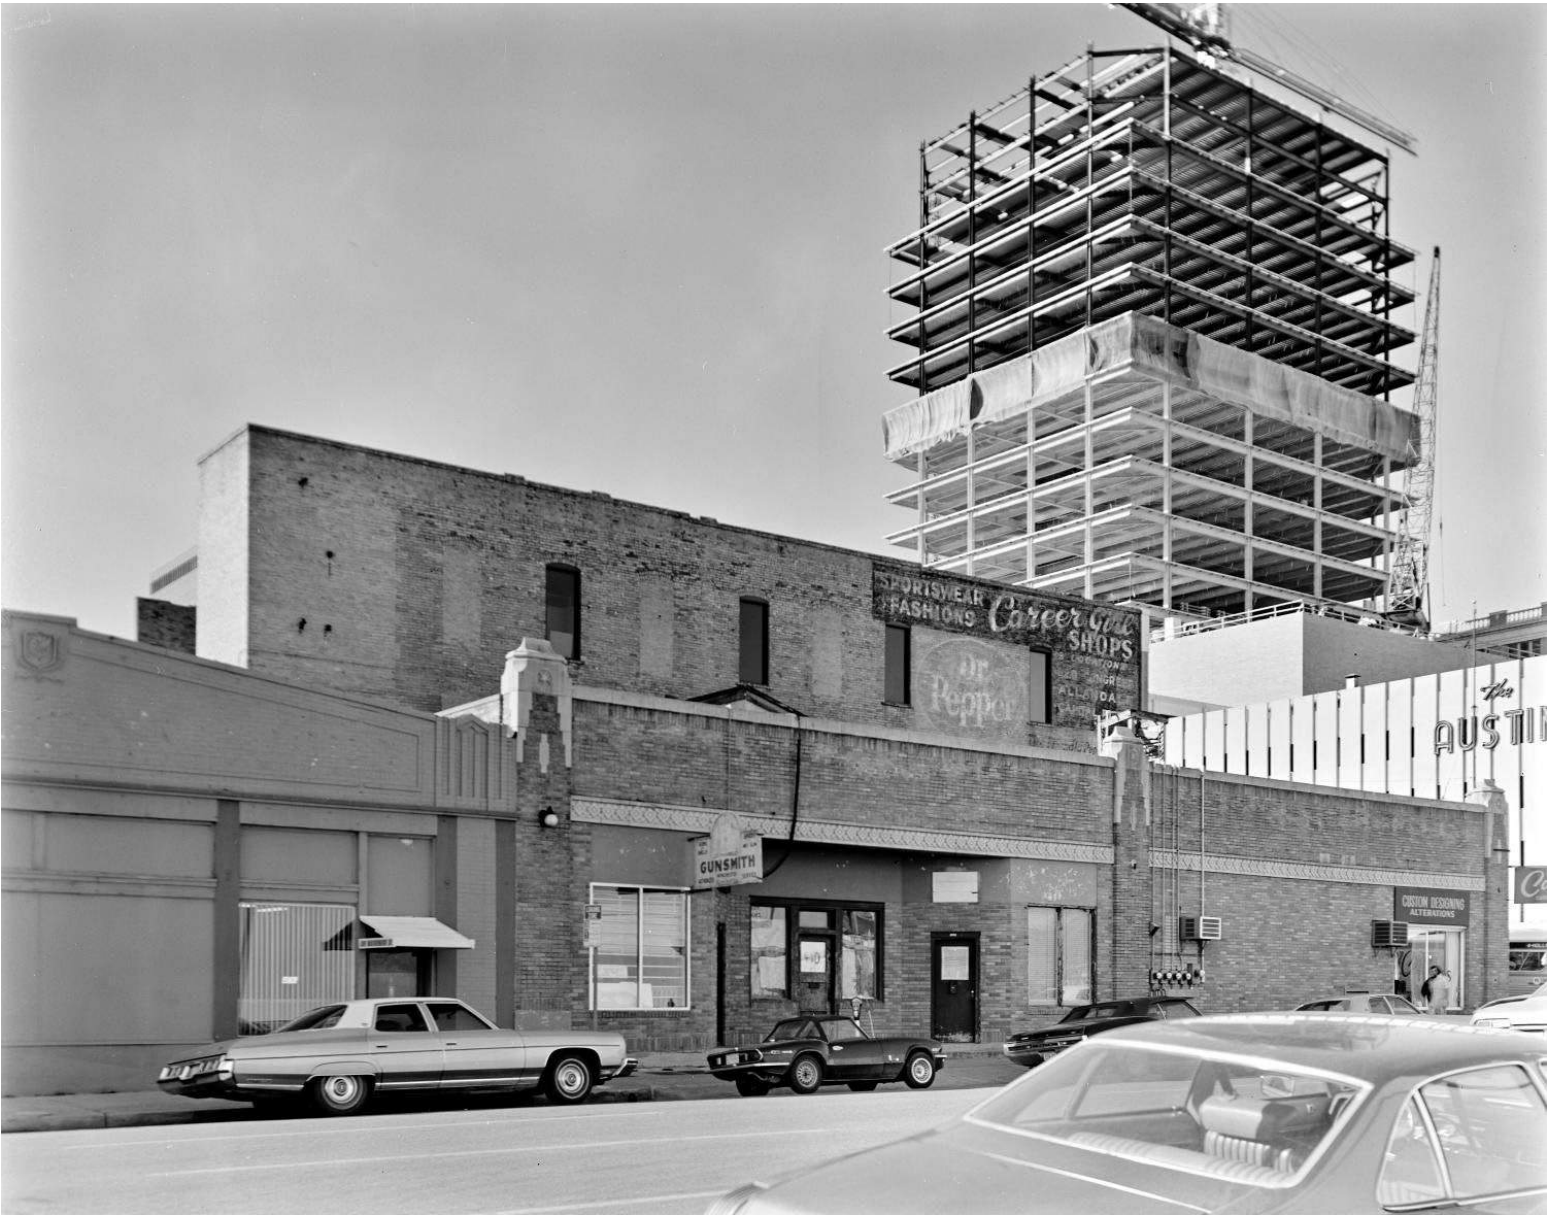
c. 1975

- In 1973, the building was sandblasted inside and out.
- The ground floor 1920's style storefront was replaced with one that mimicked New Orleans style facades.
- All windows on the primary facade were replaced with single pane tinted glass, fixed in wood mullions (previously double-hung).

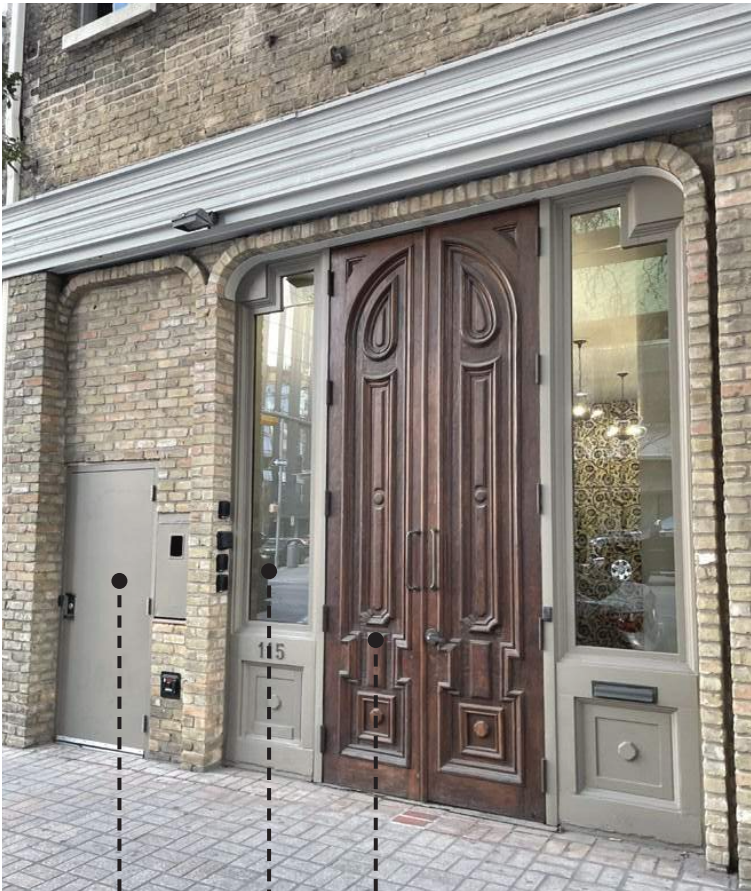
Custom steel storefront. New glass to be insulated and as clear as possible

Referencing the 1974 era design in tone and style, and are proposing a change in material to steel.
