AS-BUILT, TREE LOCATION AND TOPOGRAPHIC SURVEY

Reference: Srivathanakul Address: 101 Lago Verde Drive, Austin, Texas
1.408 Acres of land, more or less, out of the William Harrison Survey 474, Abstract No. 368 in Travis County, Texas, being all of that certain (1.001 acre) tract of land and all of that certain (0.40 Acre) tract of land as conveyed to The Srivathanakul Family Revocable Living Trust, by General Warranty Deeds as recorded in Doc. No. 2011149510 and Doc. No. 2008149697, (respectively), Official Public Records, Travis County, Texas.

BUILDABILITY EXHIBIT

**101 LAGO VERDE
101 LAGO VERDE ROAD, AUSTIN, TRAVIS COUNTY, TEXAS
HJN 200293.001 ERI**

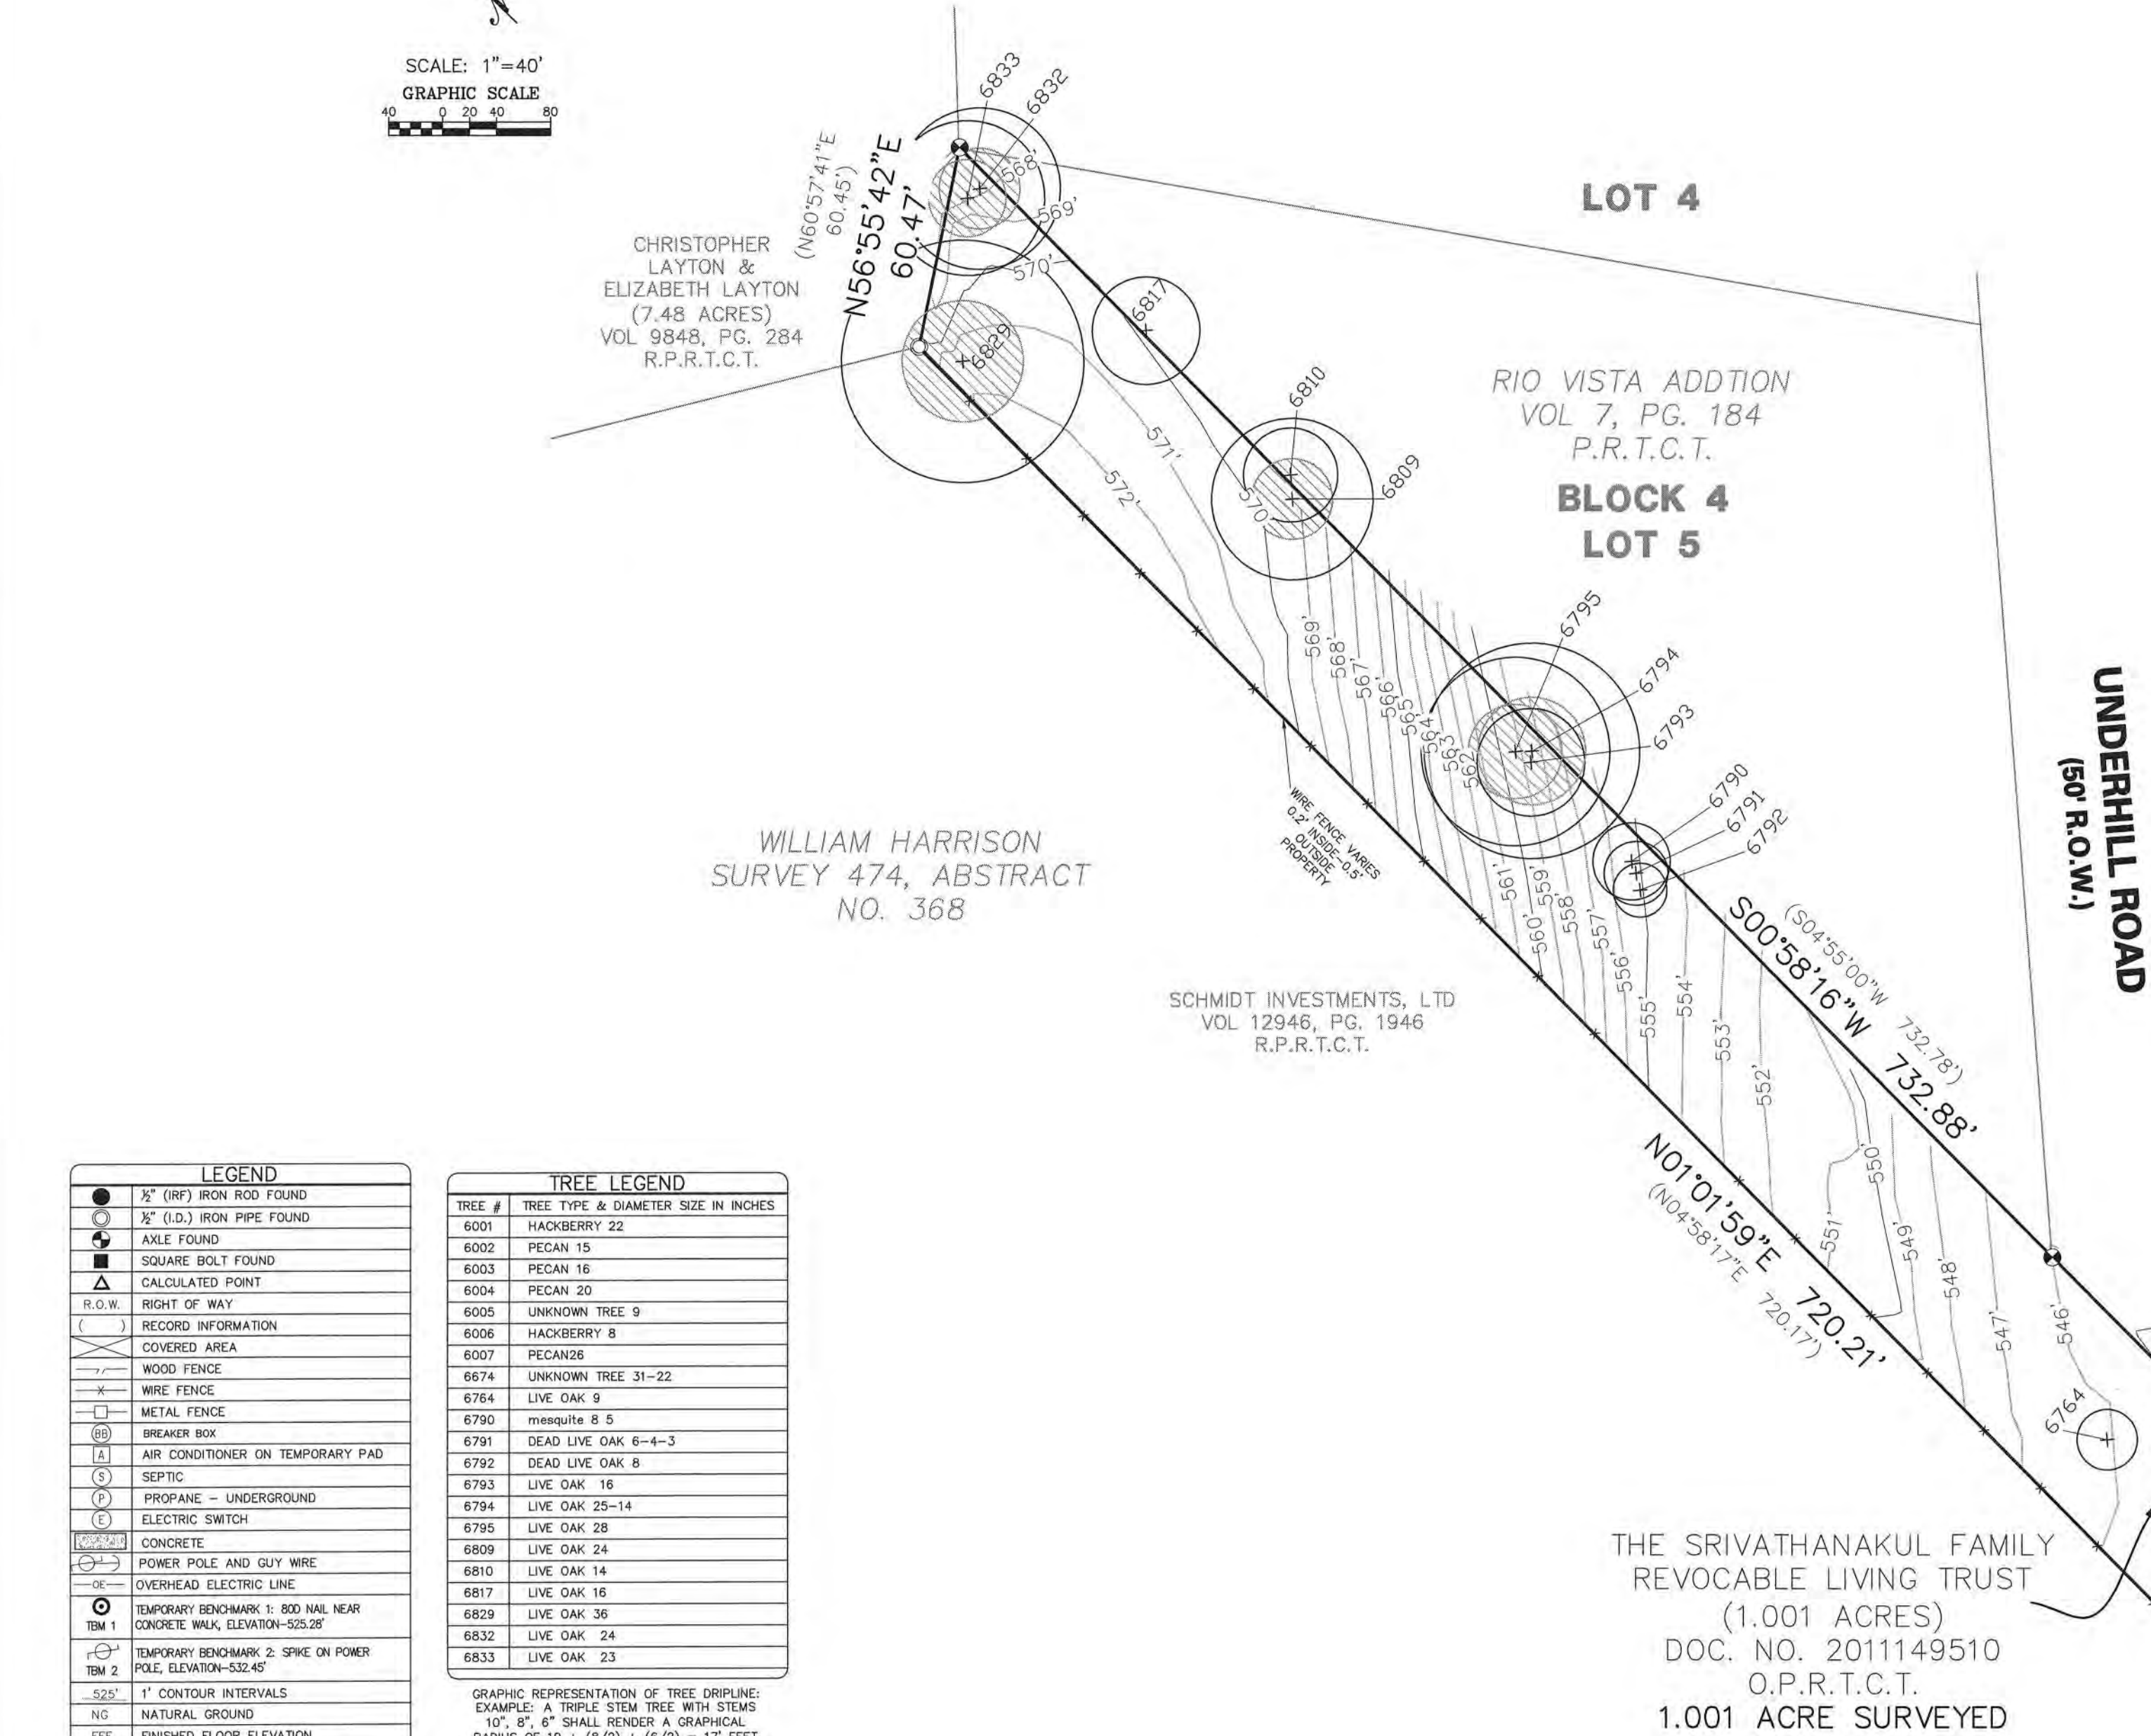
Surveyor's Note:
Bearings shown hereon are based on Texas State Plane Coordinate System, Central Zone (FIPS Code 4203), NAD 83, Grid Coordinates & Grid North, VERTICAL DATUM: NAVD 88 (GEOID 12A)

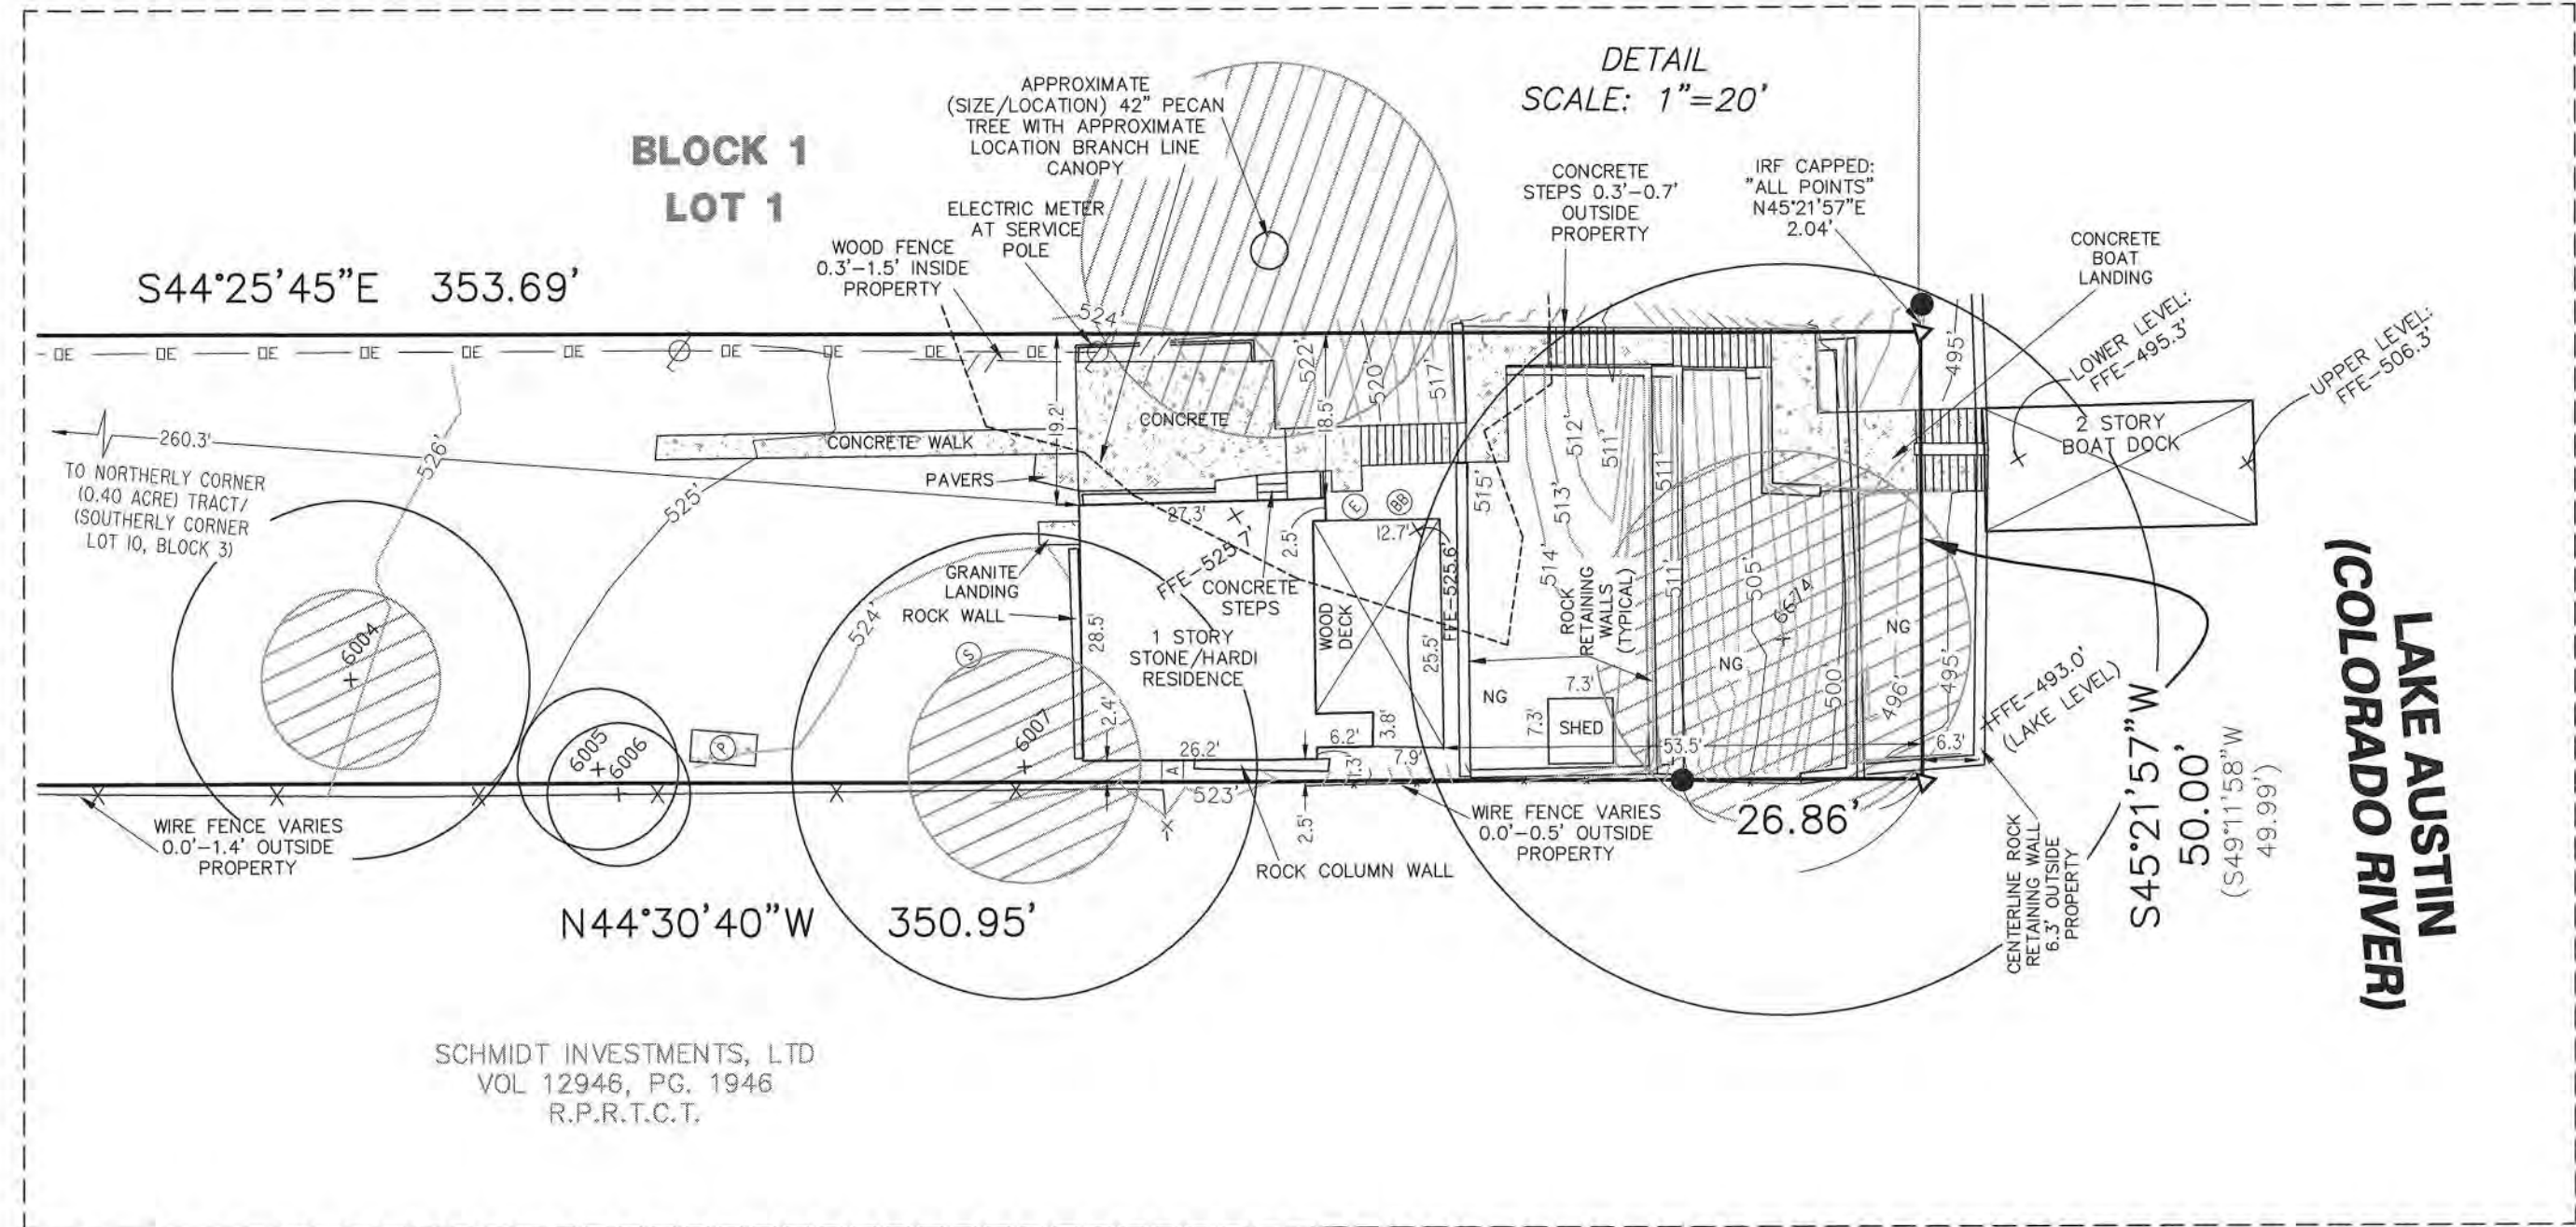
SUNTI AND JANICE CHEN-SRIVATHANAKUL,
CO-TRUSTEES OF THE SRIVATHANAKUL FAMILY
REVOCABLE LIVING TRUST
(0.40 ACRE)
DOC. NO. 2008149697
O.P.R.T.C.T.
0.407 ACRE SURVEYED

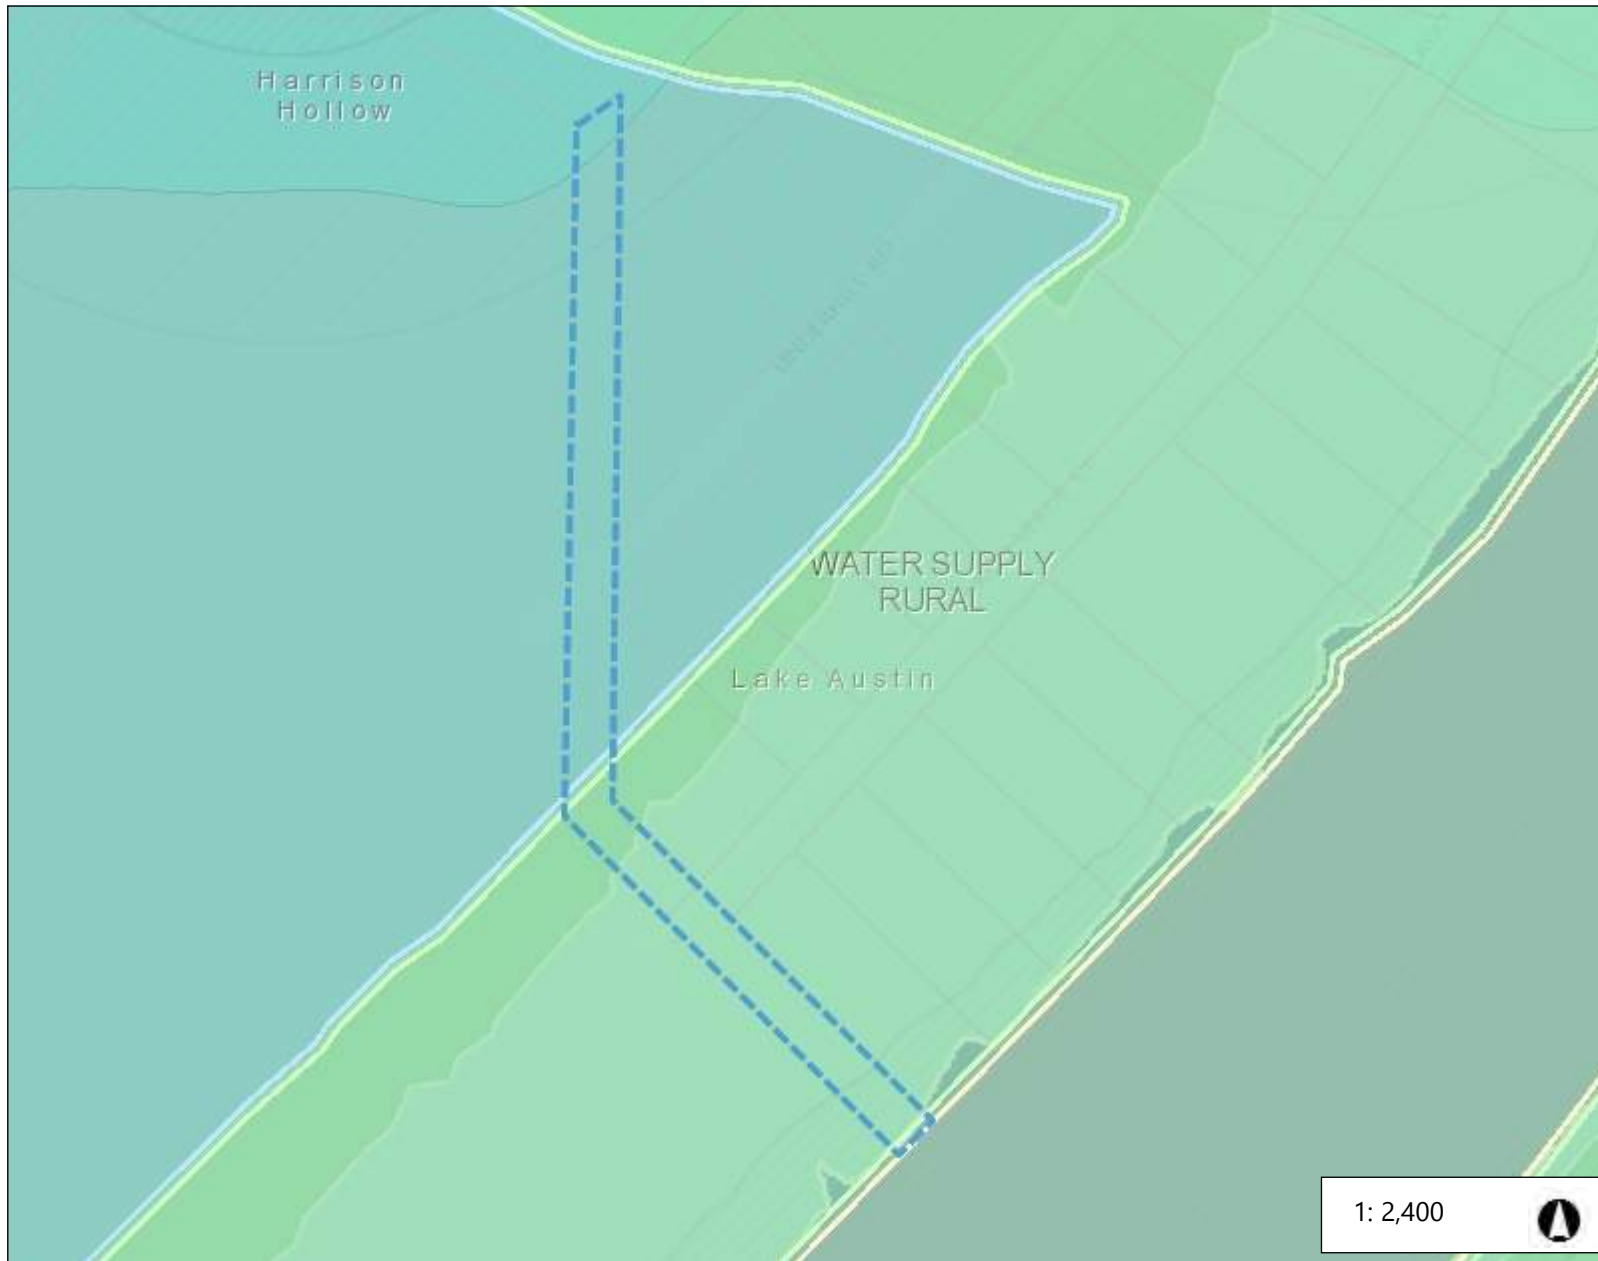
Environmental Map

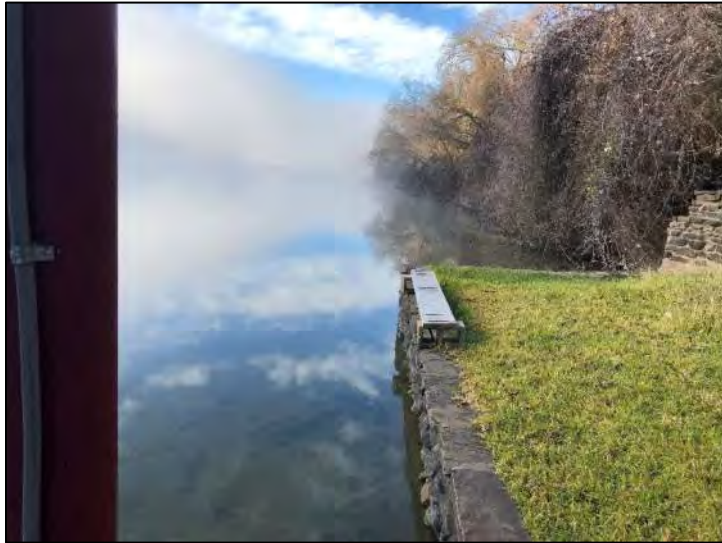
PHOTO 1

Wetland CEF W-1 located within 150 feet of the southern portion of the subject site

During Horizon's review of the City of Austin Property Profile website, 2 wetland CEFs were documented within 150 feet of the subject site (Figure 4). Wetland CEF W-1 was documented under case number SP-2009-0115DS and BRG ID 7449 (Photos 1 to 3). Wetland CEF W-2 was documented under case number SP-2009-0115DS and BRG ID 7450 (Photos 4 to 6). Wetlands that were documented on the City of Austin Property Profile website were not observed during the field visit. This is potentially because the wetlands were submerged by the water level of Lake Austin.

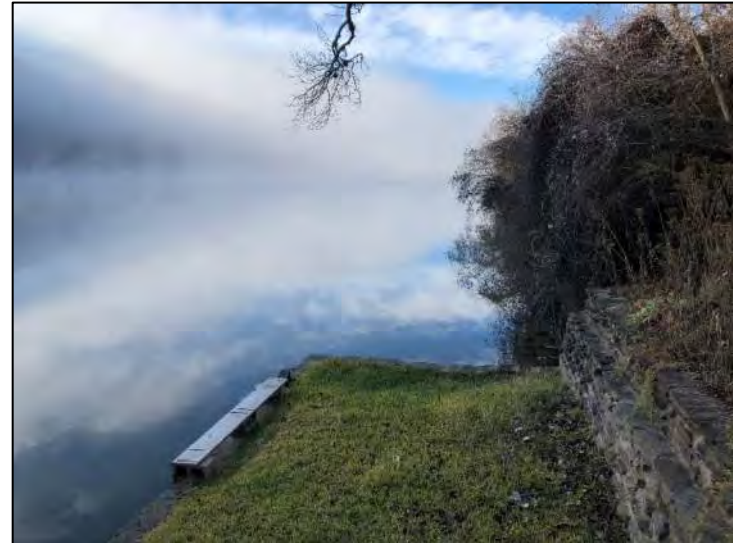
PHOTO 2

Wetland CEF W-1 located within 150 feet of the southern portion of the subject site

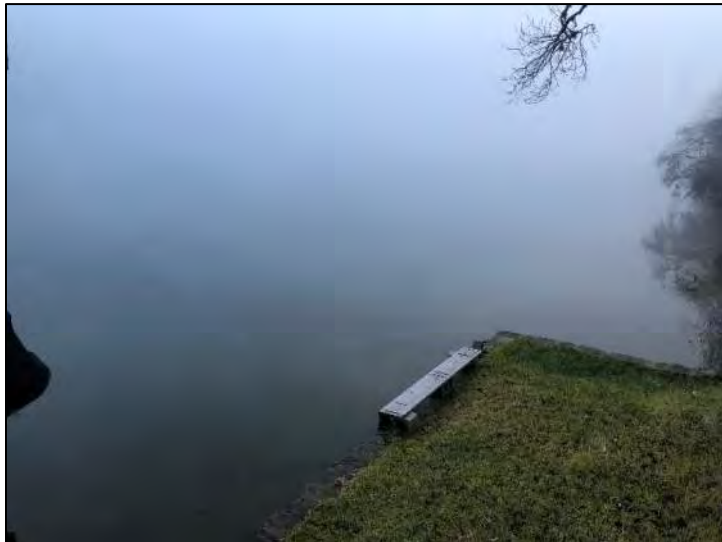
PHOTO 3

Wetland CEF W-1 located within 150 feet of the southern portion of the subject site

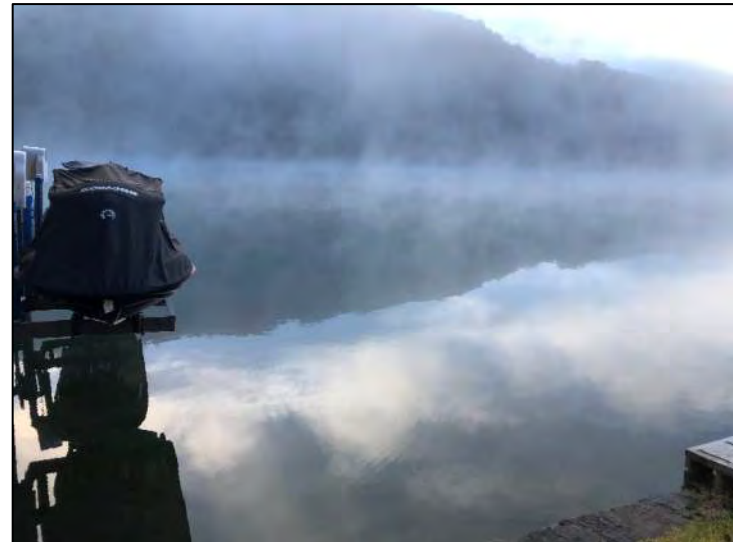
PHOTO 4

Wetland CEF W-2 located within 150 feet of the southern portion of the subject site

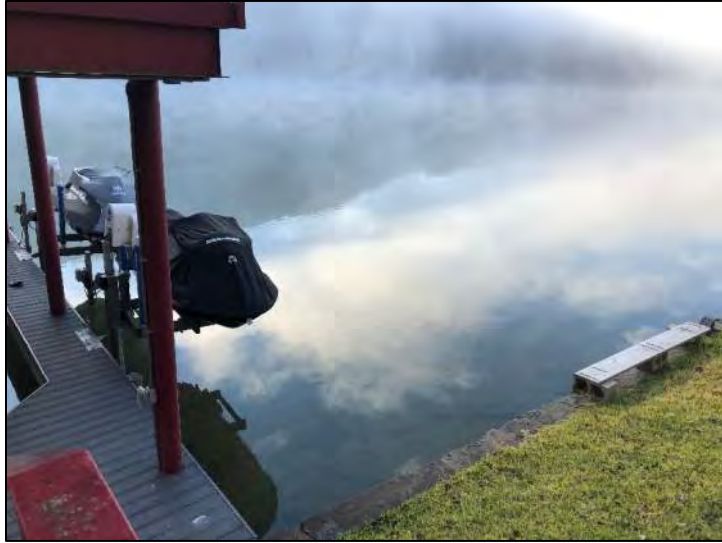
PHOTO 5

Wetland CEF W-2 located within 150 feet of the southern portion of the subject site

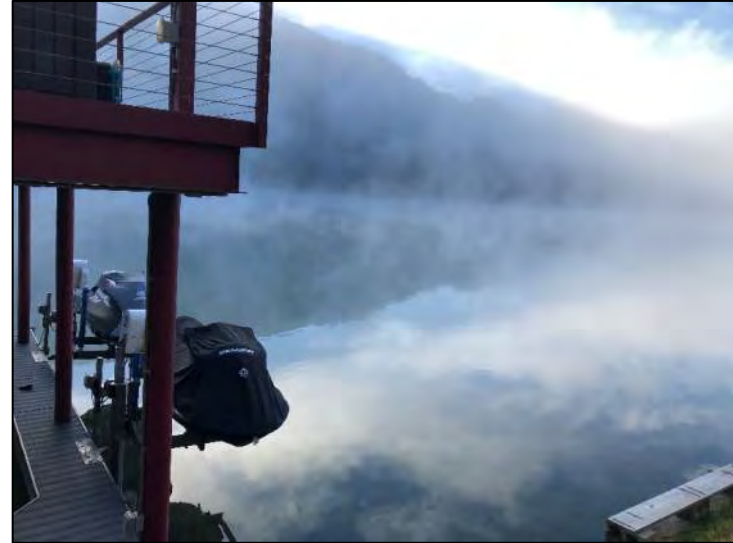
PHOTO 6

Wetland CEF W-2 located within 150 feet of the southern portion of the subject site

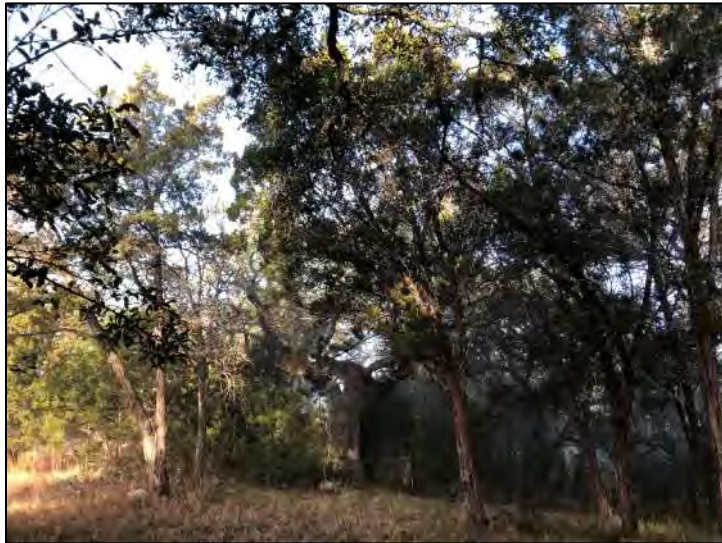
PHOTO 7

General view of the northern portion of the subject site

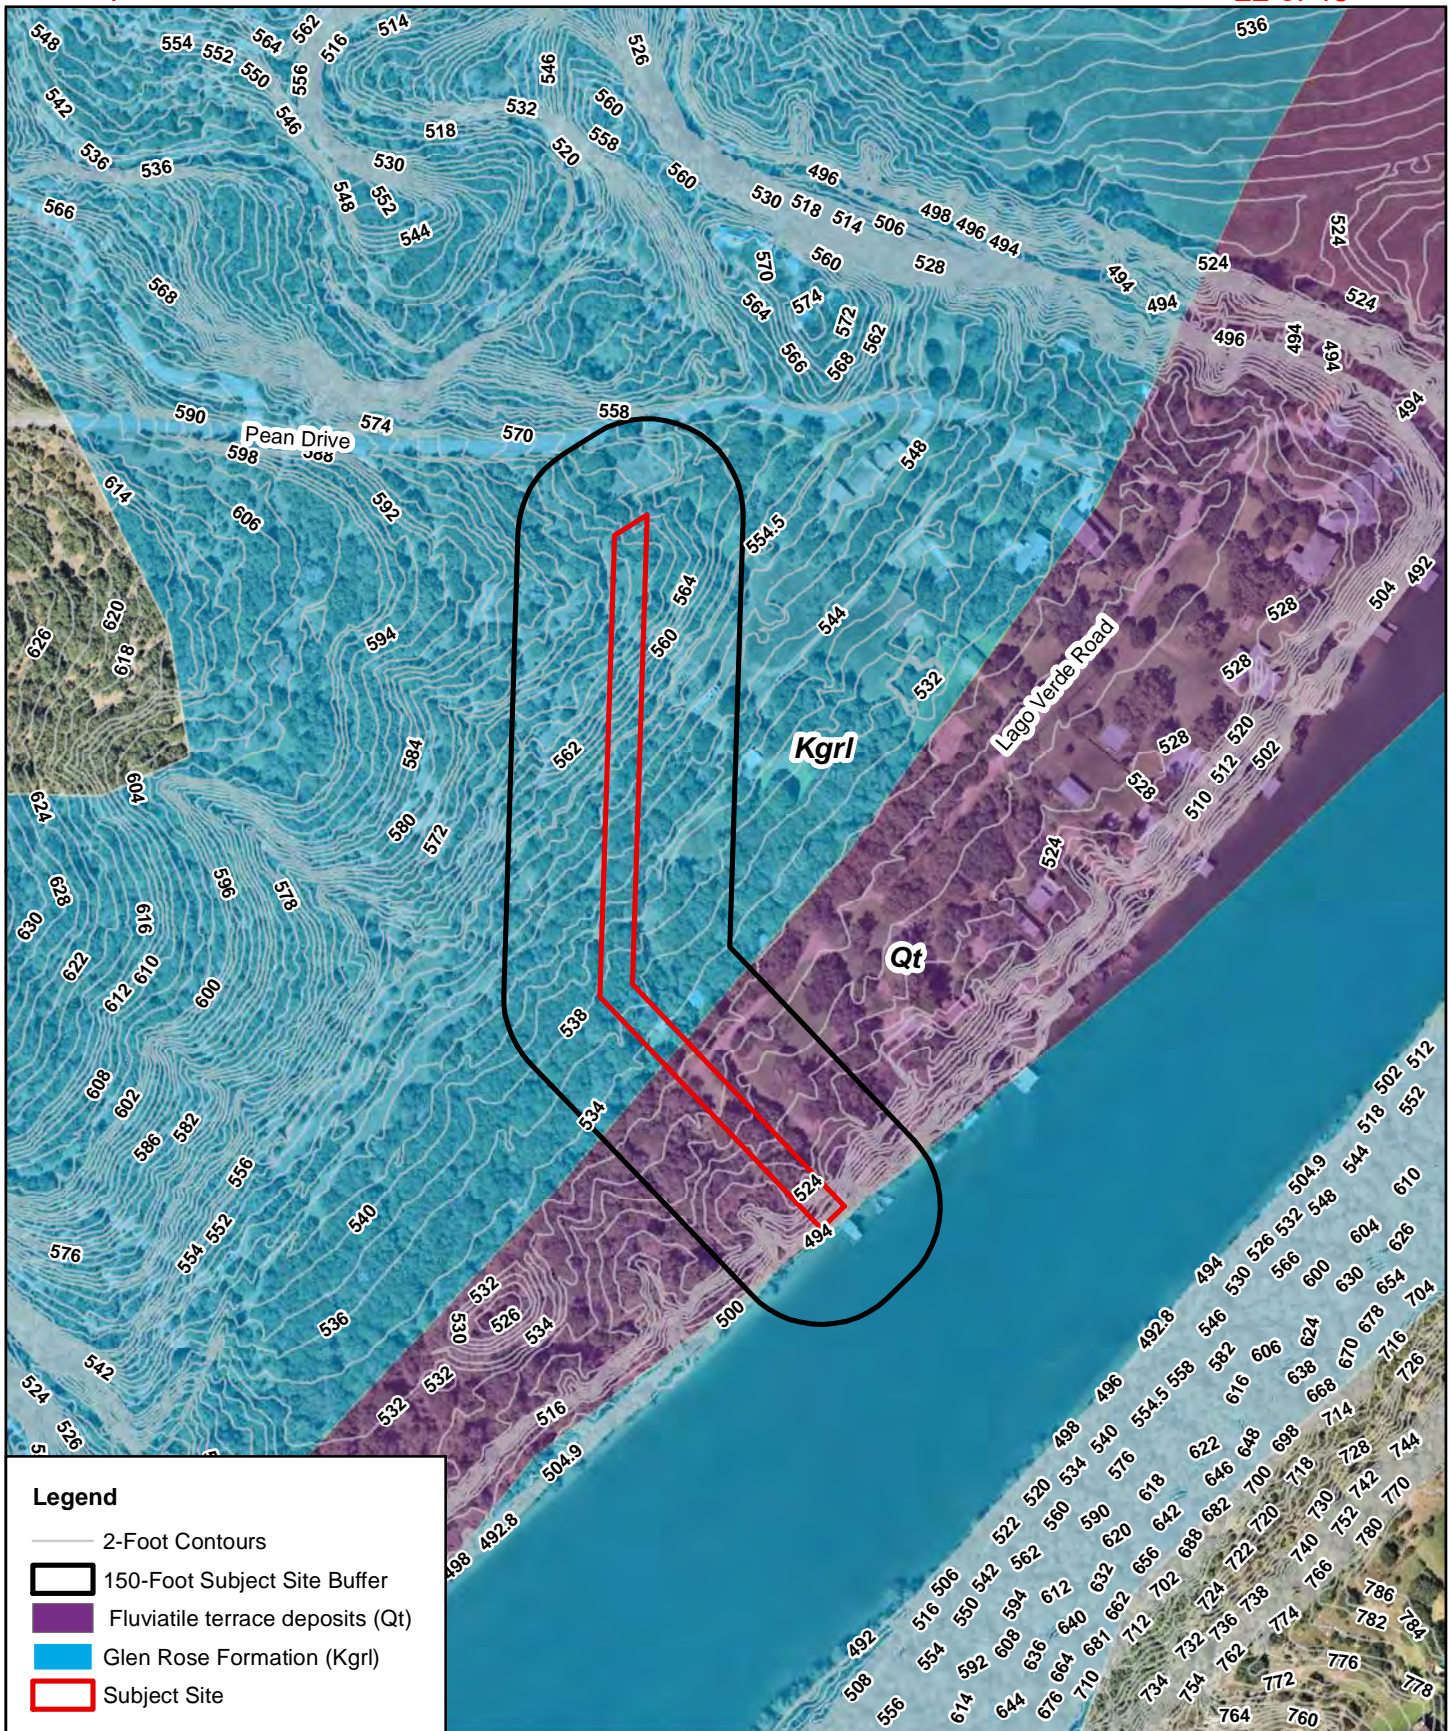
Geologic Units Exposed at Surface		
Group	Formation	Member
--	Fluviatile terrace deposits (Qt)	--
--	See attachments.	--

Fluviatile terrace deposits (Qt) -- Terraces along streams, consist of 3 or more levels which may correspond to coastal Pleistocene units; gravel, sand, silt, and clay in various proportions with gravel more prominent in the older, higher terraces; gravel along Guadalupe River, siliceous, coarse, along Colorado River, mostly dolomite, limestone, chert, quartz, and various igneous and metamorphic rocks from the Llano region and dolomite, limestone, and chert from the Edwards Plateau; sand mostly quartz (UT-BEG, 1995).

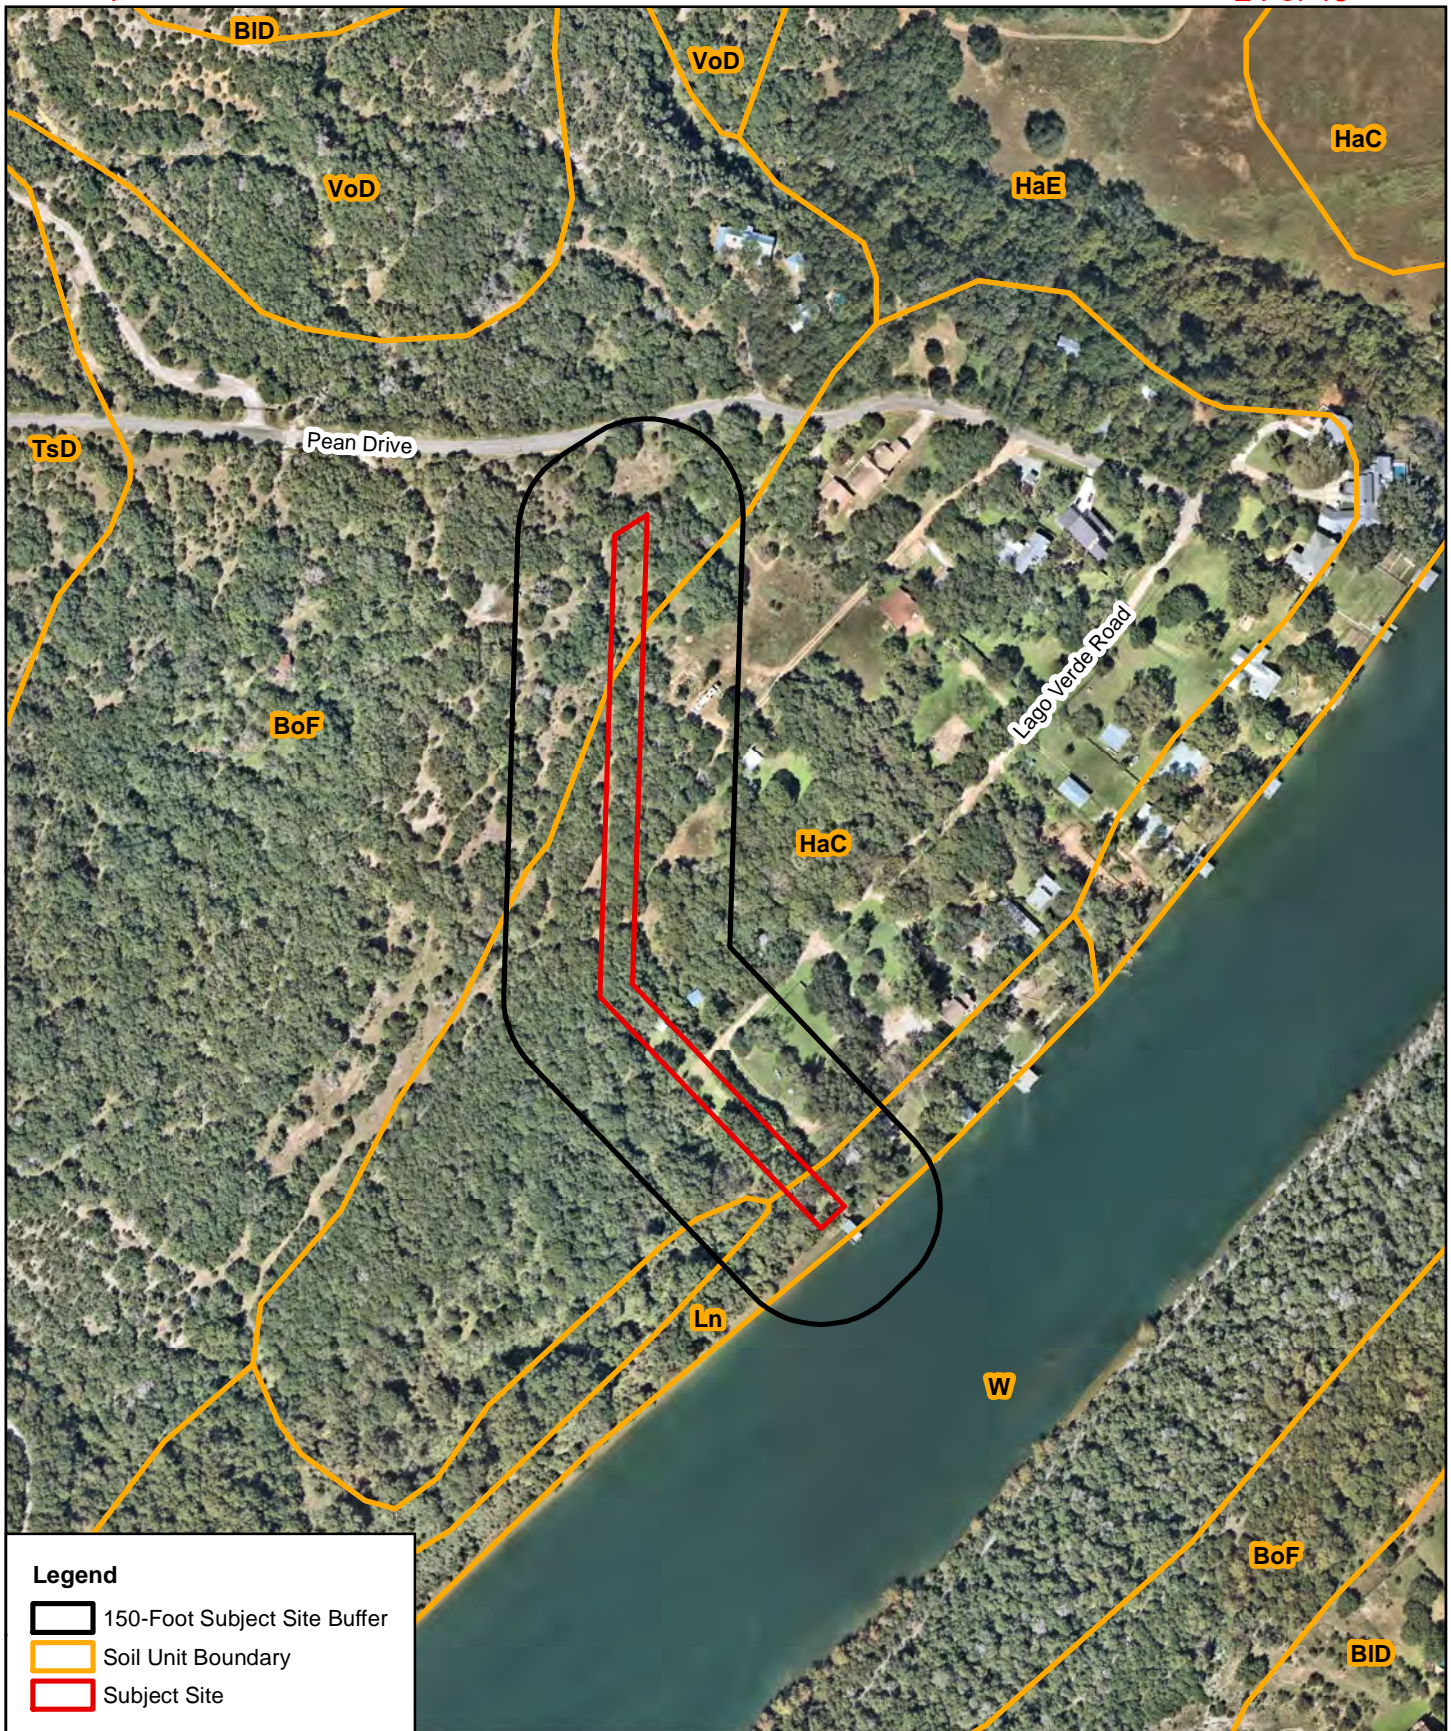
Soil Series Unit Names, Infiltration Characteristics & Thickness		
Soil Series Unit Name & Subgroup**	Group*	Thickness (feet)
Brackett - Rock outcrop-Real complex, 8-30% slopes (BoF)	D	1.2
Hardenman fine sandy loam, 2-5% slopes (HaC)	A	5.0
Gaddy loamy fine sand, 0-1% slopes, frequently flooded(Ln)	A	8.3

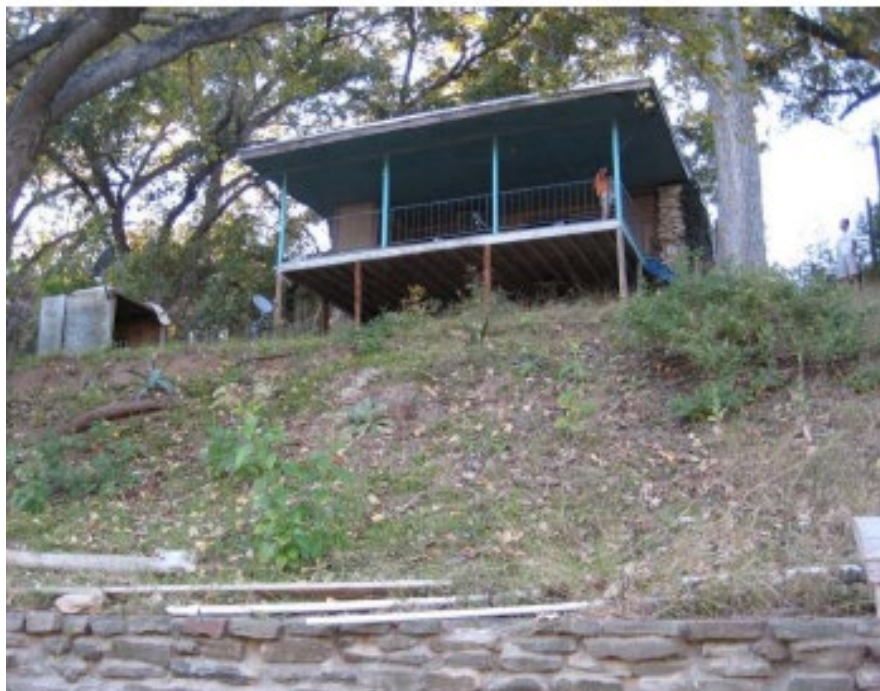
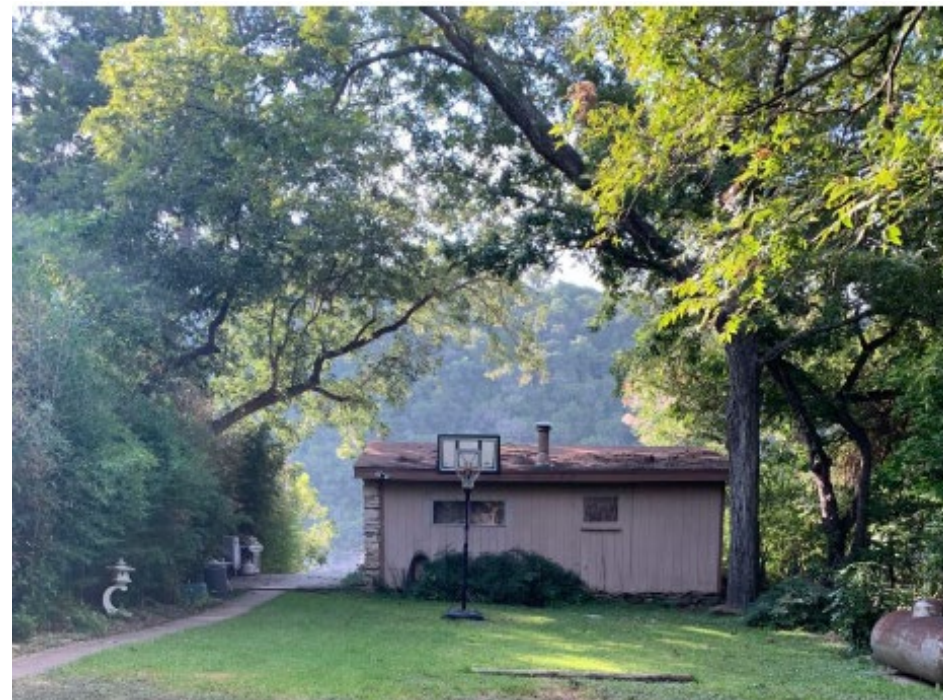
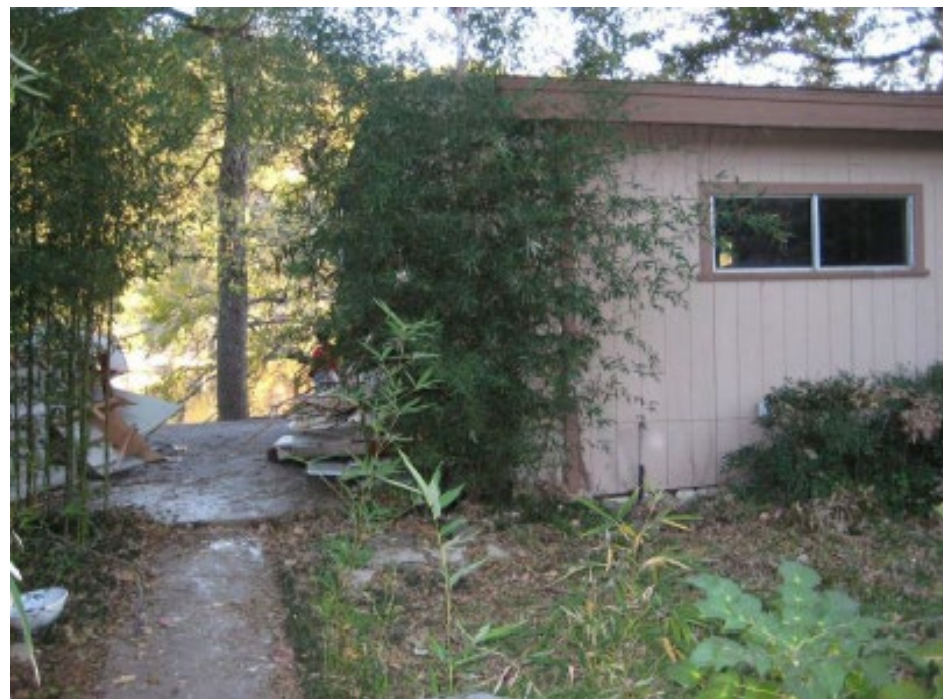
The lot is partially within the Lake Austin Critical Water Quality Zone.

Code requires that the lot have 2 acres NOT in the Critical Water Quality Zone. The whole lot is less than 2 acres in size.

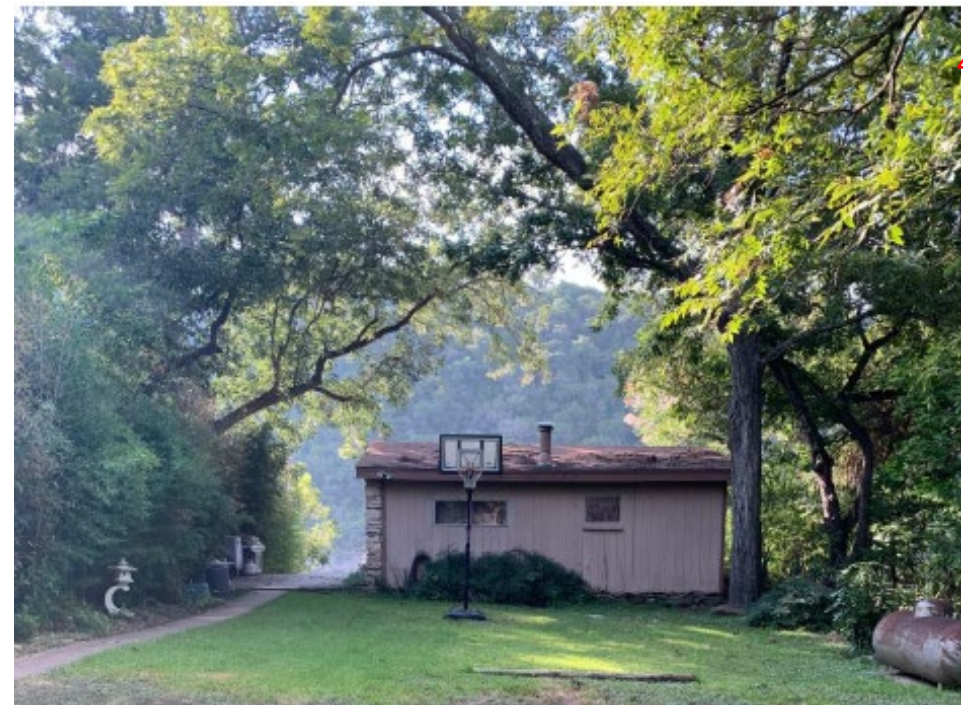
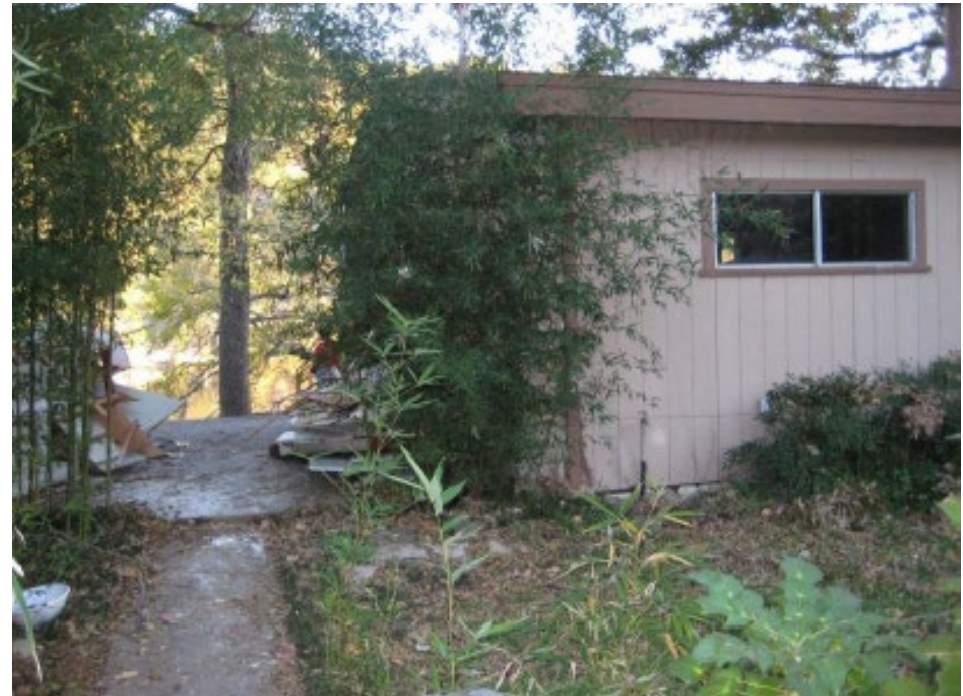
In this watershed classification, lots that are partially within the Critical Water Quality Zone must have at least **2 acres** NOT in the Critical Water Quality Zone.

Part of the lot is in the Lake Austin Critical Water Quality Zone. However, the entire lot is less than 2 acres.

The Code does not offer a method of compliance for this situation. A Land Use Commission variance is necessary.

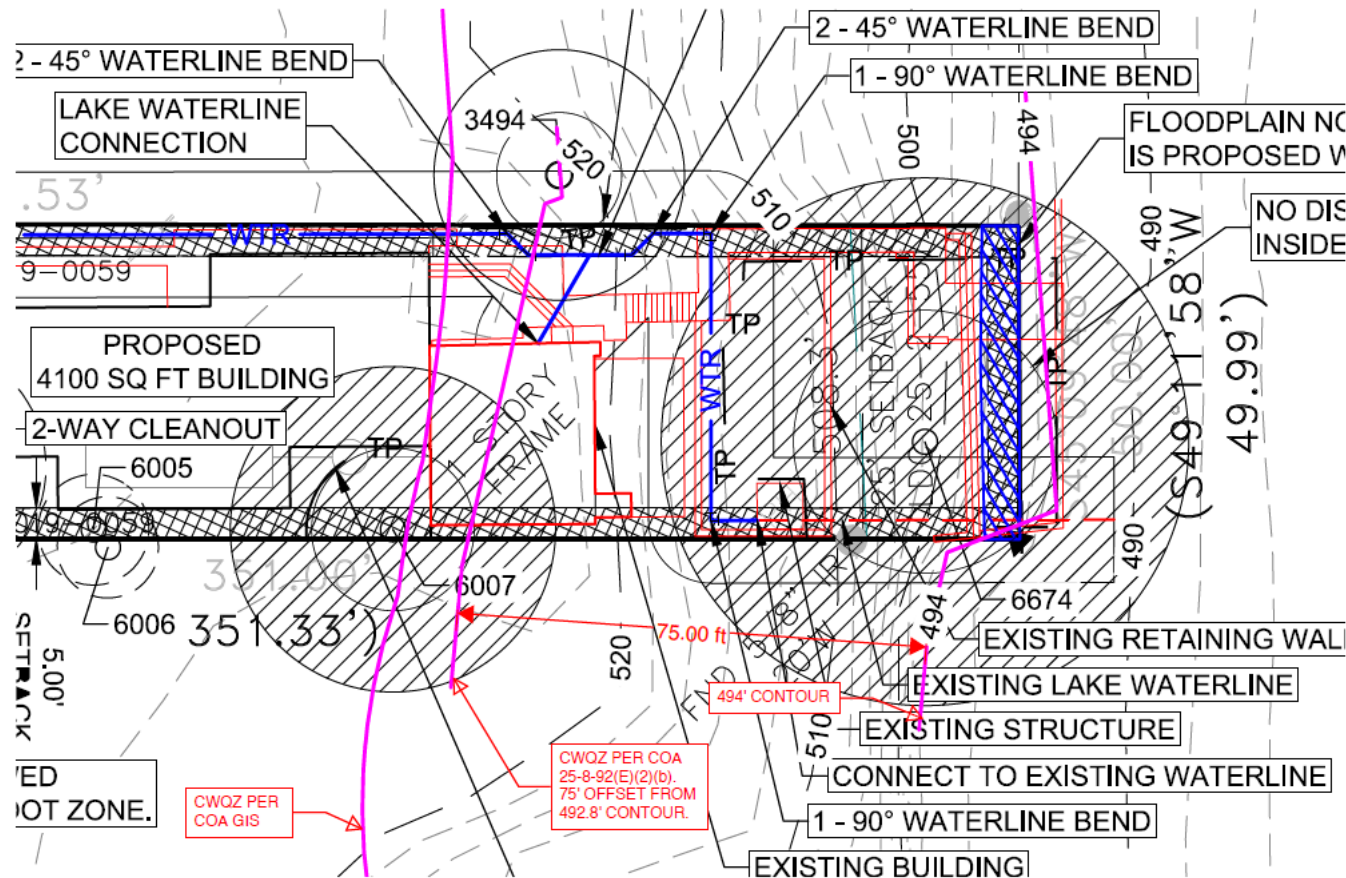
BUILDABILITY EXHIBIT

The proposed addition will be located to the northwest of the existing structure to minimize disturbance to the Critical Water Quality Zone.
