SITE PLAN REVIEW SHEET ENVIRONMENTAL VARIANCE REQUEST ONLY

CASE: SP-2021-0242C ZONING AND PLATTING COMMISSION DATE: November 15, 2022

PROJECT NAME: Loyola Junction Apartments

RE: Fill Variance Request Letter

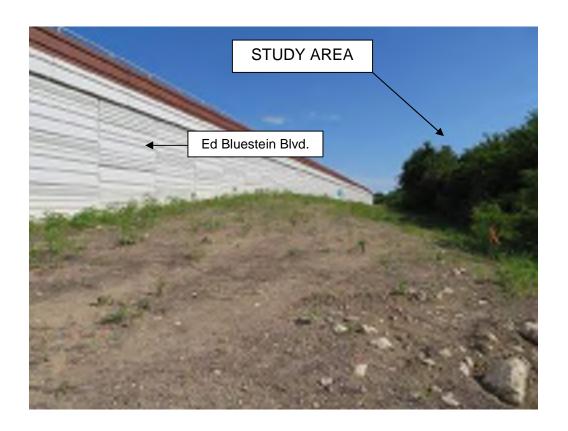
PHOTOGRAPHIC REPORTING DATA SHEET [PHOTOGRAPH 2]

Description: Typical view of the western-most portion of the study area along Ed Bluestein

Blvd. Photograph taken from near the southwest property corner facing north.

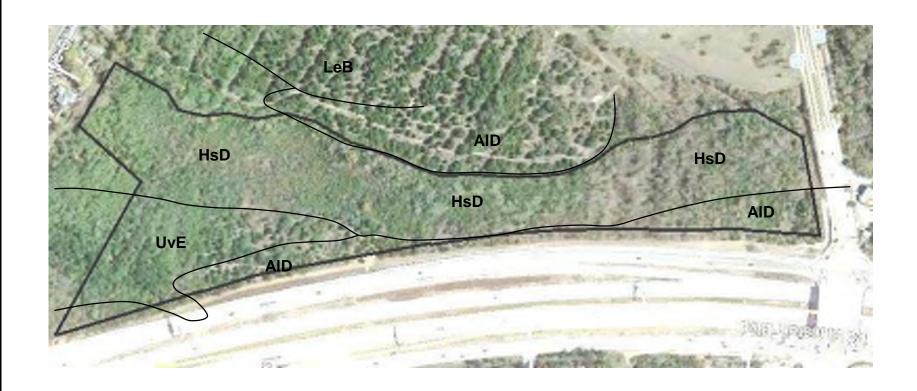
FIGURE 5 SITE SOILS MAP

AID – Altoga soils and Urban land, 2-8% slopes / HsD – Houston Black soils and Urban land, 0-8% slopes / LeB – Lewisville soils and Urban land, 1-10% slopes UvE – Urban land and Ferris soils, 10-15% slopes

Soil Series Unit Names, Infiltration			
Characteristics & Thickness Soil Series Unit Name & Group* Thicknes			
Subgroup**	Group*	(feet)	
Altoga soils and Urban		(1001)	
•	С	>5.0	
land, 2-8% slopes (AID)			
Houston Black soils and	_		
Urban land, 0-8% slopes	D	>5.0	
(HsD)			
Urban land and Ferris soils,	D	>5.0	
10-15% slopes (UvE)	D	/3.0

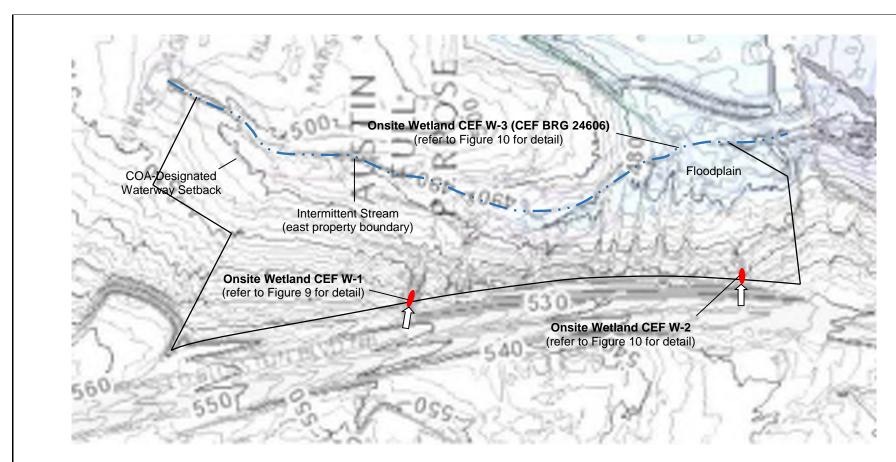
FIGURE 8 SITE CEFS MAP

Large-diameter storm sewer discharge pipes from Hwy 183 retaining wall

Patches of hydrophytic vegetation directly downstream from Hwy 183 easement discharges
 Note: Storm water discharge and hydrophytic vegetation symbols are not to scale

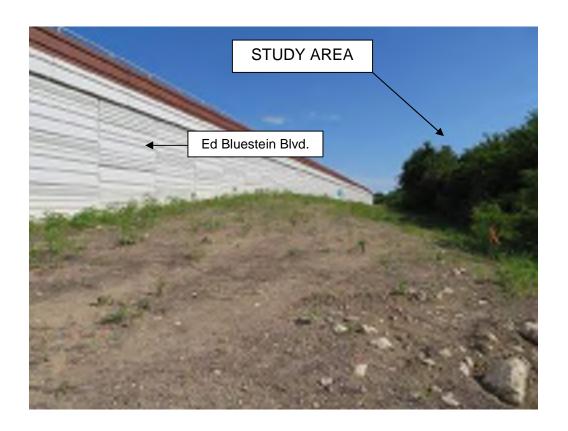
PHOTOGRAPHIC REPORTING DATA SHEET [PHOTOGRAPH 2]

Blvd. Photograph taken from near the southwest property corner facing north.

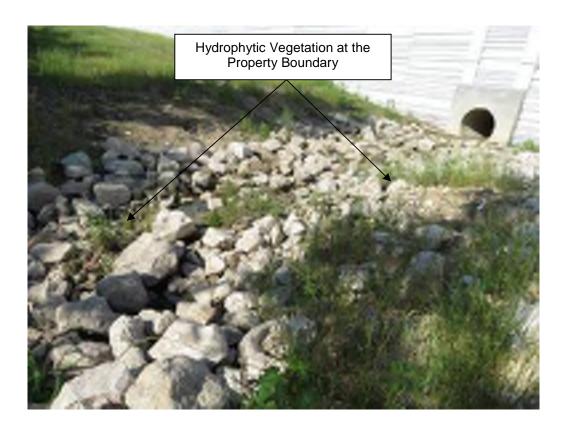
PHOTOGRAPHIC REPORTING DATA SHEET [PHOTOGRAPH 7]

and the associated area of hydrophytic vegetation (Wetland CEF W-2).
