**8020 PARMER/SH130 NW**  
 AUSTIN, TEXAS

GRADING PLAN EXHIBIT

## ±14.34-ACRE PARMER MF Environmental Resource Inventory

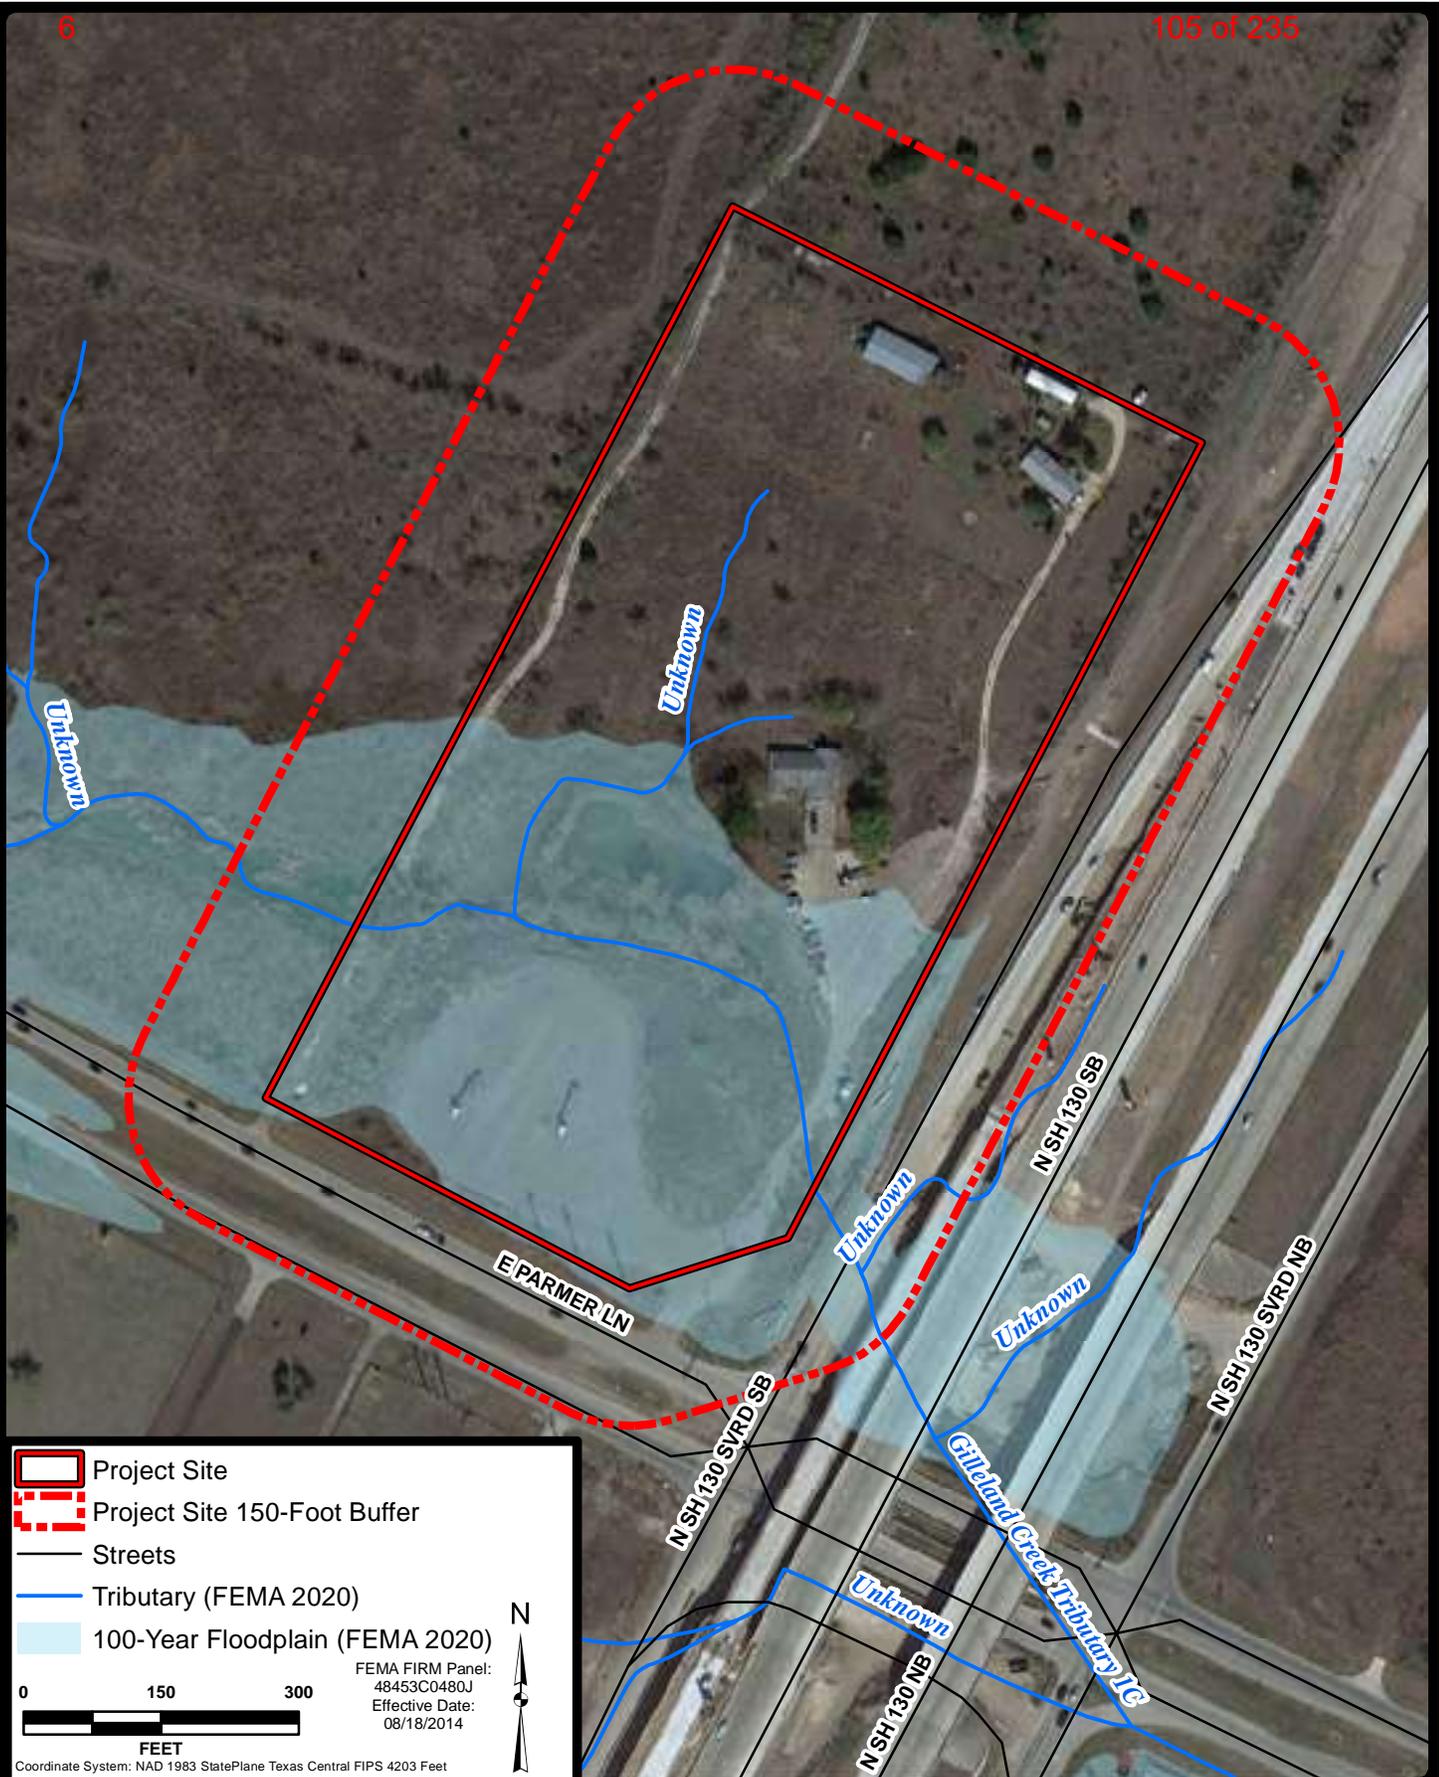
# **Floodplain Map**

Project Site  
 Project Site 150-Foot Buffer  
 Streets  
— Tributary (FEMA 2020)  
 100-Year Floodplain (FEMA 2020)

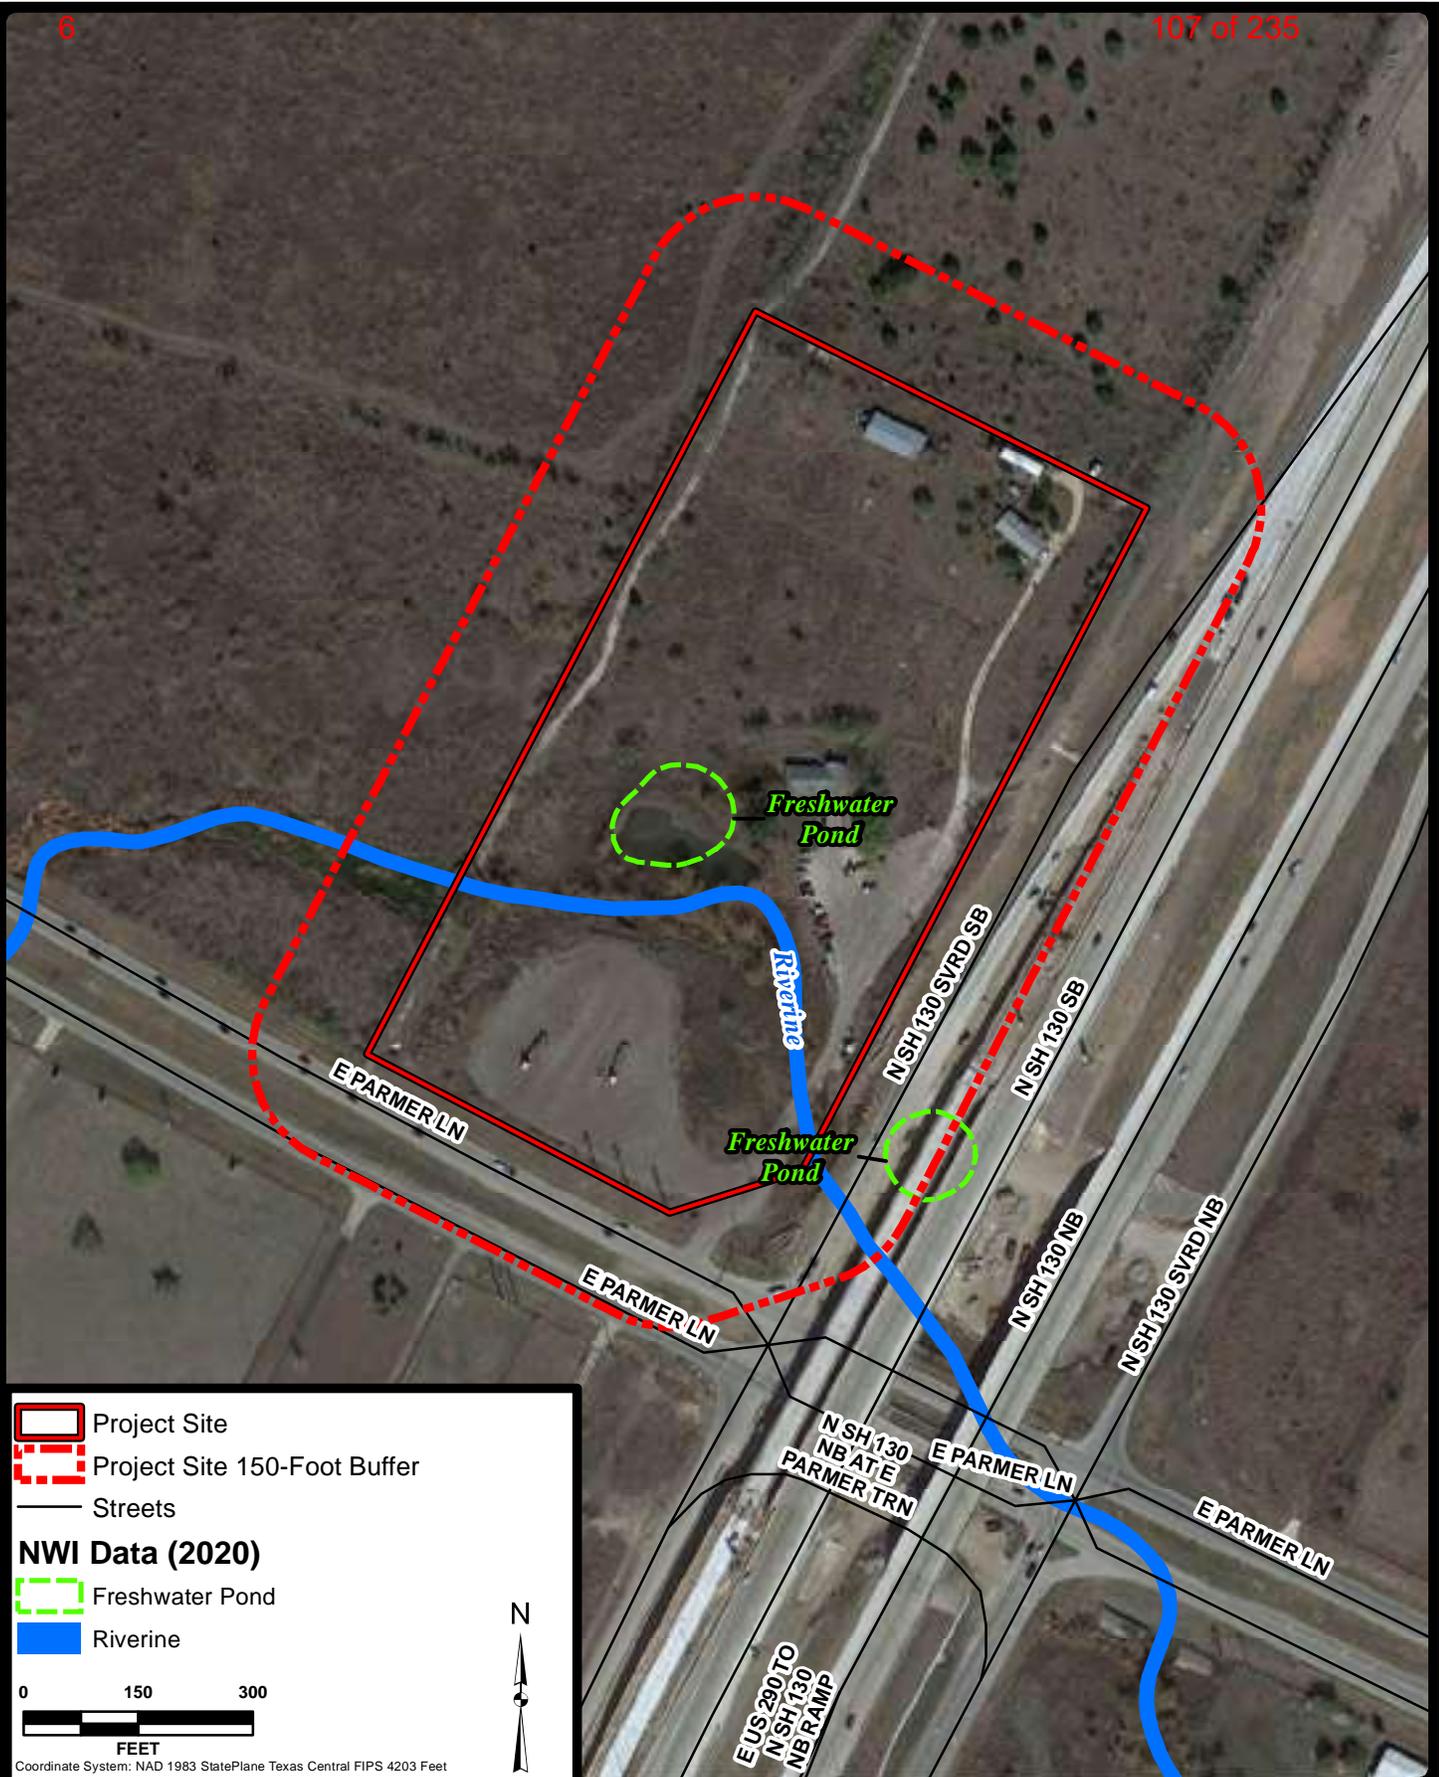
# **Map**

Project Site  
 Project Site 150-Foot Buffer  
 Streets  
**NWI Data (2020)**  
 Freshwater Pond  
 Riverine

A freshwater pond (W-03) was identified within the project site. The freshwater pond is located approximately 75 feet north of S-01, near the center of the project site. This pond is separated by a natural berm. No direct channelized surface water connection was observed between the pond and S-01.

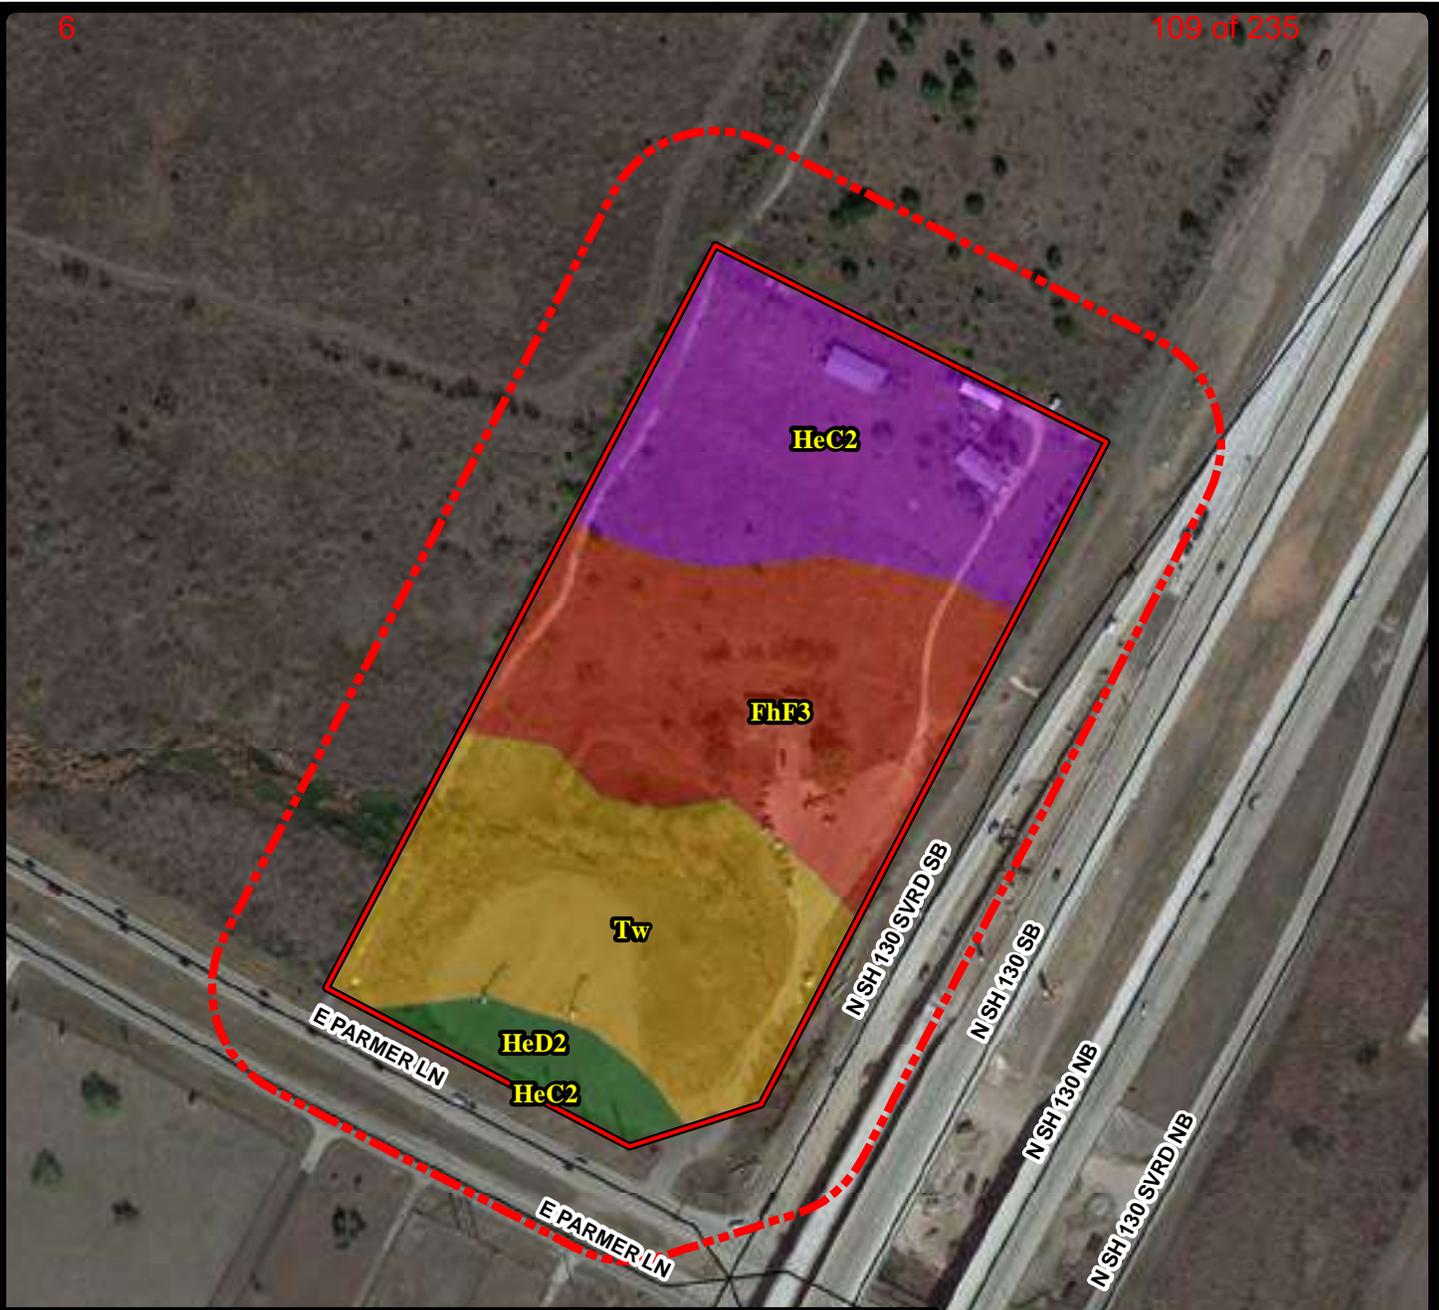
## **Soils Map**

- Project Site
- Project Site 150-Foot Buffer
- Streets

**NRCS Soil Units (2021)**

Soil Series Unit Names, Infiltration Characteristics & Thickness		
Soil Series Unit Name & Subgroup**	Group*	Thickness (feet)
See Table 1 & Exhibit 7

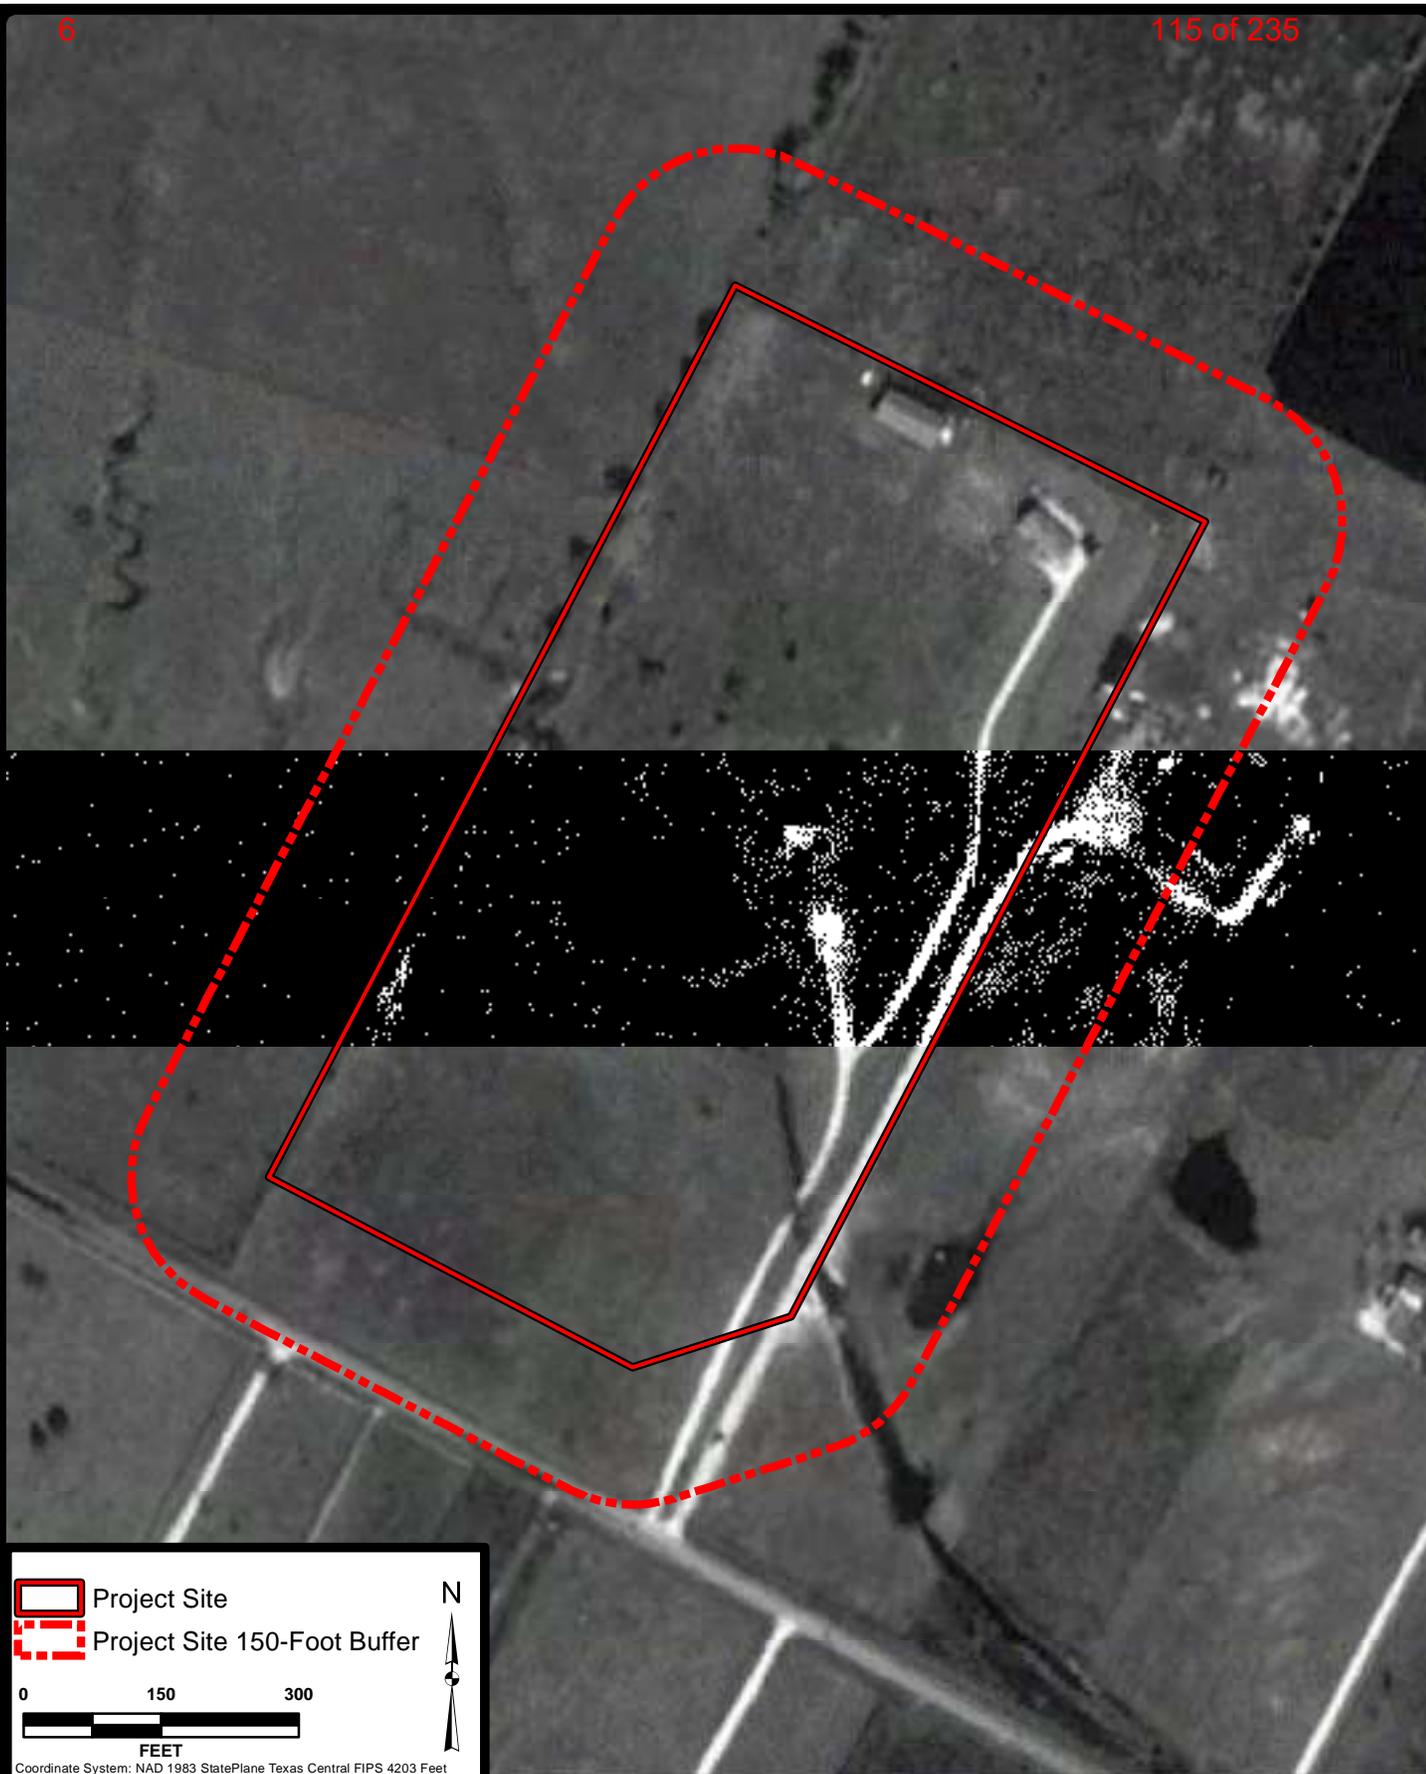
# **Photograph Map**

Project Site  
 Project Site 150-Foot Buffer

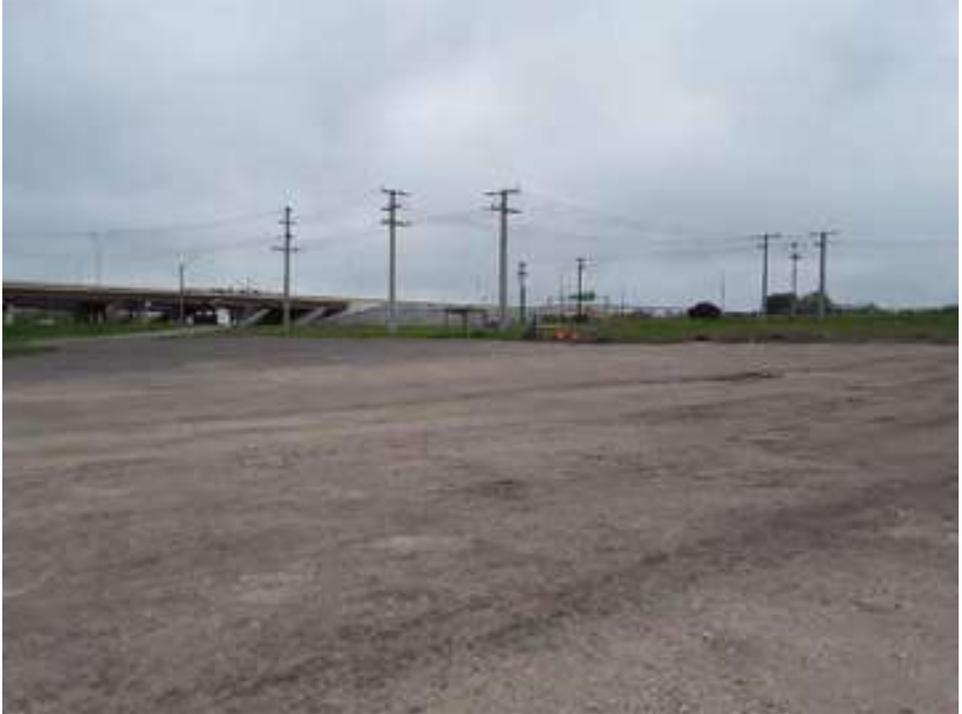
<b>Photo No.</b> 1	<b>Date:</b> 03-30-2021

<b>Description:</b> View of the paved portion of the project site facing southeast, on the southeastern corner of the project site.

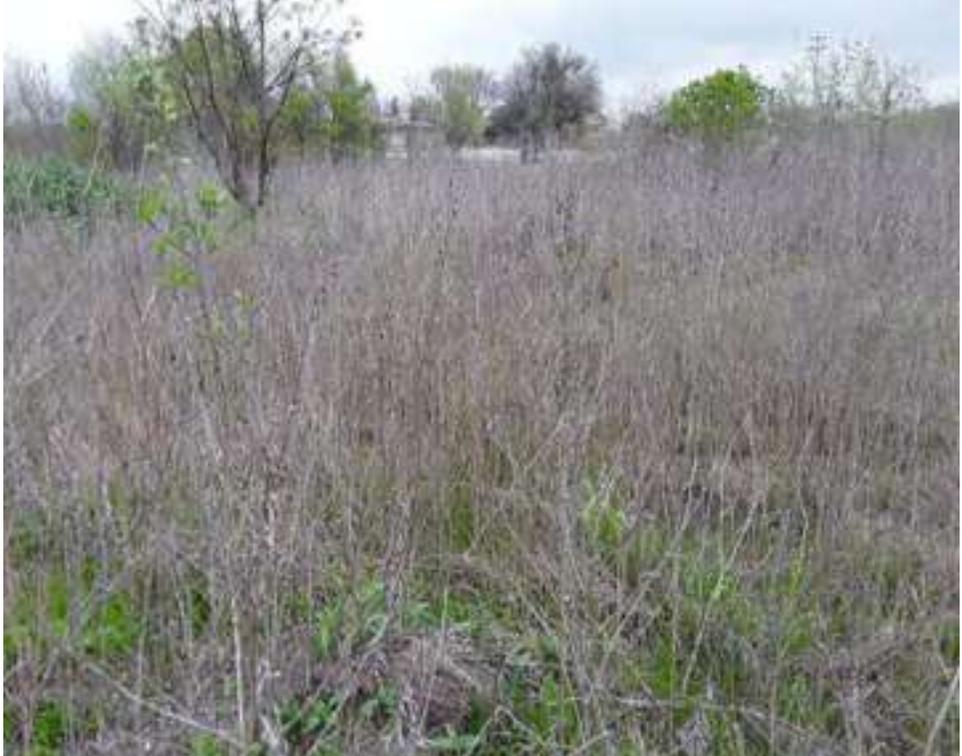
<b>Photo No.</b> 2	<b>Date:</b> 03-30-2021

<b>Description:</b> A typical view of upland habitat that bordered the paved parking lot, on the southeastern portion of the project site. The habitat was a largely mixture of disturbed herbaceous vegetation.

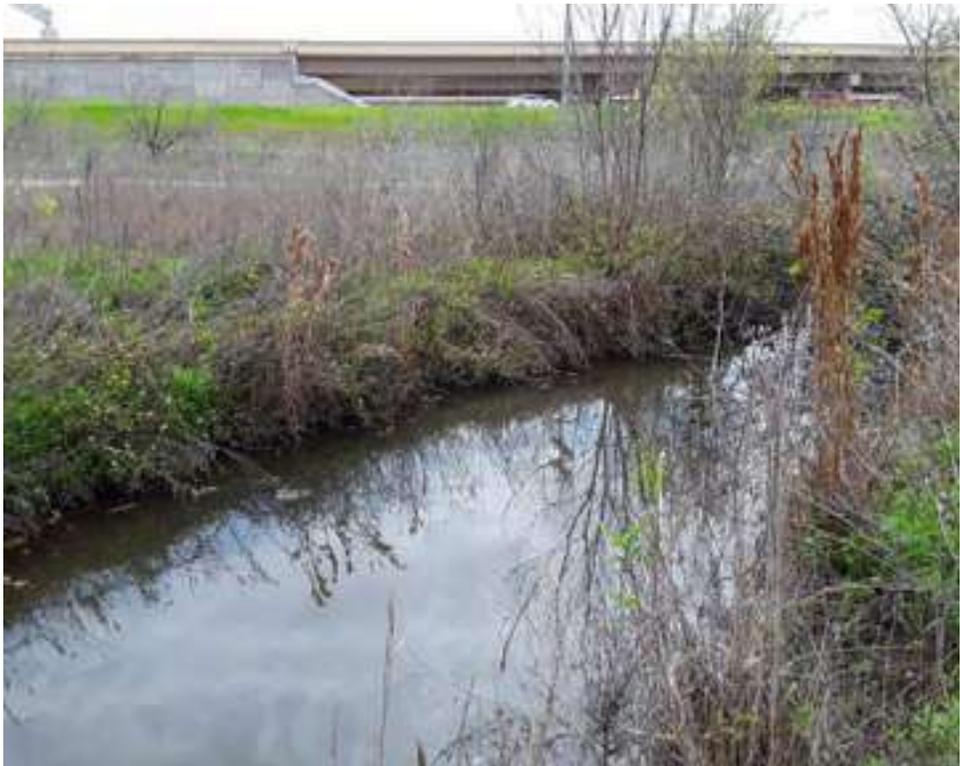
<b>Photo No.</b> 3	<b>Date:</b> 03-30-2021

<b>Description:</b> A typical view of the intermittent stream (S-01) identified on the project site, facing east, near the southeastern boundary of the project site.

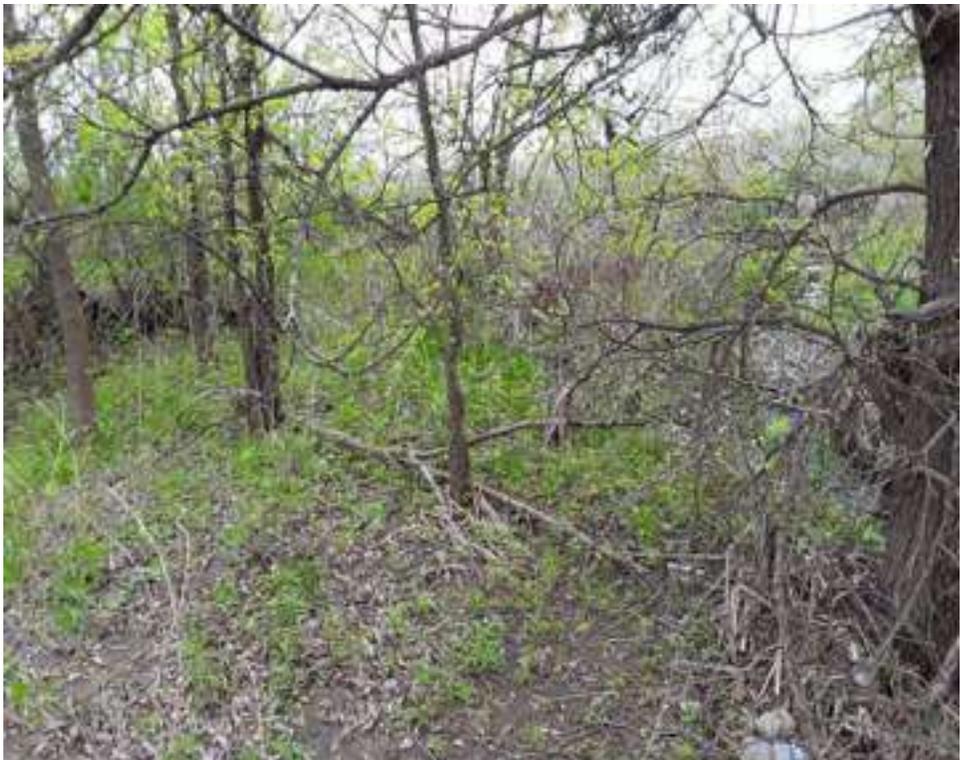
<b>Photo No.</b> 4	<b>Date:</b> 03-30-2021

<b>Description:</b> A view of one of the freshwater scrub-shrub wetlands (W-01) identified on the project site. This wetland was topographically elevated and within the OHWM of the intermittent stream (S-01) identified.

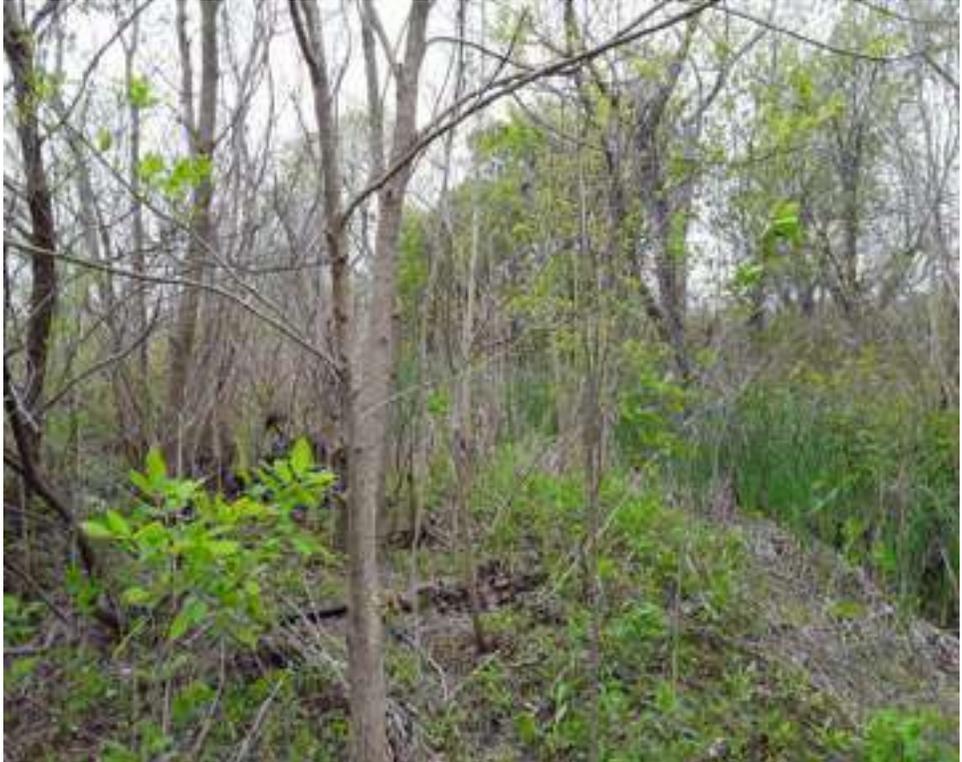
<b>Photo No.</b> 5	<b>Date:</b> 03-30-2021

<b>Description:</b> A view of the second freshwater scrub-shrub wetland (W-02) observed on the project site. This wetland abutted the intermittent stream (S-01) identified.

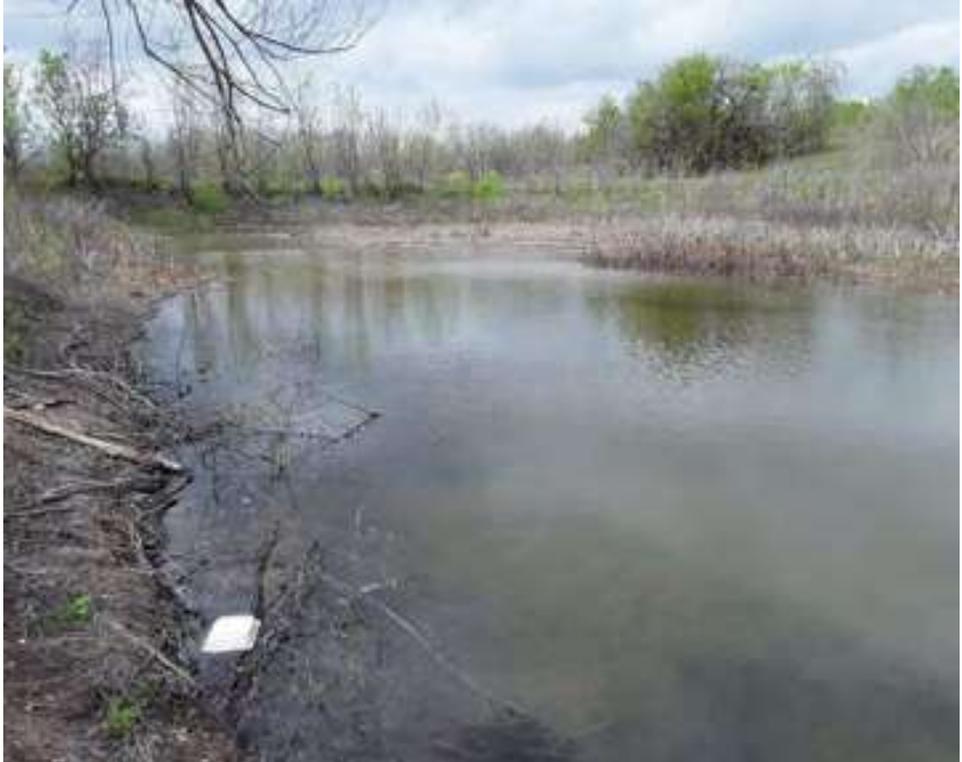
<b>Photo No.</b> 6	<b>Date:</b> 03-30-2021

<b>Description:</b> A view of the freshwater pond (W-03) observed on the project site. This pond is located north of the intermittent stream (S-01) identified. The pond was topographically depressed and separated from S-01 by a natural berm.

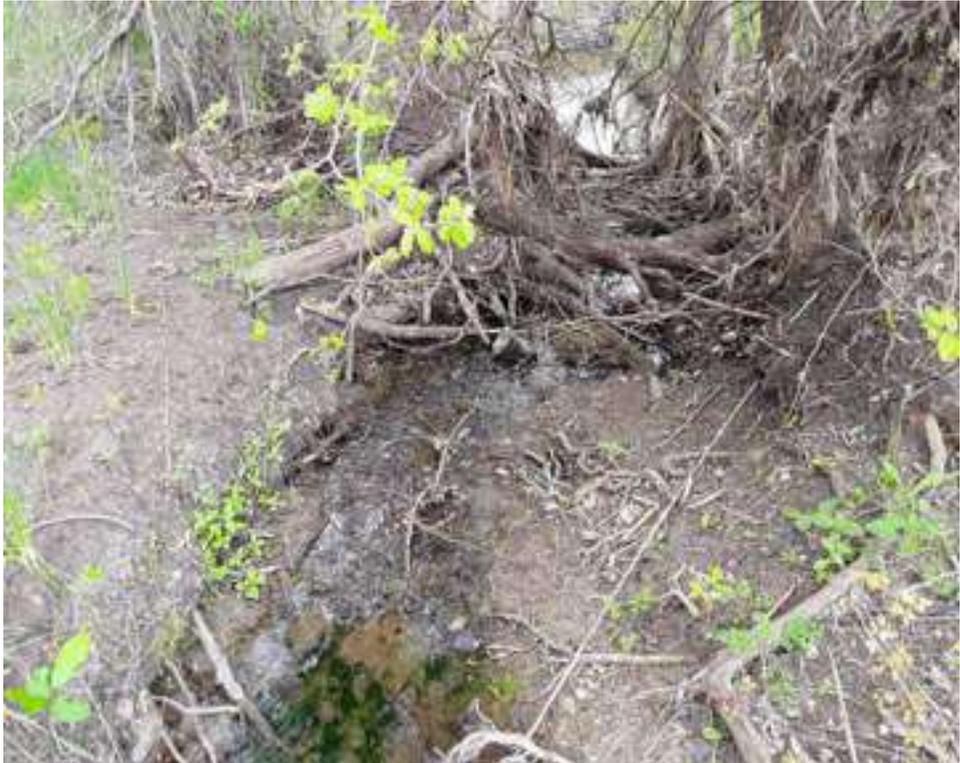
<b>Photo No.</b> 7	<b>Date:</b> 03-30-2021

<p><b>Description:</b> Another view of the intermittent stream (S-01) identified. This photo was taken on the western boundary of the project site. S-01 drained across an existing cobble road and diverged around the freshwater scrub-shrub wetland (W-01) identified above.</p>

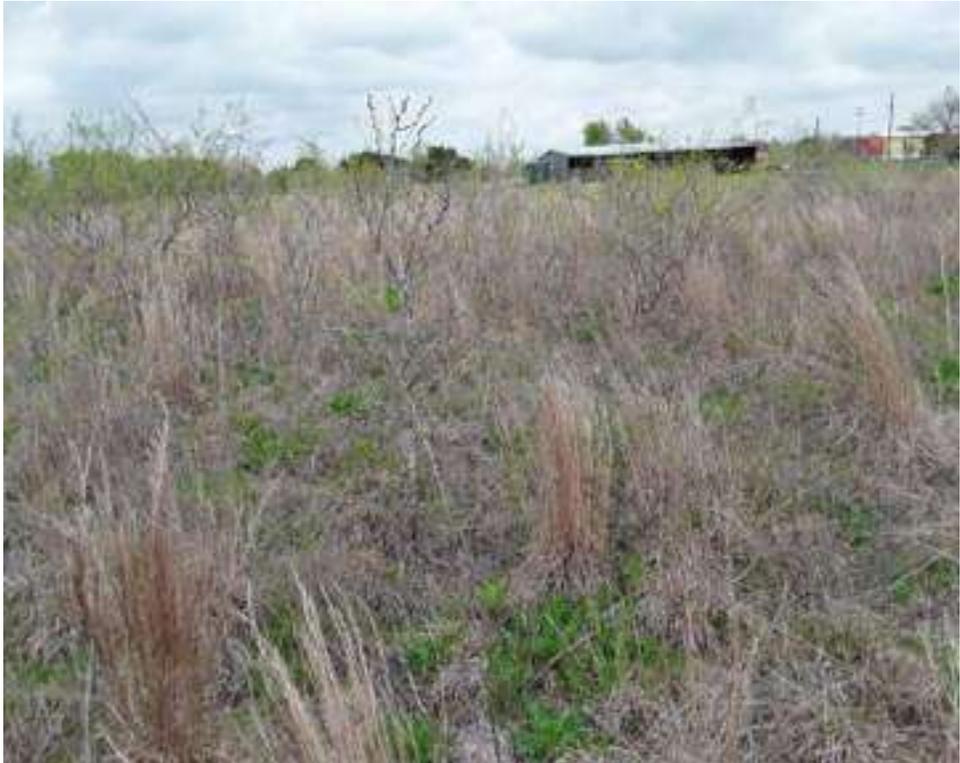
<b>Photo No.</b> 8	<b>Date:</b> 03-30-2021

<p><b>Description:</b> A typical view of upland habitat near the center of the project site, facing northeast.</p>

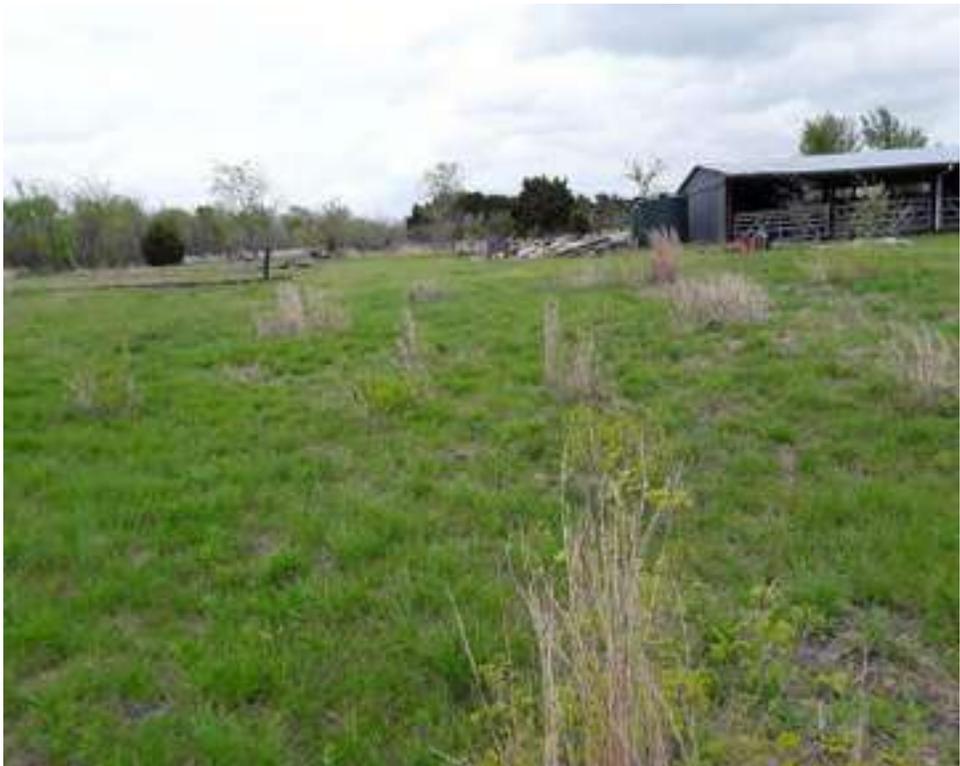
<b>Photo No.</b> 9	<b>Date:</b> 03-30-2021

<b>Description:</b> A view of the upland habitat observed on the northern portion of the project site.

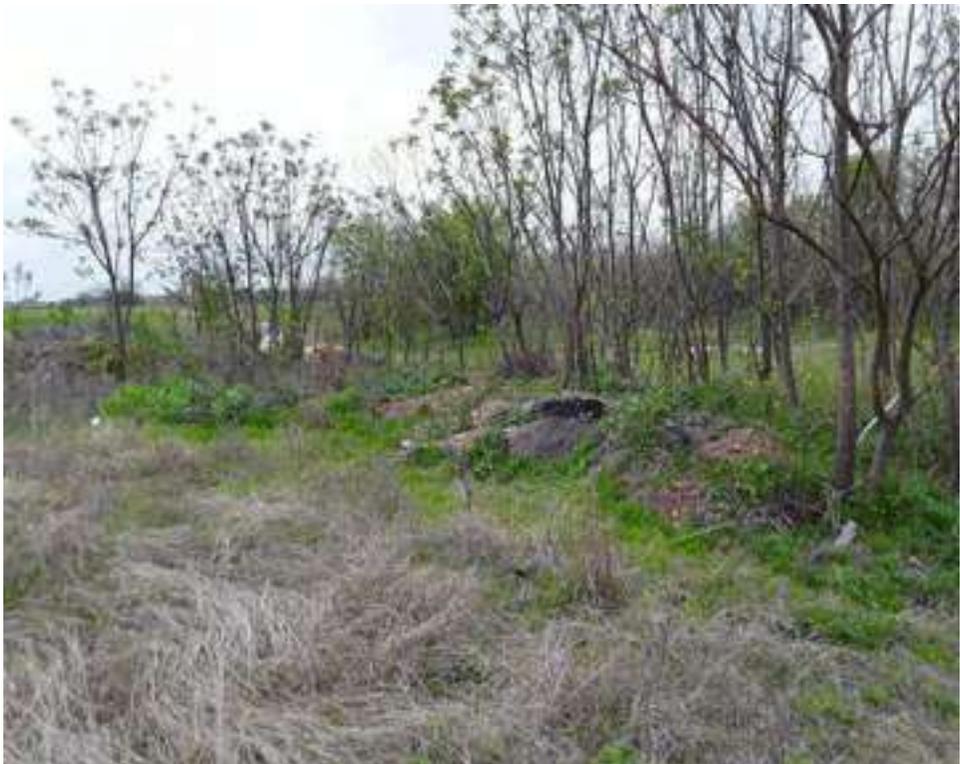
<b>Photo No.</b> 10	<b>Date:</b> 03-30-2021

<b>Description:</b> A view of piles of fill observed on the southwestern portion of the project site facing southwest.

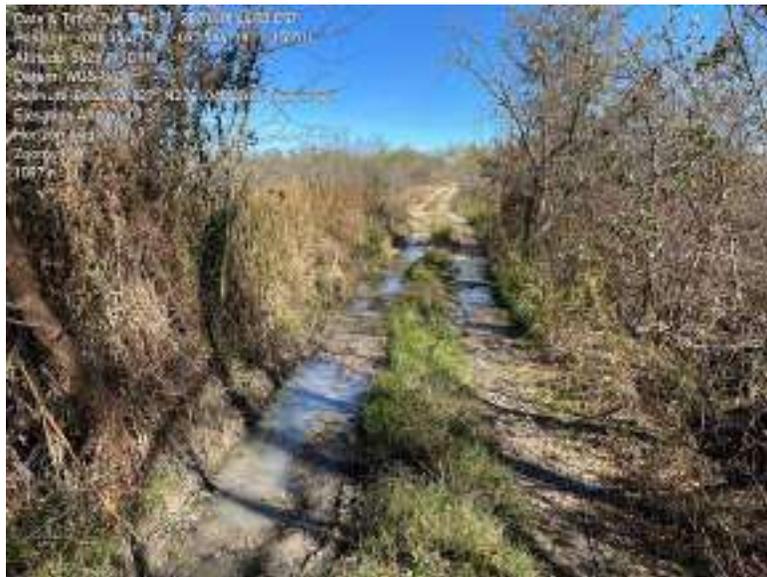
CEF-1 is an emergent wetland located in the southern portion of the subject area. CEF-1 was inundated at the time of the field visit. CEF-1 has wetland hydrology, hydric soils, and is dominated by hydrophytic vegetation such as spike rush and cattails. The boundary between CEF-1 and the adjacent non-wetland was identified based on changes in hydrology, dominant plant composition, and soils. The 1% Annual Chance FEMA Flood Hazard Zone extends on subject area at CEF-1. The total area of CEF-1 is approximately 1,012 square feet, or approximately 0.023 acre within the subject area (Photo 1).

8020 East Parmer ERI Tract  Date: 12/1/2020	<b>Feature</b>	CEF-1	Photo 1
	<b>Description</b>	CEF-1 in the southern portion of the subject area	<b>Direction:</b>  North
	<b>Photographer</b>	aci consulting
