8020 EAST PARMER ERI

Project: 8020 East Parmer ERI Tract Functional Assessment of Floodplain Health

Subject: **Supporting Documentation for the City of Austin Functional Assessment of Floodplain Health of the Zone 1 Floodplain Health and Zone 2 Critical Water Quality Zone**

EXHIBIT 11 – PRELIMINARY BRIDGE PLANS

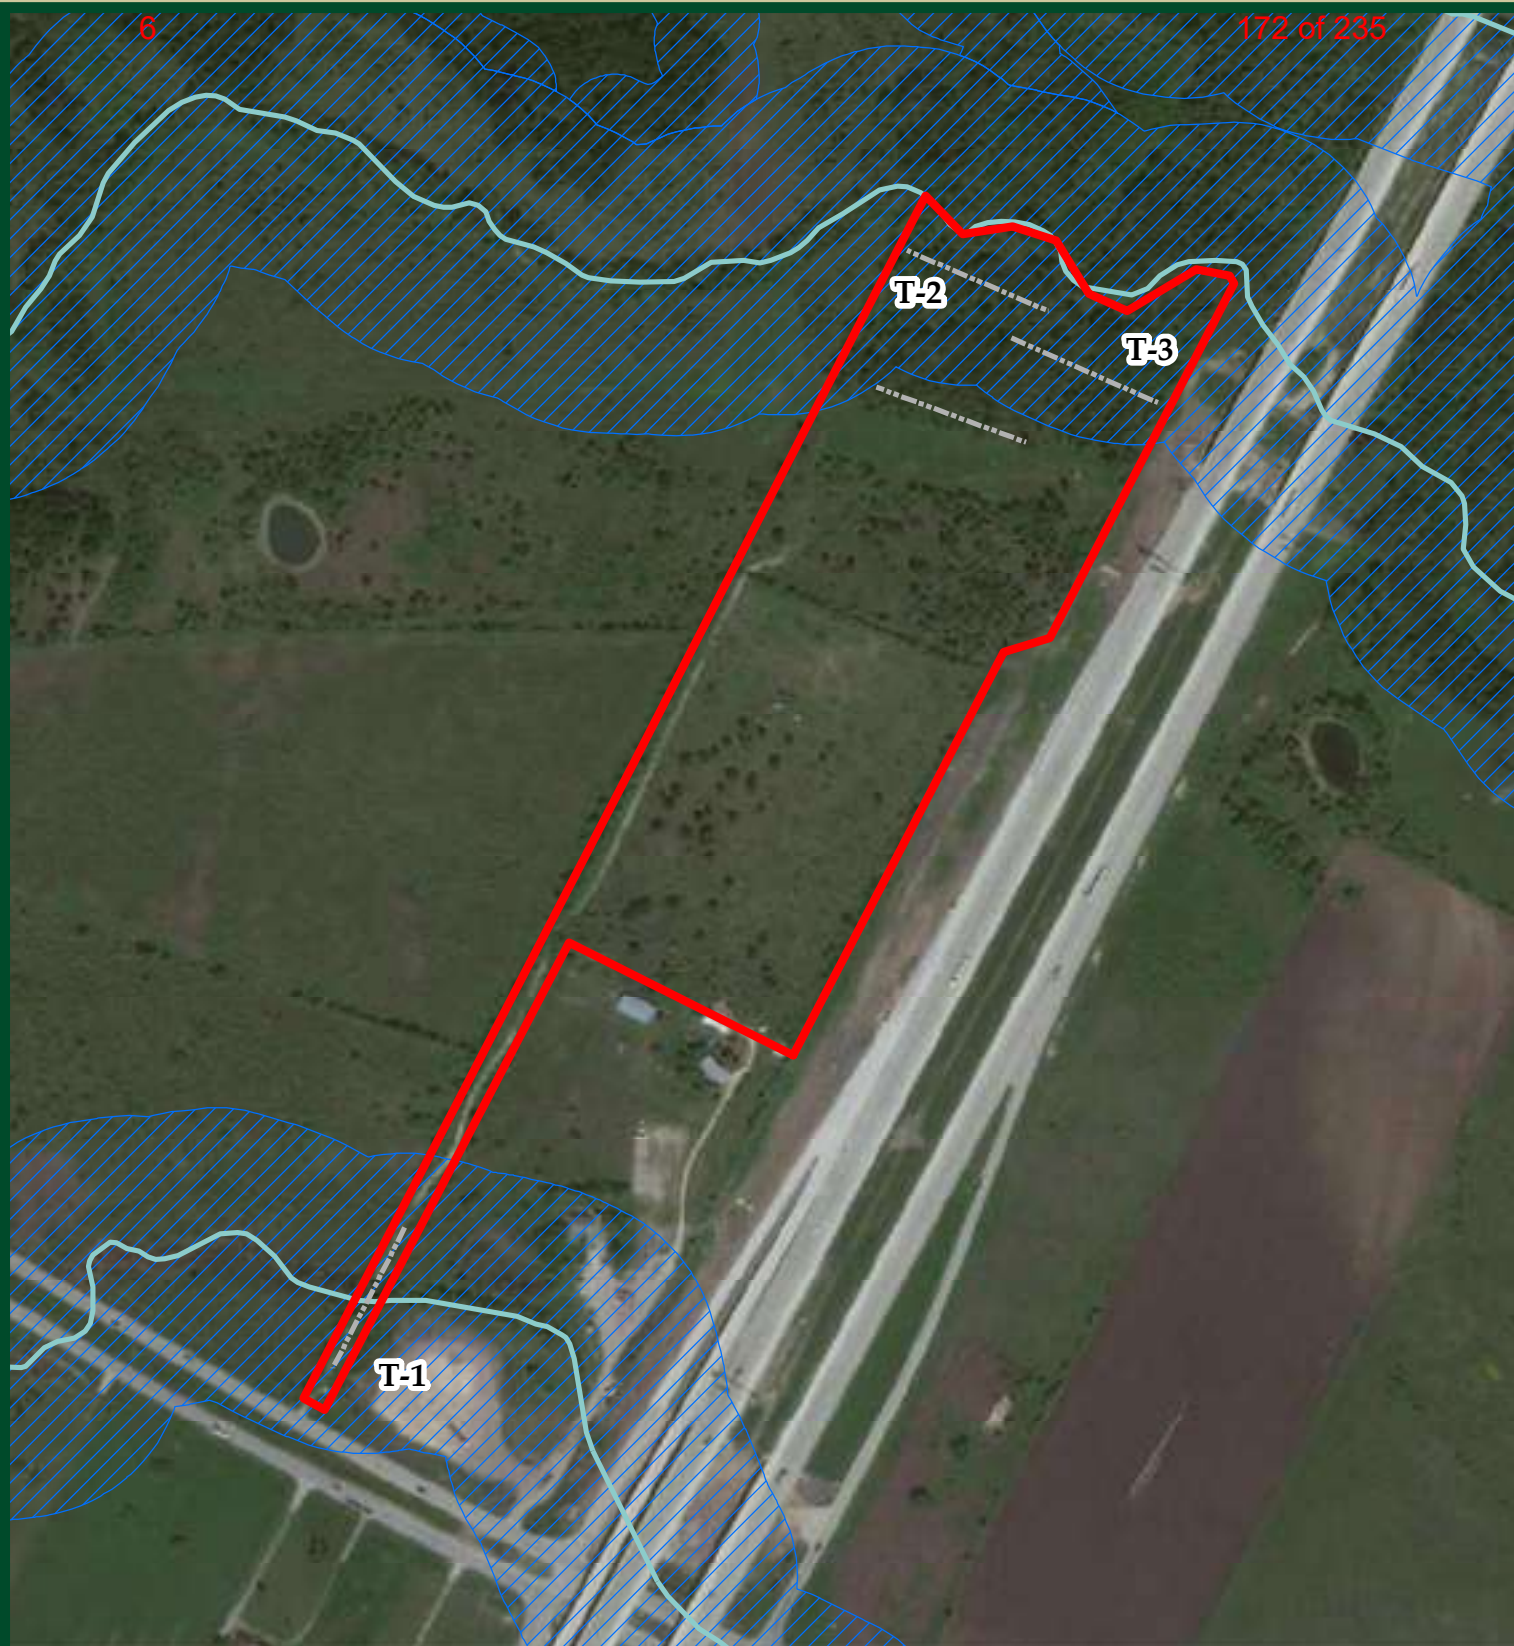
ATTACHMENT A

Transects T-1, T-2, and T-3 were positioned within the CWQZ; therefore, the methods and scoring for *Zone 2: Critical Water Quality Zone* were used during the field investigations. Attachment A shows the placement of the transects within the subject area.

ZONE 2 TRANSECT LOCATIONS

There were three transects within the Critical Water Quality Zone (CWQZ) (Zone 2), that were evaluated for the FAFH: T-1, T-2, and T-3 (Attachment A). There was one transect within the FEMA Floodplain Health Zone (Zone 1) that was evaluated for the FAFH: T-4 (Attachment B).

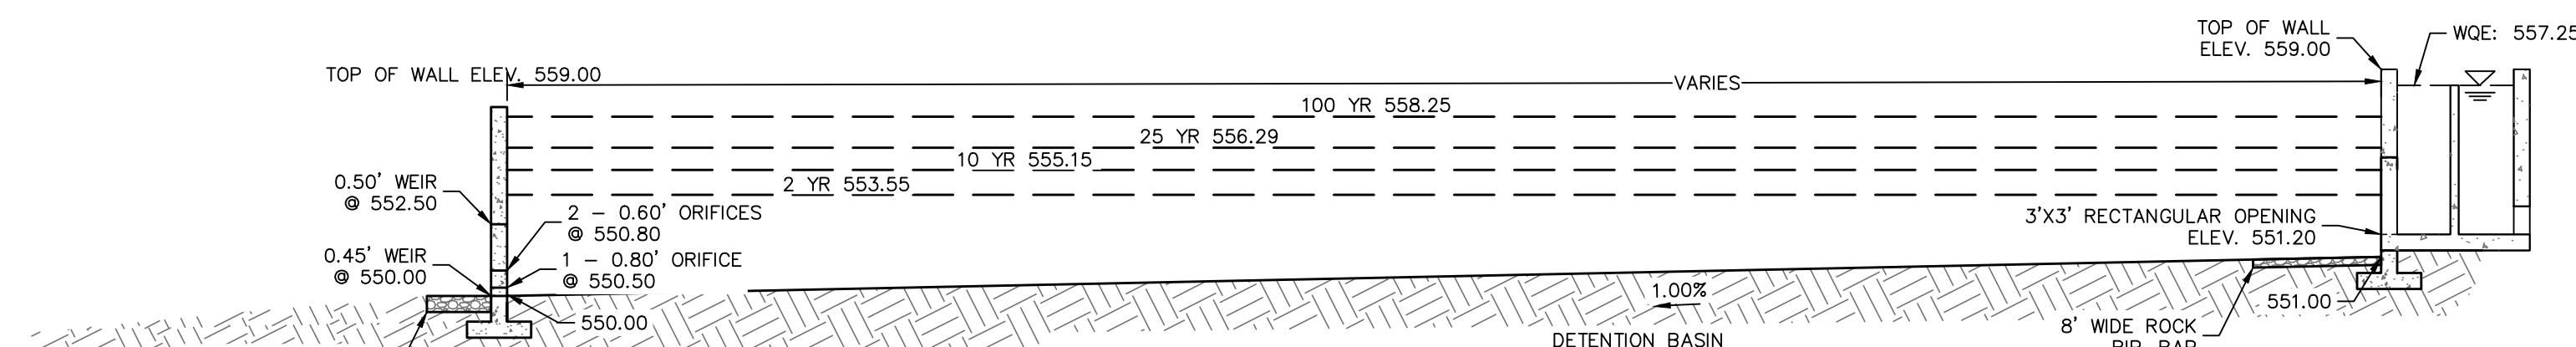
SECTION A-A
1" = 10'

DETENTION POND 1 WSEL		
2 YEAR	553.55	
10 YEAR	555.15	
25 YEAR	556.29	
100 YEAR	558.25

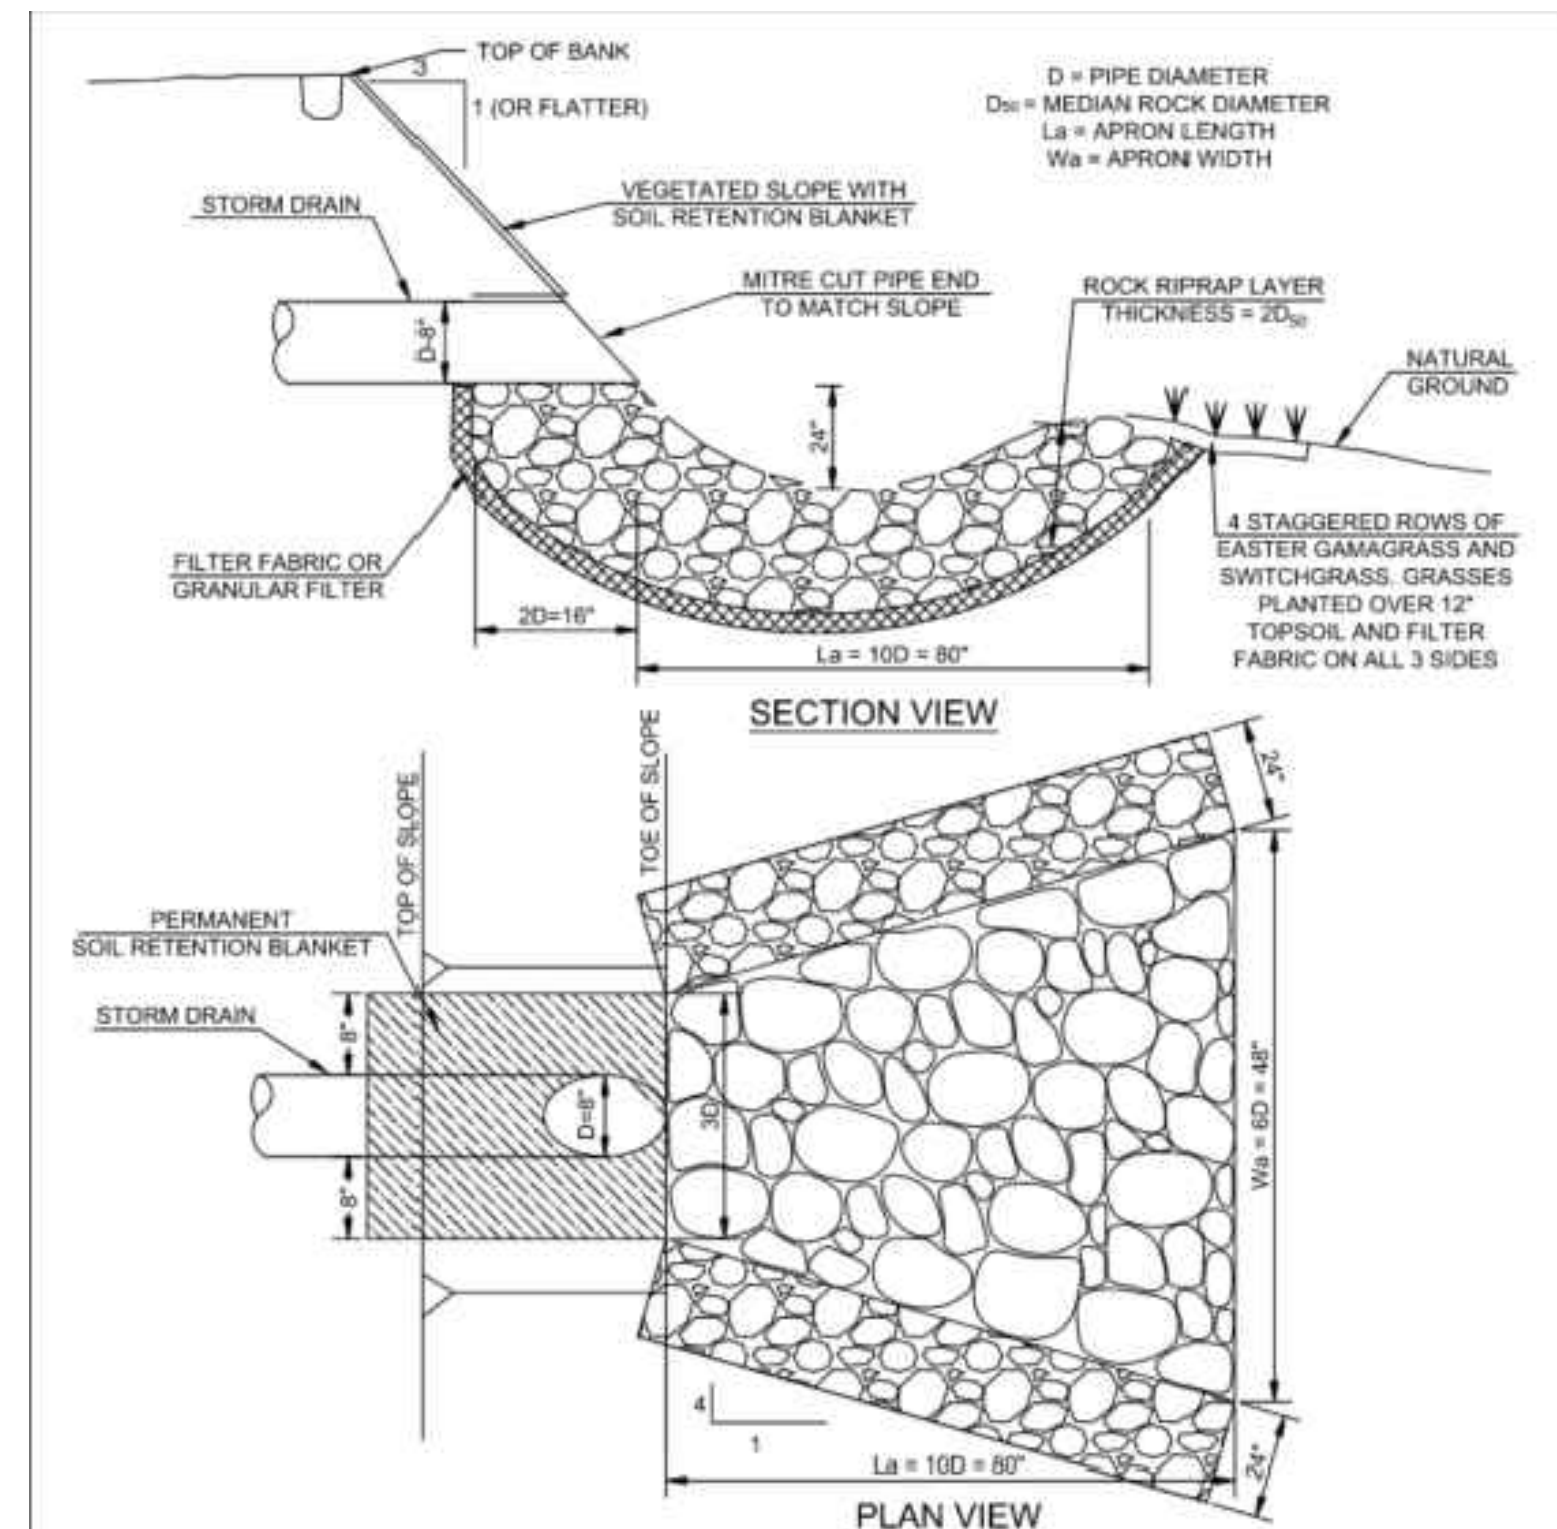
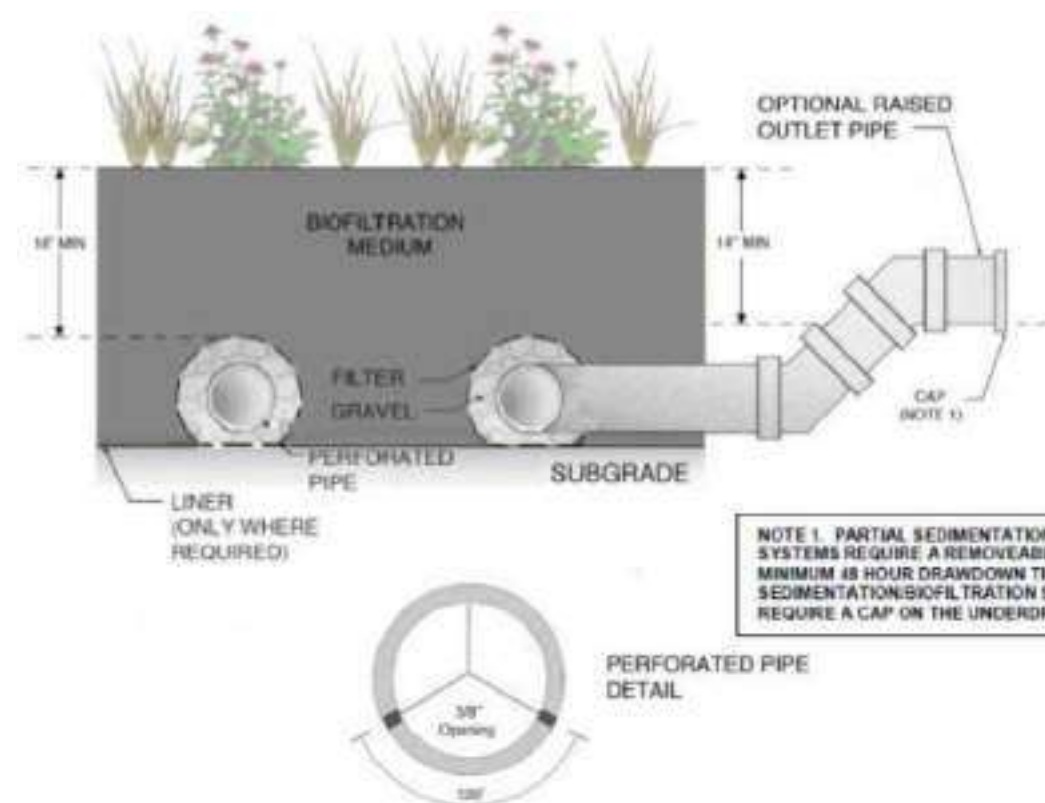
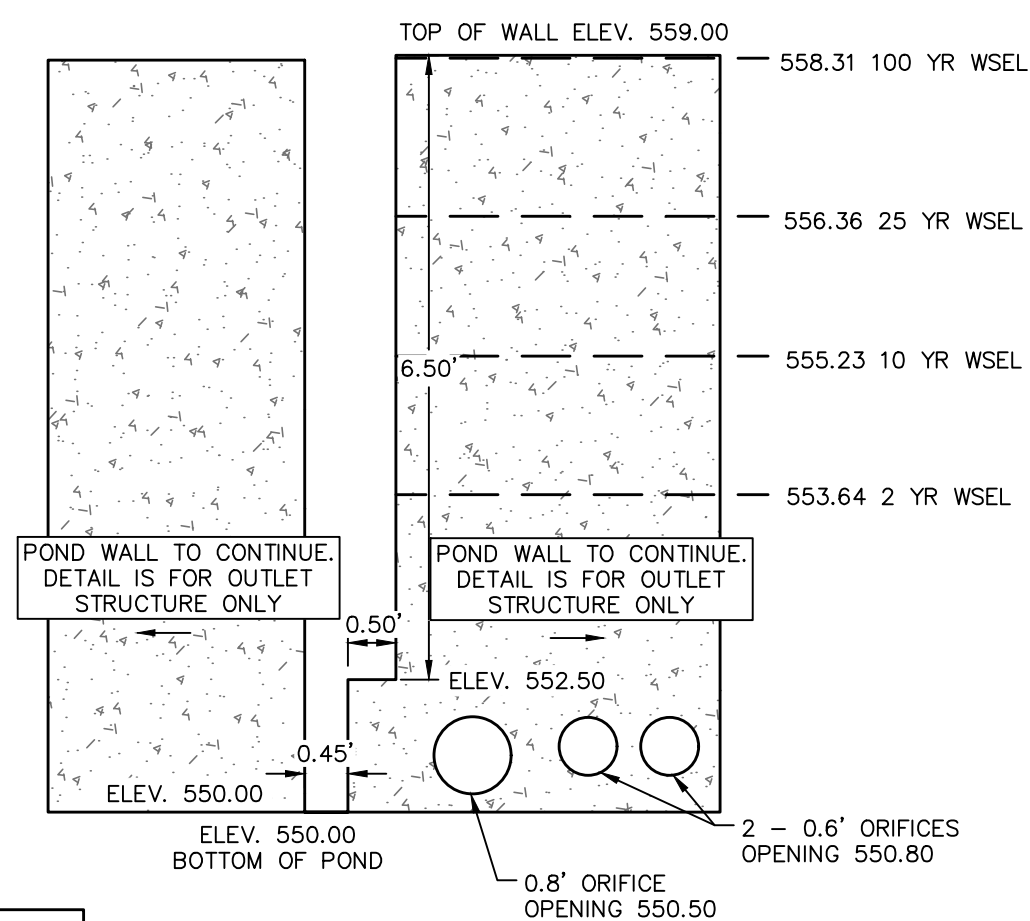
DETENTION POND 1 OUTFALL

- NOTE:
- ROCK RIPRAP SHALL BE SOUND MATERIAL AND GRADED PER REQUIREMENTS SPECIFIED IN STANDARD SPECIFICATION ITEM NO. 591S.
 - ROCK SIZE (D_{50}) AND GRADATION SHALL BE STABLE FOR THE DESIGN HYDRAULIC CONDITIONS AND IN ACCORDANCE WITH THE EGM 1.4.6.D PERMANENT STRUCTURAL PRACTICES, STONE RIPRAP OR OTHER ENGINEERING STANDARD OF PRACTICE FOR SIZING ROCK RIPRAP. ROCK RIPRAP D_{50} AND FILTER TYPE SHALL BE NOTED ON PLANS.
 - GEOTEXTILE FILTER FABRIC SHALL MEET THE REQUIREMENTS SPECIFIED IN STANDARD SPECIFICATION ITEM NO. 620S.
 - AGGREGATE FOR GRANULAR FILTER SHALL MEET THE REQUIREMENTS SPECIFIED IN STANDARD SPECIFICATION ITEM NO. 403. AGGREGATE SIZE CLASSIFICATION/GRADE, NUMBER OF LAYERS AND LAYER THICKNESS SHOULD BE NOTED ON THE PLANS.

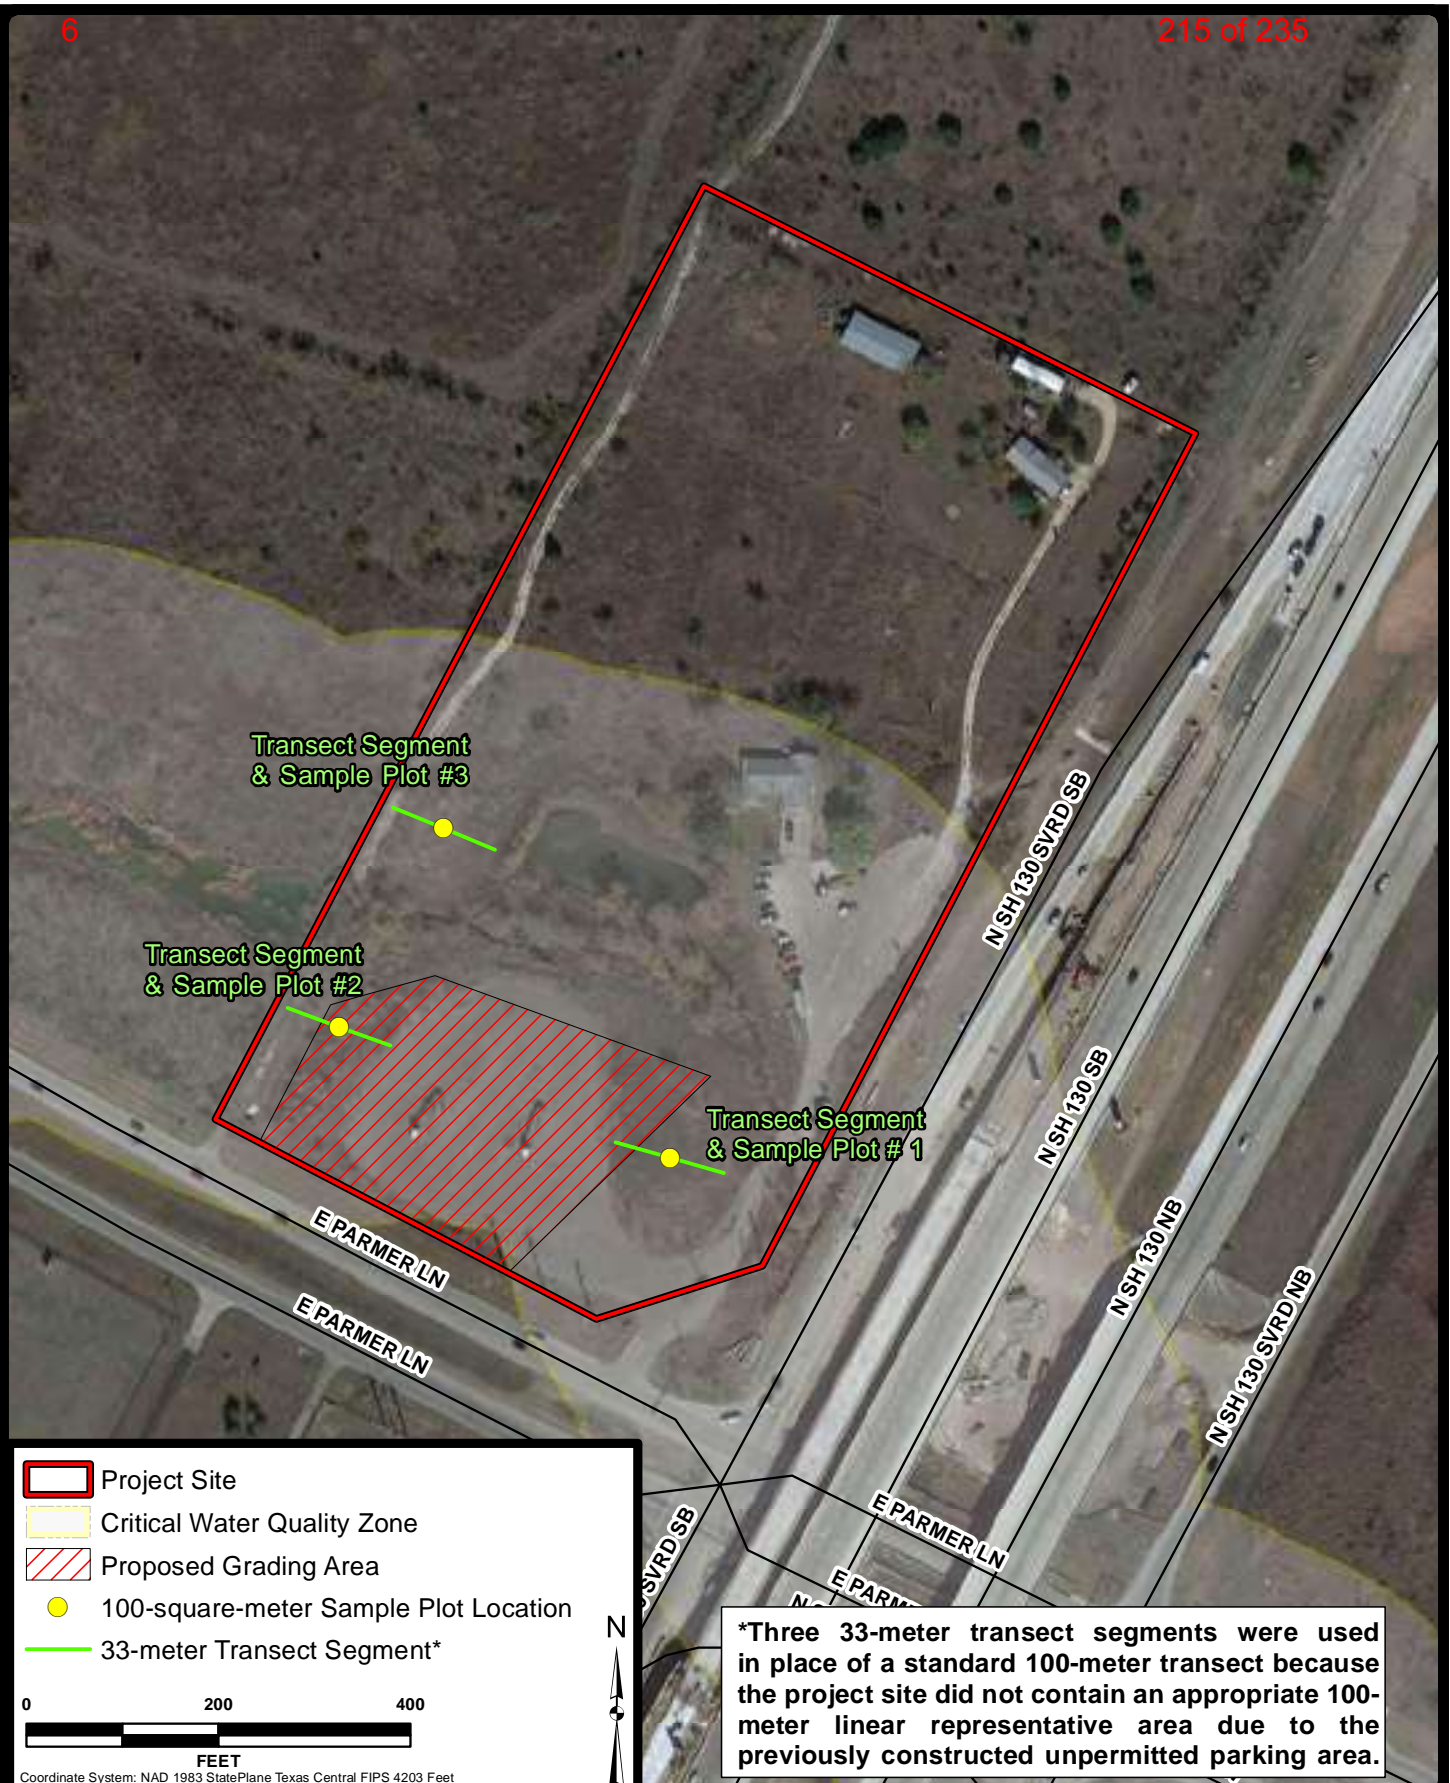
EXHIBIT 2

Site Map

*Three 33-meter transect segments were used in place of a standard 100-meter transect because the project site did not contain an appropriate 100-meter linear representative area due to the previously constructed unpermitted parking area.

The transect segments were selected utilizing a combination of the resources discussed above and field investigation to determine that the area being assessed is analogous to the preexisting floodplain condition of the area of proposed floodplain modification. The transect segments and sample plots utilized for the functional assessment are shown in **(Exhibit 2)**.

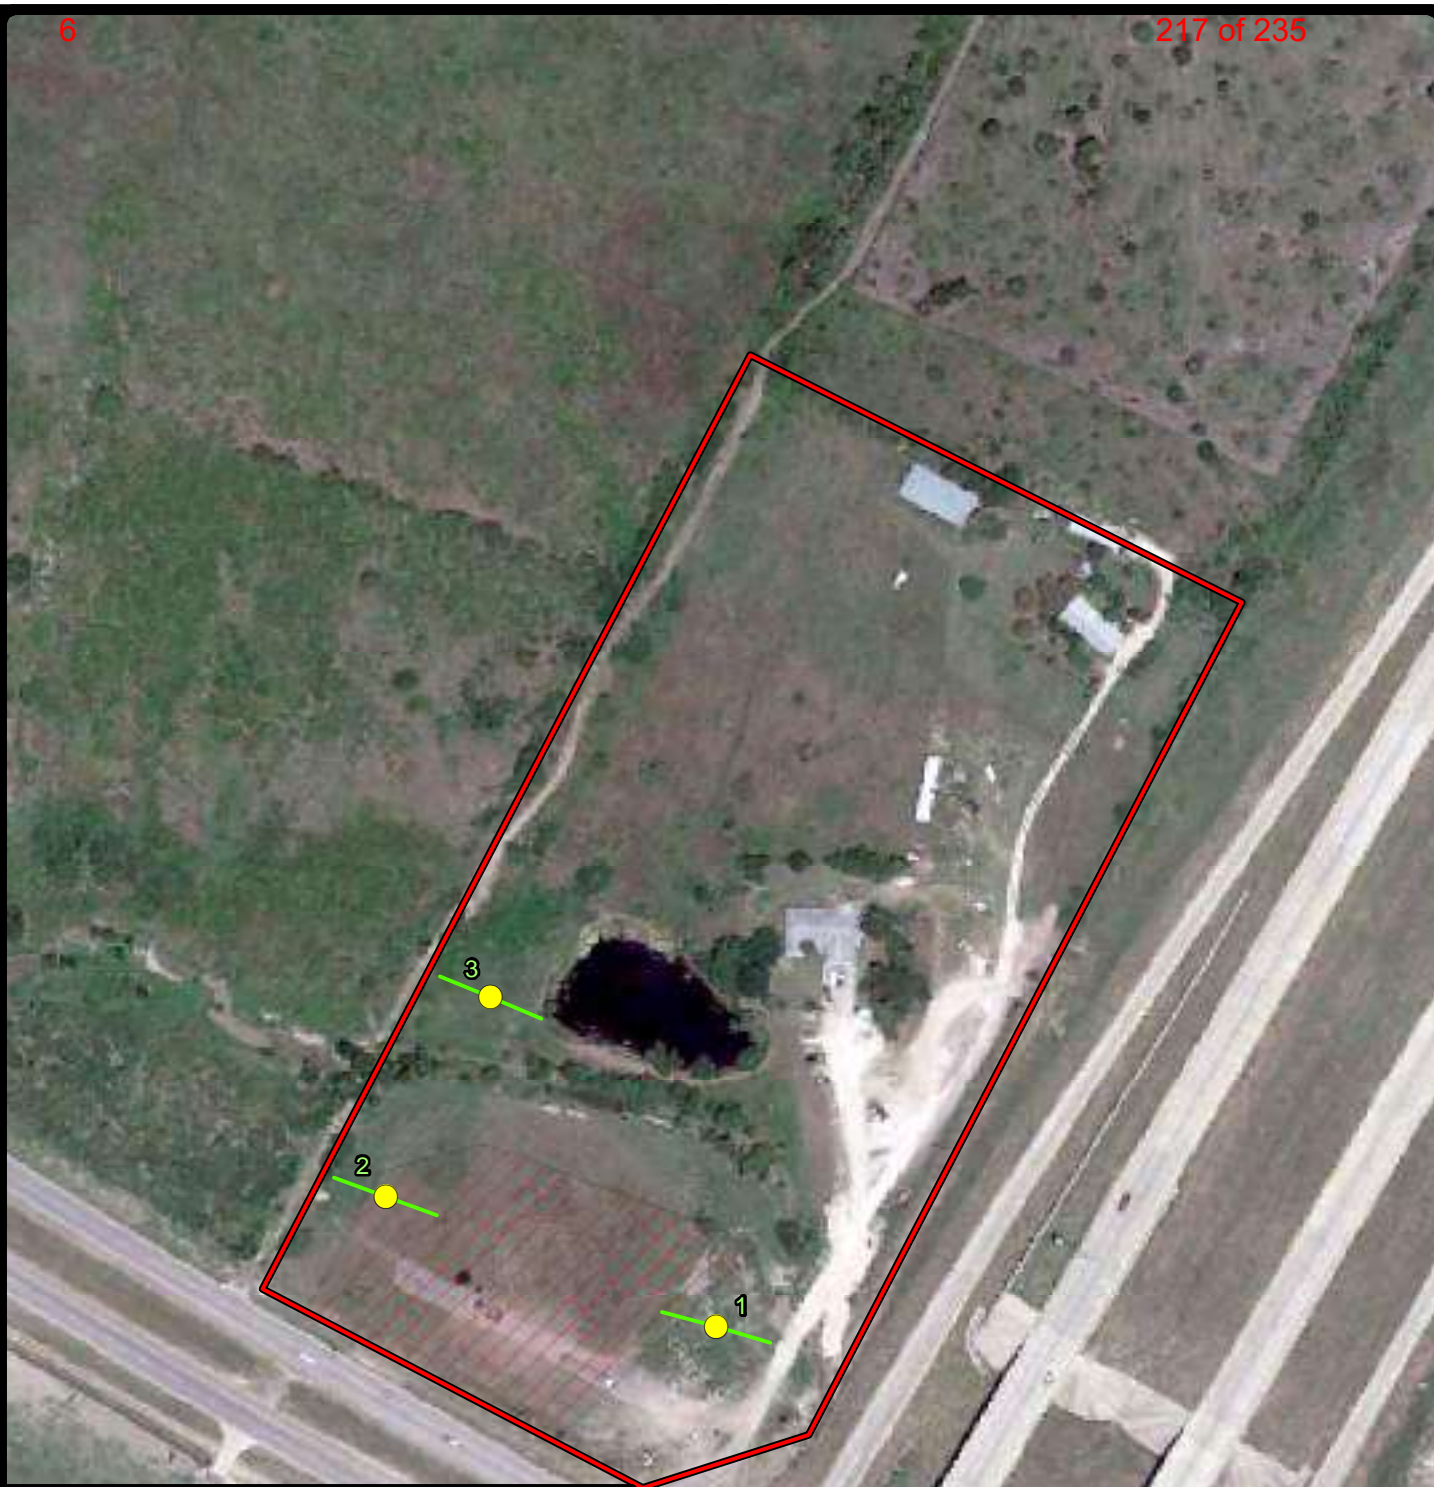
EXHIBIT 3

2015 Historical Aerial Photograph Map

*Three 33-meter transect segments were used in place of a standard 100-meter transect because the project site did not contain an appropriate 100-meter linear representative area due to the previously constructed unpermitted parking area.

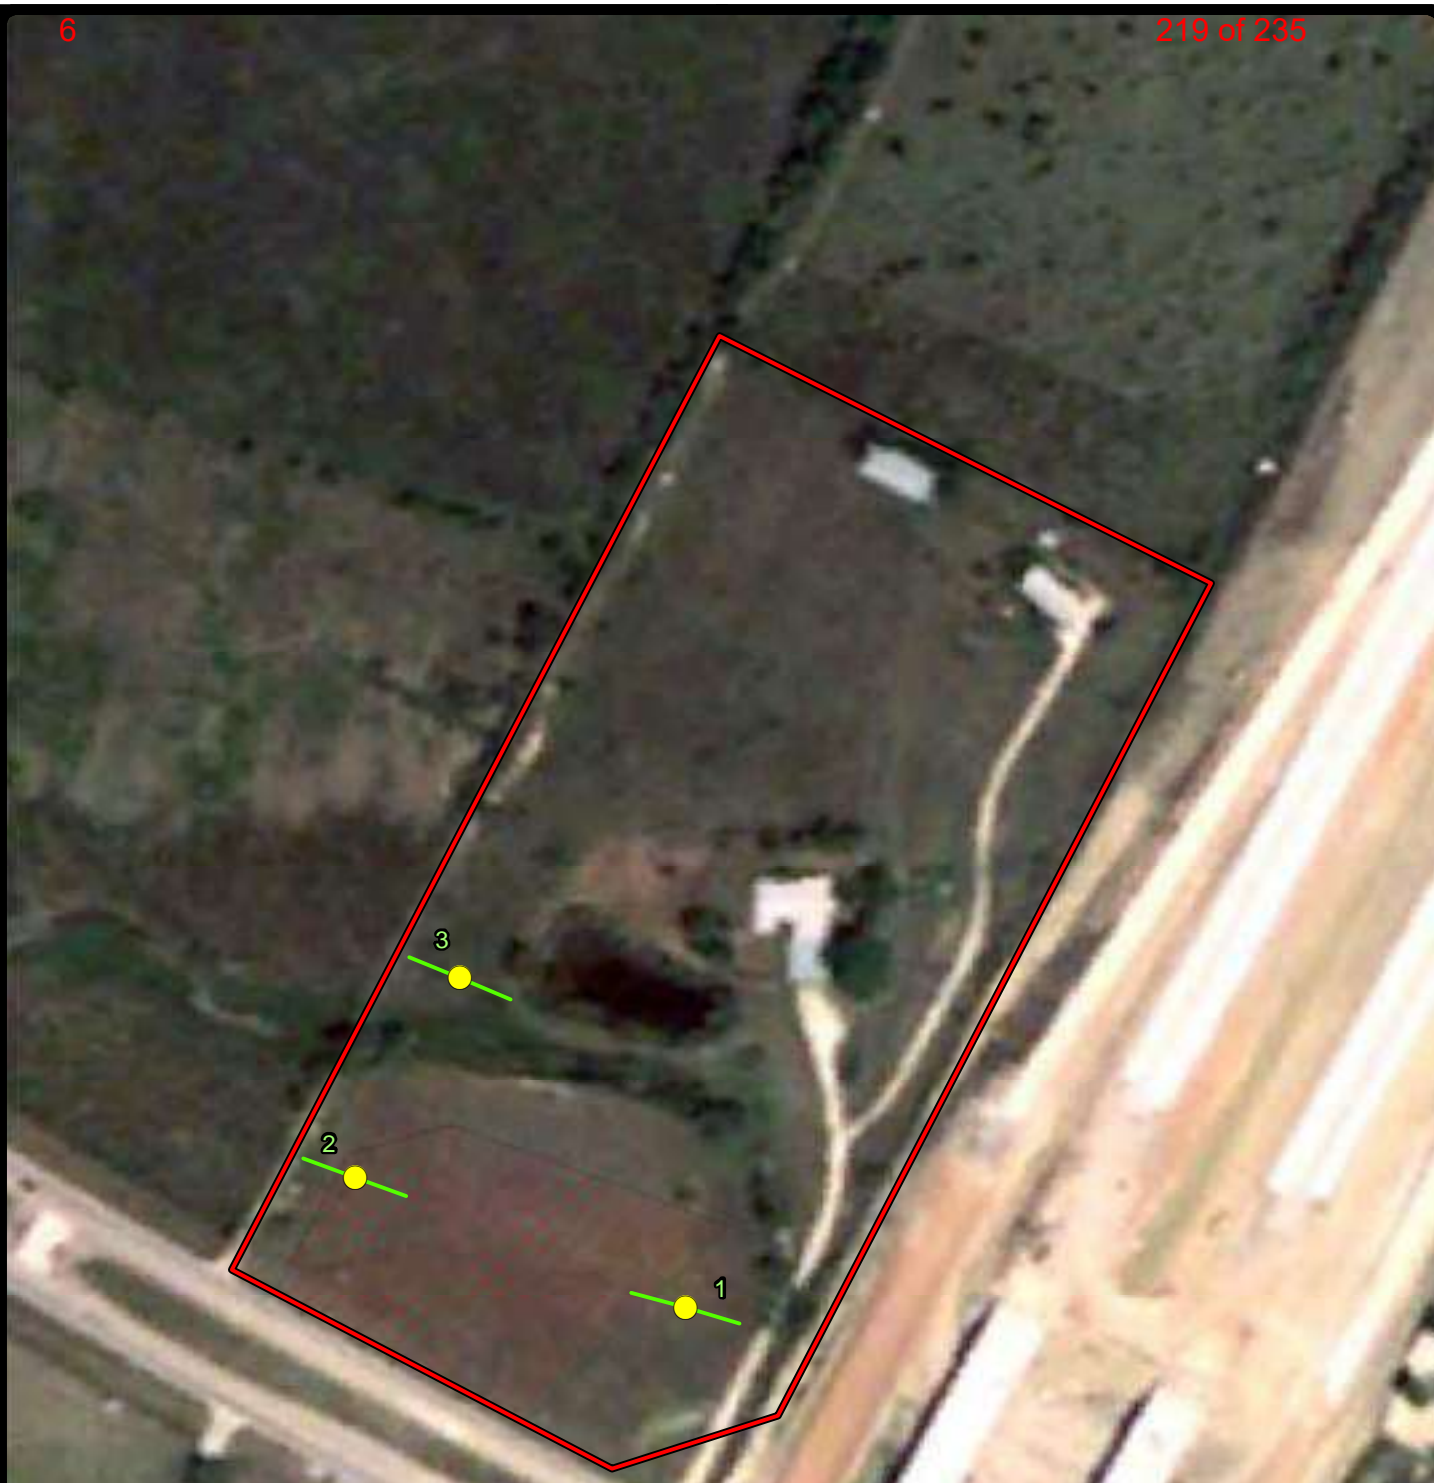
EXHIBIT 4

2005 Historical Aerial Photograph Map

*Three 33-meter transect segments were used in place of a standard 100-meter transect because the project site did not contain an appropriate 100-meter linear representative area due to the previously constructed unpermitted parking area.

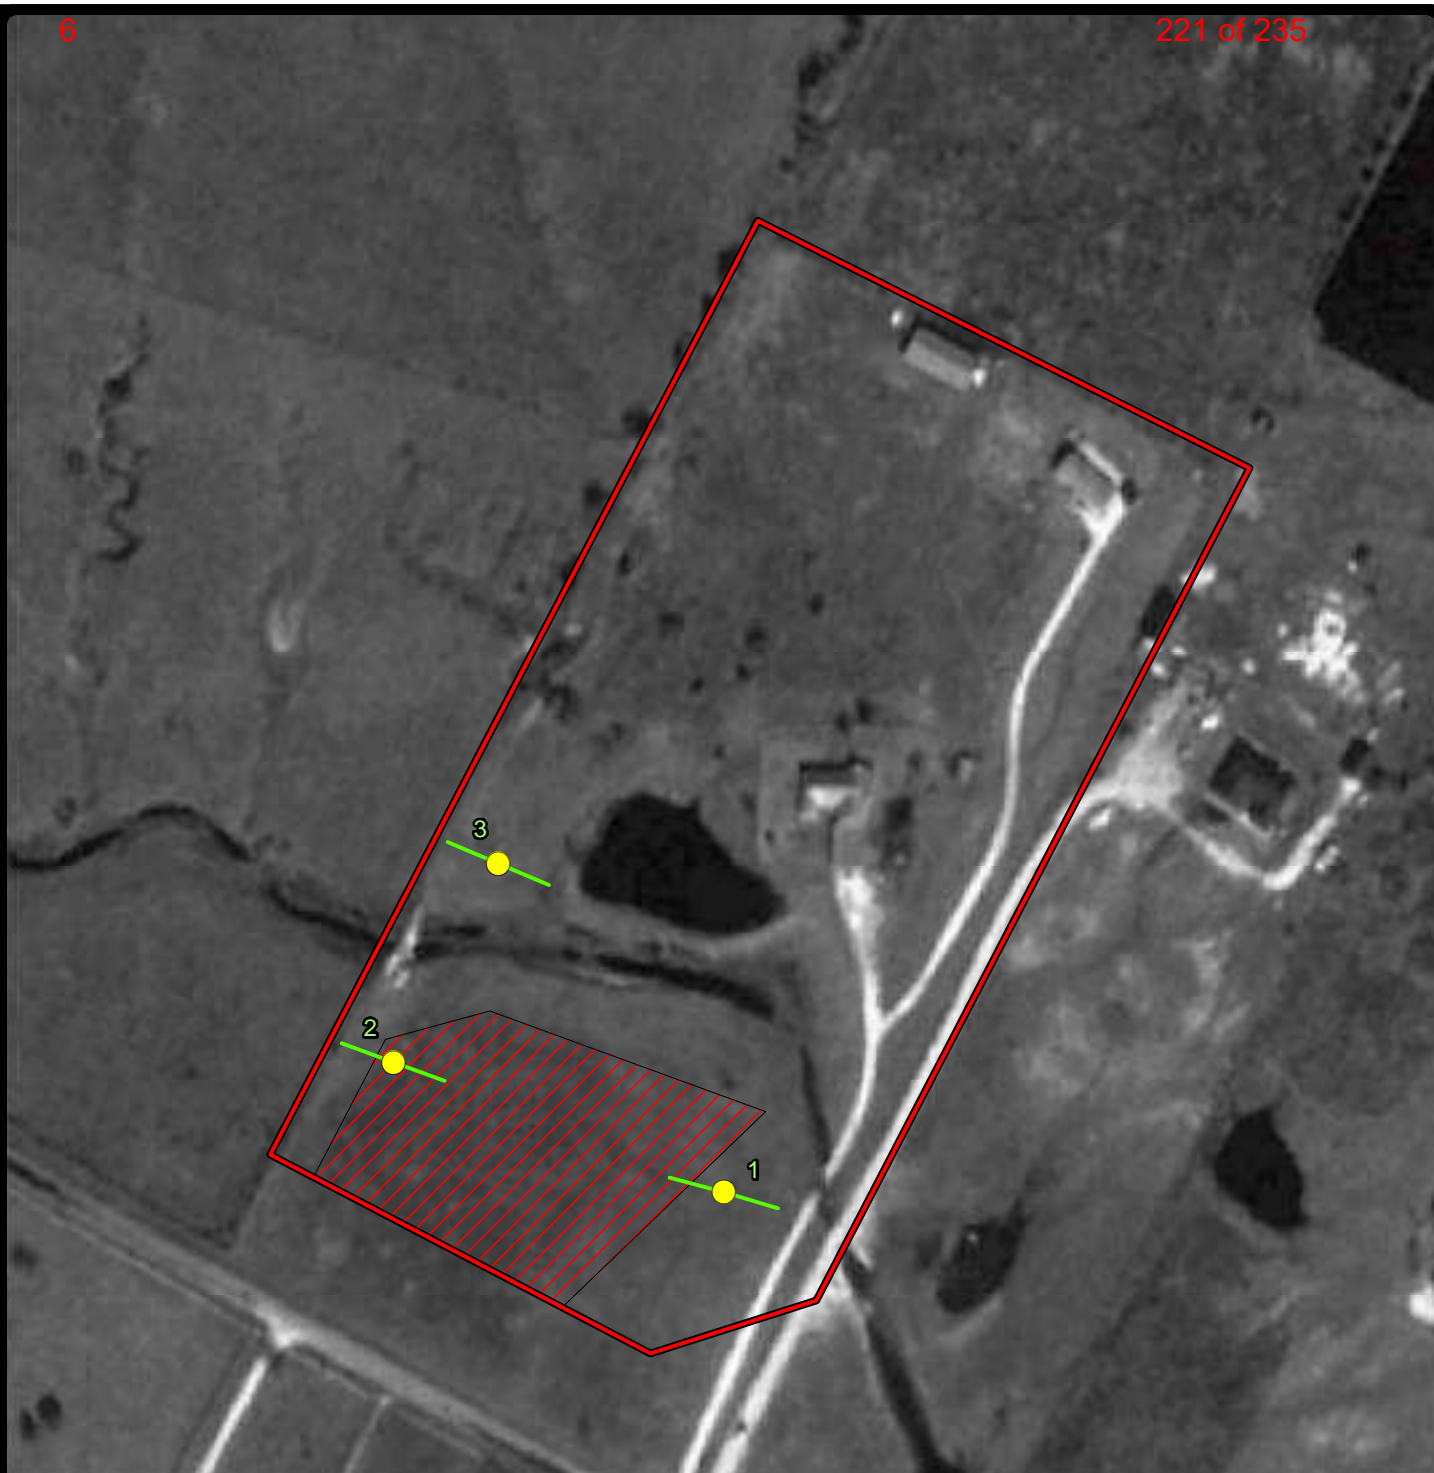
EXHIBIT 5

1995 Historical Aerial Photograph Map

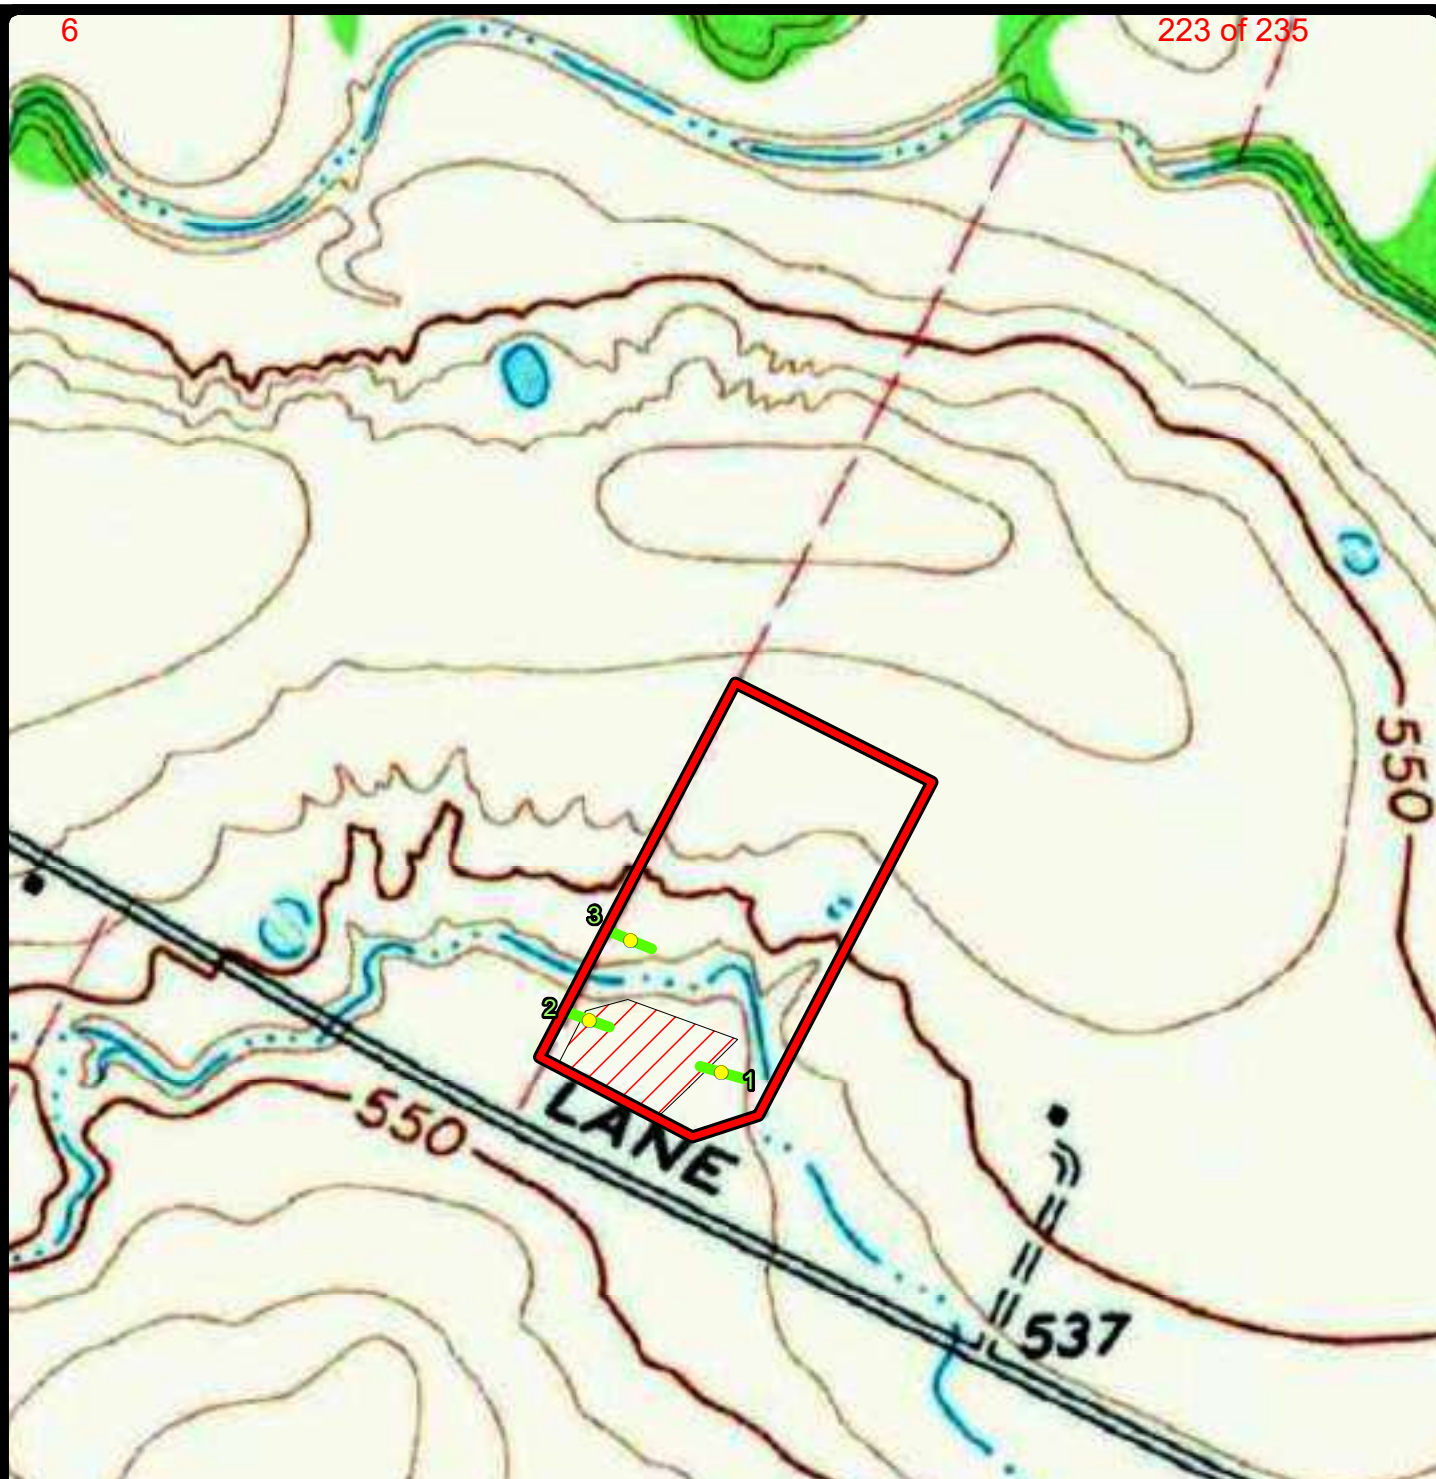
EXHIBIT 6

1968 Historical Topographic Map

- Project Site
- Proposed Grading Area
- 100-square-meter Sample Plot Location
- 33-meter Transect Segment*

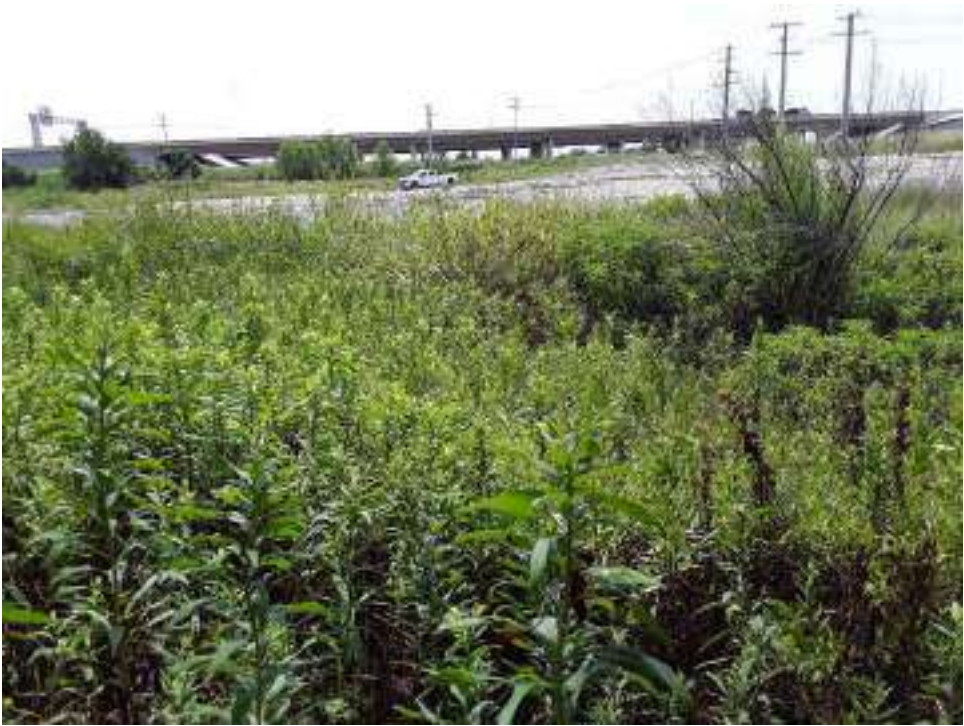
Photo No. 3	Date: 07-20-2021	<div data-bbox="203 331 483 525"> Description: A view of the vegetation found on either side of the creek with the unpermitted parking lot visible in the background. </div>

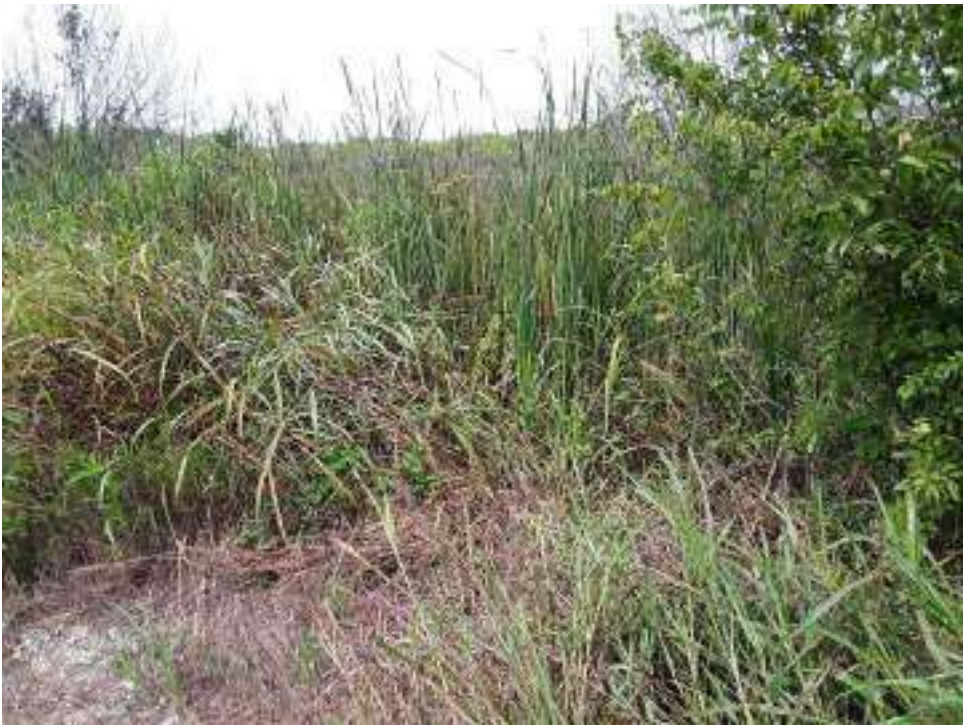
Photo No. 4	Date: 07-20-2021	<div data-bbox="203 1146 483 1339"> Description: A view the vegetation present from the northern representative transect segment, facing south, towards the creek. </div>
