Mold Assessment Summary

Client Name **Ilia Belov**
Project Address **2003 Canterbury Street ~ Austin, TX 78702**
Date of Inspection **November 21, 2022**
Scope **Entire Structure**

Mold Inspection Report

2003 Canterbury Street ~ Austin, TX 78702

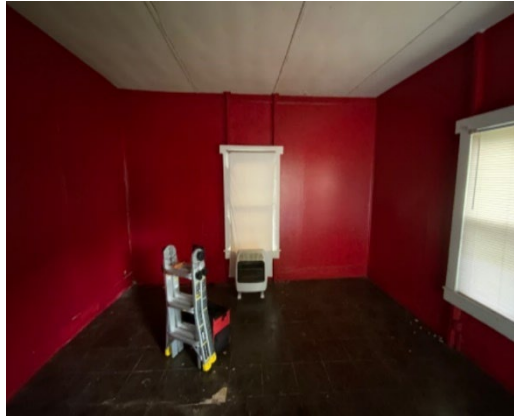
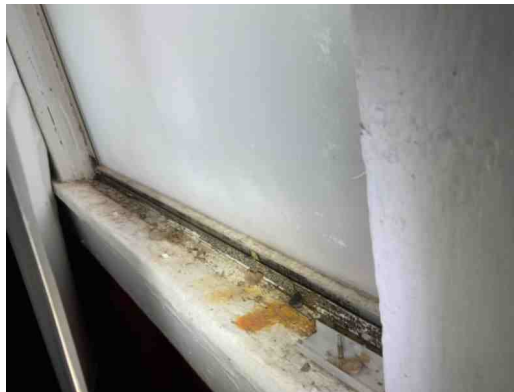
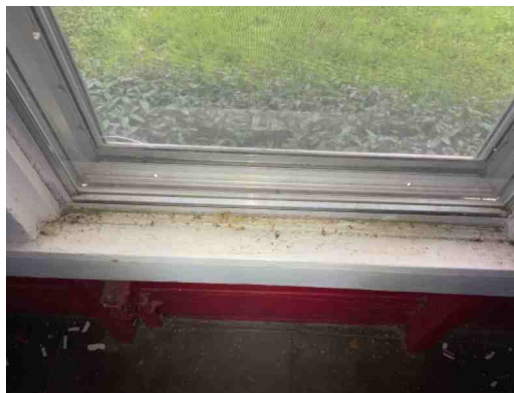
Water damage and/or staining was observed on windowsill and/or around and/or below window.

This condition may indicate a moisture problem that could lead to microbial growth.

Moisture Content: **Dry**

Humidity this area: **72%**

Suspected
source(s)/cause(s):
**Exterior Leak around
window and/or
condensation**

*** Humidity level for this area
is above the ASHRAE
recommended level for
habitable spaces. Preferable
level is between 30% and 60%.**

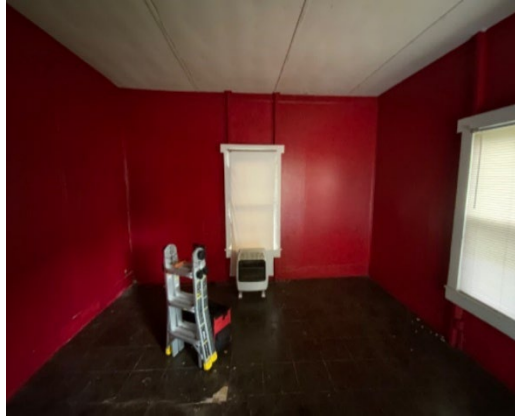
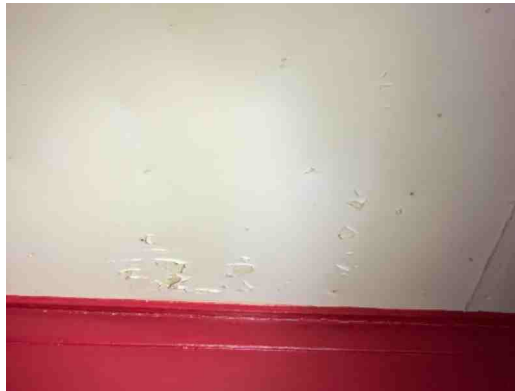
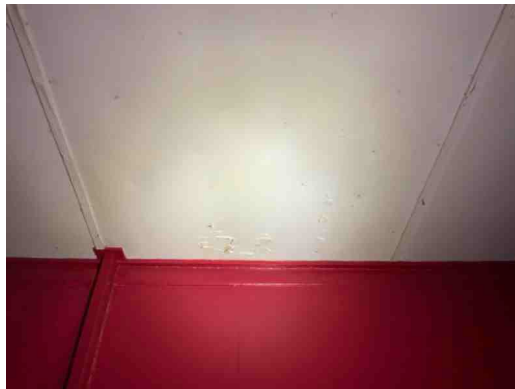
Staining or visible signs of water damage was/were observed in this area.

This condition may indicate a moisture intrusion problem. Moisture can lead to microbial growth.

Moisture Content: **Dry**

Humidity this area: **72%**

Suspected
source(s)/cause(s):
Exterior Roof leak

*** Humidity level for this area is above the ASHRAE recommended level for habitable spaces. Preferable level is between 30% and 60%.**

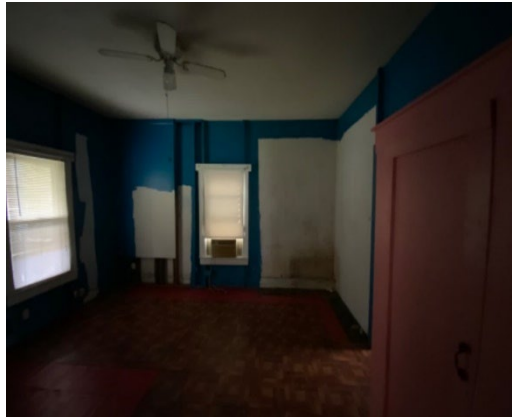
**PRIMARY BEDROOM
[NORTH] [MS-5]**

**Suspect mold growth was
observed in this area.**

Surface sample analysis can confirm
the presence of mold and determine
what type(s) of mold is/are growing
on the material.

Moisture Content: **Dry**

Humidity this area: **76%**

Suspected
source(s)/cause(s):
Exterior siding

*** Humidity level for this area
is above the ASHRAE
recommended level for
habitable spaces. Preferable
level is between 30% and 60%.**

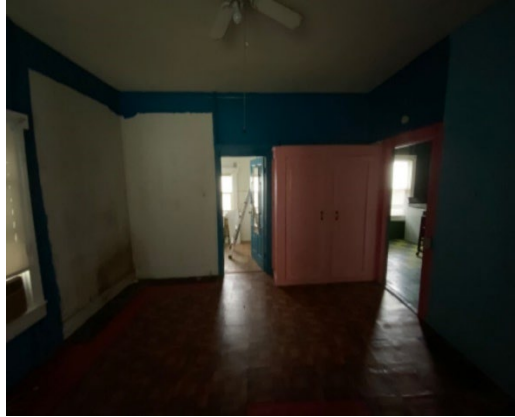
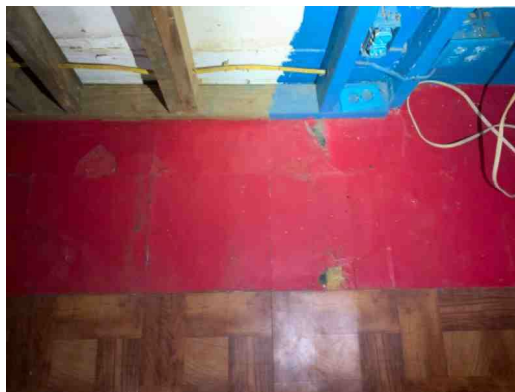
**PRIMARY BEDROOM
[NORTH] [MS-7]**

Stained and/or water damaged flooring was observed in this area.

This condition is an indicator of a past or present water/moisture problem. Moisture on/under floors can lead to microbial growth.

Moisture Content: **Dry**

Humidity this area: **76%**

Suspected
source(s)/cause(s):
Exterior siding

*** Humidity level for this area is above the ASHRAE recommended level for habitable spaces. Preferable level is between 30% and 60%.**

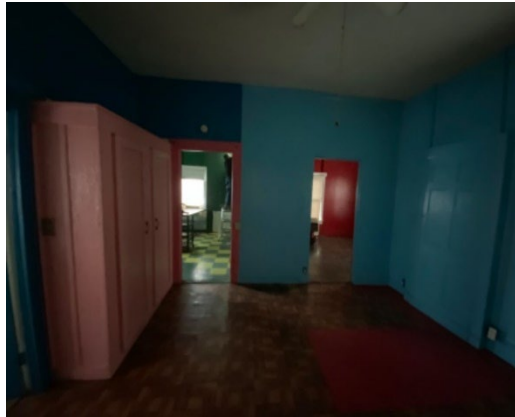
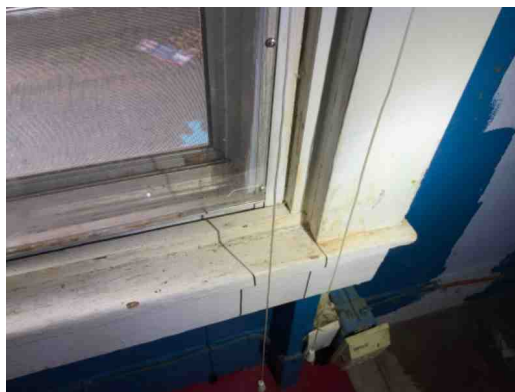
**PRIMARY BEDROOM
[NORTH] [MS-8]**

Water damage and/or staining was observed on windowsill and/or around and/or below window.

This condition may indicate a moisture problem that could lead to microbial growth.

Moisture Content: **Dry**

Humidity this area: **76%**

Suspected
source(s)/cause(s):
**Exterior Leak around
window and/or
condensation**

*** Humidity level for this area
is above the ASHRAE
recommended level for
habitable spaces. Preferable
level is between 30% and 60%.**

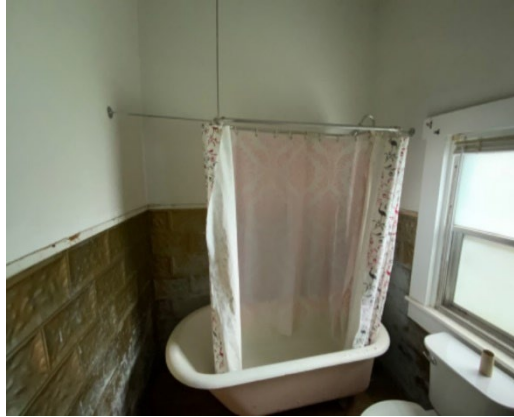
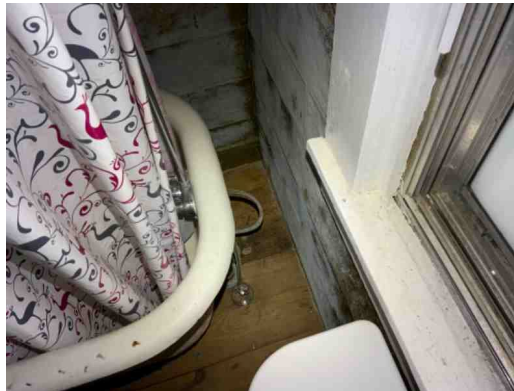
Stained and/or water damaged flooring was observed in this area.

This condition is an indicator of a past or present water/moisture problem. Moisture on/under floors can lead to microbial growth.

Moisture Content: **Dry**

Humidity this area: **77%**

Suspected
source(s)/cause(s):
Plumbing leak

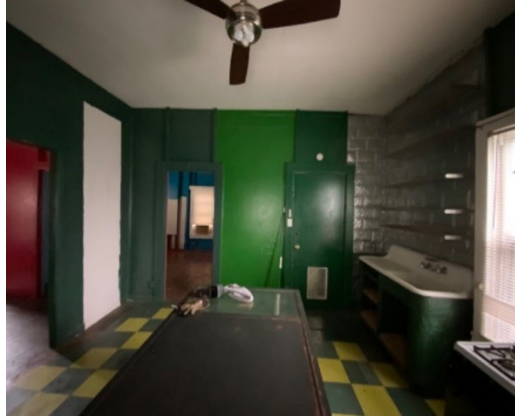
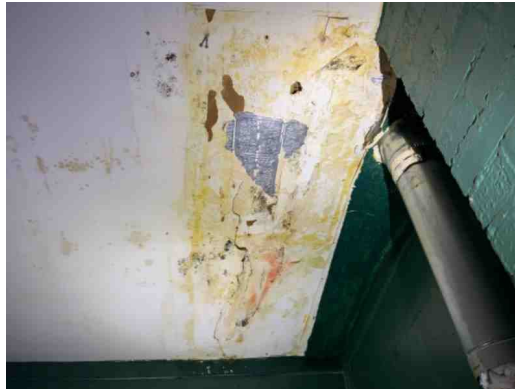
Suspect mold growth was observed in this area.

Surface sample analysis can confirm the presence of mold and determine what type(s) of mold is/are growing on the material.

Moisture Content: **Dry**

Humidity this area: **76%**

Suspected
source(s)/cause(s):
Exterior Roof leak

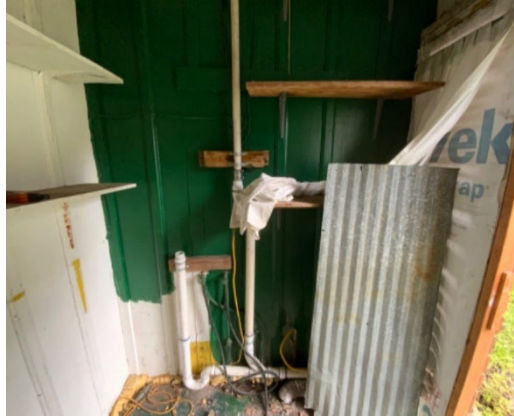
**LAUNDRY ROOM
[NORTH] [MS-12]**

**Actively wet building materials
present in this area.**

This condition indicates an active
water intrusion issue.

Moisture Content: **Wet**

Humidity this area: **80%**

Suspected
source(s)/cause(s):
Exterior Roof leak

NOTICE: All wet materials should
be dried out within 24-48 hours to
prevent mold growth.

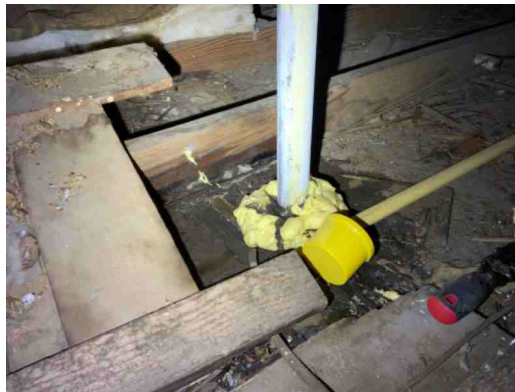
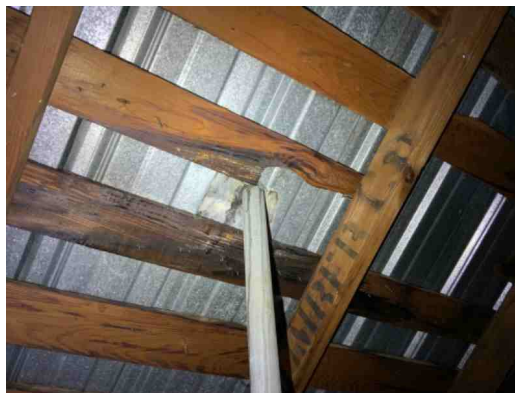
Actively wet building materials were observed under the structure.

Wet building materials within a structure provide a perfect environment for microbial growth.

Moisture Content: **Wet**

Humidity this area: **66%**

Suspected
source(s)/cause(s):
**Exterior Gutter or roof
drain leak**

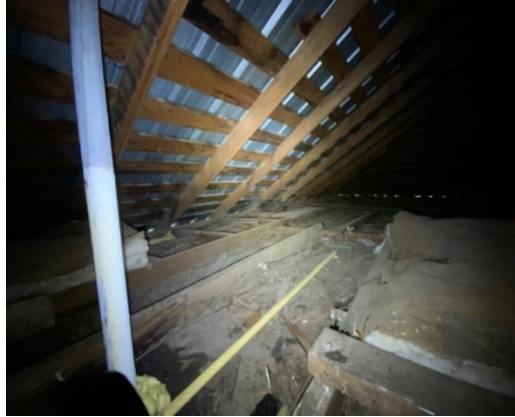
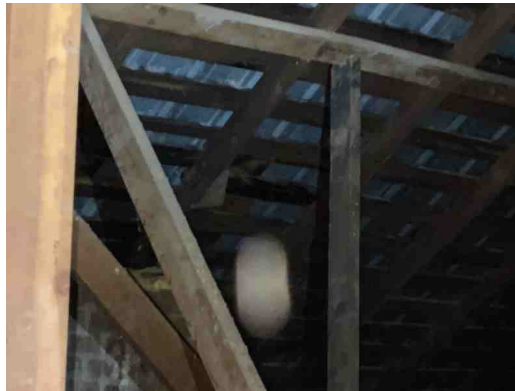
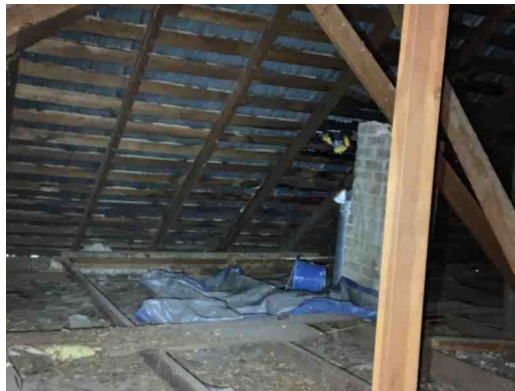
This condition indicates an active water intrusion issue.

Moisture Content: **Wet**

Humidity this area: **66%**

Area Affected: **12 SF**

Suspected
source(s)/cause(s):
Exterior Roof leak

NOTICE: All wet materials should be dried out within 24-48 hours to prevent mold growth.

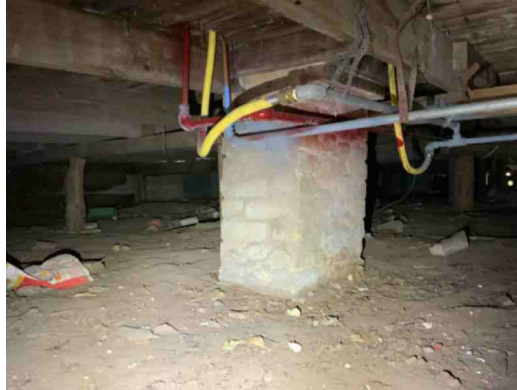
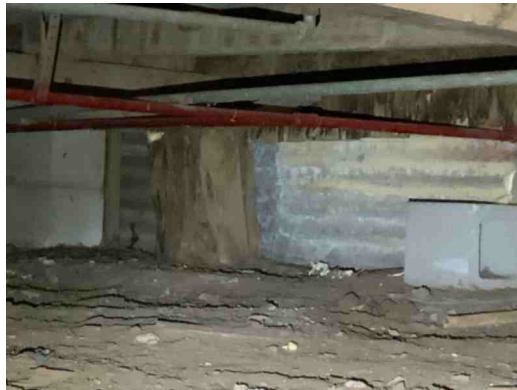
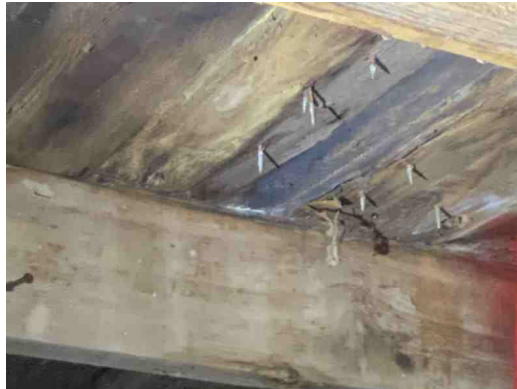
**CRAWLSPACE [NORTH]
[MS-15]**

**Suspect mold growth was
observed in this area.**

Surface sample analysis can confirm
the presence of mold and determine
what type(s) of mold is/are growing
on the material.

Moisture Content: **Dry**

Humidity this area: **72%**

Area Affected: **1 SF**

Suspected
source(s)/cause(s):
Condensation

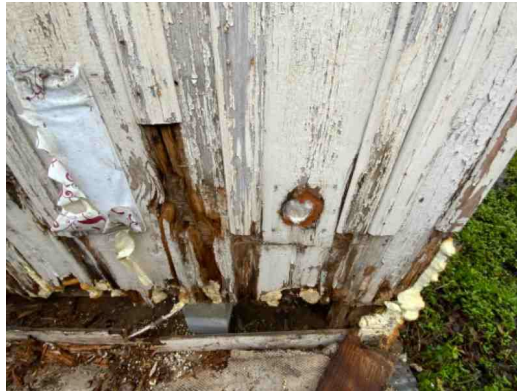
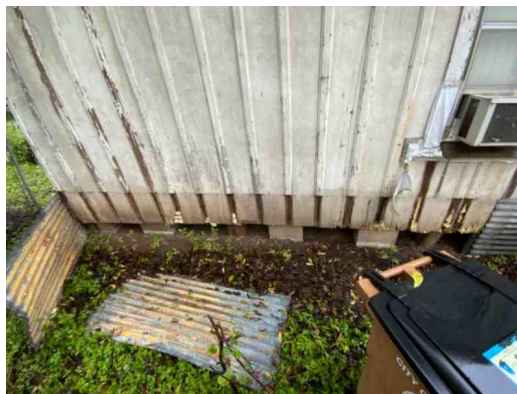
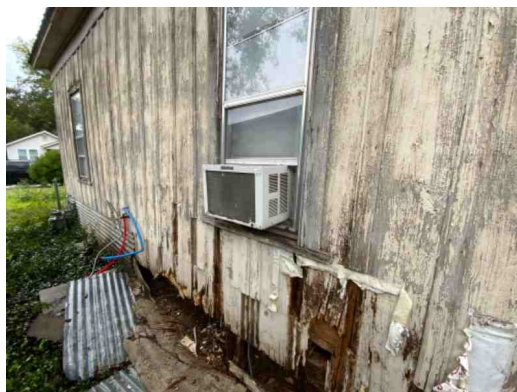
EXTERIOR [NORTH] [PM-1]

Splitting/bowing, water damaged and/or deteriorated siding materials were observed on exterior walls.

This condition can allow water to infiltrate the interior of the structure and lead to excessive moisture and microbial growth.

Consider contacting a licensed contractor to assess the condition of the siding materials on the exterior walls.

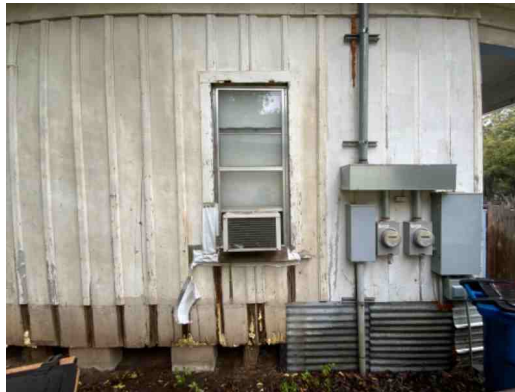
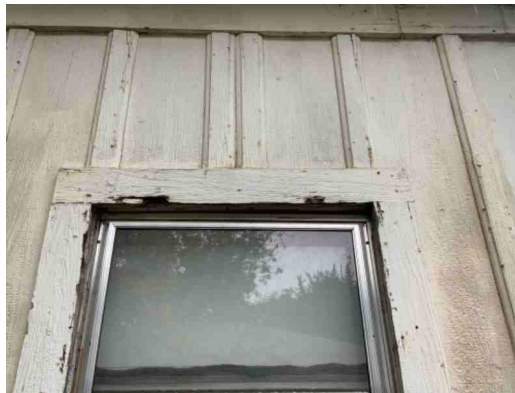
EXTERIOR [NORTH] [PM-3]

Damaged window frames was/were observed.

Windows should be properly sealed to prevent water from entering the living spaces of a structure. Excessive water in a structure's building materials can lead to microbial growth.

This issue was noted for preventative maintenance purposes. Consider consulting a licensed contractor for evaluation and correction or repair.

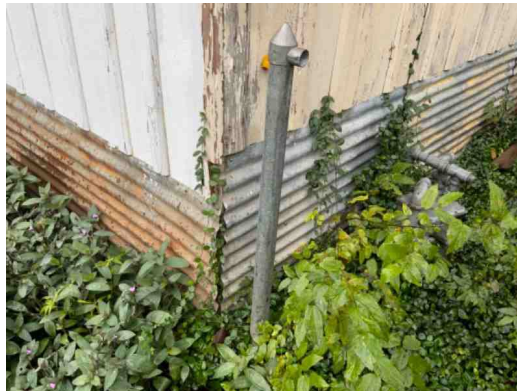
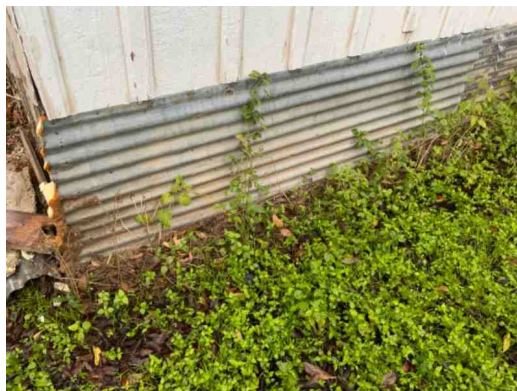
EXTERIOR [NORTH] [PM-4]

Plants/trees are coming into contact with the roof/walls.

Plants/trees excrete enzymes that can deteriorate building materials. In addition, they can trap water against the structure. This can create an environment conducive to microbial growth.

Consider trimming back trees/plants and removing any plants growing directly on the exterior.

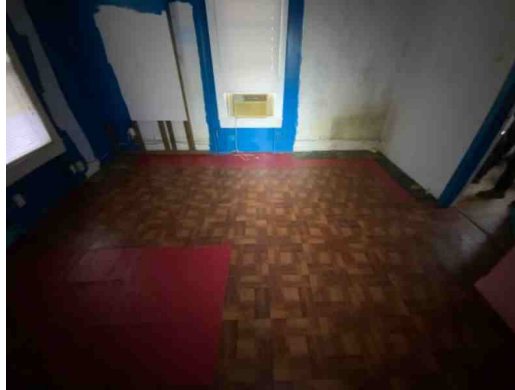
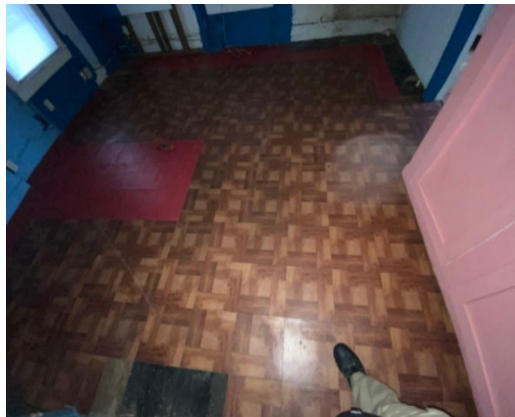
PRIMARY BEDROOM [NORTH] [PM-5]

**Floor appears to be sloped
and/or uneven.**

Sloping and/or uneven floors may be an indication of a subterranean moisture problem that could compromise the structure and provide an environment for microbial growth.

Moisture Content: **Dry**

Humidity this area: **76%**

Suspected
source(s)/cause(s):
Floor joists

This issue was noted for preventative maintenance purposes. Consider consulting a licensed contractor for evaluation and correction or repair.
